JOINT USER COMPLEX AND WHOLESALE FISH MARKET AT AREA 44, TUEN MUN

SIXTH QUARTERLY ENVIRONMENTAL MONITORING & AUDIT REPORT (NOVEMBER 2009 – JANUARY 2010)

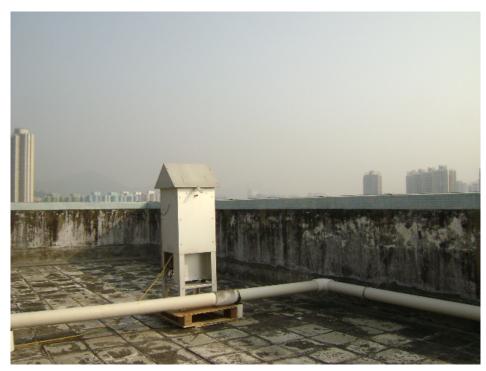
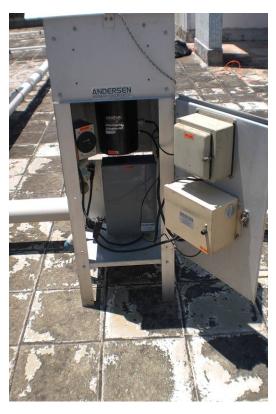
| JOINT USER COMPLEX AND WHOLESALE FISH MARKET AT AREA 44, TUEN MUN Photos of Air Quality Monitoring Station | Figure No. 4 | Rev.: 0 | 6 |

Roof top of Block 15, Yuet Wu Villa

High-Volume Dust Sampler

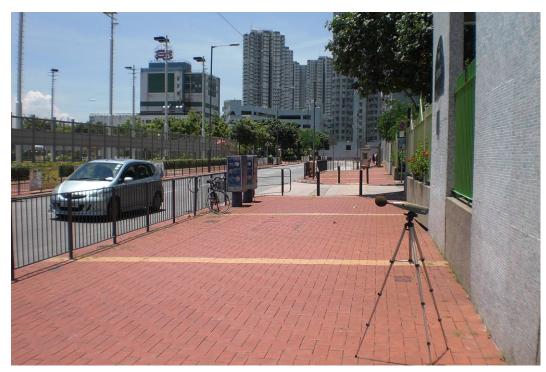
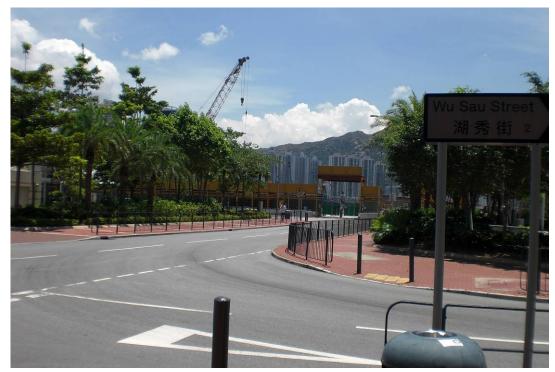
| JOINT USER COMPLEX AND WHOLESALE FISH MARKET AT AREA 44, TUEN MUN Photos of Noise Monitoring Station | Figure No. 5 | Rev.: O | 6 |

Noise monitoring station

View from the noise monitoring station
