JOINT USER COMPLEX AND WHOLESALE FISH MARKET AT AREA 44, TUEN MUN

NINTH QUARTERLY ENVIRONMENTAL MONITORING & AUDIT REPORT (AUGUST 2010 – OCTOBER 2010)

ALLIED ENVIRONMENTAL CONSULTANTS LTD.

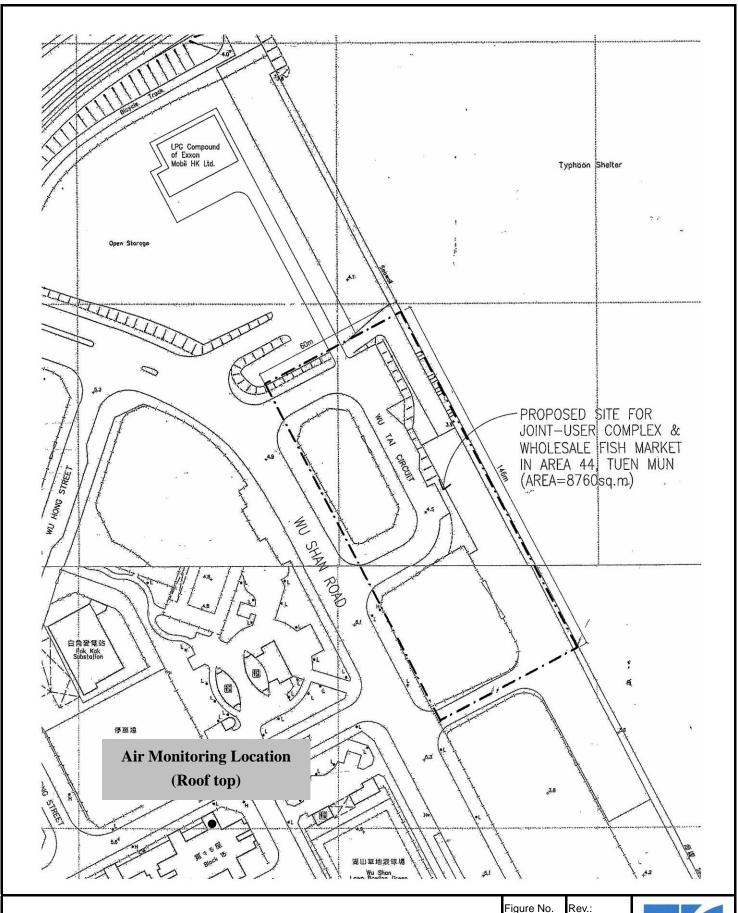
Figure No.	Rev.:
2	0
Scale	Date
NTS	12/10

JOINT USER COMPLEX AND WHOLESALE FISH MARKET AT AREA 44,
TUEN MUN
LOCATION OF AIR QUALITY MONITORING STATION

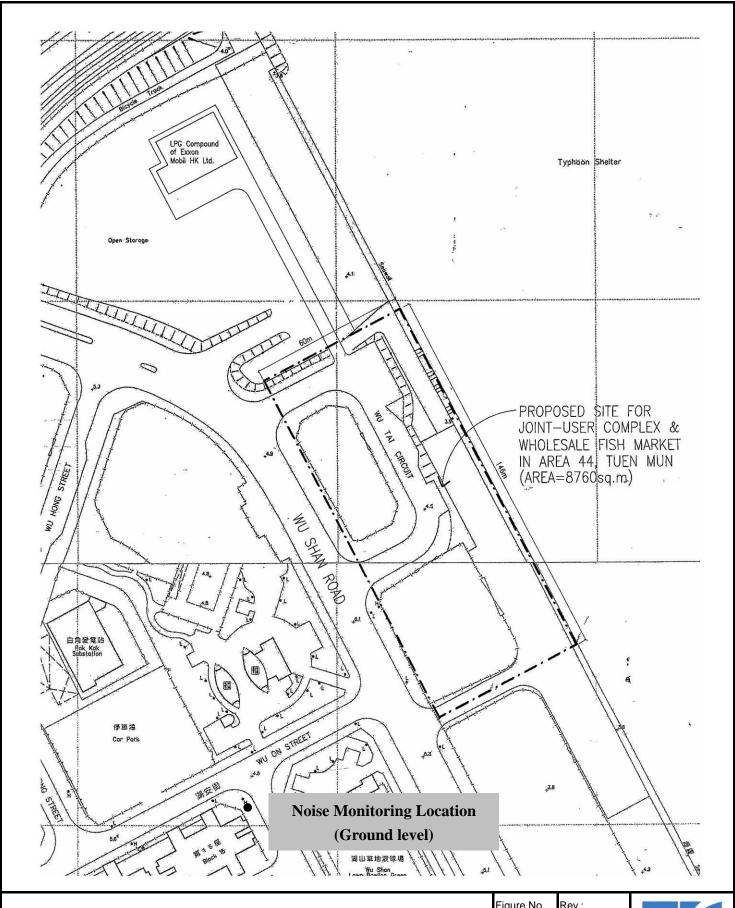
Figure No.	Rev.:
3	0
Scale	Date
NTS	12/10

LOCATION OF NOISE MONITORING STATION

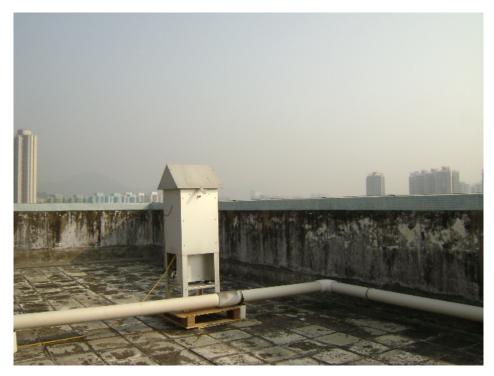
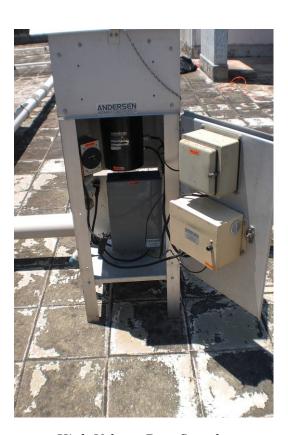
Figure No.	Rev.:
	4	0
1	Caala	_
	Scale	Date
	NTS	8/10

Roof top of Block 15, Yuet Wu Villa

High-Volume Dust Sampler

PHOTOS OF AIR QUALITY MONITORING STATION

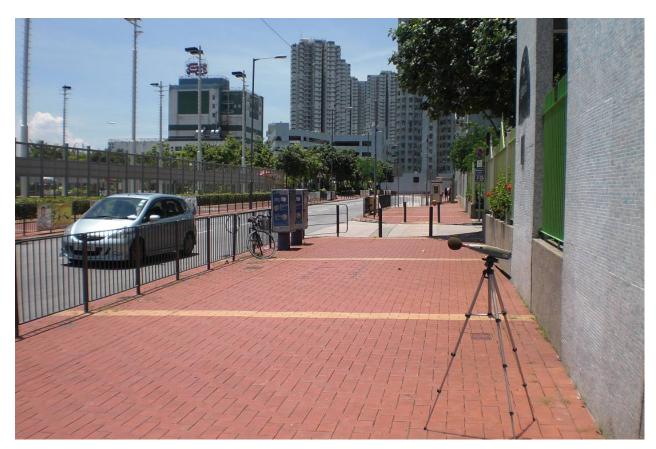
Figure No.	Rev.:
	5	0
- 1		
	Scale	Date
	Scale NTS	Date 12/10

Noise monitoring station

PHOTOS OF NOISE MONITORING STATION

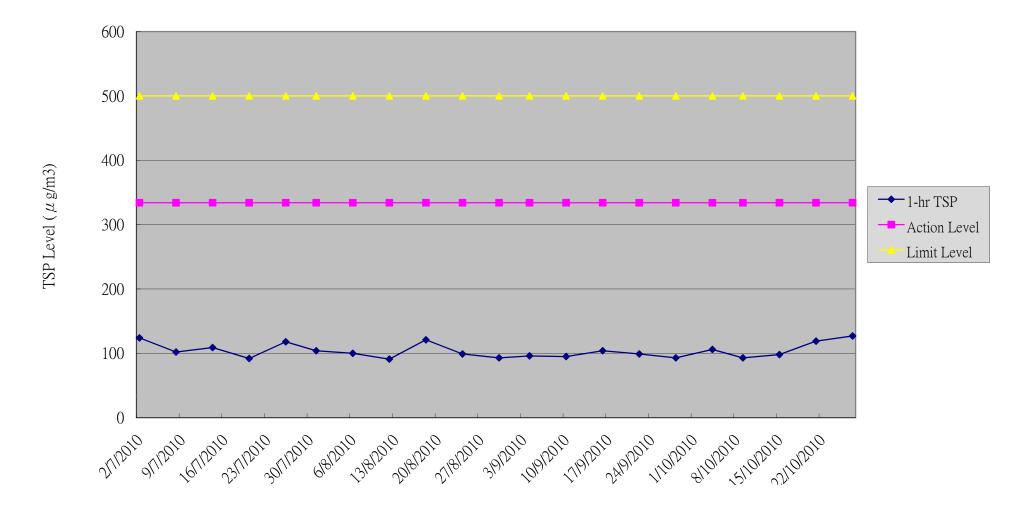
Summary and Graphical Plot of 1-Hour TSP Monitoring Record Impact Monitoring for Fish Market Project in Tuen Mun Air Quality Monitoring: 1-hour TSP Quarter: August 2010 - October 2010

No exceedance was recorded in this quarter. Summary and graphical plots of air quality monitoring record of 1-hour TSP levels and 24-hour TSP levels are provided in Appendices D and E. The weighing of the filter paper used in the monitoring was undertaken by ALS Laboratory Group Environmental Division. (HOKLAS Registration No.: 066)

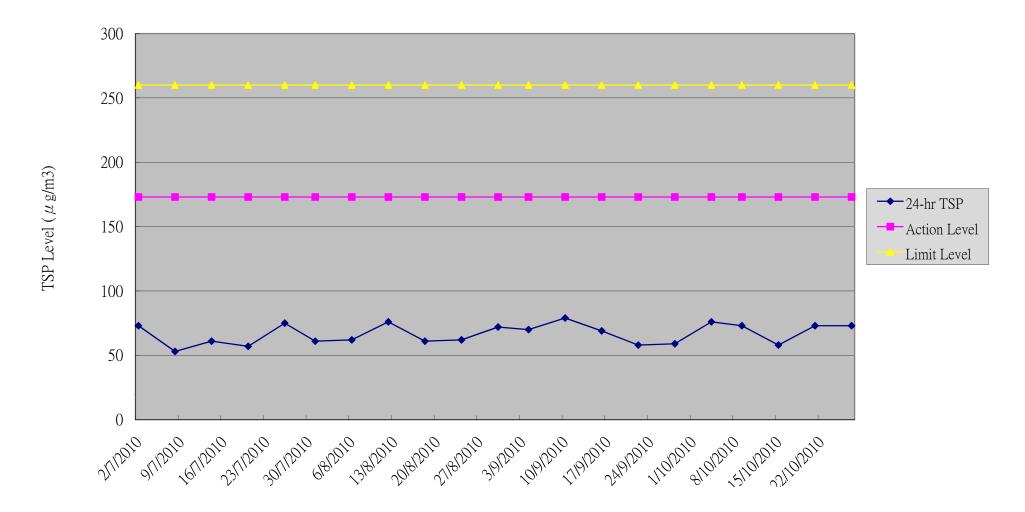
Summary and Graphical Plot of 24-Hour TSP Monitoring Record

Air Quality Monitoring: 24-hour TSP Ouarter: August 2010 - October 2010

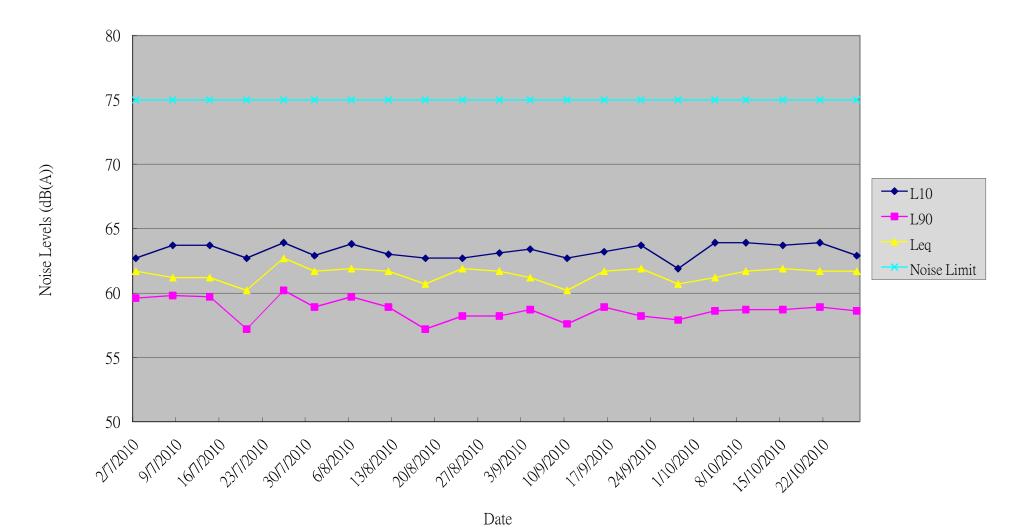
Appendix F
Summary and Graphical Plot of	Noise Monitoring
	Record

Noise monitoring results in terms of  $L_{eq(30min)}$ ,  $L_{10(30min)}$   $L_{90(30min)}$  were measured at the designated noise monitoring location.  $L_{10}$  and  $L_{90}$  represent sound levels that are exceeded 10% and 90% of the time respectively. Normally,  $L_{10}$  measurements can be considered as the average peak levels, whilst  $L_{90}$  levels can be considered as the average background noise levels.

No exceedance was recorded in this quarter. Summary of noise monitoring record is provided in Appendix F.
