Monthly Environmental Monitoring & Auditing report for

Contract No.DC/2009/22

Drainage Improvement in Shuen Wan, Tai Po – Contract 1

April 2011

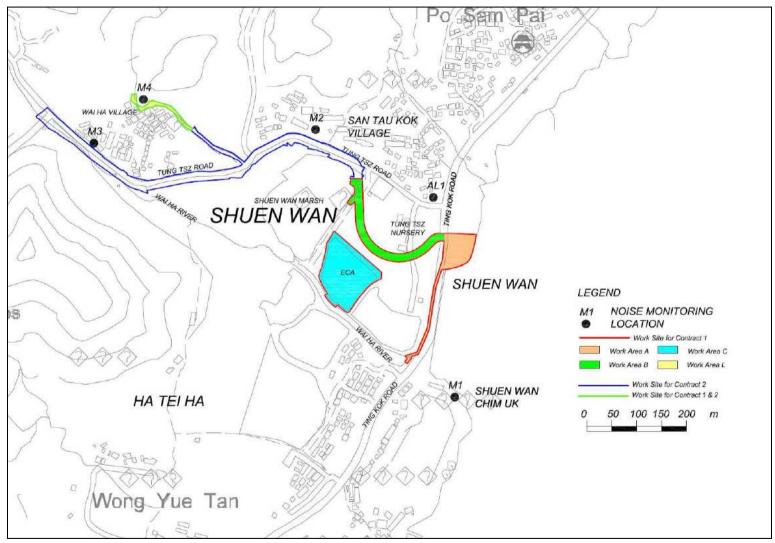
Figure 3.3.1 Impact noise monitoring locations

In accordance with the requirements in the EM&A manual (revision 3), weekly impact monitoring was conducted. For the time period between 0700 and 1900 hours on normal weekdays, and noise parameter of $L_{eq~(30minutes)}$ was measured. As if the construction works were carried out during restricted period (i.e. 1900-2300, 2300-0700 of next day and Sundays / general holiday), impact monitoring that comprises 3 consecutive $L_{eq~(5minutes)}$ would be carried out.

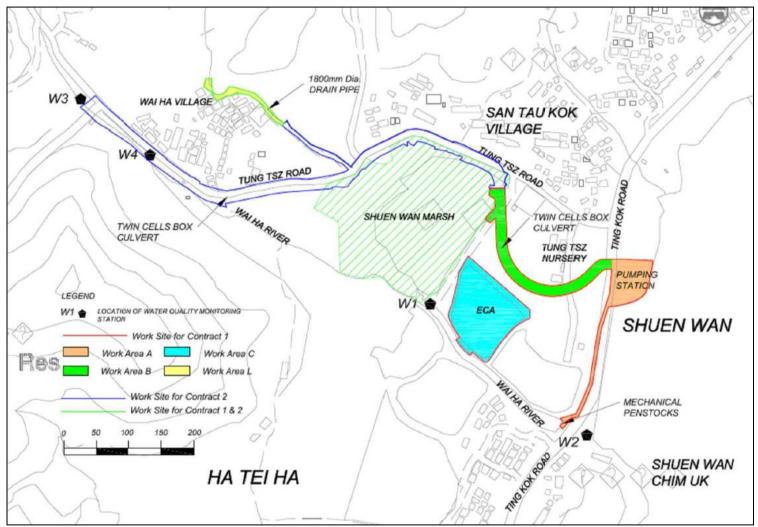
Figure 4.3.1 Water Quality Monitoring Locations

As the depth of water was less than 3m, water samples were collected at mid-depth of each proposed monitoring stations for measurements and sample collection.

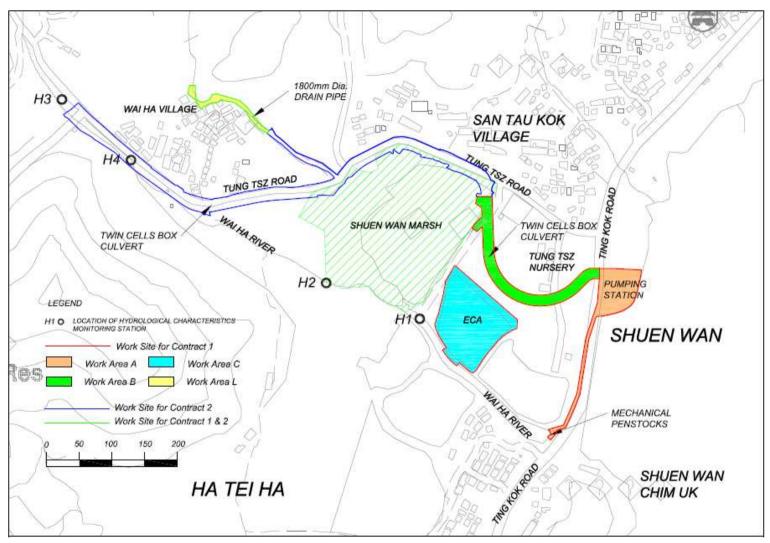
Figure 5.3.1 Hydrological Characteristics Monitoring Locations

As illustrated in Figure 5.3.1, H2 served as the control station while H1 was the monitoring location of hydrological characteristics.

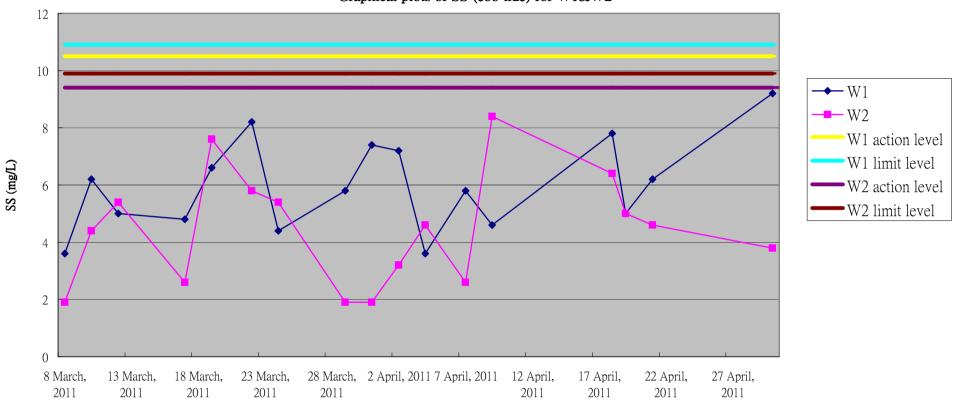
Graphical plots of SS (flood tide) for W1&W2

Remarks: Action limit is 95% of baseline data or 120% of upsteam control station's SS Limit level is 99% of baseline data or 130% of upsteam control station's SS

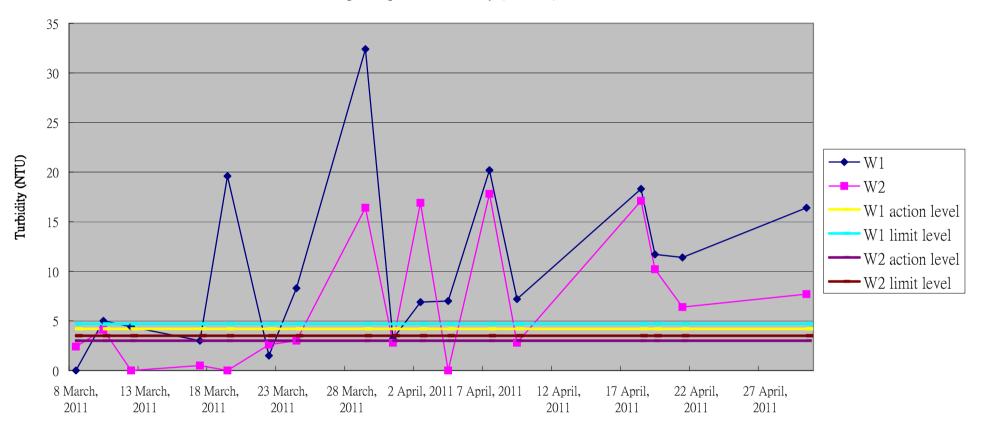
Graphical plots of Turbidity (flood tide) for W1&W2

Remarks: Action limit is 95% of baseline data or 120% of upsteam control station's Turbidity Limit level is 99% of baseline data or 130% of upsteam control station's Turbidity

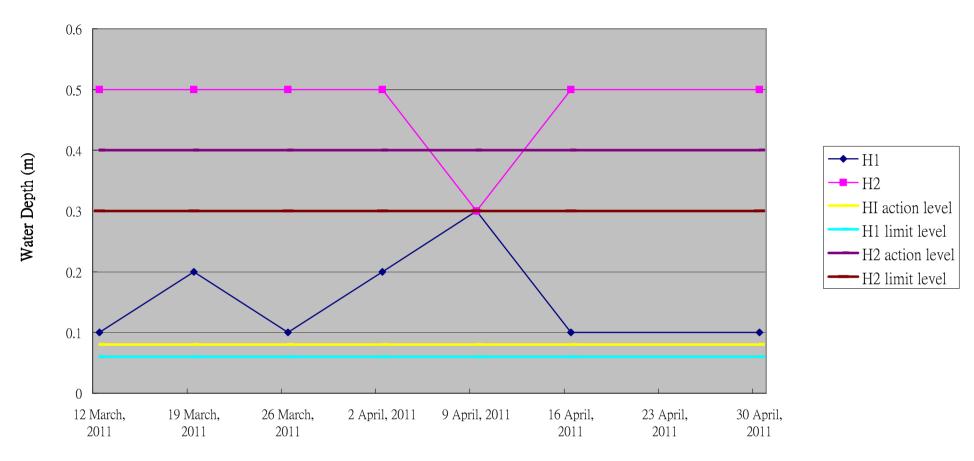
Graphical plots of Hydrological Monitoring(water depth at ebb tide) for H1 & H2

Remarks: Action level: 80% of baseline water depth. Limit level: 60% of baseline water depth.

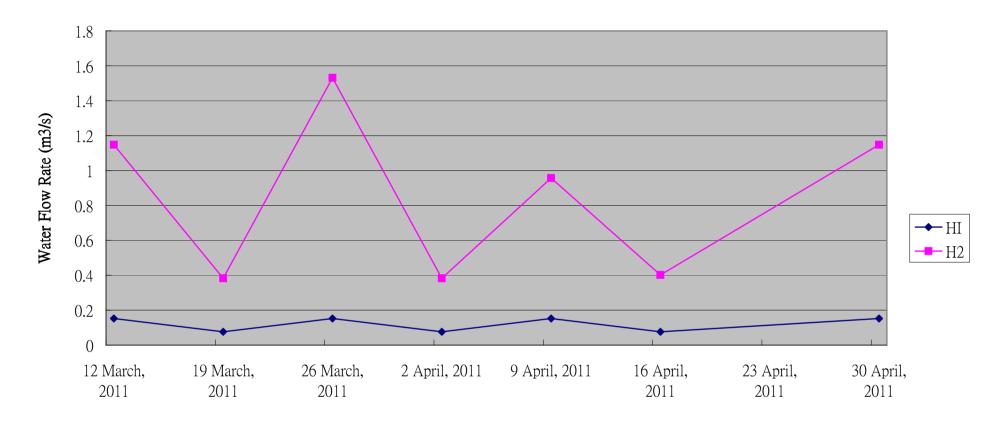
Graphical plots of Hydrological Monitoring(water flow rate at ebb tide) for H1 & H2

Remarks: Action level: 120% of control station's water flow rate on the same day of measurement. Limit level: 140% of control station's water flow rate on the same day of measurement.
