Monthly Environmental Monitoring & Auditing report for

Contract No.DC/2009/22

Drainage Improvement in Shuen Wan, Tai Po – Contract 1

May 2011

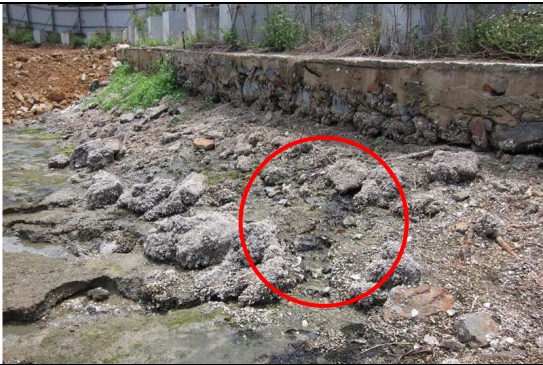
<p>Photo 1- Minor water leakage from the adjacent recreational fish pond is highlighted.</p>	<p>Photo 2 - Large rubbles were observed. These rubbles should be broken or removed.</p>

The contractor should inspect and determine the source of leakage at the eastern pond edge, continue the percolation test at the pond and break/remove the large rubbles from the site.

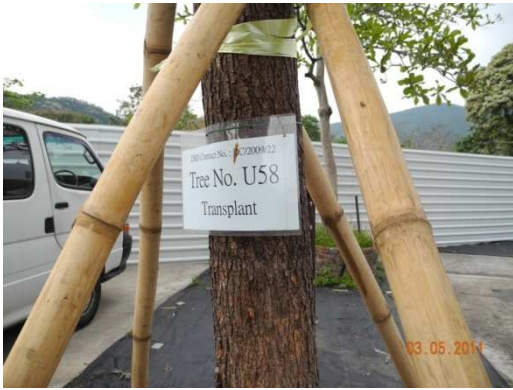
Decline in health condition of Tree No.U58 *Grevillea robusta* was reported in late April. A tree hazard assessment was conducted on 3rd May 2011. Tree defects of defoliation and bleeding were found due to the shock of transplantation. No other significant defects were further reported in May 2011(Photos 7-11).

Photo 7 - Decline of health condition of the transplanted tree no. U58 was reported by the Manager of Tung Tsz Nursery

All transplanted trees should be watered regularly (e.g. at least every two days) by the appointed landscape contractor.
Regular monitoring and watering of *Grevillea robusta* (U58) are recommended.

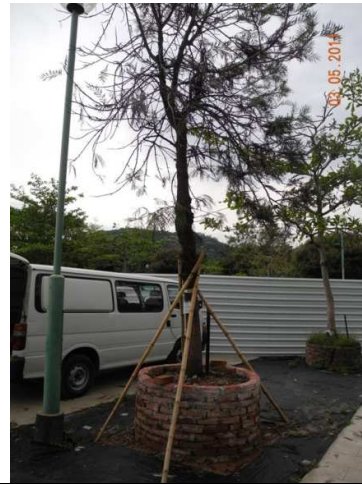
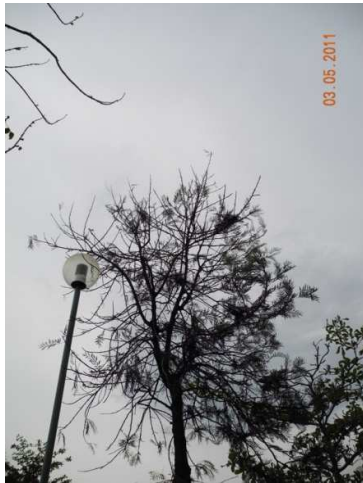
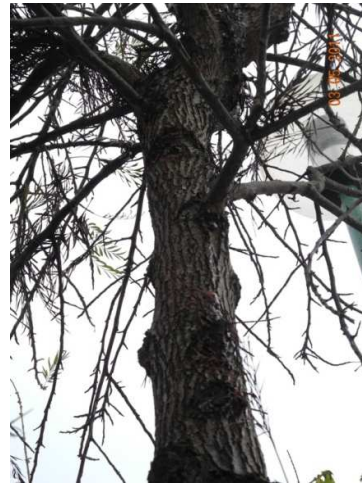
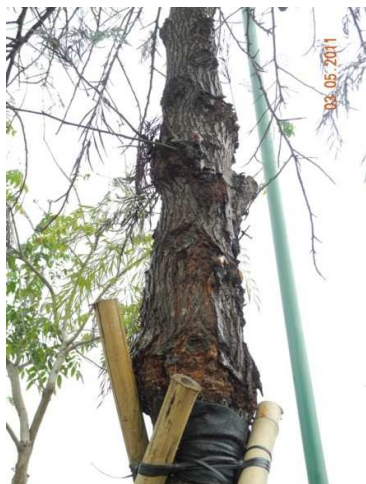
Photo 8 - General view of U58

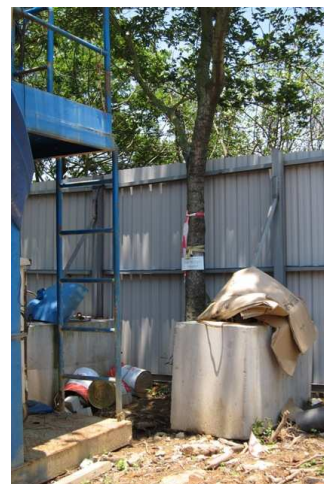
Maintenance of Tree Protection Zones (TPZs) was improved but observation of temporary storage of construction equipment and materials was still made in Area A. Significant signs of damage of existing tree crowns, trunks and roots were not observed in this monthly monitoring. Any observed issues related to the maintenance of existing trees within works areas are highlighted in this section

Photo 12 – No proper Tree Protection Zone (T250 as an example in Area A)

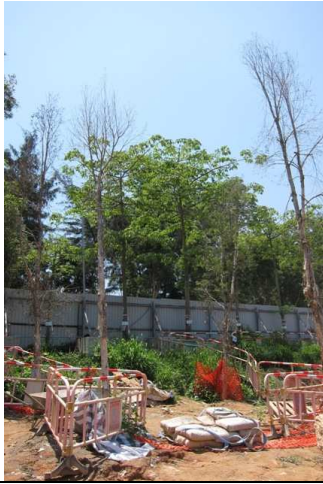
Two *Melaleuca quinquenervia* (E21 and E22) (Photo 20-21), which are proposed to be transplanted, remained in poor health condition as in previous monitoring period (Photo13). As reported in the Monthly EM&A Report for April 2011, poor health condition may due to the transplantation shock and unskillful transplantation practice. Health condition of E22 would be partially affected by the installation of a temporary site office nearby its roots.

Photo 13 - Poor health condition of E21 and E22 in Area A

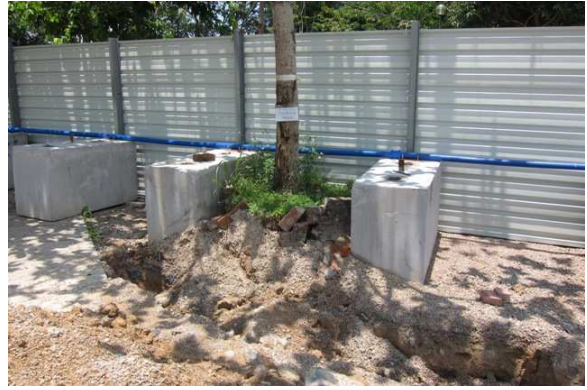
Planter of the transplanted tree *Terminalia catappa* U46 was found broken (**Photo 14**).

Photo 14 - Broken planter of U46 *Terminalia catappa* in Area B

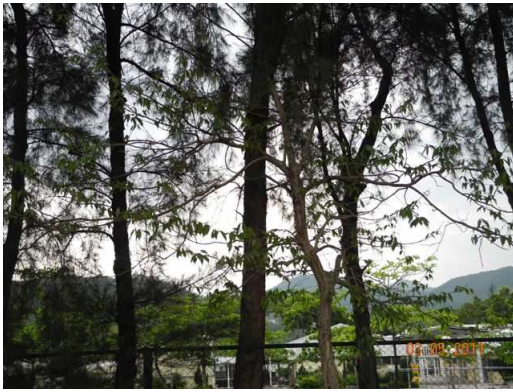
Foliage regeneration in the canopy and vigorous watersprouts development at trunk base were observed on the tree *Lagerstroemia speciosa* (T97) (**Photo 15**) during the inspection in May 2011. Though the canopy has been resumed, the structural condition of this tree has been remained poor due to the presence of decayed wood along trunks and branches, and the suspected internal decay with the sign of vigorous watersprout development.

Photo 15 - Poor health condition of T97 *Lagerstroemia speciosa* in Area B

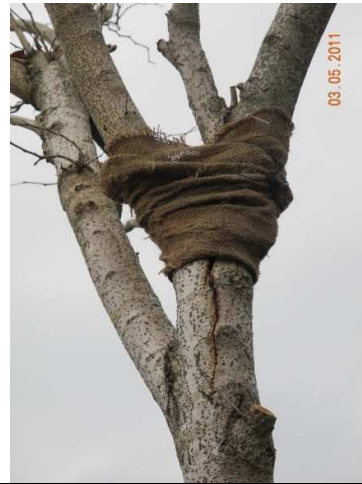
Photo 16 - Hessian wrapping on some transplanted trees

All Hessian wrapping for the transplanted tree should be removed after transplanting works as it poses risk of wood decay especially in this wet season (**Photo 16**).

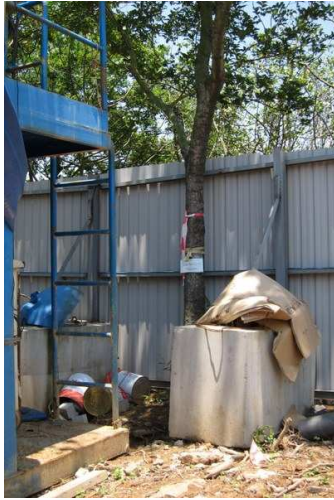
Photo 19 – E250 without proper Tree Protection Zone in Area A

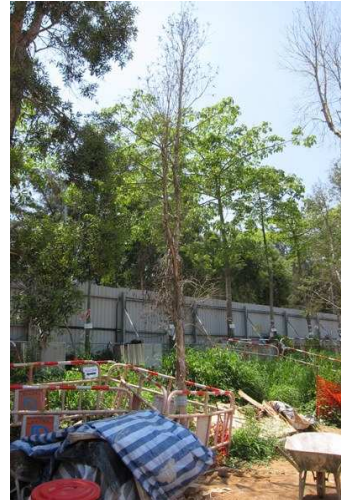
Photo 20- Poor health condition of E21

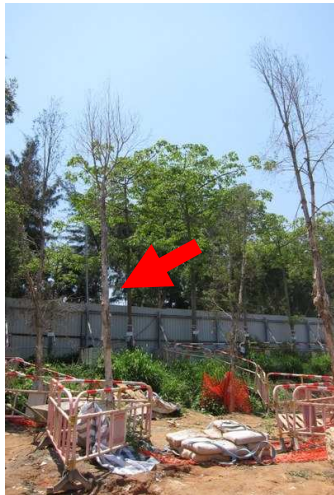
Photo 21 – Poor health condition of E22
