**Monthly Environmental Monitoring & Auditing report for**

**Contract No.DC/2009/22**

**Drainage Improvement in Shuen Wan, Tai Po – Contract 1**

**June 2011**

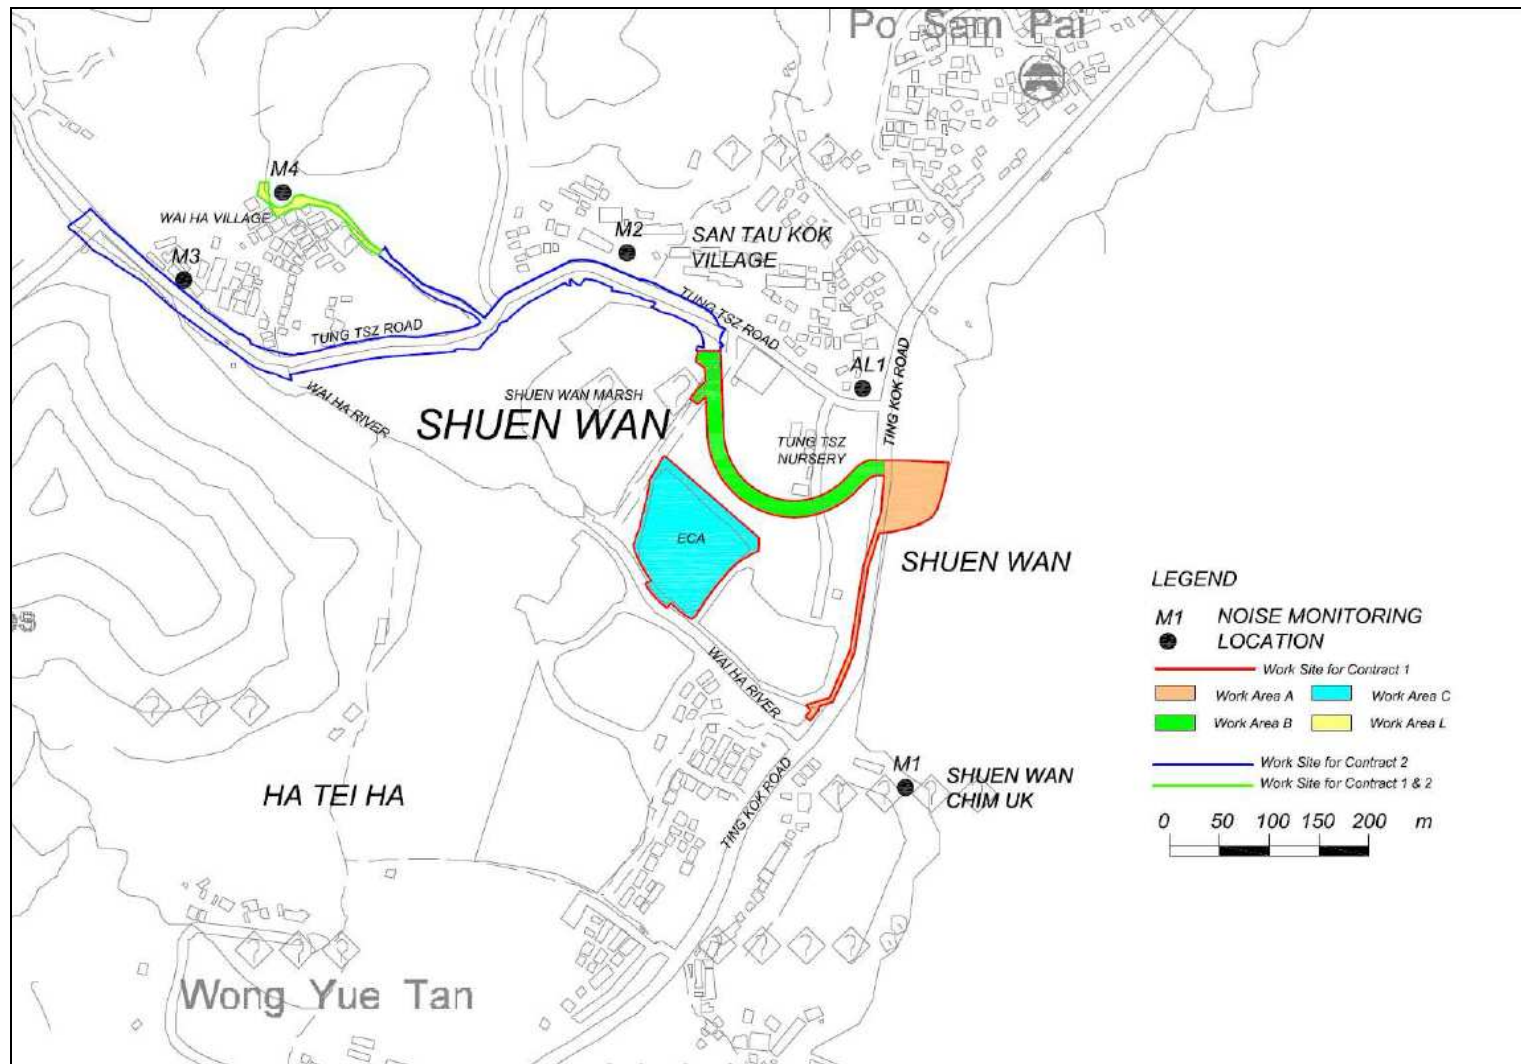
Figure 3.3.1 Impact noise monitoring locations

Noise Monitoring Station	Location
M1	14, Shuen Wan Chim Uk
AL1	Joint Village Office for Villages in Shuen Wan, Tai Po

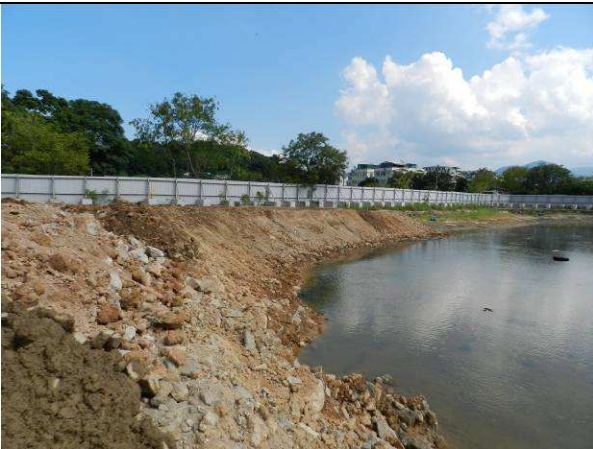
<p>Photo 1- Recontouring works along the southeastern boundary of the ECA.</p>	<p>Photo 2 - Recontouring works along the northeastern part of the ECA.</p>

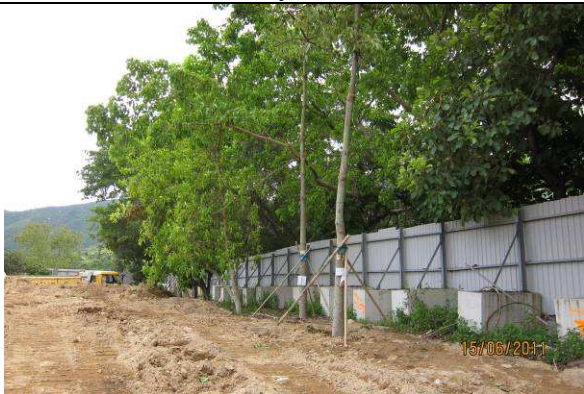
<p>Photo 3 – Trees transplanted from Area A to the ECA on 14 June 2011.</p>

The contractor should maintain adequate watering of the transplanted trees in the ECA during the construction and establishment phases. Proper tree protection zones are recommended to avoid any mechanical damage from the construction vehicles.

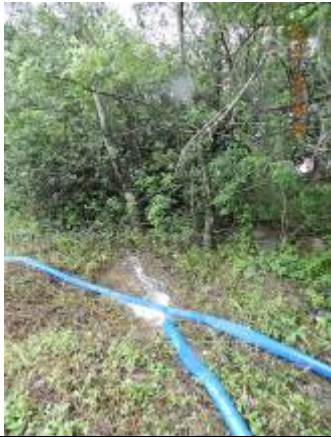
Used water for washing vehicle wheel and groundwater from the excavated sites were pumped into the silt/sand removal facilities for filtration before discharging into the manhole adjacent to Area A. However, one drainage pipe, which discharged treated water, connecting to the manhole was found to be overlaid on the adjacent wasteground next to Area A. The Contractor was informed and removal of such drainage pipe was observed as a remedial measure (**Photos 1 – 2**).

**Photo 1** - Water leakage from a drainage pipe was found on the adjacent wasteground next to Area A

As abovementioned in Section 3.3.2, one drainage pipe connecting to the manhole was found to be overlaid on the adjacent wasteground next to Area A. The Contractor was informed and removal of such drainage pipe was observed as a remedial measure (**Photos 1 – 2**).

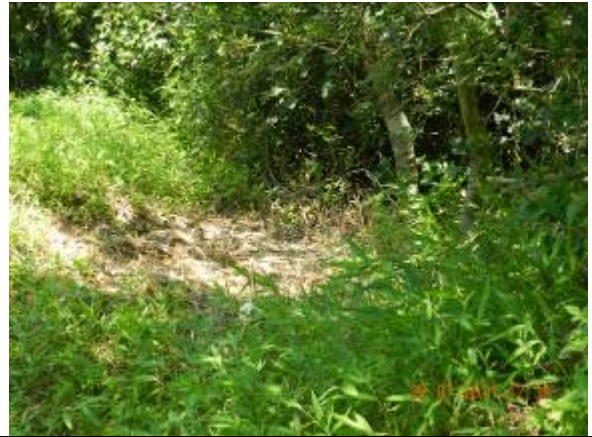
**Photo 2** - The Contractor was informed and removal of such drainage pipe was observed

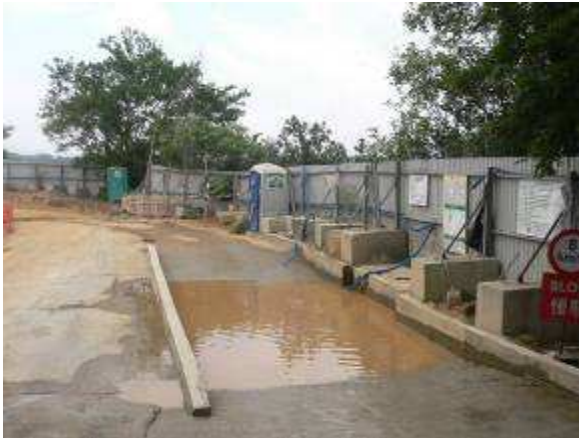
Provision of vehicle wheel washing facilities was observed at the exit point of Area A to reduce the contamination to the surrounding habitats in Plover Cove (**Photo 3**). Used water for washing vehicle wheel and groundwater from the excavated sites were pumped into the silt/sand removal facilities for filtration before discharging into the manhole adjacent to Area A.

**Photo 3** - Vehicle wheel washing facilities in Area A

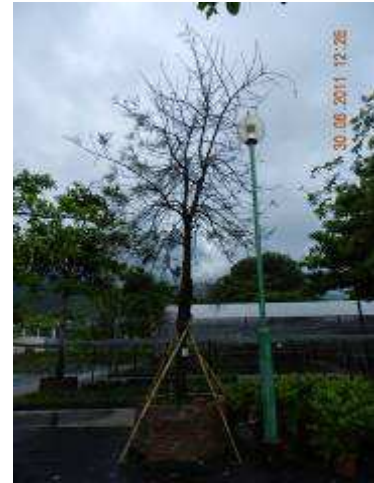
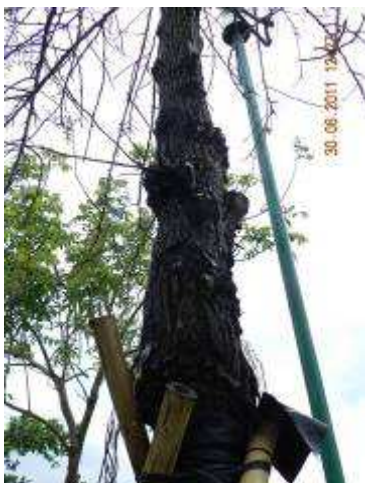
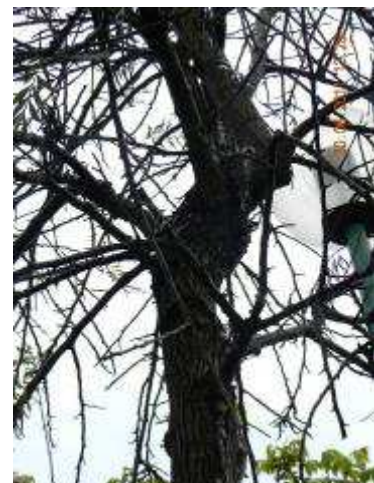
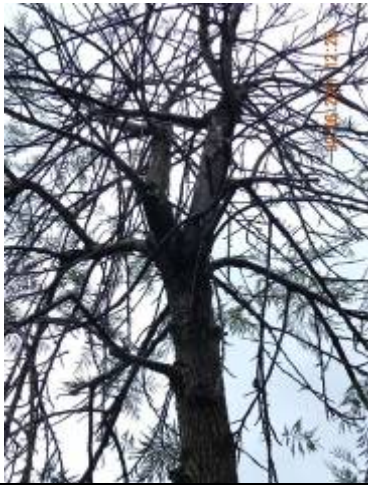
Decline in health condition for the transplanted tree U58 *Grevillea robusta* was reported in late April. Regular monitoring for the subject tree was conducted bi-weekly. Tree defects of defoliation and bleeding were still found. Chlorotic leaves and defoliation were further reported in June 2011. (**Photos 4 – 7**)

Trees, including retained and transplanted specimens, within the nursery were maintained generally in fair condition. However, the transplanted tree U58 was in declining health condition (such as defoliation and exudation of sap from tree bark) after the transplant. These signs may be due to transplantation shock.

**Photo 4** - Decline in health condition for the transplanted tree U58 *Grevillea robusta*.

**Photo 5** - Suspected canker formation and exudation of sap from the tree bark of U58.

**Photo 6** - Suspected cankers with abnormal tree form of U58.

**Photo 7** - Defoliation was observed on the canopy of U58.

Regular monitoring and watering of *Grevillea robusta* (U58) are recommended. The appointed landscape contractor and the Contractor should closely monitor the health conditions throughout the establishment period.

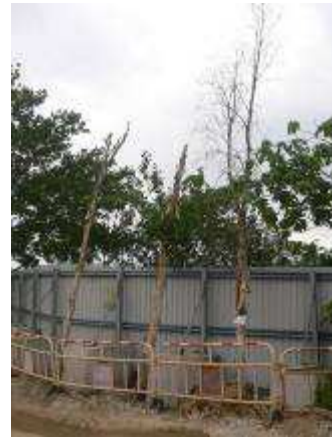
On 4<sup>th</sup> June 2011, three untagged trees (presumed to be trees proposed to be felled and were of poor health conditions) were found relocated to new locations next to a retained tree E55 (**Photo 8**). As informed by the Contractor, relocation of the trees was undertaken to free-up space for a temporary site office. These trees were poorly transplanted with soil piling around the tree trunk bases. These trees were subsequently removed in the followed monitoring.

**Photo 8** - Three untagged trees were found relocated to new locations next to a retained tree E55.

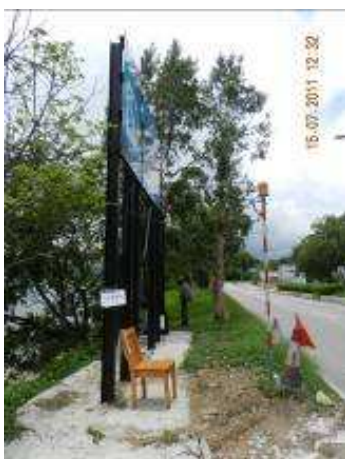
As reported by the Contractor, two retained trees E23 and E24 along Ting Kok Road (**Photo 11**) and three trees to be transplanted (namely E21, E28 and E32 within the active works area) were collapsed under the influence of heavy rain and Tropical Cyclone “Haima” in the week of 18<sup>th</sup> June 2011. The five hazardous trees were removed immediately for safety reason.

**Photo 11** - Original locations of two retained trees E23 and E 24 along Ting Kok Road.

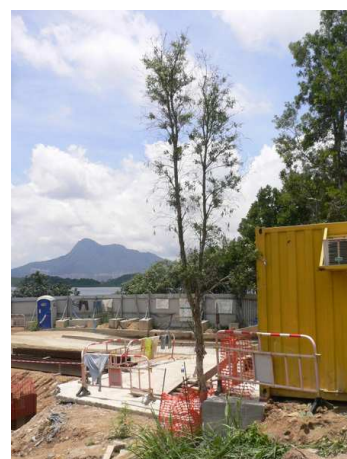
The transplanted tree *Melaleuca quinquenervia* (E22) remained in poor health condition as in previous monitoring period (**Photo 12**).

**Photo 12** - General view of E22 in Area A.

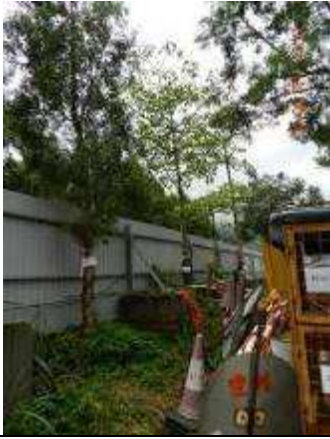
**Photo 13** - No proper Tree Protection Zones were established for the highlighted trees in Area A.

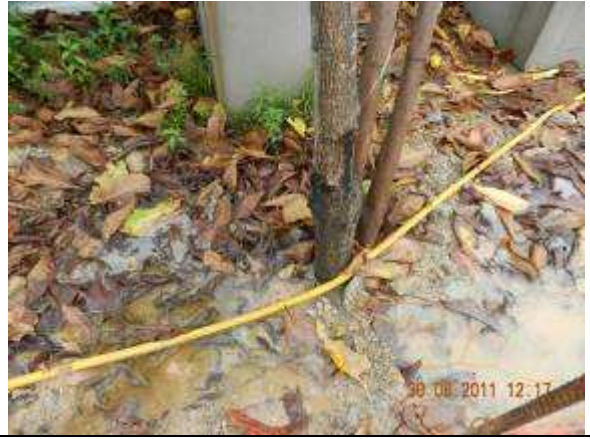
The temporary relocated trees U34, U35, U36 and U37 were found transplanted too deep on 15<sup>th</sup> June 2011. The grade was found lowered in the root flare and a sink was formed (**Photo 14**).

**Photo 14** - A sink of water was formed with the grade lowered at the root flares of the relocated trees U34, U35, U36 and U37.

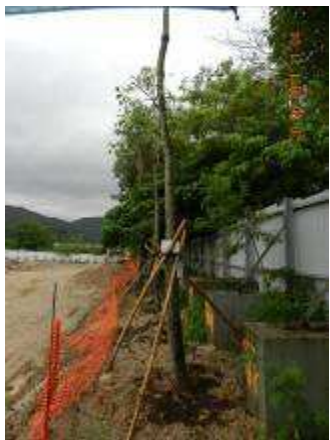
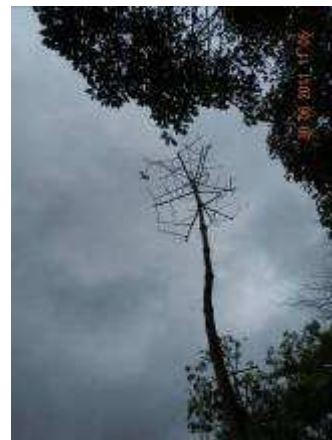
The health condition of the transplanted tree T153 was poor with defoliation (**Photos 9 and 10**).

**Photo 15** - The transplanted tree T153 *Bomax ceiba* was in poor health with defoliation after the transplant.

**Photo 16** - Very few leaves have been developed in the canopy of the transplanted tree T153.
