Monthly Environmental Monitoring & Auditing report for

Contract No.DC/2009/22

Drainage Improvement in Shuen Wan, Tai Po – Contract 1

August 2011

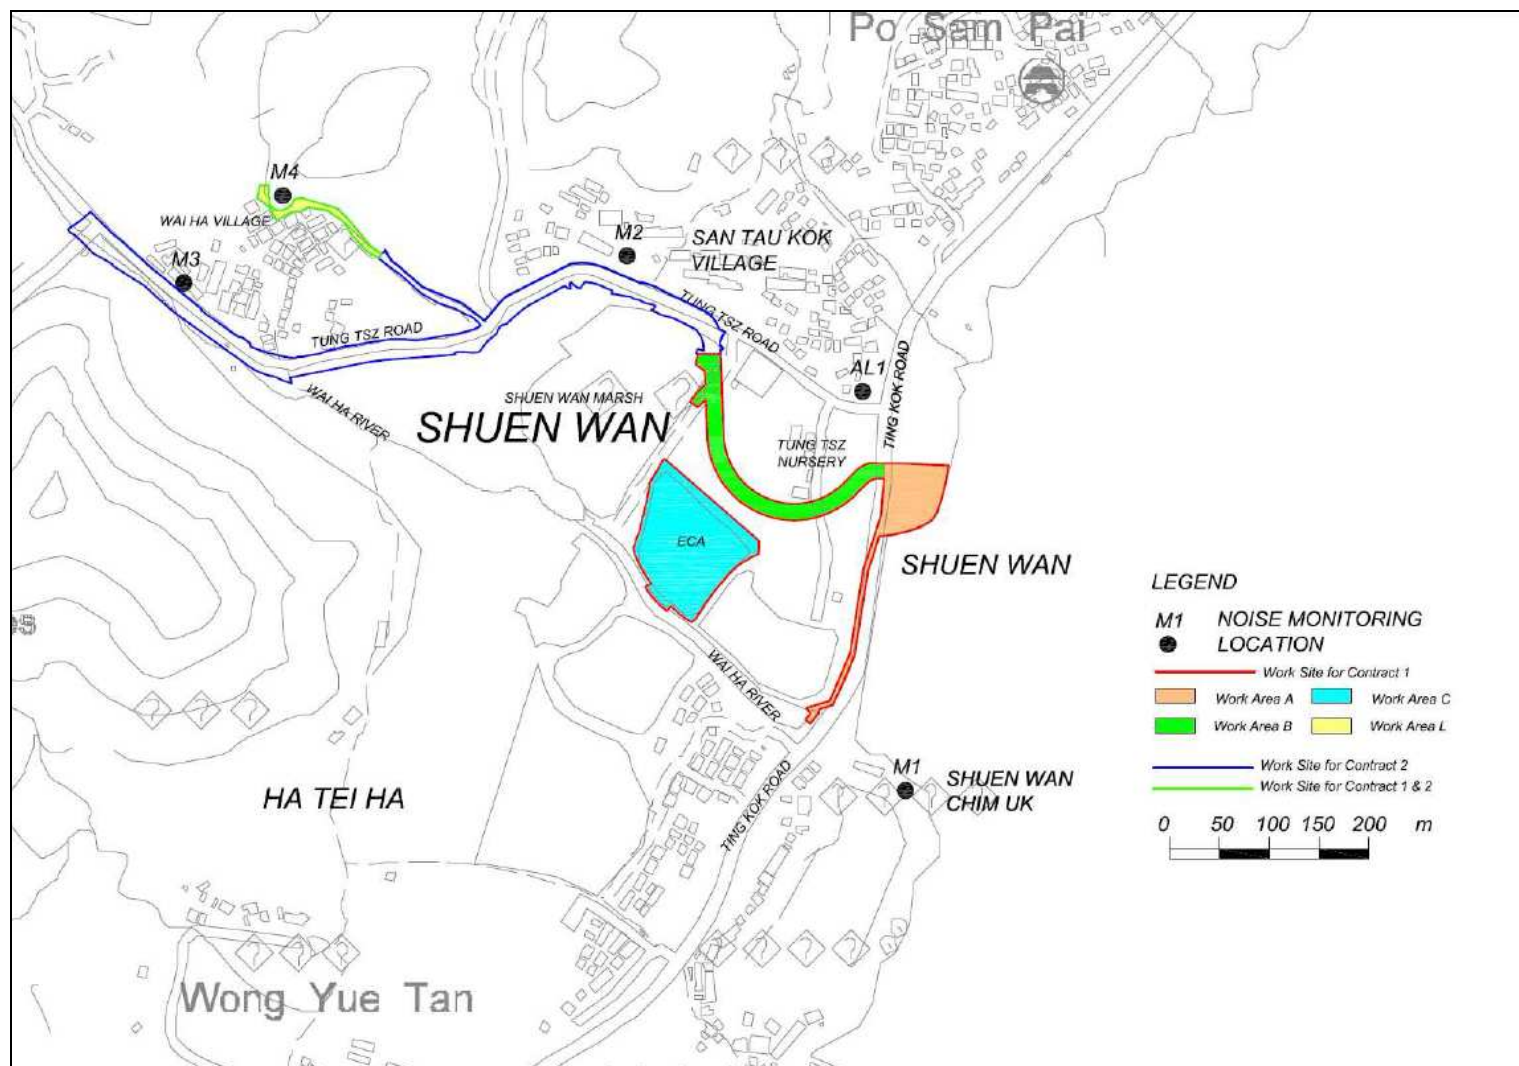
Figure 3.3.1 Impact noise monitoring locations

Noise Monitoring Station	Location
M1	14, Shuen Wan Chim Uk
AL1	Joint Village Office for Villages in Shuen Wan, Tai Po

Relevant details of the noise monitoring results are presented in Table 3.4.1. The results of M1, ranged between 60.0dB (A) and 61.9dB (A), and AL1, ranged between 60.7dB (A) and 69.2dB (A), were within the limit levels and therefore, no exceedance was found.

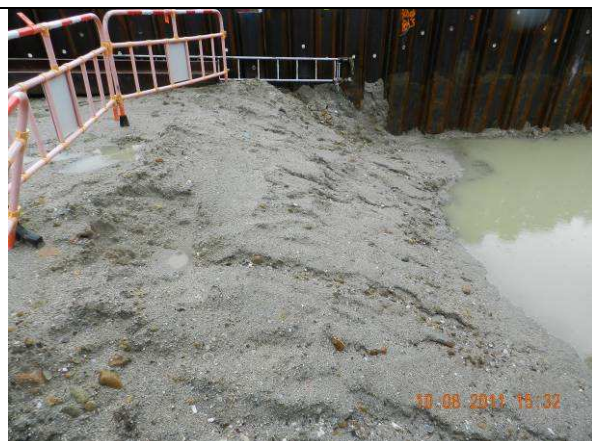
Photo 1 – Subsoil from area in Contract 2 was inspected by the Wetland Specialist on 10th August 2011.

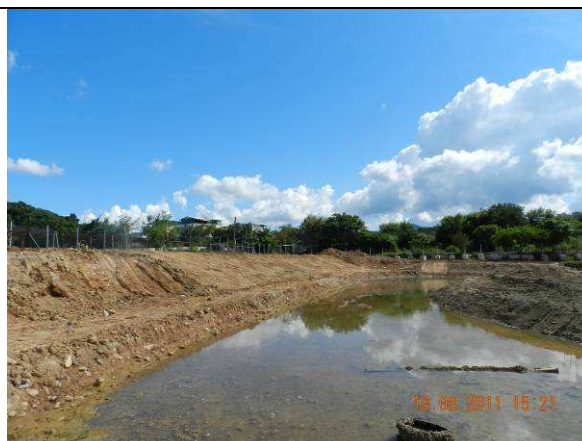
Photo 2 – Landforming and shaping of the southeastern boundary of the ECA were completed as seen from the site inspection on 18th August 2011.

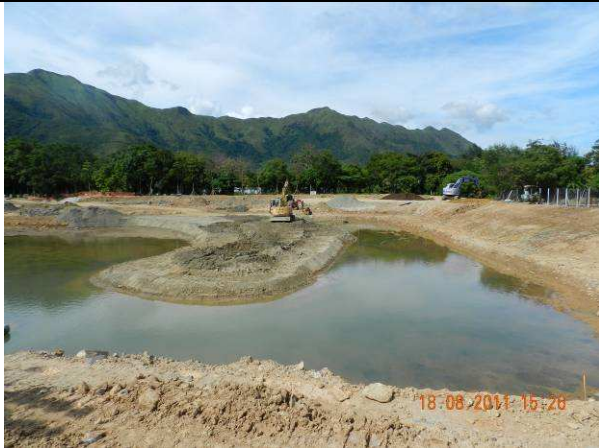
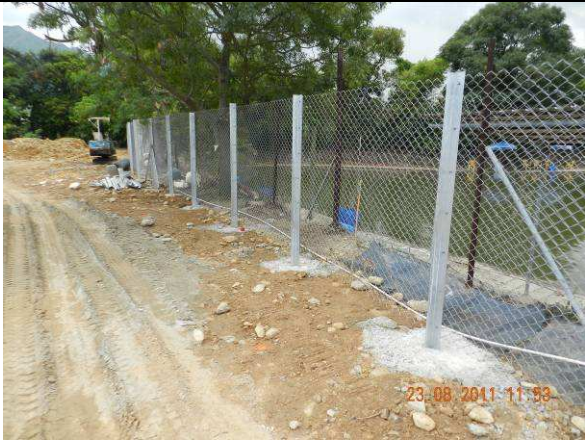
<p>Photo 3 – Formation of the island in the ECA was in progress as seen from the inspection on 18th August 2011.</p>	<p>Photo 4 – The chain link fence had been erected around the ECA boundaries.</p>

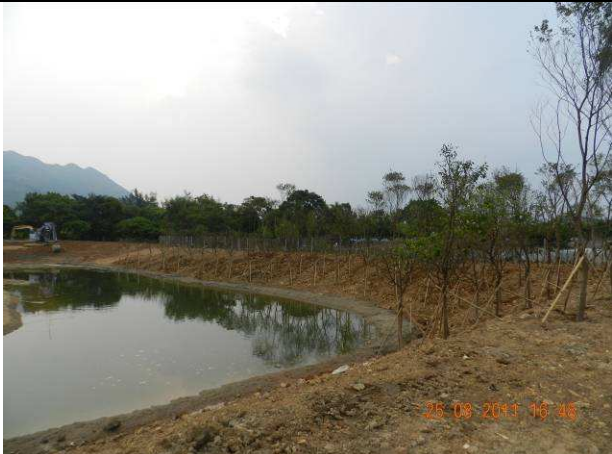
<p>Photo 5 – Tree planting was commenced along the southeastern boundary of the ECA.</p>

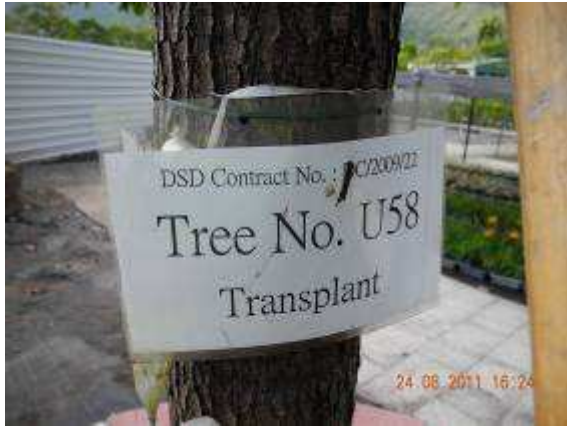
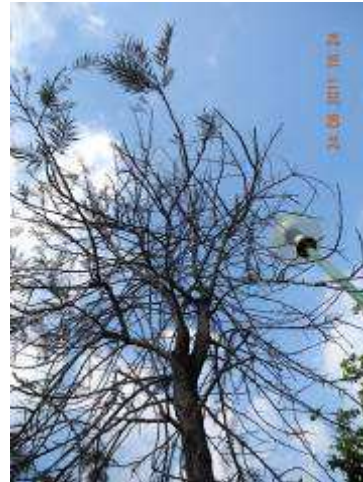
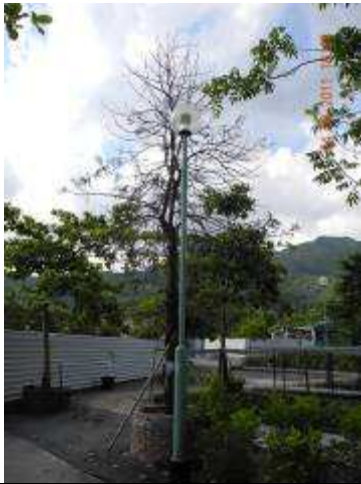
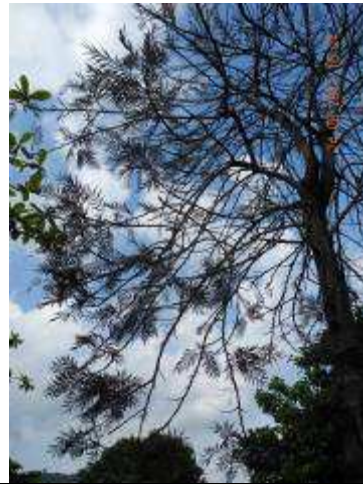
Decline in health condition for the transplanted tree U58 *Grevillea robusta* was reported in late April. Regular monitoring for the subject tree was conducted bi-weekly. Tree defects of chlorotic leaves and defoliation were still found, but a few new leaves developed on the branches. No further health decline was observed in August 2011. (**Photos 1-4**)

Photo 1 – Poor health condition for the transplanted tree U58 *Grevillea robusta*.

Photo 2 - Overall view of the transplanted tree U58 *Grevillea robusta*.

Regular monitoring and watering of *Grevillea robusta* (U58) are recommended. The appointed landscape contractor and the Contractor should closely monitor the health conditions throughout the establishment period.

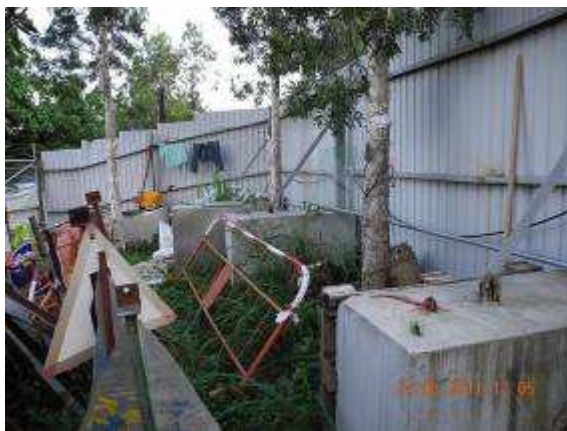
No proper TPZs were still recorded for trees to be transplanted T163, E16, E17, E18, E19 and E20 (**Photo 5**). A few observations of temporary storage of construction materials within the dripline area of trees was made. However, less construction materials and fewer equipments were found within the tree dripline area.

Photo 5 – No proper Tree Protection Zones were observed along the southern boundary of Area A.

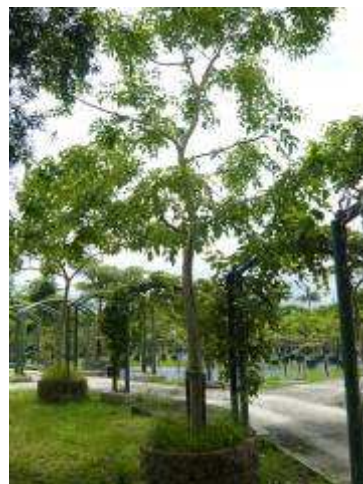
Trees, including retained and transplanted specimens, within the nursery were maintained generally in fair condition, with no significant damages on tree crowns, trunks and roots observed during the monitoring in August 2011. However, the transplanted tree U58 was still in poor health condition (**Photos 1-4**) (such as defoliation and exudation of sap from tree bark) after the transplant. These signs may be due to transplantation shock to the tree. And health condition of U67 was recorded fair in this monitoring period (**Photo 6**).

Photo 6 – Overall view of the retained tree U67 *Cassia fistula*

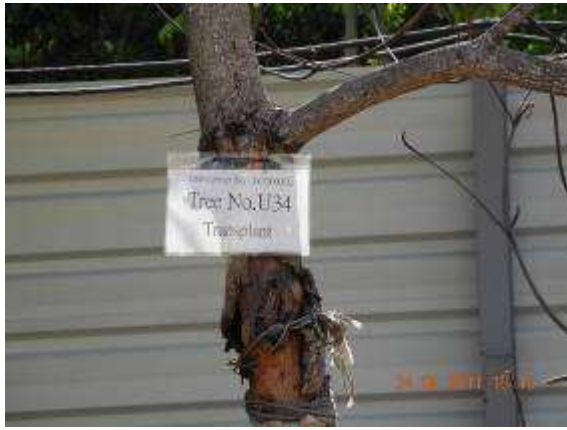
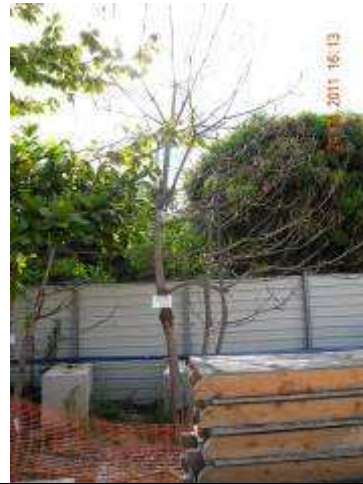
No accumulation of water at the root flares of U34, U35, U36 and U37 was observed in August 2011. However, the health condition of both U34 (**Photo 7-8**) and U37 (**Photo 9**) was found declining with defoliation and dried tree bark.

Photo 7 – Declining health condition of U34

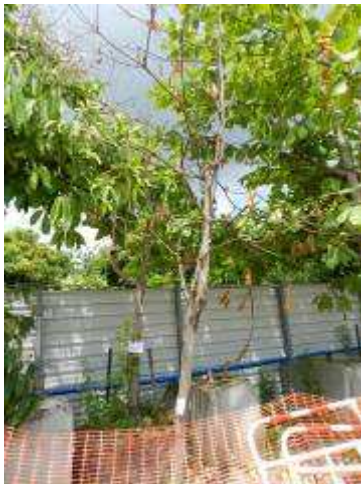
Photo 9 – Declining health condition of U37

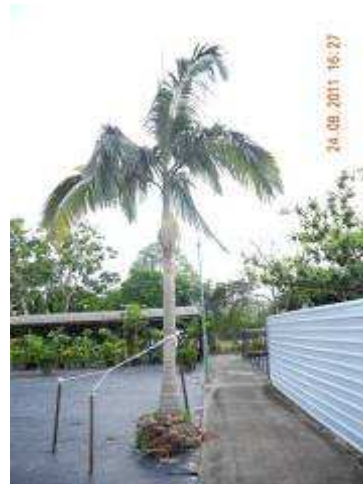
The planter for a tree to be transplanted (A36) was not yet repaired by the time of the inspections. Two ropes have been used for guying the tree to prevent tree failure (**Photos 10**).

Photo 10 – The planter of a tree to be transplanted (A36) was found broken. It was guyed by 2 ropes for supporting the tree.

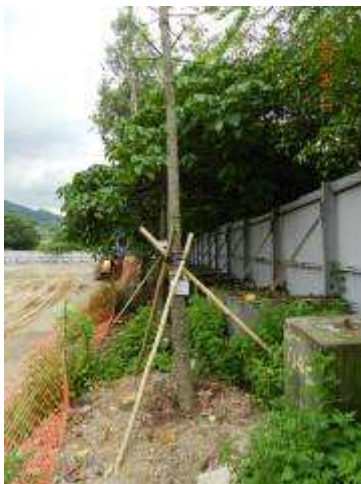
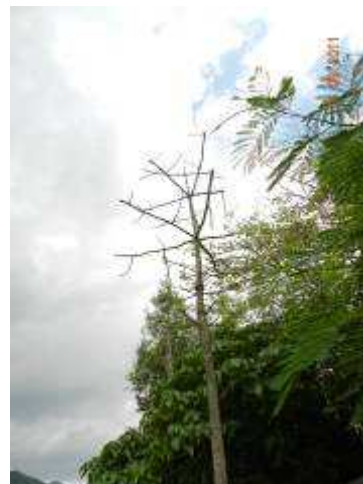
Slight defoliation was observed in three of the transplanted *Bombax ceiba* (T 151,

T152 & T153), although some new leaves were emerging. Regular watering and application of organic soil are recommended. Relevant mitigation measures will be proposed when necessary.

Photo 11 – Sparse foliage of the transplanted tree T152 in Area C.

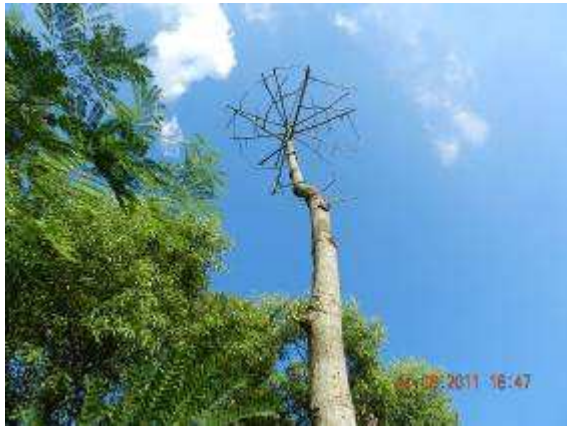
Photo 13 – Sparse foliage of the transplanted tree T153 in Area C.

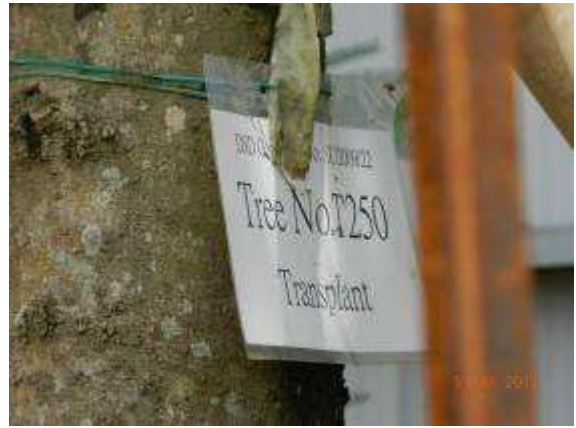
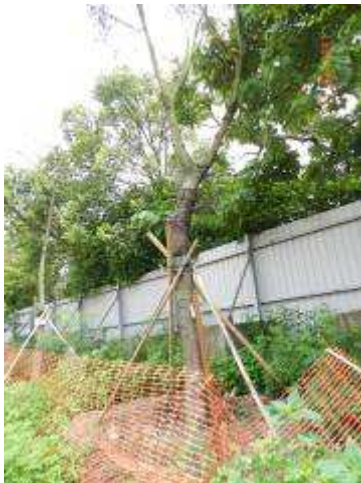
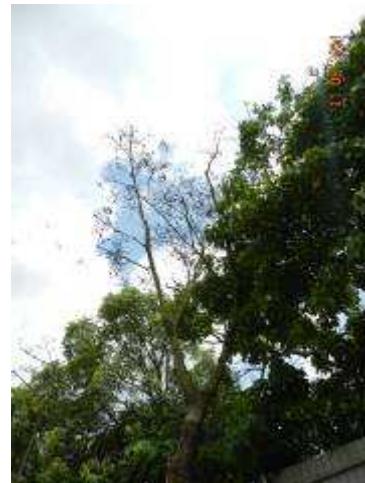
Photo 14 – Poor health condition of transplanted tree T250 in Area C

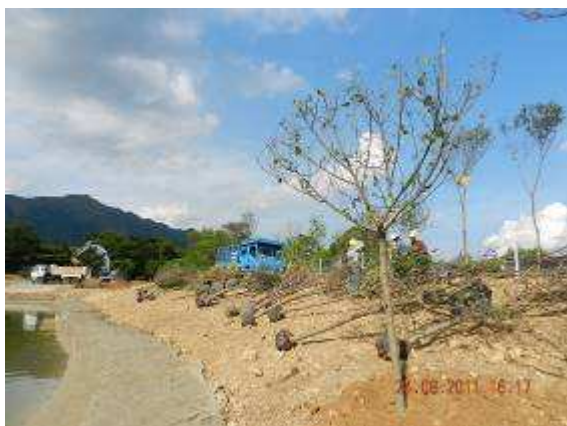
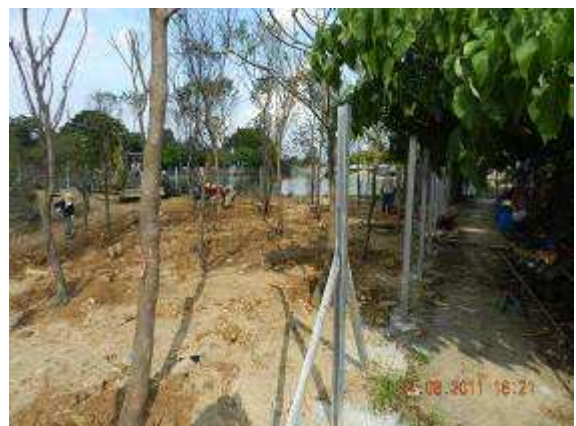
Photo 17 – Compensatory planting in Area C
