Monthly Environmental Monitoring & Auditing report for

Contract No.DC/2009/22

Drainage Improvement in Shuen Wan, Tai Po – Contract 1

September 2011

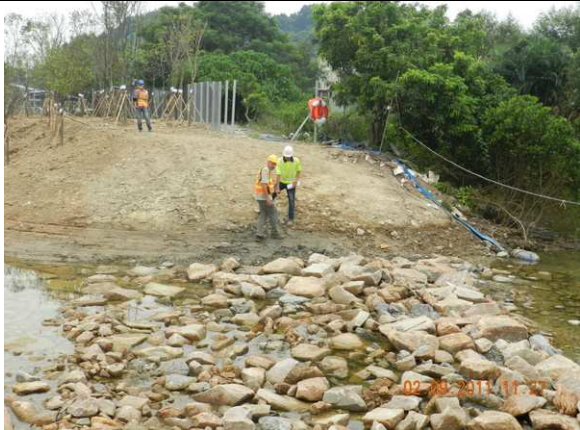
Inspection Date	Observation	Recommendation
02 September 2011	The wetland was recently connected with the Wai Ha River and new trees had been planted along the eastern and southeastern boundaries of the ECA. Rubble stones were found at the connection to the stream (Photo 1). The maximum high tide height was determined on-site and the Wetland Specialist had to determine the need of fine-tuning the formed level by checking the water level at high tide in the following week.	The Contractor should add additional rubble stones at the connection to the Wai Ha River. More rubble stones should be placed and piled to the higher bank of the wetland.
09 September 2011	Additional rubble stones were added at the connection of the Wai Ha River. The ECA was inspected at the predicted tide height of 2.2m which should flood all proposed intertidal area in the ECA. However, as observed, only 90% of the proposed intertidal area was flooded by the tide. The Wetland Specialist recommended to slightly lower the higher part of intertidal area to ensure sufficient flooding in the land. The newly planted trees <i>Hibiscus tiliaceus</i> were inspected. Health and structure of some of these trees were not satisfactory. The trees planted at the lowest row were flooded by the high tide along the southeastern part of the ECA (Photo 2).	The Contractor should lower the higher part of the intertidal area along the northeastern part of the ECA by 5-10cm. Such reprofiling work should be finished within 2 weeks. The newly planted <i>Hibiscus tiliaceus</i> showing poorest growth performance should be replaced by new trees and the growth of the remaining <i>Hibiscus tiliaceus</i> should be monitored closely. The trees planted at the lowest row and flooded by the high tide were recommended to be re-planted at the higher level along the bund.

<p>Photo 1 – Rubble stones were placed at the connection point of the Wai Ha River.</p>	<p>Photo 2 – Row of <i>Hibiscus tiliaceus</i> was planted along the lower wetland bund.</p>

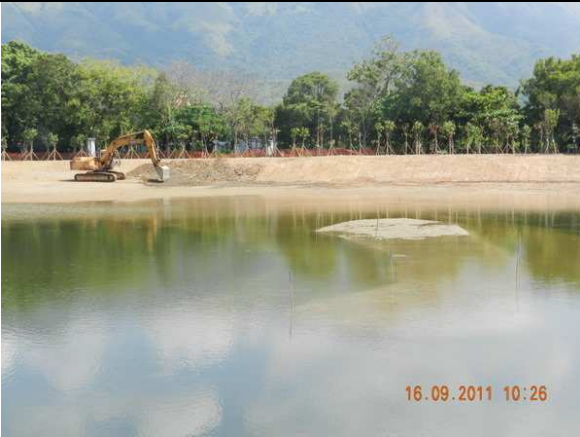
16 September 2011	The works for adjusting the level along the northeastern part had been in progress on the date of inspection (Photo 3). The adjustment to the level was almost completed. As observed, tidal water could reach the base of bund in general except the area where the works was still being completed. Replacement of tree <i>Hibiscus tiliaceus</i> with poor growth performance and tree planting in the whole ECA were completed.	The Contractor should continue the level adjustment works in the following week.
19 September 2011	The level adjustment works was almost completed on the date of inspection) (Photo 4) and the tidal water was found reaching and covering the proposed intertidal area. Watering of newly planted trees by the landscape contractor was observed on-site.	The Contractor was suggested to increase the frequency of watering to the newly planted trees and remove any rubbish and old chain-link fence in the ECA

<p>Photo 3 – The level adjustment works was undertaken along the northeastern part of the wetland.</p>	<p>Photo 4 – The level adjustment works was almost completed by the date of inspection on 19th September 2011.</p>

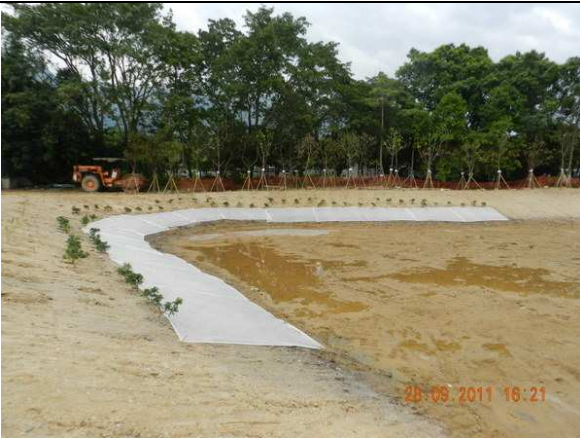
28 September 2011	The level adjustment works was completed. Shrubs (only planting the proposed <i>Bridelia tomentosa</i> and a wrong shrub species of <i>Pittosporum</i> spp.) and grasses area were planted and hydroseeded along the northeastern part of the ECA (Photo 5). The shrubs were planted on 23 rd September 2011 but a	The Contractor should replace the wrong shrub species with the correct shrub species <i>Scaevola taccada</i> .

<p>Photo 5 – Shrubs and grass were planted and hydroseeded along the northeastern bund in the ECA.</p>

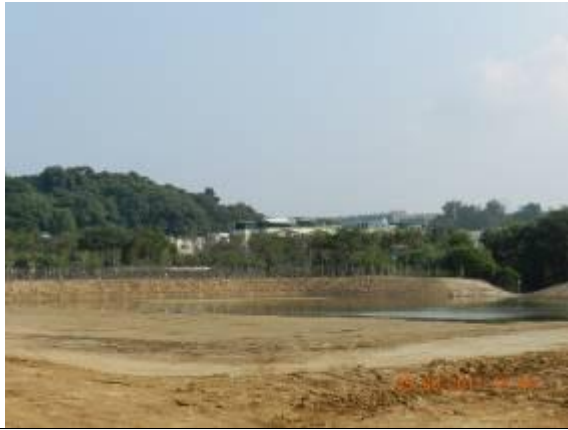
Photo 1 – The construction hoardings surrounding Area C have been removed and replaced by chain link fence.

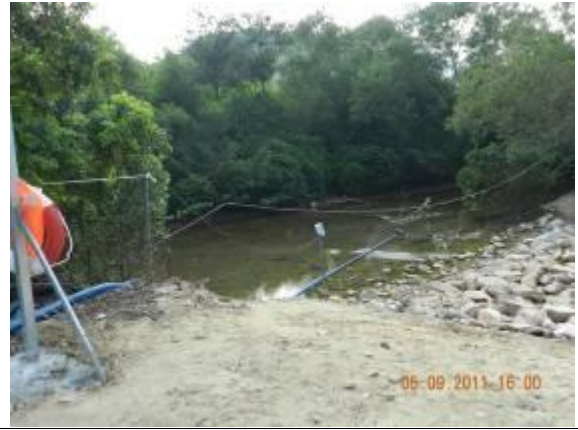
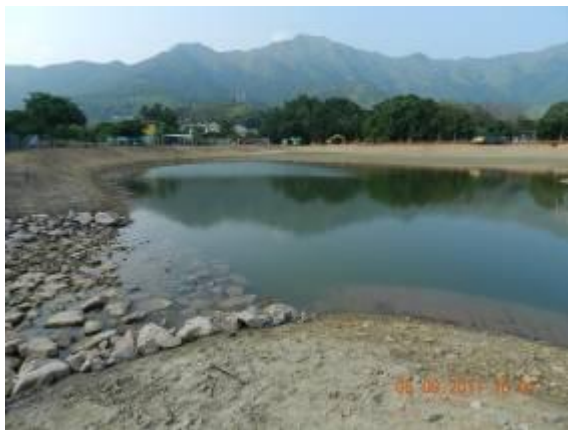
The pond of the ECA was observed to be connected to Wai Ha River directly as following the scheme design of Habitat Compensatory Plan (**Photos 2-3**). No direct discharge of turbid water into the adjacent Wai Ha River was observed.

Photo 2 – The Pond of the Ecological Compensatory Area was observed to be connected to Wai Ha River directly.

Photo 3 – The Pond of the Ecological Compensatory Area was observed to be connected to Wai Ha River directly.

No specific recommendation is required for Areas A, B and C. However, as a reminder, the Contractor should regularly check the condition of the drainage pipe and ensure that the used water should be appropriately filtrated and discharged to the manhole/other discharge point agreed by the Engineer and EPD. This is to avoid any potential contamination to the vegetation in Shuen Wan marsh and other vegetated/marinated areas adjacent to the active works area.

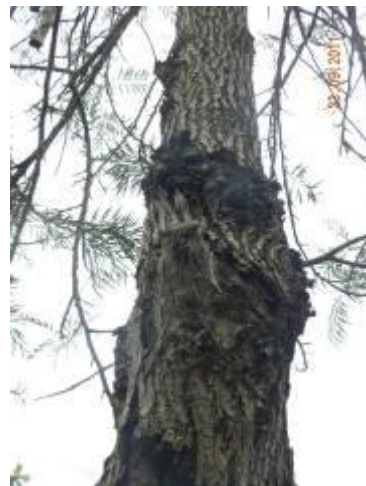
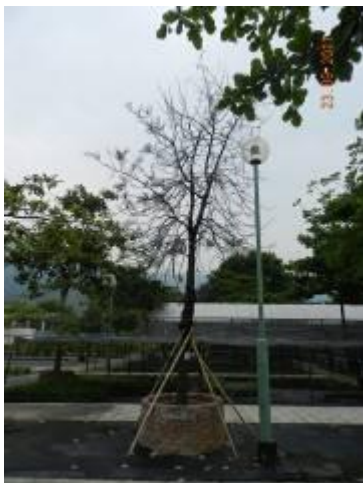
Decline in health condition for the transplanted tree U58 *Grevillea robusta* was reported in late April. Regular monitoring for the subject tree was

conducted bi-weekly. Tree defects of chlorotic leaves and defoliation were still found, but a few new leaves developed on the branches. No further health decline was observed in September 2011. (**Photos 4-5**)

Photo 4 – Overall view of the transplanted tree U58 *Grevillea robusta*.

Photo 5 – Overall view of the transplanted tree U58 *Grevillea robusta*.

Regular monitoring and watering of *Grevillea robusta* (U58) are recommended. The appointed landscape contractor and the Contractor should closely monitor the health conditions throughout the establishment period.

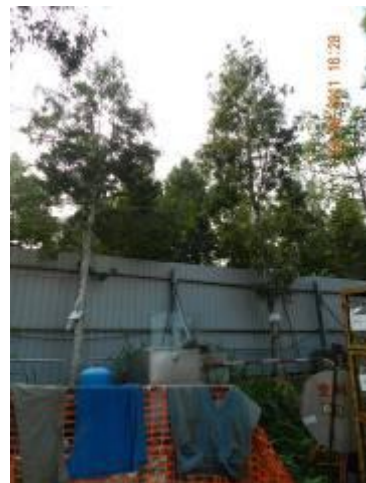
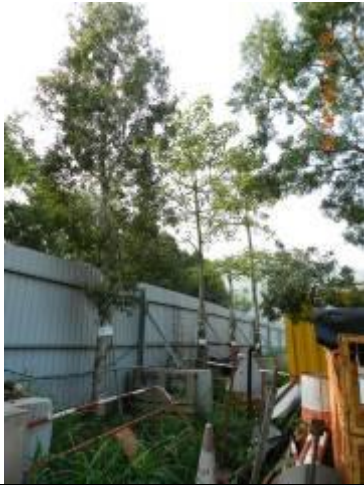
Tree Protection Zones (TPZs) in Areas A and B were demarcated within the construction sites as following the recommendation stated in the *Monthly EM&A Report for August 2011*, but temporary storage of construction materials was still observed in September 2011 (see details in the following section).

Photo 6 – No proper TPZs were observed along the southern boundary of Area A.

Photo 7 – No proper TPZs were observed along the southern boundary of Area A.

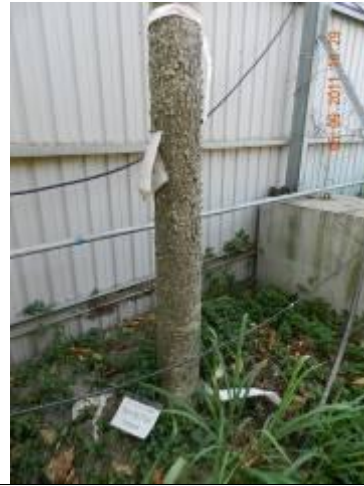
Tree tag of T163 was found on ground (**Photo 8**)

Photo 8 – Tree tag of T163 was found on ground.

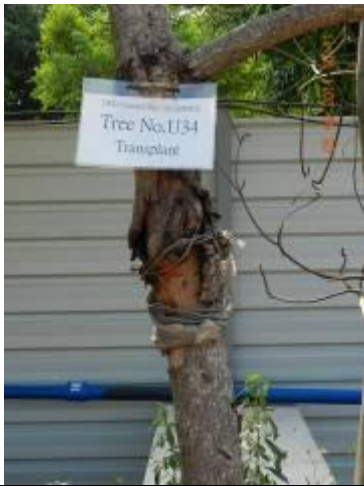
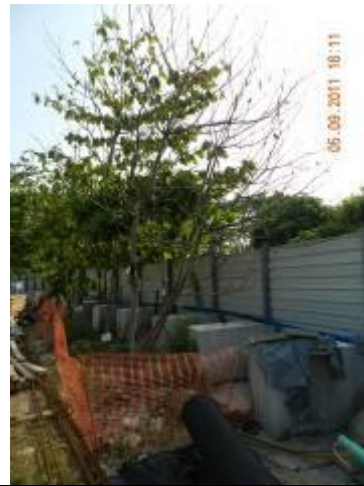
Photo 9 – Declining health condition of U34.

Photo 10 – Declining health condition of U34.

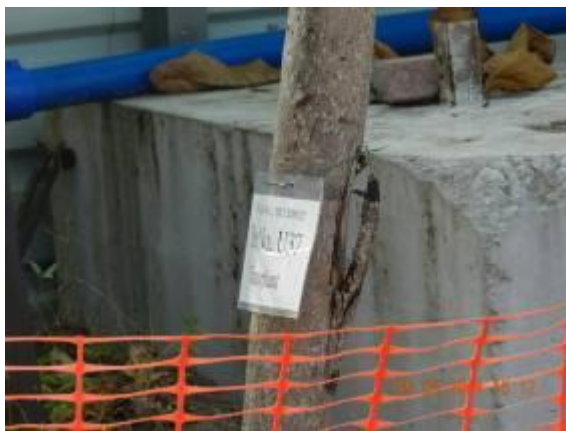
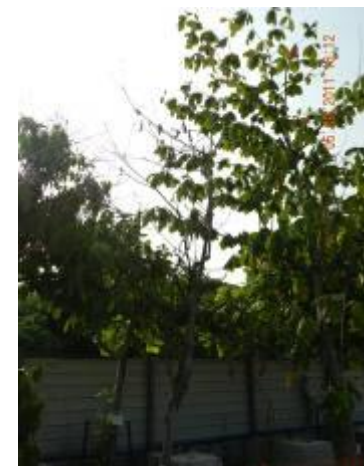
Photo 11 – Declining health condition of U37.

Photo 12 – Declining health condition of U37.

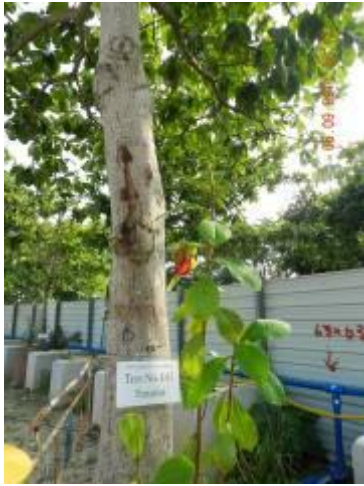
Photo 13 – Trunk of the U47 was found damaged.

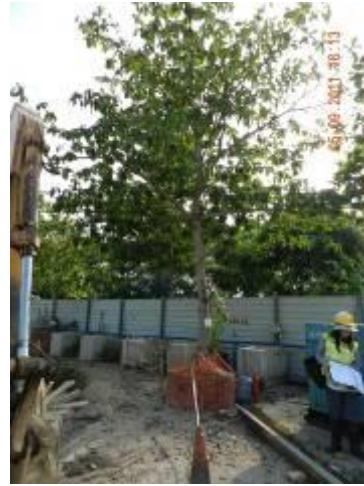
Photo 14 – No proper TPZ for U47 was observed.

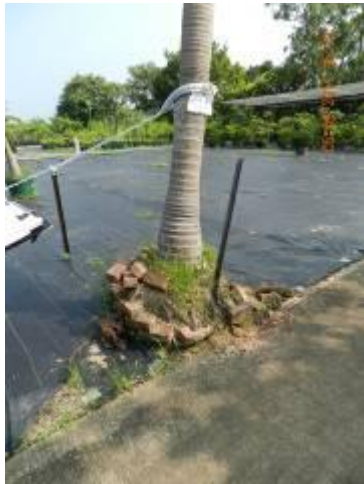
Photo 15 The planter of a tree to be transplanted (A36) was found broken. It was guyed by 2 ropes for supporting the tree.

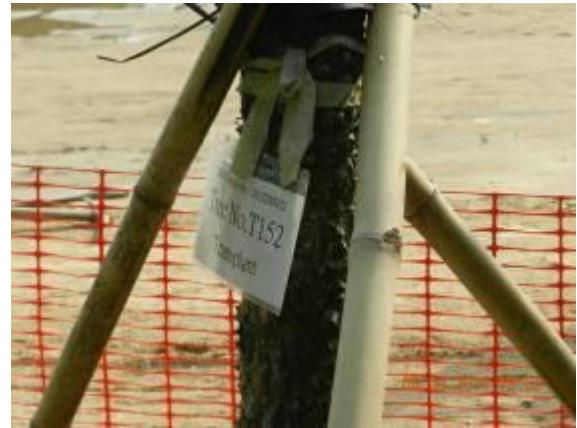
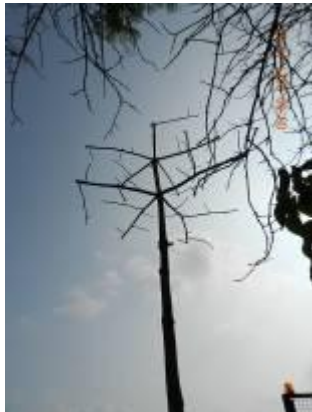
Photo 16 – Poor health condition of transplanted tree T152 in Area C.

Photo 17 – Sparse foliage of the transplanted tree T152 in Area C.

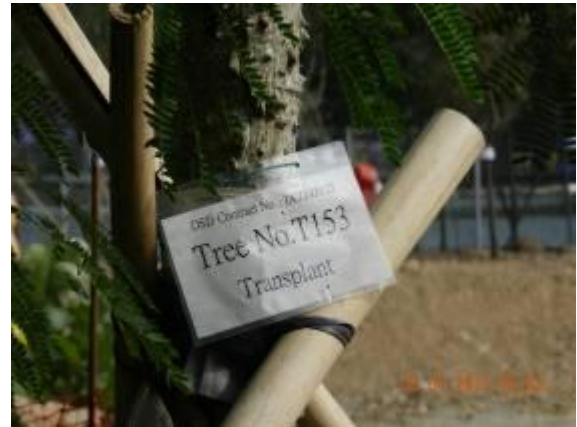
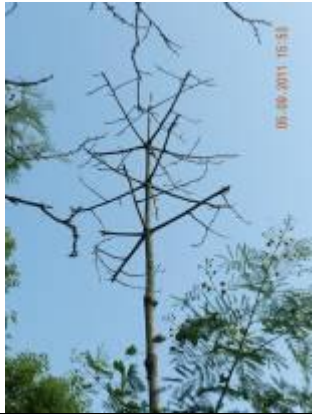
Photo 18 – Poor health condition of transplanted tree T153 in Area C.

Photo 19 – Sparse foliage of the transplanted tree T153 in Area C.

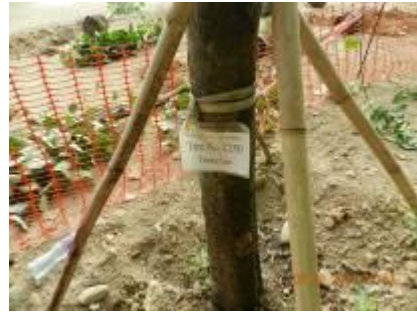
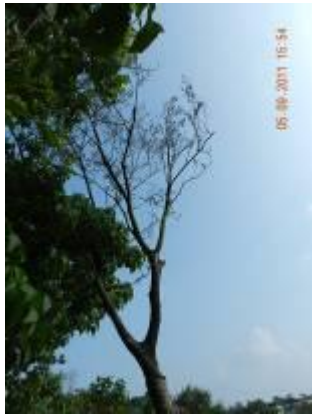
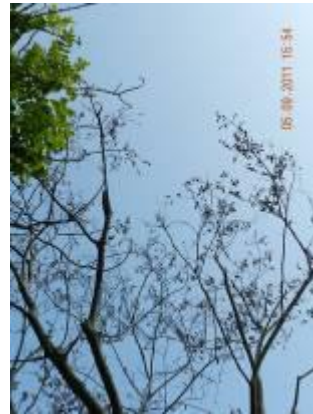
Photo 20 – Poor health condition of transplanted tree T250 in Area C.

Photo 21 – Poor health condition of transplanted tree T250 in Area C.

Photo 22 – Sparse foliage of the transplanted tree T250 in Area C.

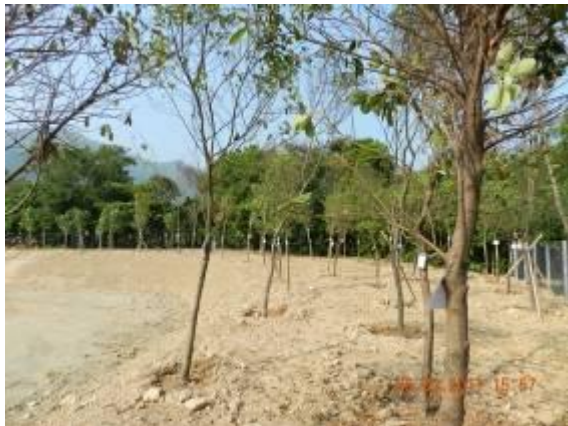
Photo 23 – Spacing of at least 2500mm between each planted tree individual was observed.
