**Monthly Environmental Monitoring & Auditing report for**

**Contract No.DC/2009/22**

**Drainage Improvement in Shuen Wan, Tai Po – Contract 1**

**December 2011**

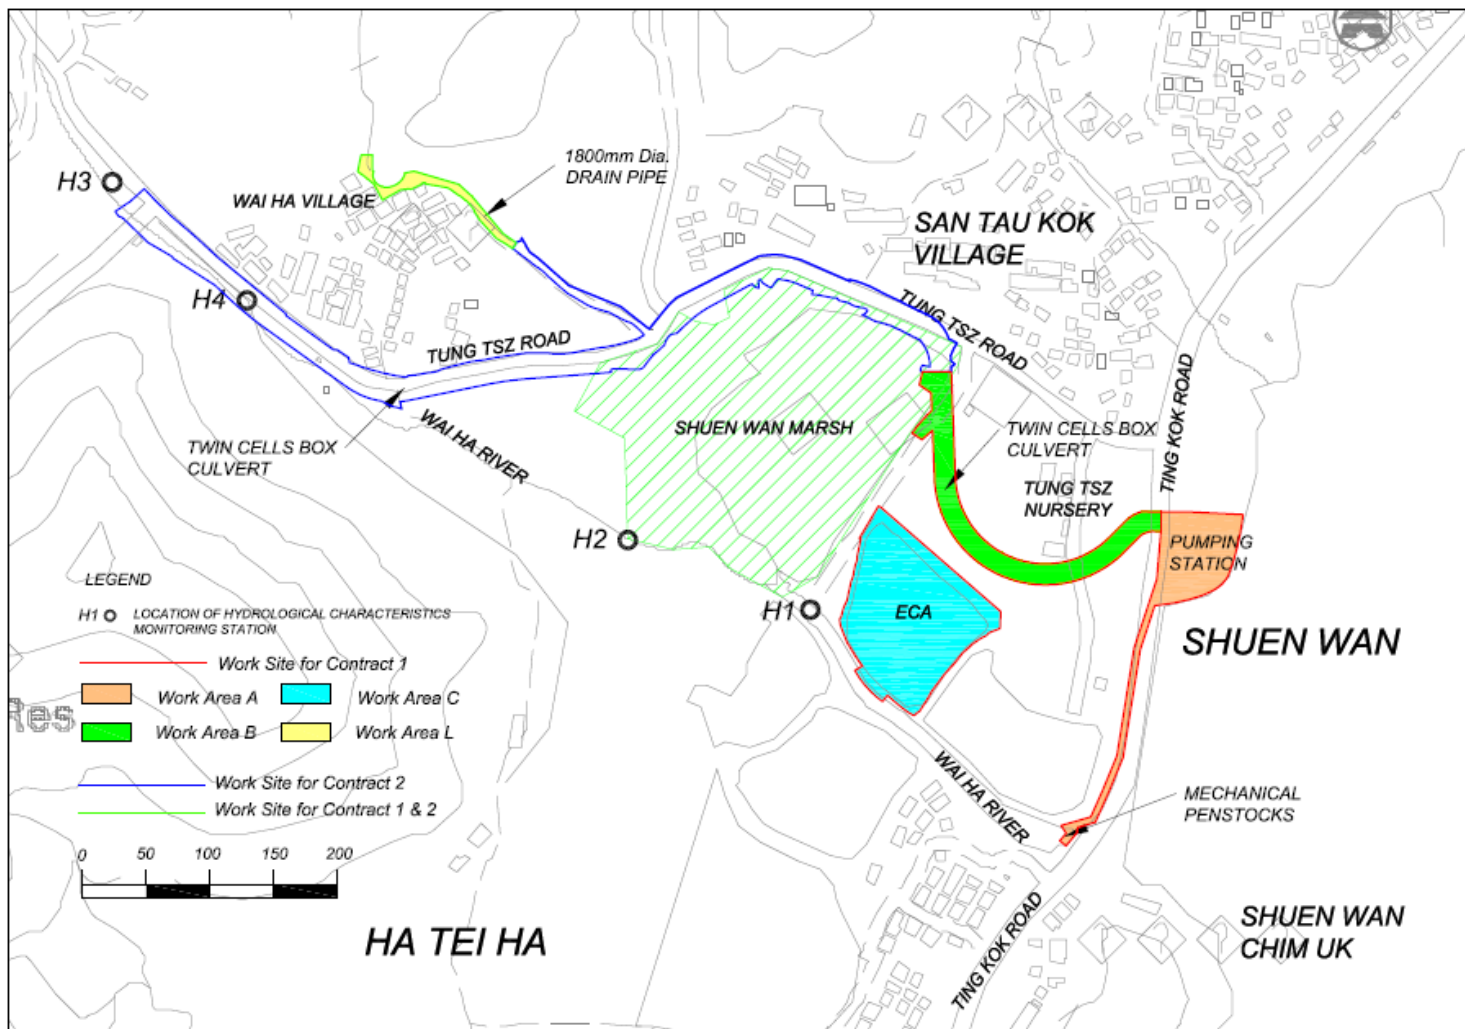
Figure 5.3.1 Hydrological Characteristics Monitoring Locations

As illustrated in Figure 5.3.1, H2 served as the control station while H1 was the monitoring location of hydrological characteristics.

Hydrological characteristics monitoring was carried out five times in this reporting period. The monitoring results are summarized in Table 5.5. All results were within the action and limit levels, therefore, no exceedance was found.

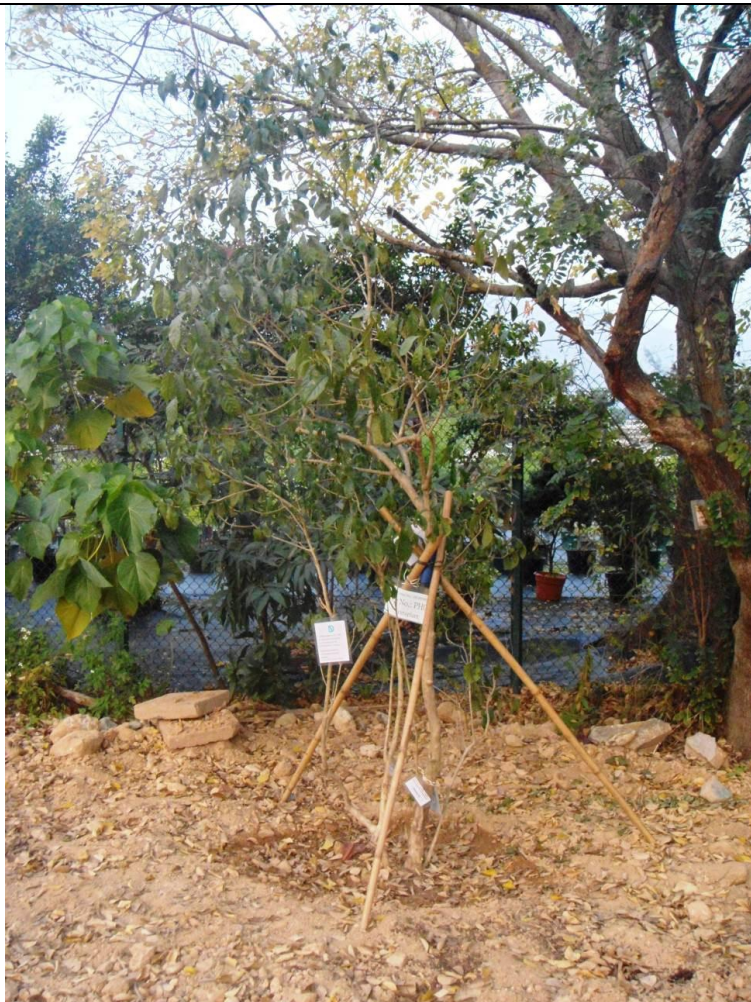
Figure 2.2a. Specimens 1 & 2.

Three specimens of protected species *Pavetta hongkongensis* were transplanted from work area under Contract 2 to ECA at Zone D on 20<sup>th</sup> December 2011. Weekly monitoring was carried out and their overall conditions are fair so far (**Appendix L(C)**). Representative photographs of the transplanted *P. hongkongensis* are showed on **Figure 6.3.2.2**.

**Figure 6.3.2.2.** Representative photographs of transplanted *Pavetta hongkongensis* in ECA since the first transplantation in Dec 2011.

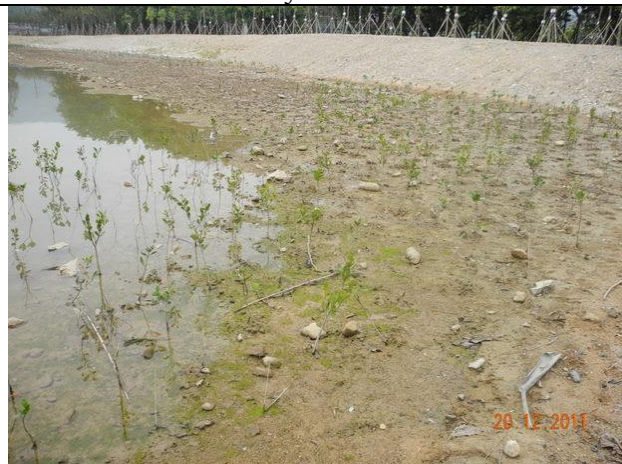
**Photo 1.** The mangrove planting along the northern and northeastern part of the created wetland has established satisfactorily.

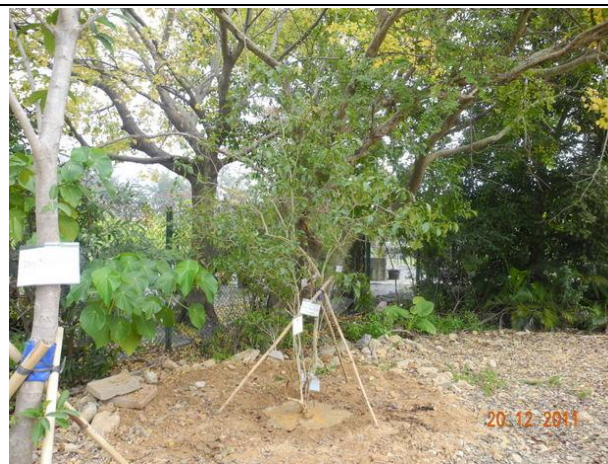
**Photo 2.** The newly transplanted and watered *Pavetta hongkongensis* (Specimens (T1) and (T2) in the ECA.

As observed, the planted terrestrial trees and shrubs and their surrounding soil were found to be too dry in December 2011. The Contractor should maintain frequent (such as at least twice per week) and adequate watering for all planted terrestrial plants throughout the establishment period of the ECA

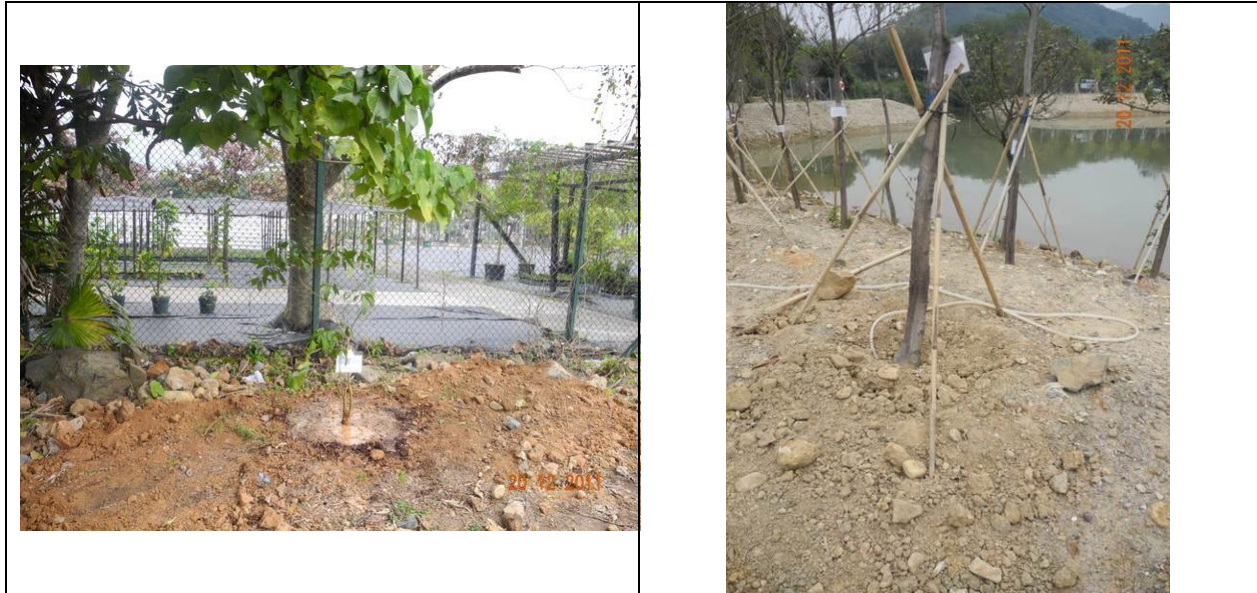
**Photo 4.** The replanted compensatory tree *Celtis sinensis* (Tree No. N13) was found partly fallen again in the ECA.

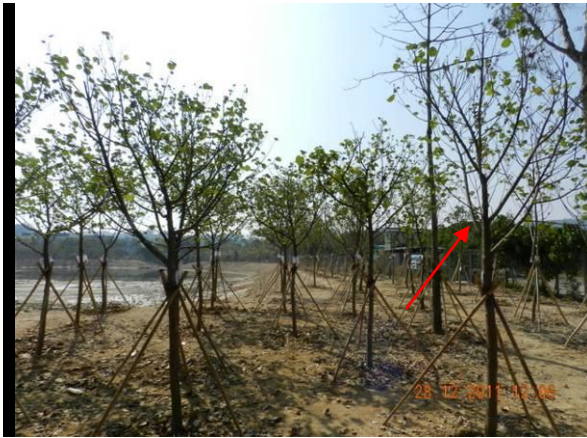
A line of chain link fence has been erected to replace the temporary hoarding and surrounded Area C (Photo 1).

**Photo 1** – The chain link fences were established to surround Area C.

No specific recommendation is required.

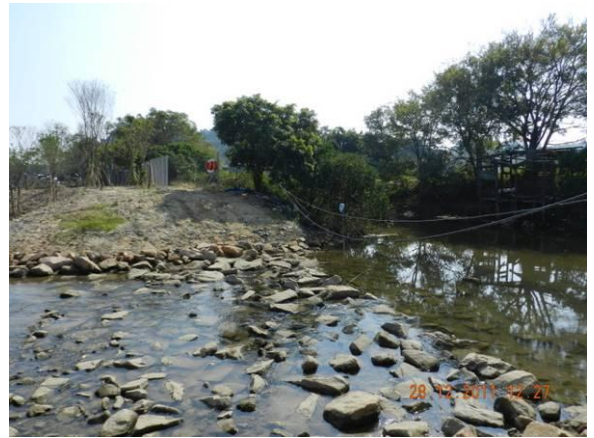
The pond of the ECA was observed to be connected to Wai Ha River directly as following the scheme design of Habitat Compensatory Plan (Photo 2). No direct discharge of turbid water into the adjacent Wai Ha River was observed.

**Photo 2** – No polluted water was observed in the pond of the ECA and the adjacent Wai Ha River.

No specific recommendation is required for Areas A, B and C. As a reminder, the Contractor should regularly check the condition of the drainage pipe and ensure that the used water should be appropriately filtrated and discharged to the manhole/other

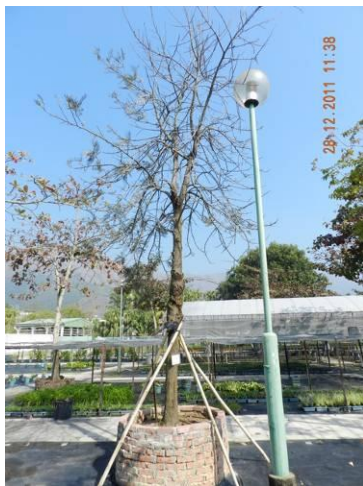
**Photo 3** – Overall view of the transplanted tree U58 *Grevillea robusta*, newly regenerated leaves were observed on the tree branches.

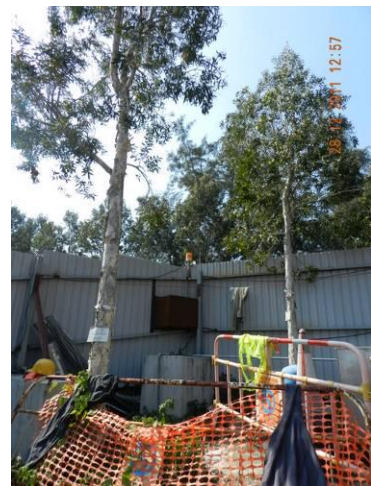
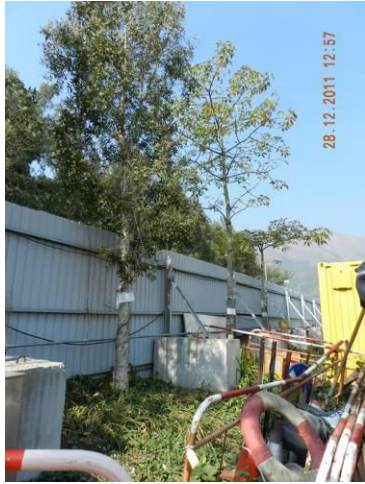
**Photo 4** – Large construction materials that were temporarily stored within the TPZs were removed in Area A.

**Photo 5** – Large construction materials that were temporarily stored within the TPZs were removed in Area A.

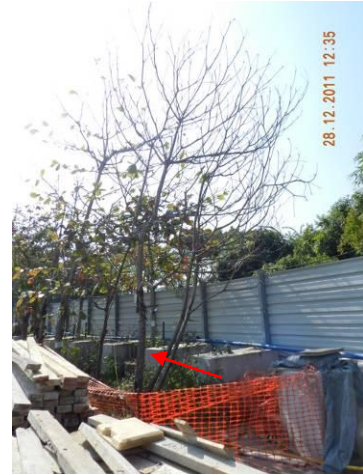
**Photo 6** – Declining health condition of U34.

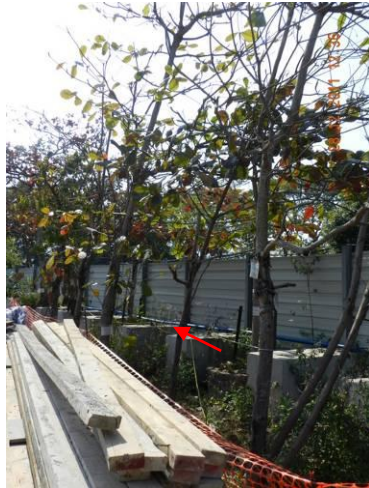
**Photo 7** – Declining health condition of U35.

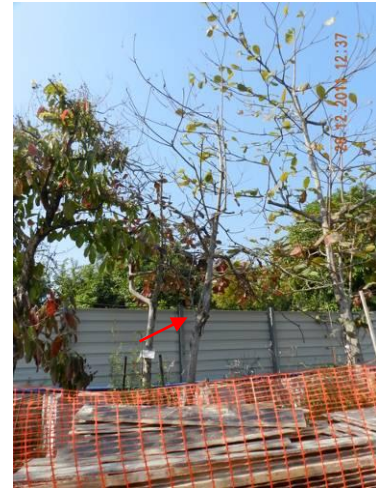
**Photo 8** – Declining health condition of U37.

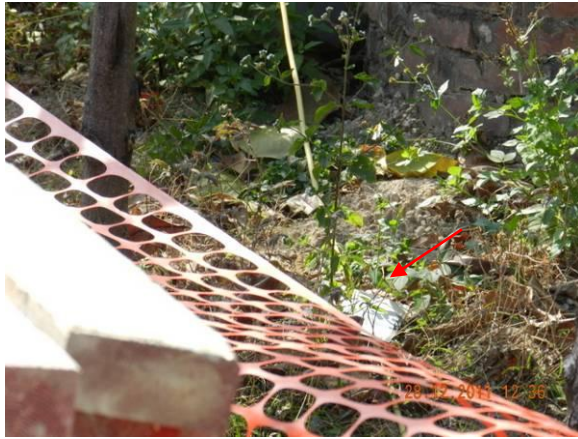
**Photo 9** – Tree tag of U35 was found on the ground.

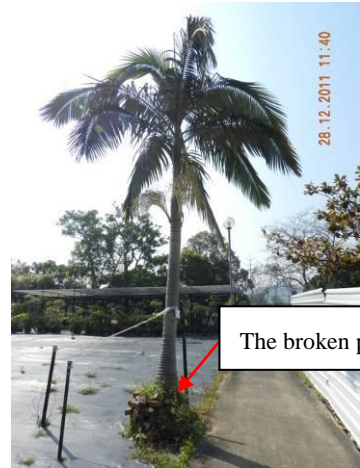
**Photo 10** – Broken planter of A36 in Area B.

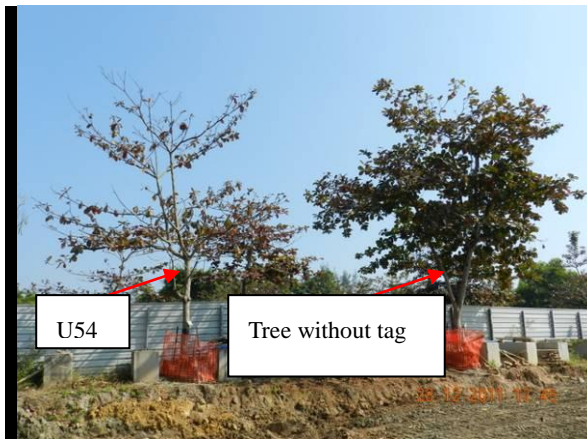
**Photo 11** – Broken planter of U54 and the tree without tree tag on the south of U54 in Area B.

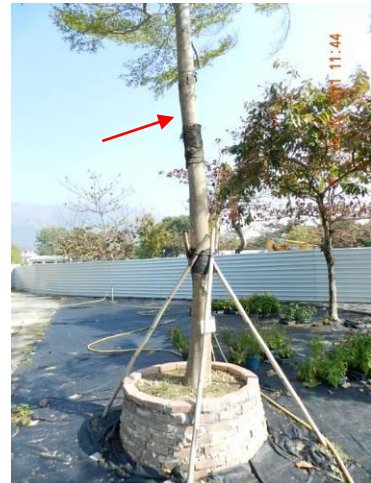
**Photo 12** – The trunk of U57 was covered by a sheet of shading net.

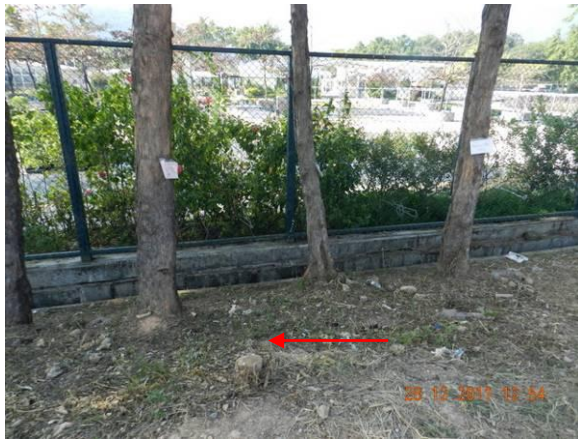
**Photo 13** – Sprouts of T97 was removed by the government department for maintenance practice outside the Tung Tsz Nursery.

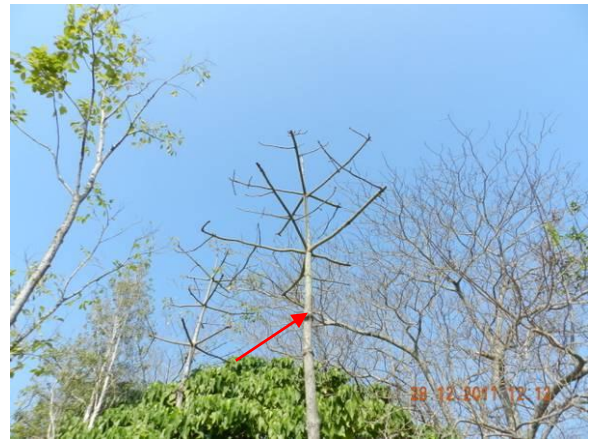
**Photo 14** – Poor condition of the transplanted tree T152 in Area C.

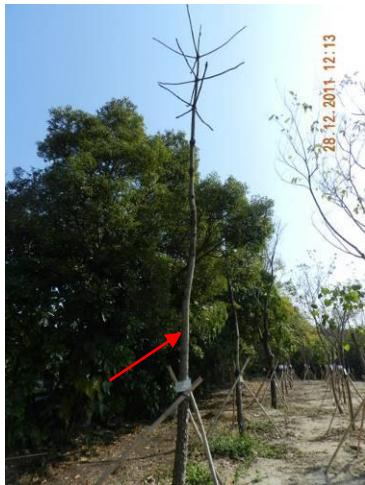
**Photo 15** – Poor condition of the transplanted tree T153 in Area C.

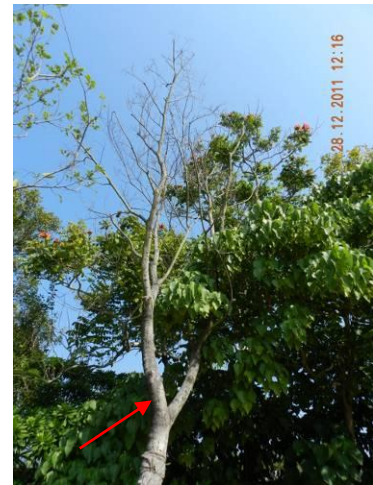
**Photo 16** – Poor condition of the transplanted tree T250 in Area C.

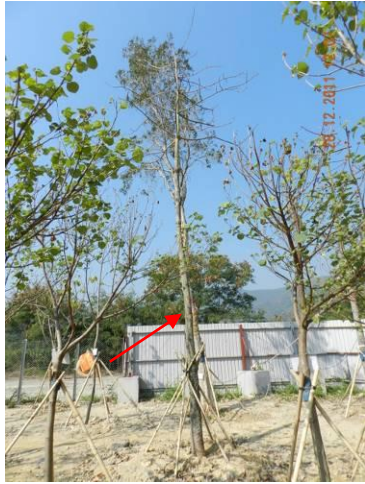
**Photo 17** – Poor health condition of the transplanted tree without tree tag in Area C.

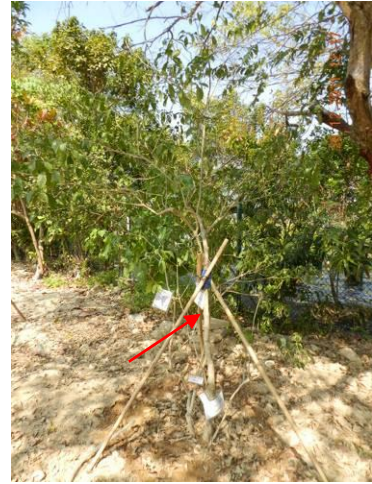
**Photo 18** – The protected shrubs species of conservation interest *Pavetta hongkongensis* (PH01 and PH02) were transplanted to Area C.

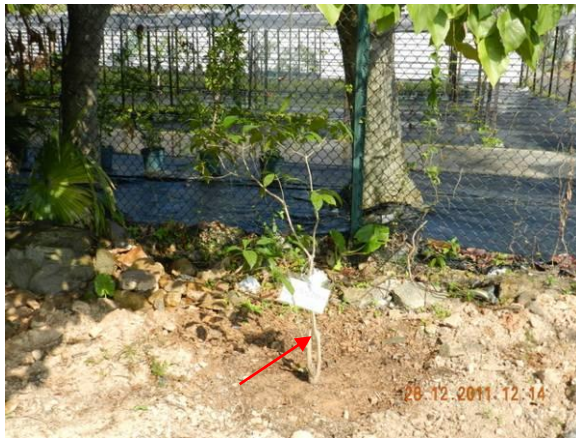
**Photo 19** – The protected shrub species of conservation interest *Pavetta hongkongensis* (PH03) was transplanted to Area C.

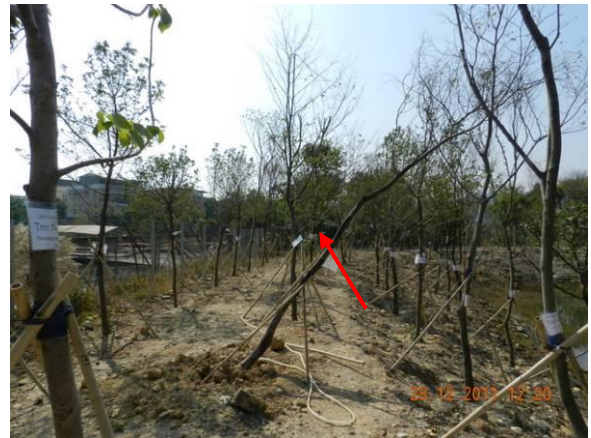
**Photo 20** – The compensatory tree *Celtis sinensis* (N13) was found uprooted and fallen in Area C.

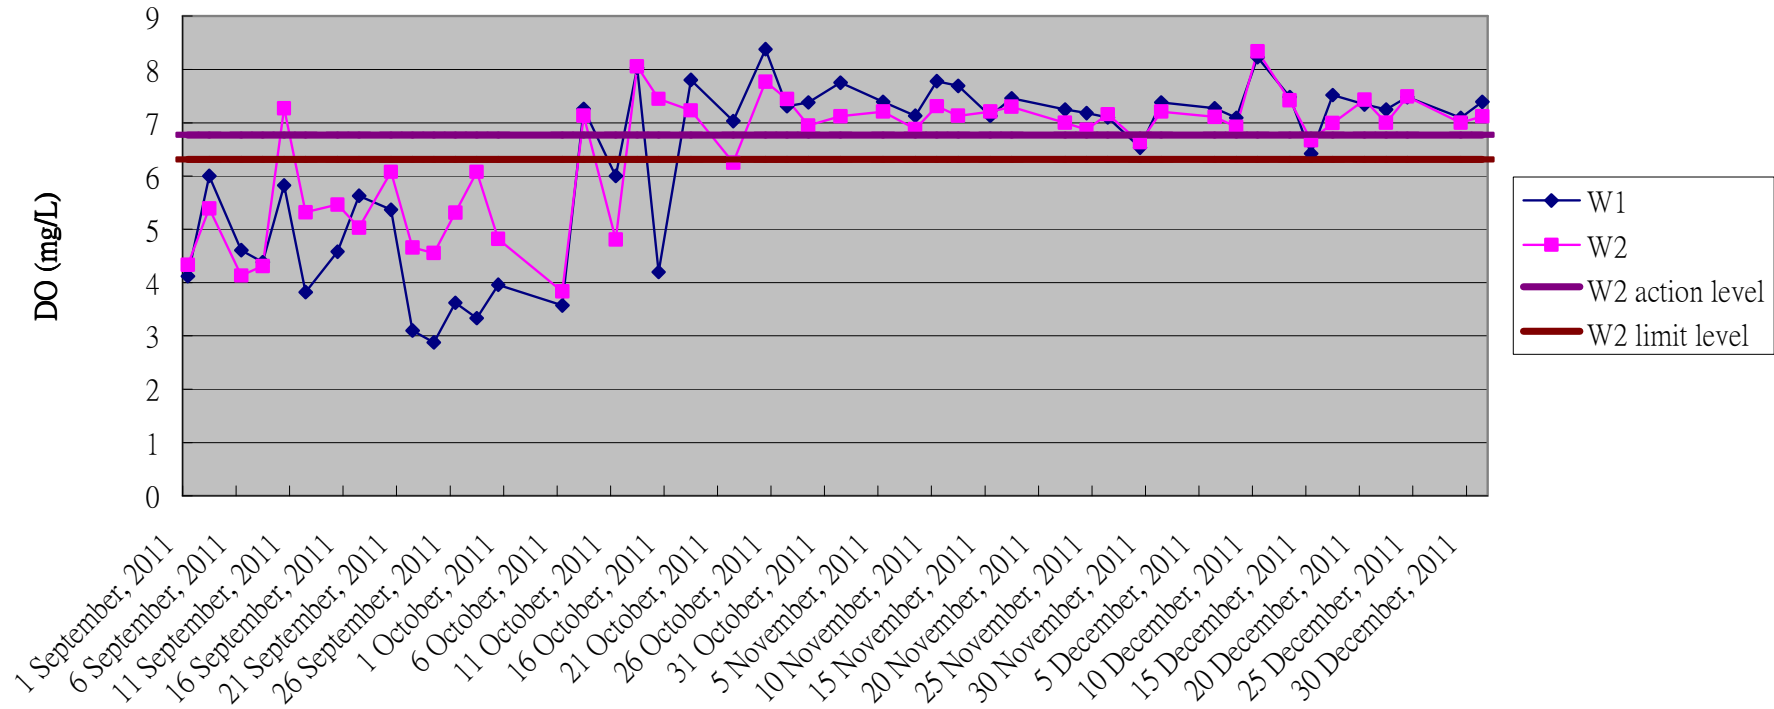
Graphical plots of DO (ebb tide) for W1&W2

Remarks: Action level: 5 percentile of baceline data  
 Limit level: 1 percentile of baceline data

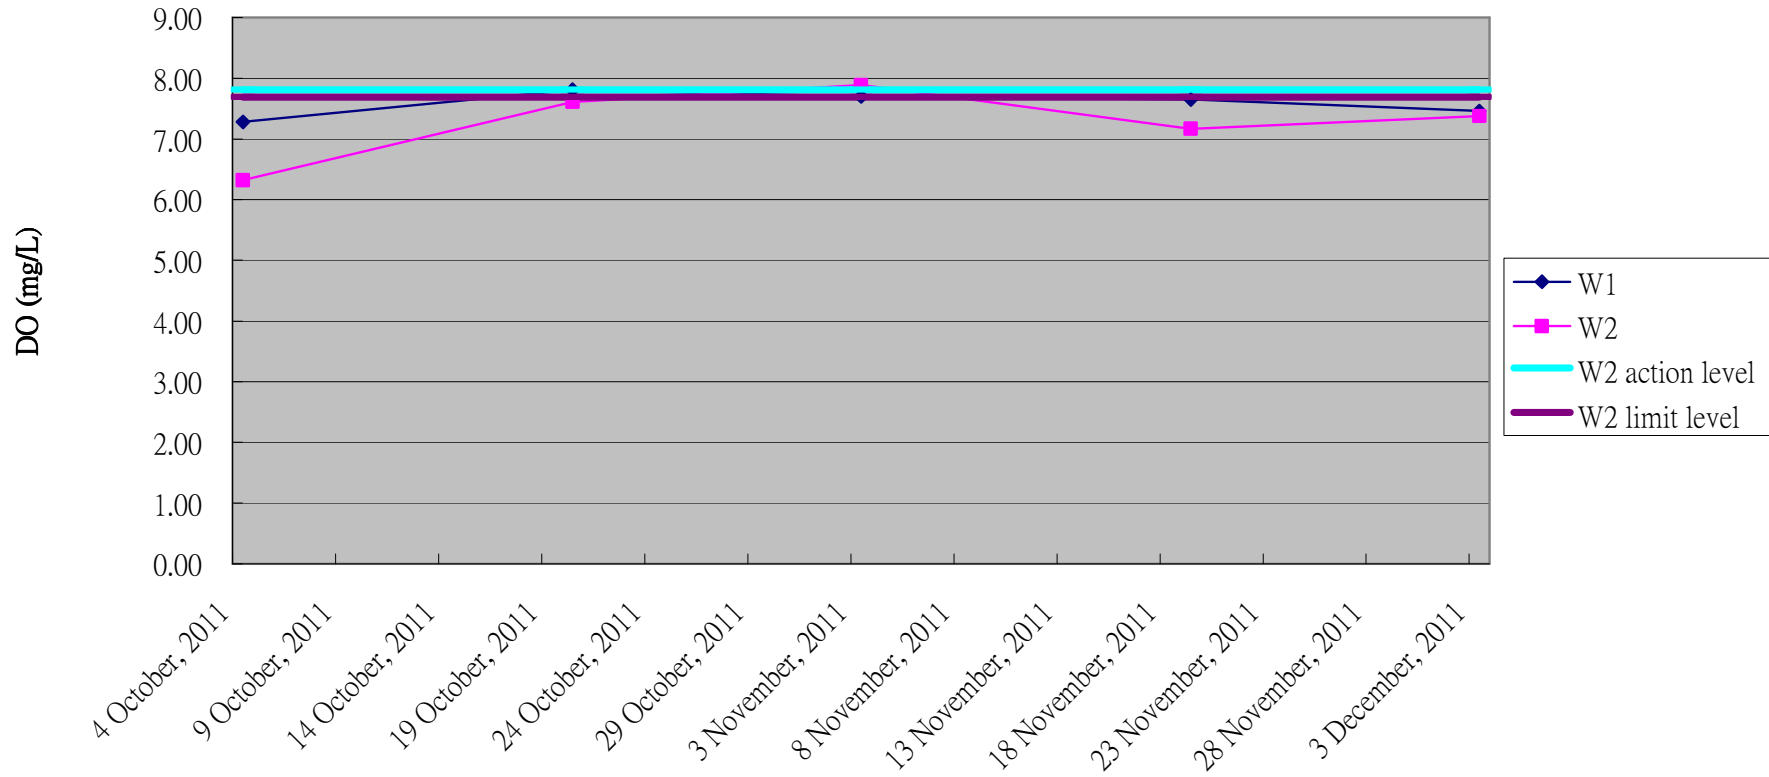
Graphical plot of DO (flood tide) of W1&W2

Remarks: Action level: 5 percentile of baseline data  
Limit level: 1 percentile of baseline data

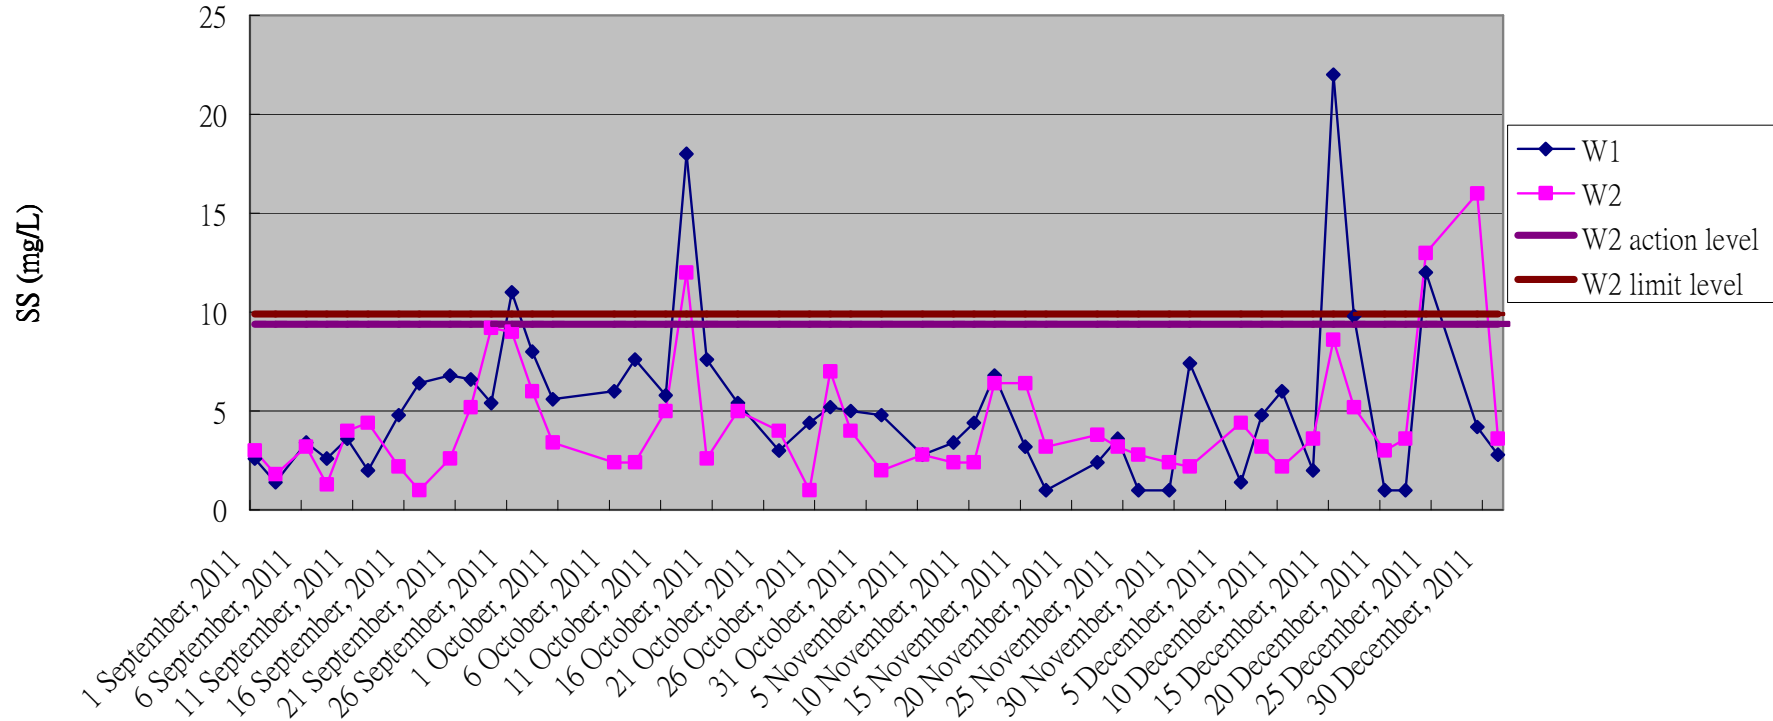
Graphical plots of SS (ebb tide) for W1&W2

Remarks: Action limit is 95% of baseline data or 120% of upstream control station's SS  
 Limit level is 99% of baseline data or 130% of upstream control station's SS

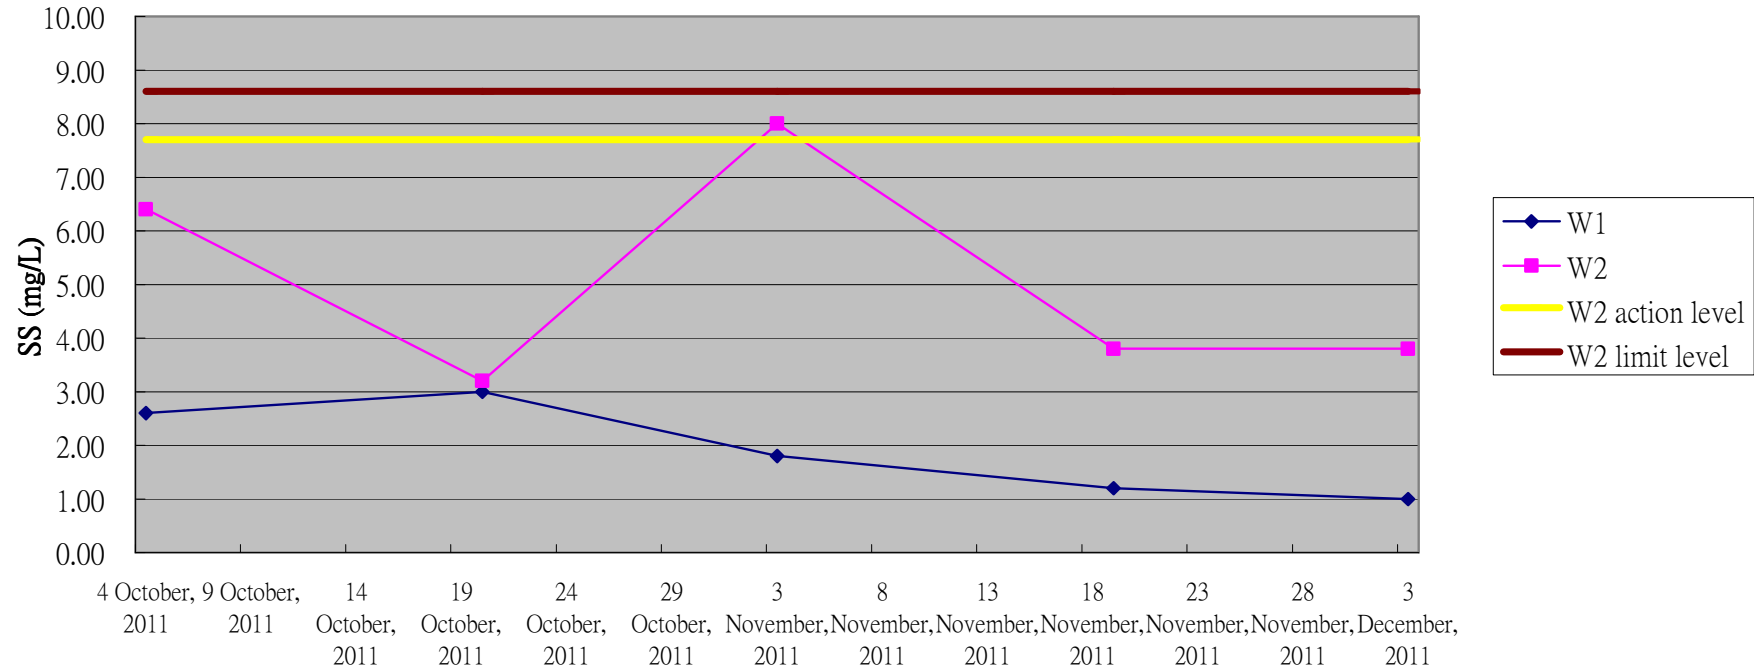
Graphical plots of SS (flood tide) for W1&W2

Remarks: Action limit is 95% of baseline data or 120% of upstream control station's SS  
 Limit level is 99% of baseline data or 130% of upstream control station's SS

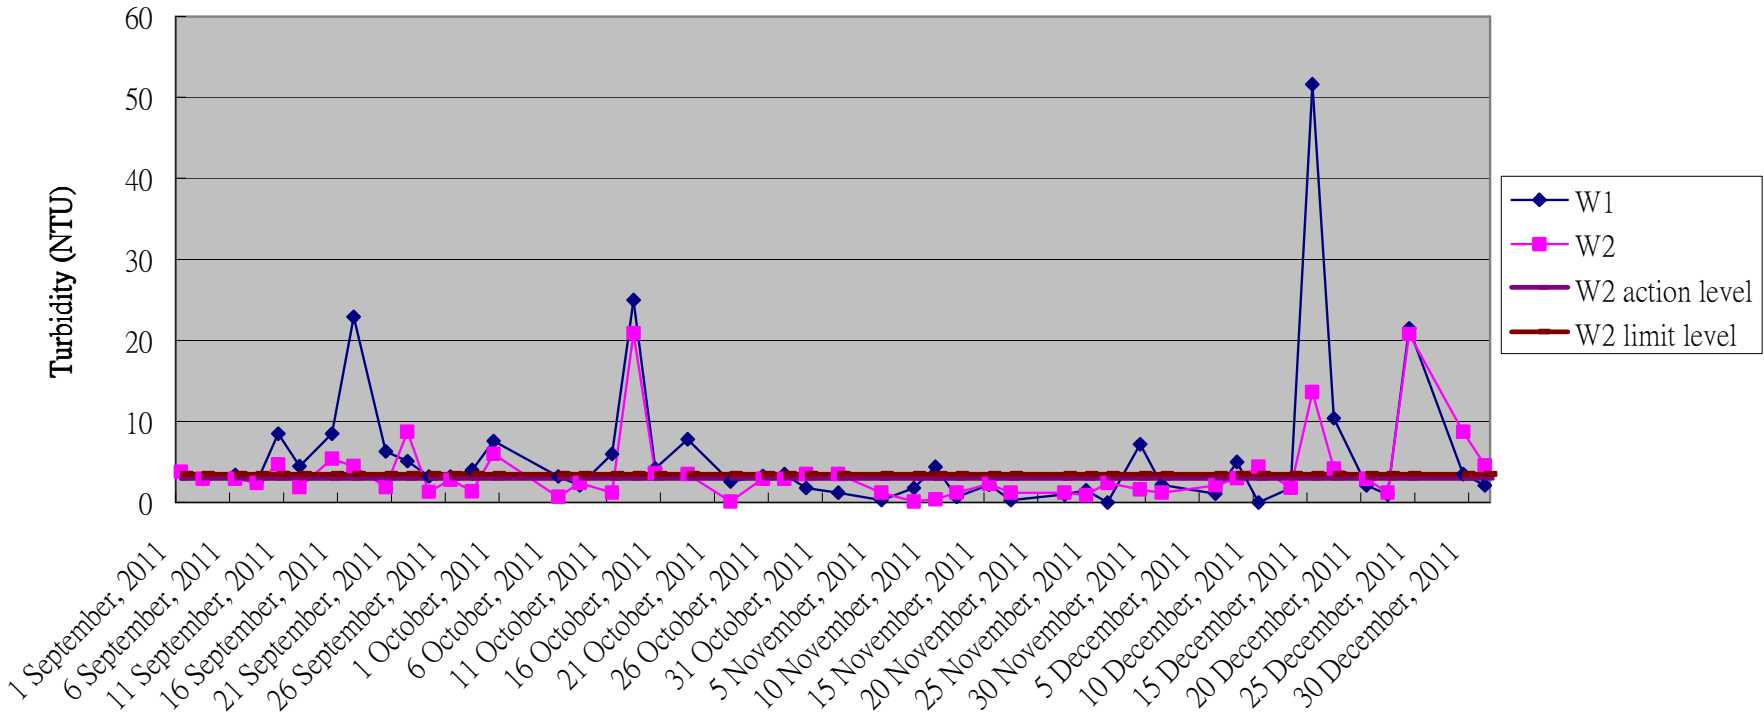
Graphical plots of Turbidity (ebb tide) for W1&W2

Remarks: Action limit is 95% of baseline data or 120% of upstream control station's Turbidity  
 Limit level is 99% of baseline data or 130% of upstream control station's Turbidity

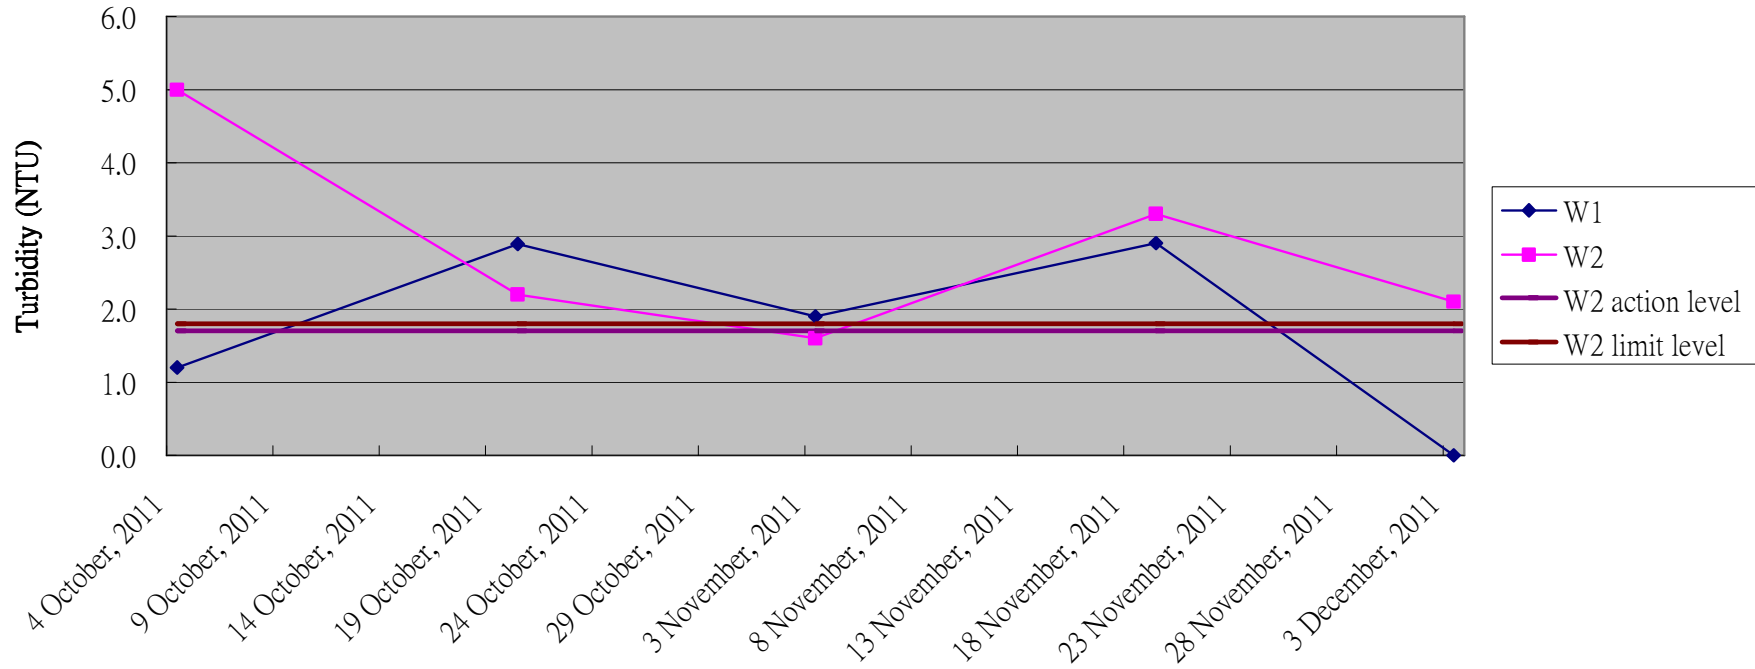
Graphical plots of Turbidity (flood tide) for W1&W2

Remarks: Action limit is 95% of baseline data or 120% of upstream control station's Turbidity  
Limit level is 99% of baseline data or 130% of upstream control station's Turbidity

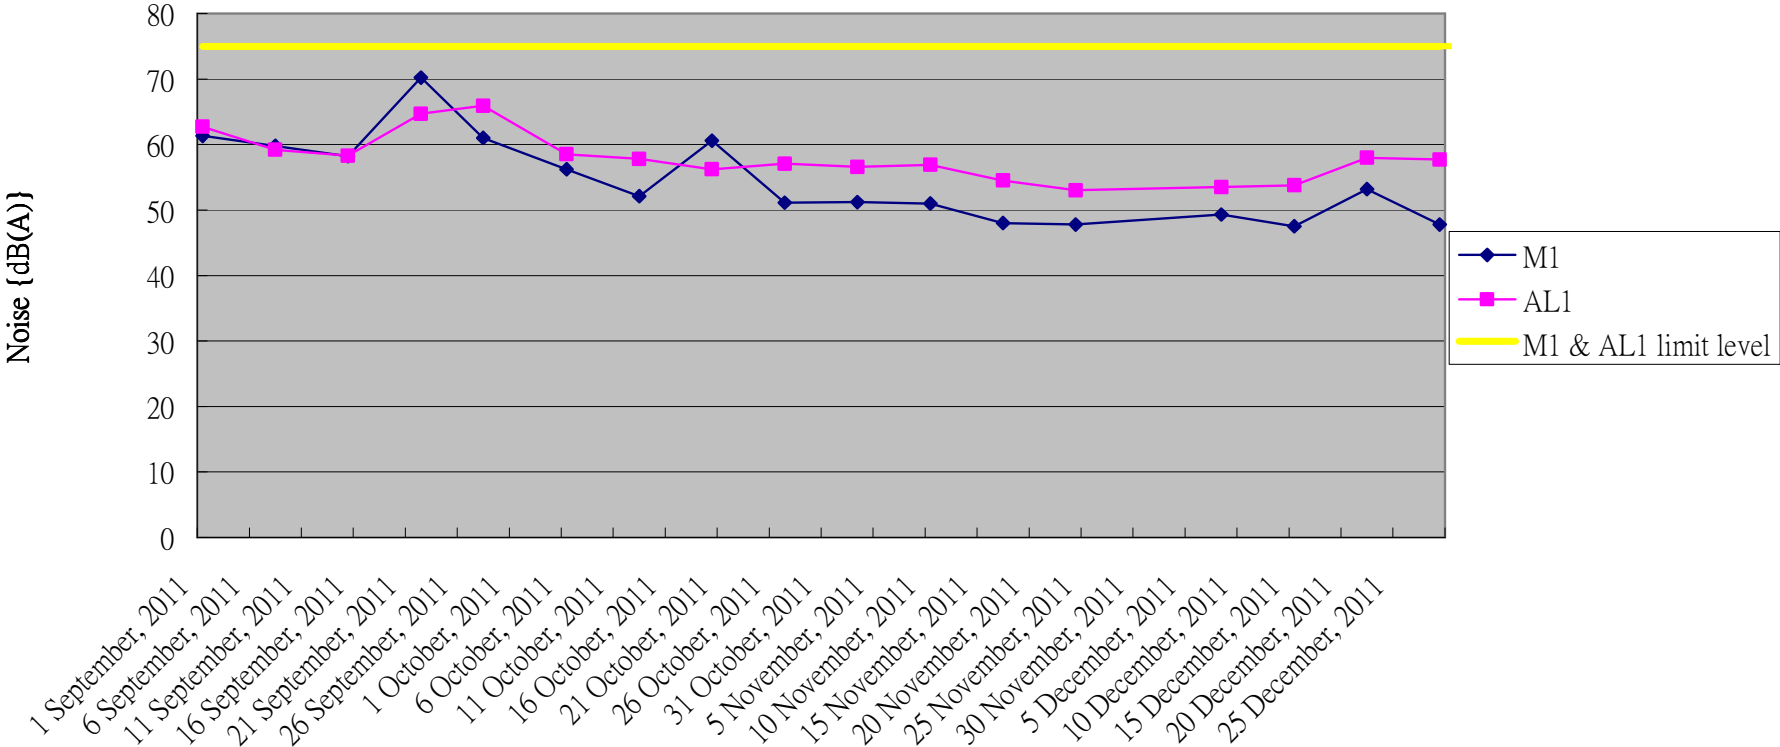
Graphical plots of Noise for M1 & AL1

Relevant details of the noise monitoring results are presented in Table 3.4.1. The results of M1, ranged between 47.5dB (A) and 53.2dB (A), and AL1, ranged between 53.5dB (A) and 58.0dB (A), were within the limit levels and therefore, no exceedance was found.

Remarks: Action limit is when one documented complaint is received

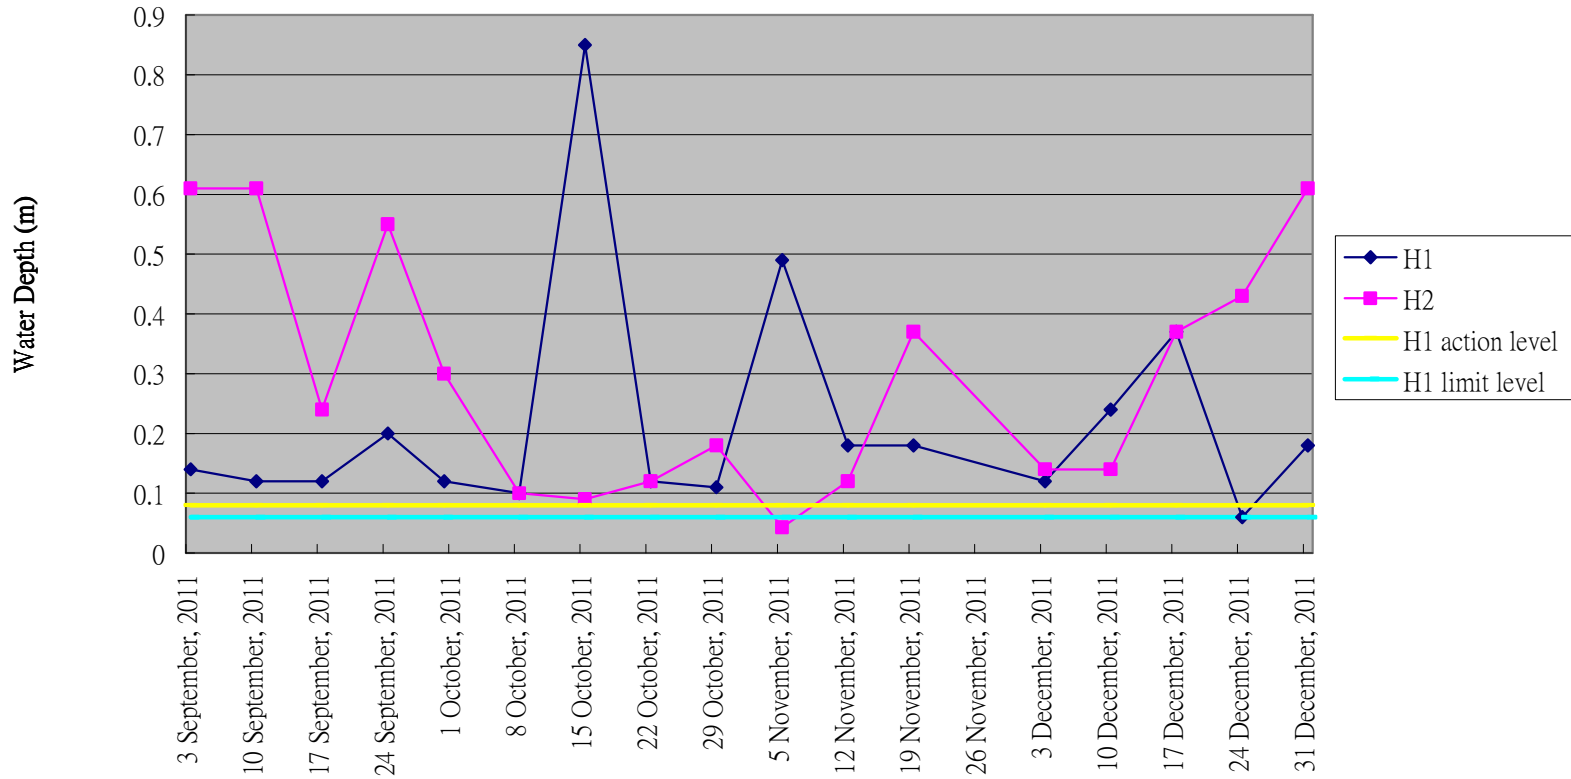
Graphical plots of Hydrological Monitoring(water depth at flood tide) for H1 & H2

Remarks: Action level: 80% of baseline water depth.  
 Limit level: 60% of baseline water depth.

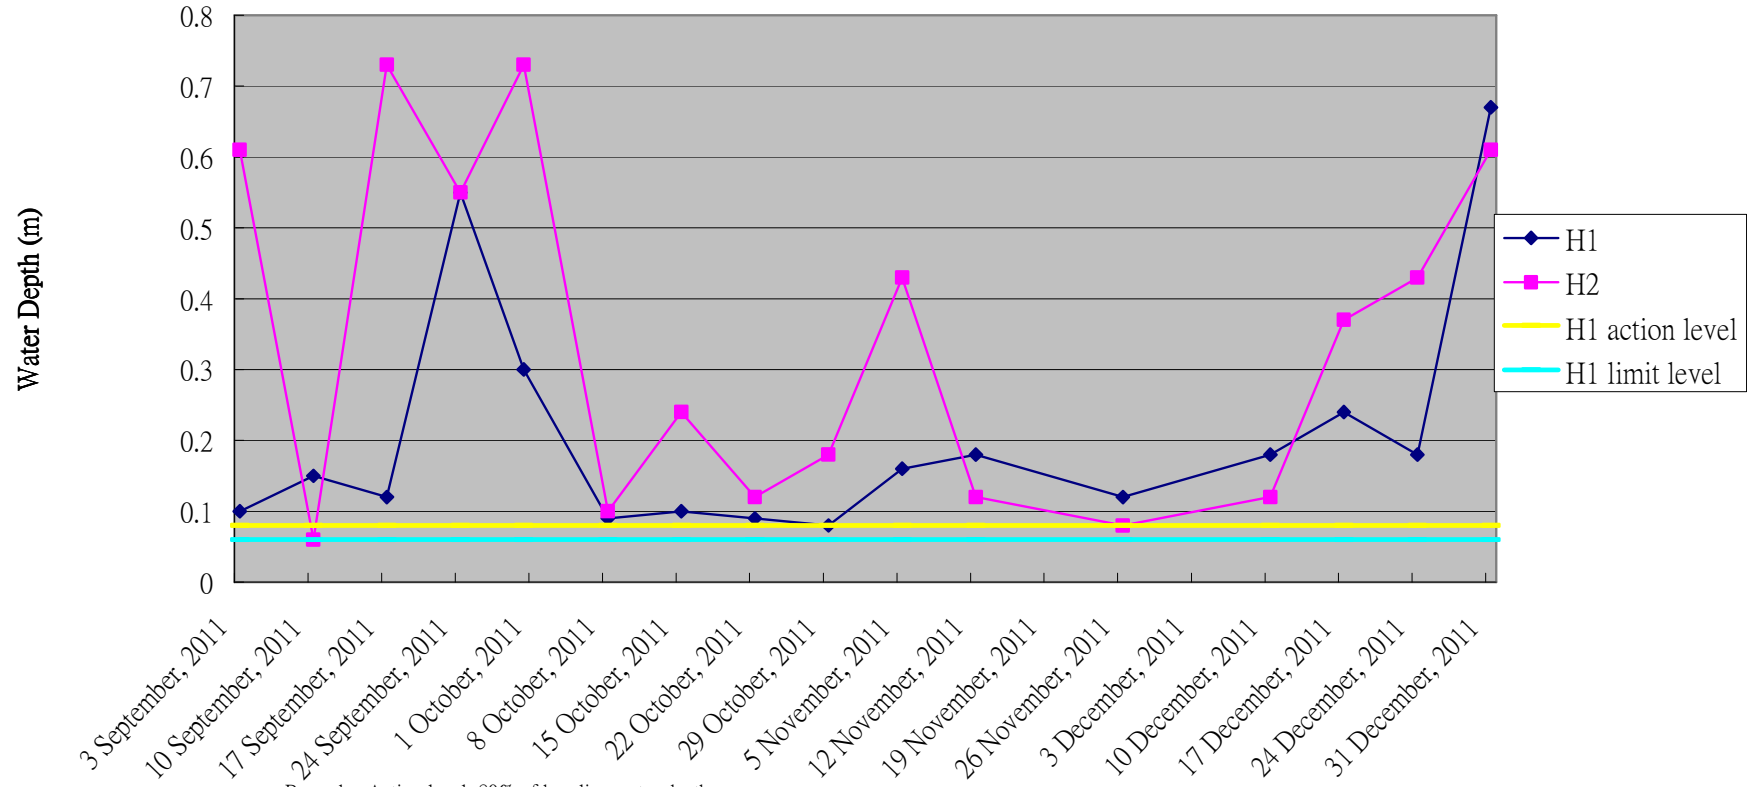
Graphical plots of Hydrological Monitoring(water depth at ebb tide) for H1 & H2

Remarks: Action level: 80% of baseline water depth.  
 Limit level: 60% of baseline water depth.

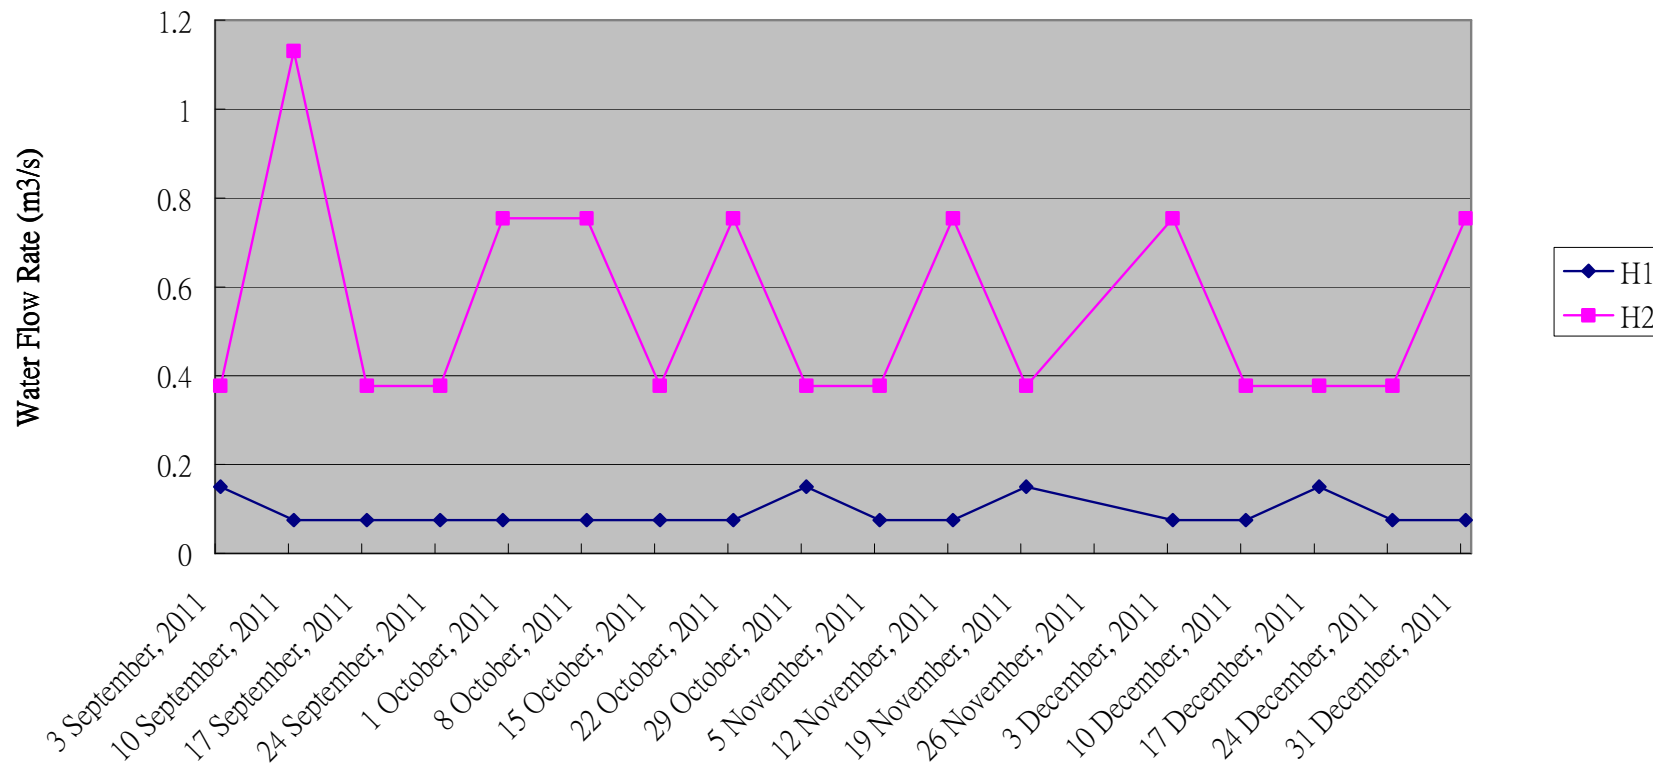
Graphical plots of Hydrological Monitoring(water flow rate at flood tide) for H1 & H2

Remarks: Action level: 120% of control station's water flow rate on the same day of measurement.  
 Limit level: 140% of control station's water flow rate on the same day of measurement.
