**Monthly Environmental Monitoring & Auditing report for**

**Contract No.DC/2009/22**

**Drainage Improvement in Shuen Wan, Tai Po – Contract 1**

**December 2011**

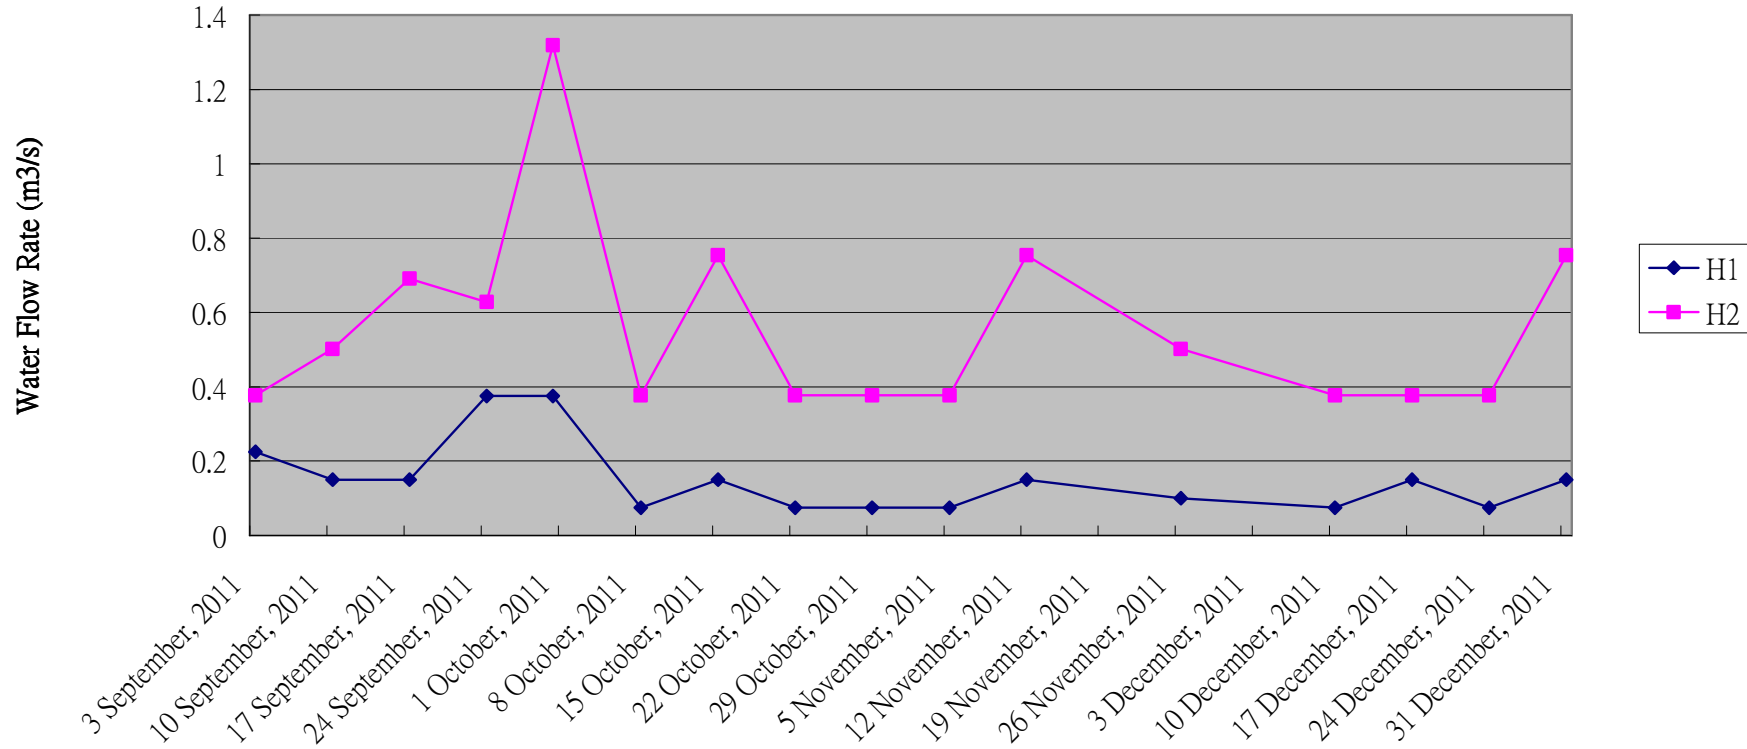
Graphical plots of Hydrological Monitoring(water flow rate at ebb tide) for H1 & H2

Remarks: Action level: 120% of control station's water flow rate on the same day of measurement.

Limit level: 140% of control station's water flow rate on the same day of measurement.

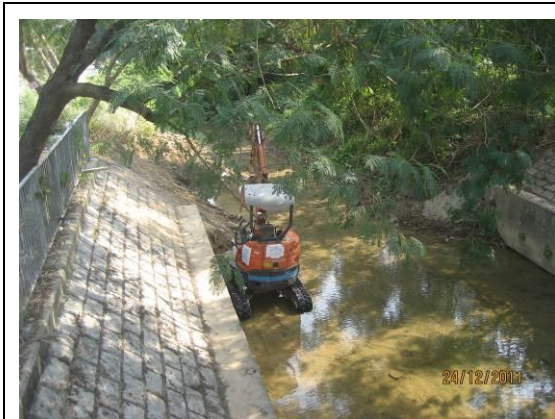
**Photo7. Excavation Works from other construction site at upstream**

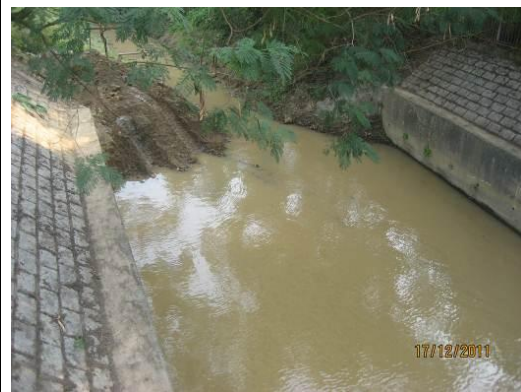
**Photo8. pollution by other construction site at upstream**
