PROJECT NO.: TCS/00553/11

CONTRACT NO. DC/2010/02 – DRAINAGE IMPROVEMENT IN SHUEN WAN AND SHEK WU WAI

MONTHLY ENVIRONMENTAL MONITORING AND AUDIT REPORT (NO.6) – DECEMBER 2011

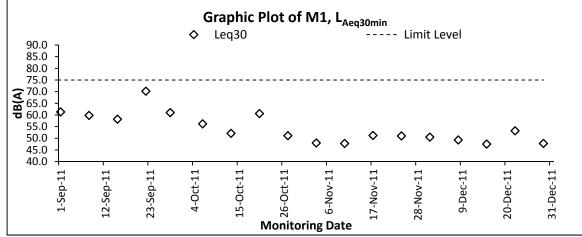
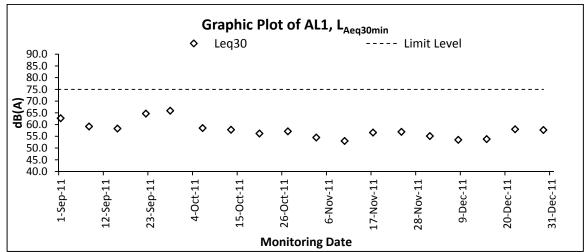
Graphic Plot – Construction Noise

Remark: The monitoring is undertaken under façade situation. No façade correction is added according to acoustical principles and EPD guidelines.

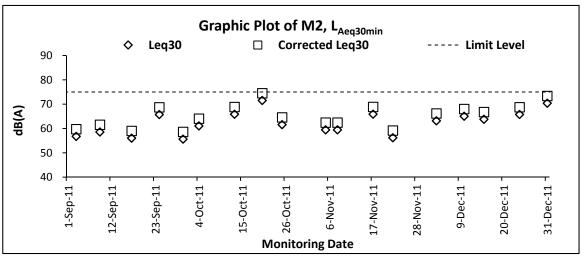
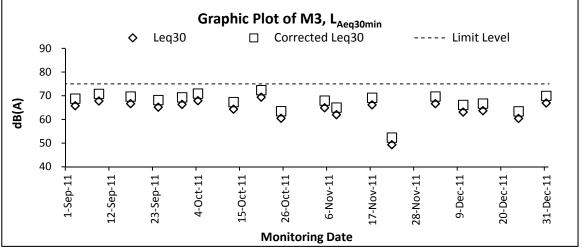
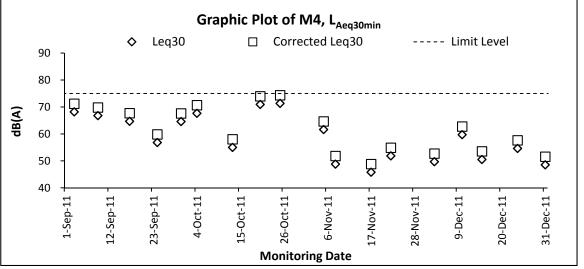
Remark: The monitoring is undertaken under free field situation. A façade correction of $+3 \, dB(A)$ has been added according to acoustical principles and EPD guidelines

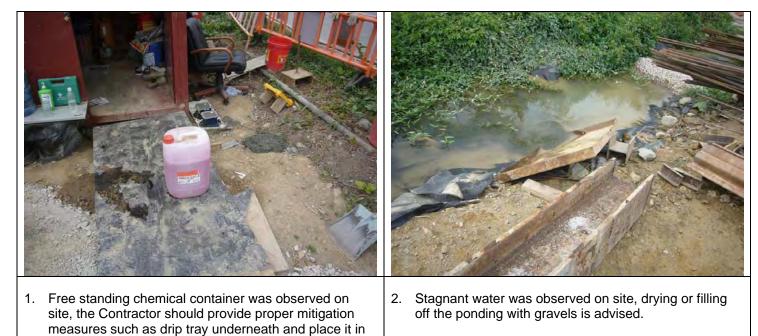
Observations recorded in this Site Inspection (21-12-2011):

21 Dec 11	 Free standing chemical container was observed on site, the Contractor should provide proper mitigation measures such as drip tray underneath and place it in the chemical storage area after use. Stagnant water was observed on site, drying or filling off the ponding with gravels is advised. 	The observations have been rectified before the site inspection on 29 Dec 2011
29 Dec 11	• Stagnant water was observed on site, the Contractor is advised to improve the drainage system of the ponding.	The observation has been rectified before the site inspection on 5 Jan 2012.

the chemical storage area after use.

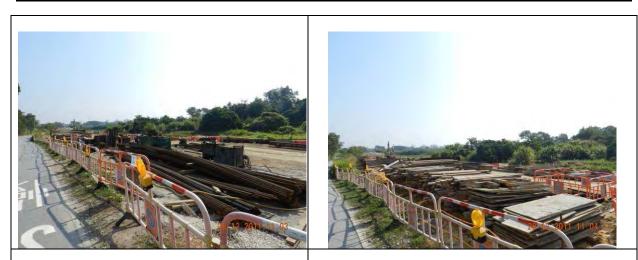
Photo 1 - Temporary hoardings have been
erected around the active works areaPhoto 2 - Temporary hoardings have been
erected along Tung Tsz Road

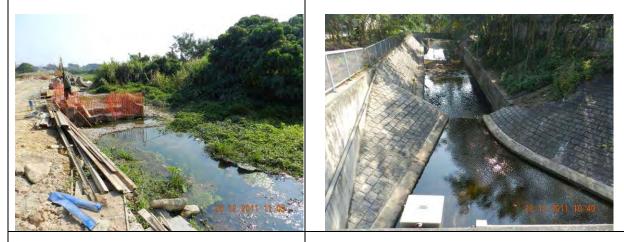
Photo 3 – Sedimentation tank for water drained from the underground

Photo 4 – Upper stream of Wa Ha River. No direct water discharge into the Wai Ha River since no active construction work from the Project has been commenced adjacent to the River.

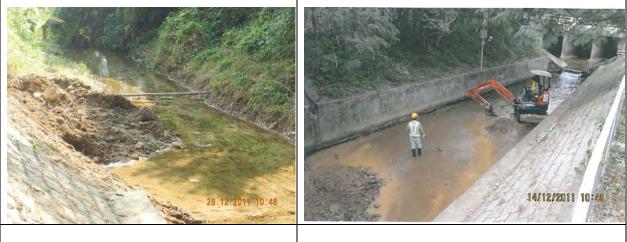
Photo 5 – Stockpiled soil was observed at the bank of the Wai Ha River during the monitoring on 28th December 2011.

Photo 6 – Excavation work was conducted by other contractor in the Wai Ha River on 14^{th} December 2011 (Photo provided by the Main Contractor).

• Large stockpiles of soil were observed on	water body adjacent to the Project
	15th and 28th December 2011 at the bank of	Area by any contract work other
	Wai Ha River to the southwest of Wai Ha.	than the current Project, the
	The Main Contractor was immediately	contractor and the Project Proponent
	contacted. It was found that the stockpiled	should have routine inspection
	soil was formed by other contractor for the	within and adjacent to the Project
	excavation work other than the current	Area and the Wai Ha River.
	Project. The soil was stockpiled along the	
	river bank to ease the access of a small-scale	
	dredger to undertake the excavation work in the section of the Wei He Biyer leasted to	
	the section of the Wai Ha River located to	
	the northeast of Tai Po Area 5 Sewage Treatment Works	
Existing Trees		• Within the active works area proper
within Works	• No further tree felling work was observed in this month. Clearance of	• Within the active works area, proper TPZs should be demarcated for the

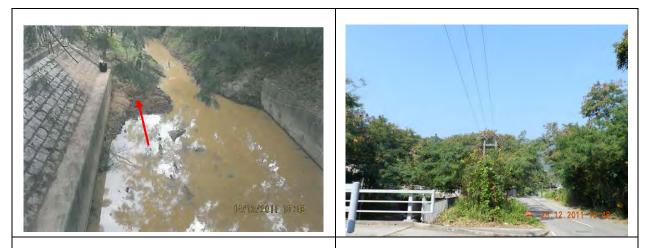
Photo 7 – Soil was stockpiled at the bank of the Wai Ha River for the excavation work (Photo provided by the Main Contractor).

Photo 8 – Excessive pruning and topping of T075 and T076.

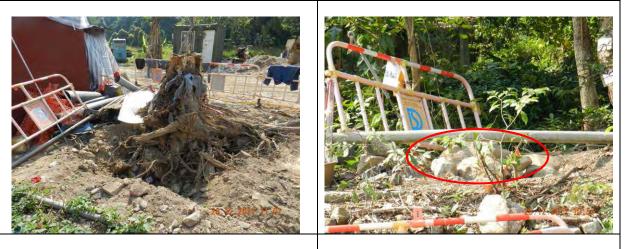
Photo 11 – The protected shrubs of *P. hongkongensis* (PH01 and PH02) were transplanted, leaving the wood debris at their original locations.

Photo 12. The protected shrub of *P. hongkongensis* (PH03) was transplanted and the excavated planted hole was filled with stones after the transplantation.
