**CONTRACT NO. DC/2010/02 –
DRAINAGE IMPROVEMENT IN SHUEN WAN AND
SHEK WU WAI**

**MONTHLY ENVIRONMENTAL MONITORING AND
AUDIT REPORT (NO.7) – JANUARY 2012**

PREPARED FOR
KWAN LEE-KULY JOINT VENTURE

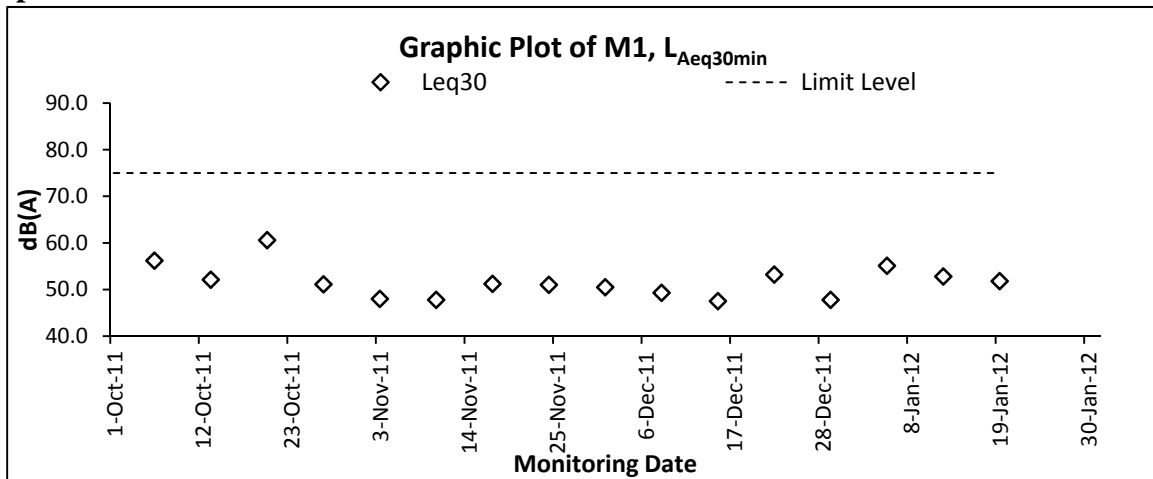
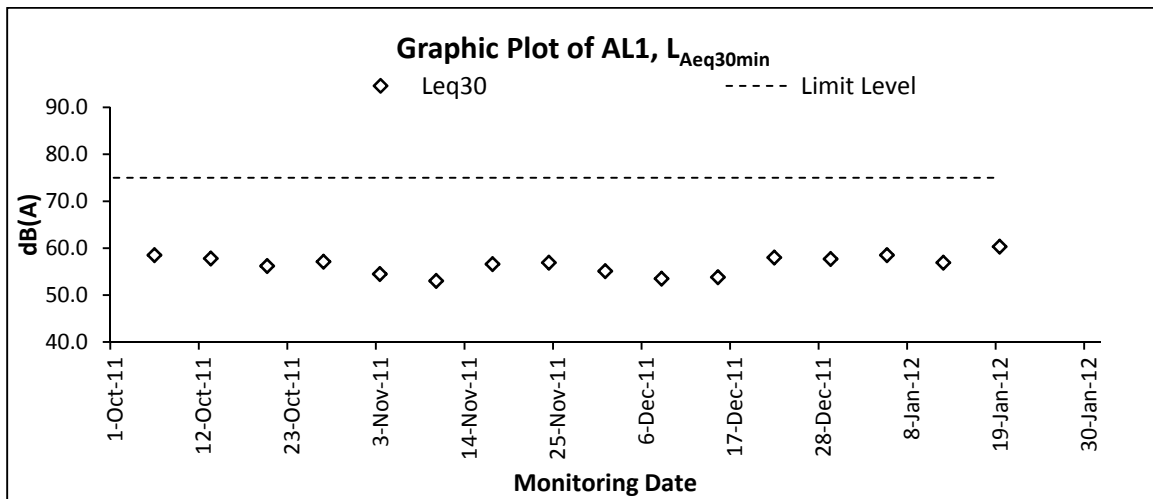
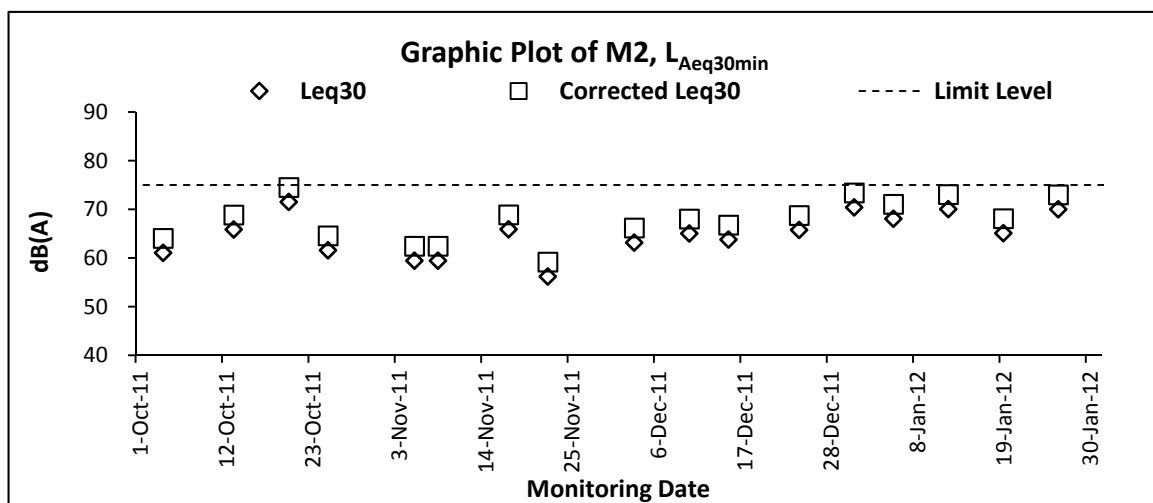
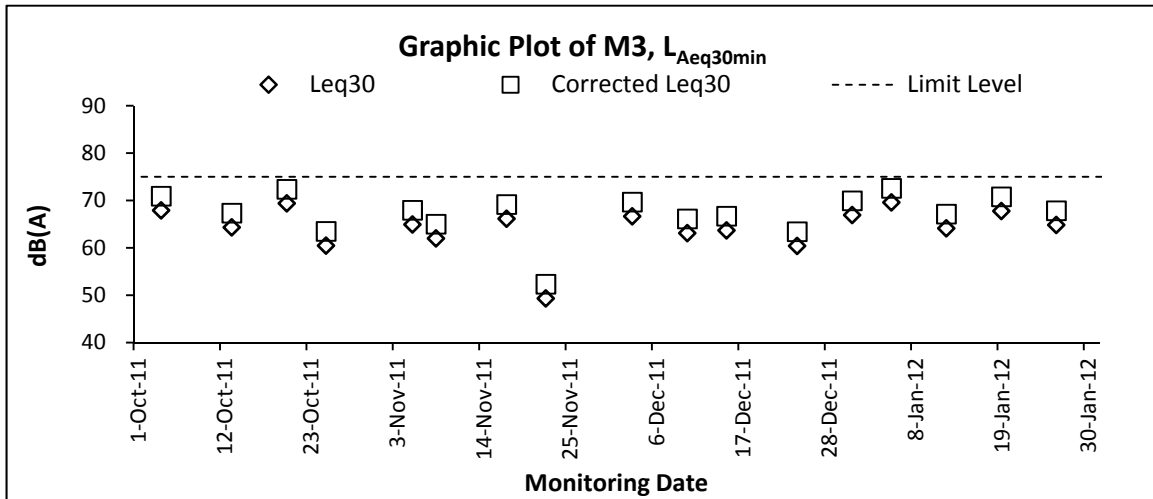
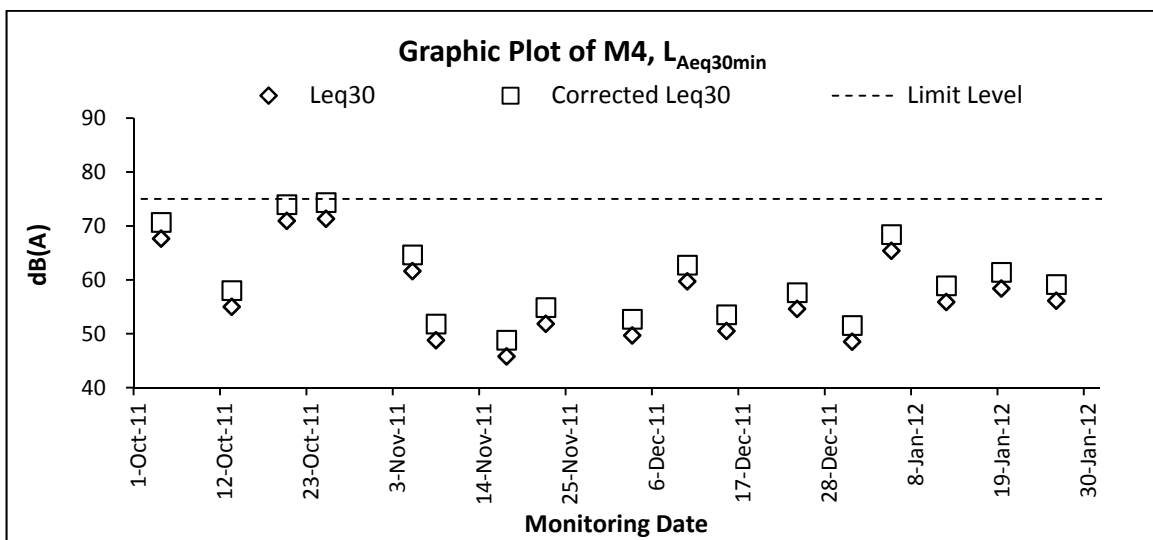
Graphic Plot – Construction Noise

Remark: The monitoring is undertaken under façade situation. No façade correction is added according to acoustical principles and EPD guidelines.

Remark: The monitoring is undertaken under free field situation. A façade correction of +3 dB(A) has been added according to acoustical principles and EPD guidelines

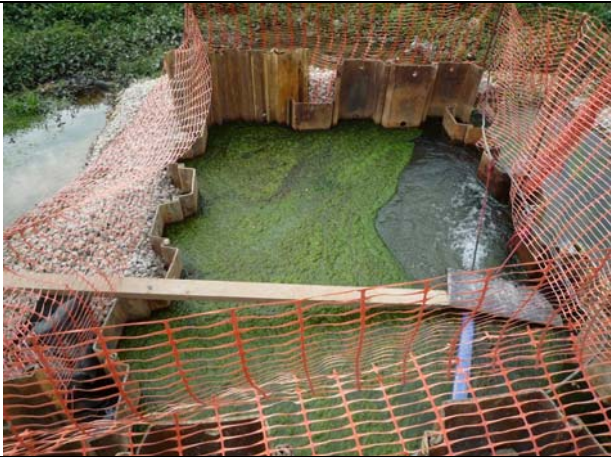
<p>1) The algae and mud accumulated in the sedimentation tanks should be cleaned regularly in order to maintain its functioning.</p>

<p>2) Chemical container should be stored in proper area with drip tray provided.</p>	
<p>As a reminder, the Contractor should properly implement the air quality mitigation measure such as covering of soil stockpile and cleaning of exit of the site before public holiday.</p>

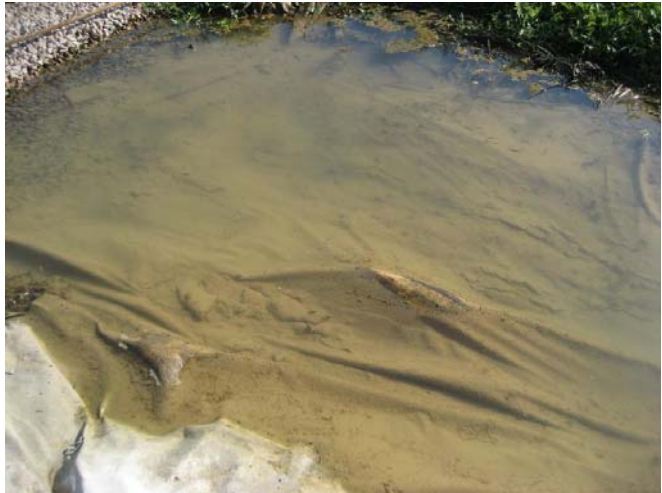
<ol style="list-style-type: none"> 1) The algae and mud accumulated in the sedimentation system should be cleaned regularly in order to maintain its functioning.

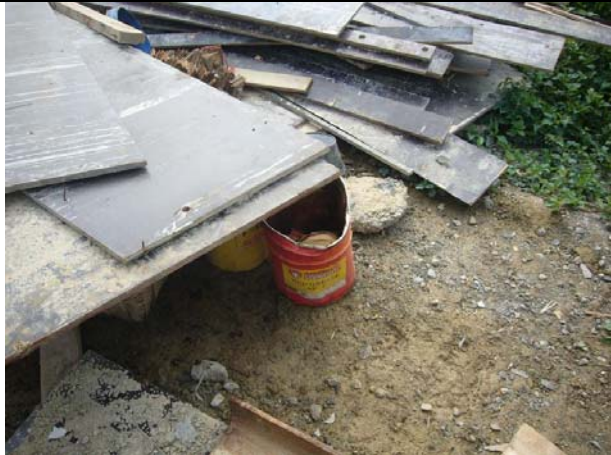
<p>Free chemical container was found standing on bare ground, the Contractor should store them in proper area with drip tray provided to avoid chemical leakage.</p>

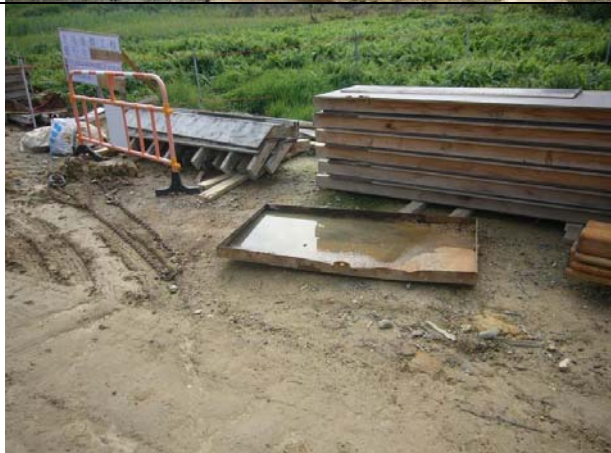
<p>1) Stagnant water accumulated in the trip tray was observed after rainfall, the Contractor should clean it to avoid mosquito breeding.</p>

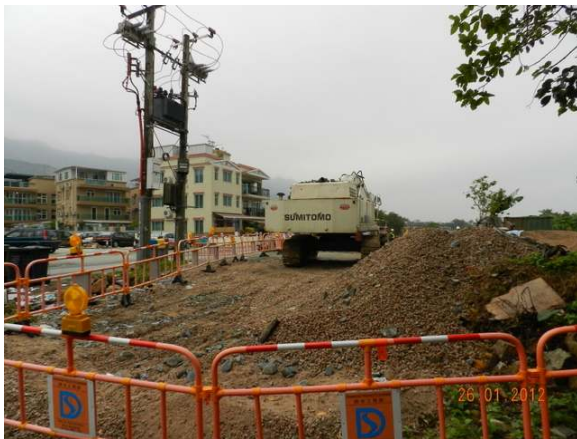
Photo 1 – Temporary hoardings have been erected around the active works area.

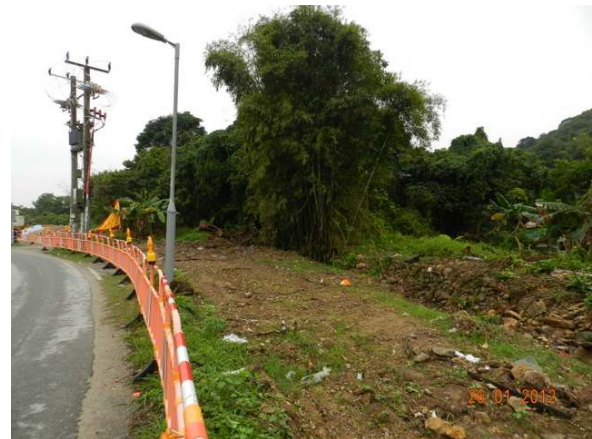
Photo 2 - Temporary hoardings have been erected along Tung Tsz Road.

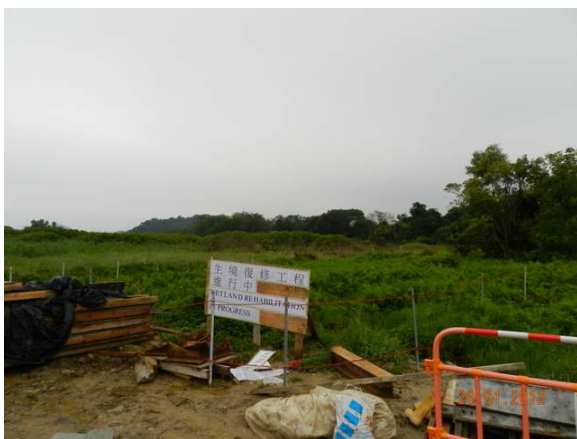
3.2.4 As observed on 26th January 2012, a wetland rehabilitation area, which has been maintained by parties other than the Project Proponent, the Project's Contractor and Sub-contractors, has been demarcated to the southeast of Jade View Villa and adjacent to the active works area (**Photo 3**).

Photo 3 – Wetland rehabilitation area was observed adjacent to the active works area.

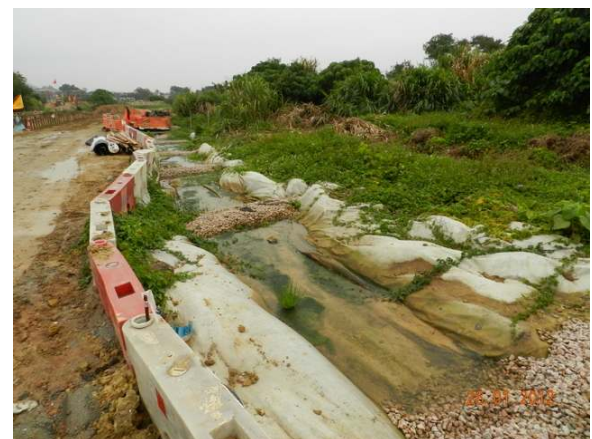
Photo 4 – Sedimentation tank for water drained from the underground.

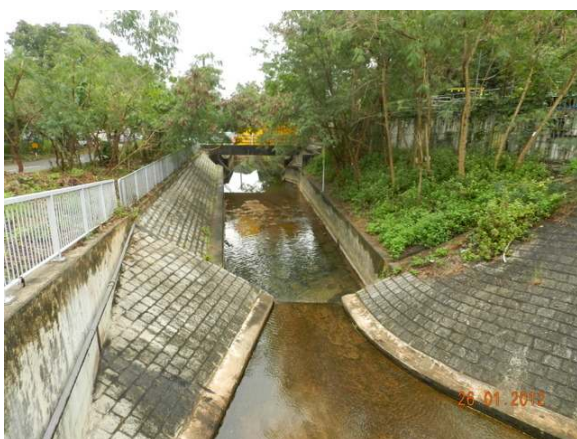
Photo 5 – Upper stream of Wa Ha River. No direct water discharge into the Wai Ha River since no active construction work from the Project has been commenced adjacent to the River.

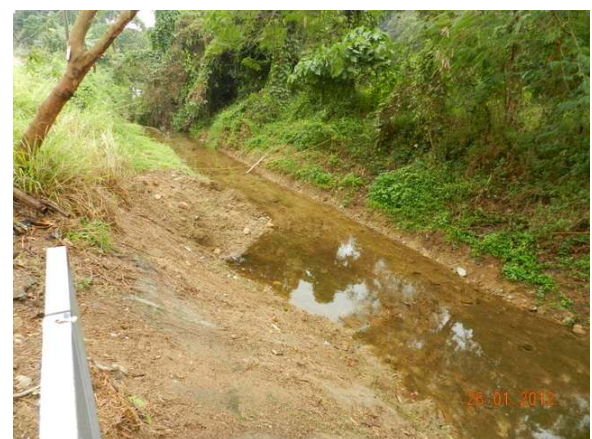
Photo 6 – Stockpiled soil was still observed at the bank of the Wai Ha.

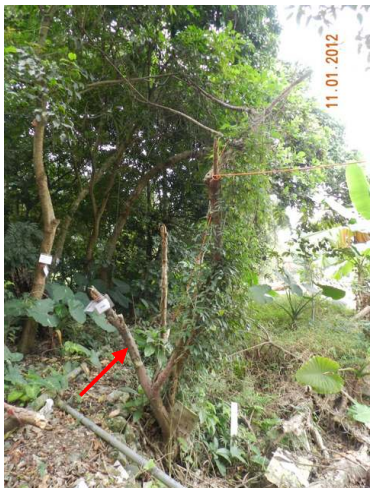
<p>Photo 7 – Retain tree T180 was suspected dying.</p>	<p>Photo 8 – Pruned and topped trees T075 and T076.</p>

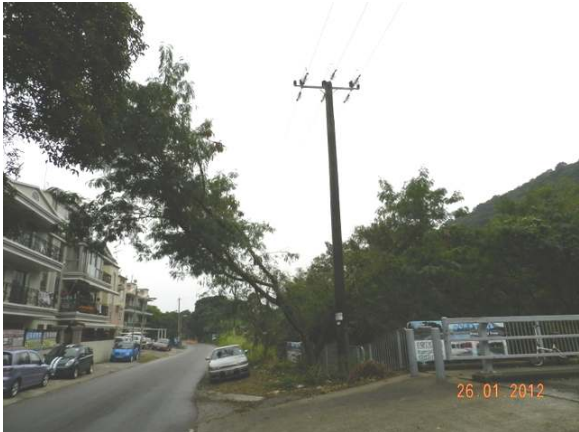
<p>Photo 9 – Pruned and topped trees (T069-T073) along Tung Tsz Road. Regeneration of branches and leaves was slow.</p>	<p>Photo 10 – A TPZ has been established around the Tree T025 and the stockpiled soil around the tree trunk base was removed.</p>

Parameter	Observation	Recommendation
	<p>(Tree no. T069 – T073 and T075) and <i>Macaranga tanarius</i> (血桐) (Tree no. T076) located close to the Project's site office were recorded in the monitoring in December 2011 (Photos 8-9). Regeneration of branches and leaves around the wounds was slow.</p> <ul style="list-style-type: none"> • A TPZ was observed for the tree T025, which is regarded as a "Retained Tree" in accordance with the approved Tree Felling Application Report. Stockpiled soil around the tree trunk base was removed as following the recommended stated in the Monthly EM&A Report for December 2011. • A fallen scaffold branch was observed on the retained tree T168. This tree has been extensively covered by the weedy climbers, which has put additional loading to the tree canopy. This excessive loading to the tree canopy could increase the limb breakage. • No significant signs of damage on other existing tree crowns, trunks and roots resulting from the construction works were observed in this monthly monitoring. • Three specimens (Tree No.: PH01, PH02 and PH03) of the protected shrub species of conservation interest <i>Pavetta hongkongensis</i> was transplanted to Area C under Contract 1 of the Project since December 2011. The dead specimen (Tree No.: PH04, due to natural dieback) was still remained at its original location. 	<ul style="list-style-type: none"> • Disturbance is prohibited in all TPZs. In any practical circumstances, the contractor should follow Section 8 of Annex 4 of the approved Landscape Plan for protecting the existing trees from any potential damages resulting from the construction works. In addition, the Main Contractor and the Project Proponent should have routine inspection on any tree remedial works conducted by other party on the trees within the Project Area.

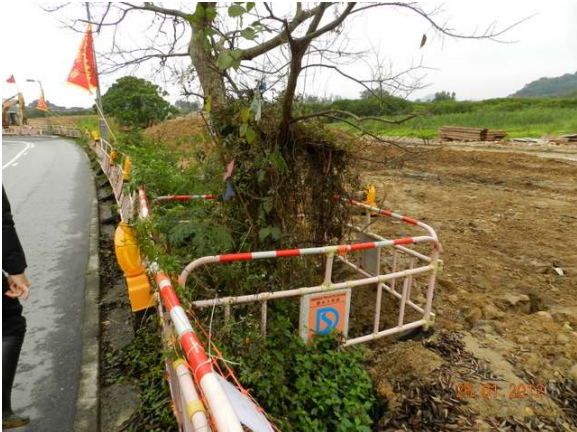
- 3.6.5 A TPZ was observed for the tree T025, which is regarded as a "Retained Tree" in accordance with the approved Tree Felling Application Report (**Photo 10**). Stockpiled soil around the tree trunk base was removed as following the recommended stated in the *Monthly EM&A Report for December 2011*.

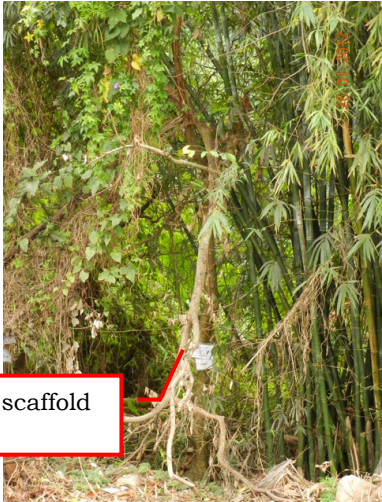
<p>Photo 11 – A fallen scaffold branch was observed on the retained tree T168.</p>	<p>Photo 12 – The protected shrubs of <i>P. hongkongensis</i> (PH01 and PH02) were transplanted to Area C under Contract 1.</p>

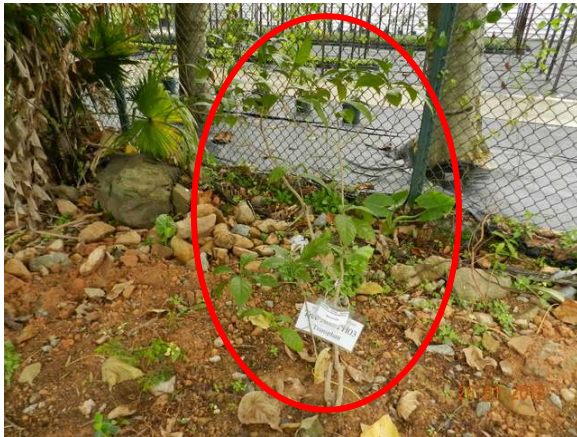
Photo 13. The protected shrub of *P. hongkongensis* (PH03) was transplanted to Area C under Contract 1.

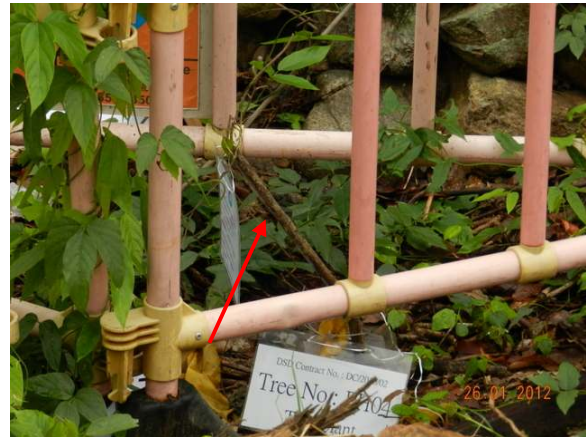
Photo 14 – The dead *P. hongkongensis* PH04 was remained in the same location. Climber was observed on this dead specimen.

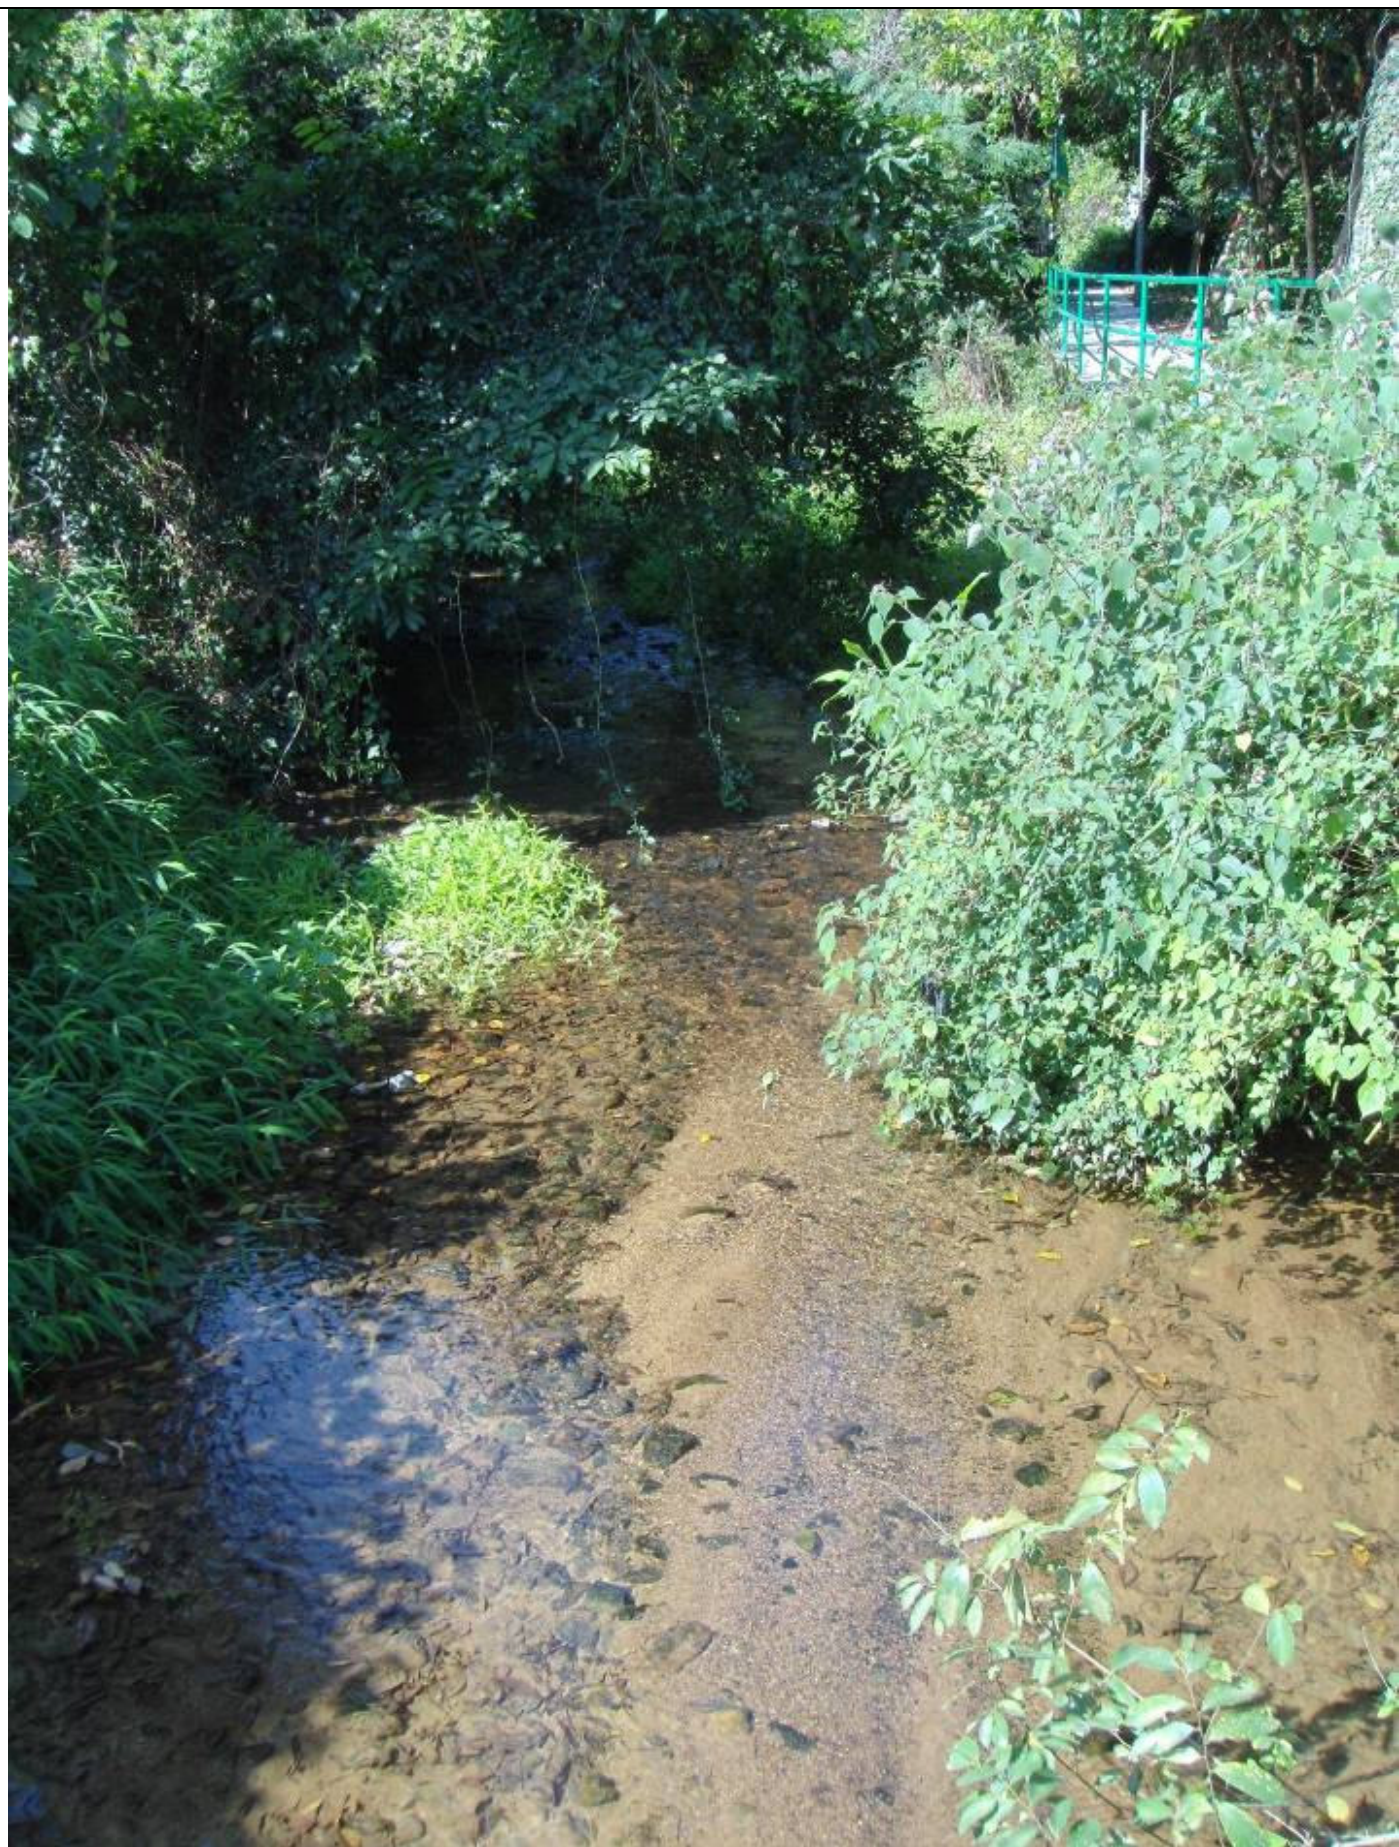
Figure: 2

Title: SEMP 3, the third sampling point of Wai Ha River under Contract 2.

It is not actively recorded in the current survey, but three Red-eared sliders (*Trachemys scripta elegans*) were observed at SEMP3.
