PROJECT NO.: TCS/00553/11

CONTRACT NO. DC/2010/02 – DRAINAGE IMPROVEMENT IN SHUEN WAN AND SHEK WU WAI

MONTHLY ENVIRONMENTAL MONITORING AND AUDIT REPORT (NO.8) – FEBRUARY 2012

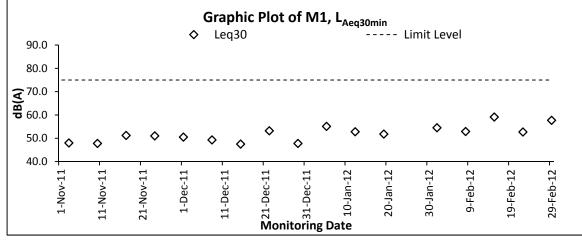
Graphic Plot – Construction Noise

Remark: The monitoring is undertaken under façade situation. No façade correction is added according to acoustical principles and EPD guidelines.

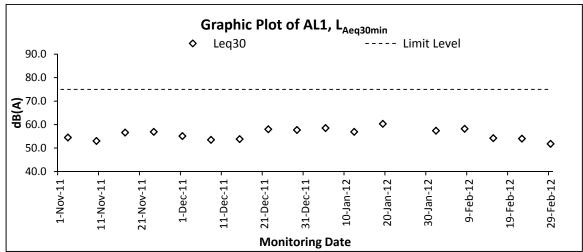
Remark: The monitoring is undertaken under façade situation. No façade correction is added according to acoustical principles and EPD guidelines.

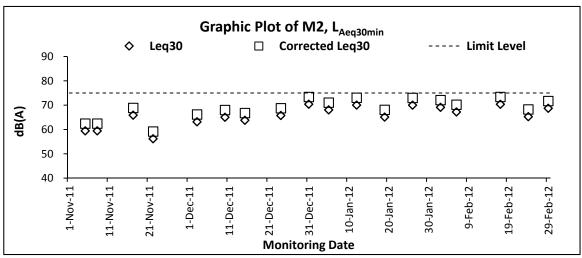
Remark: The monitoring is undertaken under free field situation. A façade correction of $+3 \, dB(A)$ has been added according to acoustical principles and EPD guidelines

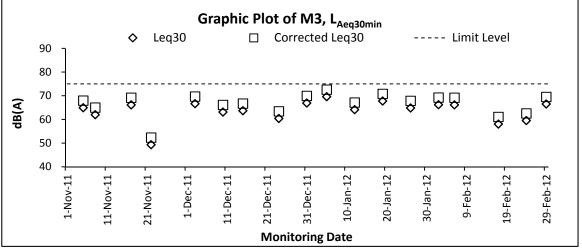
Remark: The monitoring is undertaken under free field situation. A façade correction of $+3 \, dB(A)$ has been added according to acoustical principles and EPD guidelines

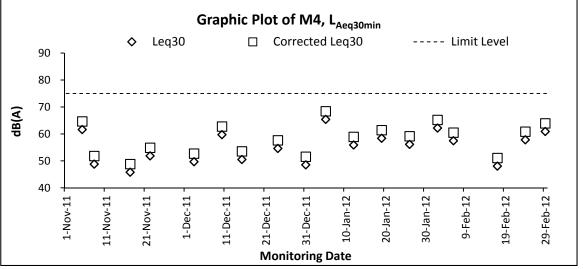
Remark: The monitoring is undertaken under free field situation. A façade correction of $+3 \, dB(A)$ has been added according to acoustical principles and EPD guidelines

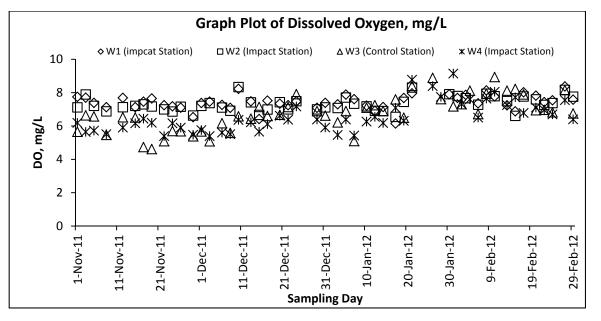
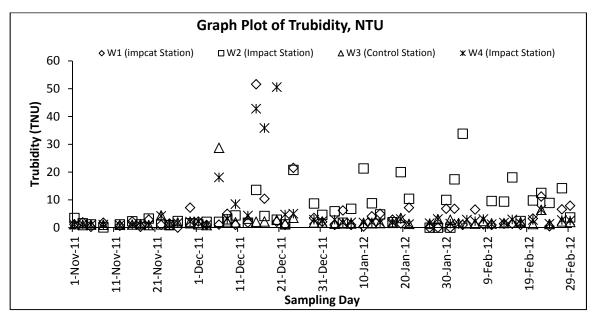
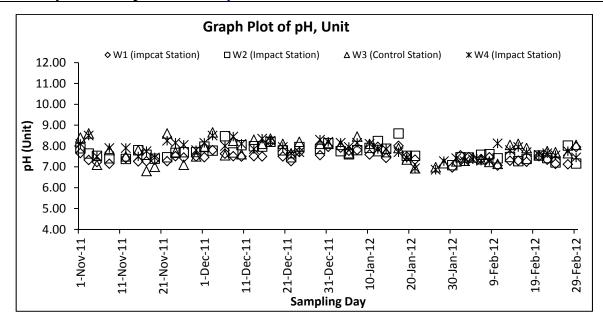
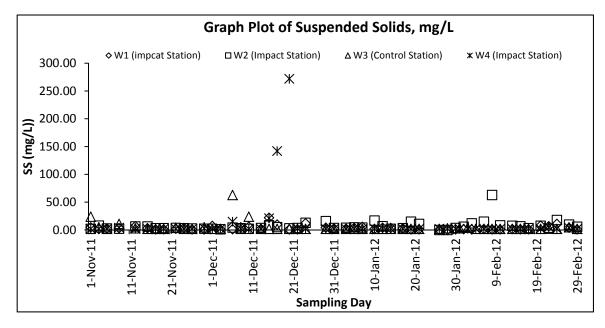
Graphic Plot – Water Quality

- 4.13 For the DO exceedances, it is noted that the construction activities comprised none of DO depleting characteristics. However, algae grow was observed inside the existing channel during joint site inspection which may affect the water quality such as turbidity and oxygen concentration in stream water. The Contractor has been reminded to clean the accumulated algae regularly in order to maintain the water quality of the existing stream. Besides, the recent major construction works of the Project are located at downstream of Locations W3 and W4. Therefore, the water quality exceedances at Locations W3 and W4 affected by the Project are unlikely.

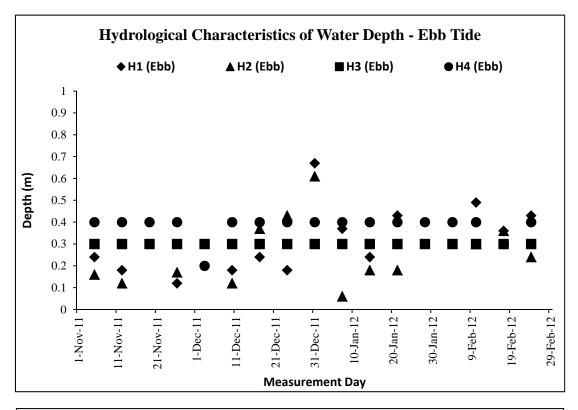
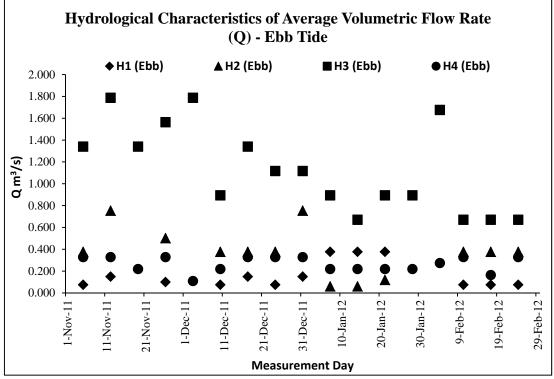
Graphic Plot – Hydrological Characteristics (Water Depth)

4.18 To compare the monitoring data between the Reporting Period (rainy season) and baseline monitoring period, the currently water depth and volumetric flow rate has insignificant changed. Furthermore, water depth and water flow rate were found no exceedance in this Reporting Period.
