PROJECT NO.: TCS/00553/11

**CONTRACT NO. DC/2010/02 –
DRAINAGE IMPROVEMENT IN SHUEN WAN AND
SHEK WU WAI**

**MONTHLY ENVIRONMENTAL MONITORING AND
AUDIT REPORT (NO.9) – MARCH 2012**

PREPARED FOR
KWAN LEE-KULY JOINT VENTURE

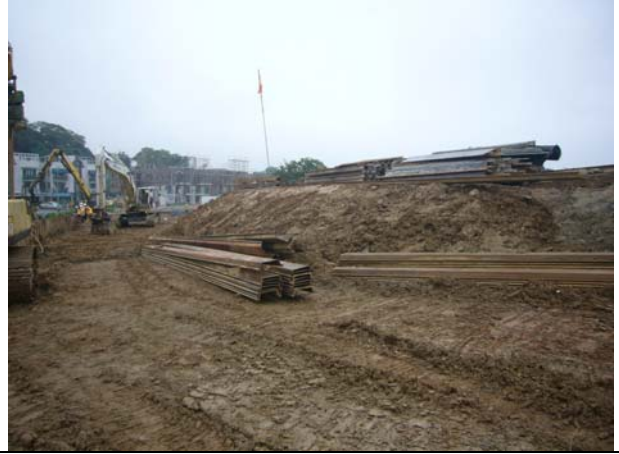
<p>1. Muddy water discharged from the de-silting channel was observed, the Contractor should improve the de-silting system and repair it regularly.</p>	 
<p>2. Tree protection fencing was broken, the contractor was reminded to provide proper protection to the tree within the site area.</p>

3. As a reminder, stockpile within the site should provide mitigation measure to prevent dust generation.

<ol style="list-style-type: none"> 1. No muddy water discharge was observed. 2. Broken fencing for tree protection has been repaired. 3. Water spraying was observed for the dusty stockpile. 	
--	--

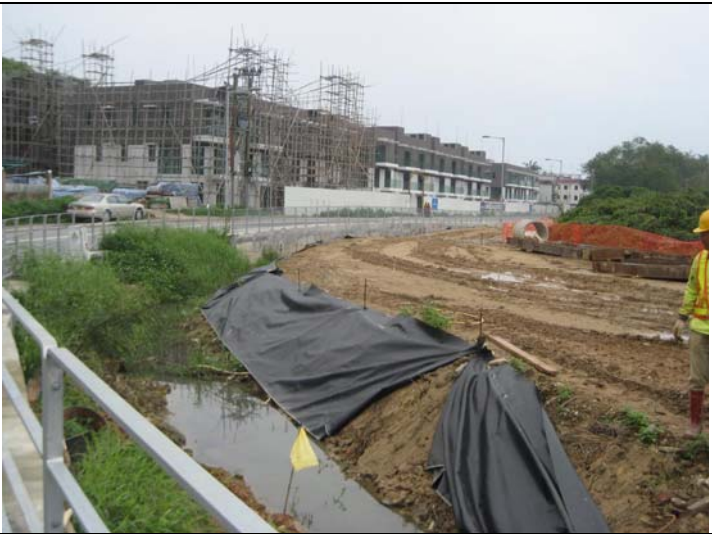
Observations recorded in this Site Inspection (14-3-2012):

<ol style="list-style-type: none"> 1. To avoid washing out of loose soil to the existing stream, fully covering of the exposed slopes by tarpaulin sheet should properly maintain.

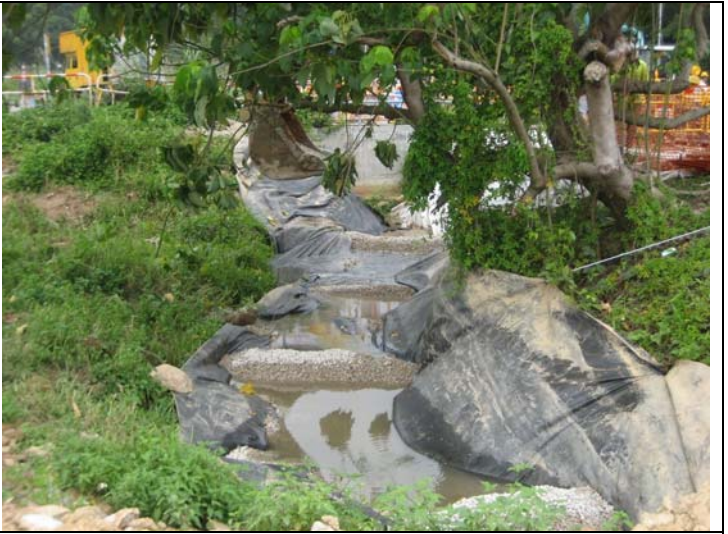
Observations recorded in this Site Inspection (21-3-2012):

1. To improve the desilting facility, more gravel should be placed in the of temporary artificial precipitation stream.

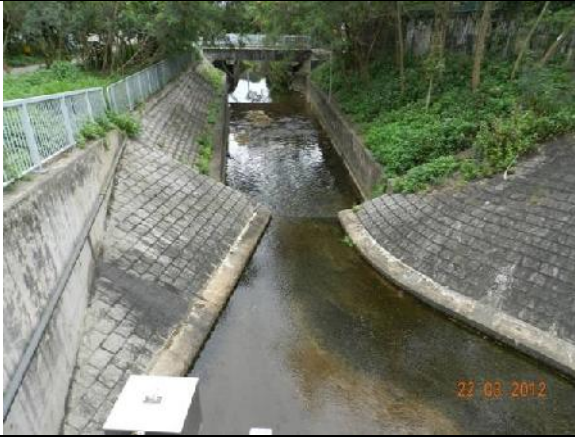
<p>Photo 5 – A new sedimentation beds and PVC liner were installed and aligned from north to south near the retained tree T196 (<i>Macaranga tanarius</i>).</p>	<p>Photo 6 – A new sedimentation beds and PVC liner were installed and aligned from western to eastern parts along Tung Tsz Road and opposite to San Tau Kwok.</p>

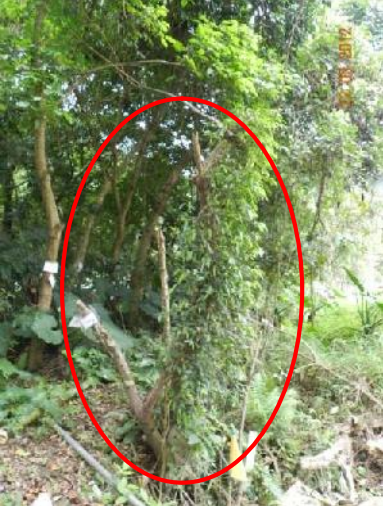
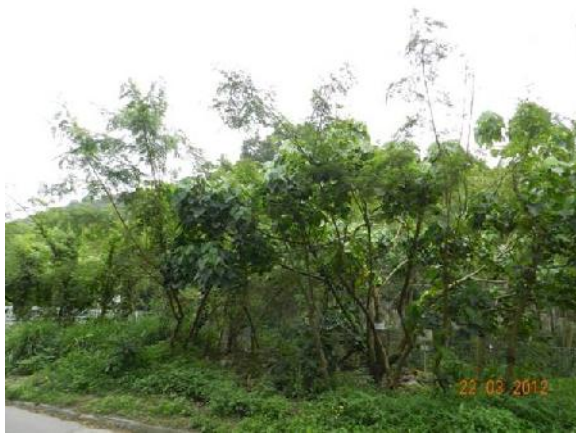
<p>Photo 7 – Upper stream of Wa Ha River. No direct water discharge into the Wai Ha River since no active construction work from the Project has commenced adjacent to the River.</p>	<p>Photo 8 – Stockpiled soil was still observed at the bank of the Wai Ha. Weedy herbs have started colonizing the soil.</p>

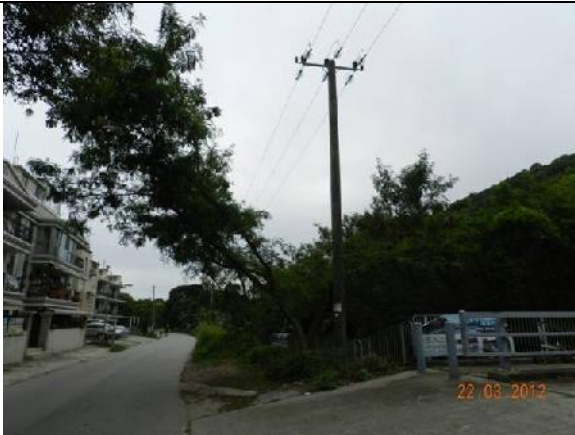
<p>Photo 9 – Retained tree T180 has been covered by weedy climbers extensively. It was suspected to be a dead specimen due to natural dieback.</p>	<p>Photo 10 – The pruned and topped trees T075 and T076 were found to have resprouted slowly.</p>

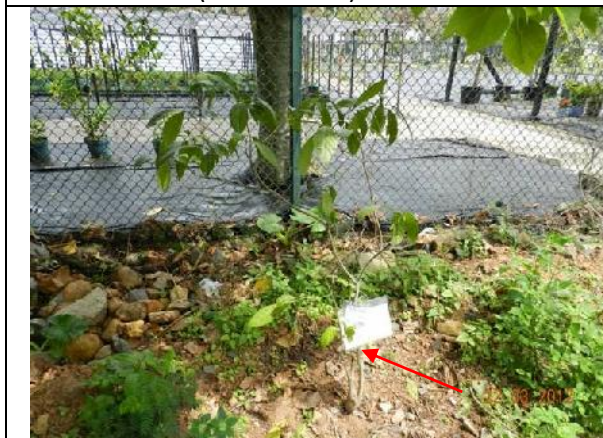
Photo 14 – The transplanted shrubs of *P. hongkongensis* (PH01 and PH02) showed fair health condition in Area C under Contract 1.

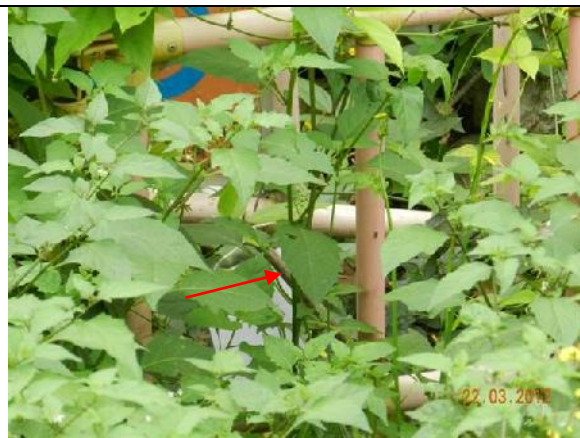
Photo 15 – The protected shrub of *P. hongkongensis* (PH03) showed fair health condition in Area C under Contract 1.
