**CONTRACT NO. DC/2010/02 –
DRAINAGE IMPROVEMENT IN SHUEN WAN AND
SHEK WU WAI**

**MONTHLY ENVIRONMENTAL MONITORING AND
AUDIT REPORT (NO.10) – APRIL 2012**

PREPARED FOR
KWAN LEE-KULY JOINT VENTURE

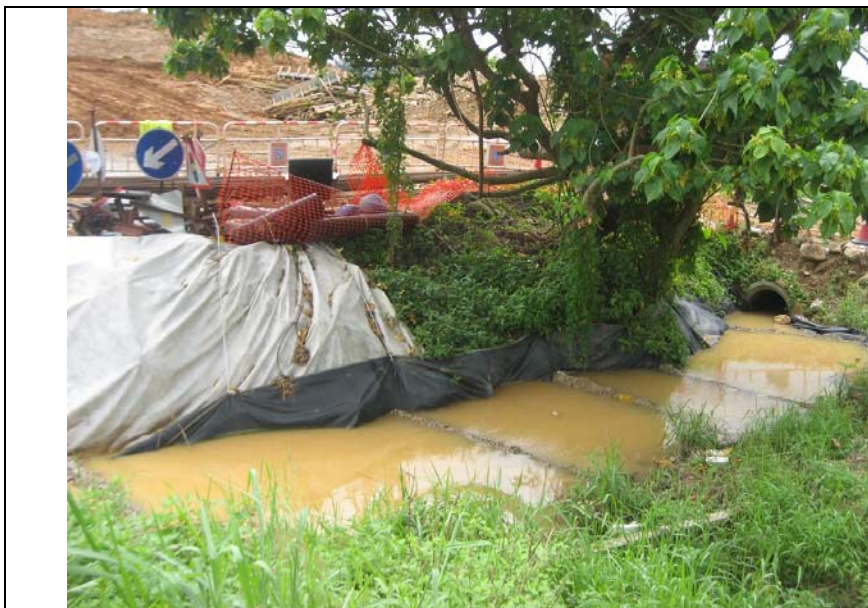
Observations recorded in this Site Inspection (25-4-2012):

1. Muddy water discharged from the de-silting channel was observed after rainfall, the Contractor should improve the de-silting system and repair it regularly.

The de-silting channel is being improved.	
---	--

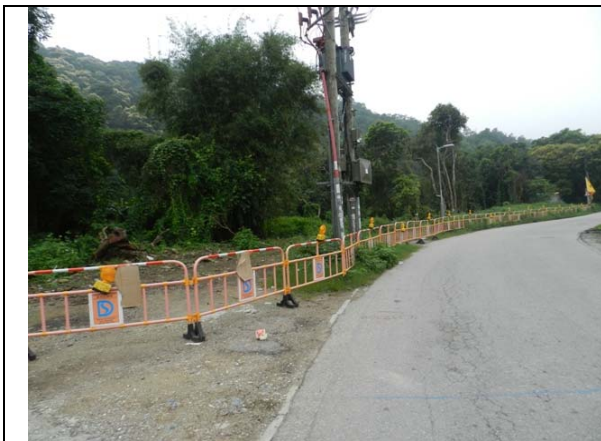
Photo 1 – Temporary hoardings have been erected around the active works area.

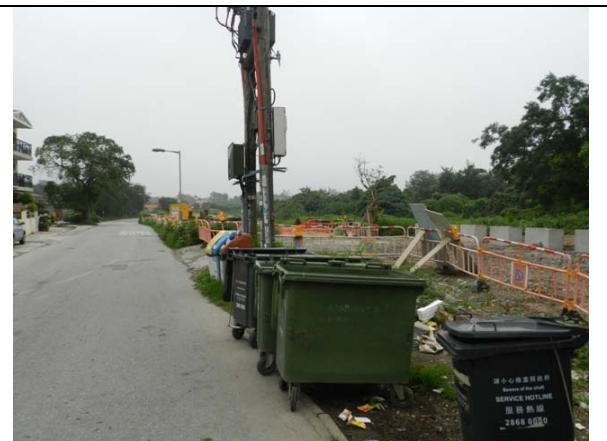
Photo 2 – Temporary hoardings have been erected around the active works area.

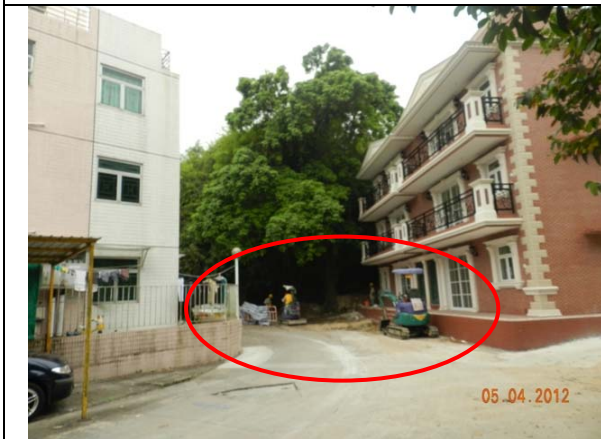
Photo 3 – Site preparation works were recorded at the northwest of the Treasure Spot Garden II during the monitoring on 5th April 2012.

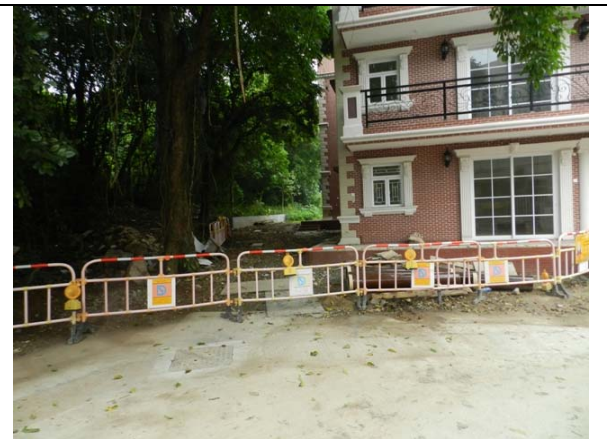
Photo 4 – Temporary hoardings were found erected at the northwest of the Treasure Spot Garden II on 19th April 2012.

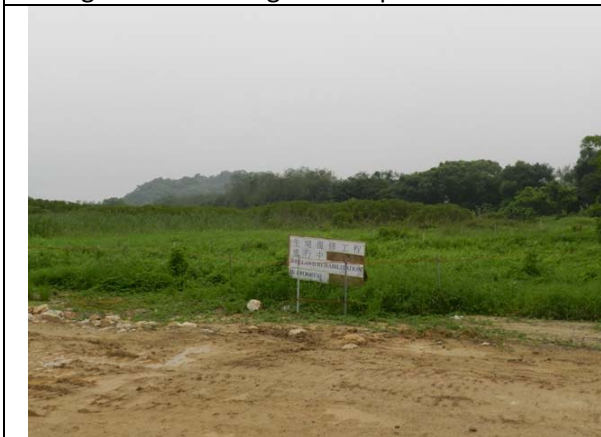
Photo 5 – Wetland rehabilitation area was observed adjacent to the active works area.

Parameter	Observation	Recommendation
	<p>adjacent to the current active works area, a demarcated wetland rehabilitation area has been maintained by parties other than the Project Proponent, the Project's Contractor and Sub-contractors since January 2012. No vegetation clearance or any other works were observed within this wetland rehabilitation area.</p>	
<p>Contaminant / Sediment Control</p>	<ul style="list-style-type: none"> A few sections of sedimentation beds with gravels was aligned along the boundary of the active works area to the south of Wai Ha, as observed during the monitoring in April, 2012. These graveled sedimentation beds were not continued and a few sections along this drainage area were aligned with the PVC liner only. However, no direct discharge of contaminants or any polluted fluid was observed within these active works areas. The sedimentation beds located from north to south near the retained tree T196 (<i>Macaranga tanarius var. tomentosa</i>) and another aligned from western to eastern parts along Tung Tsz Road and opposite to San Tau Kwok, of which both were installed since March 2012, were maintained appropriately. 	<ul style="list-style-type: none"> Regular monitoring should be conducted to ensure no direct discharge or leakage of contaminants or any polluted fluid into the adjacent Wai Ha River. The Contractor should maintain appropriate sedimentation beds and/or tanks throughout the construction phase.

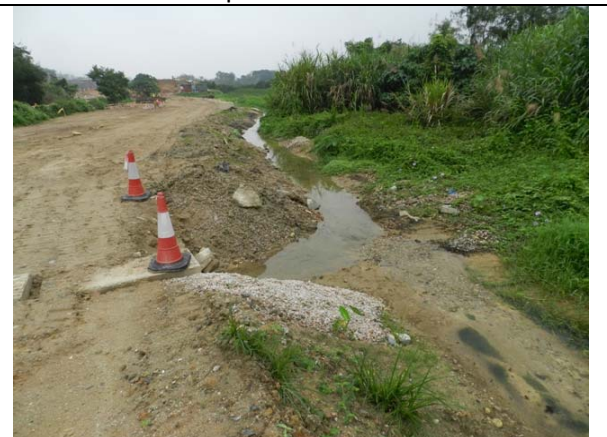
Photo 6 – A few sections of sedimentation beds with gravels was observed.

<p>Pollution Control</p>	<ul style="list-style-type: none"> As abovementioned, a few sections of sedimentation beds with gravels was aligned along the boundary of the active works area to the south of Wai Ha, as observed during the monitoring in April, 2012. These graveled sedimentation beds were not continued and a few sections along this drainage area were aligned with the PVC liner only. However, no direct discharge of contaminants or any polluted fluid was observed within these active works areas. The sedimentation beds located from north to south near the retained tree T196 (<i>Macaranga tanarius var. tomentosa</i>) and another aligned from western to eastern parts along Tung Tsz Road and opposite to San Tau Kwok, of which both were installed since March 2012, were maintained appropriately. No direct discharge of polluted water from the active works area into the adjacent Wai Ha River was observed. The piled soil resulting from other contract work at the bank of Wai Ha River (as reported since December 2011) was overgrown by weedy herbs as observed in April, 2012. 	<ul style="list-style-type: none"> The Contractor should prevent any contaminants and sediments from entering the sensitive water-based habitats and implement pollution control measures to minimize any adverse environmental impacts to the water body. The Contractor should maintain appropriate sedimentation beds and/or tanks throughout the construction phase.

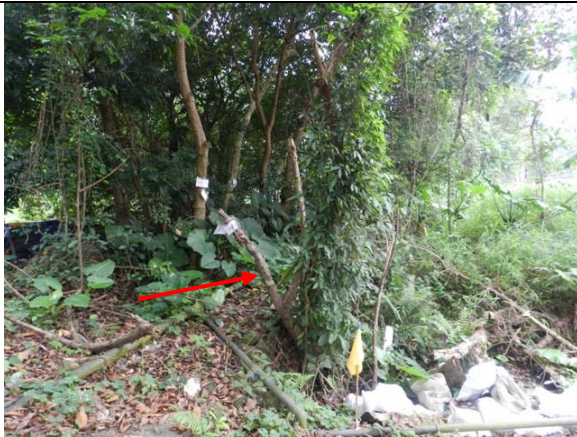
Photo 13 – Retained tree T180 was suspected to be a dead specimen due to natural dieback and found being covered by weedy climbers extensively.

Parameter	Observation	Recommendation
	<p>the Project Area were recorded generally in fair health conditions. As reported since January 2012, a retained tree T180 has showed poor health condition with its canopy being extensively covered by climber. It is suspected that this tree was dead due to natural dieback.</p> <ul style="list-style-type: none"> • A few trees of <i>Leucaena leucocephala</i> (Tree no. T069 – T073 and T075) and <i>Macaranga tanarius var. tomentosa</i> (Tree no. T076) located close to the previous Project's site office near the junction of Tung Tsz Road and Tung Tsz Shan Road were recorded to be pruned/topped by other parties in December 2011. Regeneration of branches and leaves around the pruned wounds was observed. • As reported in Monthly EM&A Report for January 2012, the broken scaffold branch hanging over the canopy of the retained tree T168 was found on the ground. No regenerated sprout has been observed from this tree since January 2012. • As observed on 19th April 2012, the temporary site office near the leaning retained tree T190 (<i>Ficus hispida</i>) was found relocated to the southeast of T196 (<i>Macaranga tanarius var. tomentosa</i>). No target (i.e. people and property) was found within the tree fall zone of this leaning retained tree. The tree was still found being supported by a wooden stand for anchorage during the monitoring in April 2012. • No significant signs of damage on other existing tree crowns, trunks and roots resulting from the construction works were observed in this monthly monitoring. • The three transplanted specimens (Tree No.: PH01, PH02 and PH03) of the protected shrub species of conservation interest <i>Pavetta hongkongensis</i> have remained in fair health condition in Area C under Contract 1 of the Project. Newly regenerated leaves were observed on PH01 and PH02. The dead specimen (Tree No.: PH04, due to natural dieback) was still remained at its original location and covered by adjacent herbs. 	<p>bases and within the TPZs. If necessary, these retained trees or trees to be transplanted shall be watered regularly to maintain their health.</p> <ul style="list-style-type: none"> • Disturbance is prohibited in all TPZs. In any practical circumstances, the contractor should follow Section 8 of Annex 4 of the approved Landscape Plan for protecting the existing trees from any potential damages resulting from the construction works. In addition, the Contractor and the Project Proponent should have routine inspection on any tree remedial works conducted by other party on the trees within the Project Area, and close monitoring of the tree stability of the leaning tree T190 (<i>Ficus hispida</i>) located to the south of Wai Ha. If necessary, the Contractor and the Project Proponent may restrict any access within the tree falling zone of this leaning tree.

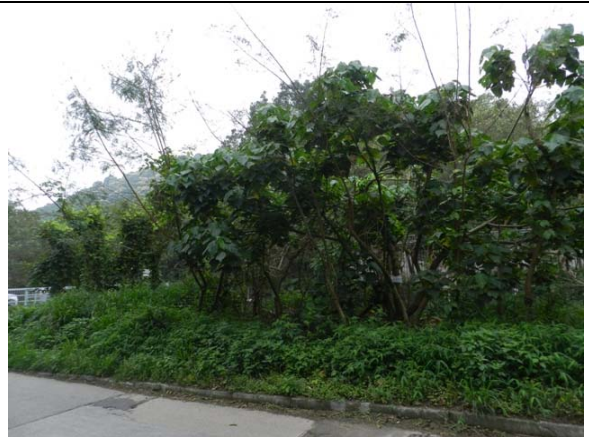
Photo 14 – The pruned and topped trees T075 and T076 were found to have resprouted slowly.

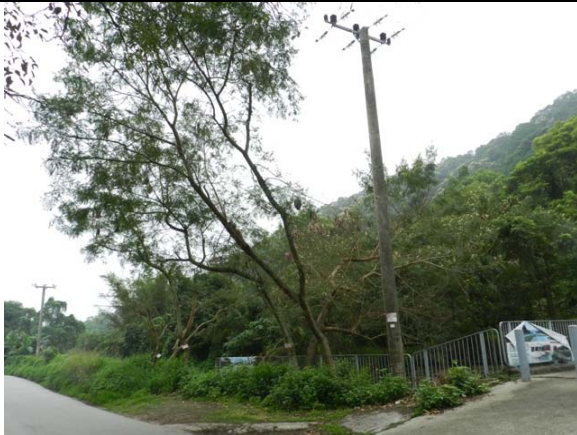
Photo 15 – Pruned and topped trees (T069-T073) along Tung Tsz Road. Regeneration of branches and leaves was slow.

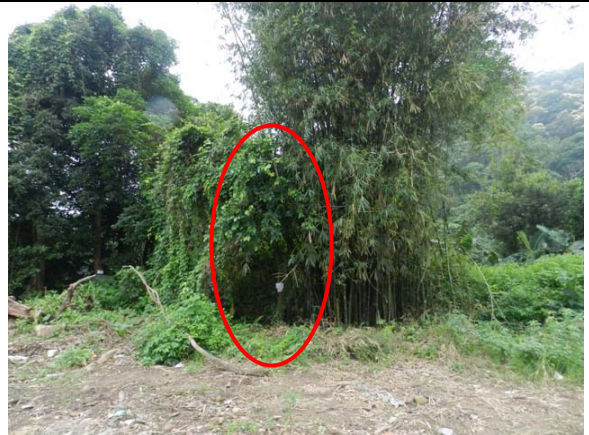
Photo 16 – The broken scaffold branch hanging over the canopy of the retained tree T168 was found on the ground.

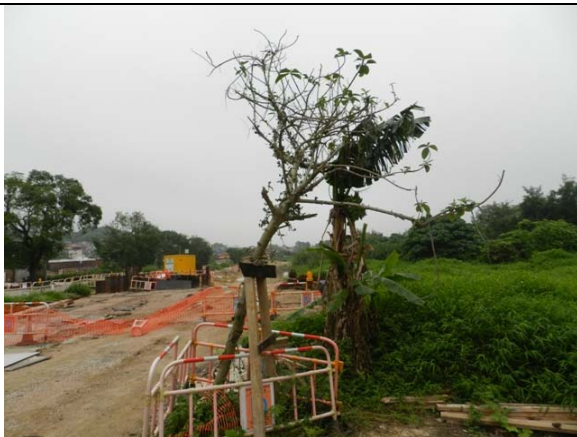
Photo 17 – The temporary site office near the leaning retained tree T190 (*Ficus hispida*) was found relocated to the southwest of the retained tree T196. The tree was still found being supported by a wooden stand.

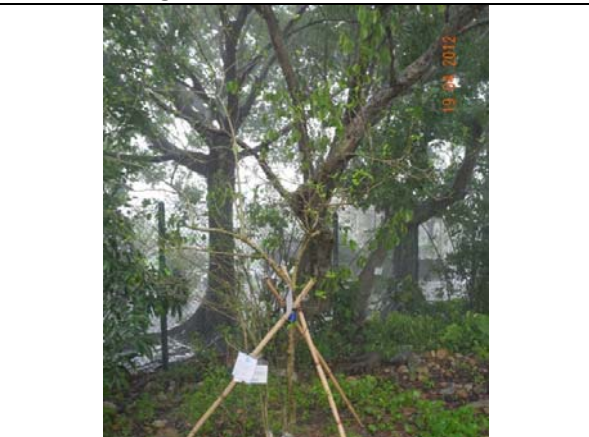
Photo 18 – The transplanted shrubs of *P. hongkongensis* (PH01 and PH02) showed fair health condition in Area C under Contract 1.

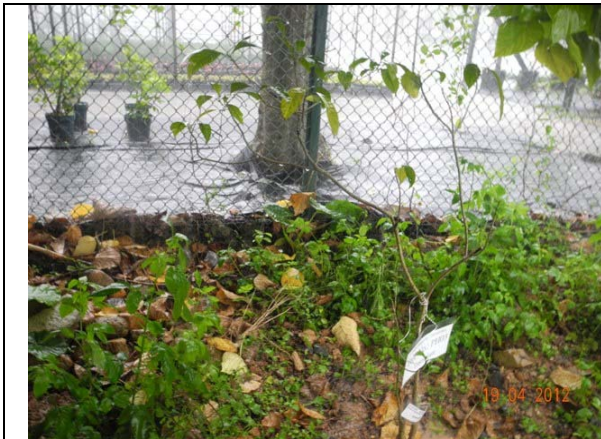
Photo 19 – The protected shrub of *P. hongkongensis* (PH03) showed fair health condition in Area C under Contract 1.

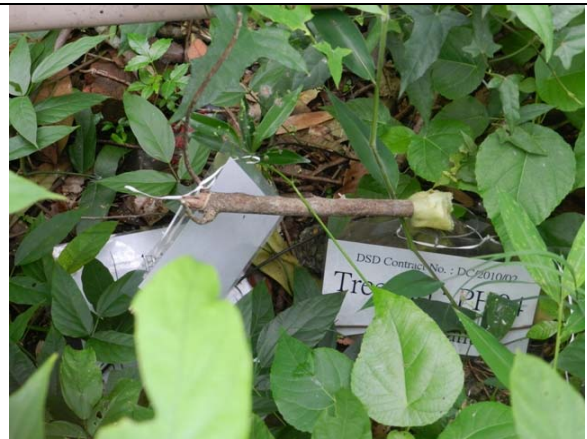
Photo 20 – The dead *P. hongkongensis* PH04 was remained in the same location and covered by adjacent herbs. Climber was also observed on this dead specimen.
