PROJECT NO.: TCS/00553/11

**CONTRACT NO. DC/2010/02 –
DRAINAGE IMPROVEMENT IN SHUEN WAN AND
SHEK WU WAI**

**MONTHLY ENVIRONMENTAL MONITORING AND
AUDIT REPORT (NO.11) – MAY 2012**

PREPARED FOR
KWAN LEE-KULY JOINT VENTURE

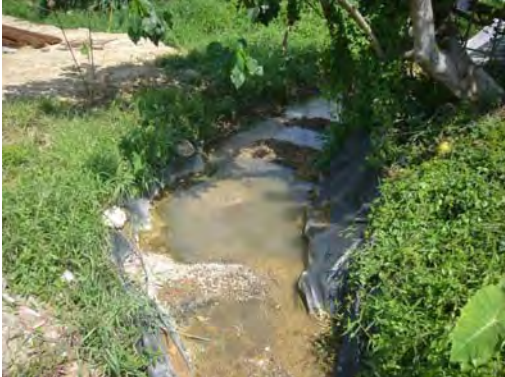
<p>1. The rock bund in the de-silting channel was broken by heavy rainstorm, the Contractor was reminded to repair it regularly to ensure the de-silting channel functional properly.</p>

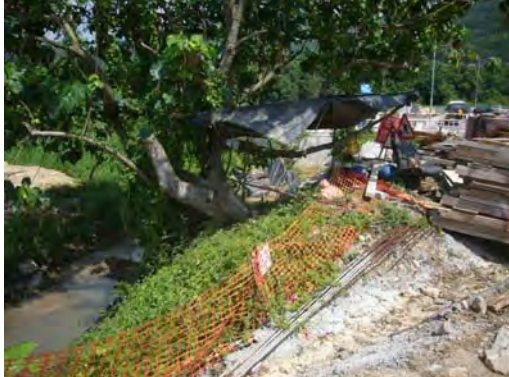
<p>2. Tarpaulin sheet covering on the retaining tree was observed, the contractor was reminded to remove the sheet and erect the protection zone properly.</p>

- 1) Tarpaulin sheet hanged on the retaining tree has been removed.
- 2) Stagnant water cumulated in the unused de-silting tank has been removed.

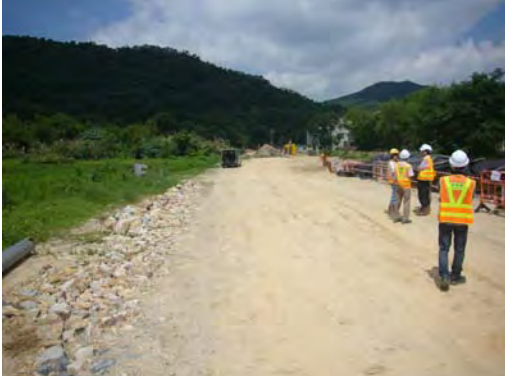
<p>3. As a reminder, water spraying should be applied to the dry haul road or stockpile to minimize dust generation.</p>

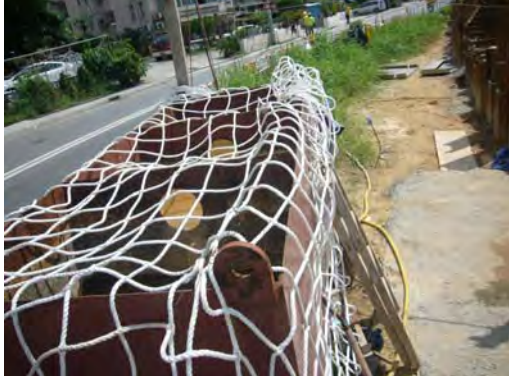
<p>4. Stagnant water cumulated in the unused de-silting tank was observed, the contractor was reminded to provide proper mosquito control for the stagnant water on-site.</p>

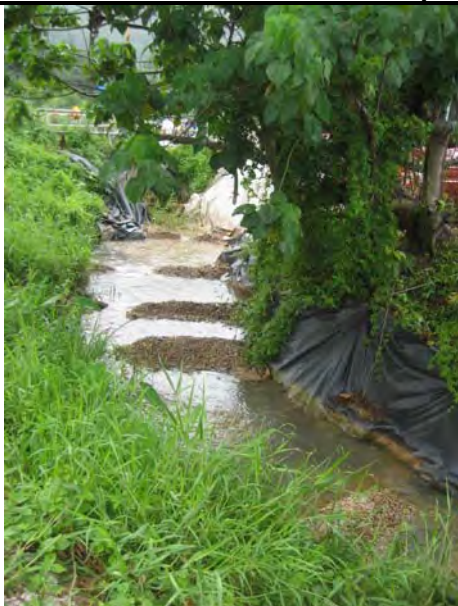
1. The rock bund in the de-silting channel was broken by heavy rainstorm, the Contractor was reminded to repair it regularly to ensure the de-silting channel functional properly.

1) The rock bund in the de-silting channel should be repaired regularly.

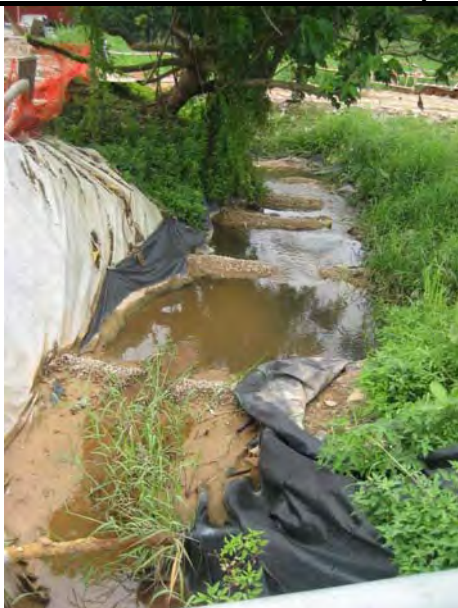
1. The rock bund in the de-silting channel was broken by heavy rainstorm, the Contractor was reminded to repair it regularly to ensure the de-silting channel functional properly.

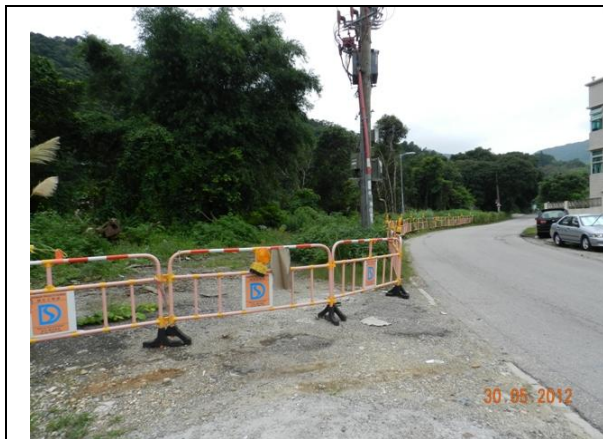
Photo 1 – Temporary hoardings have been erected around the active works area.

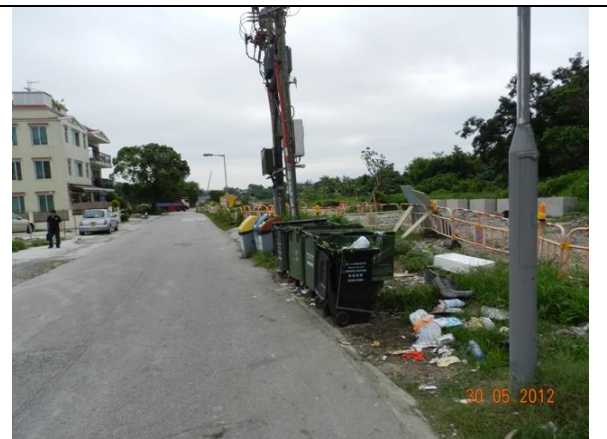
Photo 2 – Temporary hoardings have been erected around the active works area.

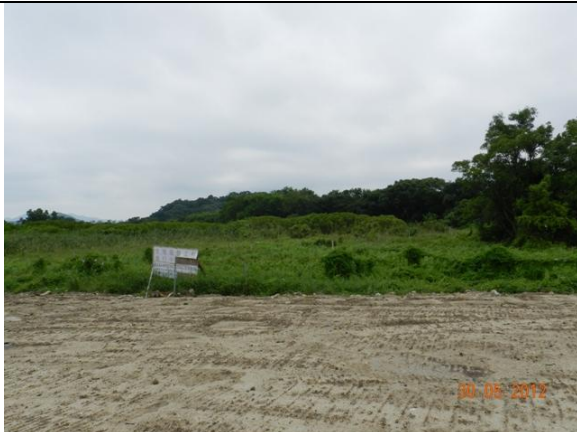
Photo 3 – Wetland rehabilitation area was observed adjacent to the active works area.

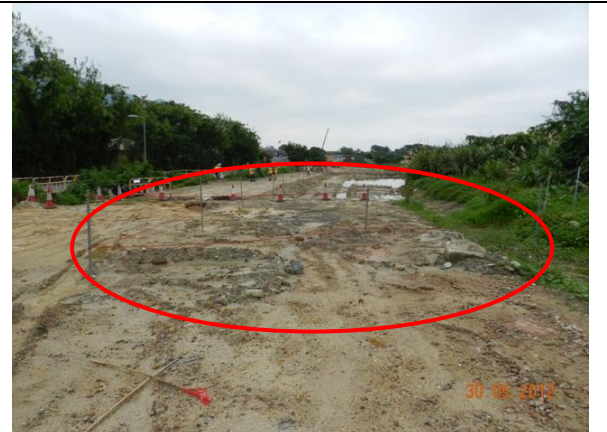
Photo 4 – The wetland rehabilitation area was expanded to the west of the works area (i.e. to the south of Wai Ha) and surrounded by red strings.

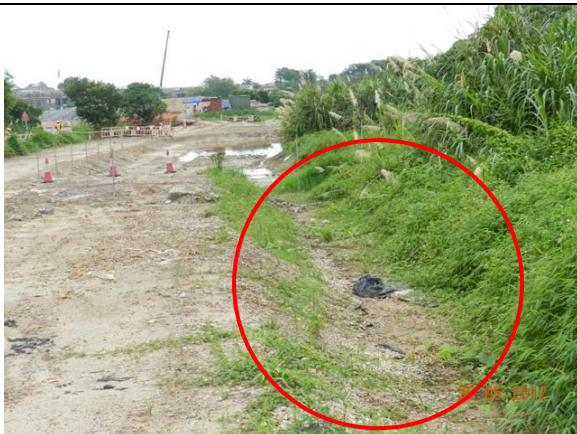
Photo 5 – The sedimentation beds aligned along the boundary of the works area to the south of Wai Ha was removed.

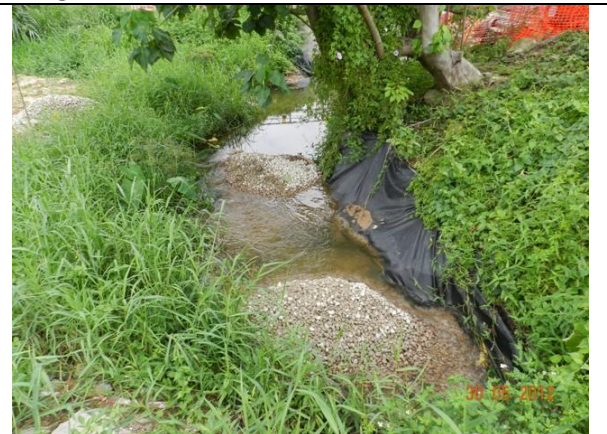
Photo 6 – The sedimentation beds and PVC liner were aligned from north to south near the retained tree T196 (*Macaranga tanarius* var. *tomentosa*).

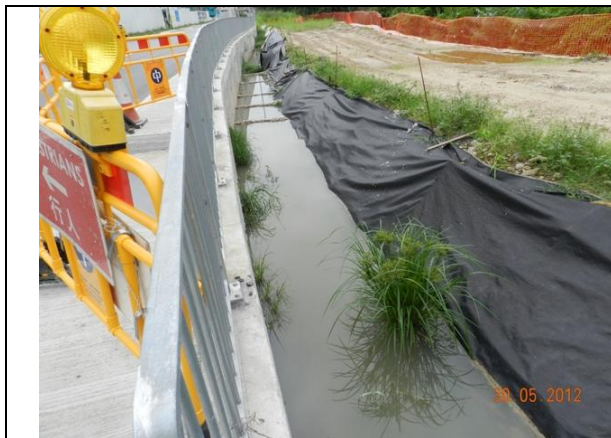
Photo 7 – The sedimentation beds and PVC liner were aligned from western to eastern parts along Tung Tsz Road and opposite to San Tau Kwok.

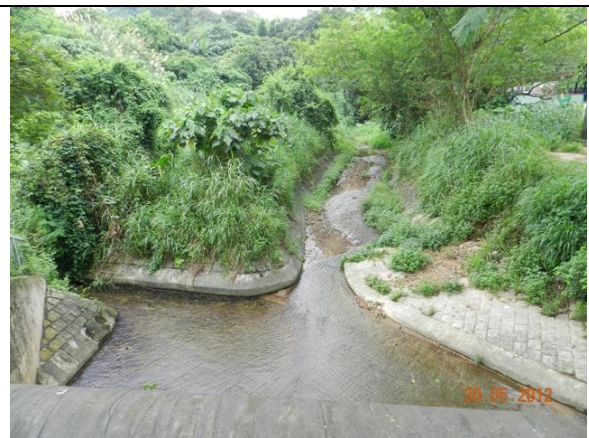
Photo 8 – No direct water discharge into the upper stream of Wai Ha River since no active construction work from the Project has commenced adjacent to the River.

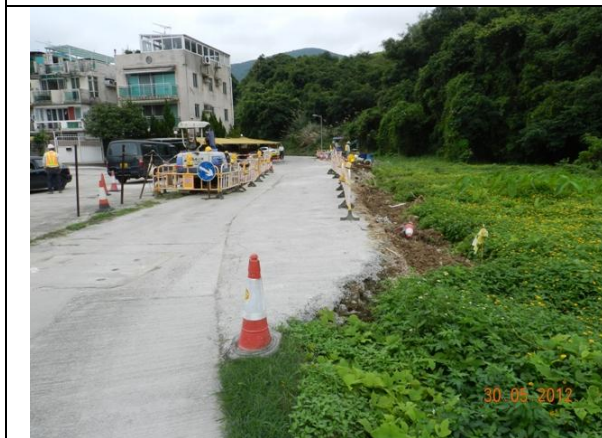
Photo 9 – Herbaceous vegetation clearance was performed along the pathway from Tung Tsz Road to Treasure Spot Garden II.

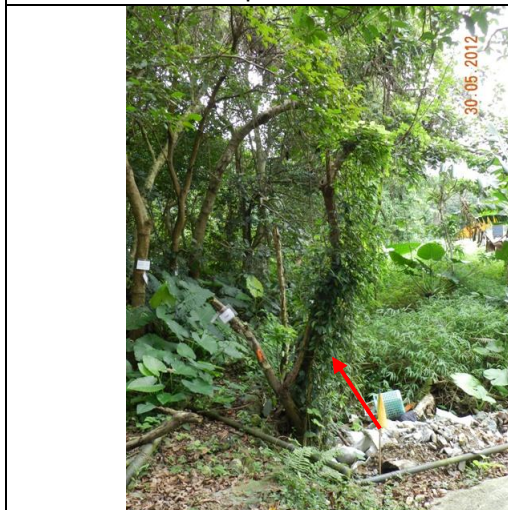
Photo 11 – Retained tree T180 was suspected to be a dead specimen due to natural dieback and found being covered by weedy climbers extensively.

Parameter	Observation	Recommendation
	<p>2012, a retained tree T180 was still in poor health condition with its canopy being extensively covered by climber. It is suspected that this tree was dead due to natural dieback.</p> <ul style="list-style-type: none"> • The temporary site office close to the leaning, retained tree T190 (<i>Ficus hispida</i>) was relocated. The tree was still found being supported by a wooden stand for anchorage during the monitoring. A TPZ has been established around T190 to protect the tree and restrict access close to the tree. No further deterioration in tree health condition and stability was observed. • No significant signs of damage on other existing tree crowns, trunks and roots resulting from the construction works were observed in this monthly monitoring. • The three transplanted specimens (Tree No.: PH01, PH02 and PH03) of the protected shrub species of conservation interest <i>Pavetta hongkongensis</i> have remained in fair health condition in Area C under Contract 1 of the Project. Newly regenerated leaves were observed on all three shrubs. The dead specimen (Tree No.: PH04, due to natural dieback) was still remained at its original location and extensively covered by climbing herbs. 	<p>trunk bases and within the TPZs. If necessary, these retained trees or trees to be transplanted shall be watered regularly to maintain their health.</p> <ul style="list-style-type: none"> • Disturbance is prohibited in all TPZs. In any practical circumstances, the contractor should follow Section 8 of Annex 4 of the approved Landscape Plan for protecting the existing trees from any potential damages resulting from the construction works. In addition, the Contractor and the Project Proponent should have routine inspection on any tree remedial works conducted by other party on the trees within the Project Area, and close monitoring of the tree stability of the leaning tree T190 (<i>Ficus hispida</i>) located to the south of Wai Ha. If necessary, the Contractor and the Project Proponent have to restrict any access within the tree falling zone of this leaning tree.

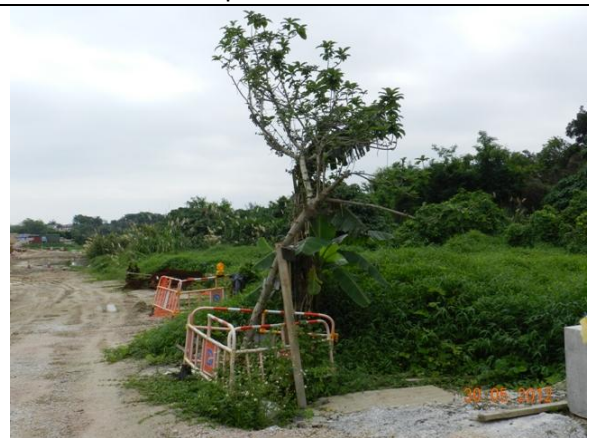
Photo 12 – The leaning retained tree T190 (*Ficus hispida*) was supported by a wooden stand.

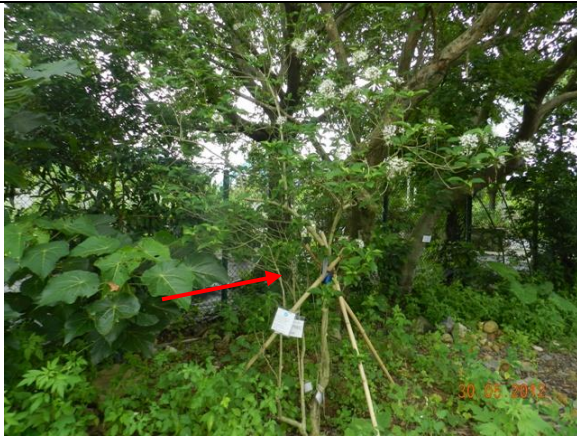
Photo 13 – The transplanted shrubs of *P. hongkongensis* (PH01 and PH02) showed fair health condition in Area C under Contract 1.

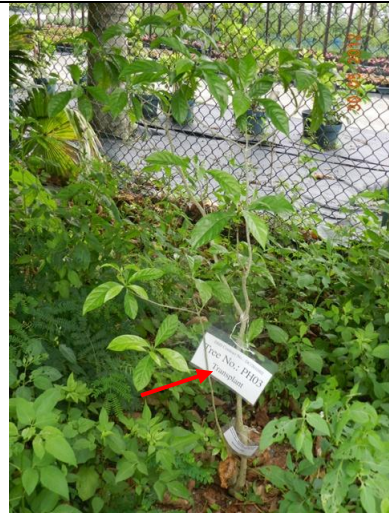
Photo 14 – The protected shrub of *P. hongkongensis* (PH03) showed fair health condition in Area C under Contract 1.
