PROJECT No.: TCS/00553/11

CONTRACT NO. DC/2010/02 –
DRAINAGE IMPROVEMENT IN SHUEN WAN AND SHEK WU WAI

MONTHLY ENVIRONMENTAL MONITORING AND AUDIT REPORT (No.12) – June 2012

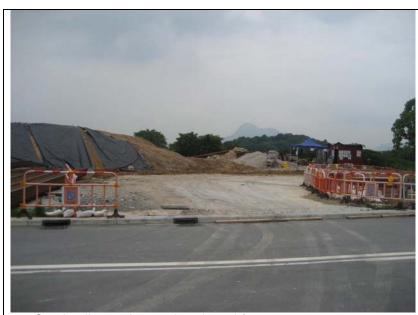
Observations recorded in this Site Inspection (20-6-2012):

1. Sand trail was observed at site exit/ entrance, wheel washing is reminded prior to exit the site to ensure no dusty materials are carried to adjacent public roads.
