PROJECT No.: TCS/00553/11

CONTRACT NO. DC/2010/02 –
DRAINAGE IMPROVEMENT IN SHUEN WAN AND SHEK WU WAI

MONTHLY ENVIRONMENTAL MONITORING AND AUDIT REPORT (No.14) – AUGUST 2012

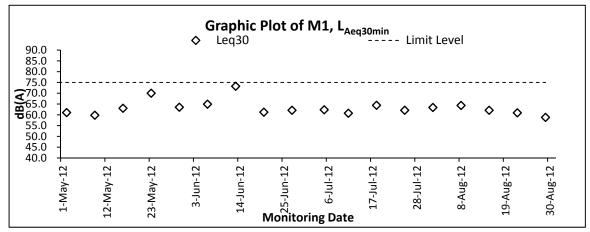
Remark: The monitoring is undertaken under façade situation. No façade correction is added according to acoustical principles and EPD guidelines.

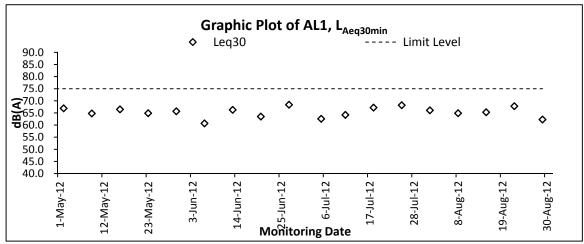
Remark: The monitoring is undertaken under façade situation. No façade correction is added according to acoustical principles and EPD guidelines.

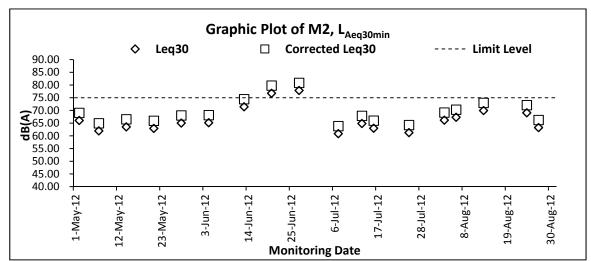
Remark: The monitoring is undertaken under free field situation. A façade correction of +3 dB(A) has been added according to acoustical principles and EPD guidelines.

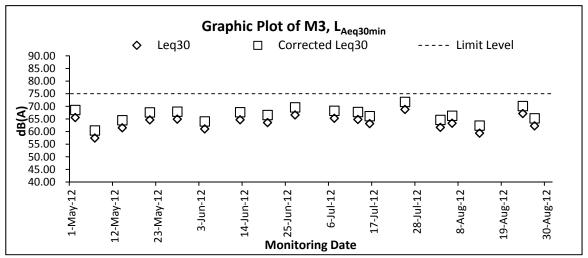
Remark: The monitoring is undertaken under free field situation. A façade correction of +3 dB(A) has been added according to acoustical principles and EPD guidelines

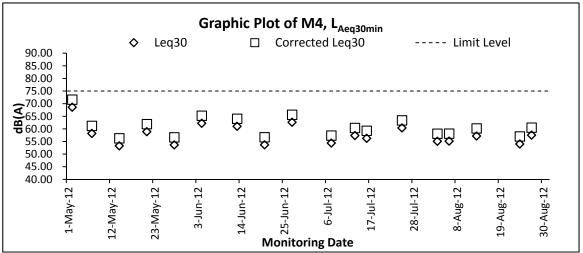
Remark: The monitoring is undertaken under free field situation. A façade correction of +3 dB(A) has been added according to acoustical principles and EPD guidelines

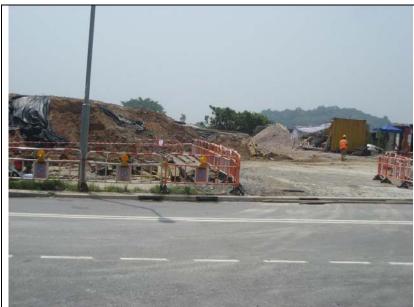
### Observations recorded in this Site Inspection (1-8-2012):

1. Mud trail was observed at the site exit/ entrance, the Contractor should provide water spraying regularly in order to maintain the site cleanliness.

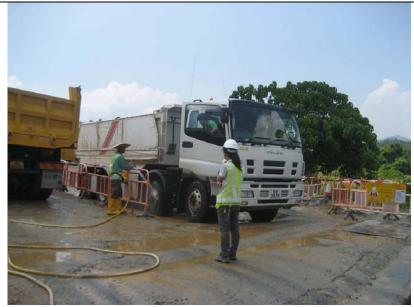
#### Observations recorded in this Site Inspection (15-8-2012):

) Wastewater generated from the wheel washing facility should be cleared regularly to avoid overflow out of the site.

( Photo 1)
Cleaning of site exit is observed and no wastewater from the wheel washing facility was found to be overflowed from site.
