Monthly Environmental Monitoring & Auditing report for

Contract No.DC/2009/22

Drainage Improvement in Shuen Wan, Tai Po – Contract 1

October 2012

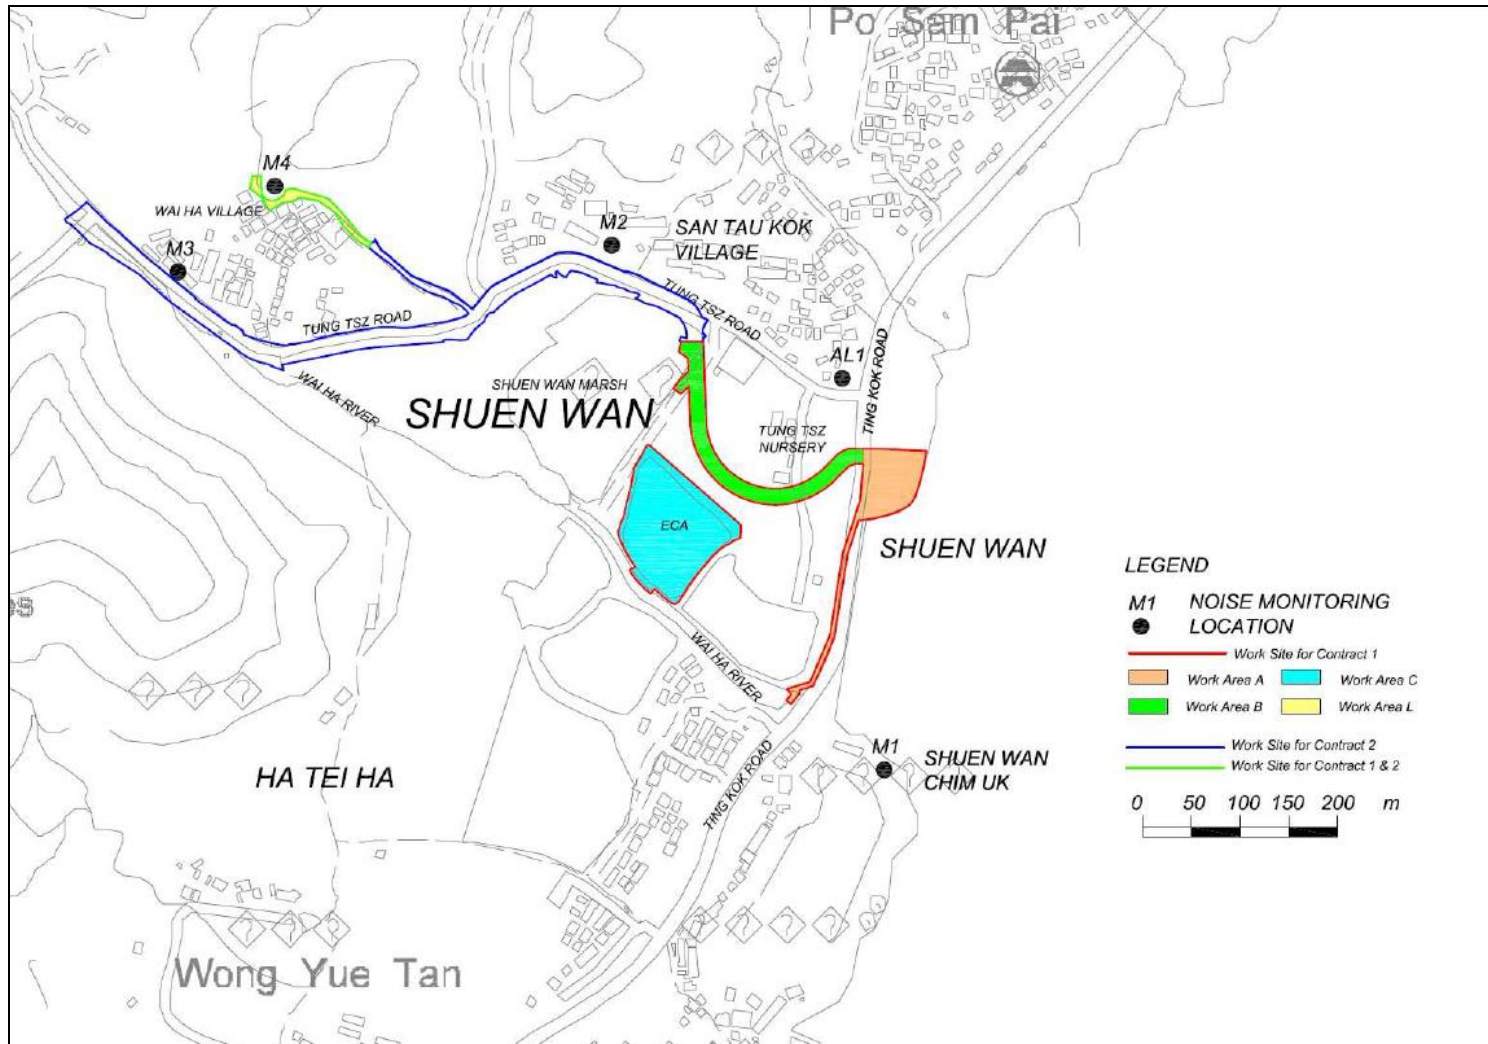
Figure 3.3.1 Impact noise monitoring locations

Noise Monitoring Station	Location
M1	14, Shuen Wan Chim Uk
AL1	Joint Village Office for Villages in Shuen Wan, Tai Po

Relevant details of the noise monitoring results are presented in Table 3.4.1. The results of M1, ranged between 59.9dB (A) and 66.8dB (A), and AL1, ranged between 64.3dB (A) and 67.3dB (A), were within the limit levels and therefore, no exceedance was found.

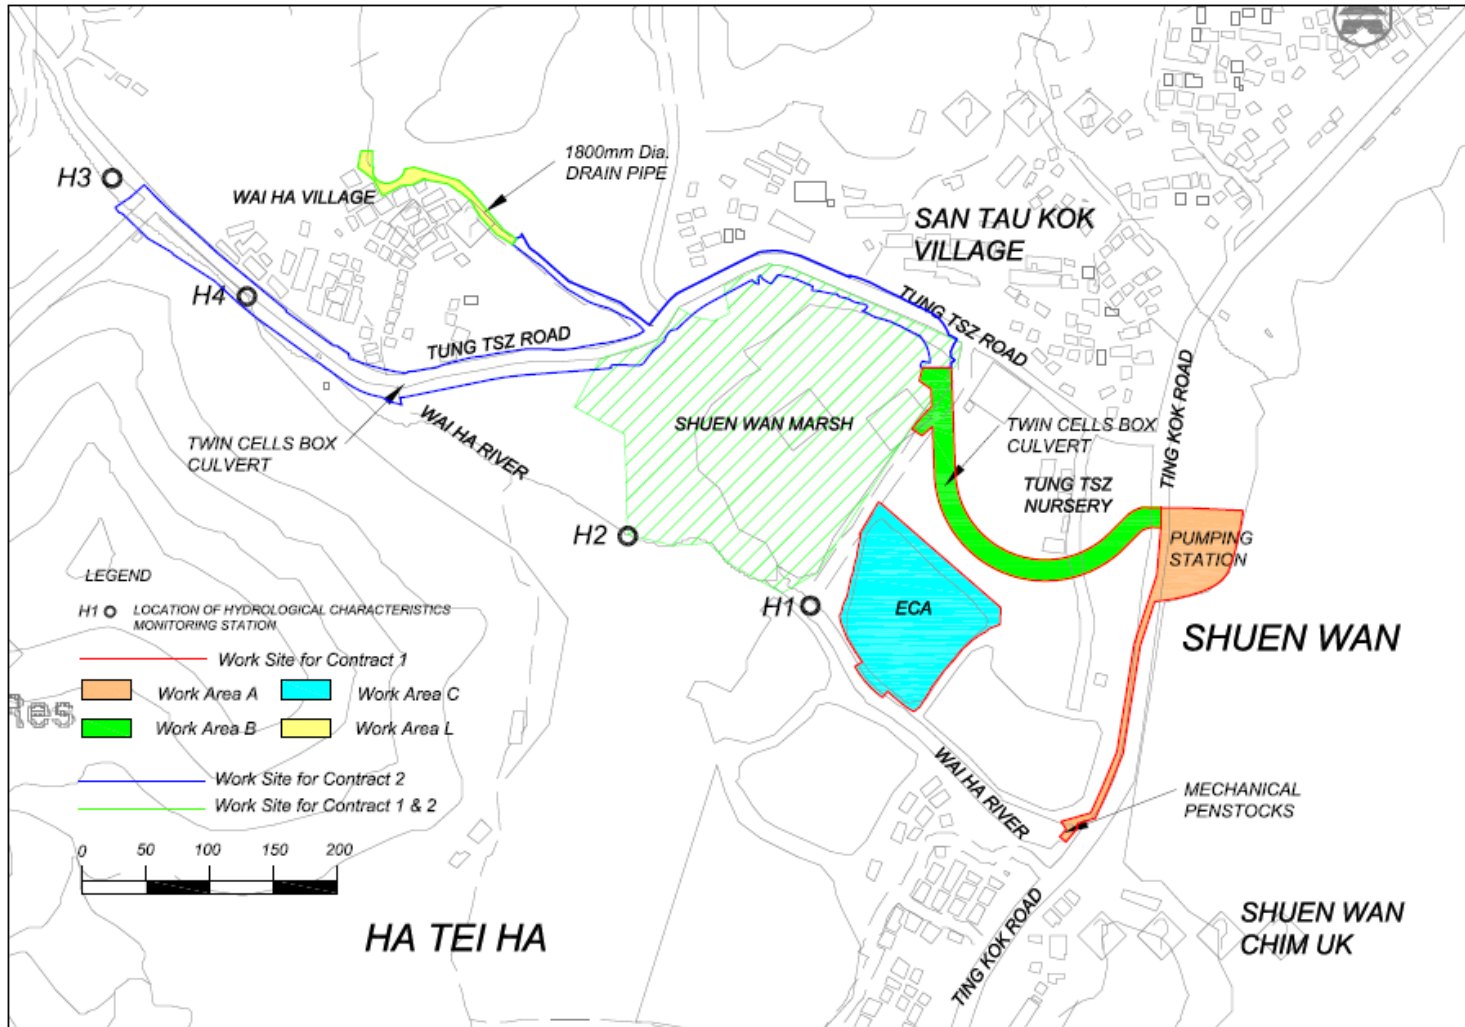
Figure 5.3.1 Hydrological Characteristics Monitoring Locations

As illustrated in Figure 5.3.1, H2 served as the control station while H1 was the monitoring location of hydrological characteristics.

Hydrological characteristics monitoring was carried out four times in this reporting period. The monitoring results are summarized in Table 5.5. All results were within the action and limit levels, therefore, no exceedance was found.

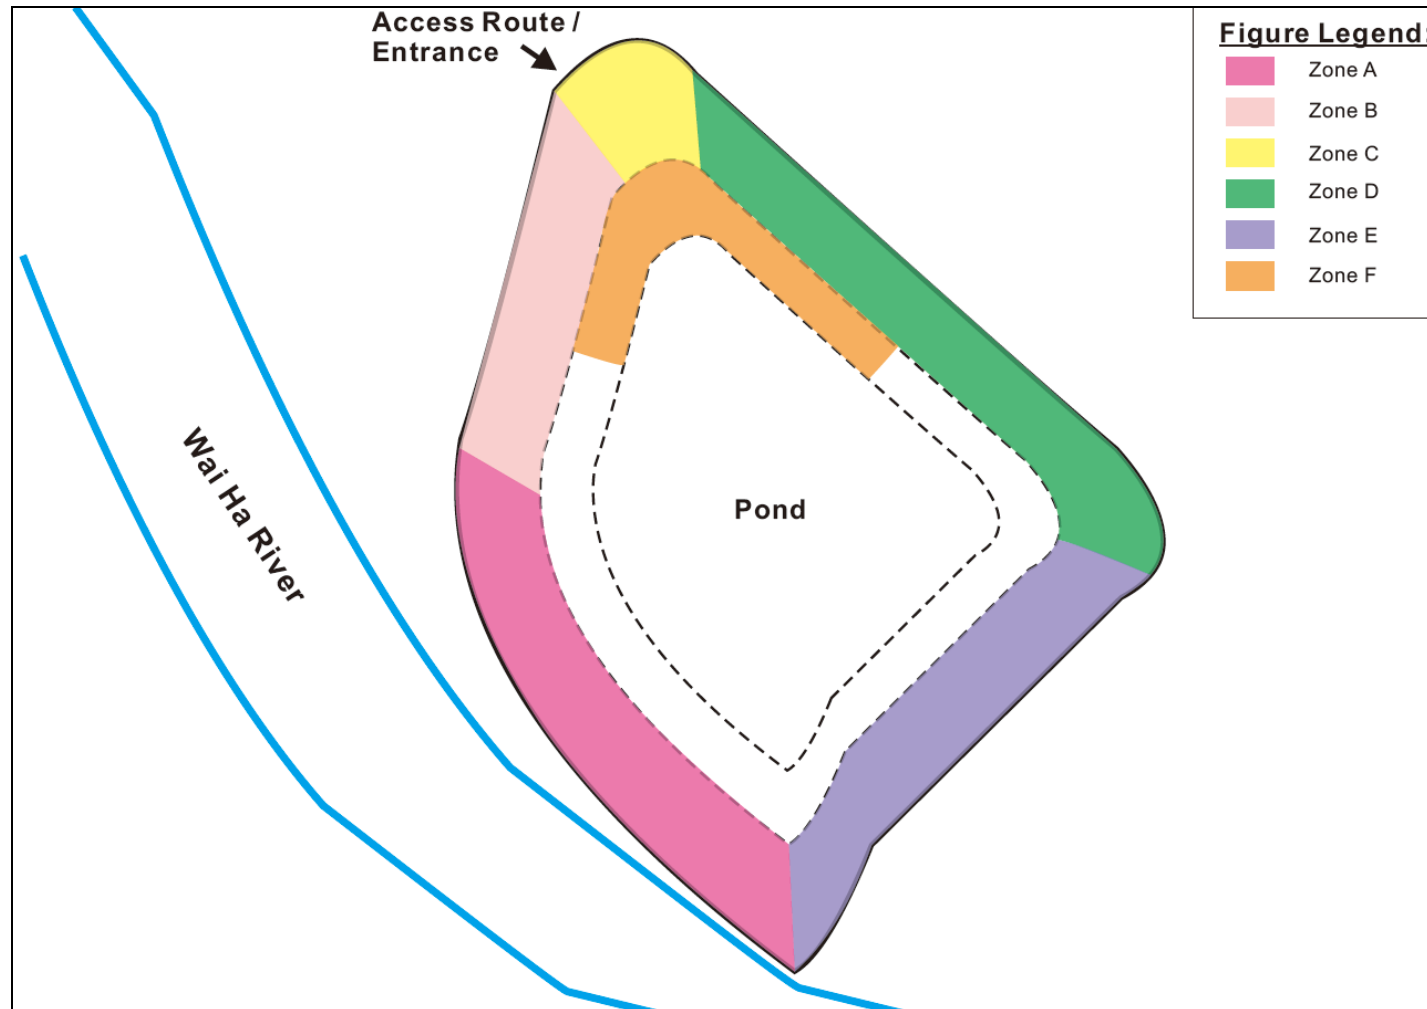
Figure 6.3.2.1 Landscape floor plan of ECA during establishment phase.

Three specimens of protected species *Pavetta hongkongensis* were transplanted from work area under Contract 2 to ECA at Zone D (Figure 6.3.2.1) on 20th December 2011. Monthly monitoring was carried out and their overall conditions are fair so far (Appendix L). Representative photographs of the transplanted *P. hongkongensis* are showed on Figure 6.3.2.2.

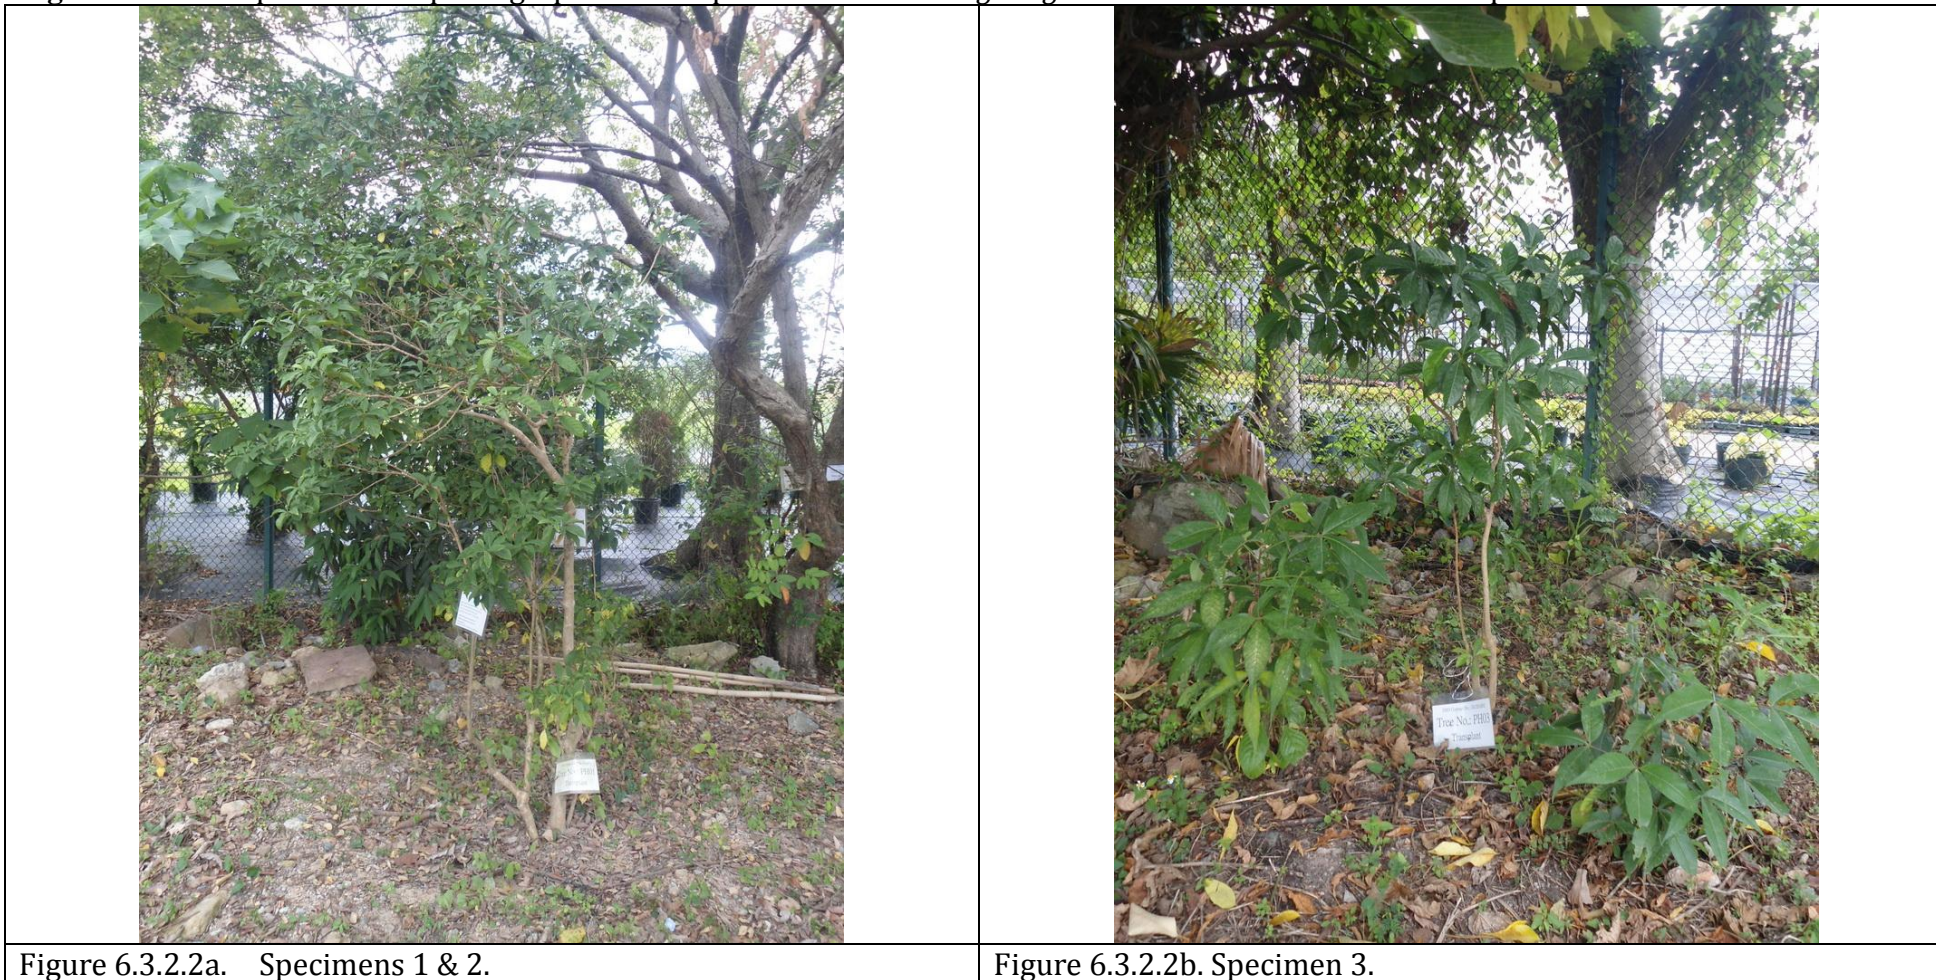
Figure 6.3.2.2. Representative photographs of transplanted *Pavetta hongkongensis* in ECA since the first transplantation in 19 Oct. 2012.

Figure 6.3.2.2a. Specimens 1 & 2.

Figure 6.3.2.2b. Specimen 3.

Three specimens of protected species *Pavetta hongkongensis* were transplanted to ECA on 20th December 2011 and Monthly monitoring was carried out on 19th October 2012. All of them were in fair condition. Although there is no sign of pest outbreak or dieback , regular watering and close monitoring are still be recommended.

Regular watering is recommended to improve the condition of the transplanted *Pavetta hongkongensis* during non-raining period. Relevant mitigation measures will be proposed when necessary.

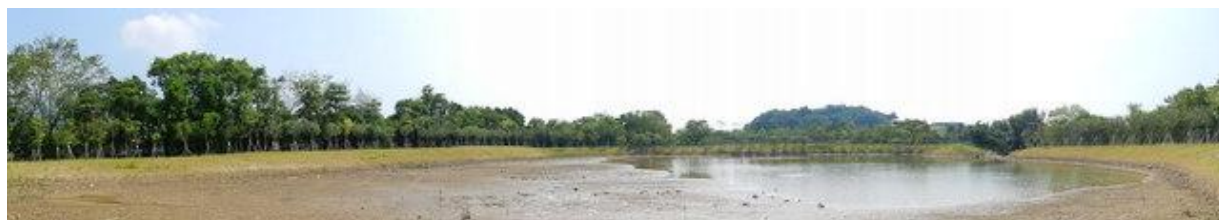
Photo 1. General view of the wetland as inspected on 5th October 2012.

Inspection Dates	Observation	Recommendations
5 th October 2012	<p>A routine site visit to inspect the latest wetland performance and condition of about 30 newly replaced compensatory trees around the terrestrial areas. The newly replaced compensatory trees were in fair health and tree form, and sign of recent watering around the trunk base was observed on these compensatory trees.</p> <p>The created wetland and the remaining planted vegetation (including the shrubs, mangrove seedlings and the compensatory trees) have been maintained in fair to good condition. Small patches of planted wetland herbs (<i>Bacopa monnieri</i> and <i>Cyperus malaccensis</i>) appeared dry and weak, but it is a normal natural dieback phenomenon for perennial herbs and new population will resume in the next wet season. Naturally established wetland herbs (such as <i>Alternanthera</i> spp. and <i>Lindernia</i> spp.), other terrestrial herbs (such as <i>Abutilon indicum</i>) and seedlings of tree <i>Macaranga tanarius</i> var. <i>tomentosa</i> were observed in the created wetland and terrestrial pond, implying a gradual natural establishment of plants.</p> <p>The trees transplanted from Area A to the ECA have been maintained generally in fair to good condition. The three transplanted shrubs of conservation interest, <i>Pavetta hongkongensis</i>, were fruiting by the time of site visit and have shown satisfactory performance.</p>	<p>The Contractor should maintain regular watering on all planted shrubs, newly planted and established compensatory trees in the whole ECA. The temporary site hoardings at the main site entrance should be replaced with a permanent wire mesh fence prior to the final handover meeting in mid-October 2012.</p>

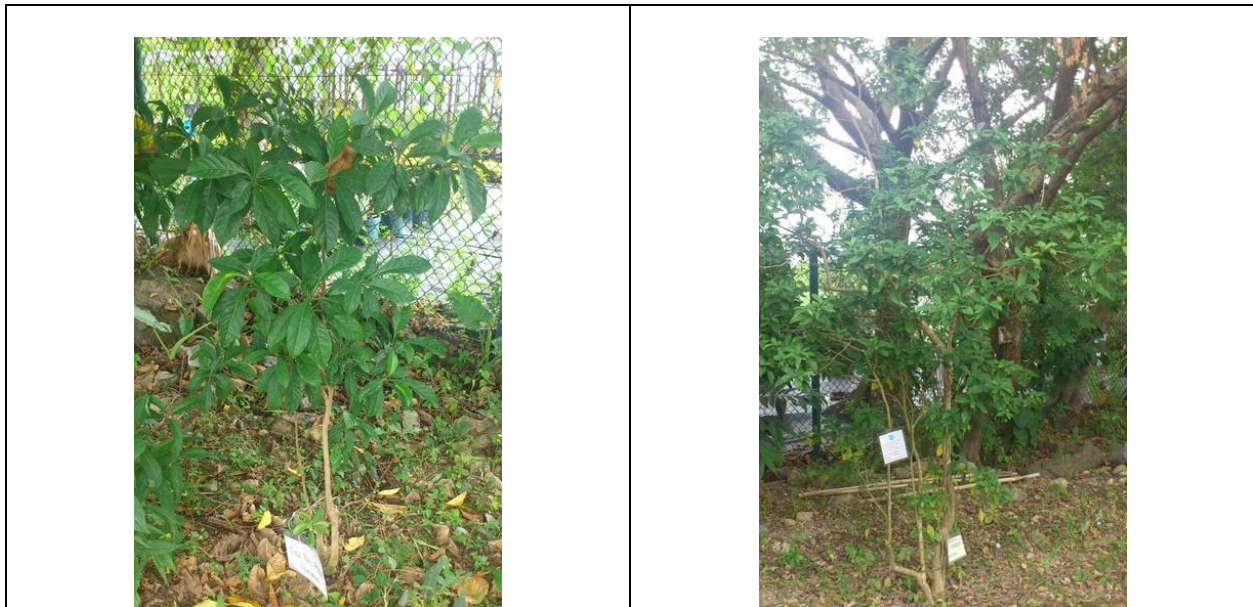
Photo 4. Transplanted *Pavetta hongkongensis* PH-03 was in good condition.

Photo 5. Transplanted *Pavetta hongkongensis* PH-01 and PH-02 were in good condition.

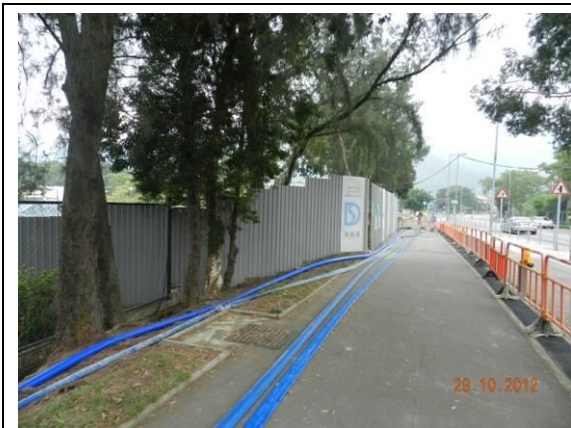
Construction hoardings have been erected in Area A along the entire site boundary. Temporary construction hoardings have been erected around Wai Ha River estuary since the commenced work for building an automatic mechanical penstock at the area. Since February 2012, temporary construction hoardings have also been erected to surround the works area for constructing a drain pipe along Ting Kok Road. A section of cycling track outside Tung Tsz Nursery along Ting Kok Road was found surrounded by temporary hoardings (Photo 1).

Photo 1 – Temporary hoardings have been established along Ting Kok Road outside Tung Tsz Nursery.

No specific recommendation is required.

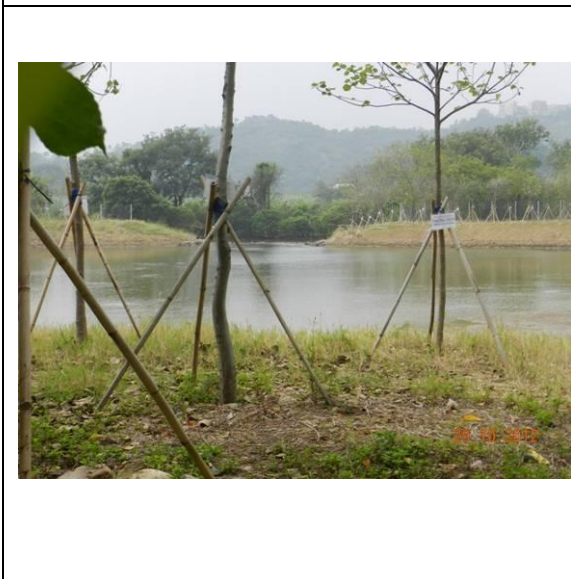
Area C was formally handed over to AFCD on 16th October 2012 for management and maintenance. The pond of the ECA has been connected to Wai Ha River directly as following the scheme design of Habitat Compensatory Plan. No direct discharge of turbid water into the adjacent Wai Ha River was observed through the fence of Tung Tsz Nursery (Photo 3).

Photo 3 – No discharge of muddy water was observed in Area C.

No specific recommendation is required for Areas A, B and C. As a reminder, the Contractor should regularly check the condition and locations of the drainage pipes and ensure that all used water should be appropriately filtered and discharged to the manholes/other discharge points agreed by the Engineer and EPD. This is to avoid any potential contamination to the vegetation in Shuen Wan marsh and other vegetated/marinated areas adjacent to the active works area.

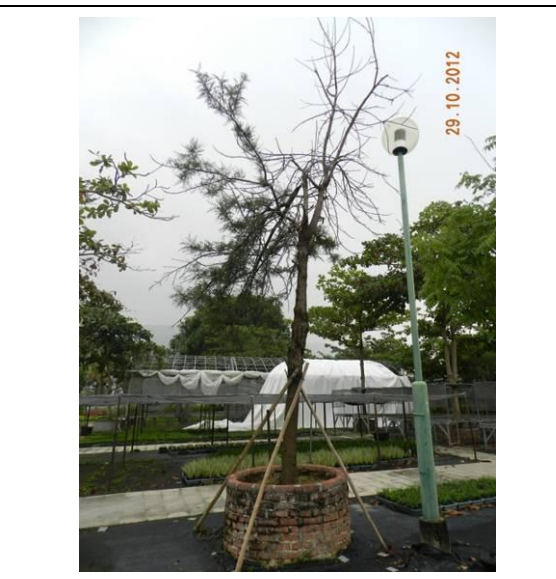
Regular monitoring for all transplanted trees within the nursery was conducted on a bi-weekly basis. For tree U58 (*Grevillea robusta*) (Photo 4), the broken scaffold branch was still found to be overhung in the canopy. New but small leaves were observed along the branches and watersprouts were found along the trunk. The physiological condition of U58 has remained fairly poor in October 2012 and close monitoring has to be continued to update its health and structural conditions.

Photo 4 – Overall view of the transplanted tree U58 *Grevillea robusta*.

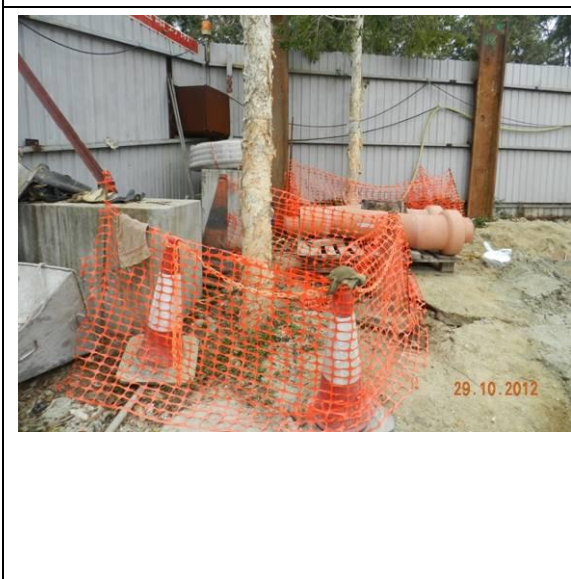
TPZs with temporary storage of construction materials were not observed for trees to be transplanted (E19 to E20) at the southwestern part of Area A (Photo 5) during the monitoring in October 2012.

Photo 5 – No temporary storage of construction materials were observed within the TPZs in Area A.

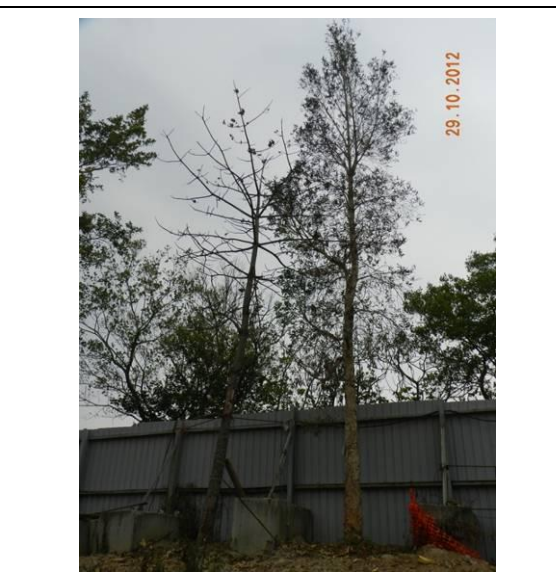
Photo 6 – Poor condition of translocated tree E17 (*Bombax ceiba*) and E18 (*Melaleuca cajuputi* subsp. *cumingiana*).

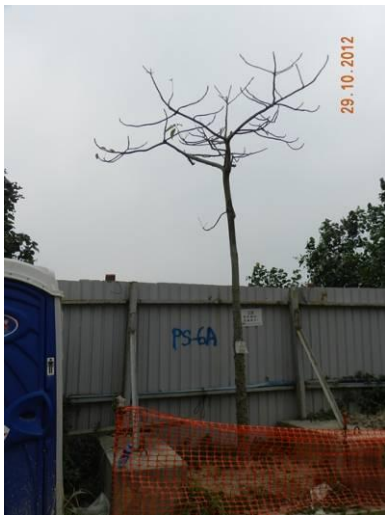
Photo 7 – Poor condition of translocated tree E16 (*Bombax ceiba*).

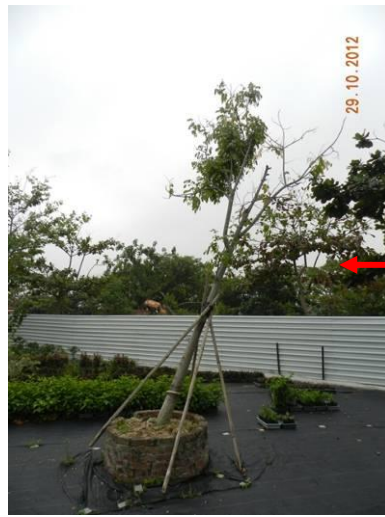
Photo 8 – Severe leaning tree trunk of the transplanted tree U61 was observed in Area B.

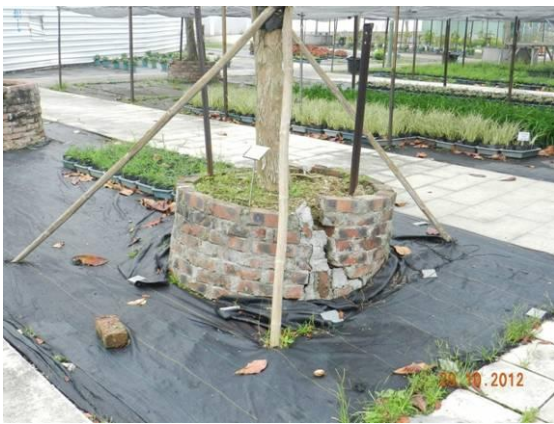
Photo 9 – Crack on the planter of U75 became more obvious in Area B.

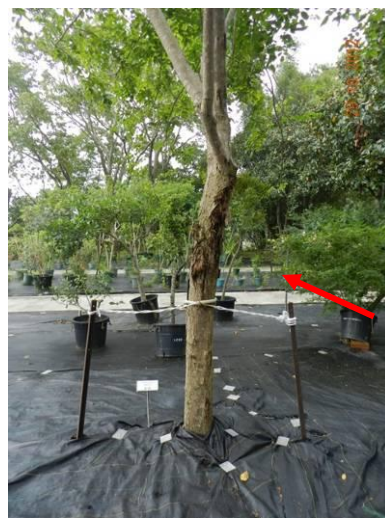
Photo 10 – Decayed wood was observed along the trunk.

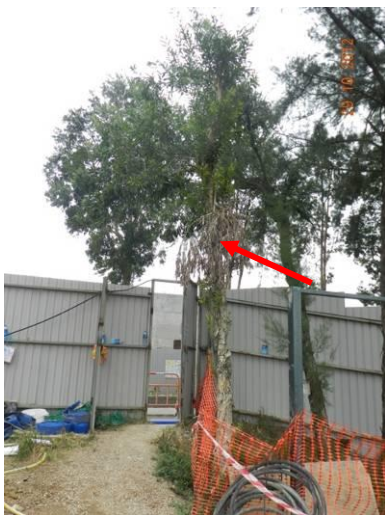
Photo 11 – A broken scaffold branch was observed on the tree to be transplanted (T102) in Area B.

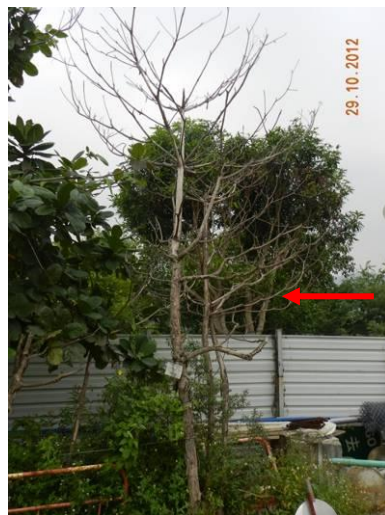
Photo 12 – Declining health condition of U34 in Area B.

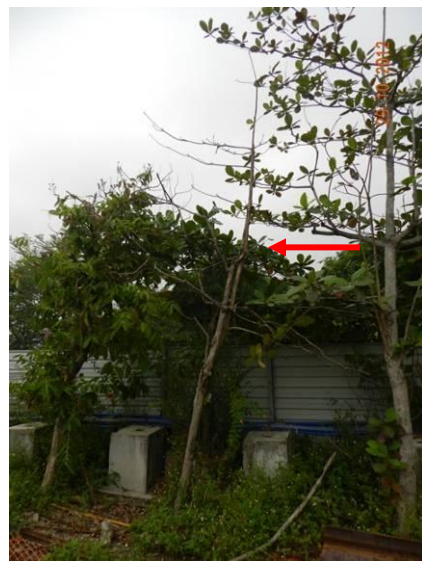
Photo 14 – Declining health condition of U37 in Area B.

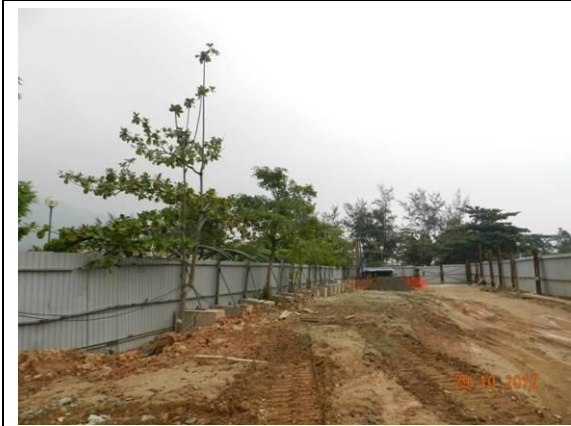
Photo 15 – No proper tree protection zones were set up along the transplanted tree in Area B.

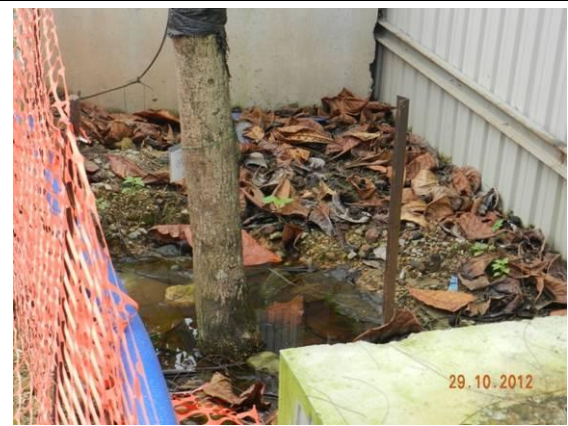
Photo 16 – Waterlogged area was observed at the base of the relocated tree U6 in Area B.

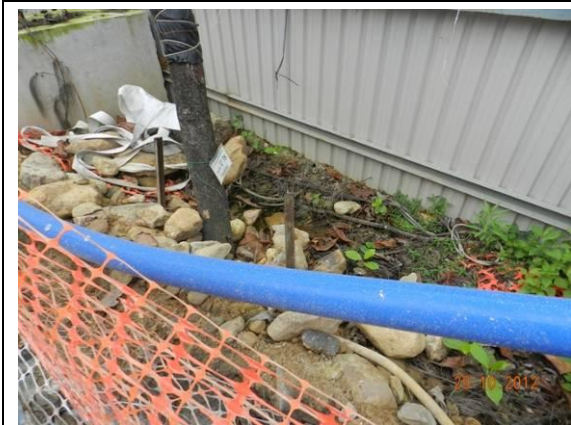
Photo 17 – Soil and stones were piled close to the base of the relocated tree U8 in Area B.

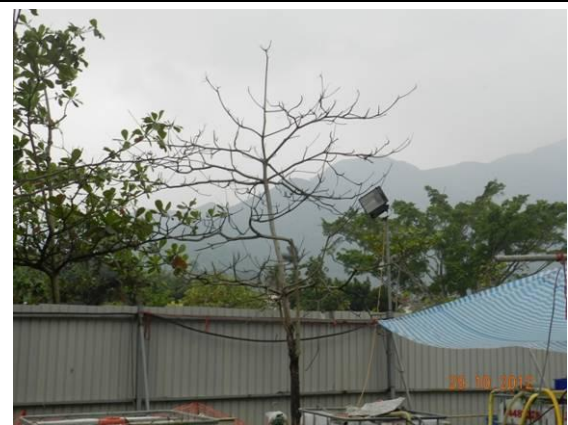
Photo 18 – Poor health condition was observed in the canopy of the relocated tree U77 in Area B.

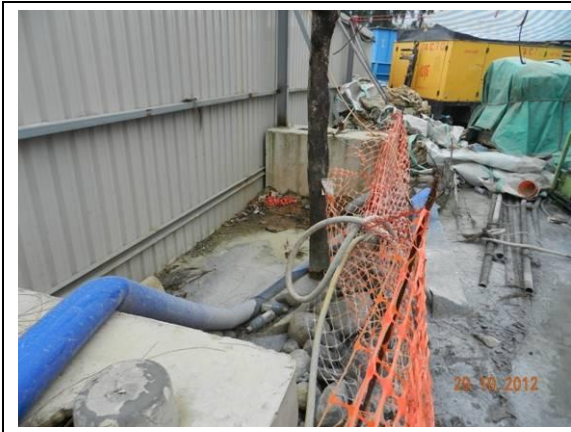
Photo 19 – The base of the tree U77 was waterlogged with used water from the construction work.

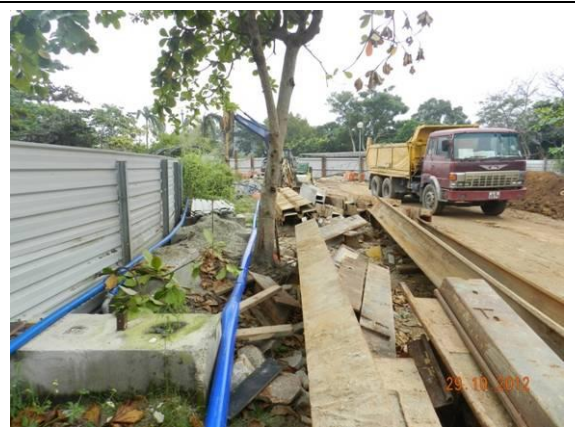
Photo 20 – Stockpiling of construction materials were observed immediately next to the trunk and damage was observed near the tree U54 and two existing trees with no tag next to U54
