**CONTRACT NO. DC/2010/02 –  
DRAINAGE IMPROVEMENT IN SHUEN WAN AND  
SHEK WU WAI**

**MONTHLY ENVIRONMENTAL MONITORING AND  
AUDIT REPORT (NO.17) – NOVEMBER 2012**

PREPARED FOR  
**KWAN LEE-KULY JOINT VENTURE**

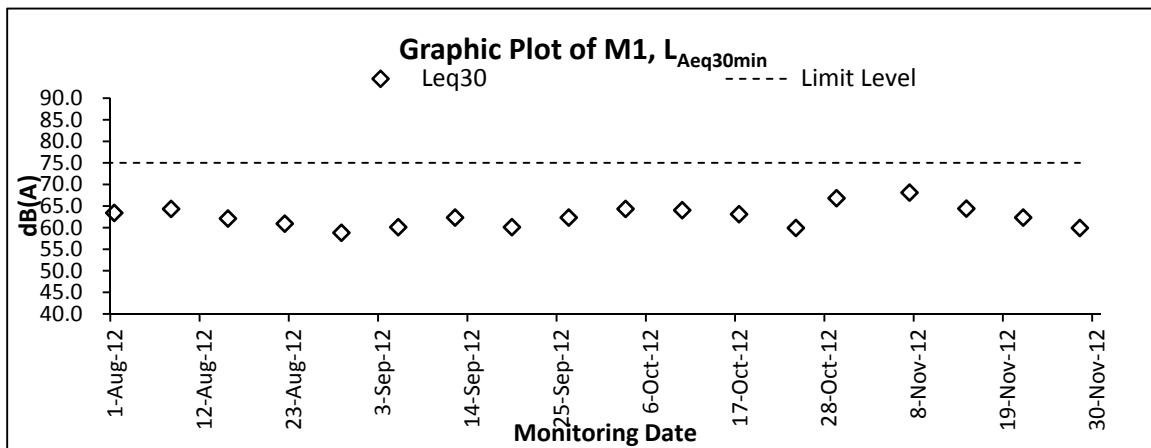
Remark: The monitoring is undertaken under façade situation. No façade correction is added according to acoustical principles and EPD guidelines.

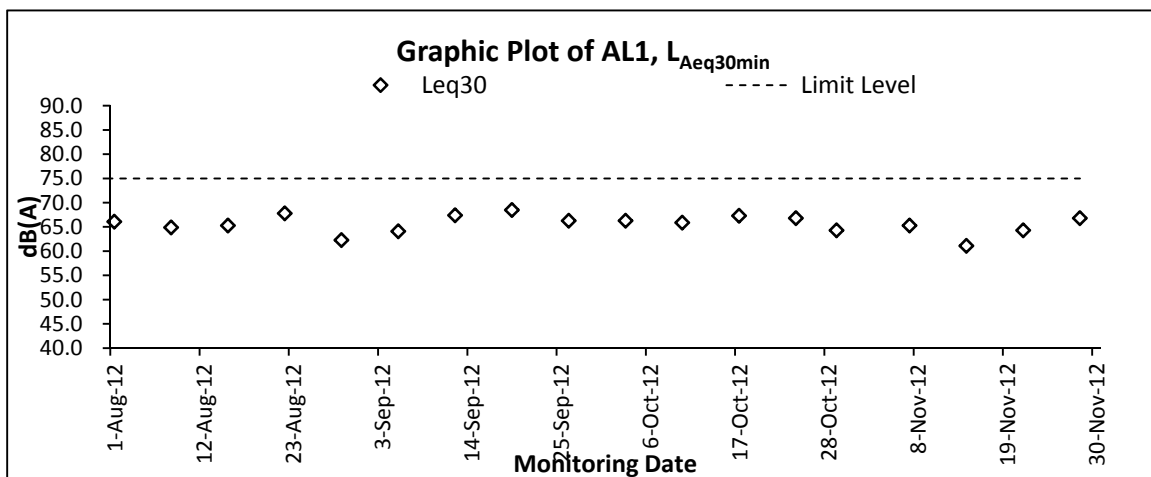
Remark: The monitoring is undertaken under façade situation. No façade correction is added according to acoustical principles and EPD guidelines.

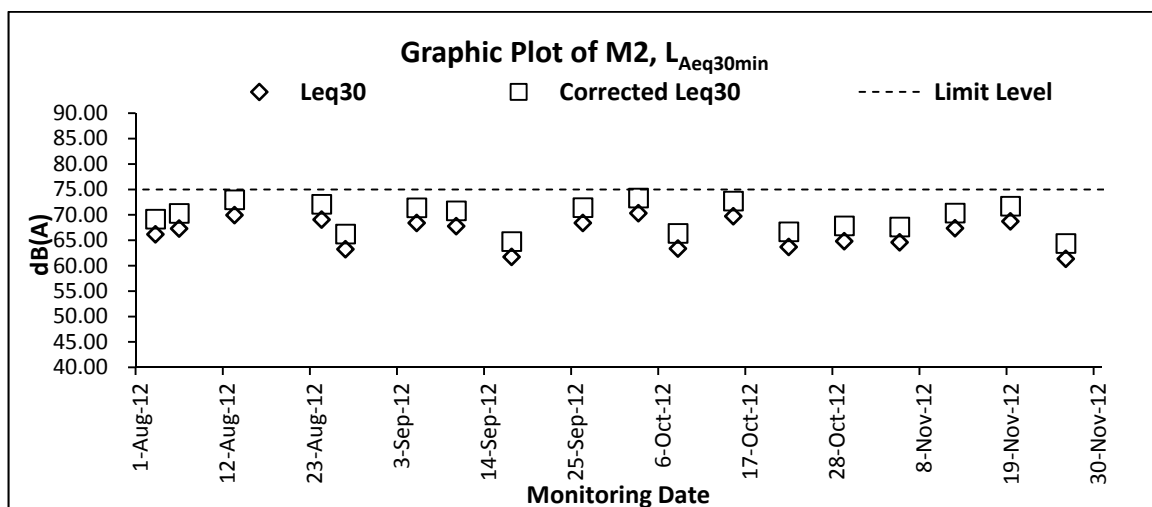
Remark: The monitoring is undertaken under free field situation. A façade correction of +3 dB(A) has been added according to acoustical principles and EPD guidelines.

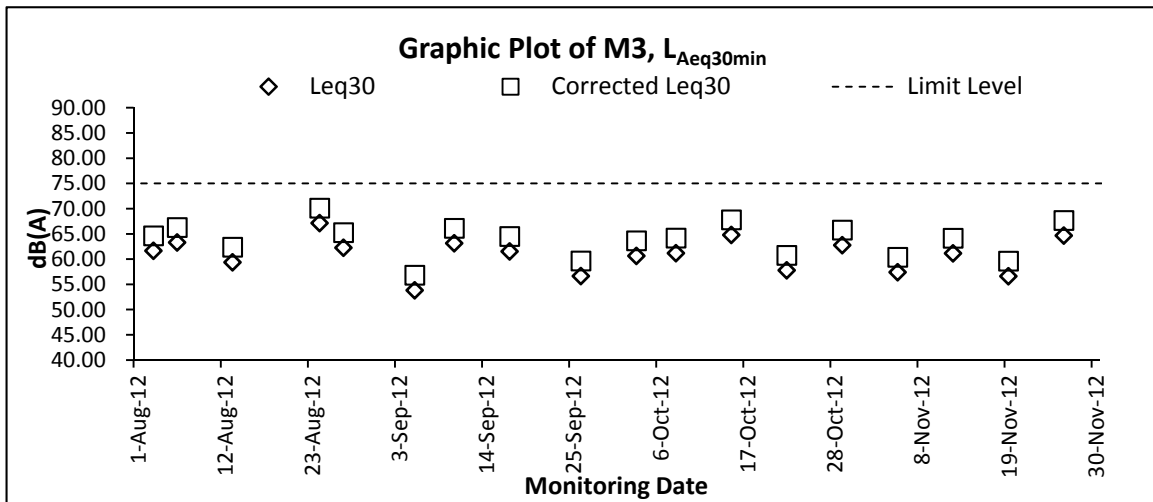
Remark: The monitoring is undertaken under free field situation. A façade correction of +3 dB(A) has been added according to acoustical principles and EPD guidelines

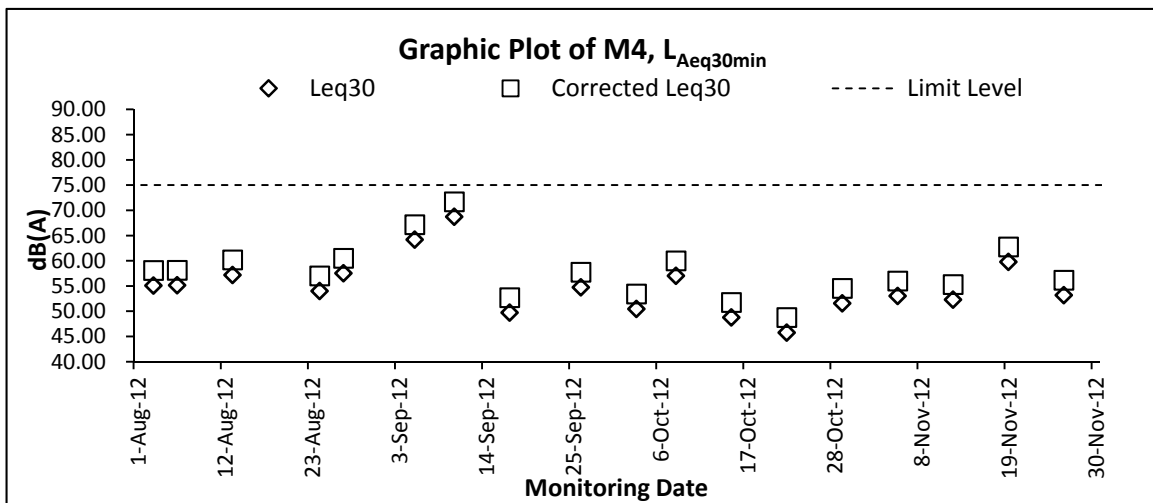
Remark: The monitoring is undertaken under free field situation. A façade correction of +3 dB(A) has been added according to acoustical principles and EPD guidelines

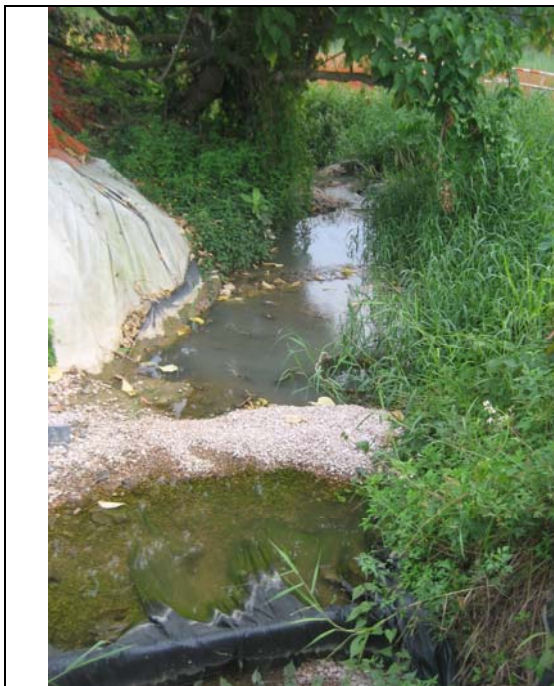
1. The rock bund was found to be repaired.

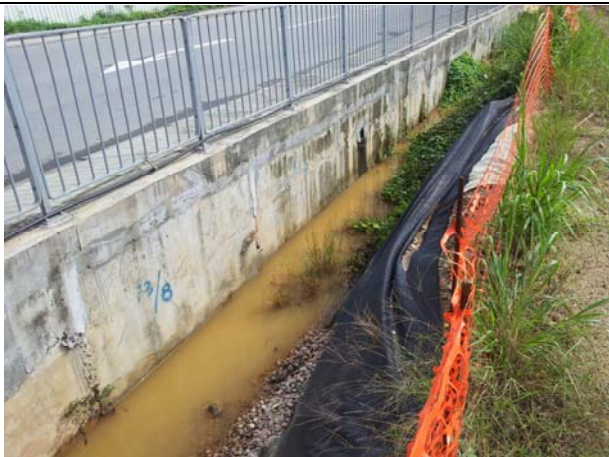
Photo 1 :  
The sediment inside the de-silting channel should be cleared regularly in order to maintain its function.

1. The sediment inside the de-silting channel has been cleared.
2. Housekeeping has been improved.

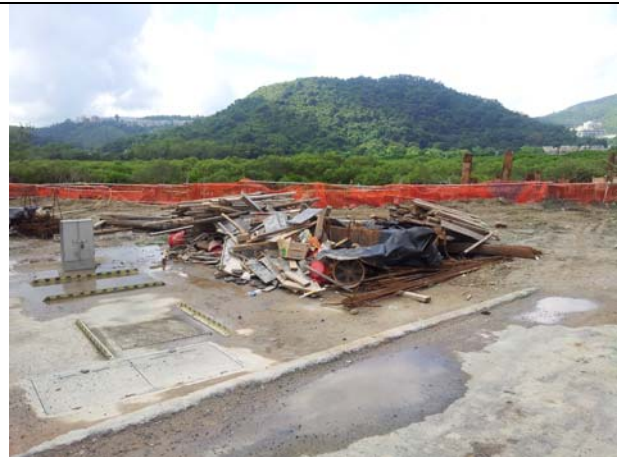
Photo 2 :  
Construction waste should be sorted and disposed of properly.

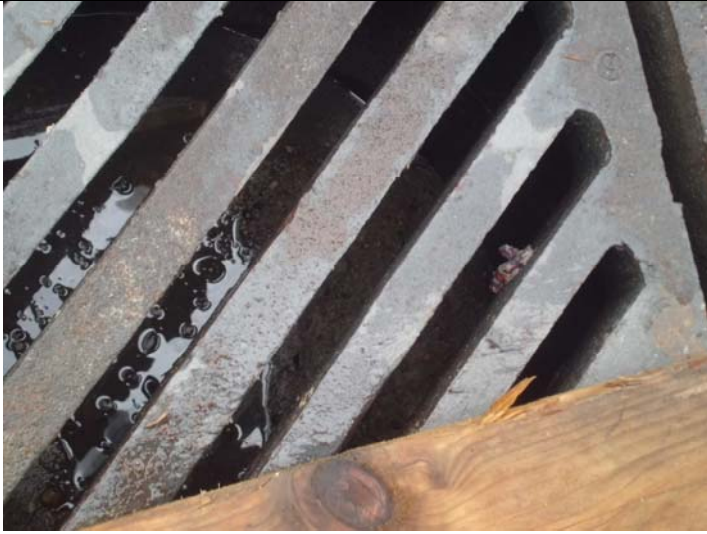
Photo 1 :  
The gully at the boundary of the site was found to be blocked by the sediment, the Contractor should scoop out the sediment immediately in order to maintain drainage system in proper function.

| Date | Findings / Deficiencies | Follow-Up Status |
|---|--|---|
| 29 November 2012 | <ul style="list-style-type: none"><li>The gully at the boundary of the site was found to be blocked by the sediment, the Contractor should scoop out the sediment immediately in order to maintain drainage system in proper function.</li></ul> | Rectified on 5 December 2012. |

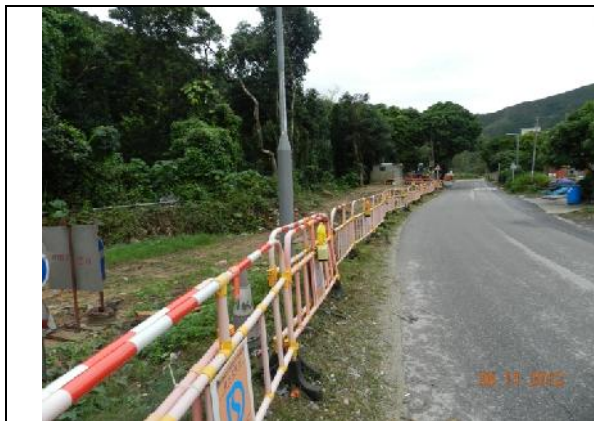
**Photo 1** – Temporary hoardings have been erected around the active works area to the south of Wai Ha.

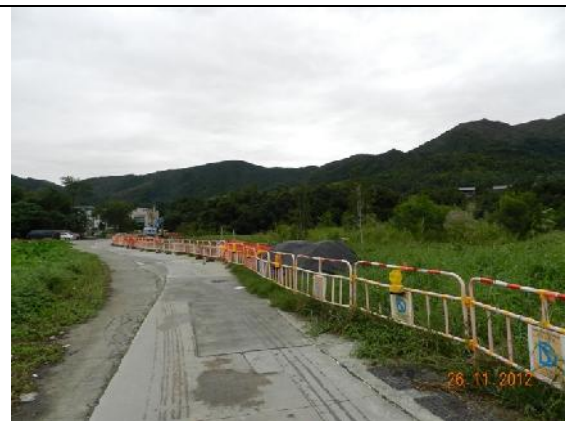
**Photo 2** – Temporary hoardings have been erected around the active works area along the access road to Treasure Spot Garden II.

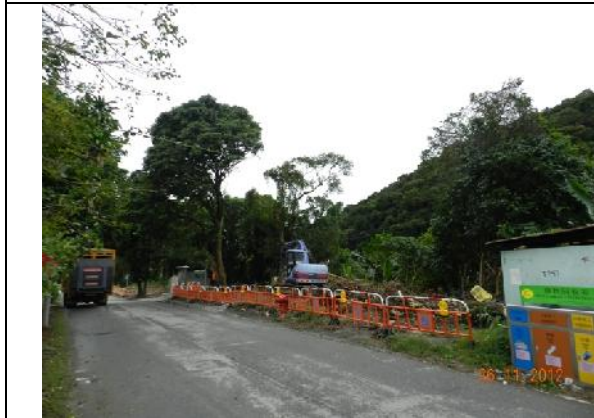
**Photo 3** – New temporary hoardings have been erected along the west of Tung Tsz Road near the refuse collection point.

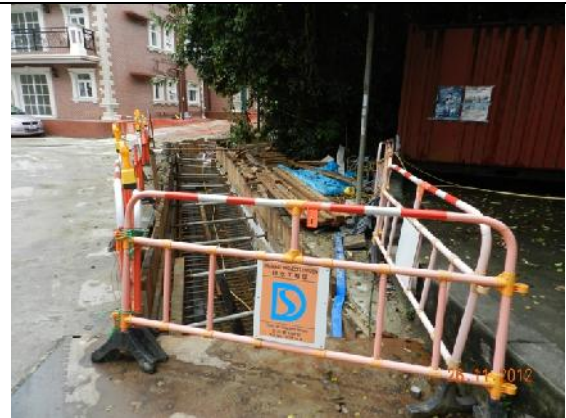
**Photo 4** – New temporary hoardings have been erected on the path near Treasure Spot Garden II.

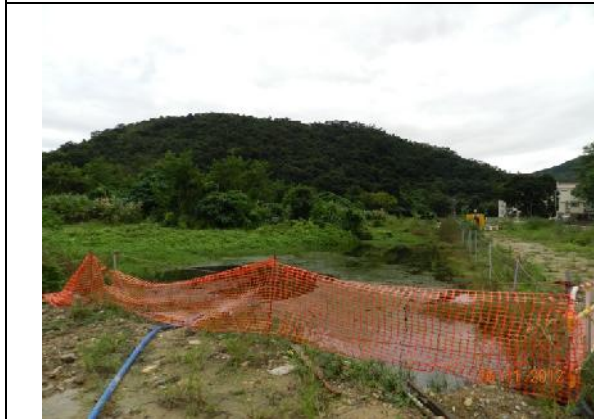
**Photo 5** – The wetland rehabilitation area has been demarcated with red strings.

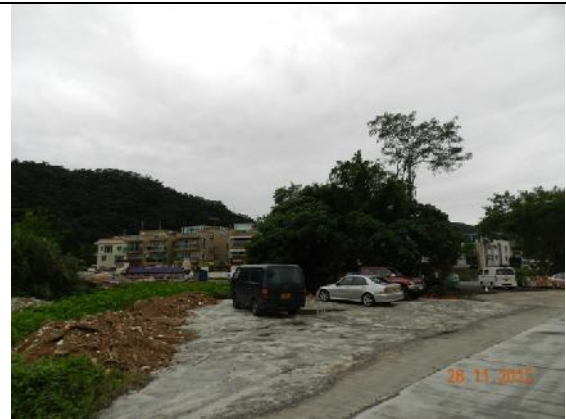
**Photo 6** – A newly paved area was created for parking next to the retained tree groups (T088 – T091).

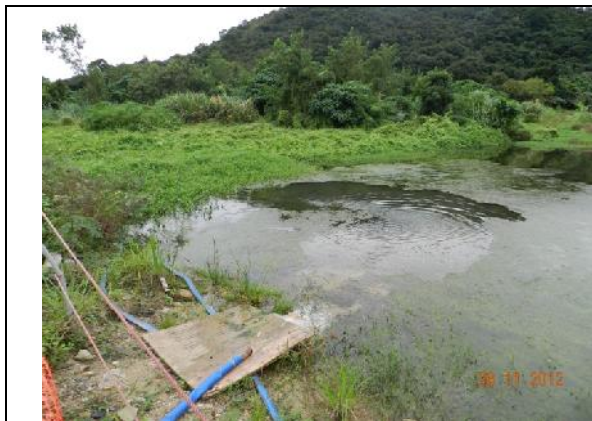
**Photo 13** – Discharge of filtered water from the works area into the wetland rehabilitation area

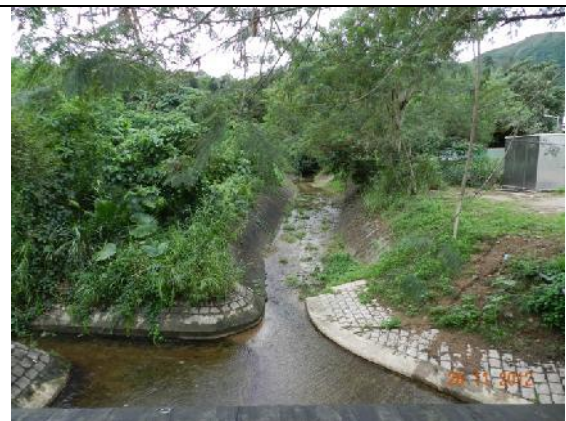
**Photo 14** – No discharge of used water was observed in Wai Ha River.

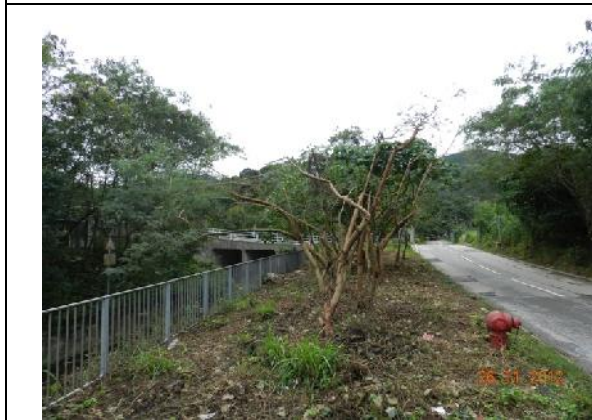
**Photo 15** – The tree proposed to be removed T075 and its surrounding undersized trees (all are of undesirable tree species of *Leucaena leucocephala*) were topped.

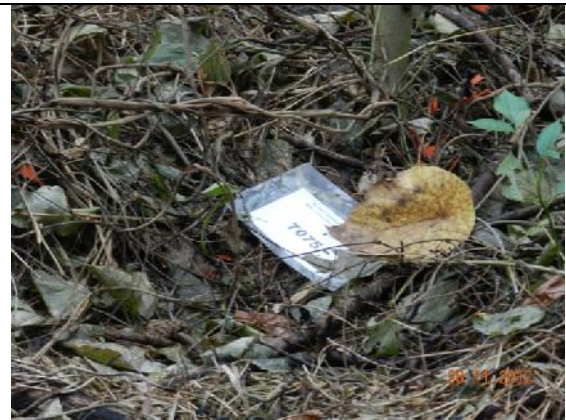
**Photo 16** – The tree tag of T075 was left on the ground.

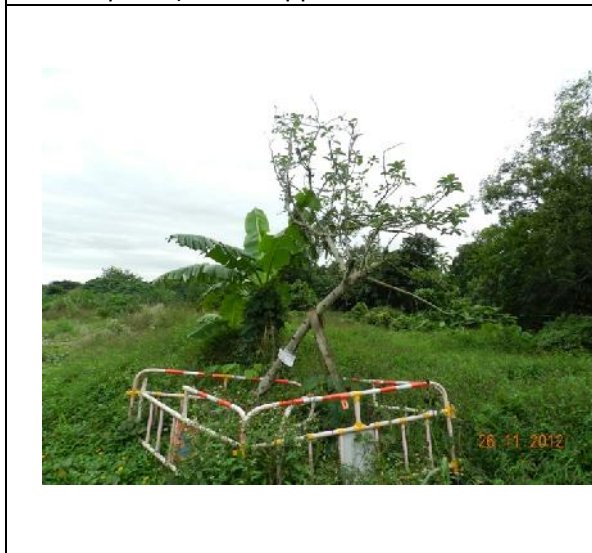
**Photo 17** – The leaning, retained tree T190 (*Ficus hispida*) was protected within a demarcated zone and supported by a wooden stand.

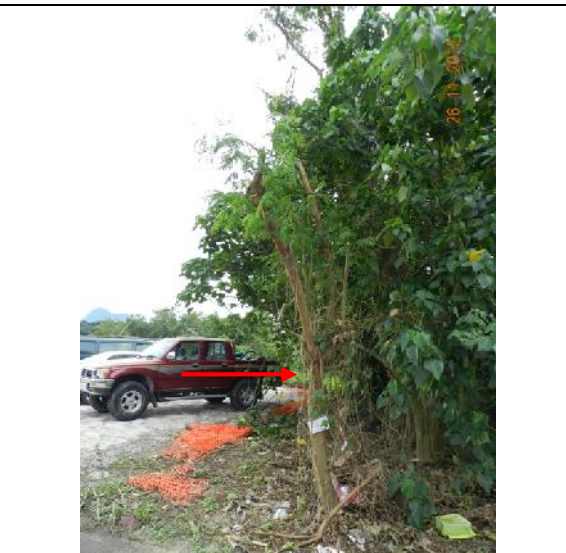
**Photo 18** – The retained tree T089 (*Leucaena leucocephala*) next to the access path from Tung Tsz Road to Treasure Spot Garden II was topped and the adjacent vegetations were removed by other contractor.

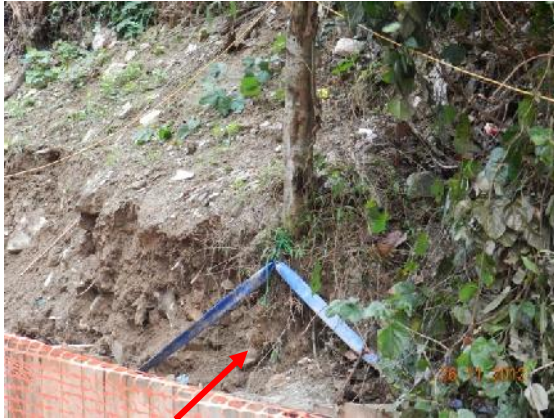
**Photo 19** – Excavated work close to the retained tree T103 was observed and it covers almost half of the root zone area of the tree.

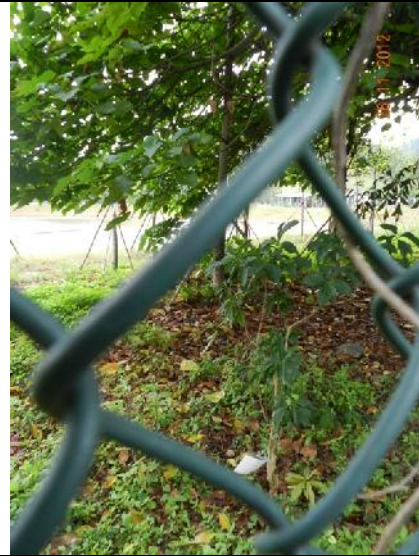
**Photo 20** – The transplanted shrub of *Pavetta hongkongensis* (PH03) has remained in satisfactory condition in Area C under Contract 1.

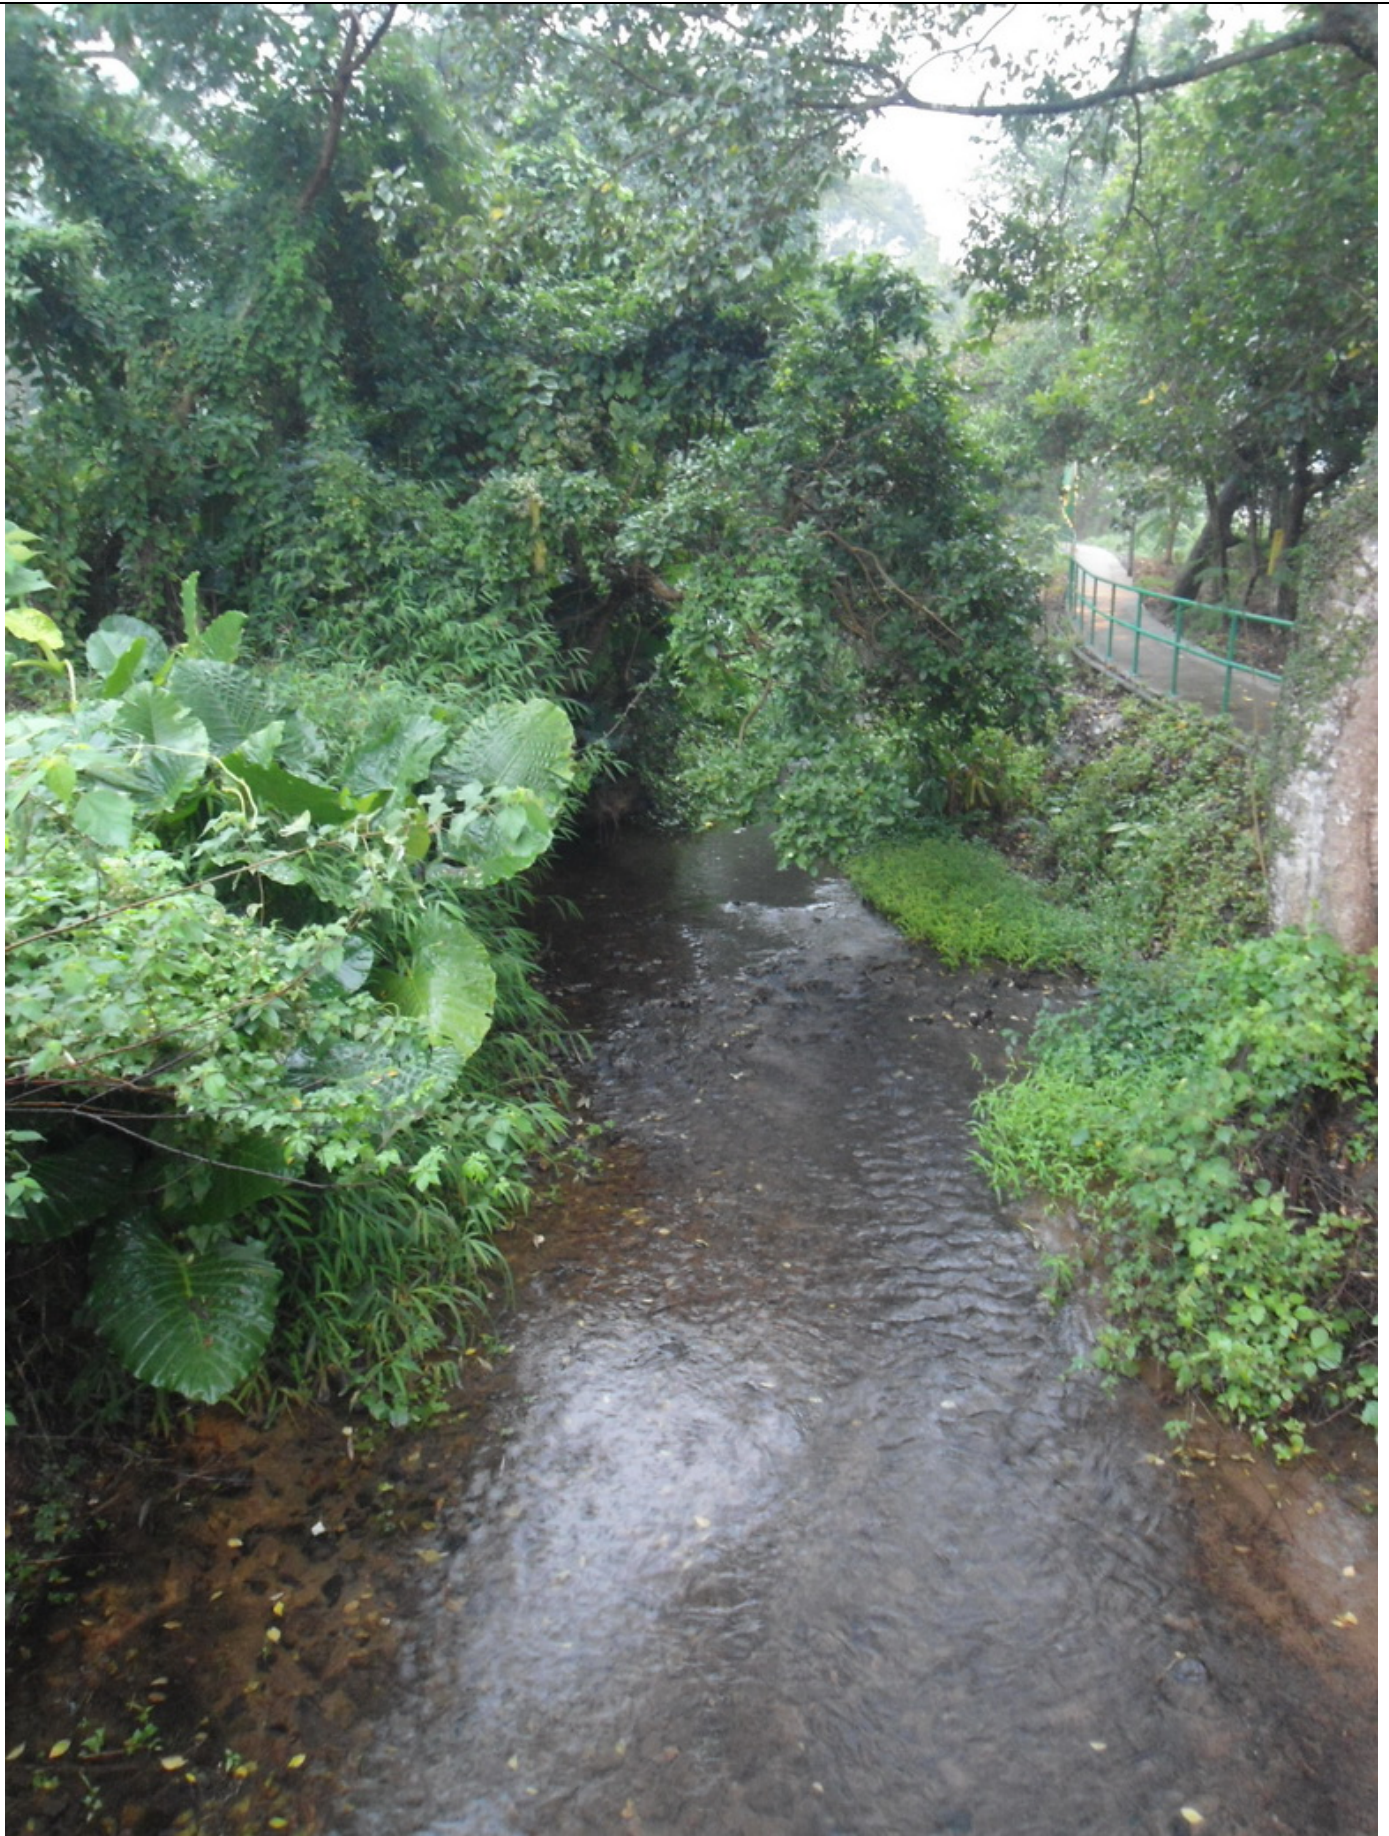
**Figure: 2**

**Title:** SEMP 3, the third sampling point of Wai Ha River under Contract 2.

Under Contract 2 (i.e. SEMP 3 & 4), a total of 9 fish species, 1 crustacean, 1 gastropod and 1 arthropod were recorded and most of them were freshwater species (**Table 4**). *Carassius auratus* was commonly observed at SEMP 3 because of the traditional Buddhist practice from the nearby temple in which captured organisms were released back to nature. In addition, river section at SEMP 3 is relatively natural and the presence of *Parazacco spilurus* may imply that good water quality at this section is maintained. Overall, no protected or rare species were recorded.

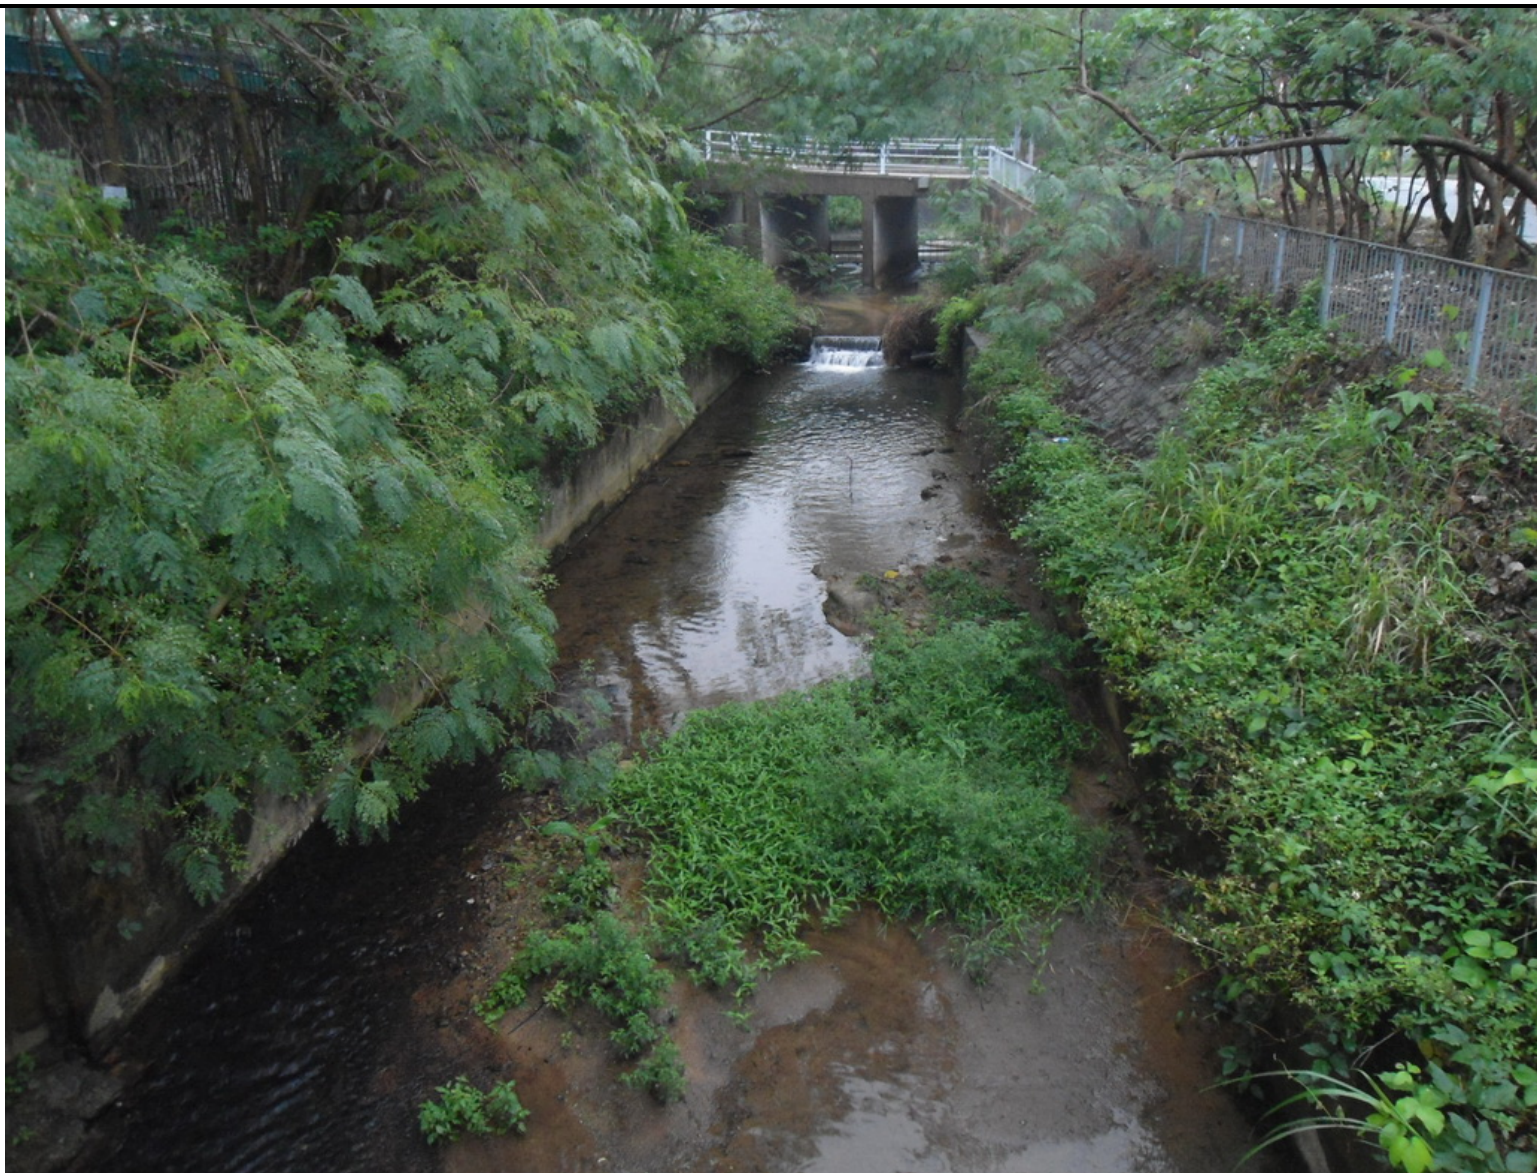
**Figure:** 3

**Title:** SEMP 4, the second sampling point along Wai Ha River under Contract 2.
