Monthly Environmental Monitoring & Auditing report for

Contract No.DC/2009/22

Drainage Improvement in Shuen Wan, Tai Po – Contract 1

December 2012

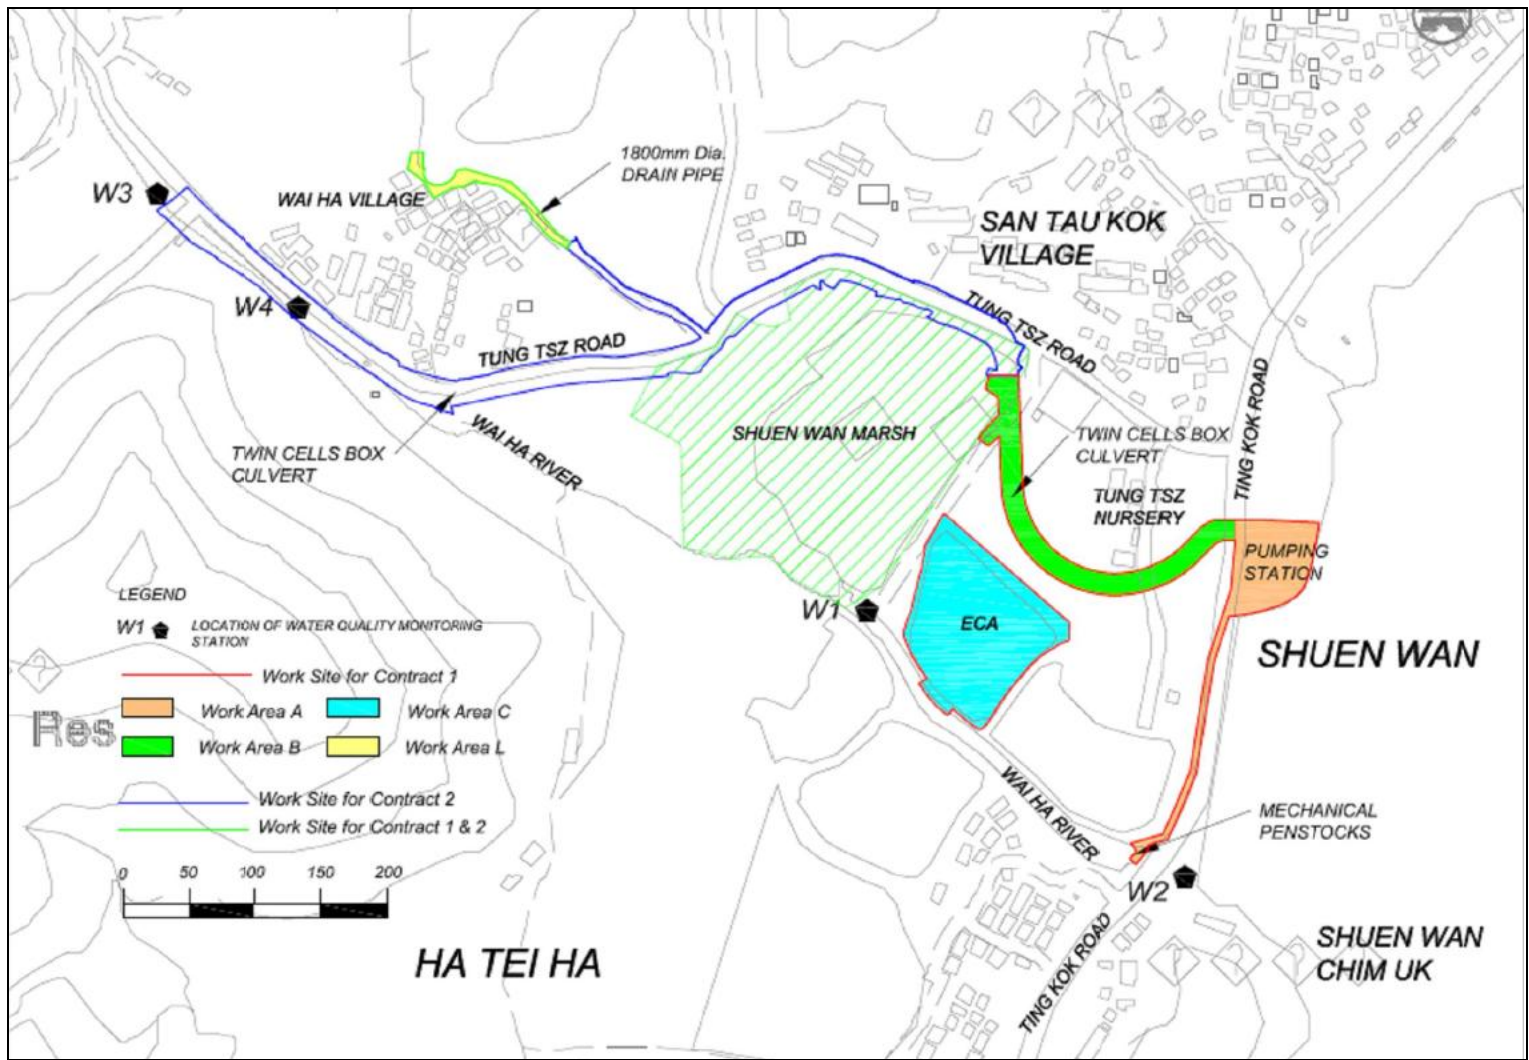
Figure 4.3.1 Water Quality Monitoring Locations

As the depth of water was less than 3m, water samples were collected at mid-depth of each proposed monitoring stations for measurements and sample collection.

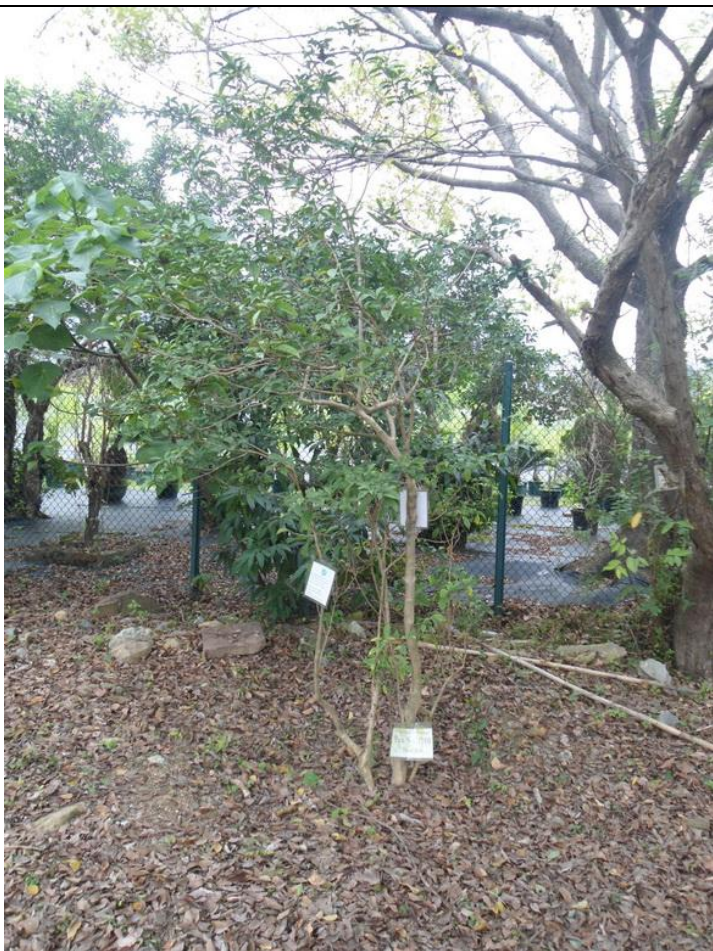
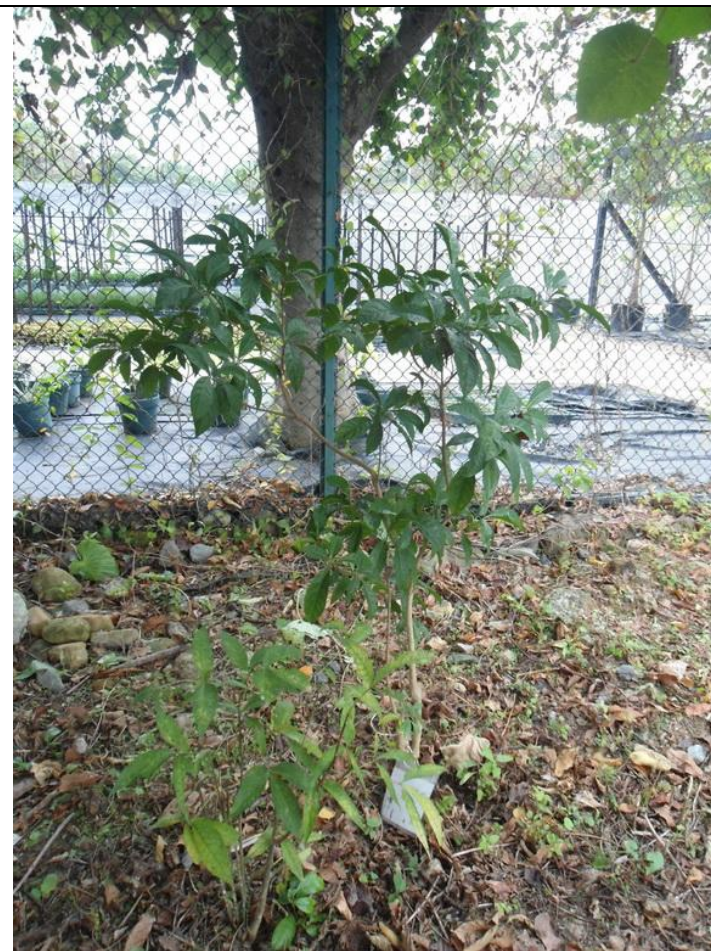
Figure 6.3.2.2. Representative photographs of transplanted *Pavetta hongkongensis* in ECA since the first transplantation in 20 Dec 2012.

Three specimens of protected species *Pavetta hongkongensis* were transplanted from work area under Contract 2 to ECA at Zone D (Figure 6.3.2.1) on 20th December 2011. Monthly monitoring was carried out and their overall conditions are fair so far (Appendix L). Representative photographs of the transplanted *P. hongkongensis* are showed on Figure 6.3.2.2.

There is no sign of pest outbreak or dieback took place in the current monitoring.

Regular watering is recommended to improve the condition of the transplanted

Pavetta hongkongensis during non-raining period. Relevant mitigation measures will be proposed when necessary.

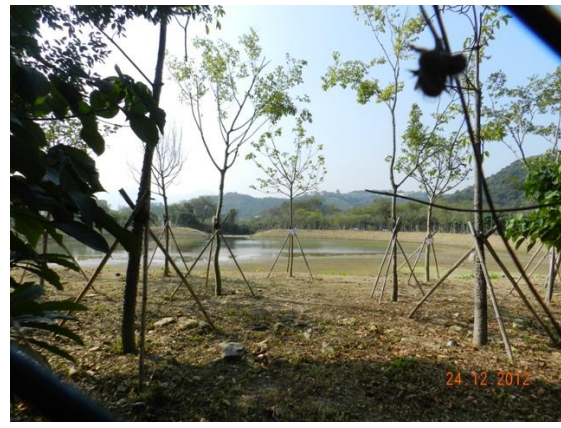
Area C was formally handed over to AFCD on 16th October 2012 for management and maintenance. The pond of the ECA has been connected to Wai Ha River directly as following the scheme design of Habitat Compensatory Plan. No direct discharge of turbid water into the adjacent Wai Ha River was observed through the fence of Tung Tsz Nursery (**Photo 2**).

Photo 2 – No discharge of muddy water was observed in Area C.

No specific recommendation is required for Areas A, B and C. As a reminder, the Contractor should regularly check the condition and locations of the drainage pipes and ensure that all used water should be appropriately filtered and discharged to the manholes/other discharge points agreed by the Engineer and EPD. This is to avoid any potential contamination to the vegetation in Shuen Wan marsh and other vegetated/marinated areas adjacent to the active works area.

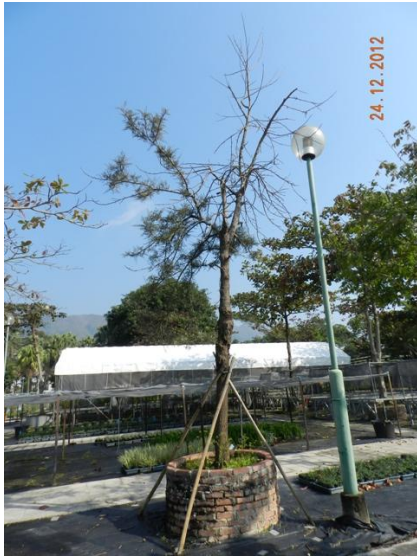
Regular monitoring for all transplanted trees within the nursery was conducted on a bi-weekly basis. For tree U58 (*Grevillea robusta*) (**Photo 3**), the broken scaffold branch overhanging in the canopy was removed. Leaves as watersprouts were observed along the branches and the trunk. The physiological condition of U58 has remained fairly poor in December 2012 and close monitoring has to be continued to update its health and structural conditions.

Photo 3 – Overall view of the transplanted tree U58 *Grevillea robusta*.

Regular monitoring and watering of *Grevillea robusta* (U58) are still recommended to be the major treatment to the tree. The appointed landscape contractor and the Contractor should closely monitor the health conditions of all transplanted and retained trees throughout the construction period of the Project.

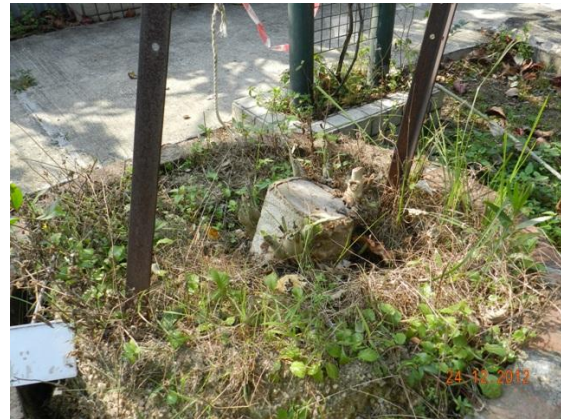
The tree to be retained U68 (*Gmelina arborea*) was found fallen after the severe typhoon in July 2012 with its leaning trunk being pruned and removed in August 2012 (as reported in *Monthly EM&A Report for August 2012*). As reported in the *Monthly EM&A Report for November 2012*, the developed watersprouts at the remained stump was recorded. However, such watersprouts were removed as inspected in December 2012 (**Photo 4**), possibly by the daily horticultural maintenance performed by the Nursery staff.

Photo 4 – Removal of watersprouts from the remained stump of U68.

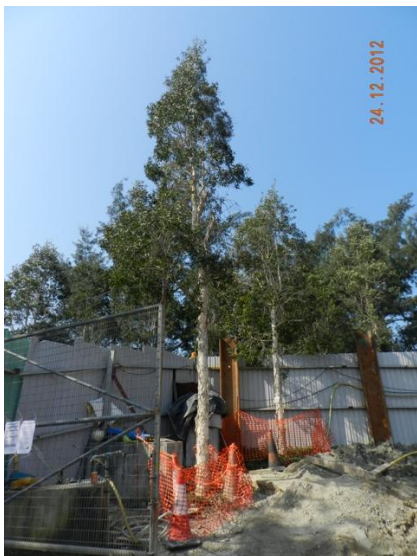
Appropriate TPZs (e.g. with no temporary storage of construction materials) were observed for trees to be transplanted (E19 to E20) at the southwestern part of Area A (**Photo 5**) during the monitoring in December 2012.

Photo 5 – No temporary storage of construction materials were observed within the TPZs in Area A.

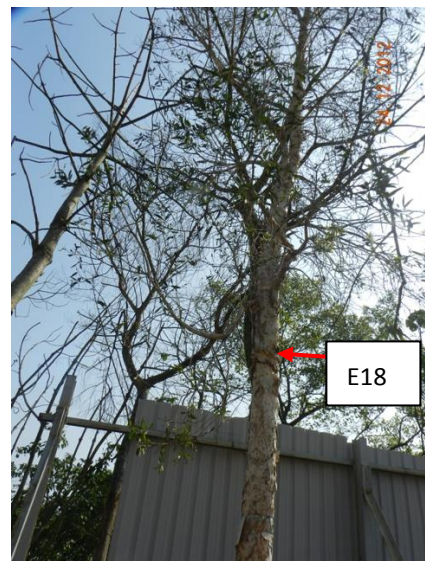
found in poor condition due to transplantation shock and poor planting skills. E17 was found to be dead as no foliage was found in the canopy and loose bark was observed along the trunk (**Photo 7**). For E18, living foliage was only observed at the lower canopy (**Photo 8**).

Photo 8 – Living foliage was only observed at the lower canopy of E18 (*Melaleuca cajuputi* subsp. *cumingiana*).

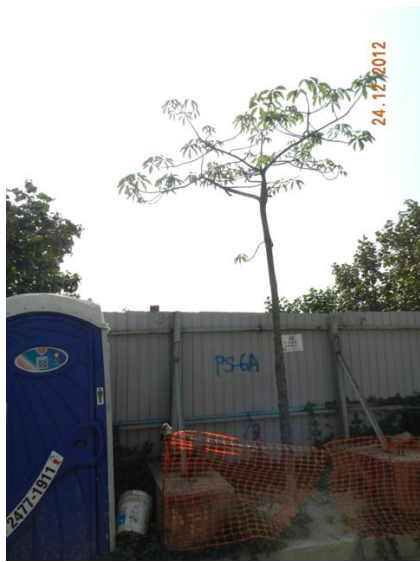
As observed since July 2012, the tree to be transplanted E16 (*Bombax ceiba*) has been relocated to the southern side of Area A next to the site hoarding. A TPZ was set up at the base by orange construction nets. The tree was in fair condition during the monitoring in December 2012 (**Photo 9**).

Photo 9 – Fair condition of relocated tree E16 (*Bombax ceiba*).

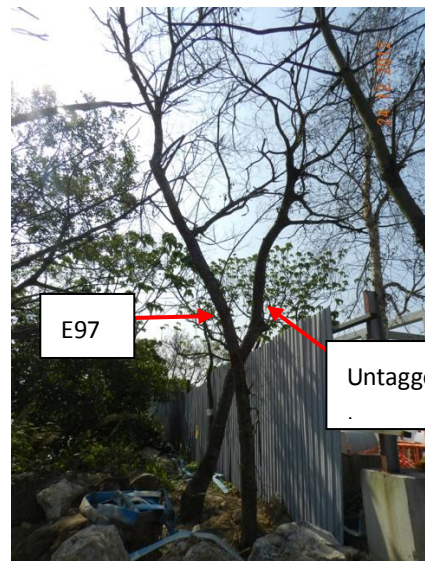
E97 (*Celtis sinensis*) and an untagged tree were also found being relocated at the northeastern part of Area A as their locations have direct conflict with the on-going construction works (**Photo 10**). Both trees were transplanted poorly and were suspected to be dead due to transplantation shock and poor planting skills.

Photo 10 – E97 and an untagged trees relocated in the northeastern part of Area A were in poor condition.

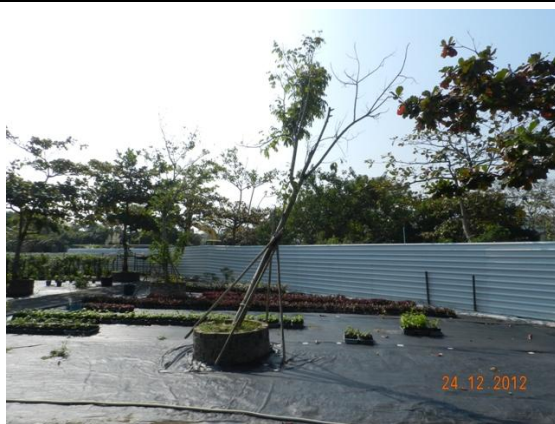
The transplanted tree U61 (*Lysidice rhodostegia*) was still found leaning severely with its propping uplifted (**Photo 11**), and the cracks on the planter of U75 (*Dolichandrone cauda-felina*) was still observed (**Photo 12**). As informed by the contractor in late December 2012, the contractor will arrange the appointed landscape contractor in early January 2013 to check both trees and provide appropriate tree remedial measures.

Photo 11 – Severe leaning tree trunk of the transplanted tree U61 was observed in Area B.

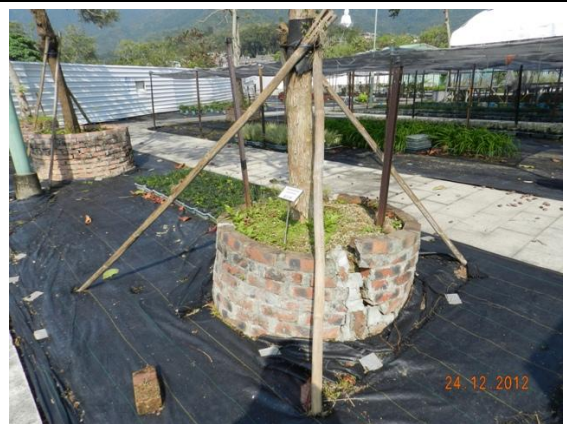
Photo 12 – Cracks on the planter of U75 became more obvious in Area B.

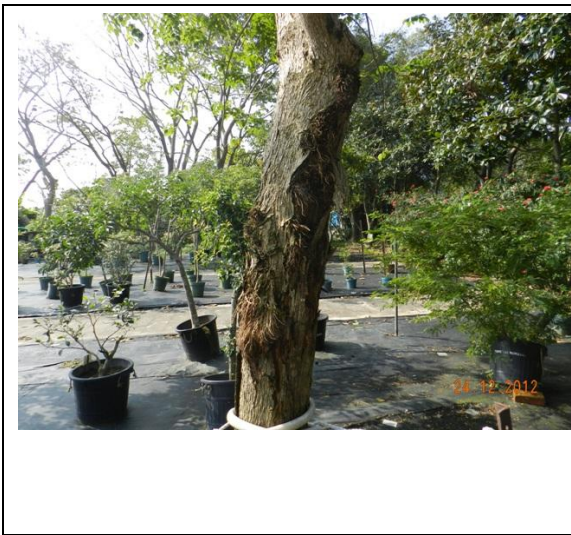
The transplanted tree U55 (*Pterocarpus indicus*) was planted directly into the ground as permitted by the nursery. Decayed wood was found along the tree trunk (**Photo 13**) and

such decay may be due to wood borers. The contractor informed that the appointed landscape contractor will have further pest control and detailed assessment for this tree.

Photo 13 – Decayed wood was observed along the trunk of U55.

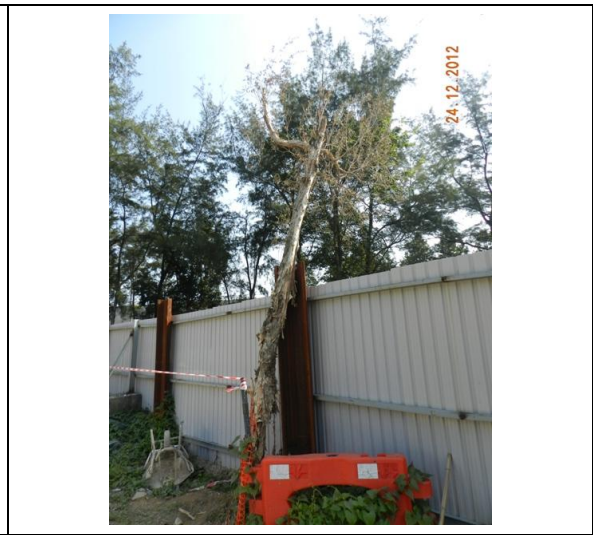
Photo 14 – The tree T102 relocated to the southern part within the Phase 2 works area of Area B was in poor condition.

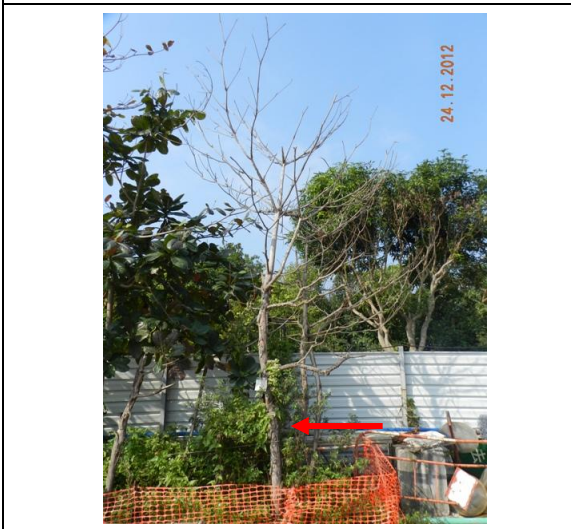
No recovery signs have been observed on the relocated trees U34 (**Photo 15**), U35 (**Photo 16**) and U37 (**Photo 17**) and they are regarded as dead specimens.

Photo 15 – Declining health condition of U34 in Area B.

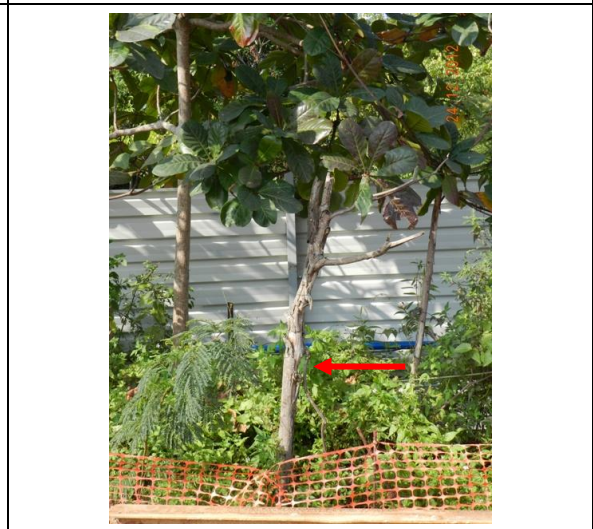
Photo 16 – Declining health condition of U35 in Area B.

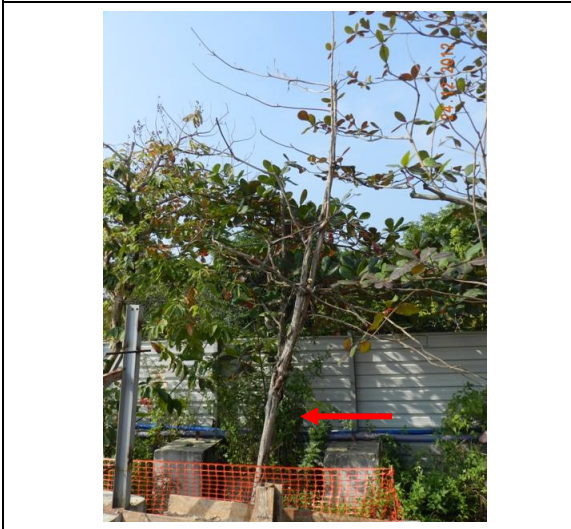
Photo 17 – Declining health condition of U37 in Area B.

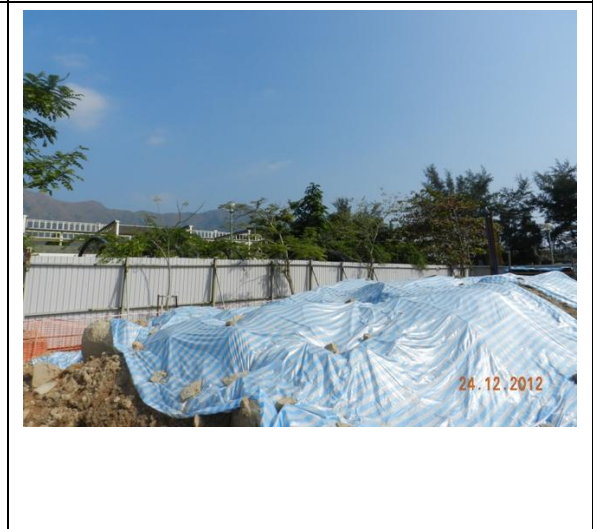
Photo 18 – Relocated trees were not inspected closely as piling of soil and stones were next to them.

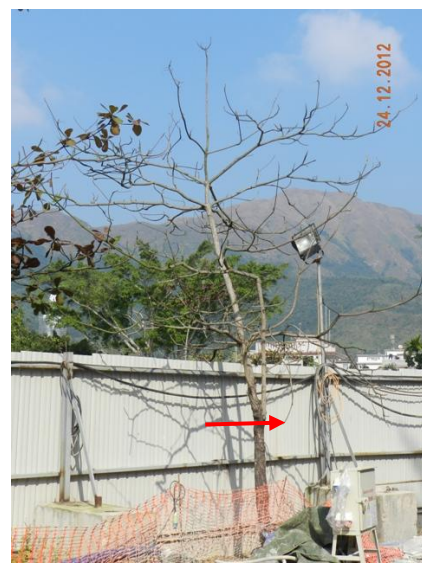
Photo 20 –The relocated tree U77 in Area B was suspected dead as no foliage was found in the canopy.

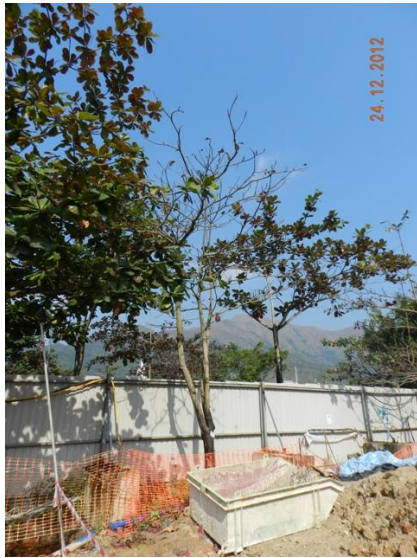
Photo 21 – Poor health condition was observed in the canopy of the relocated trees U79 in Area B.
