PROJECT No.: TCS/00553/11

CONTRACT NO. DC/2010/02 –
DRAINAGE IMPROVEMENT IN SHUEN WAN AND SHEK WU WAI

MONTHLY ENVIRONMENTAL MONITORING AND AUDIT REPORT (NO.18) – DECEMBER 2012

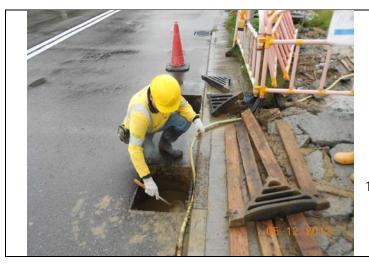
. The sediment in the gully has been cleared.

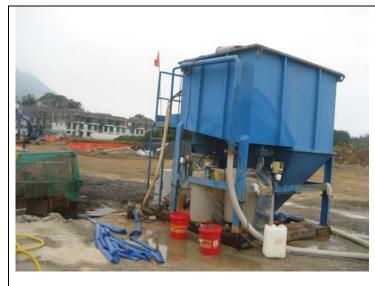
. The unused chemical drums should be removed and placed to a designate storage area.
