**CONTRACT NO. DC/2010/02 –  
DRAINAGE IMPROVEMENT IN SHUEN WAN AND  
SHEK WU WAI**

**MONTHLY ENVIRONMENTAL MONITORING AND  
AUDIT REPORT (NO.19) – JANUARY 2013**

PREPARED FOR  
**KWAN LEE-KULY JOINT VENTURE**

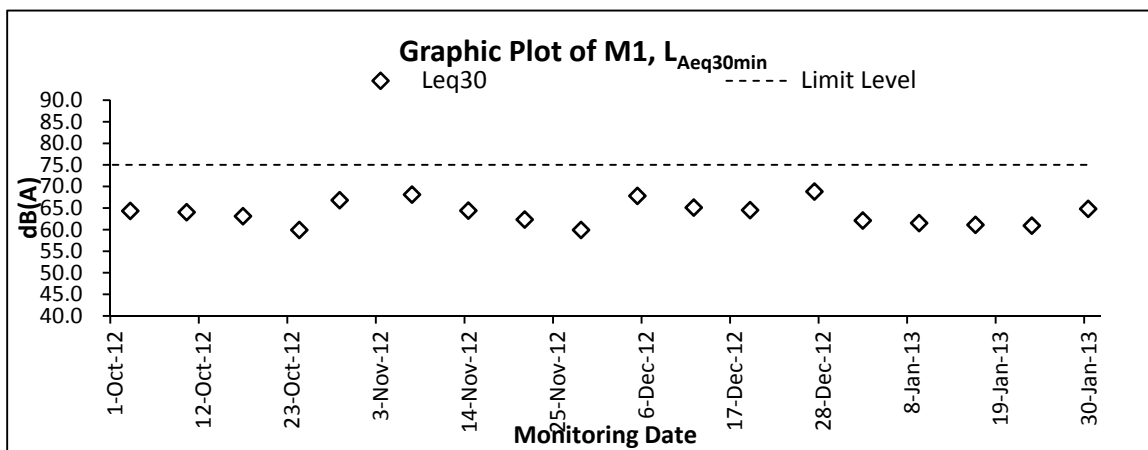
Remark: The monitoring is undertaken under façade situation. No façade correction is added according to acoustical principles and EPD guidelines.

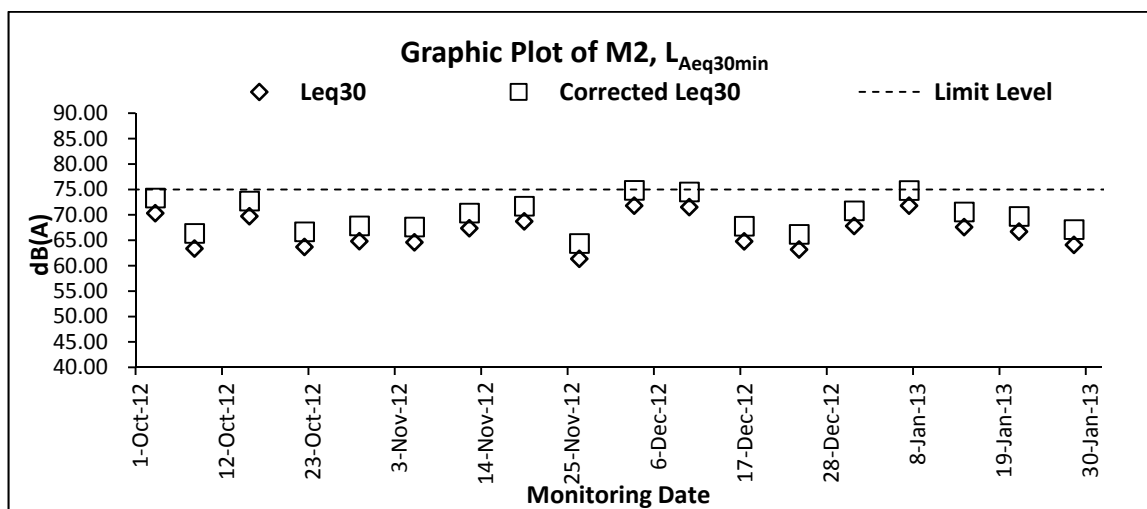
Remark: The monitoring is undertaken under free field situation. A façade correction of +3 dB(A) has been added according to acoustical principles and EPD guidelines.

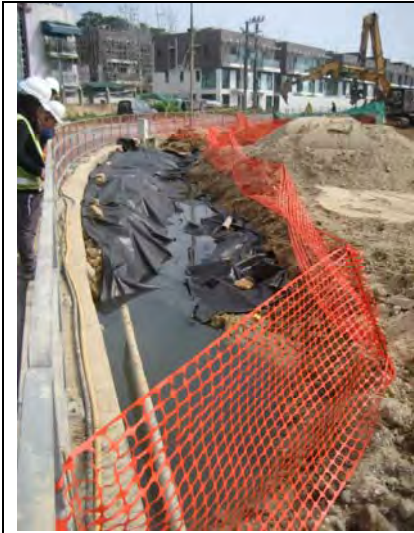
Photo 1: The exposed slope has been covered by tarpaulin sheet.

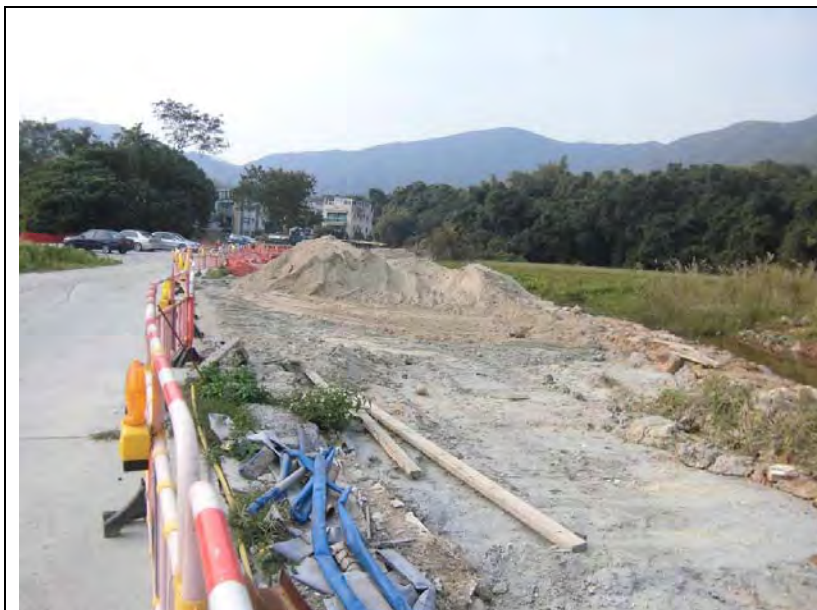
Photo 1: An uncovered sand stockpile was observed, the Contractor should cover it with tarpaulin sheet to prevent fugitive dust during dry season.

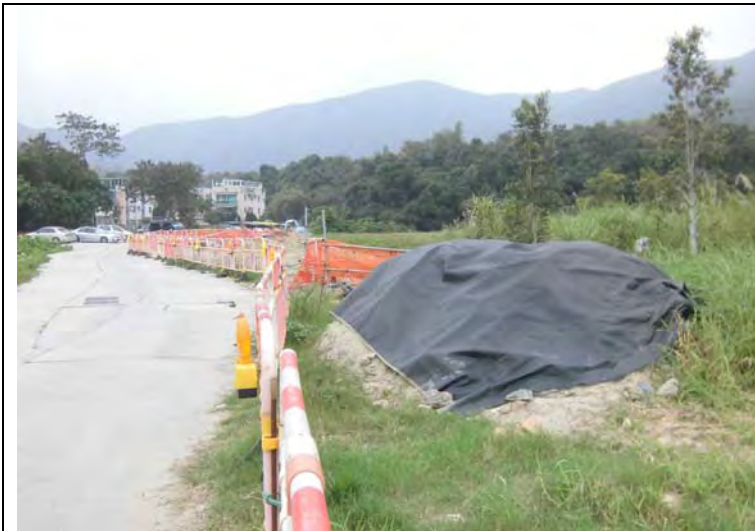
Photo 1: The sand stockpile has been covered with tarpaulin sheet.

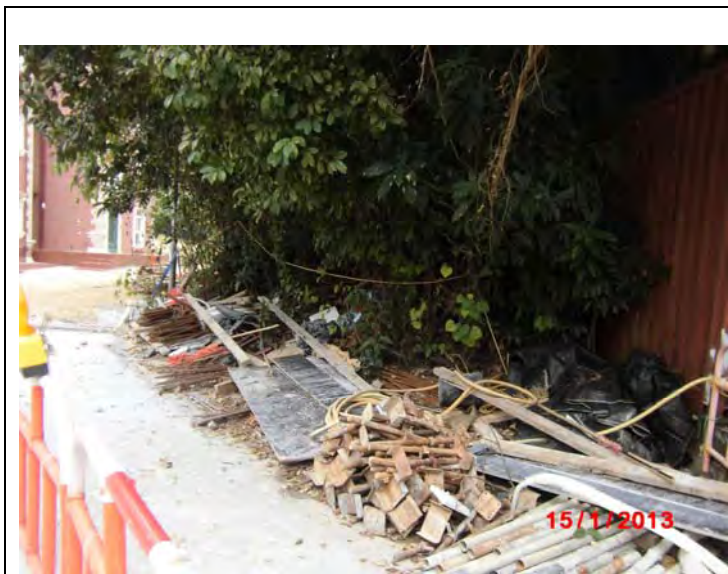
Photo 1:  
Scattered of construction waste was observed, the Contractor should improve housekeeping of the site.

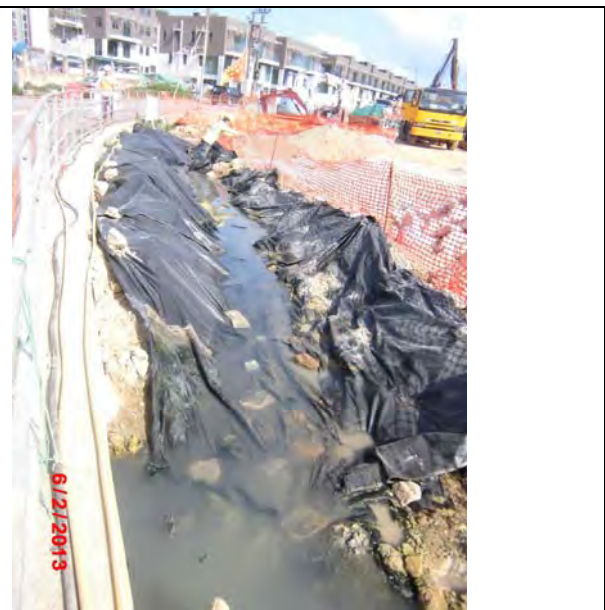
Photo 2:  
The channel for discharging water diversion should be improved.

Date	Findings / Deficiencies	Follow-Up Status
3 January 2013	No adverse environmental impact was observed during site inspection.	N.A.
10 January 2013	<ul style="list-style-type: none"><li>No adverse environmental impact was observed during site inspection.</li></ul>	N.A.
15 January 2013	<ul style="list-style-type: none"><li>An uncovered sand stockpile was observed, the Contractor should cover it with tarpaulin sheet to prevent fugitive dust during dry season.</li></ul>	Rectified on 24 January 2013.
24 January 2013	No adverse environmental impact was observed during site inspection.	N.A.
30 January 2013	<ul style="list-style-type: none"><li>Scattered of construction waste was observed, the Contractor should improve housekeeping of the site.</li><li>The channel for discharging water diversion should be improved.</li></ul>	Rectified on 5 February 2013.

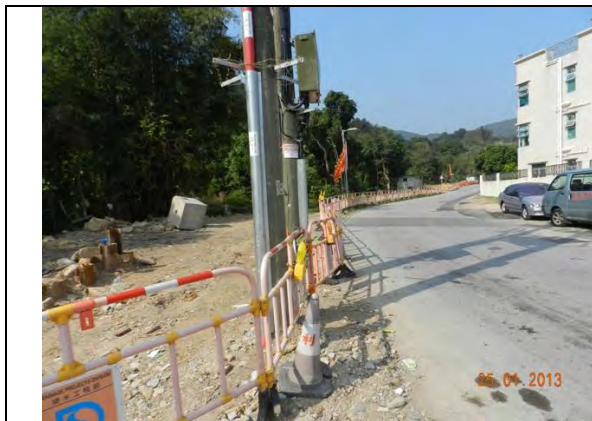
**Photo 1** – Temporary hoardings have been erected around the active works area to the south of Wai Ha.

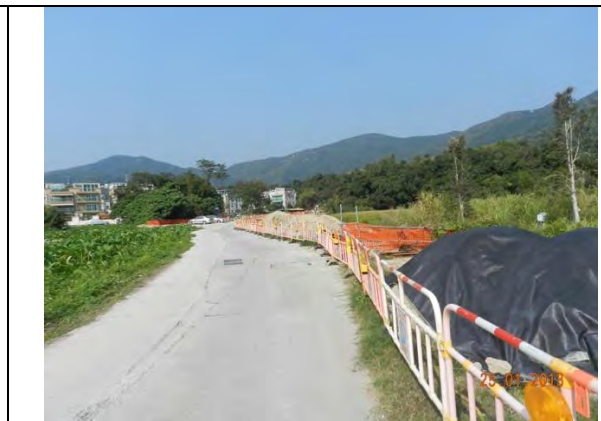
**Photo 2** – Temporary hoardings have been erected around the active works area along the access road to Treasure Spot Garden II.

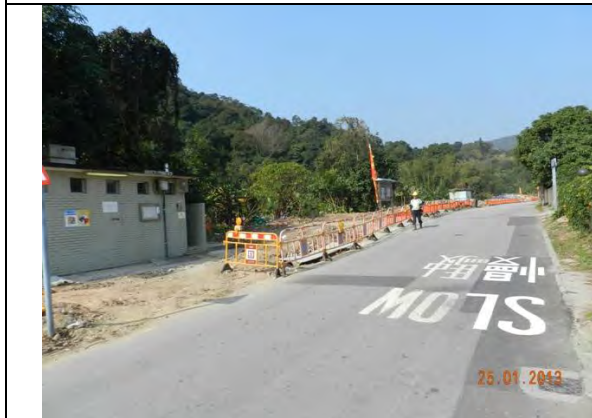
**Photo 3** – Temporary hoardings have been erected along the west of Tung Tsz Road near the refuse collection point.

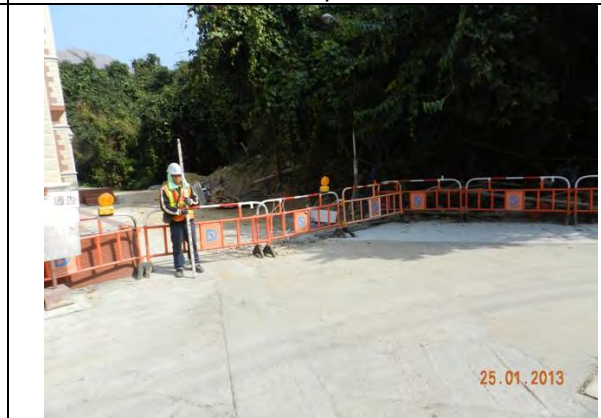
**Photo 4** – Temporary hoardings have been erected on the path near Treasure Spot Garden II.

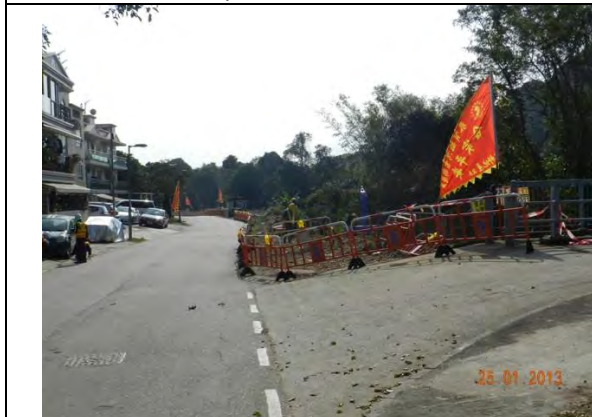
**Photo 5** – New temporary hoardings have been erected at the northwest part of Tung Tsz Road near the removed tree group of T069-070.

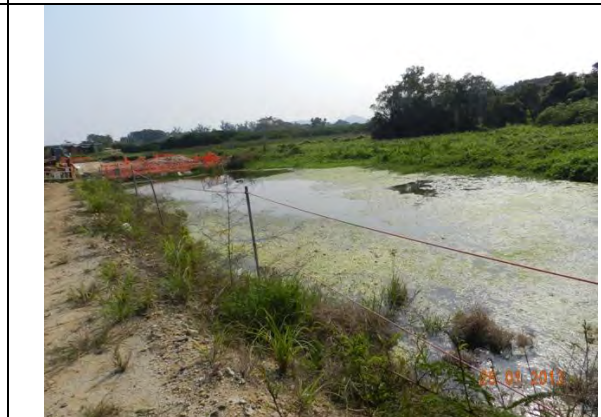
**Photo 6** – The wetland rehabilitation area has been demarcated with red strings.

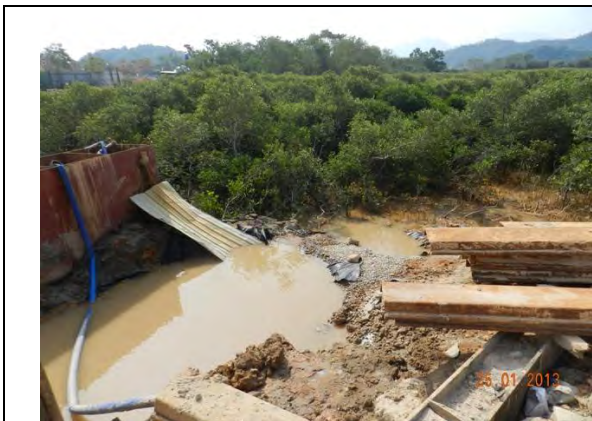
**Photo 13** – The filtrate from the filtration tank was then run along a sedimentation bed and discharge into the vegetated area. The discharge was found muddy.

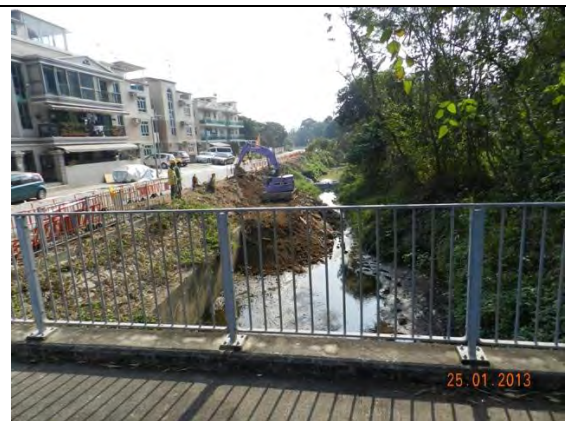
**Photo 14** – Works have been commenced in Wai Ha River.

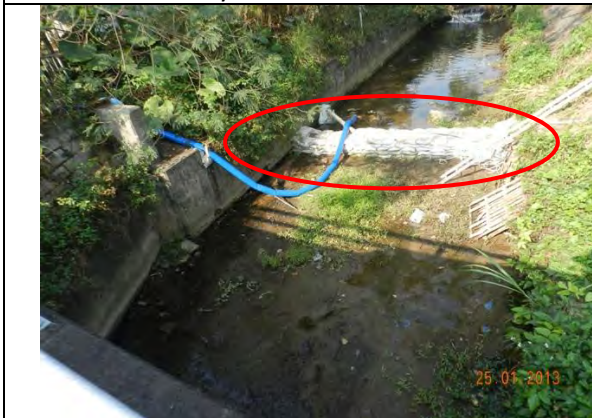
**Photo 15** – Wai Ha river was blocked by sand bags to fragment a works area. The running water of the river was pumped to the end of the works area and then released back to the river.

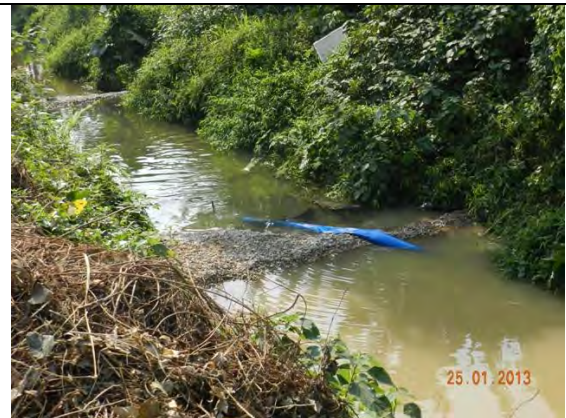
**Photo 16** – Granules were put in Wai Ha river for filtration.

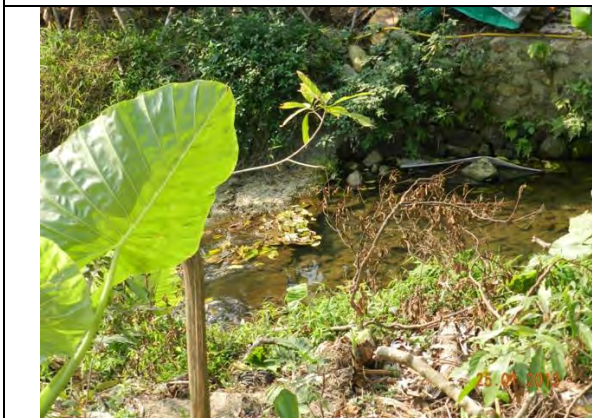
**Photo 17** – The lower stream of Wai Ha river below the works area was observed to be clean.

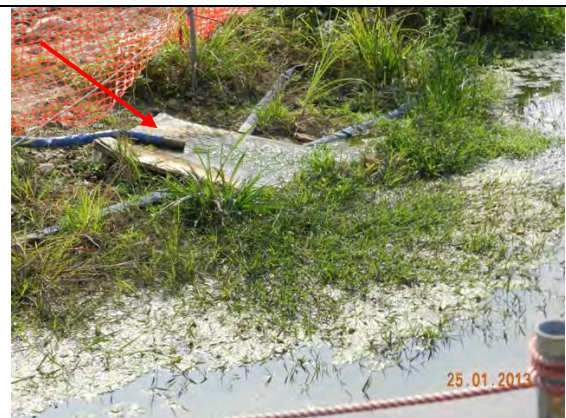
**Photo 18** – Discharge of filtered water from the works area into the wetland rehabilitation area.

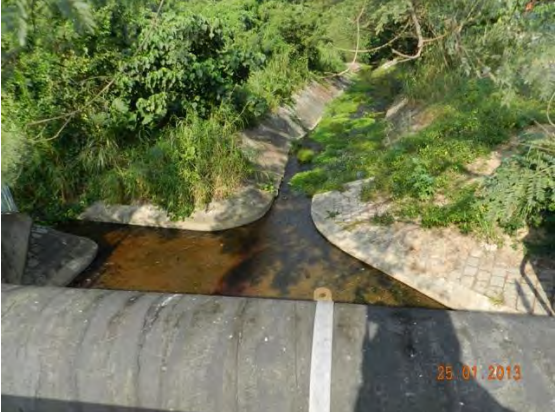
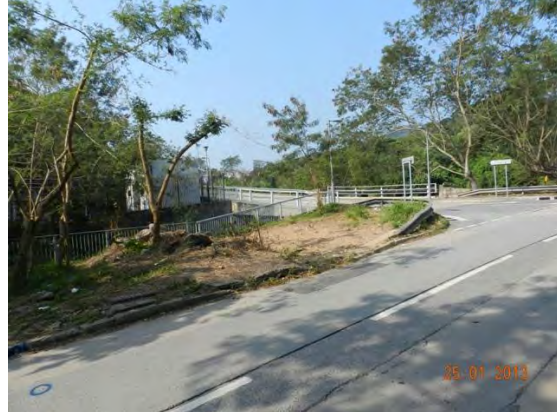
<p><b>Photo 19</b> – No discharge of used water was observed in Wai Ha River.</p>	<p><b>Photo 20</b> – Vegetation clearance was noted along Tung Tsz Road close to Tung Tsz Shan Road.</p>

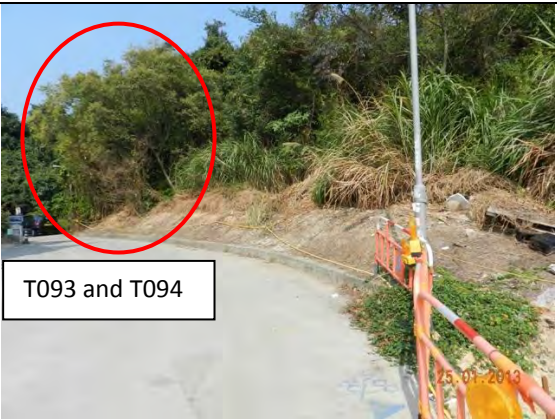
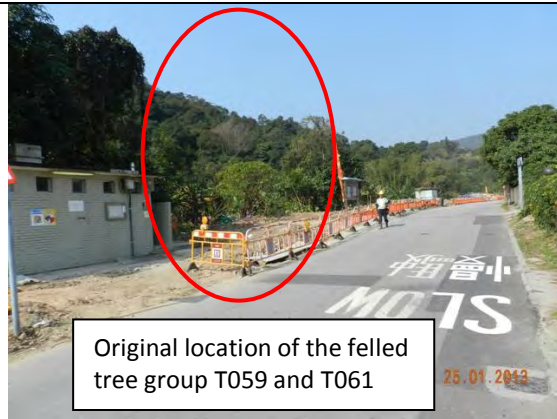
<p>T093 and T094</p>

<p>Original location of the felled tree group T059 and T061</p>
<p><b>Photo 21</b> – Vegetation clearance was observed next to the access road towards Treasure Spot Garden II close to the retained tree T093 and T094.</p>	<p><b>Photo 22</b> – T059 and T061 (Proposed to be felled) was felled in January 2013.</p>

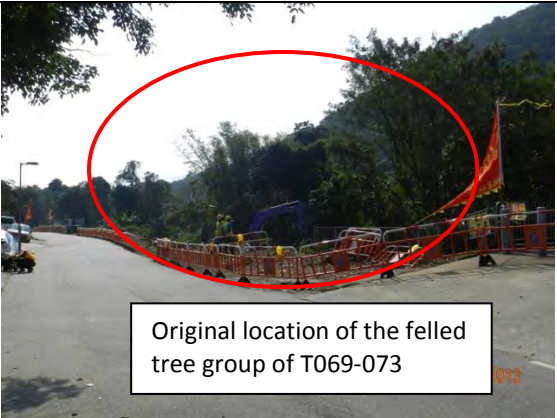
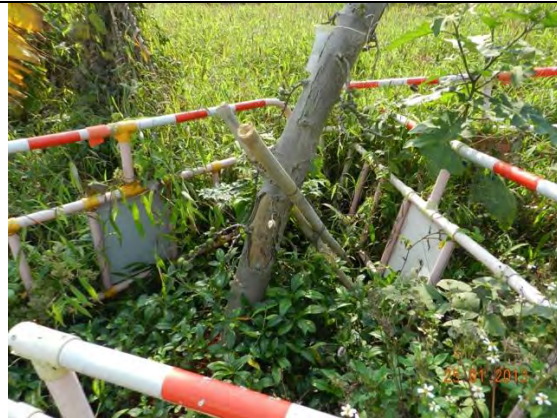
<p>Original location of the felled tree group of T069-073</p>

<p><b>Photo 23</b> – Trees T069, T070, T071, T072 and T073 (Proposed to be felled) were felled in January 2013.</p>	<p><b>Photo 24</b> – The leaning, retained tree T190 (<i>Ficus hispida</i>) was protected within a demarcated zone and bamboo props were established to support the tree.</p>

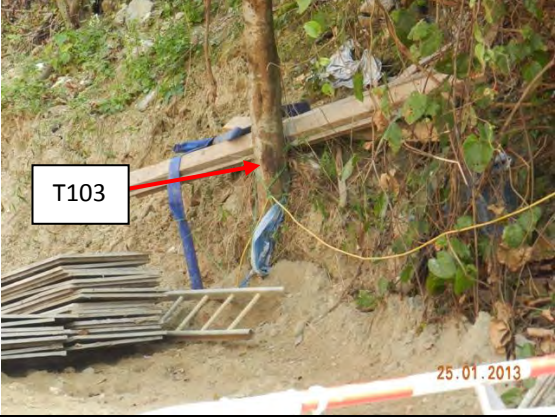
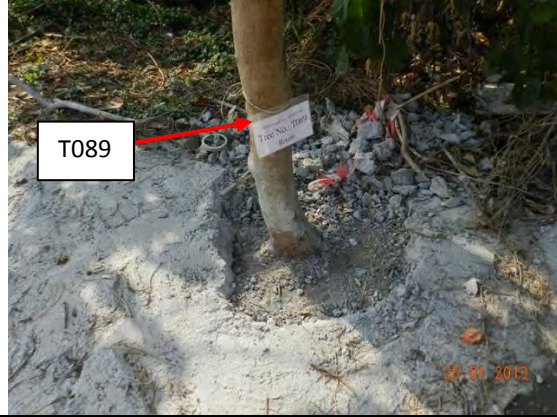
<p><b>Photo 25</b> – Excavated work close to the retained tree T103 was finished and soil was refilled to the root zone area of the tree. Cables and ropes were still found on the trunk.</p>	<p><b>Photo 26</b> – The soil surface within the tree root zone of T089 (Proposed to be retained) was paved with concrete.</p>

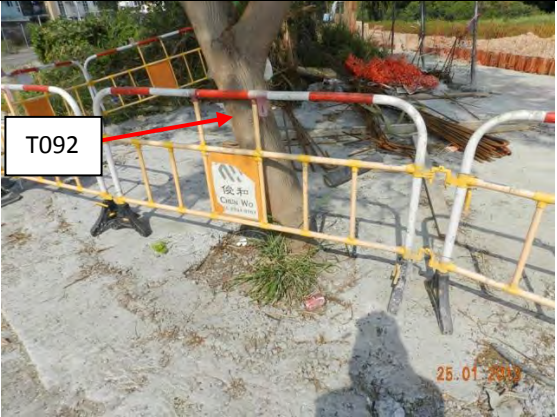
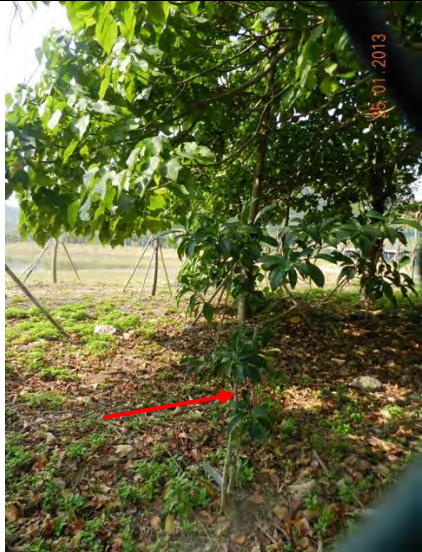
<p><b>Photo 27</b> – The soil surface within the tree root zone of T092 (Proposed to be retained) was paved with concrete.</p>	<p><b>Photo 28</b> – The transplanted shrub of <i>Pavetta hongkongensis</i> (PH03) has remained in satisfactory condition in Area C under Contract 1.</p>
