**CONTRACT NO. DC/2010/02 –
DRAINAGE IMPROVEMENT IN SHUEN WAN AND
SHEK WU WAI**

**MONTHLY ENVIRONMENTAL MONITORING AND
AUDIT REPORT (NO.20) – FEBRUARY 2013**

PREPARED FOR
KWAN LEE-KULY JOINT VENTURE

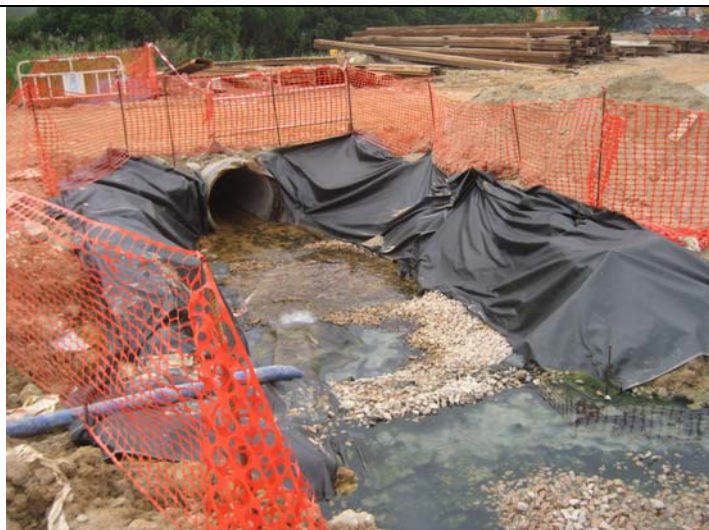
Photo 1: The general refuse inside the de-silting channel has been removed.

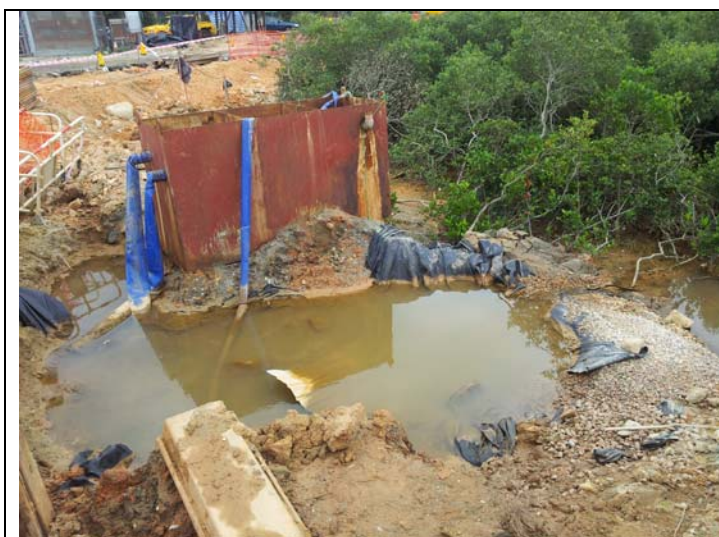
Photo 1:

Cloudy water was observed inside the site area, the Contractor should improve the de-silting facilities under the project.

Date	Findings / Deficiencies	Follow-Up Status
7 February 2013	<ul style="list-style-type: none">General refuse inside the desilting channel should be cleared regularly.	Rectified on 14 February 2013.
14 February 2013	<ul style="list-style-type: none">No adverse environmental issue was observed during site inspection.	N.A.
21 February 2013	<ul style="list-style-type: none">No adverse environmental issue was observed during site inspection.	N.A.
25 February 2013	<ul style="list-style-type: none">Cloudy water was observed inside the site area, the Contractor should improve the de-silting facilities under the project.	Rectified on 7 March 2013.

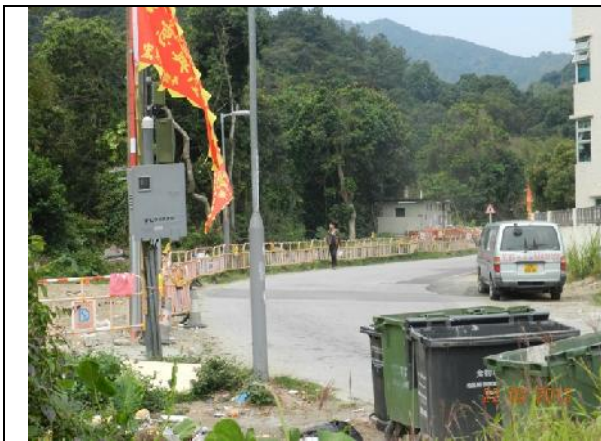
Photo 1 – Temporary hoardings have been erected around the active works area to the south of Wai Ha.

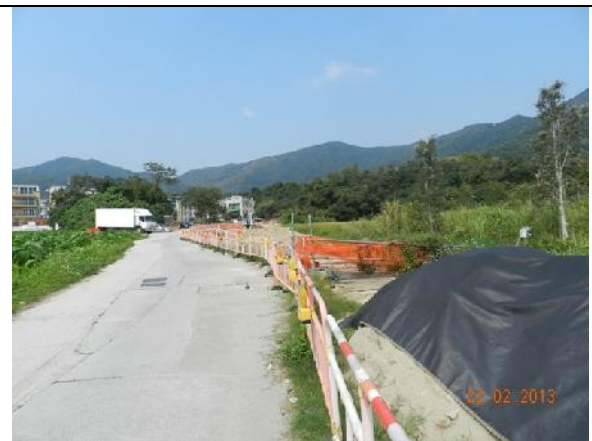
Photo 2 – Temporary hoardings have been erected around the active works area along the access road to Treasure Spot Garden II.

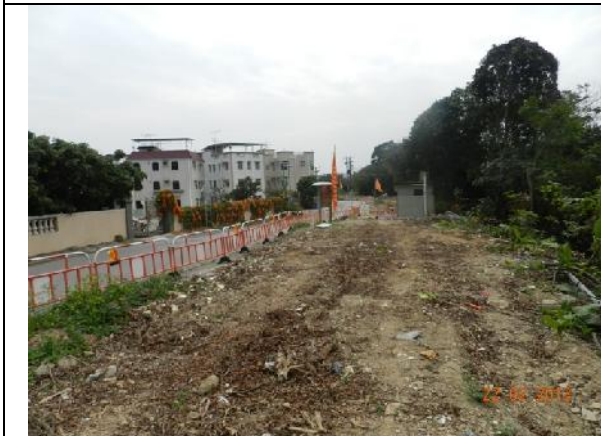
Photo 3 – Temporary hoardings have been erected along the west of Tung Tsz Road near the refuse collection point.

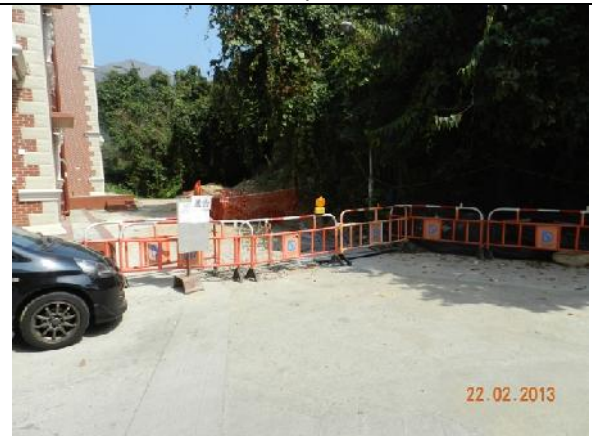
Photo 4 – Temporary hoardings have been erected on the path near Treasure Spot Garden II.

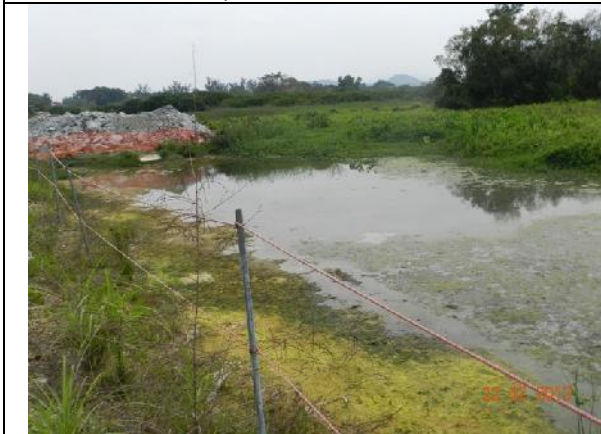
Photo 5 – The wetland rehabilitation area has been demarcated with red strings.

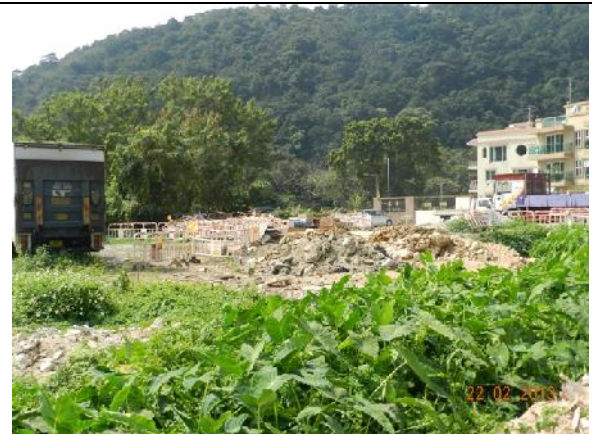
Photo 6 – New dumping area on the Toro field close to the paved parking area was observed.

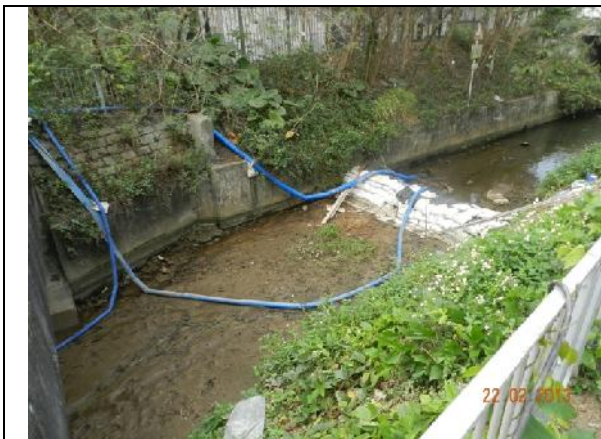
Photo 13 – Wai Ha River was blocked by sand bags to separate the works area. The running water of the river was pumped to the end of the works area.

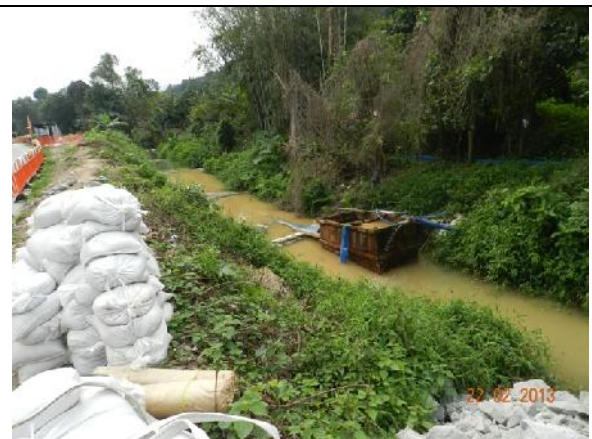
Photo 14 – The running water of the river was pumped to a sedimentation tank at the end of the works area. The filtrate was then discharged to the river with several sections of granules for further sedimentation.

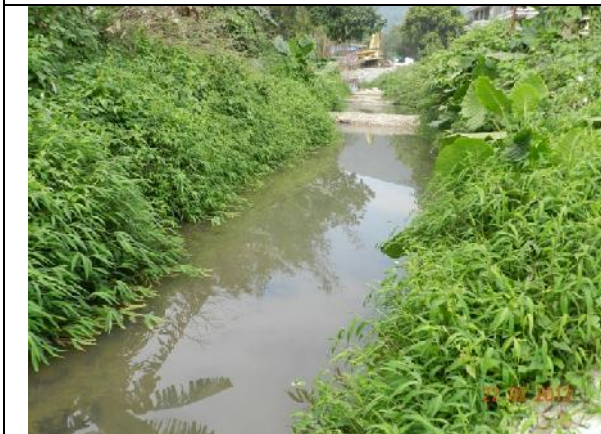
Photo 15 – The lower stream of Wai Ha River below the works area was observed to be clean.

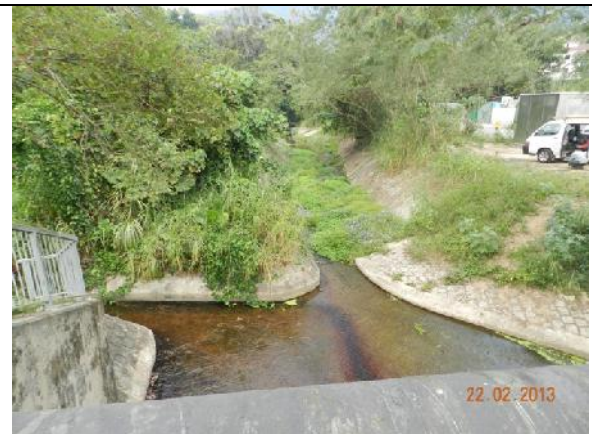
Photo 16 – No discharge of used water was observed at the upper section of Wai Ha River (i.e. to the north of Tung Tsz Shan Road).

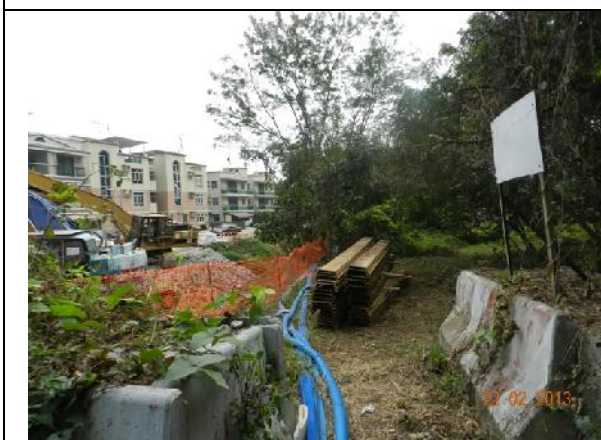
Photo 17 – Vegetation clearance was found opposite to Wai Ha next to the works area in Wai Ha River. Construction materials were observed on the cleaned area.

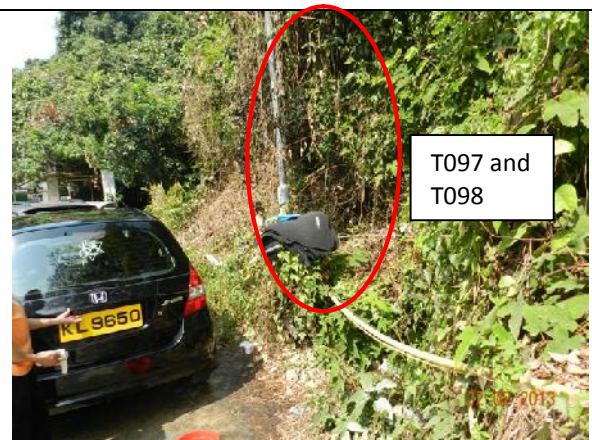
Photo 18 – Vegetation clearance was observed next to the access road towards Treasure Spot Garden II close to the two retained trees T097 and T098.

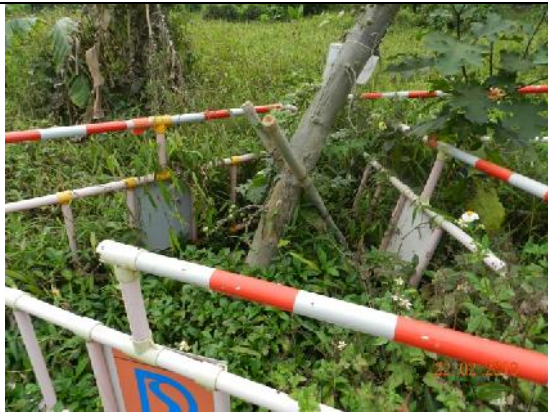
Photo 19 – The leaning, retained tree T190 (*Ficus hispida*) was protected within a demarcated zone and bamboo props were established to support the tree.

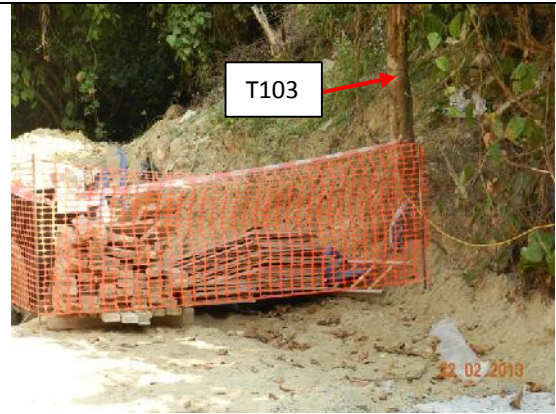
Photo 20 – The soil refilled to the retained tree T103 was loose and sandy, and cables and ropes were still found on the trunk.

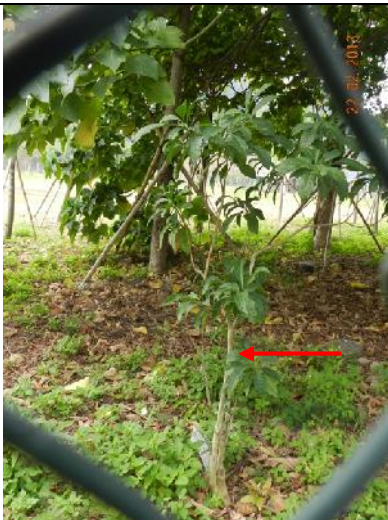
Photo 21 – The transplanted shrub of *Pavetta hongkongensis* (PH03) has remained in satisfactory condition in Area C under Contract 1.
