Monthly Environmental Monitoring & Auditing report for

Contract No.DC/2009/22

Drainage Improvement in Shuen Wan, Tai Po – Contract 1

March 2013

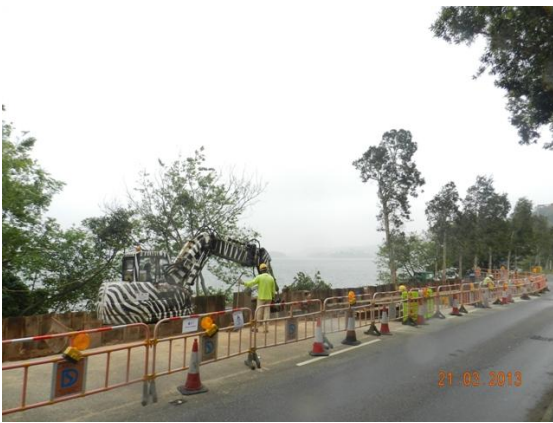
Photo 1 – Construction in a new section of road next to the main entrance of Area A was commenced.

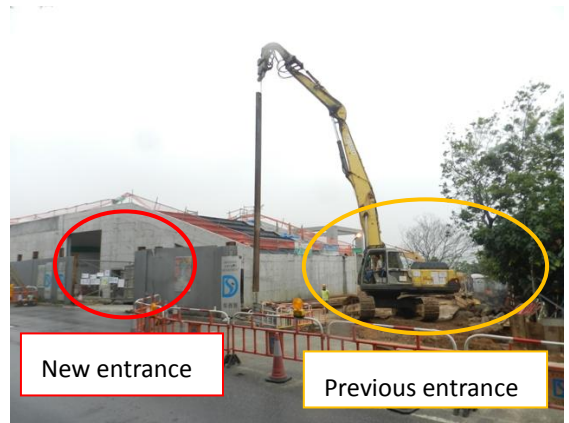
Photo 2 – The main entrance of Area A was relocated to the north of the previous one.

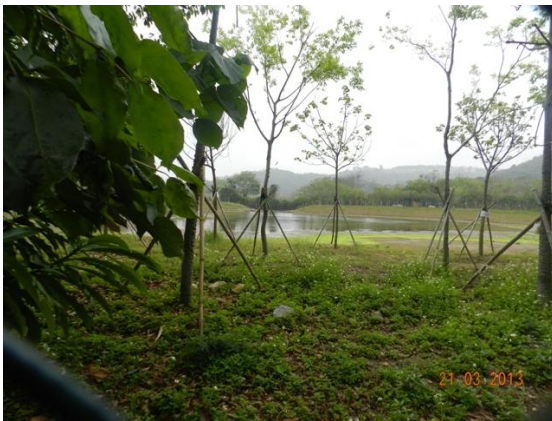
water into the adjacent Wai Ha River was observed through the fence of Tung Tsz Nursery **(Photo 3)**.

Photo 3 – No discharge of muddy water was observed in Area C.

No specific recommendation is required for Areas A, B and C. As a reminder, the Contractor should regularly check the condition and locations of the drainage pipes and ensure that all used water should be appropriately filtered and discharged to the manholes/other discharge points agreed by the Engineer and EPD. This is to avoid any potential contamination to the vegetation in Shuen Wan marsh and other vegetated/marinated areas adjacent to the active works area.

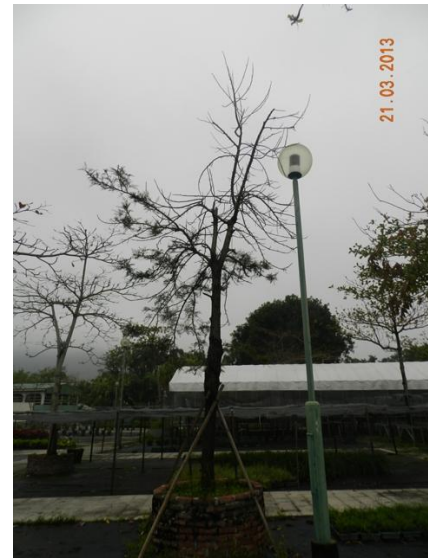
bi-weekly basis. For tree U58 (*Grevillea robusta*) (**Photo 4**), leaves as watersprouts were observed along the branches and the trunk. U58 has remained in fairly poor physiological condition in February 2013. Regular monitoring has to be continued to update its health and structural condition.

Photo 4 – Overall view of the transplanted tree U58 *Grevillea robusta*.

Regular monitoring and watering of *Grevillea robusta* (U58) are still recommended to be the major treatment to the tree. The appointed landscape contractor and the Contractor should closely monitor the health conditions of all transplanted and retained trees throughout the construction period of the Project.

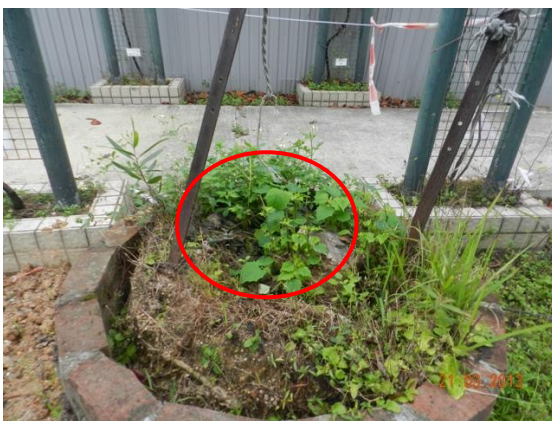
As reported in the previous *Monthly EM&A Reports*, the retained tree U68 (*Gmelina arborea*) was found fallen after the severe typhoon in July 2012, with its leaning trunk being pruned and removed in August 2012 (as reported in *Monthly EM&A Report for August 2012*). As reported since the *Monthly EM&A Report for November 2012*, the developed watersprouts at the remained stump was recorded. The watersprouts were removed as inspected in December 2012 while it has resprouted as observed since January 2013. Watersprouts were still observed in March 2013 (**Photo 5**).

Photo 5 – Resprouts from the remained stump of U68.

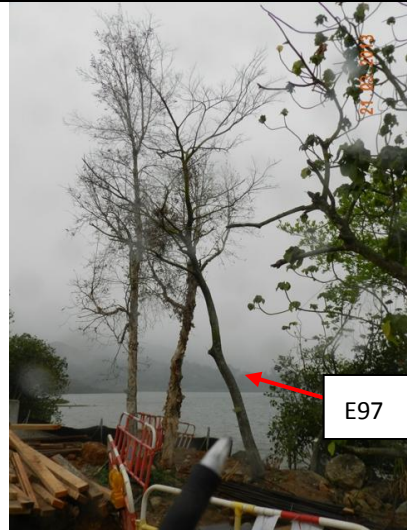
E97 (*Celtis sinensis*) has been relocated at the northeastern part of Area A since December 2012 and the tree was still in poor health condition due to transplantation shock (**Photo 8**).

Photo 8 – E97 relocated in the northeastern part of Area A was found in poor condition

All retained trees or trees to be transplanted should be watered regularly (e.g. at least every two days) by the landscape contractor or on-site workers. The Contractor should conduct regular inspection on the health condition and protection measures of each existing trees within the Area A. In particular, regular watering should be applied on those relocated trees with regard to their poor health condition. If these trees or other transplanted/ relocated trees are found to be dead specimens in the wet season, the Contractor should replace these specimens.

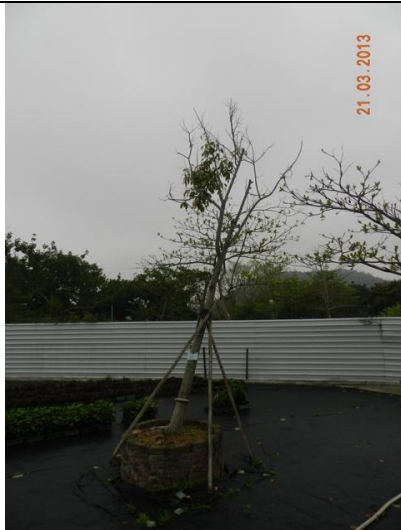
The transplanted tree U61 (*Lysidice rhodostegia*) was still found leaning severely with its propping uplifted (**Photo 9**).

Photo 9 – Severe leaning tree trunk of the transplanted tree U61 was observed in Area B.

Regular inspection of the tree health of U55 and U58, and stability of the leaning tree U61 should be undertaken to update their health condition and any tree defects. The Contractor is recommended to replant the leaning tree U61 or establish appropriate tree propping system to minimize its potential failure risk to the targets. If these trees or other

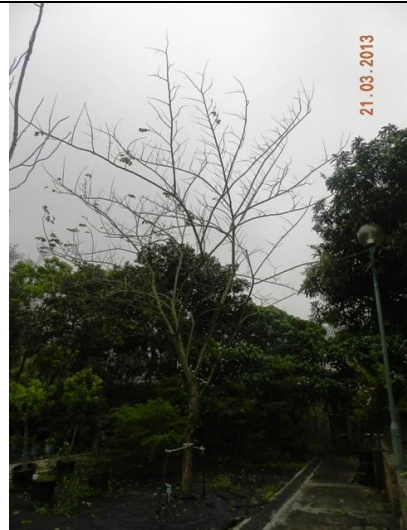
The transplanted tree U55 (*Pterocarpus indicus*) was planted directly into the ground as permitted by the nursery (**Photo 10**). Decayed wood was found along the tree trunk possibly due to the previous wood borer problems. As reported in the *Monthly EM&A Report for February 2013*, pest control measure was conducted by the appointed landscape contractor in January 2013. However, the presence of an anti-grass film (**Photo 11**) covering almost the whole trunk flare and the soil ground around within the tree root zone might retain too much moisture around the trunk flare, hence creating a favorable environment for the growth of fungi and pests around the trunk flare. This would adversely affect the tree health in the long run.

Photo 10 – Fairly poor condition of the transplanted tree U55 in Area B.

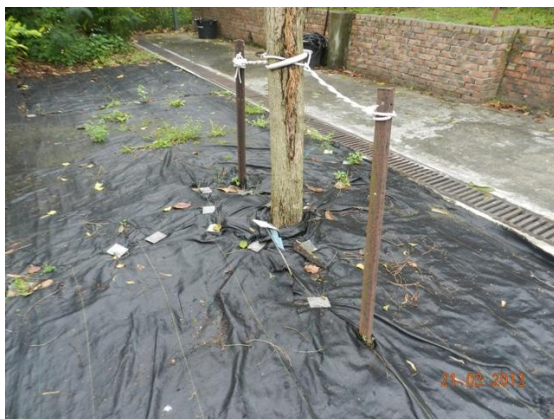
Photo 11 – Anti-grass film covering almost of the whole trunk flare of U55 and its surrounding soil ground in Area B.

For the transplanted tree U55, it is recommended to remove the anti-grass sheet from the root flare by cutting the sheet to create a circle of at least 1.5 m diameter around the tree. However, the Contractor should liaise with the Nursery Operator if the sheet is allowed to be removed for improving the tree health in the long run.

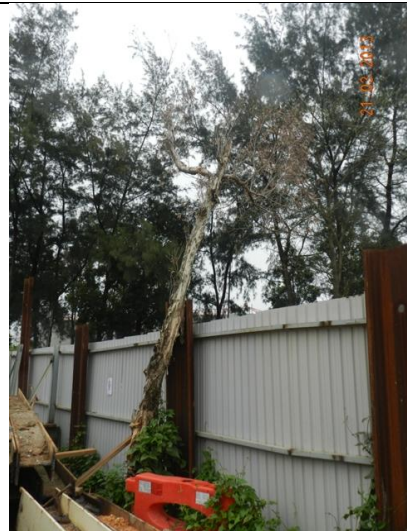
The tree to be transplanted T102 (*Melaleuca cajuputi* subsp. *cumingiana*) has been relocated to the southern part within the Phase 2 construction area of Area B next to the hoarding since November 2012 (**Photo 12**). The tree still appeared in very poor condition as almost no green leaves were noted in the canopy in March 2013.

Photo 12 – Poor condition of the relocated tree T102 as observed within the Phase 2 works area of Area B.

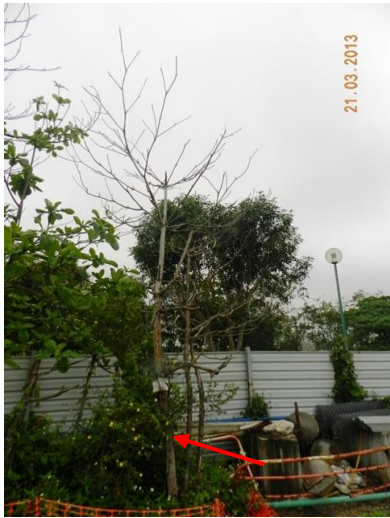
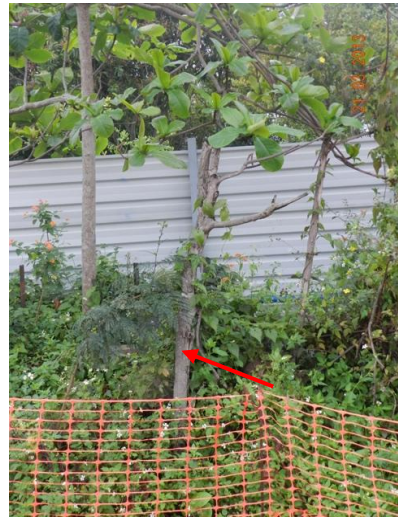
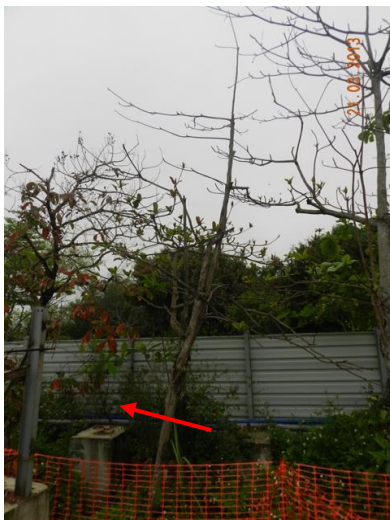
No recovery signs have been observed on the relocated trees U34 (**Photo 13**), U35 (**Photo 14**) and U37 (**Photo 15**) and they are regarded as dead specimens.

Photo 13 – No recovery sign of the relocated tree U34 in Area B was observed.

Photo 14 – No recovery sign of the relocated tree U35 was observed.

Photo 15 – No recovery sign of the relocated tree U37 was observed.

transplanted/ relocated trees are found to be dead specimens in the wet season, the Contractor should replace these specimens.

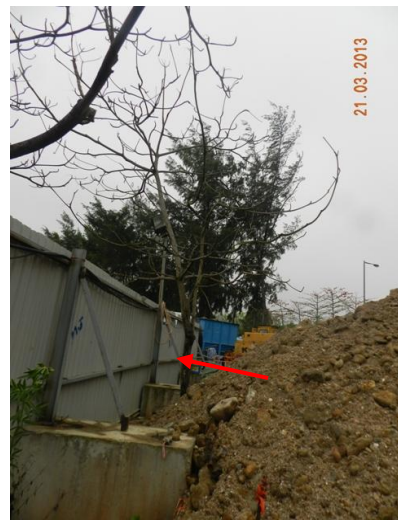
Waterlogging problem was found in the areas around the trunk bases of three relocated trees (U76, U77 and U78) before. The relocated tree U77 (*Terminalia catappa*) was suspected to be dead as no leaves was observed in the canopy (**Photo 16**). Soil was deposited close to the tree and even on the trunk of U77 as inspected on 21st March 2013 (**Photo 16**). U76 and U78 (*Terminalia catappa*) were observed in poor condition with sparse foliage in March 2013 (**Photo 17**). However, with the onset of wet season, new leaves and buds were observed on U78 as inspected on 21st March 2013 (**Photo 18**).

Photo 16 – The relocated tree U77 in Area B was suspected dead as no foliage was found in the canopy, and soil was deposited on its trunk.

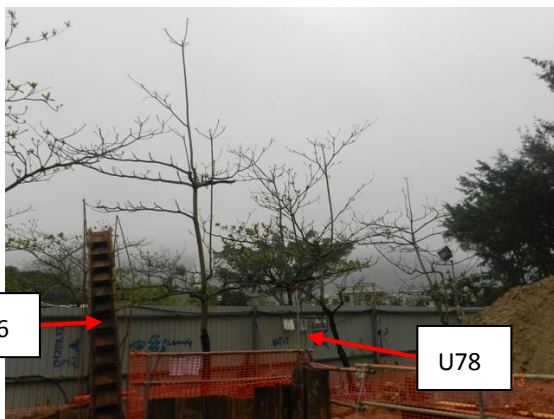
Photo 17 – Poor health condition was observed in the canopies of the relocated trees U76 and U78 in Area B.

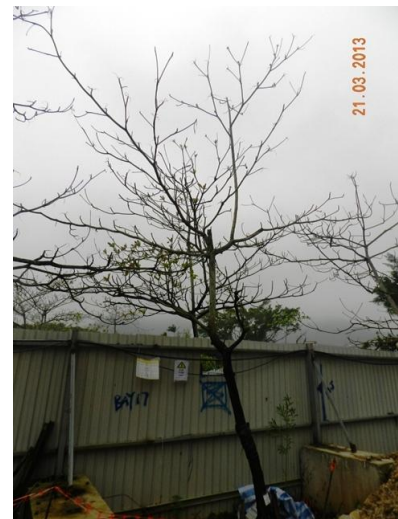
Photo 18 – New leaves and buds were found on the canopy of U78.

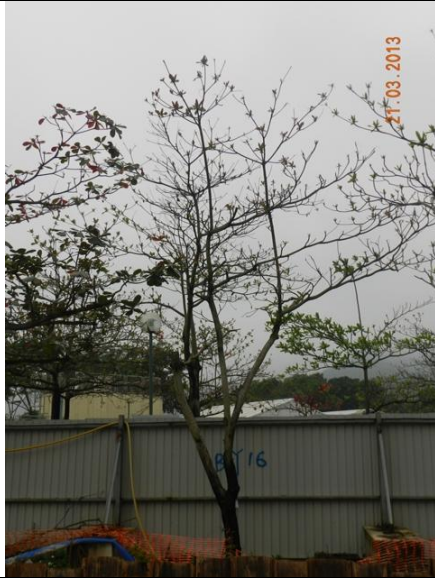
Another relocated tree U79 (*Terminalia catappa*) on the southwest of U76 was found in poor condition with sparse foliage in March 2013 (**Photo 19**). Resprouting was observed during the monitoring on 21st March 2013.

Photo 19 – New leaves and buds were observed on the canopy of the relocated trees U79 in Area B.
