**CONTRACT NO. DC/2010/02 –
DRAINAGE IMPROVEMENT IN SHUEN WAN AND
SHEK WU WAI**

**MONTHLY ENVIRONMENTAL MONITORING AND
AUDIT REPORT (NO.21) – MARCH 2013**

PREPARED FOR
KWAN LEE-KULY JOINT VENTURE

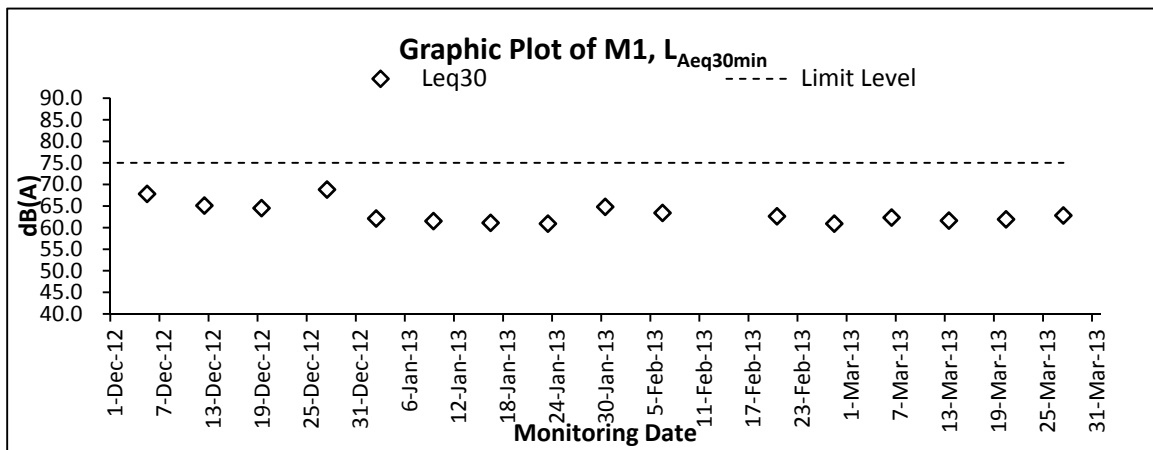
Graphic Plot – Construction Noise

Remark: The monitoring is undertaken under façade situation. No façade correction is added according to acoustical principles and EPD guidelines.

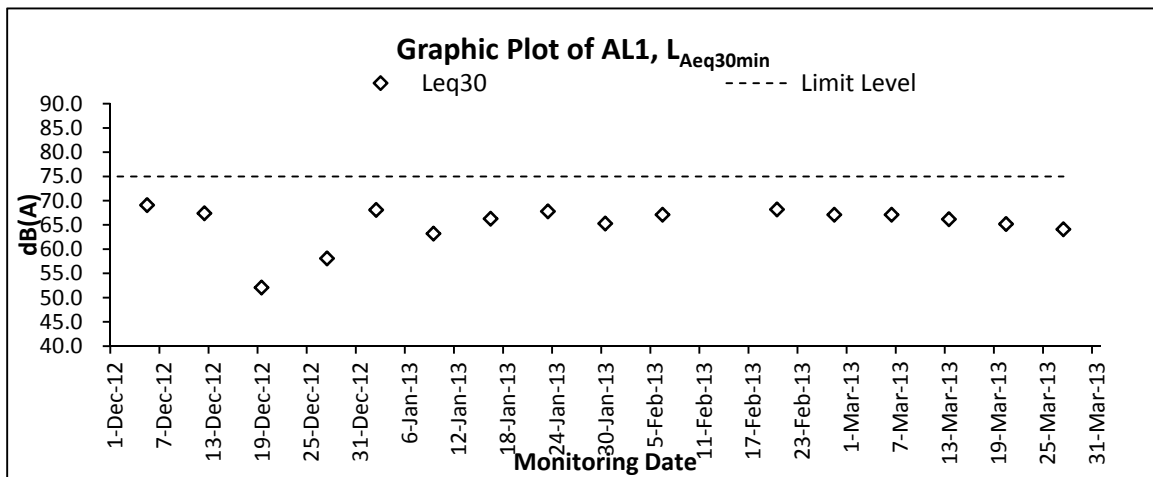
Remark: The monitoring is undertaken under façade situation. No façade correction is added according to acoustical principles and EPD guidelines.

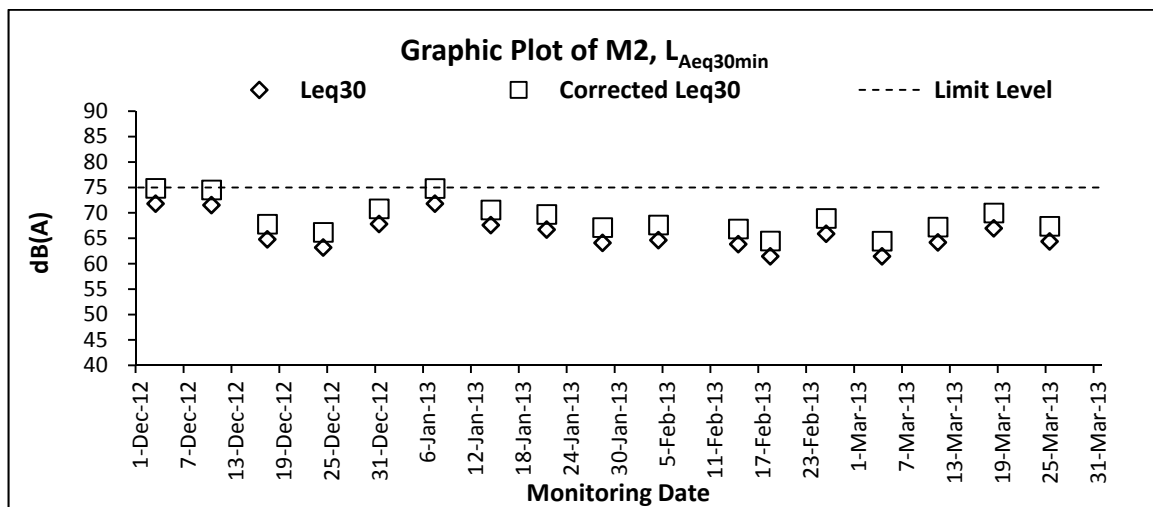
Remark: The monitoring is undertaken under free field situation. A façade correction of +3 dB(A) has been added according to acoustical principles and EPD guidelines.

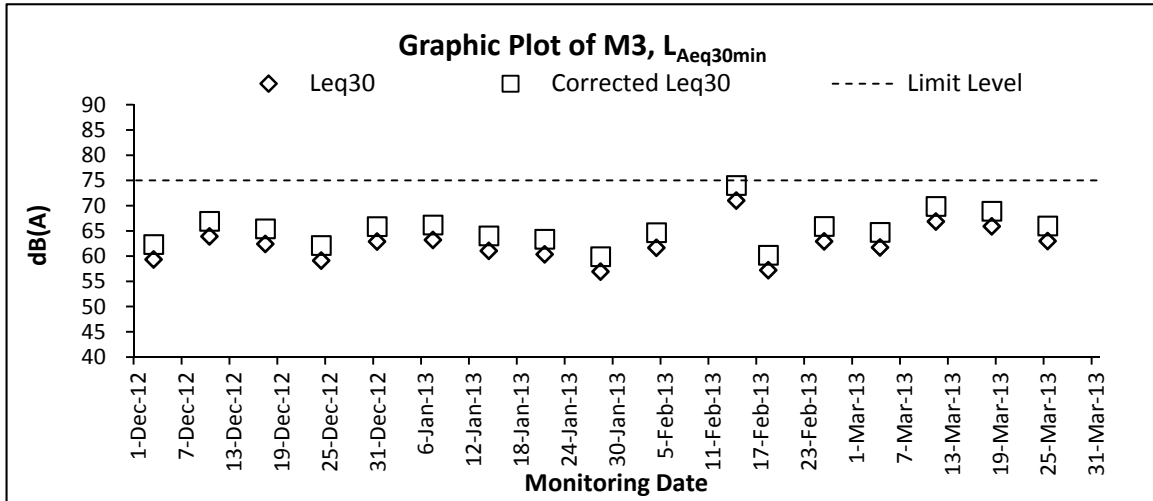
Remark: The monitoring is undertaken under free field situation. A façade correction of +3 dB(A) has been added according to acoustical principles and EPD guidelines

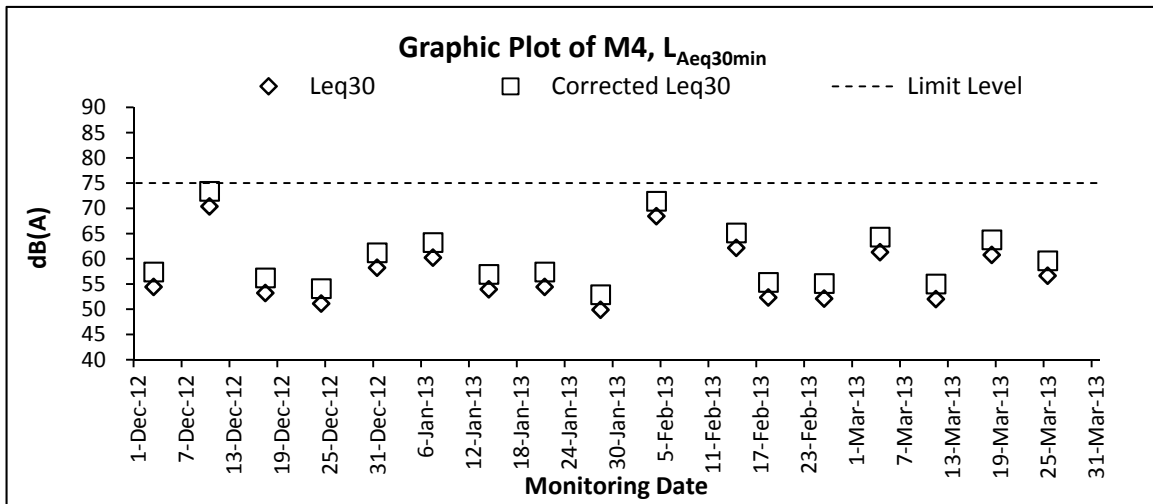
Remark: The monitoring is undertaken under free field situation. A façade correction of +3 dB(A) has been added according to acoustical principles and EPD guidelines

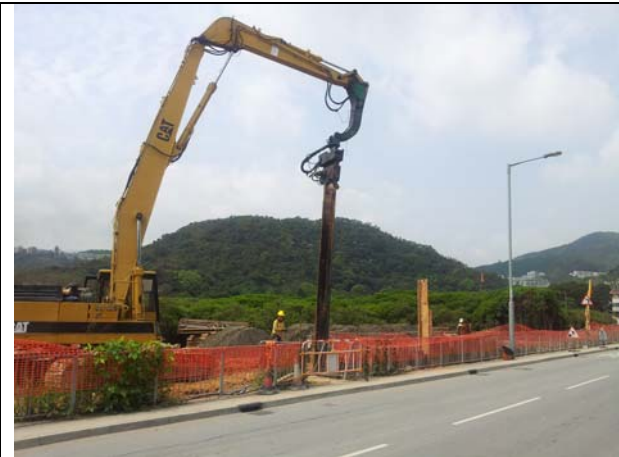
Photo 1:
Rubber tube is missing at the chain of the vibration clip, the contractor was reminded to provide the rubber tube for the chain to reduce the noise level near the works area NSR.

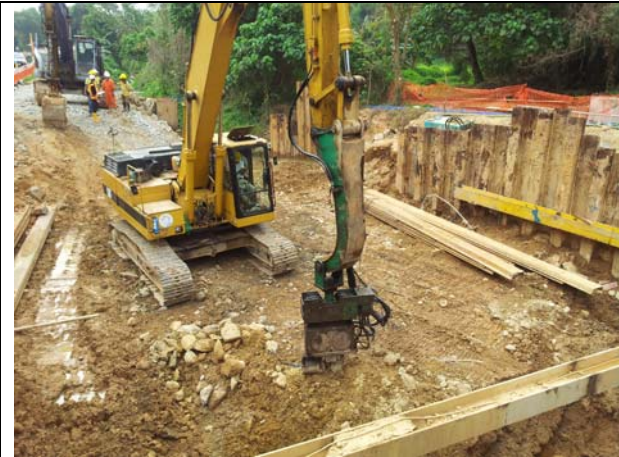
Photo 1:

Rubber tube is missing at the chain of the vibration clip; the contractor was reminded to provide the rubber tube for the chain to reduce the noise level near the works area NSR.

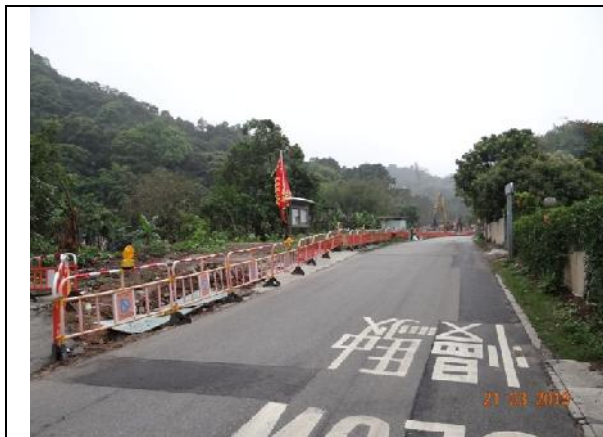
Photo 1 – Temporary hoardings have been erected along Tung Tsz Road near the refuse collection point opposite to Wai Ha.

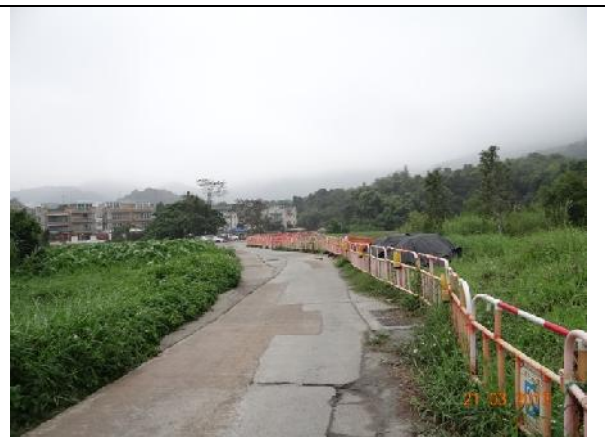
Photo 2 – Temporary hoardings have been erected around the active works area along the access road to Treasure Spot Garden II.

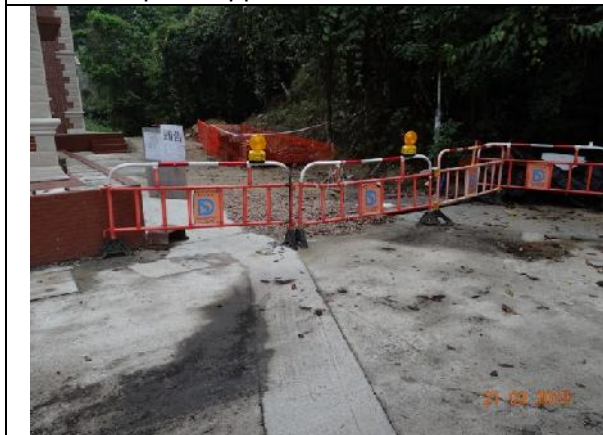
Photo 3 – Temporary hoardings have been erected on the path near Treasure Spot Garden II.

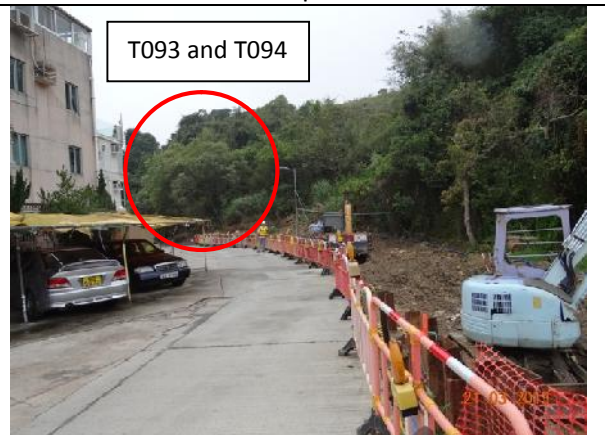
Photo 4 – Temporary hoardings have been extended to the northwest of the access road to Treasure Spot Garden II near retained trees T93 and T94.

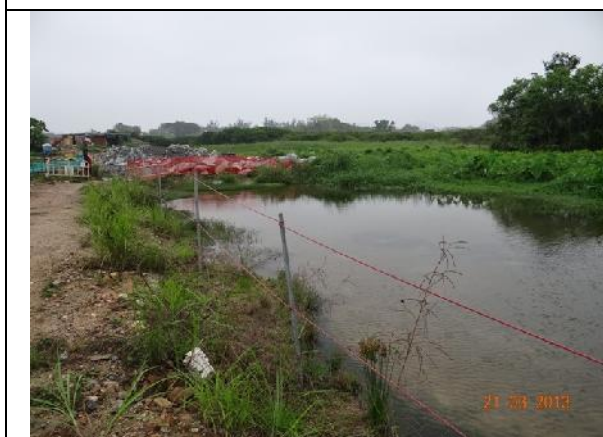
Photo 5 – The wetland rehabilitation area has been demarcated with red strings.

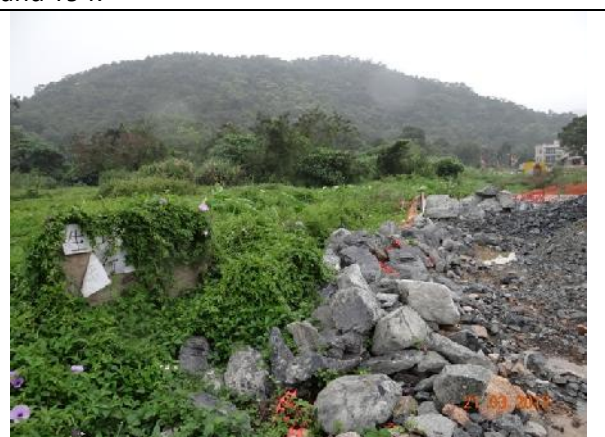
Photo 6 – Rocks were dumped close to the wetland rehabilitation area.

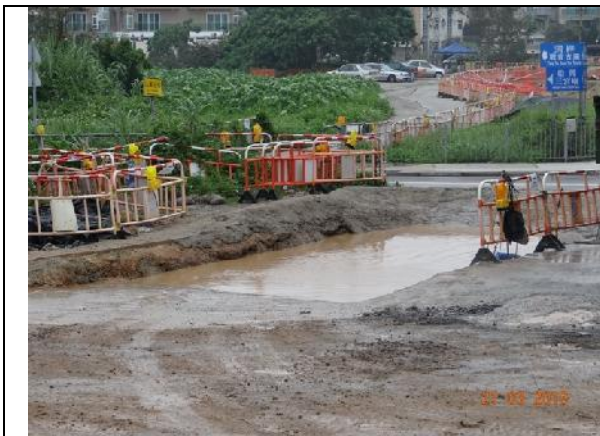
Photo 7 – Wheel washing facilities has been provided at the vehicular exit point of the works area of Contract 2.

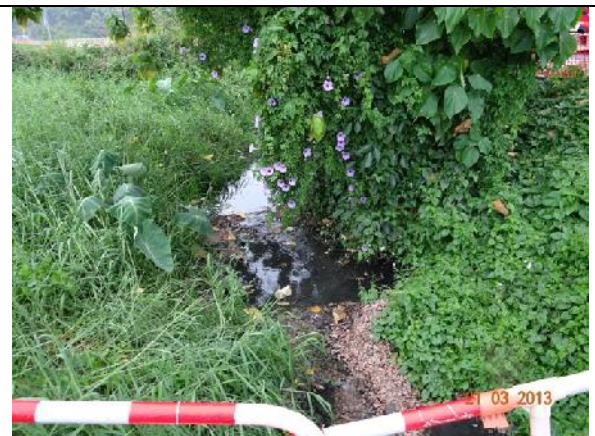
Photo 8 – The sedimentation beds and PVC liner were aligned from north to south near the retained tree T196 (*Macaranga tanarius* var. *tomentosa*) and no muddy water was discharged.

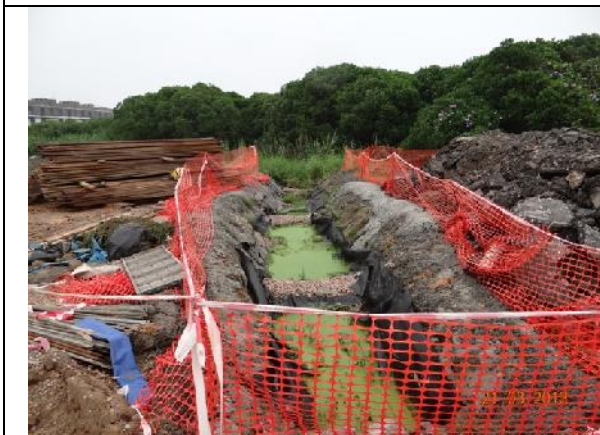
Photo 9 – The sedimentation beds with gravels and PVC liners was aligned from the area opposite to the Jade View Villa towards the marsh area at southeast.

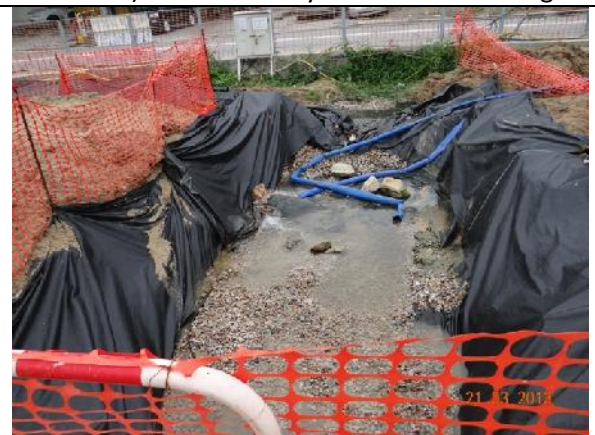
Photo 10 – The sedimentation beds with gravels and PVC liners were aligned from the area opposite to the eastern part of Jade View Villa towards the marsh area at southeast. The used water released to the sedimentation beds was generally clean.

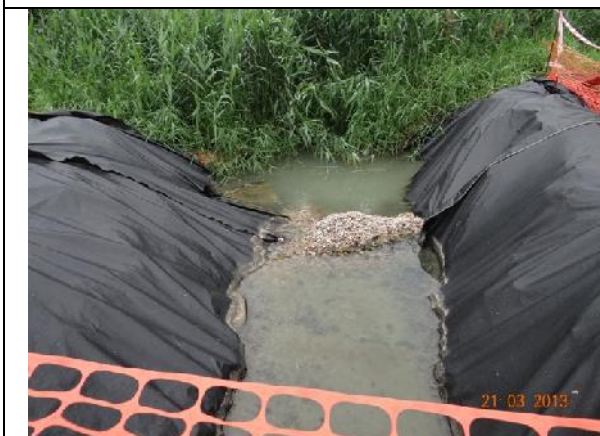
Photo 11 – The sedimentation beds with gravels and PVC liners was aligned from the area opposite to the eastern part of Jade View Villa towards the marsh area at southeast. The discharge was generally clean.

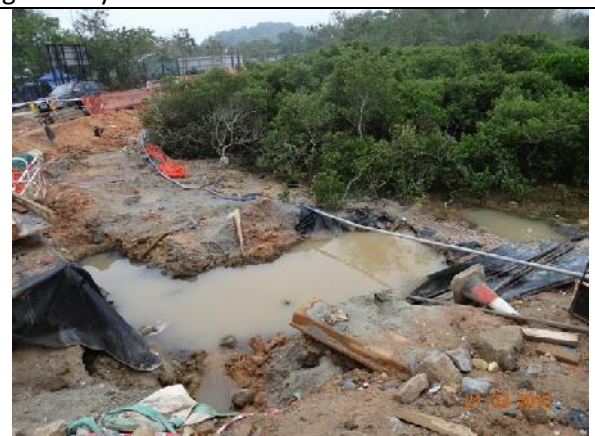
Photo 12 – The filtration tank opposite to San Tau Kok was removed and no more discharge was observed.

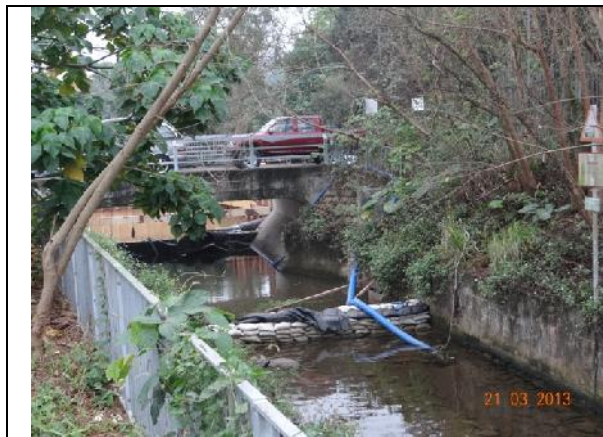
Photo 13 – Sand bags have been put in Wai Ha River to separate the works area in the river. The running water of the river was pumped to the end of the works area.

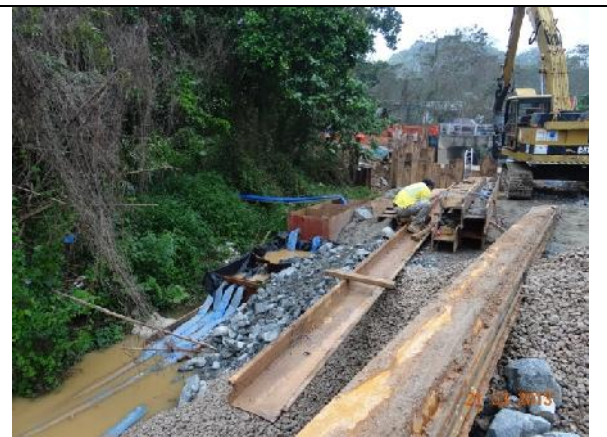
Photo 14 – The running water of the river was pumped to a sedimentation tank at the end of the works area.

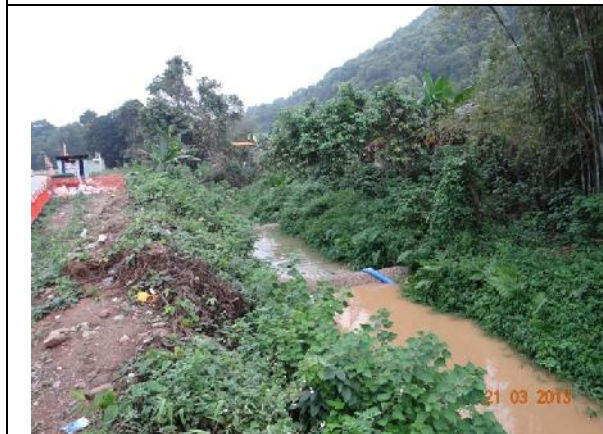
Photo 15 – The filtrate released from the sedimentation tank was then discharged to the river with several sections of granules for further sedimentation.

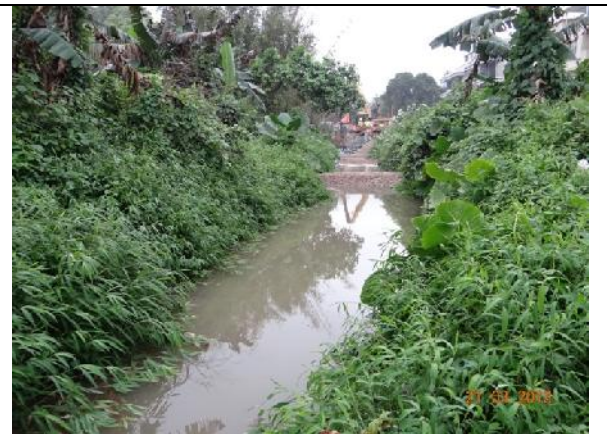
Photo 16 – The lower stream of Wai Ha River below the works area was observed to be unclean due to the recent rainfall.

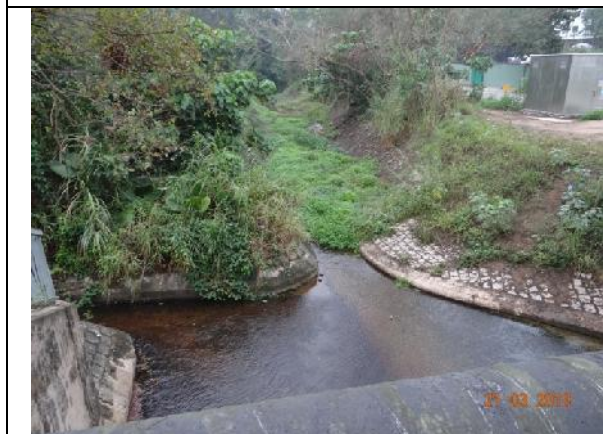
Photo 17 – No discharge of used water was observed at the upper section of Wai Ha River (i.e. to the north of Tung Tsz Shan Road).

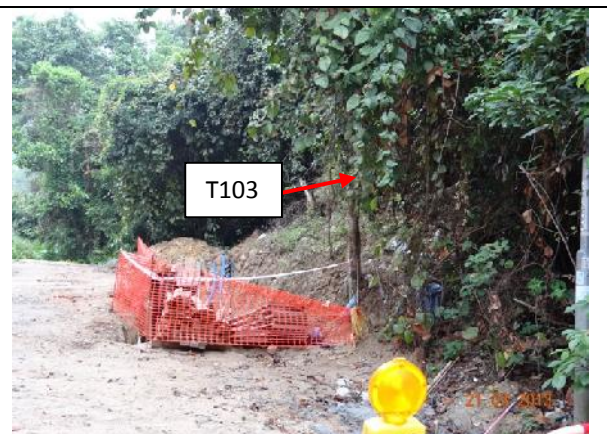
Photo 18 – The soil refilled to the retained tree T103 was loose and sandy, and tapes and ropes were found tied on the trunk.

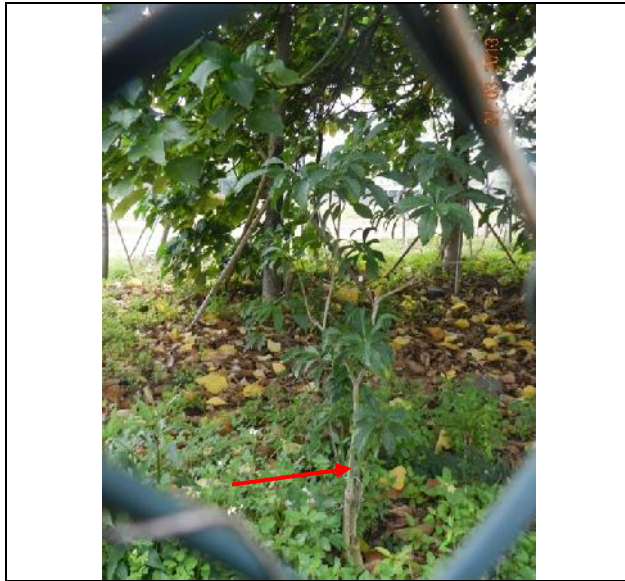
Photo 19 – The transplanted shrub of *Pavetta hongkongensis* (PH03) has remained in satisfactory condition in Area C under Contract 1.

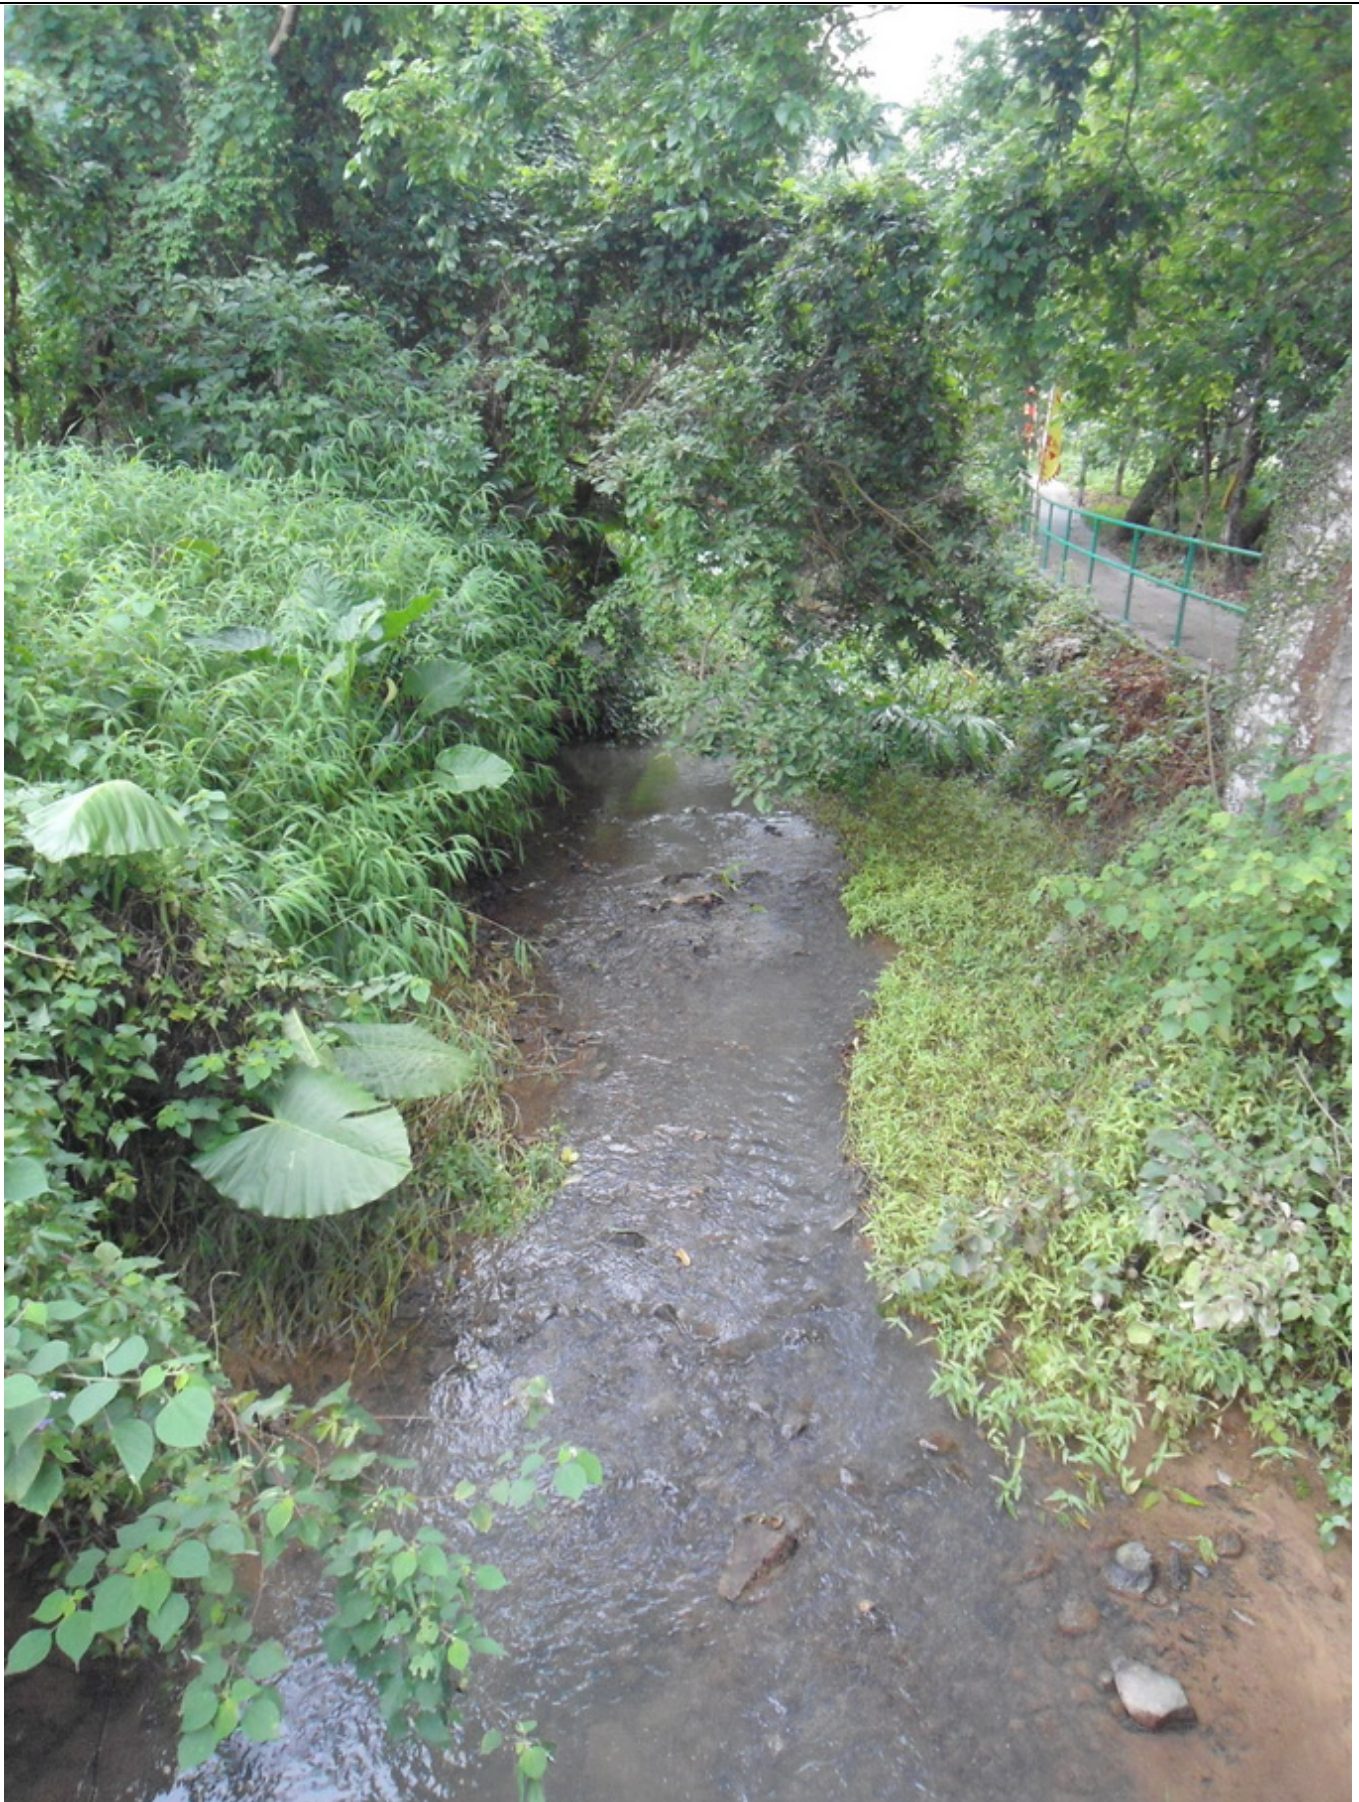
Figure: 2

Title: SEMP 3, the third sampling point of Wai Ha River under Contract 2.

- Figure 1: Map showing the ecological monitoring transect and the boundary of assessment area.
- Figure 2: SEMP 3, the third sampling point of Wai Ha River under Contract 2.
- Figure 3: SEMP 2, the second sampling point along Wai Ha River under Contract 2.

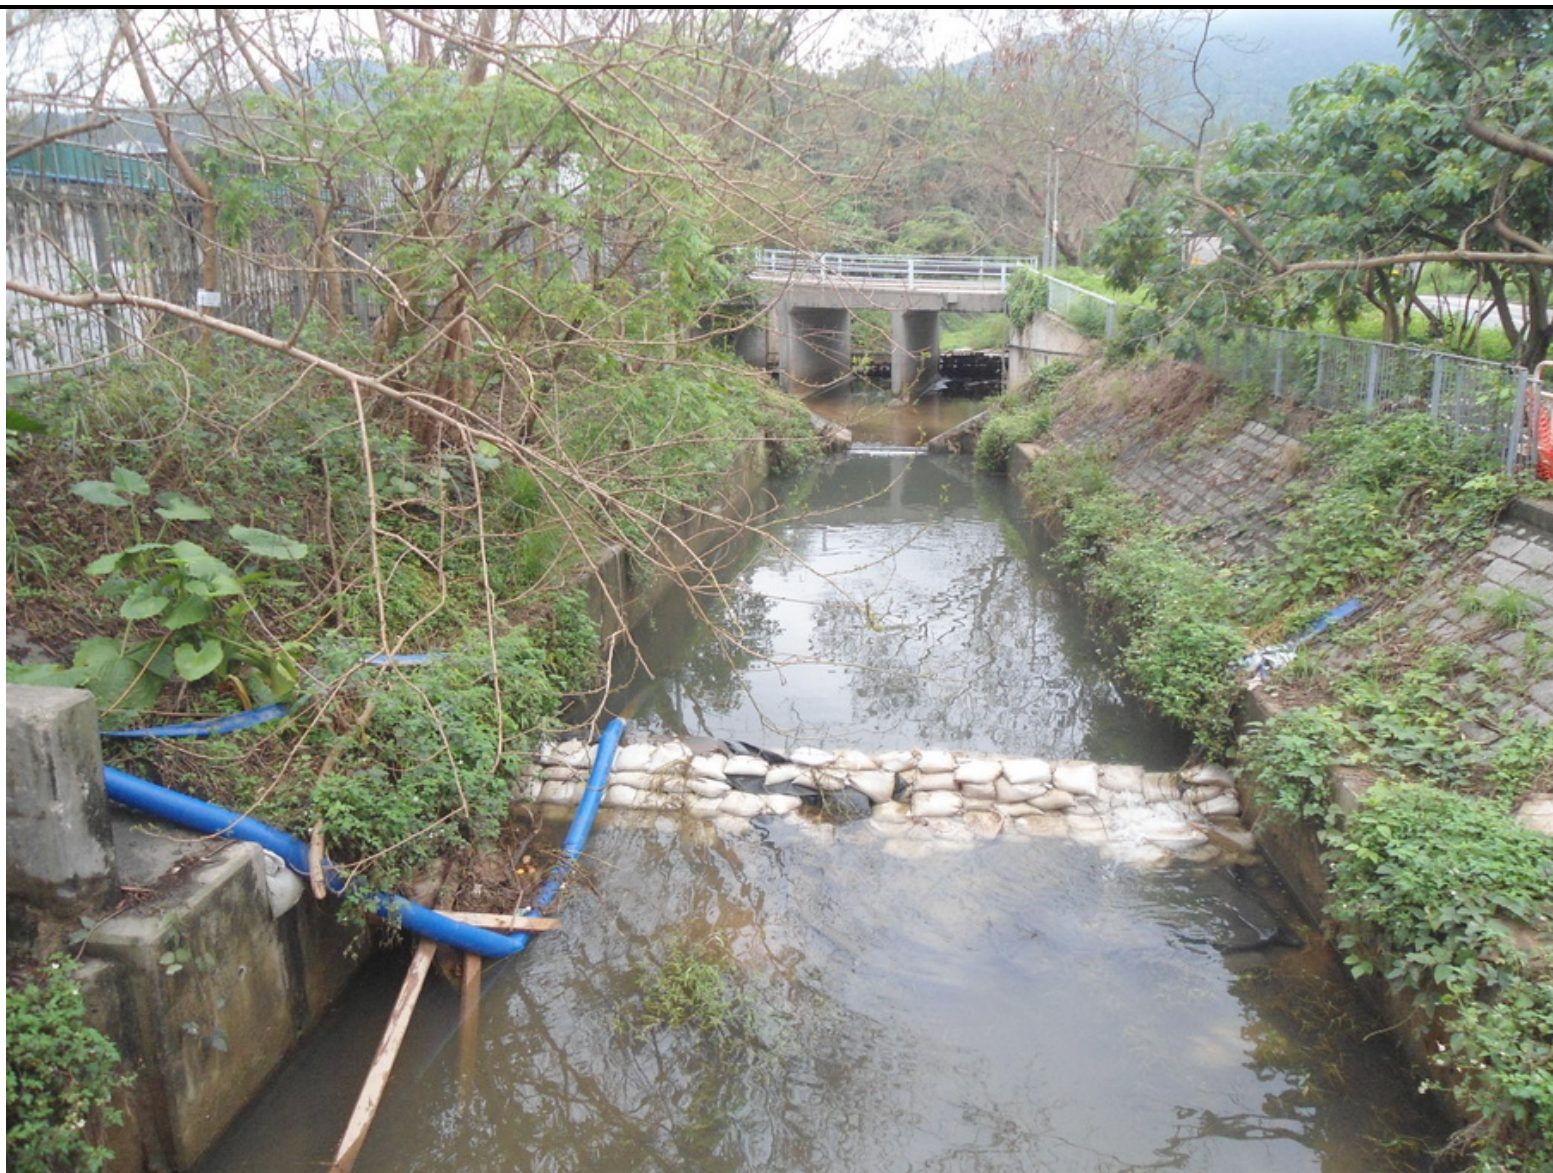
Figure: 3

Title: SEMP 4, the second sampling point along Wai Ha River under Contract 2.
