**CONTRACT NO. DC/2010/02 –
DRAINAGE IMPROVEMENT IN SHUEN WAN AND
SHEK WU WAI**

**MONTHLY ENVIRONMENTAL MONITORING AND
AUDIT REPORT (NO.22) – APRIL 2013**

PREPARED FOR
KWAN LEE-KULY JOINT VENTURE

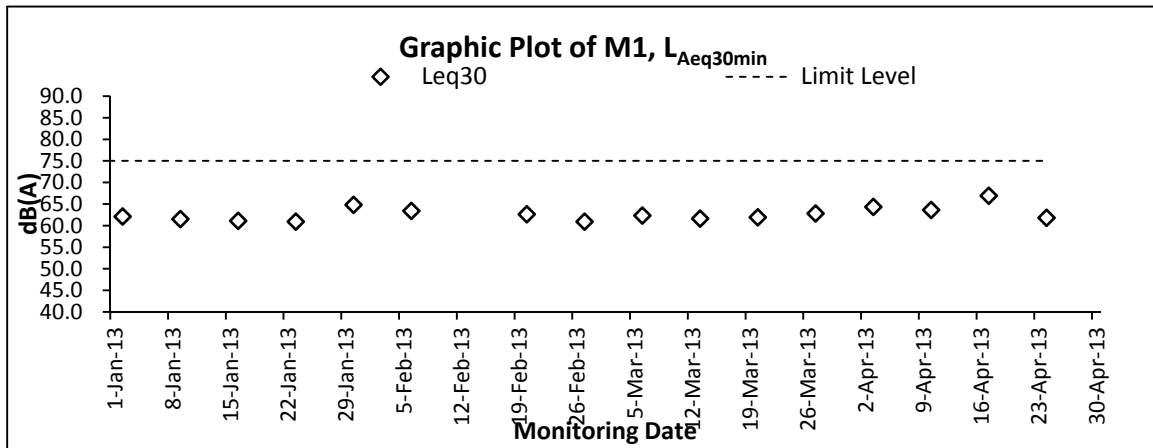
Remark: The monitoring is undertaken under façade situation. No façade correction is added according to acoustical principles and EPD guidelines.

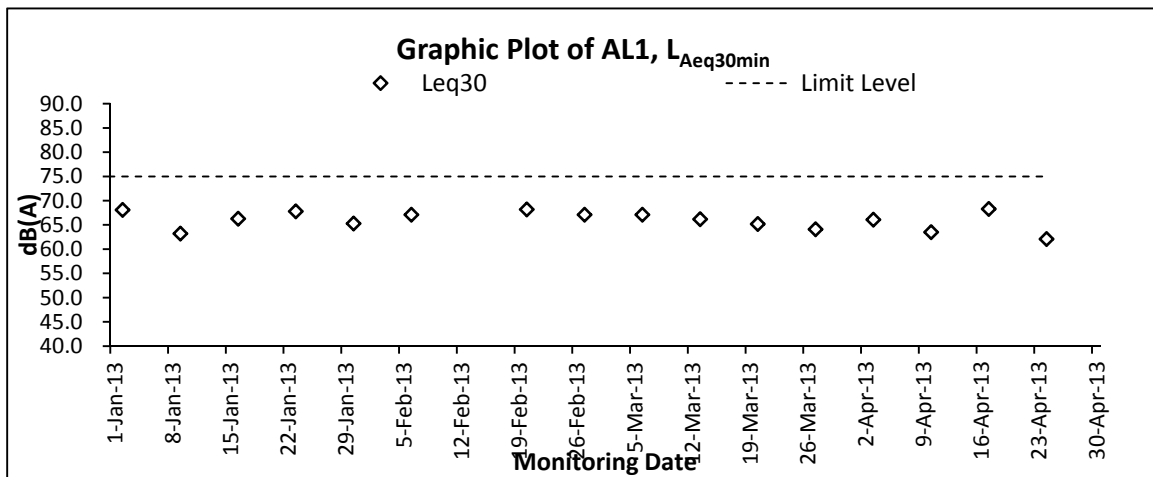
Remark: The monitoring is undertaken under façade situation. No façade correction is added according to acoustical principles and EPD guidelines.

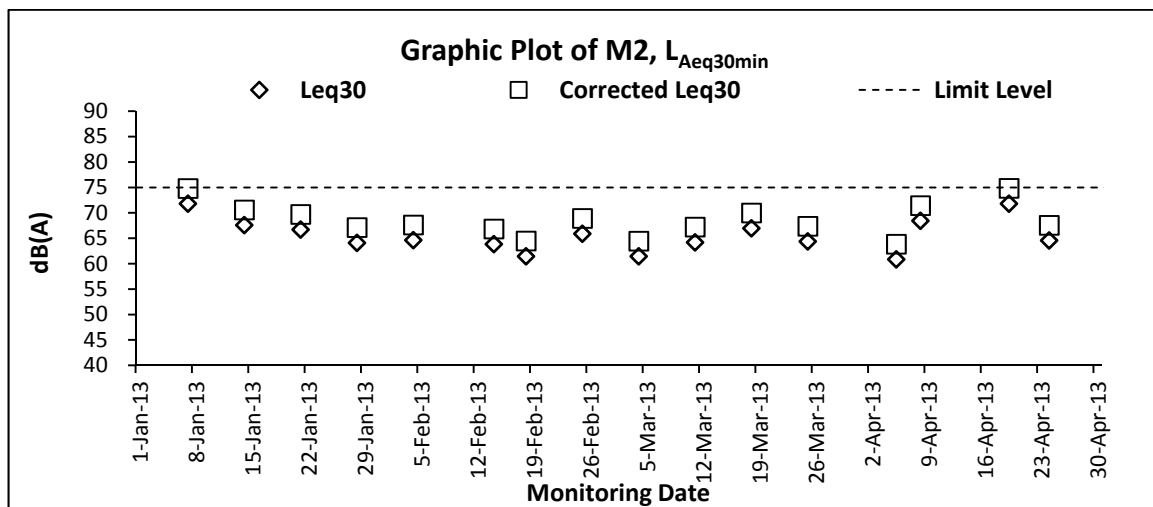
Remark: The monitoring is undertaken under free field situation. A façade correction of +3 dB(A) has been added according to acoustical principles and EPD guidelines.

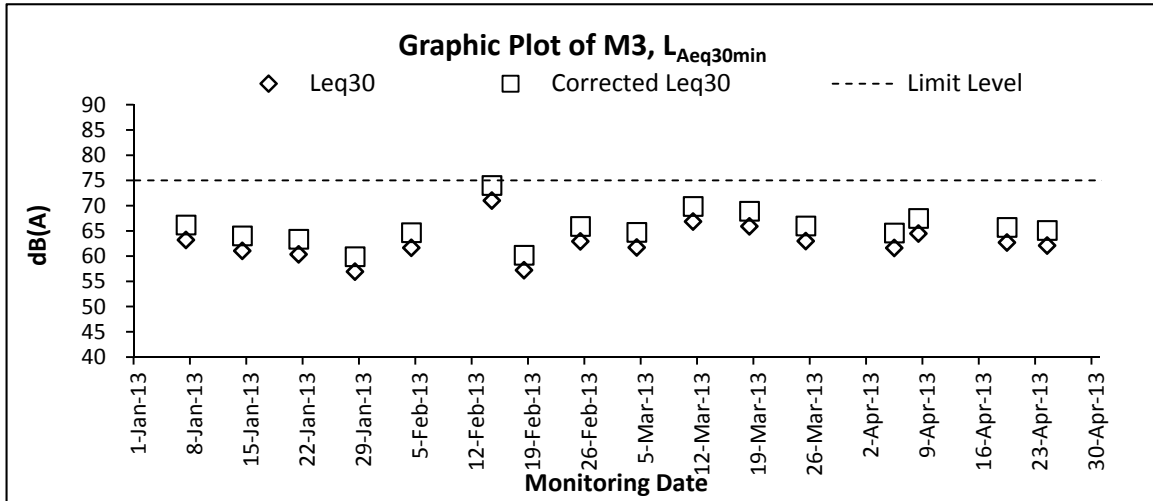
Remark: The monitoring is undertaken under free field situation. A façade correction of +3 dB(A) has been added according to acoustical principles and EPD guidelines

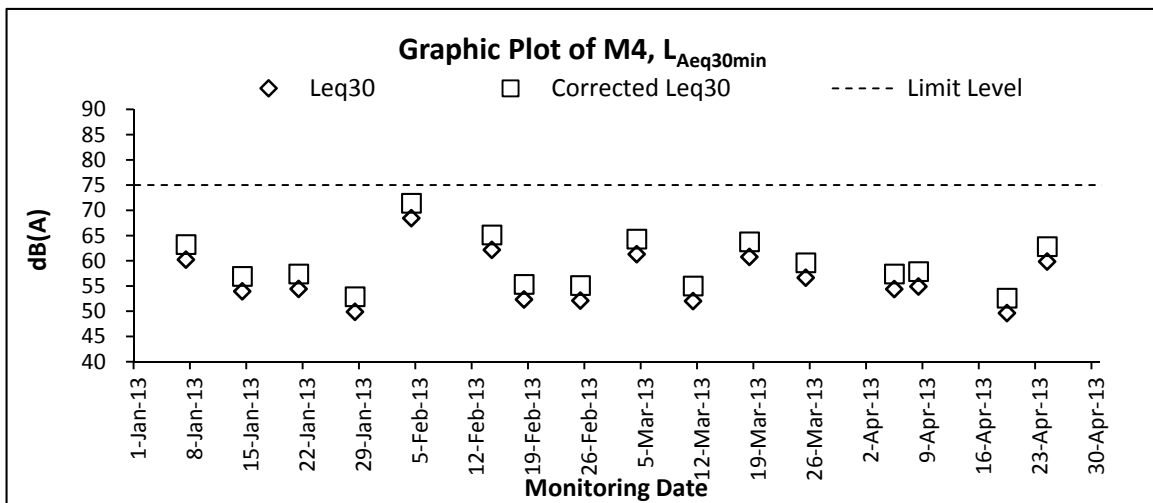
Remark: The monitoring is undertaken under free field situation. A façade correction of +3 dB(A) has been added according to acoustical principles and EPD guidelines

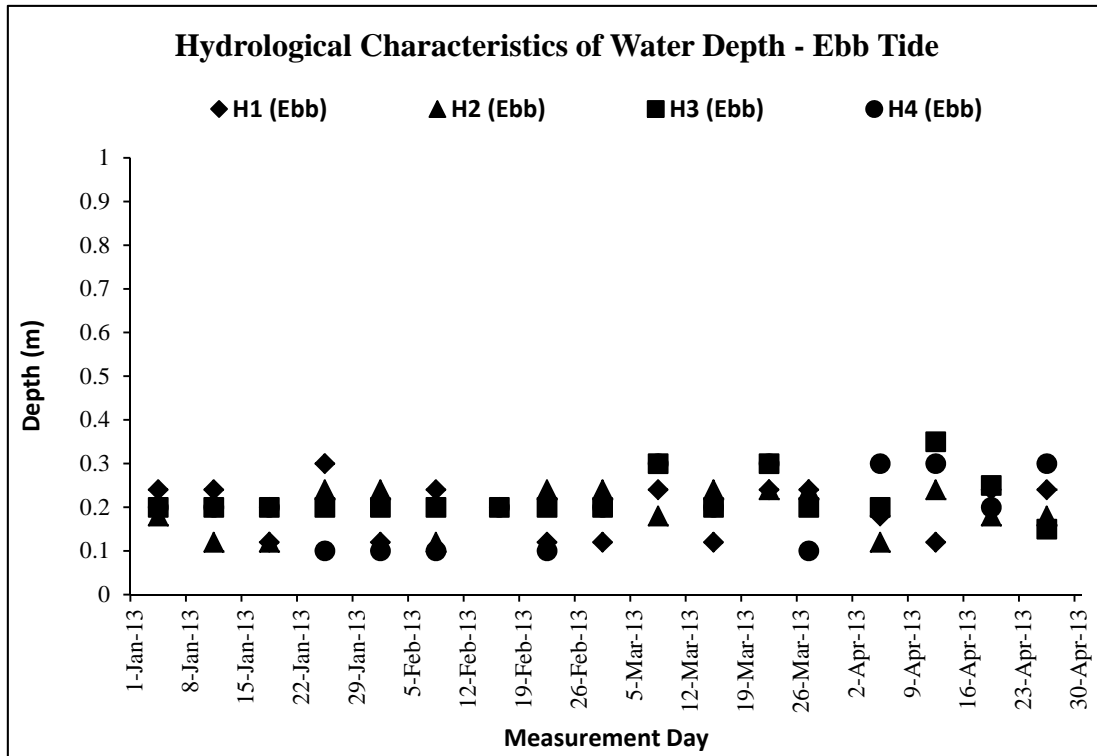
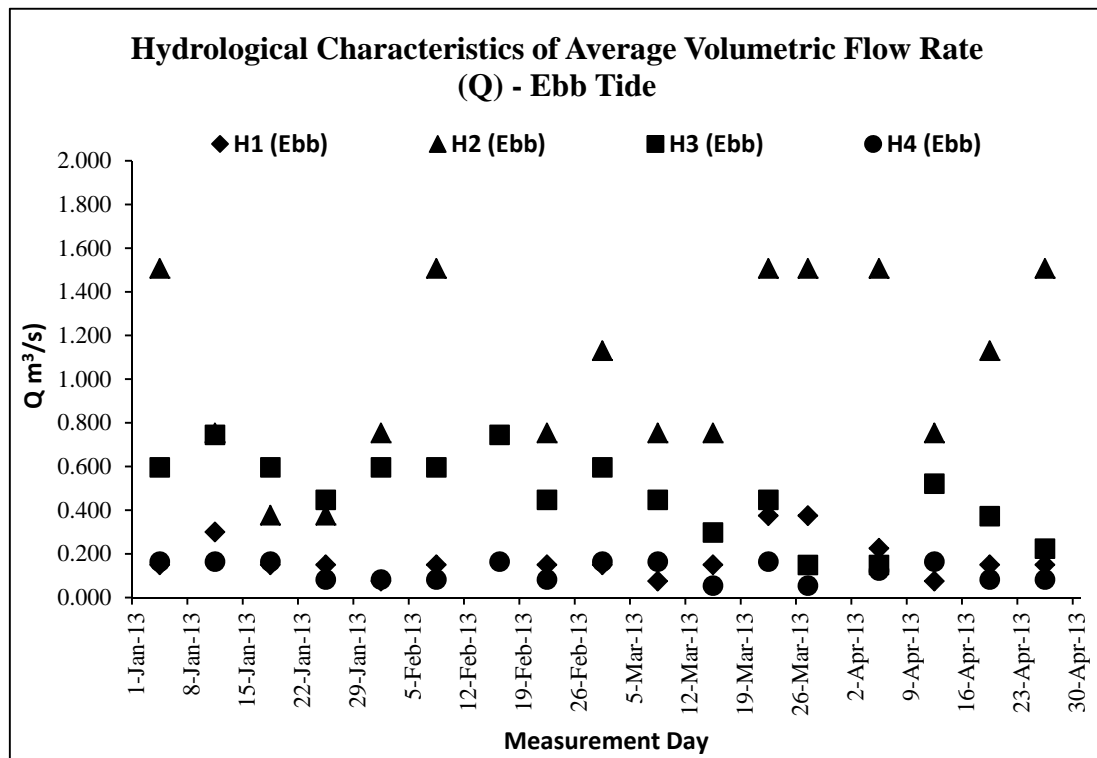
Graphic Plot – Hydrological Characteristics (Water Depth)

- 4.16 To compare the monitoring data between the Reporting Period (rainy season) and baseline monitoring period, the currently water depth and volumetric flow rate has insignificant changed. Furthermore, water depth and water flow rate were found no exceedance in this Reporting Period.

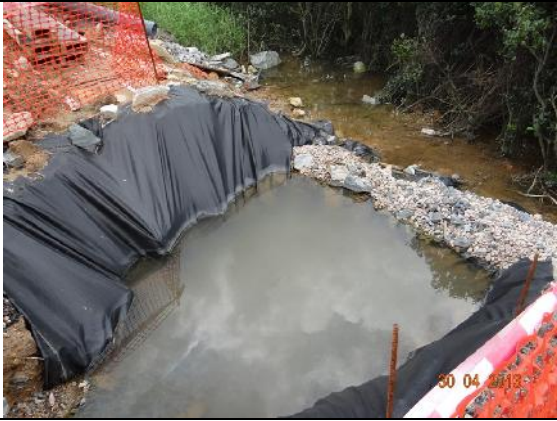
- 3.3.5 A new section of sedimentation bed was observed opposite to San Tau Kok with PVC liner underlying sections of granules in April 2013. The discharge is released to the marsh area and no muddy water was observed at the drainage point (**Photos 12-13**).

<p>Photo 13 – A new section of sedimentation bed was aligned opposite to San Tau Kok with PVC liner underlying granules in April 2013. The discharge is released to the marsh area and no muddy water was observed at the drainage point.</p>	<p>Photo 14 – Another new section of sedimentation bed was aligned with PVC liner underlying granules close to the area at which a filtration tank was previously placed opposite to San Tau Kok close to the marsh area. The discharge is released to the marsh area. No unclear water was noted in the drainage point.</p>

- 3.3.10 Regular monitoring should be conducted to ensure no direct discharge or leakage of contaminants or any polluted fluid into the adjacent Wai Ha River and the nearby Shuen Wan marsh. The Contractor should maintain regular check (e.g. daily) on the sedimentation and filtration facilities and appropriate sedimentation beds and/or tanks throughout the construction phase (e.g. check the function of the sedimentation beds and remove surplus sand and gravels deposited along the beds or within the tanks) to make sure all discharged water was filtered appropriately prior to any discharge. To prevent the impact of the unclear discharge on the nearby vegetated area, it is suggested to overlay PVC liners along the site edge and remove any surplus sand and gravels deposited in the beds and tank.

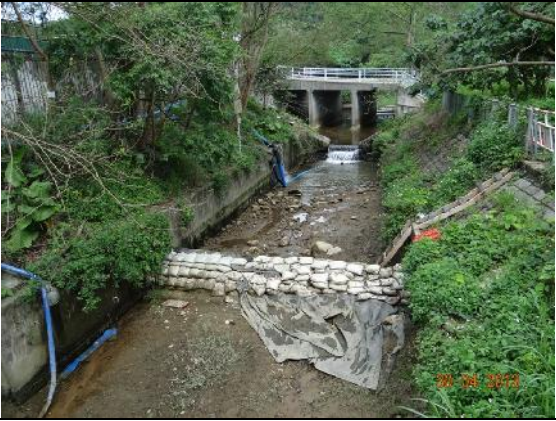
- 3.3.7 Underground water from the built box culverts opposite to San Tau Kok was observed to be released to two drainage points at the adjacent marsh area without any filtration process as inspected on 18th April 2013 (**Photos 15-18**). It was reported to the main Contractor and no more discharge was observed during the monitoring on 30th April 2013 (**Photo 19**).

<p>Photo 19 – No more discharge from the built box culverts opposite to San Tau Kok to the adjacent marsh area was observed on 30th April 2013</p>	<p>Photo 20 – Sand bags have been put in Wai Ha River to separate the works area in the river. The running water of the river was pumped to the end of the works area.</p>

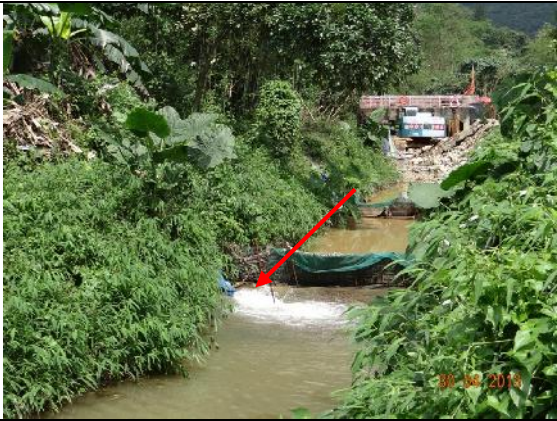
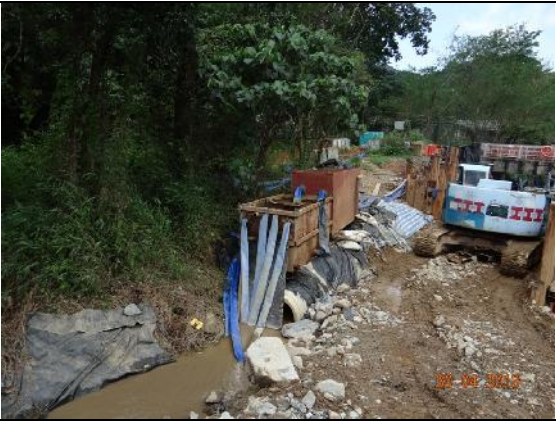
- 3.3.9 The waste water from the construction site in Wai Ha River was pumped into a sedimentation tank placed at the end of the works area (**Photo 22**). The filtrate was then discharged to the river with several sections of granules for further sedimentation (**Photo 23**). Fences were noted to prevent the granules washing away into the stream. The discharge was found muddy at the upper section near the works area and it became cleaner after passing through several sections of granules for the sedimentation (**Photo 21**).

<p>Photo 21 – The running water of the river was pumped to the end of the works area and it bypassed the sections of granules down the stream.</p>	<p>Photo 22 – The waste water from the construction site in Wai Ha River was pumped into a sedimentation tank placed at the end of the works area. The filtrate was then discharged to the river with several sections of granules for further sedimentation.</p>

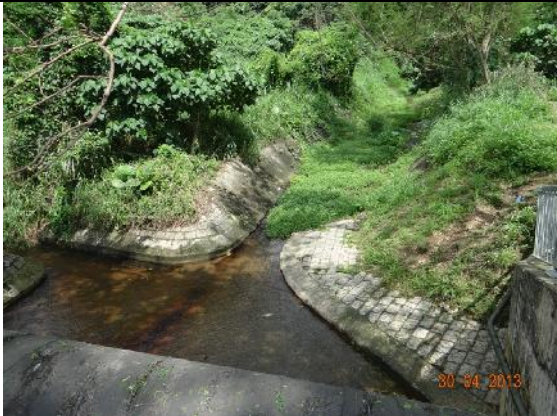
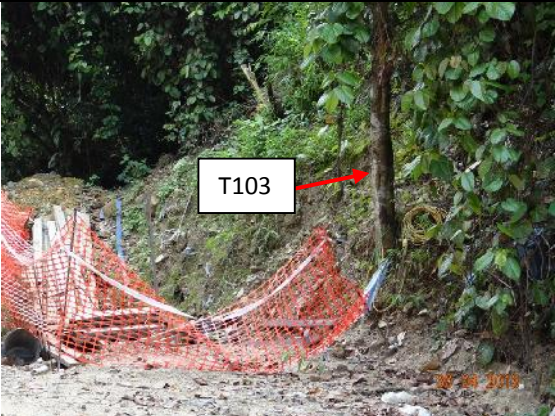
- 3.4.8 The waste water from the construction site in Wai Ha River was pumped into a sedimentation tank placed at the end of the works area (**Photo 22**). The filtrate was then discharged to the river with several sections of granules for further sedimentation (**Photo 23**). Fences were noted to prevent the granules washing away into the stream. The discharge was found muddy at the upper section near the works area and it became cleaner after passing through several sections of granules for the sedimentation (**Photo 24**).

- 3.4.9 No direct water discharge into the upper stream of Wai Ha River was observed as the active construction works have been concentrated at the lower end of Wai Ha River to the southeast of Tung Tsz Shan Road (**Photo 25**).

<p>Photo 23 –The filtrate from the sedimentation tank was then discharged to the river with several sections of granules for further sedimentation.</p>	<p>Photo 24 – The discharge was found muddy at the upper section near the works area and it became cleaner after passing through several sections of granules for the sedimentation.</p>

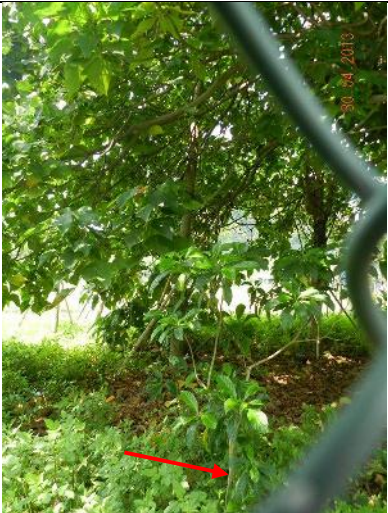
<p>Photo 27 – The transplanted shrub of <i>Pavetta hongkongensis</i> (PH03) has remained in satisfactory condition in Area C under Contract 1.</p>
