**Monthly Environmental Monitoring & Auditing report for**

**Contract No.DC/2009/22**

**Drainage Improvement in Shuen Wan, Tai Po – Contract 1**

**May 2013**

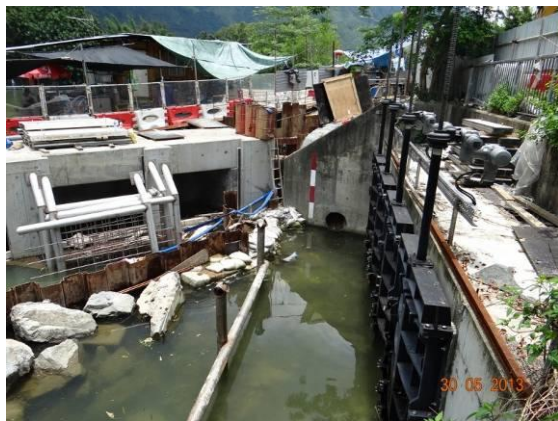
**Photo 1** – Temporary hoardings have been established to surround the works area at Wai Ha River estuary.

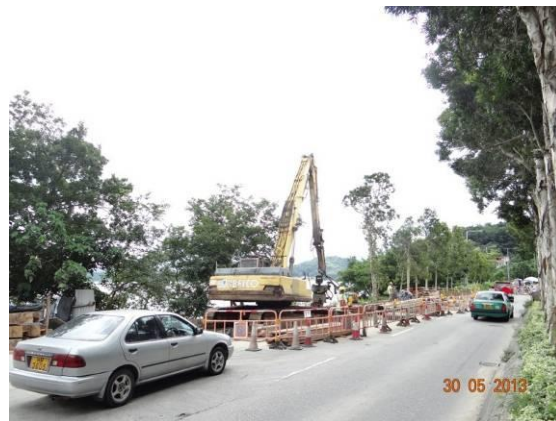
**Photo 2** – Temporary barriers along a section of Ting Kok Road next to the main entrance of Area A.

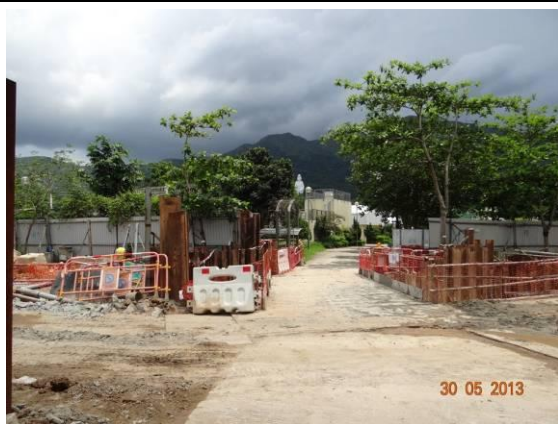
**Photo 3** – The temporary hoardings at the eastern end of Phase 1 and the western end of Phase 2 works area were replaced by temporary construction barriers.

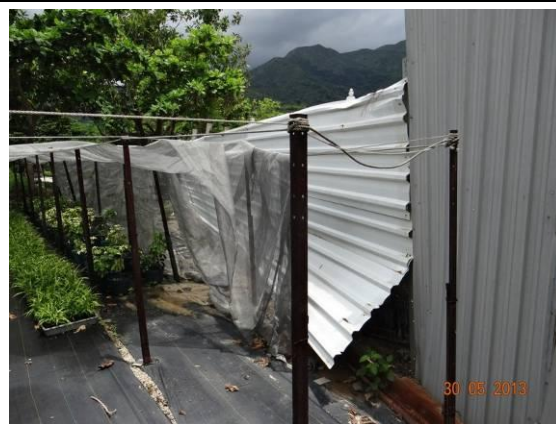
**Photo 4** – A section of hoarding close to the retained tree U50 (*Ficus elastica*) at the southwestern part of Phase 1 was opened.

The Contractor is suggested to repair the broken temporary hoarding (as shown in Photo 4) in Phase 1 construction works in Tung Tsz Nursery.

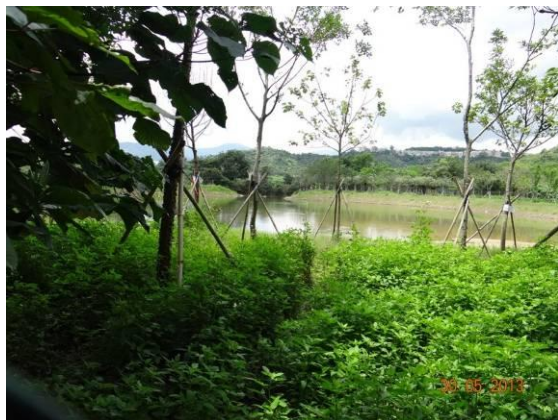
Area C was formally handed over to AFCD on 16<sup>th</sup> October 2012 for management and maintenance. The pond of the ECA has been connected to Wai Ha River directly as following the scheme design of Habitat Compensatory Plan. No direct discharge of turbid water into the adjacent Wai Ha River was observed through the fence of Tung Tsz Nursery (**Photo 5**).

**Photo 5** – No discharge of muddy water was observed in Area C.

The Contractor should regularly check the condition and locations of the drainage pipes and ensure that all used water should be appropriately filtered and discharged to the manholes/other discharge points agreed by the Engineer and EPD. This is to avoid any potential contamination to the vegetation in Shuen Wan marsh and other vegetated/marinated areas adjacent to the active works area.

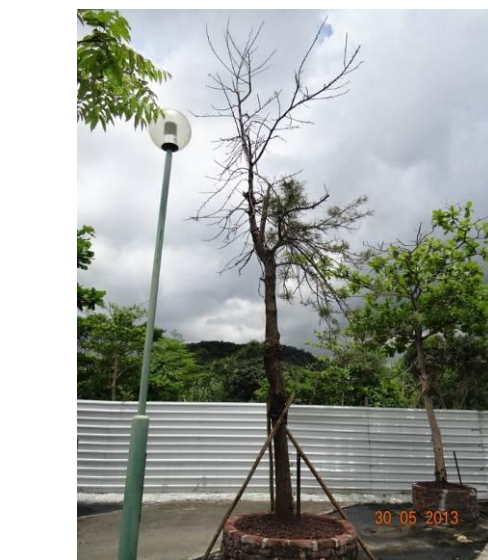
Regular monitoring for all transplanted trees within the nursery was conducted on a bi-weekly basis. For tree U58 (*Grevillea robusta*) (**Photo 6**), leaves as watersprouts were observed along the branches and lower trunk. Dead branches were observed at the eastern canopy. U58 still remained in fairly poor physiological condition in May 2013. Regular monitoring has to be continued to update its health and structural condition.

**Photo 6** – Overall view of the transplanted tree U58.

Regular watering and close monitoring of the stability of *Grevillea robusta* (U58) are still recommended to be the major treatment to this tree. The appointed landscape contractor and the Contractor should closely monitor the health conditions of all transplanted/relocated and retained trees throughout the construction period of the Project.

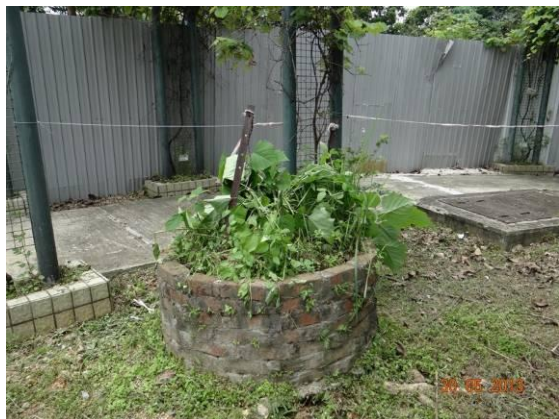
As reported in the previous *Monthly EM&A Reports*, the retained tree U68 (*Gmelina arborea*) was found fallen after the severe typhoon in July 2012, with its leaning trunk being pruned and removed in August 2012 (as reported in *Monthly EM&A Report for August 2012*). Development of watersprouts at the remained stump has been reported since November 2012. However, as observed on 30<sup>th</sup> May 2013, watersprouts were removed by the Nursery workers in the recent vegetation management practice (**Photo 7**).

**Photo 7** – Watersprouts from the remained stump of U68 were cut.

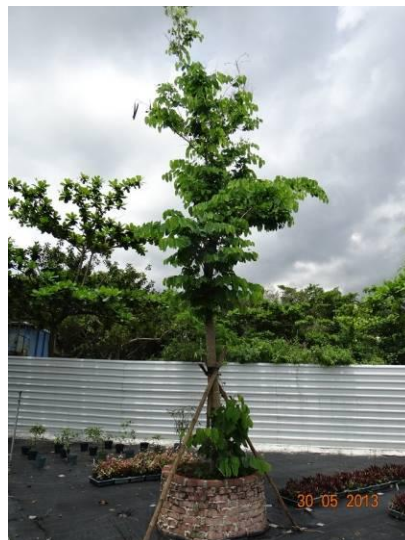
The transplanted tree U64 (*Bauhinia purpurea*) was observed to have abnormal leaves shed and lots of climbers on its lower trunk in April 2013. New leaves regenerated in the canopy in May 2013 (**Photo 8**).

**Photo 8** – Overall view of the transplanted tree U64.

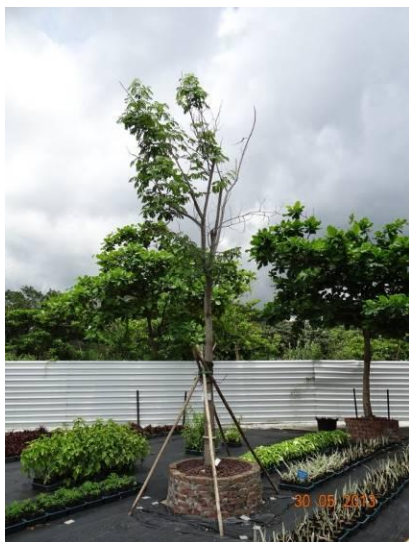
The leaning tree U61 (*Lysidice rhodostegia*) was replanted in April 2013. It appears to have improvement in its physiological condition with more foliage in the canopy (**Photo 9**).

**Photo 9** – Overall view of the transplanted tree U61.

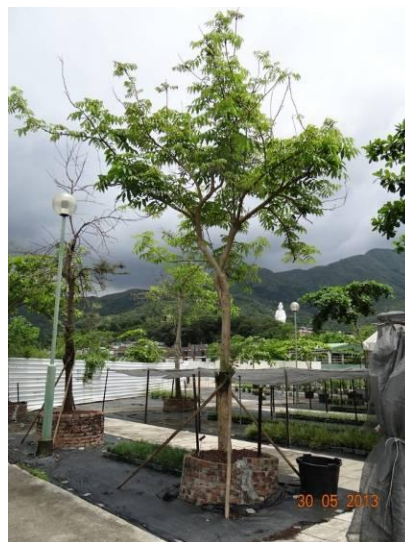
*Monthly EM&A Report for April 2013*. Green and healthier leaves were observed in the canopy in May 2013 (**Photo 10**).

**Photo 10** – Overall view of the transplanted tree U75.

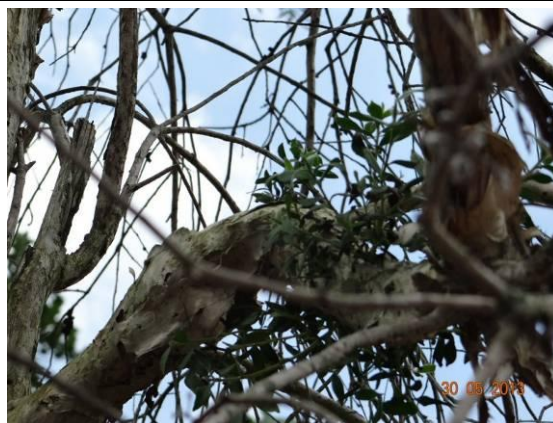
**Photo 12** – New watersprouts were noted on the branches of E18.

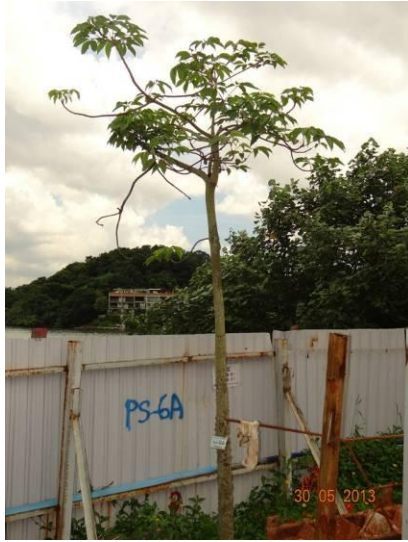
The tree to be transplanted E16 (*Bombax ceiba*) has been relocated to the southern side of Area A next to the site hoarding since July 2012. The tree was in fair condition as inspected in May 2013 (**Photo 13**). A broken branch was still found hanging in the canopy.

**Photo 13** – Fair health condition of the relocated tree E16.

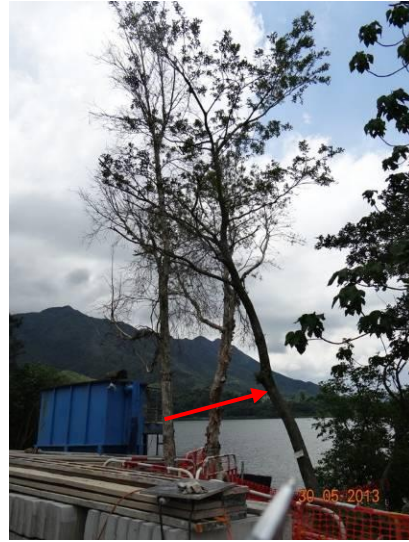
E97 (*Celtis sinensis*) has been relocated at the northeastern part of Area A since December 2012. It remains in fair health condition with normal foliage colour and density in the canopy in May 2013 (**Photo 14**).

**Photo 14** – Fair health condition of the relocated tree E97.

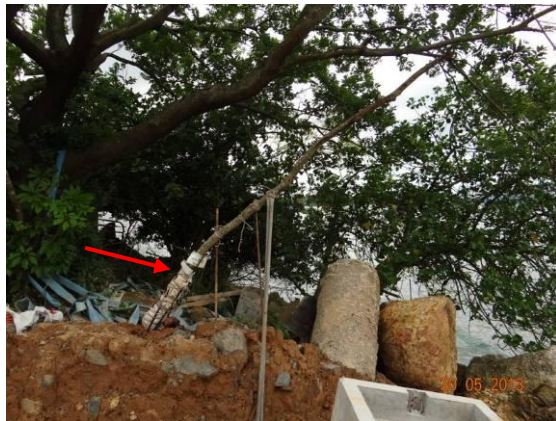
A wound was found at the trunk base of E61 (*Macaranga tanarius* var. *tomentosa*) in April 2013, with leaning tree trunk and cracked lower trunk. As inspected on 30th May 2013, the wound at the trunk flare of E61 was burlapped and the leaning tree trunk was supported by two steel poles (**Photo 15**). Only a few leaves newly emerged on the tree trunk.

**Photo 15** – The wound at the trunk flare of E61 was burlapped and the leaning tree trunk was supported by two steel poles.

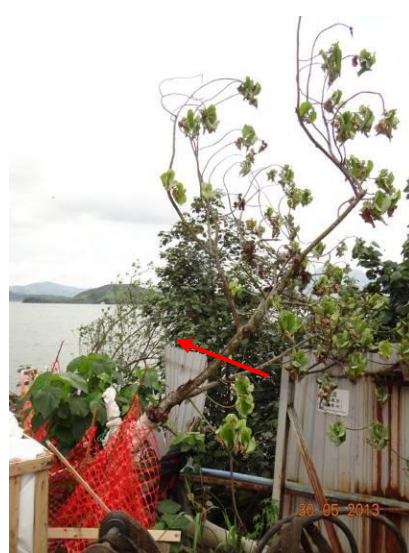
E55 (*Macaranga tanarius* var. *tomentosa*) was recorded to have been damaged with wounds on the tree trunk in April 2013. The wound on the trunk of E55 was burlapped by the Contractor in May 2013 (**Photo 16**).

**Photo 16** – The wound on the trunk of E55 was burlapped.

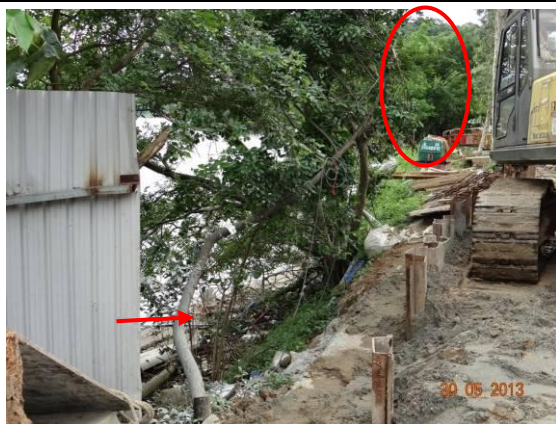
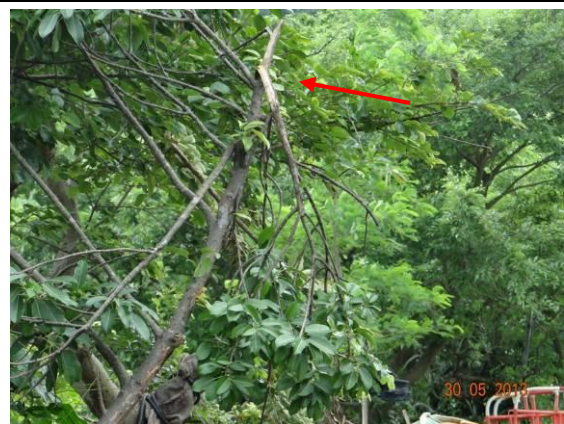
A damaged branch was observed on a retained tree E39 located close to the main entrance of Area A (**Photos 17-18**).

**Photo 17** – A damaged branch was observed on a retained tree E39 located close to the main entrance of Area A.

**Photo 18** – Close view of the damaged branch on E39.

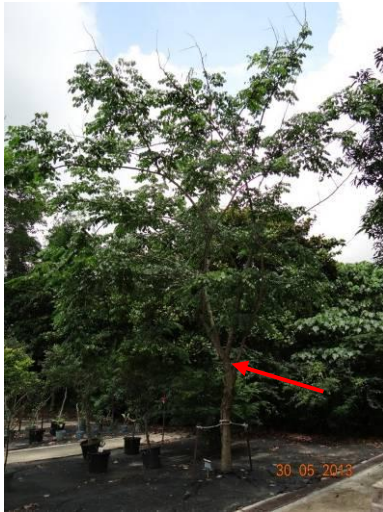
The physiological condition of the transplanted tree U55 (*Pterocarpus indicus*) has been improved in May 2013. More foliage was observed in the canopy (**Photo 19**).

**Photo 19** – The physiological condition of U55 has been improved and new foliage was observed in the canopy.

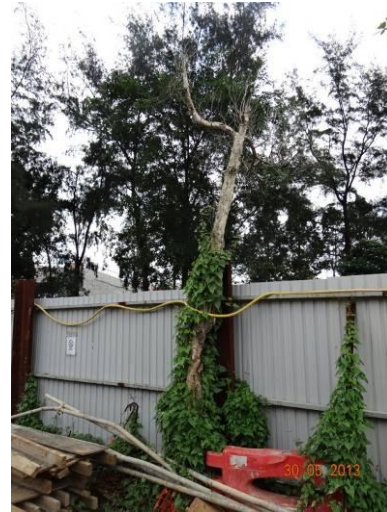
The tree to be transplanted T102 (*Melaleuca cajuputi* subsp. *cumingiana*) has been relocated to the southern part within the Phase 2 construction area of Area B next to the hoarding since November 2012 (**Photo 20**). The tree still appeared in very poor condition with no leaves in the canopy in May 2013.

**Photo 20** – Poor condition of the relocated tree T102 as observed within the Phase 2 works area of Area B.

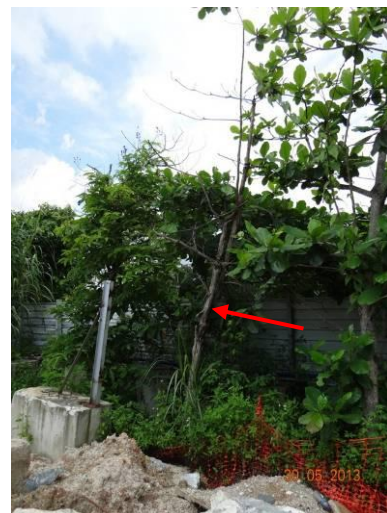
**Photo 22** – No recovery sign of the relocated tree U37 was observed.

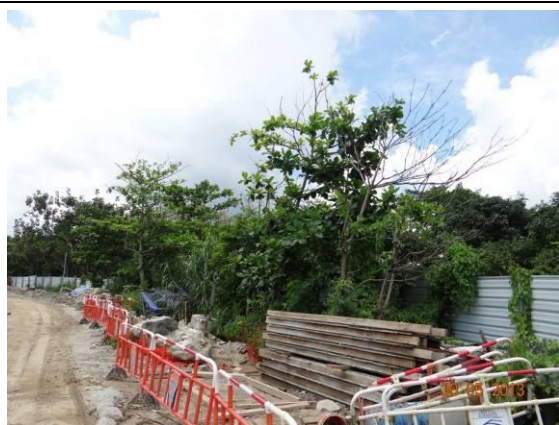
**Photo 23** – Temporary storage of construction materials was observed very close to the tree group of U34, U35, U37 and other trees in Area B.

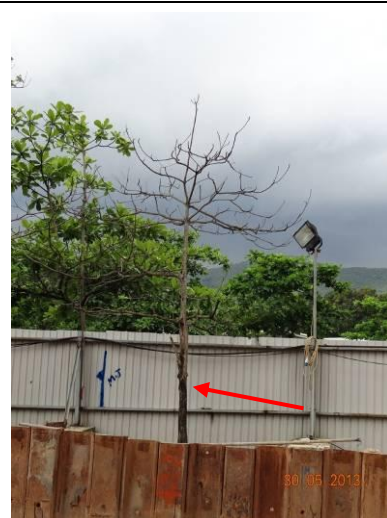
The relocated tree U77 (*Terminalia catappa*) in Phase 2 of Area B was suspected to be dead as no leaves was observed in the canopy (**Photo 24**). U76 and U78 (*Terminalia catappa*) were found with regenerated foliage in April 2013 and they remained in fair condition in May 2013 (**Photos 25-26**).

**Photo 24** – The relocated tree U77 in Area B was suspected dead as no foliage was found in the canopy.

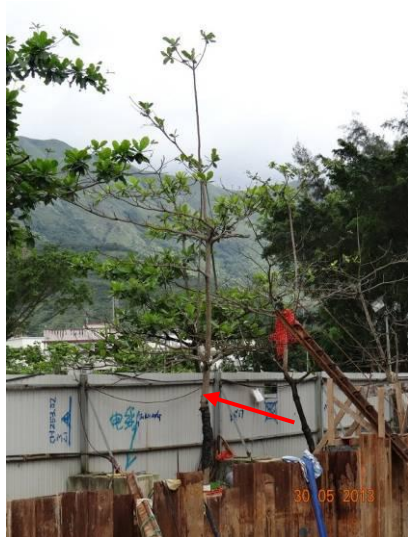
**Photo 25** – Overall view of the transplanted tree U76.

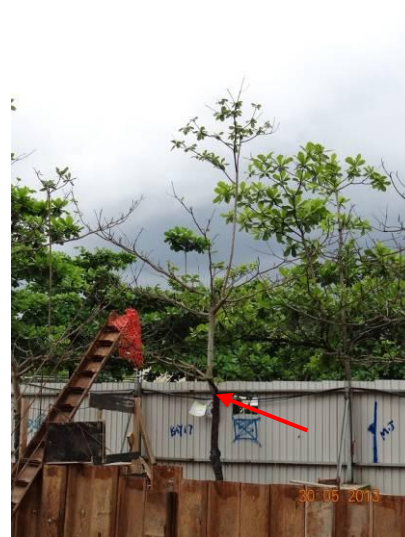
**Photo 26** – Overall view of the transplanted tree U78.

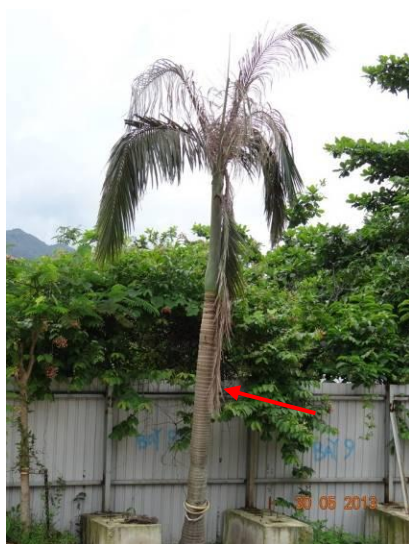
The transplanted tree A36 (*Archontophoenix alexandrae*) was still considered in marginally fair condition in May 2013, with some dry and brown fronds at the bud (**Photo 27**).

**Photo 27** – The transplanted tree A36 was in marginally fair condition in May 2013, with some dry and brown fronds at the bud.

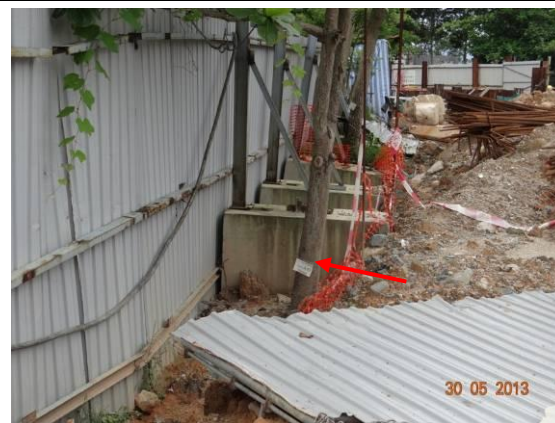
Stockpiling of soil close to the trunk flare of A43 were still observed and removal of surplus soil around the trunk flare was not yet carried out by the Contractor (**Photo 28**).

**Photo 28** – Stockpiling of soil close to the trunk flare of A43 was still observed.

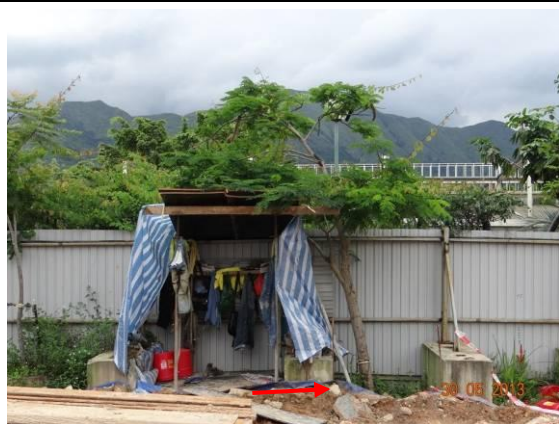
A temporary shelter has been established next to the relocated tree U74 (*Delonix regia*) since April 2013 (**Photo 29**). No significant damage on the tree trunk and canopy caused by the shelter was observed in May 2013.

**Photo 29** – A temporary shelter has been established next to the relocated tree U74 (Delonix regia).

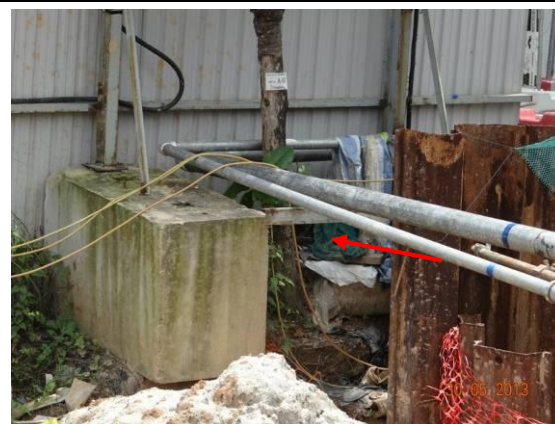
Construction materials were found around the tree root zone of A42 (*Terminalia catappa*) of which some exposed roots were found due to the absence of the planter (**Photo 30**).

**Photo 30** – Construction materials were found around the tree root zone of A42.
