Monthly Environmental Monitoring & Auditing report for

Contract No.DC/2009/22

Drainage Improvement in Shuen Wan, Tai Po – Contract 1

June 2013

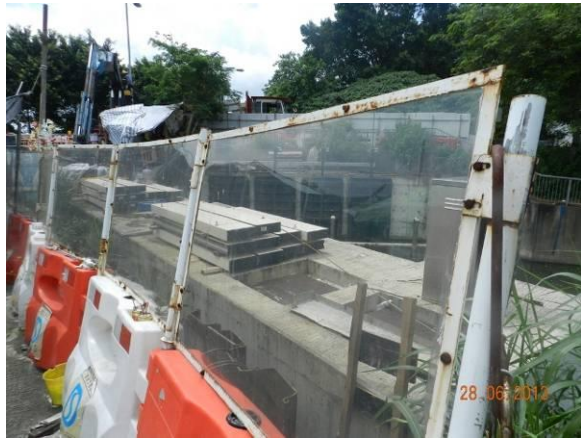
Construction hoardings have been erected in Area A along the entire site boundary. Temporary construction hoardings have been erected around Wai Ha River estuary since the building of an automatic mechanical penstock at the area (**Photo 1**). Sections of the road have been surrounded with temporary barriers to the south of Area A along Ting Kok Road for another phase of the construction work since February 2013 (**Photo 2**). The works have been continued in June 2013. As observed in June 2013, the site hoarding on the west of Area A had been replaced by temporary barriers (**Photo 3**). Since January 2013, the site hoardings along the eastern boundary of Area A have been removed due to

Photo 1 – Temporary hoardings have been established to surround the works area at Wai Ha River estuary.

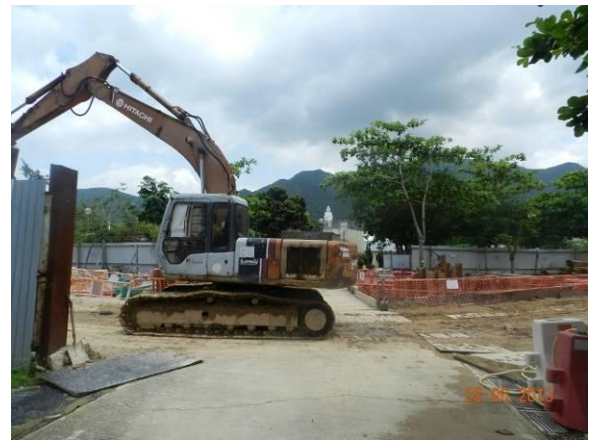
The temporary hoardings have been erected from northwest to southwest parts of Tung Tsz Nursery in Area B since April 2011. Phase 2 construction works have continued and temporary hoardings have been erected since May 2012. The major road access within the Nursery has been maintained to minimize the impact on the nursery's daily operation resulting from the construction works. A section of the temporary hoardings at the eastern end of Phase 1 and western end of Phase 2 works area have been replaced by temporary construction barriers since April 2013 (**Photo 4**).

Photo 4 – The temporary hoardings at the eastern end of Phase 1 and the western end of Phase 2 works area were replaced by temporary construction barriers.

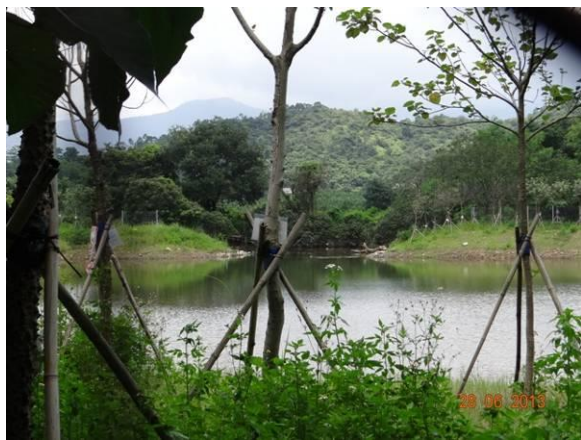
Area C was formally handed over to AFCD on 16th October 2012 for management and maintenance. The pond of the ECA has been connected to Wai Ha River directly as following the scheme design of Habitat Compensatory Plan. No direct discharge of turbid water into the adjacent Wai Ha River was observed through the fence of Tung Tsz Nursery **(Photo 5)**.

Photo 5 – No discharge of muddy water was observed in Area C.

The Contractor should regularly check the condition and locations of the drainage pipes

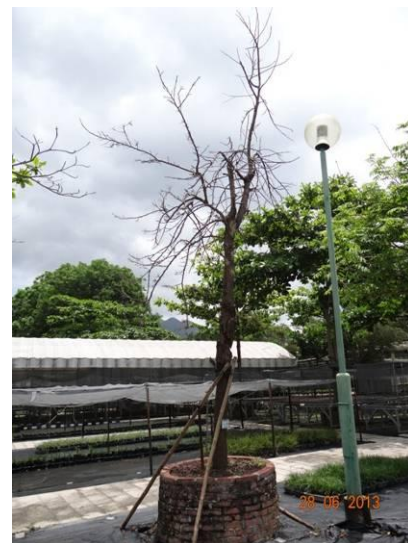
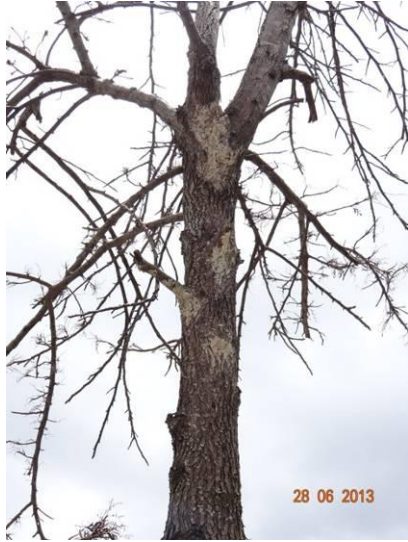
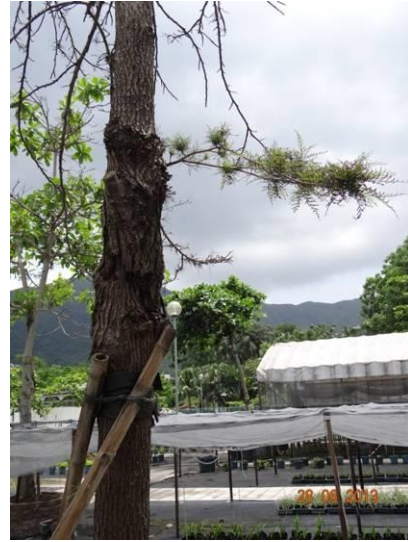
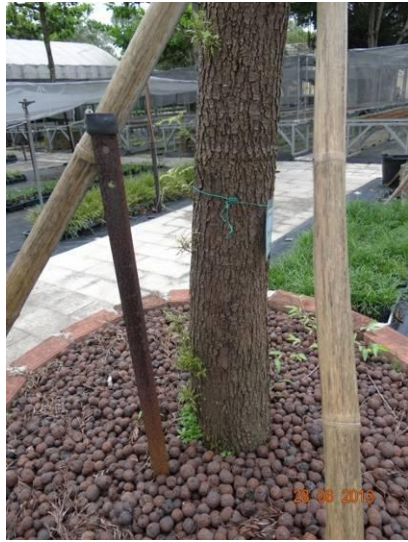
Regular monitoring for all transplanted trees within the nursery was conducted on a bi-weekly basis. For tree U58 (*Grevillea robusta*) (**Photo 6**), its health condition has deteriorated. Significant dieback twigs were observed in the tree canopy and fungal infection was found along the upper trunk with suspected decayed (**Photo 7**). The remaining leaves on the canopy were small and weak (**Photo 8**) and watersprouts had developed along the lower trunk (**Photo 9**). The tree is considered having poor health and

structural condition. There has a potential risk of whole tree failure due to the wound on the middle trunk. If it collapses, it may hit any users/ nursery workers passing-by the access path in the Nursery.

As highlighted in the Section “Liaison with Nursery”, physiological condition of the transplanted tree U58 (*Grevillea robusta*) has deteriorated. Though watersprouts had developed along the lower trunk, the remaining leaves on the canopy were small and weak, and significant dieback twigs were observed in the tree canopy (**Photos 6-9**).

Photo 6 – Overall view of the transplanted tree U58.

Photo 7 – Fungal infection on the upper trunk of U58.

Photo 8 – Remaining leaves on the canopy of U58 were small and weak.

Photo 9 – Watersprouts along the lower trunk of U58.

Close monitoring on the stability of *Grevillea robusta* (U58) are still recommended to be the major treatment to this tree. The Contractor is suggested informing the Nursery Operator to restrict any access within the tree-falling zone of U58 before any follow-up action to the tree. The landscape contractor appointed by the Contractor should assess the tree stability and consider whether the tree has to be removed or supported more appropriately.

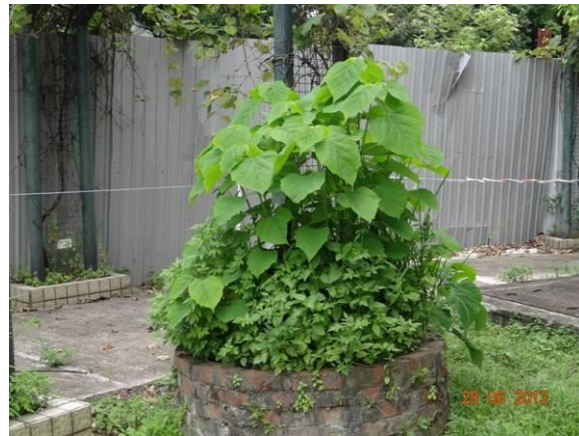
As reported in the previous *Monthly EM&A Reports*, the retained tree U68 (*Gmelina arborea*) was found fallen after the severe typhoon in July 2012, with its leaning trunk being pruned and removed in August 2012 (as reported in *Monthly EM&A Report for August 2012*). Re-developed watersprouts were removed by the Nursery workers in May 2013 and watersprouts regenerated as observed in June 2013 (**Photo 10**).

Photo 10 – Watersprouts regenerated from the remained stump of U68.

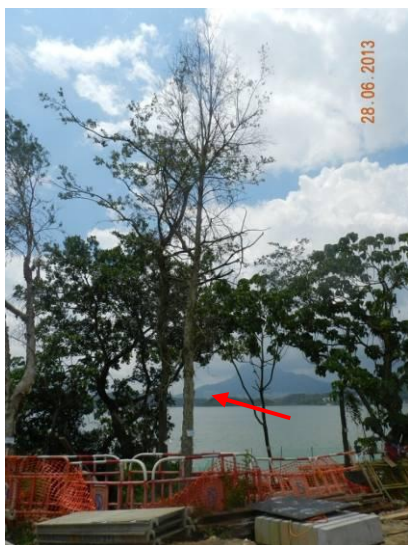
Since October 2012, E18 (*Melaleuca cajuputi* subsp. *cumingiana*) originally located within the TPZs nearby the main gate have been relocated within Area A due to its direct conflict with the works. As observed in June 2013, the tree was still found in poor condition with dry and wilt leaves due to transplantation shock and poor transplanting skills (**Photo 11**).

Photo 11 – Overall view of the relocated tree E18.

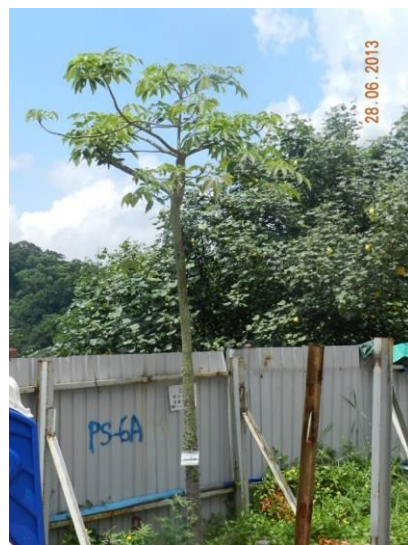
The tree to be transplanted E16 (*Bombax ceiba*) has been relocated to the southern side of Area A next to the site hoarding since July 2012. The tree was in fair condition as inspected in June 2013 (**Photo 12**).

Photo 12 – Fair health condition of the relocated tree E16.

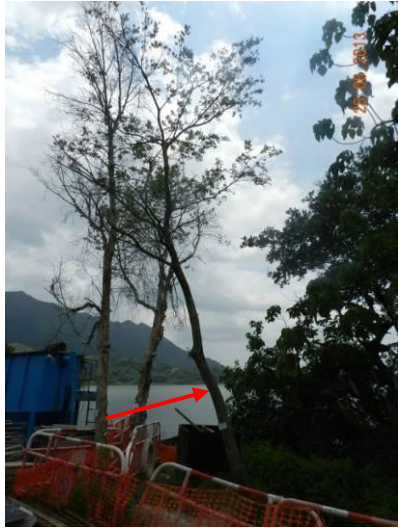
E97 (*Celtis sinensis*) has been relocated at the northeastern part of Area A since December 2012. It remained in fair health condition with normal foliage colour and density in the canopy in June 2013 (**Photo 13**).

Photo 13 – Fair health condition of the relocated tree E97.

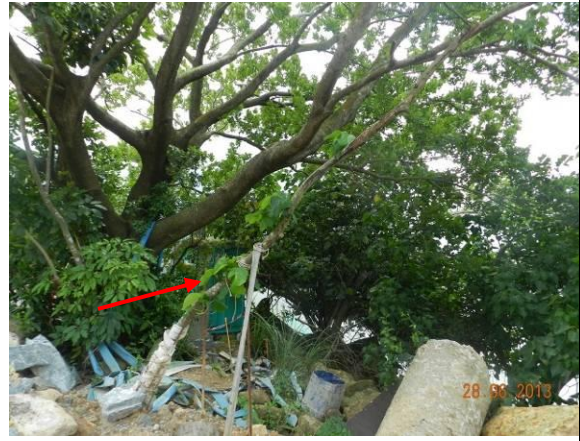
A wound was found at the trunk base of E61 (*Macaranga tanarius* var. *tomentosa*) in April 2013, with leaning tree trunk and cracked lower trunk. The wound at the trunk flare of E61 has been burlapped and the leaning tree trunk has been supported by two steel poles since May 2013. The tree still appeared to have poor health condition with only a

Photo 14 – The wound at the trunk flare of E61 was burlapped and the leaning tree trunk was supported by two steel poles.

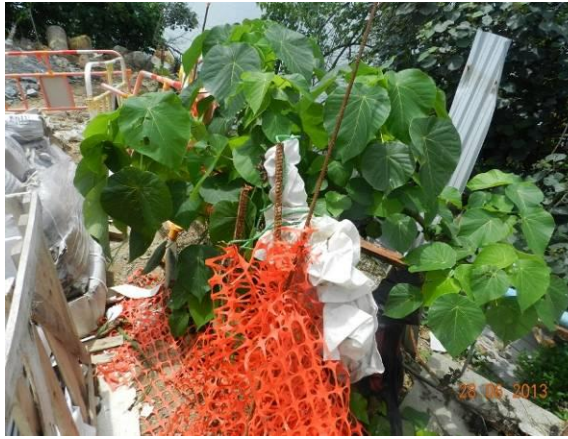
Damaged tree trunk on E55 (*Macaranga tanarius* var. *tomentosa*) was reported in *Monthly EM&A Report for April 2013*. The wound on the trunk of E55 has been burlapped in May 2013. As observed in June 2013, upper section of the tree trunk was found broken (**Photo 15**).

Photo 15 – The upper trunk of E55 was broken.

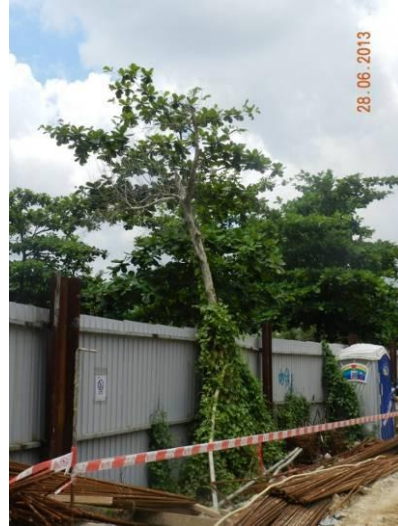
The tree to be transplanted T102 (*Melaleuca cajuputi* subsp. *cumingiana*) has been relocated to the southern part within the Phase 2 construction area of Area B next to the hoarding since November 2012 (**Photo 16**). The tree still appeared in very poor condition with no leaves in the canopy in June 2013. Climbers were observed climbing along the tree trunk.

Photo 16 – Very poor condition of the relocated tree T102 as observed within the Phase 2 works area of Area B.

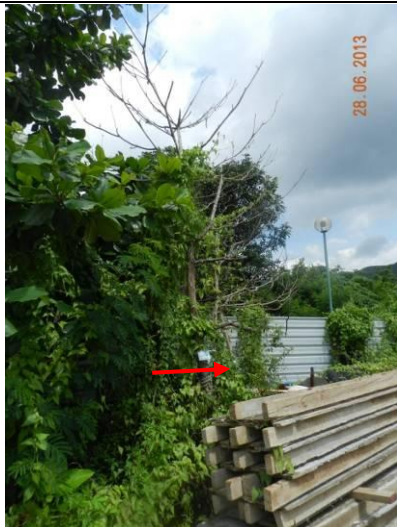
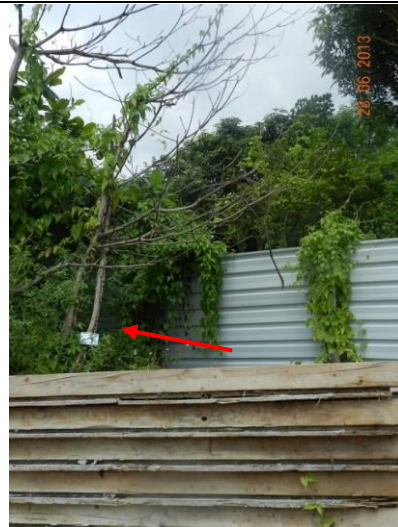
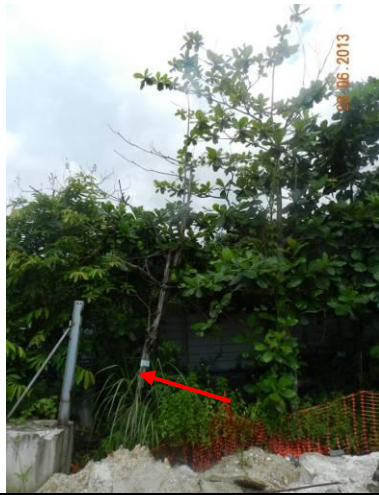
No recovery signs have been observed on the relocated trees U34, U35 and U37 and they are regarded as dead specimens (**Photos 17-19**). Temporary storage of construction materials was still observed close to the tree group of U34, U35, U37 and other trees in Area B (**Photo 20**).

Photo 17 – No recovery sign of the relocated tree U34 in Area B was observed.

Photo 18 – No recovery sign of the relocated tree U35 in Area B was observed.

Photo 19 – No recovery sign of the relocated tree U37 in Area B was observed.

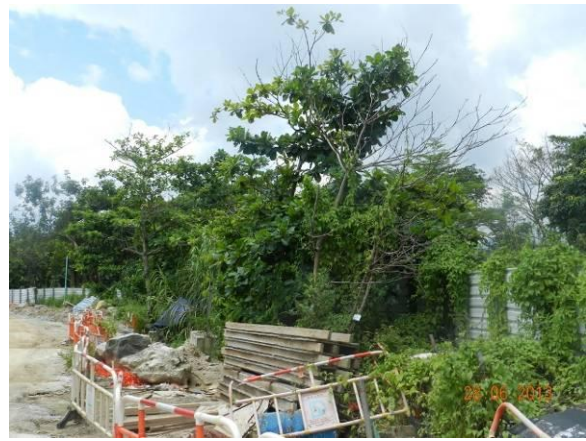
Photo 20 – Temporary storage of construction materials was observed close to the tree group of U34, U35, U37 and other trees in Area B.

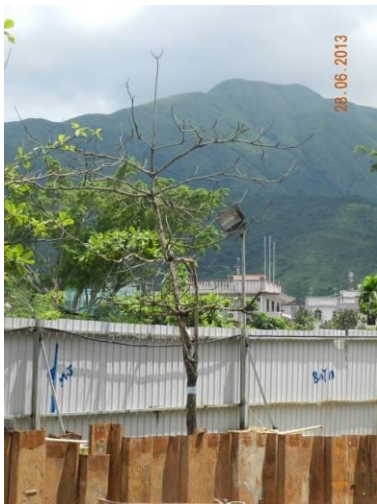
The relocated tree U77 (*Terminalia catappa*) in Phase 2 of Area B was suspected to be dead as no leaves was observed in the canopy (**Photo 21**). U76 and U78 (*Terminalia catappa*) remained in marginally fair condition with regenerated leaves concentrated in the upper canopy and dieback twigs were observed in June 2013 (**Photos 22-23**).

Photo 21 – The relocated tree U77 in Area B was suspected dead as no foliage was found in the canopy.

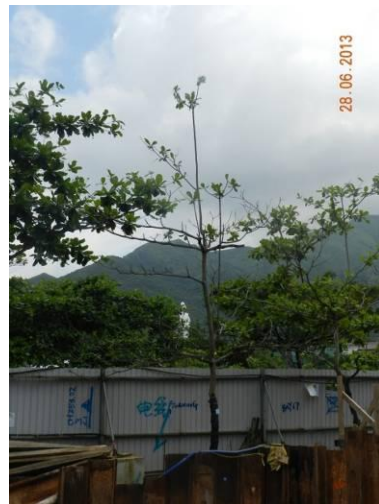
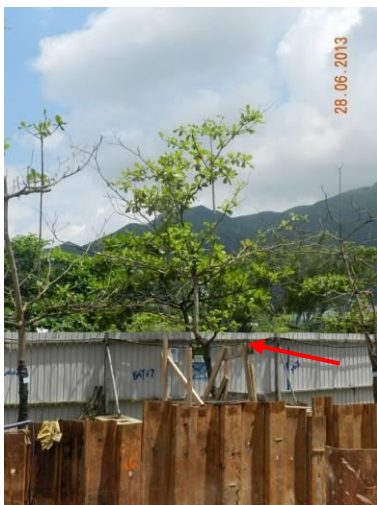
Photo 22 – Overall view of the transplanted tree U76.

Photo 23 – Overall view of the transplanted tree U78.

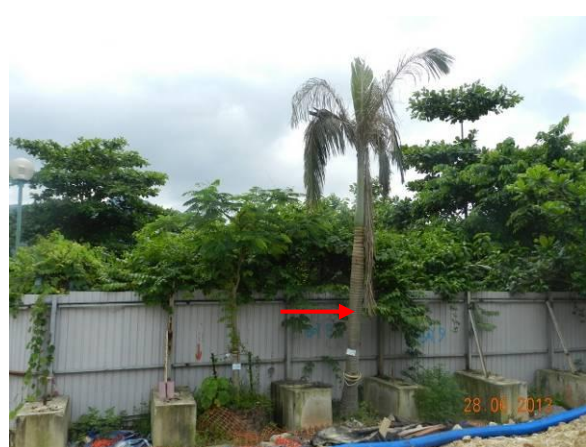
The transplanted tree A36 (*Archontophoenix alexandrae*) was still considered in marginally fair condition with some dry and brown fronds at the bud (**Photo 24**).

Photo 24 – The transplanted tree A36 was still in marginally fair condition in June 2013, with some dry and brown fronds at the bud.

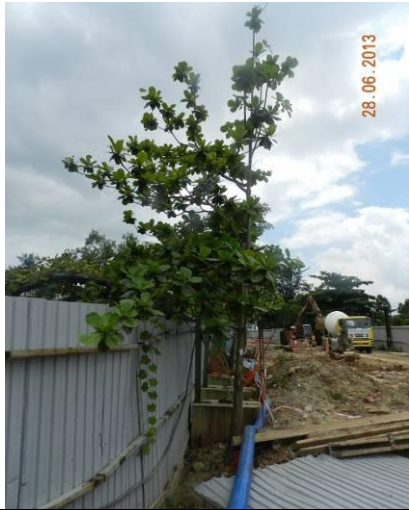
Stockpiling of soil close to the trunk flare of A43 were still observed and removal of surplus soil around the trunk flare was not yet carried out by the Contractor (**Photo 25**).

Photo 25 – Stockpiling of soil close to the trunk flare of A43 was still observed.

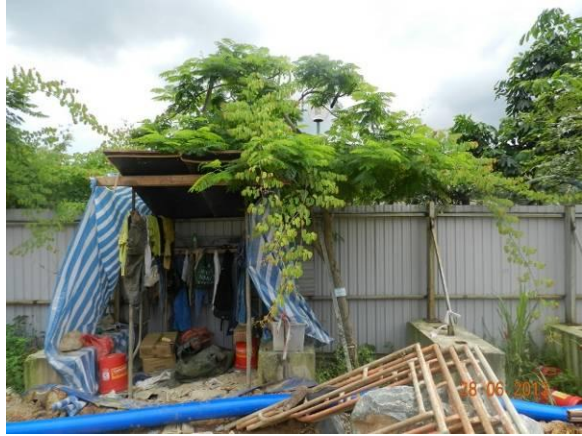
A temporary shelter was still observed next to the relocated tree U74 (*Delonix regia*), in which the shelter was established in April 2013 (**Photo 26**). No significant damage on the tree trunk and canopy caused by the shelter was observed in June 2013.

Photo 26 – A temporary shelter has been established next to the relocated tree U74 (*Delonix regia*).

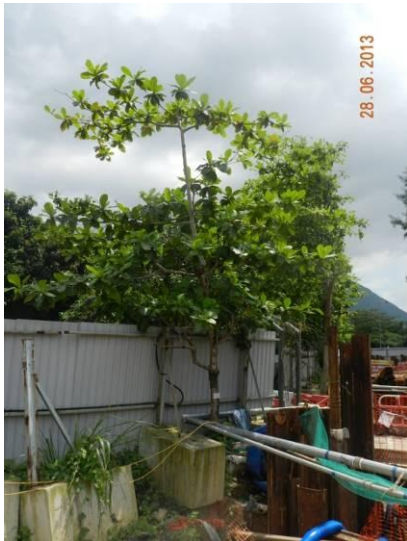
Construction materials were still found around the tree root zone of A42 (*Terminalia catappa*) of which some exposed roots were found due to the absence of the planter (**Photo 27**).

Photo 27 – Construction materials were found around the tree root zone of A42.
