PROJECT NO.: TCS/00553/11

**CONTRACT NO. DC/2010/02 –
DRAINAGE IMPROVEMENT IN SHUEN WAN AND
SHEK WU WAI**

**MONTHLY ENVIRONMENTAL MONITORING AND
AUDIT REPORT (NO.24) – JUNE 2013**

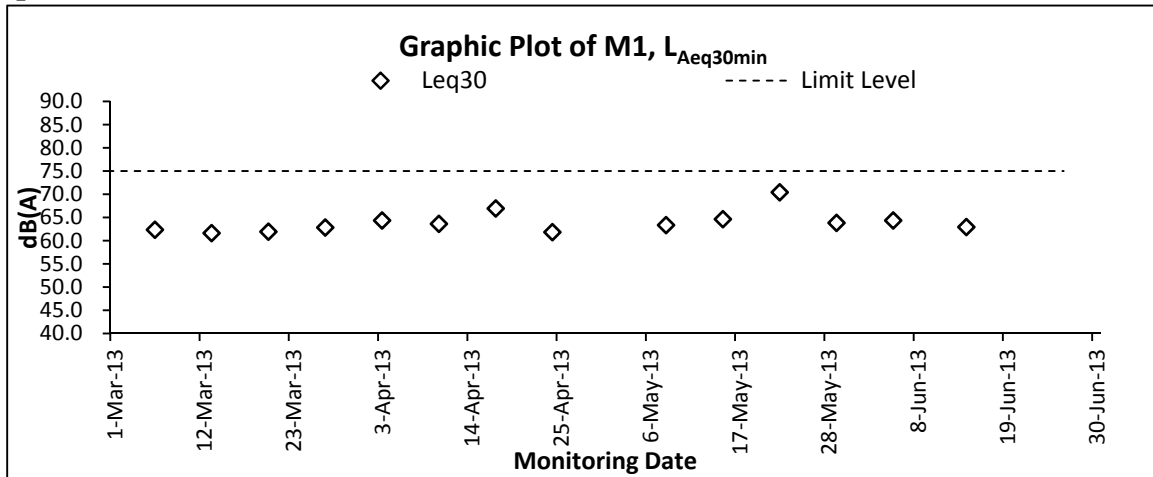
Graphic Plot – Construction Noise

Remark: The monitoring is undertaken under façade situation. No façade correction is added according to acoustical principles and EPD guidelines.

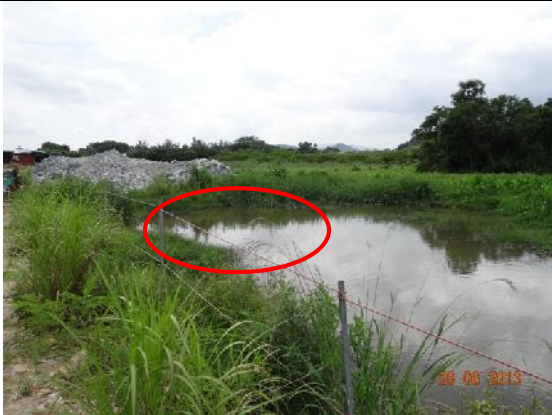
<p>Photo 5 – The wetland rehabilitation area has been demarcated with red strings.</p>	<p>Photo 6 – Loosened red strings were noted on the eastern side of the area.</p>

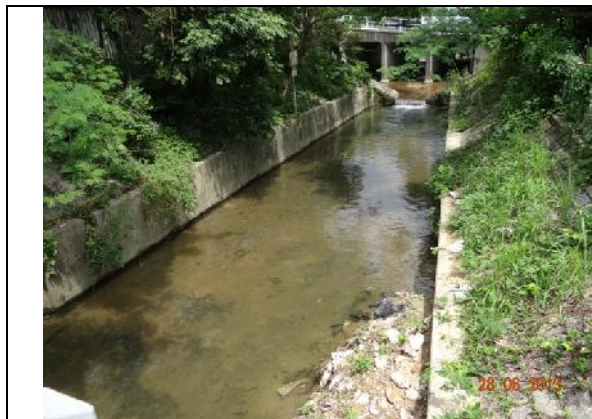
- 3.3.8 Works in Wai Ha River were finished in June 2013. No more sand bag was placed in the river (**Photo 19**). Several sections of granules, which were used for sedimentation of waste water from the construction area in the river, were still observed downstream of Wai Ha River (**Photo 20**).

Photo 19 – Works in Wai Ha River were finished and no more sand bag was placed in the river.

- 3.3.9 Regular monitoring should be conducted to ensure no direct discharge or leakage of contaminants or any polluted fluid into the adjacent Wai Ha River and the nearby Shuen Wan marsh. The Contractor should maintain regular check (e.g. daily) on the sedimentation and filtration facilities and appropriate sedimentation beds and/or tanks throughout the construction phase (e.g. check the function of the sedimentation beds and remove surplus sand and gravels deposited along the beds or within the tanks) to make sure all discharged water was filtered appropriately prior to any discharge. To prevent the impact of the unclear discharge on the nearby vegetated area, it is suggested to overlay PVC liners along the site edge and remove any surplus sand and gravels deposited in the beds and tank.

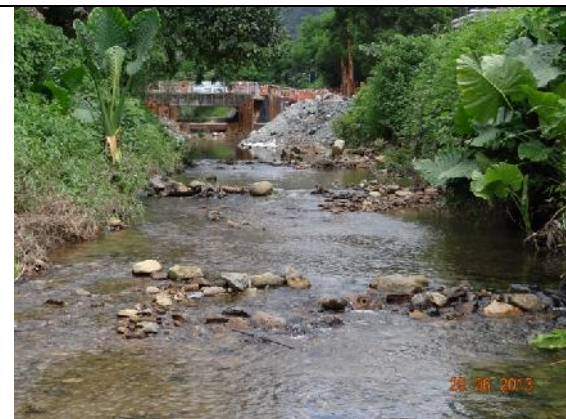
Photo 20 – Sections of granules were still observed downstream of Wai Ha River.

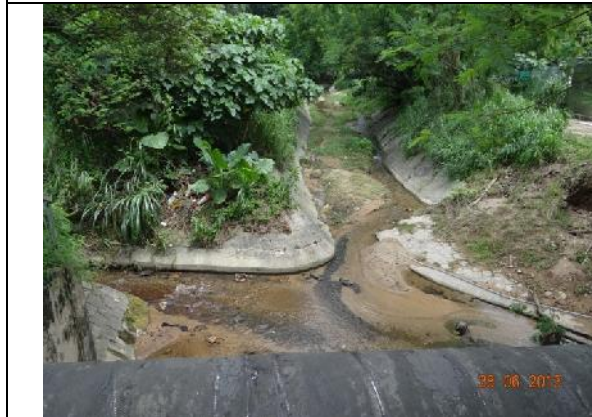
Photo 21 – No discharge of used water was observed at the upper section of Wai Ha River (i.e. to the north of Tung Tsz Shan Road).

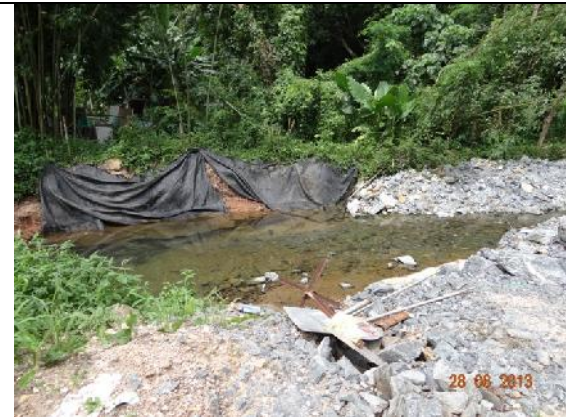
Photo 22 – The collapsed bamboos nearby the tree group (T119-121) were removed from Wai Ha River.

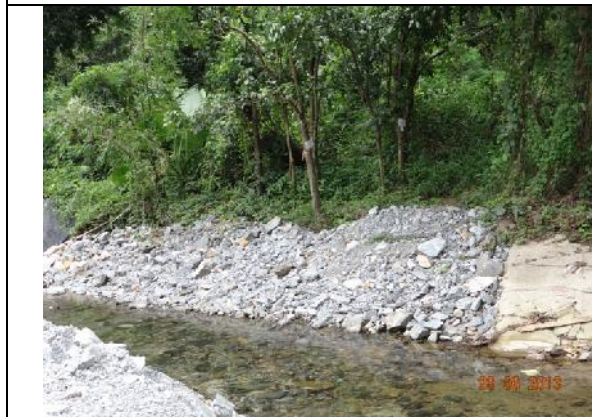
Photo 23 – The section of river bank with loose soil was refilled by stones and cobbles.

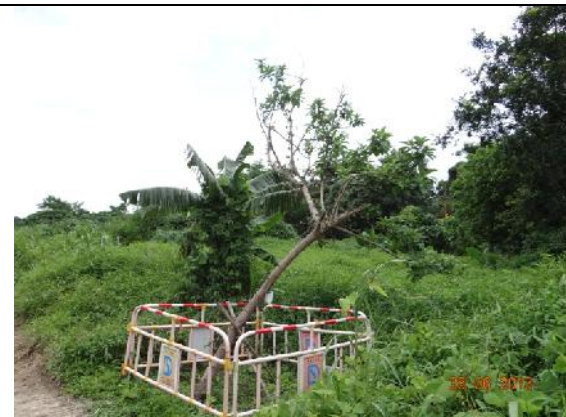
Photo 24 – The leaning tree T190 was still supported by the bamboo props in June 2013.

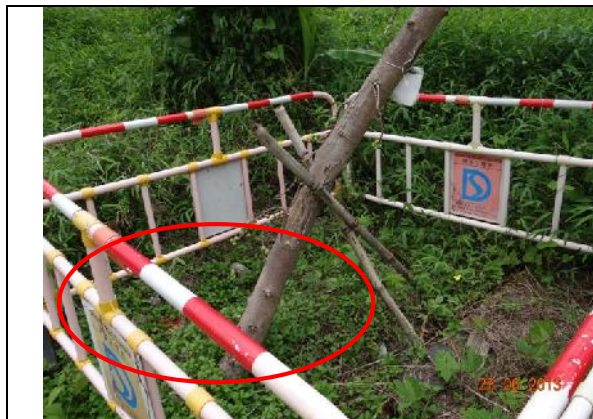
Photo 25 – Overgrown groundcover surrounding the tree root zone of T190 was removed in June 2013.

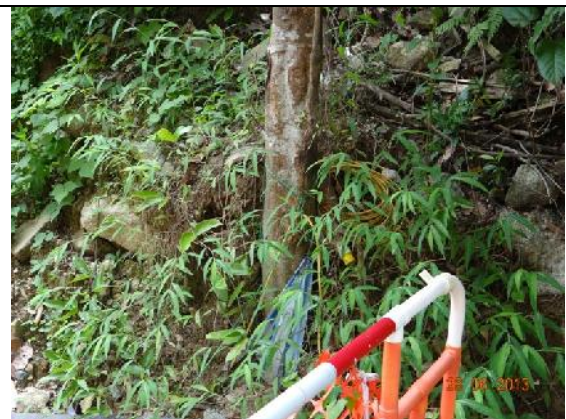
Photo 26 – The refilled soil at the trunk base of the retained tree T103 was loose and sandy, and tapes and ropes were still found tied on the trunk.

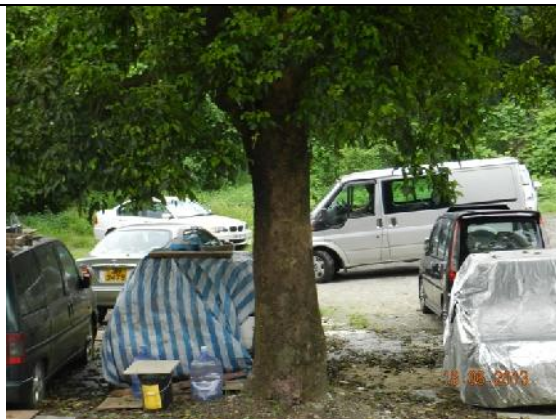
Photo 27 – No more strings and other construction materials was hung on the tree trunk of T074 in June 2013.

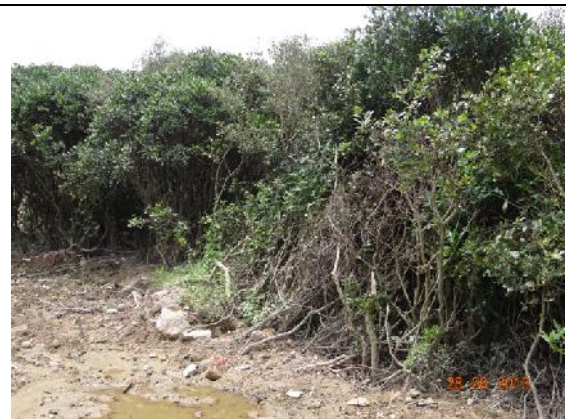
Photo 28 – Some mangrove trees located opposite to San Tau Kok were found to be damaged.

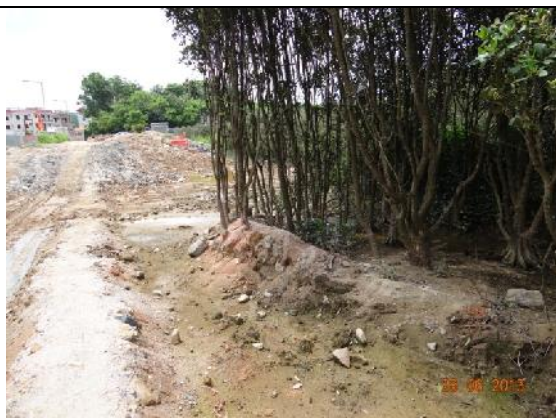
Photo 29 – Some piled soil was noted at the trunk base of the mangroves opposite to San Tau Kok.

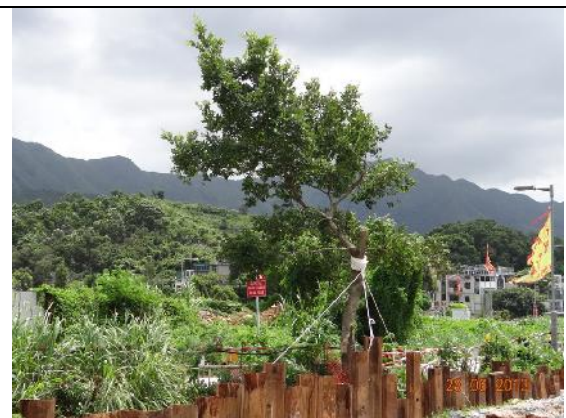
Photo 30 – Pruning wounds and topped tree crown were noted on the retained tree T025, The tree was temporarily guyed by strings so as to provide additional support to the tree.
