Monthly Environmental Monitoring & Auditing report for

Contract No.DC/2009/22

Drainage Improvement in Shuen Wan, Tai Po – Contract 1

July 2013

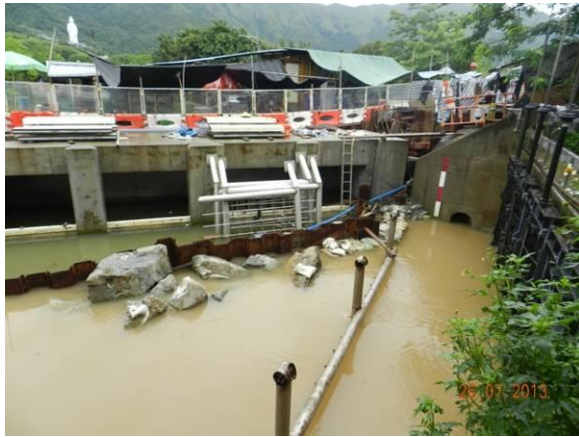
Construction hoardings have been erected in Area A along the entire site boundary. Temporary construction hoardings have been erected around Wai Ha River estuary since the building of an automatic mechanical penstock at the area (**Photo 1**). Some road sections close to the estuary have been surrounded with temporary barriers to the south of Area A along Ting Kok Road for another phase of the construction work since February 2013 (**Photo 2**). The works have been continued in July 2013. As observed in July 2013, temporary barriers were still erected as the site hoarding at the western side of Area A for building the pumping station (**Photo 3**). Since January 2013, the site hoardings along the

Photo 1 – Temporary hoardings have been established to surround the works area at Wai Ha River estuary.

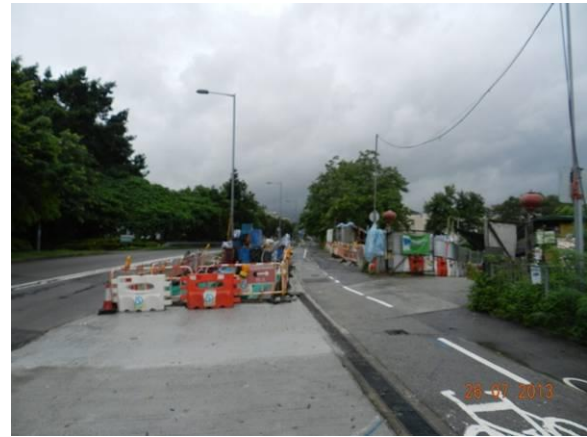
Photo 2 – Temporary barriers established along a section of Ting Kok Road to the south of Area A.

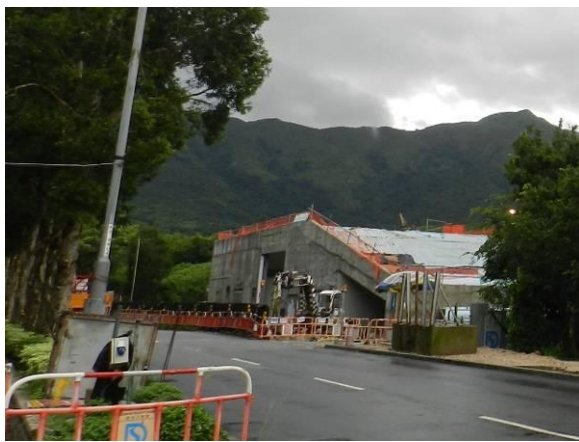
Photo 3 – The site hoardings on the west of Area A had been replaced by temporary construction barriers.

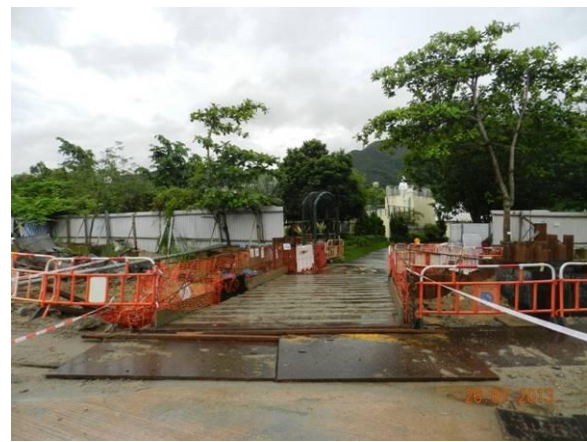
The temporary hoardings have been erected from northwest to southwest parts of Tung Tsz Nursery in Area B since April 2011. Phase 2 construction works have continued and temporary hoardings have been erected since May 2012. The major road access within the Nursery has been maintained to minimize the impact on the nursery's daily operation resulting from the construction works. A section of the temporary hoardings at the eastern end of Phase 1 and western end of Phase 2 works area have been replaced by temporary construction barriers since April 2013 **(Photo 4)**.

Photo 4 – The temporary hoardings at the eastern end of Phase 1 and the western end of Phase 2 works area were replaced by temporary construction barriers.

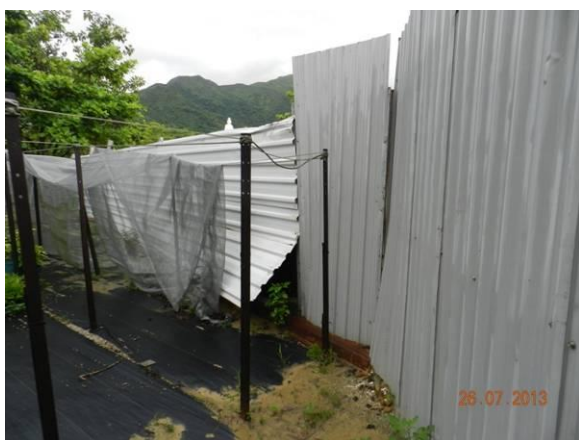
The damaged hoarding close to the retained tree U50 (*Ficus elastica*) at the southwestern part of Phase 1 has not yet fixed in July 2013. No other follow-up action by the Contractor is required as from the *Monthly EM&A Report for June 2013*.

Photo 5 – No repair was observed on the broken section of site hoarding close to the retained tree U50 (*Ficus elastica*) at the southwestern part of Phase 1.

The Contractor is suggested to repair the broken site hoarding in Phase 1 construction works in Tung Tsz Nursery.

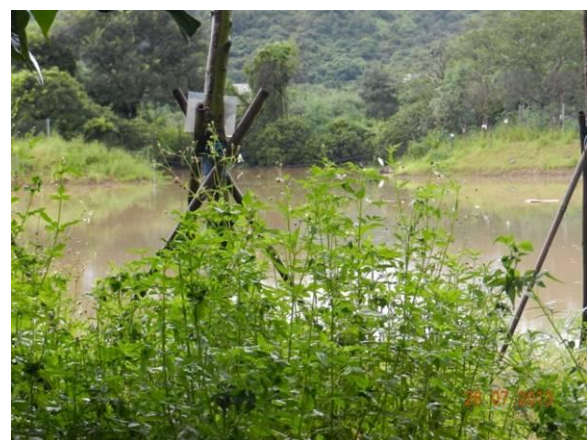
water into the adjacent Wai Ha River was observed through the fence of Tung Tsz Nursery **(Photo 6)**.

Photo 6 – No discharge of muddy water was observed in Area C.

The Contractor should regularly check the condition and locations of the drainage pipes and ensure that all used water should be appropriately filtered and discharged to the manholes/other discharge points agreed by the Engineer and EPD. This is to avoid any potential contamination to the vegetation in Shuen Wan marsh and other vegetated/marinated areas adjacent to the active works area.

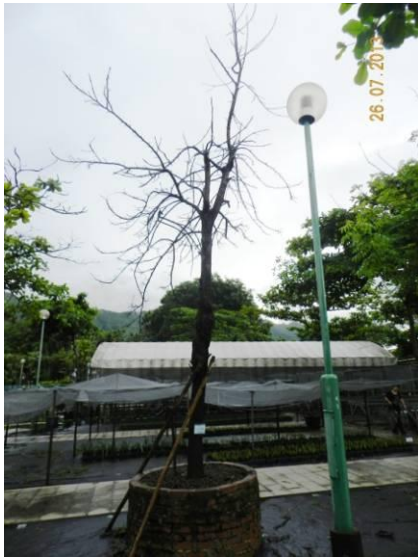
Regular monitoring for all transplanted trees within the nursery was conducted on a bi-weekly basis. For tree U58 (*Grevillea robusta*) (**Photo 7**), its health condition has no sign of improvement. The tree was so poor that even the watersprouts along the trunk appeared dry and wilt. Only dead branches were found in the canopy (**Photo 8**) and a few broken twigs and dry tree bark were found fallen onto the ground (**Photo 9**). Therefore, U58 is considered having very poor health and structural condition. Given one of the bamboo prop for supporting the tree was broken and a significant wound has observed on the middle tree trunk, there is a potential risk of whole tree failure, with its falling zone covering the assess path used by any visitors/ nursery workers in the Nursery.

As highlighted in the Section “Liaison with Nursery”, physiological condition of the transplanted tree U58 (*Grevillea robusta*) has deteriorated significantly since June 2013. The tree was so poor that even the watersprouts along the trunk appeared dry and wilt and only dead branches remained in the canopy (**Photos 7-9**). A bamboo prop for supporting U58 was broken.

Photo 7 – Overall view of the transplanted tree U58.

Close monitoring on the stability of *Grevillea robusta* (U58) has been continued as the major management to this tree. The Contractor is suggested to replace the broken bamboo prop with a new one, as well as informing the Nursery Operator to restrict any access within the tree-falling zone of U58 before any follow-up action to the tree. The landscape

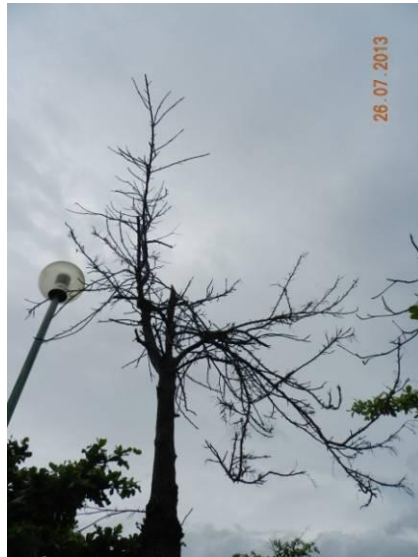
Photo 8 – Only dead branches were found in the canopy of U58.

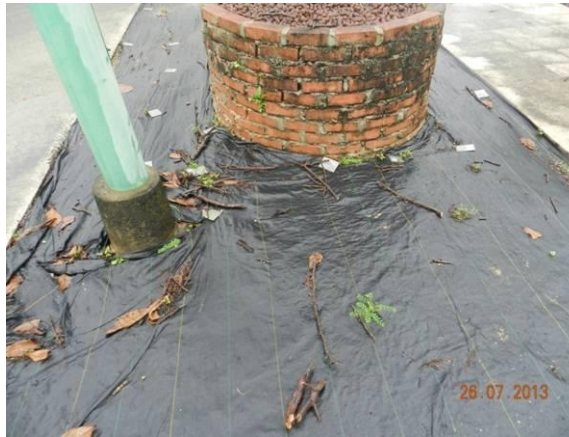
Photo 9 – Fallen twigs and dry tree bark of U58 were found on the ground.

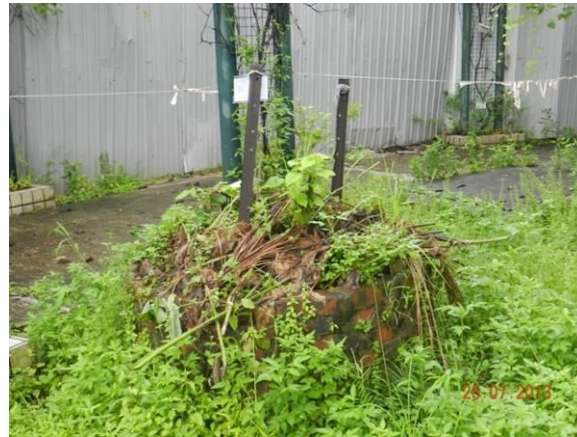
As reported in the previous *Monthly EM&A Reports*, the retained tree U68 (*Gmelina arborea*) was found fallen after the severe typhoon in July 2012, with its leaning trunk being pruned and removed in August 2012 (as reported in *Monthly EM&A Report for August 2012*). Watersprouts redeveloped in June 2013 were partially removed in July 2013 (**Photo 10**).

Photo 10 – Watersprouts regenerated from the remained stump of U68 were partially removed again.

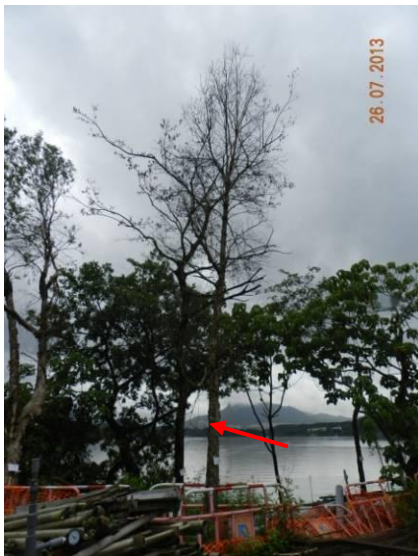
Since October 2012, E18 (*Melaleuca cajuputi* subsp. *cumingiana*) originally located within the TPZs nearby the main gate have been relocated within Area A due to its direct conflict with the works. The tree was still found in poor condition with dry and wilt leaves in July 2013 due to transplantation shock and poor transplanting skills (**Photo 11**).

Photo 11 – Overall view of the relocated tree E18.

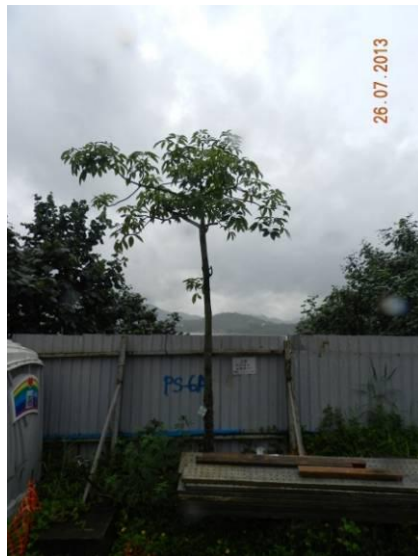
The tree to be transplanted E16 (*Bombax ceiba*) has been relocated to the southern side of Area A next to the site hoarding since July 2012. The tree was in fair condition in July 2013 (**Photo 12**).

Photo 12 – Fair health condition of the relocated tree E16.

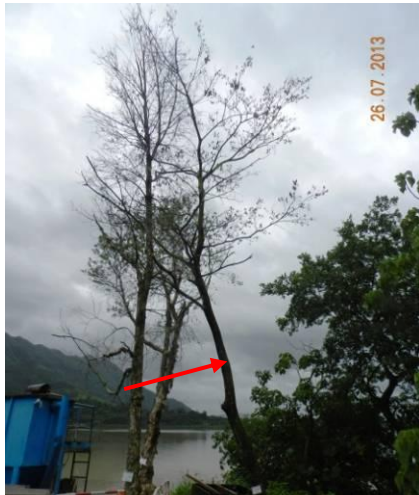
E97 (*Celtis sinensis*) has been relocated at the northeastern part of Area A since December 2012. Its canopy regenerated with small and green leaves in early wet season, but it showed significant decline in health condition with wilted foliage in July 2013 (**Photo 13**).

Photo 13 – Poor health condition of the relocated tree E97.

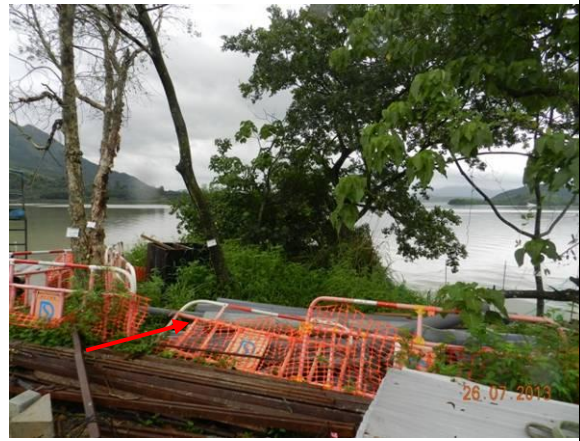
Photo 14 – Temporary storage of construction materials close to the trunk base of E97.

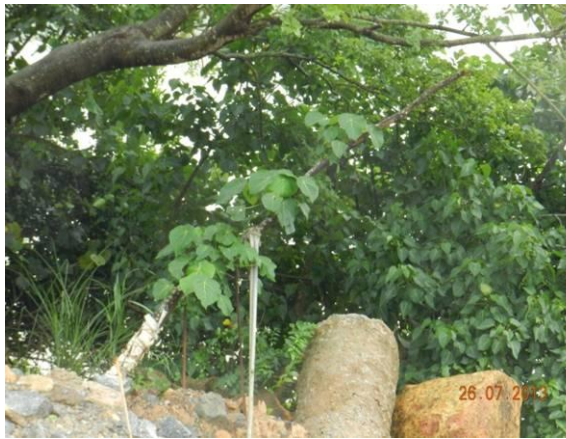
E61 (*Macaranga tanarius* var. *tomentosa*) has been burlapped on the wound at the trunk flare and its leaning trunk has been supported by two steel poles since May 2013. The tree still appeared to have poor health condition with only few leaves regenerated on the tree trunk (**Photo 15**).

Photo 15 – The wound at the trunk flare of E61 was burlapped and the leaning tree trunk was supported by two steel poles.

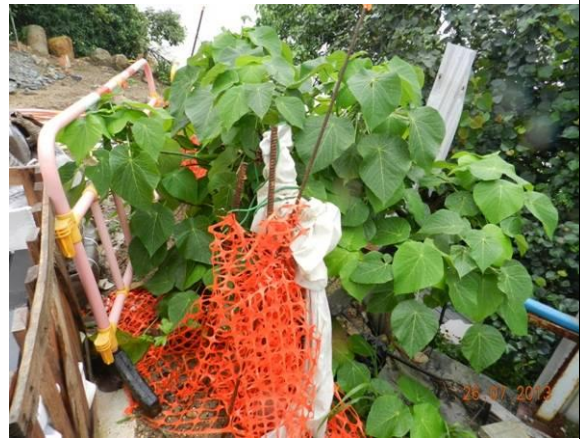
Damaged tree trunk on E55 (*Macaranga tanarius* var. *tomentosa*) was reported in *Monthly EM&A Report for April 2013*. The wound on the trunk of E55 has been burlapped since May 2013. The upper section of the tree trunk was found broken in June 2013. The tree was still in poor condition with most of its foliage as watersprouts only (**Photo 16**).

Photo 16 – E55 with burlapped broken trunk was still in poor condition.

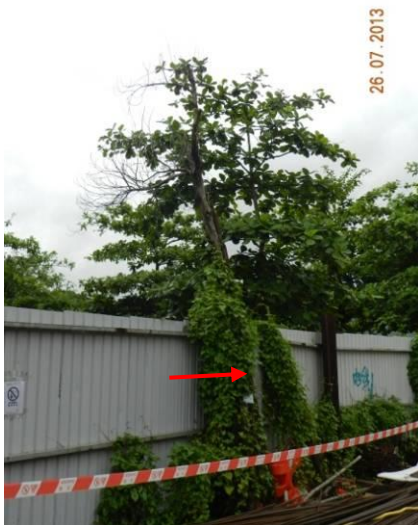
The tree to be transplanted T102 (*Melaleuca cajuputi* subsp. *cumingiana*) has been relocated to the southern part within the Phase 2 construction area of Area B next to the hoarding since November 2012 (**Photo 17**). The tree still appeared in very poor condition with no leaves in the canopy in July 2013. Excessive climbers were still observed climbing along the tree trunk.

Photo 17 – Very poor condition of the relocated tree T102 as observed within the Phase 2 works area of Area B.

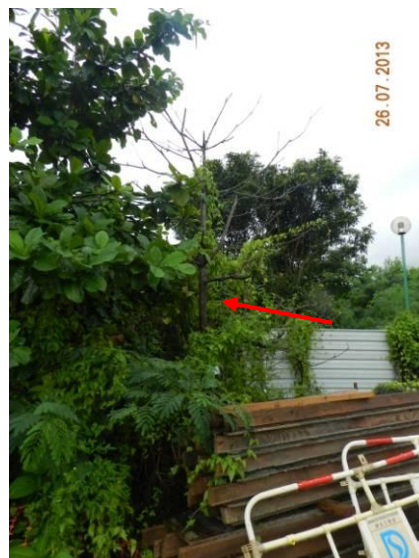
Photo 18 – No recovery sign of the relocated tree U34 in Area B was observed.

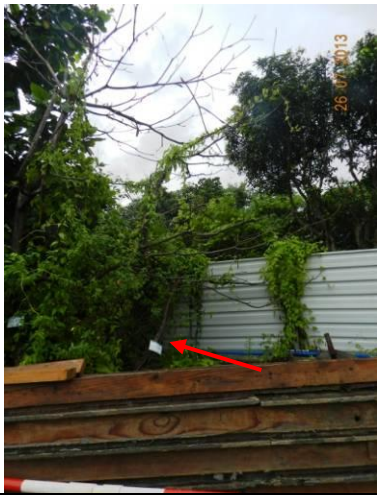
Photo 19 – No recovery sign of the relocated tree U35 in Area B was observed.

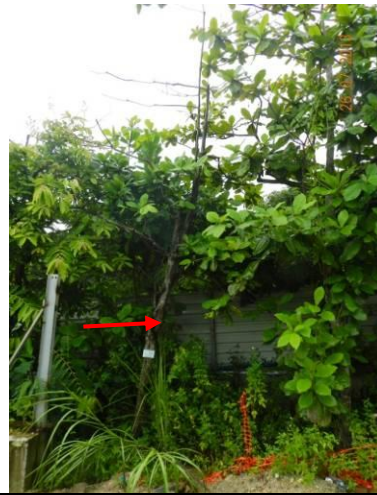
Photo 20 – No recovery sign of the relocated tree U37 in Area B was observed.

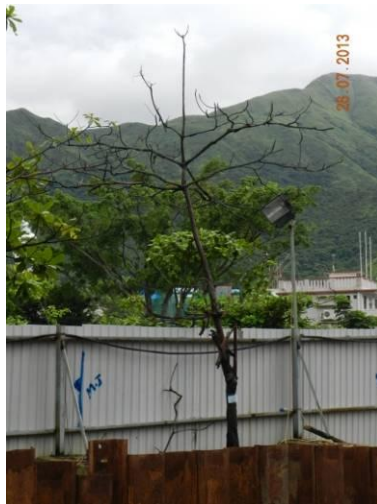
Photo 21 – The relocated tree U77 in Area B was suspected dead as no foliage was found in the canopy.

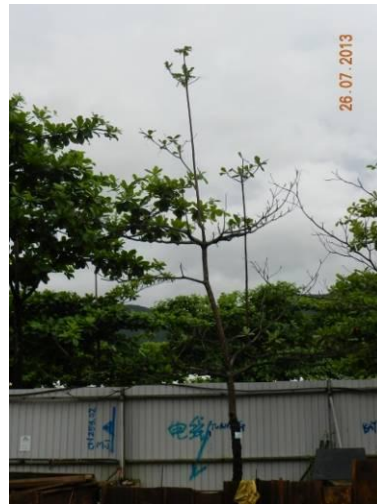
Photo 22 – Overall view of the transplanted tree U76. Only a few new leaves generated on the branches.

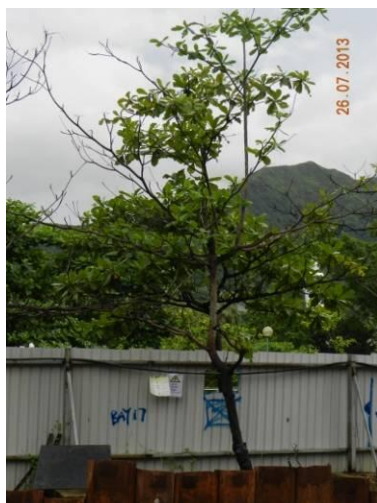
Photo 23 – Overall view of the transplanted tree U78. Only a few new leaves generated on the branches.

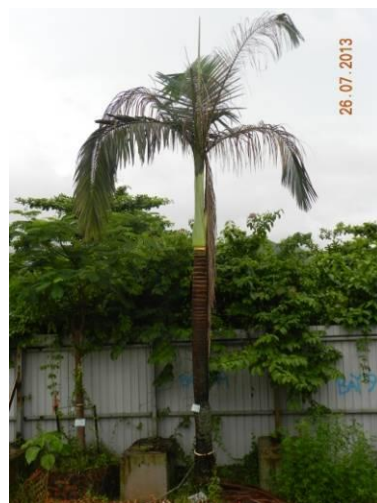
Photo 24 – The transplanted tree A36 was still in marginally fair condition with some dry and brown fronds at the bud.

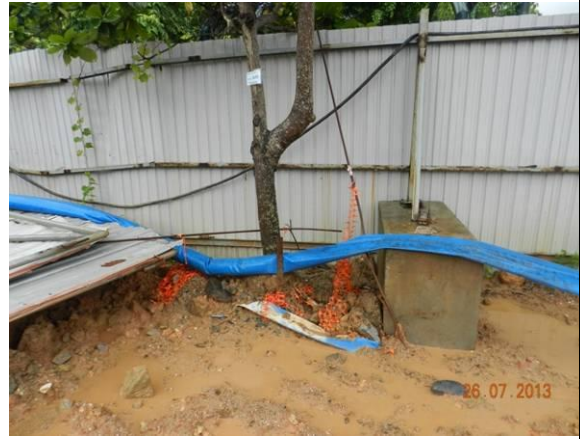
Photo 26 – Temporary stored construction materials were removed but soil piling was still observed close to the trunk flare of A43.

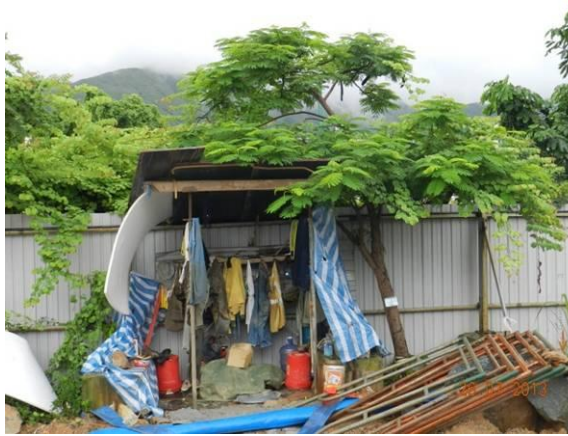
Photo 27 – A temporary shelter has been established next to the relocated tree U74.

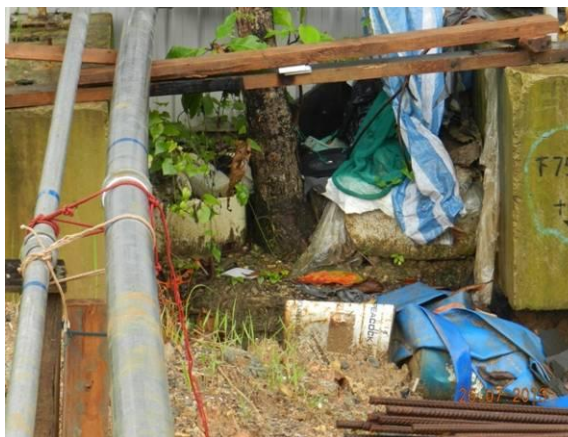
Photo 29 – Construction materials were found around the tree root zone of A42.

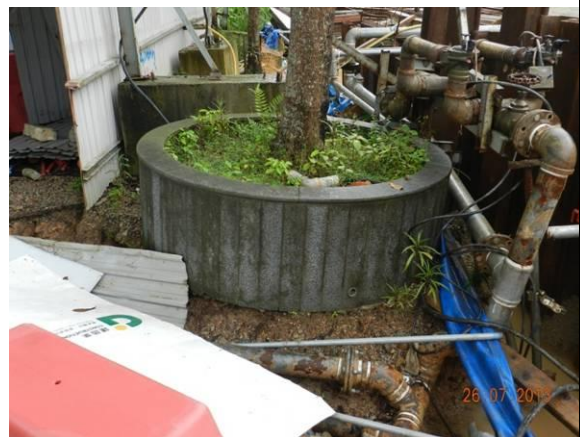
Photo 30 – Soil excavation works was observed around the planter of a retained tree A40 (*Terminalia catappa*) at the entrance of Phase 2 construction areas.

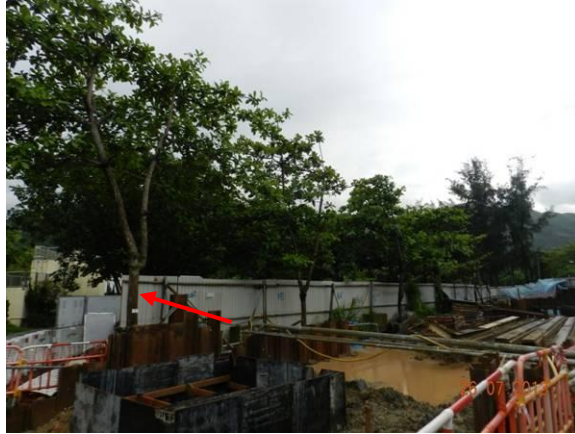
Photo 31 – The southern side of the tree planter of A40 has already been excavated for building the box culvert.

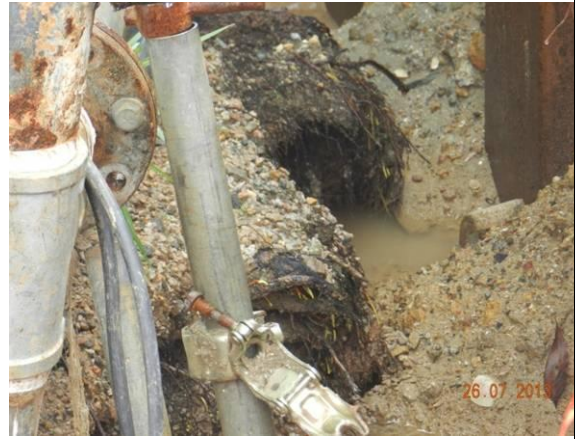
Photo 32 – Some of the tree roots growing underneath the tree planter of A40 could be damaged by the works.

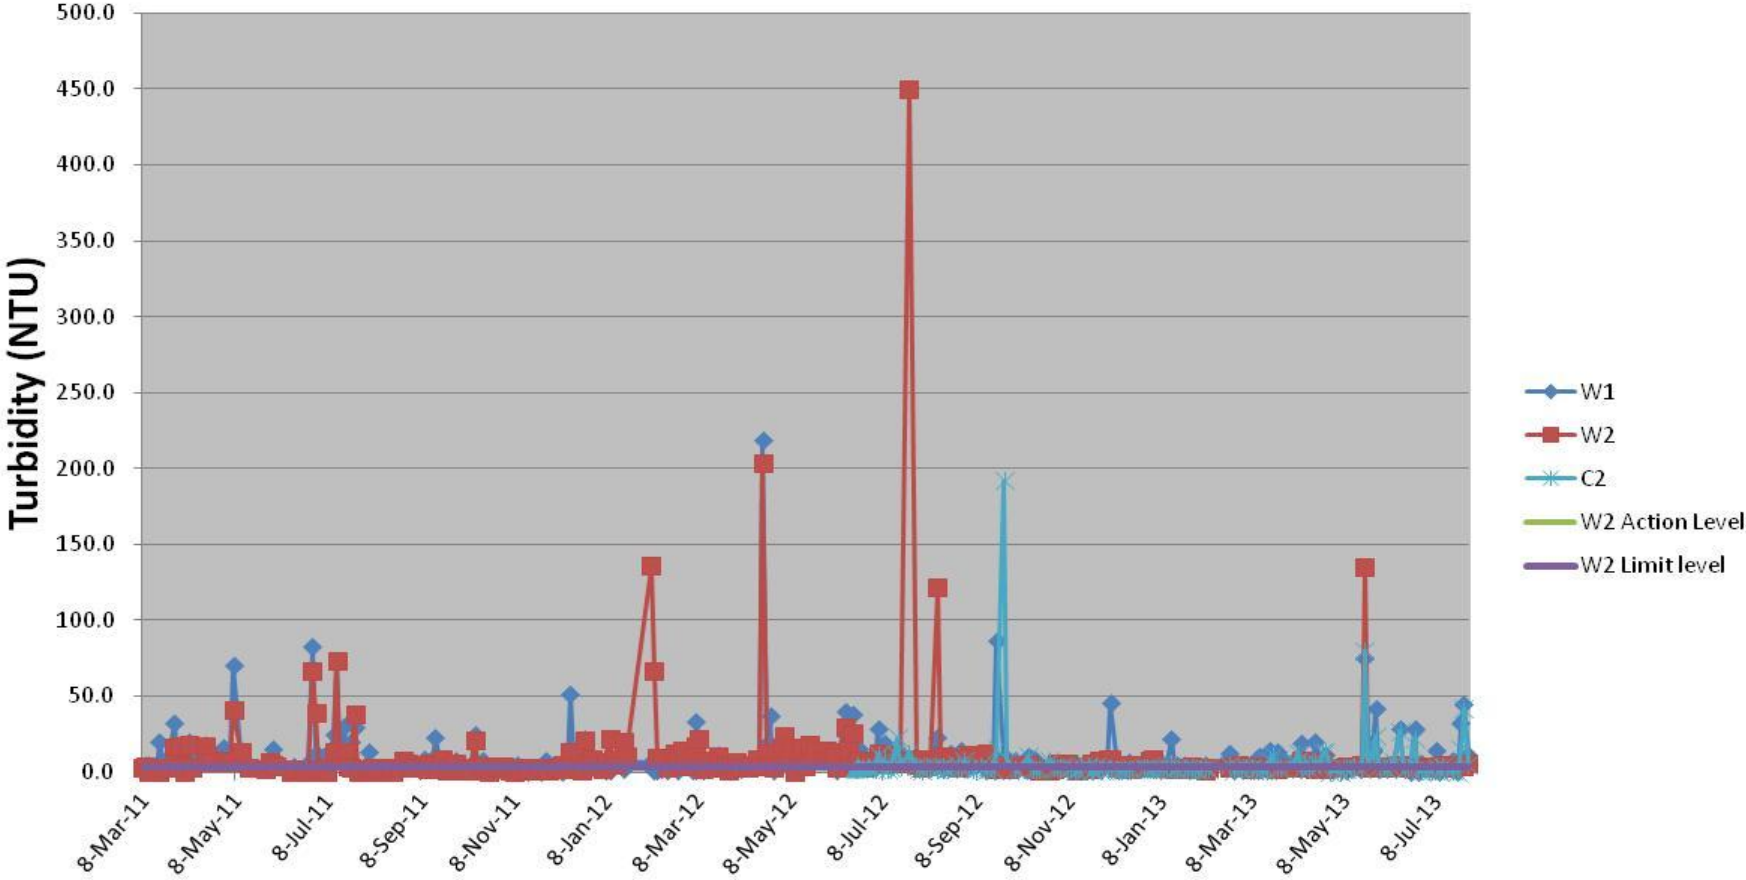
Graphical plots of Turbidity (ebb tide) for W1&W2

Remarks: Action limit is 95% of baseline data or 120% of up stream control station's Turbidity
 Limit level is 99% of baseline data or 130% of upstream control station's Turb

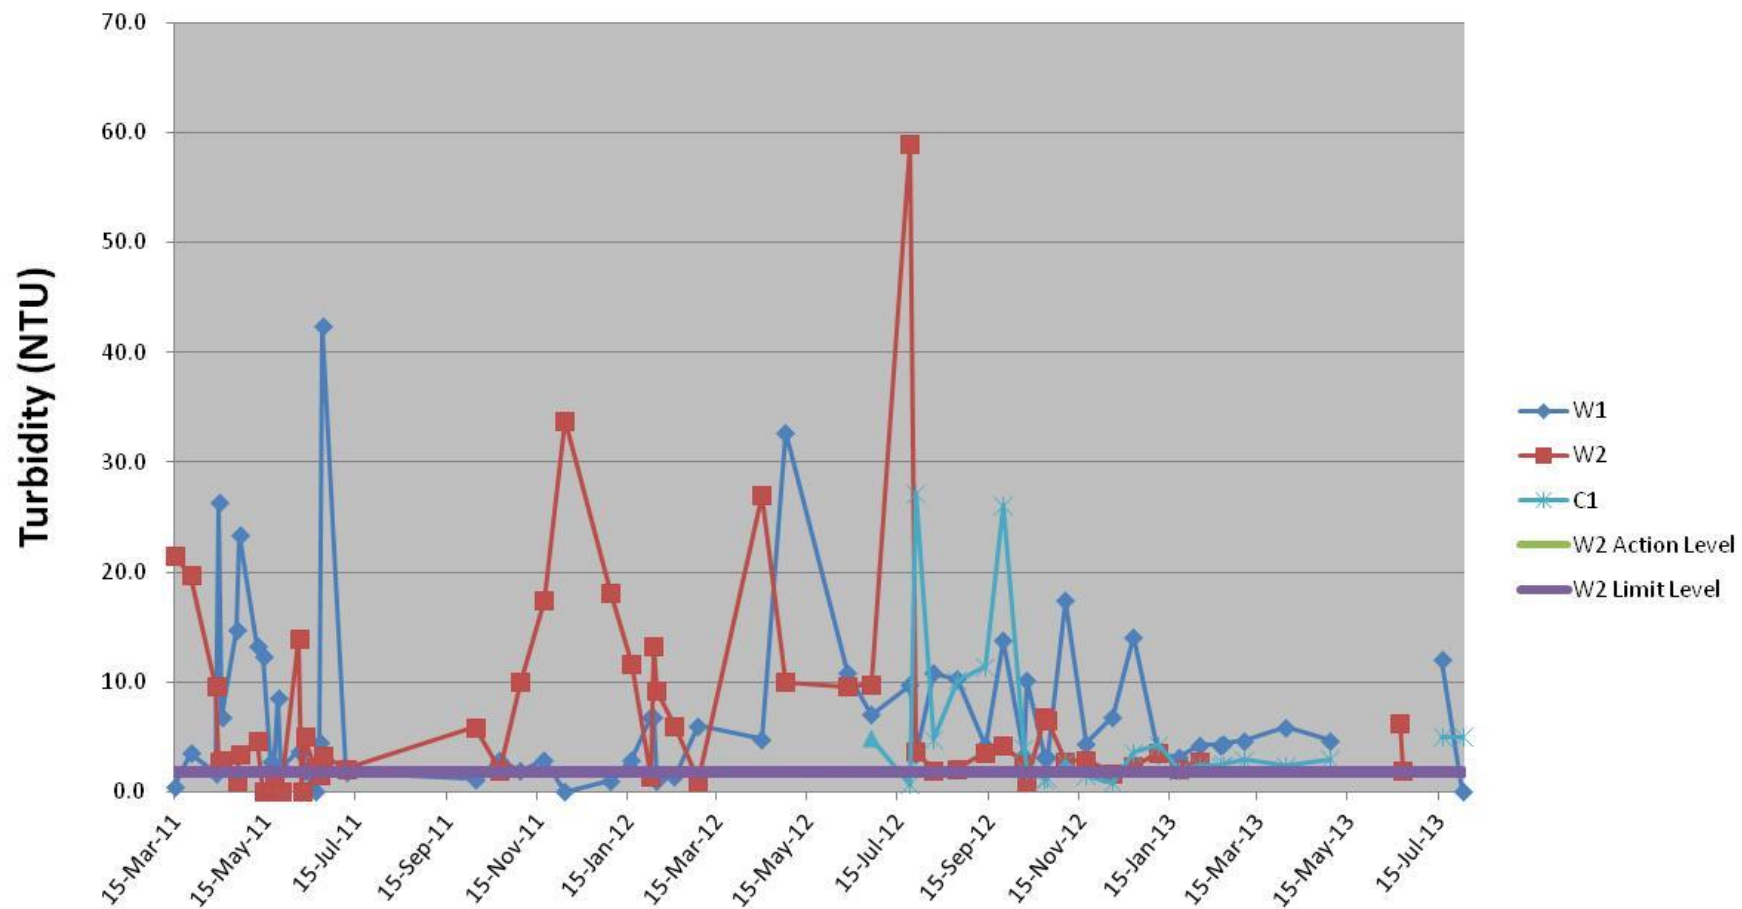
Graphical plots of Turbidity (flood tide) for W1&W2

Remarks: Action limit is 95% of baseline data or 120% of up stream control station's Turbidity
 Limit level is 99% of baseline data or 130% of up stream control station's Turb

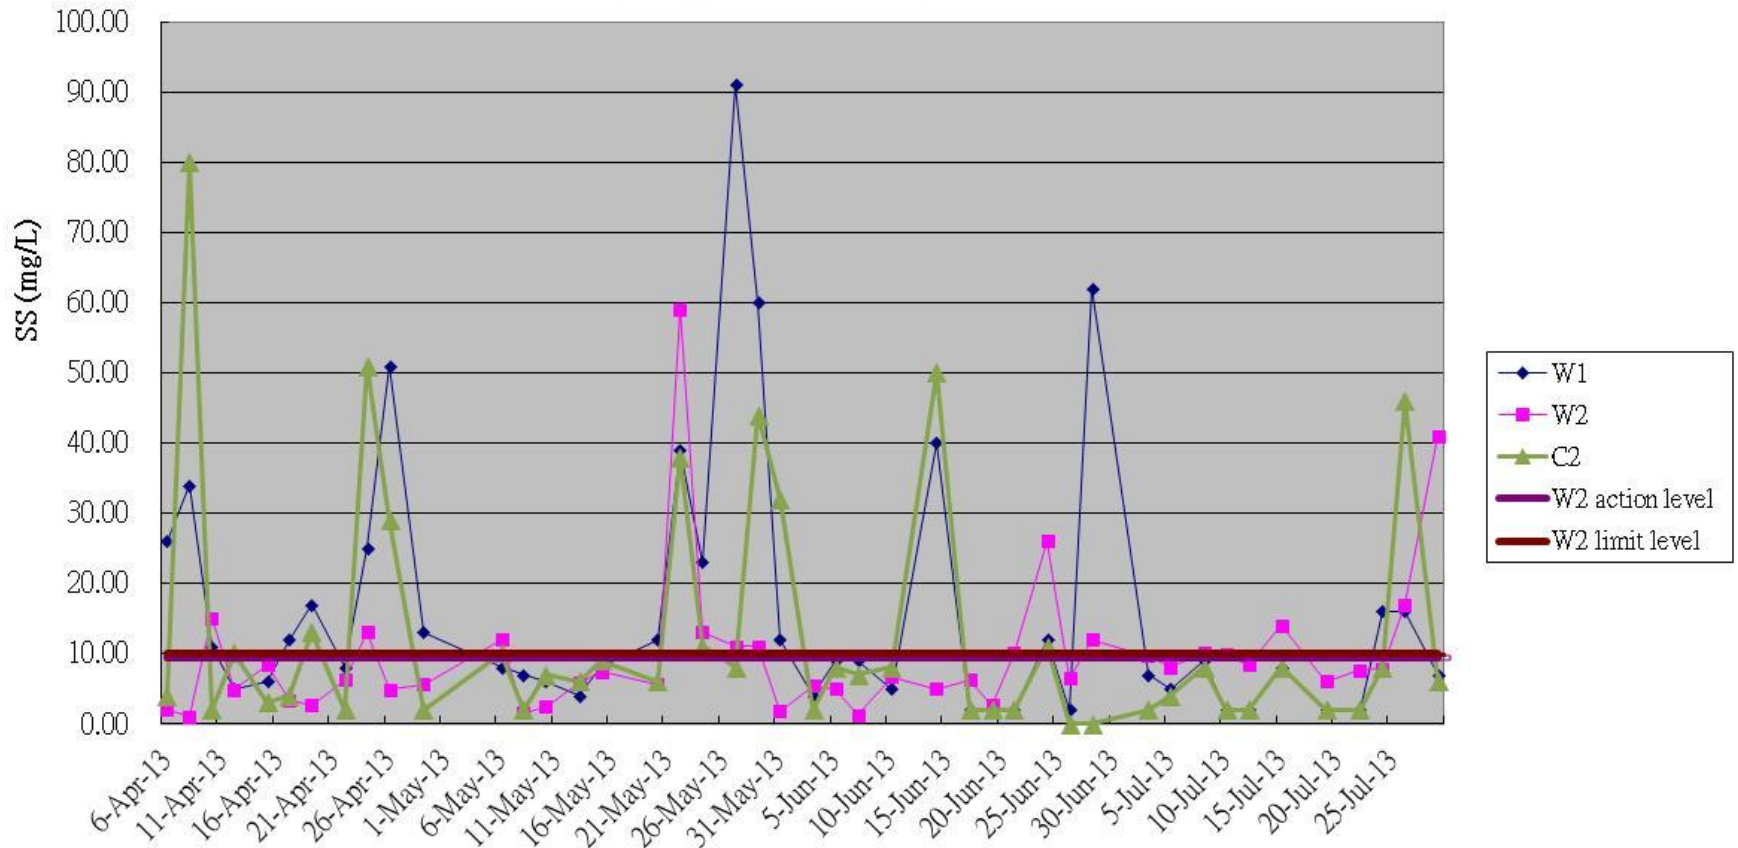
Graphical plots of SS (ebb tide) for W1&W2

Remarks: Action limit is 95% of baseline data or 120% of upsteam control station's SS
 Limit level is 99% of baseline data or 130% of upsteam control station's SS

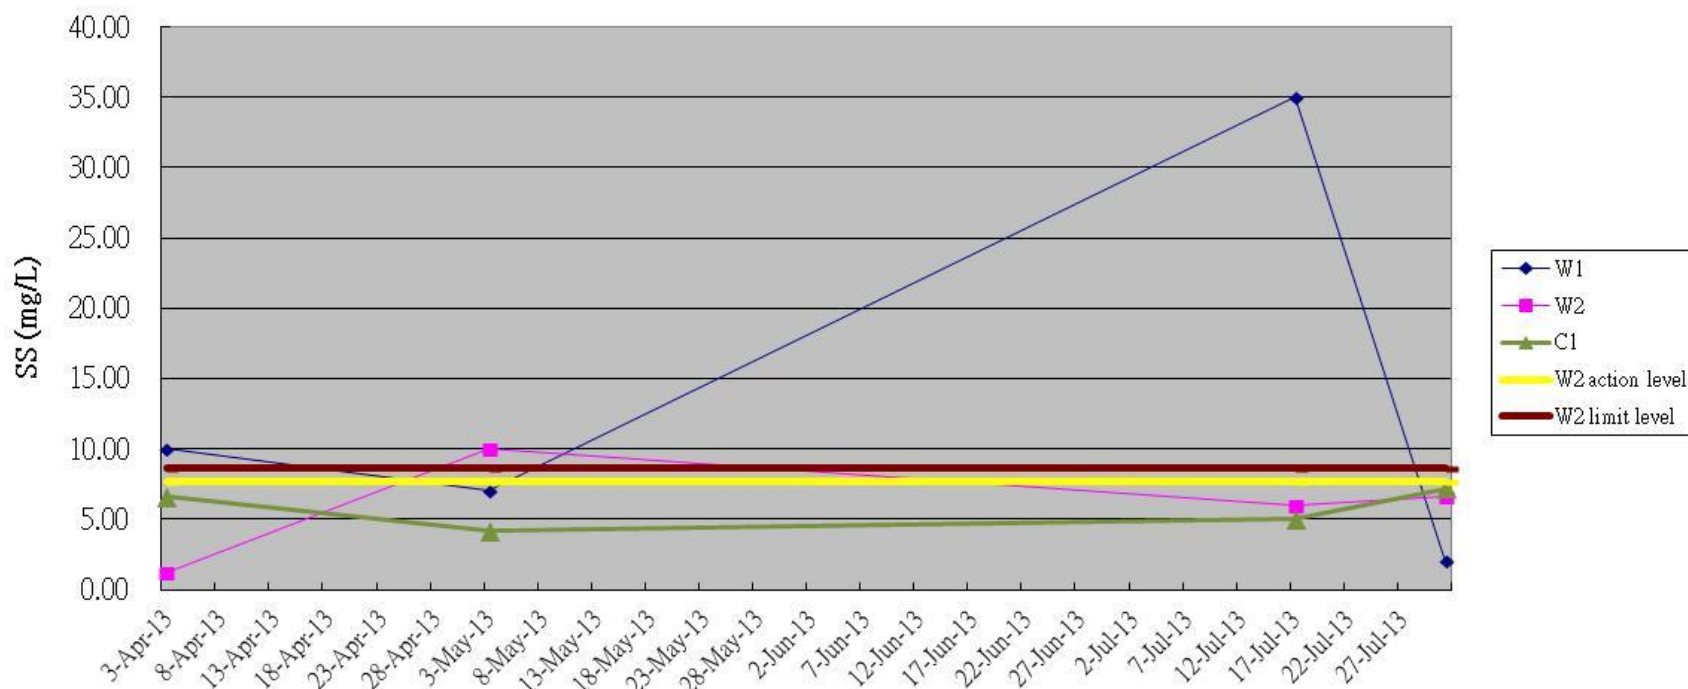
Graphical plots of SS (flood tide) for W1&W2

Remarks: Action limit is 95% of baseline data or 120% of upstream control station's SS
 Limit level is 99% of baseline data or 130% of upstream control station's SS

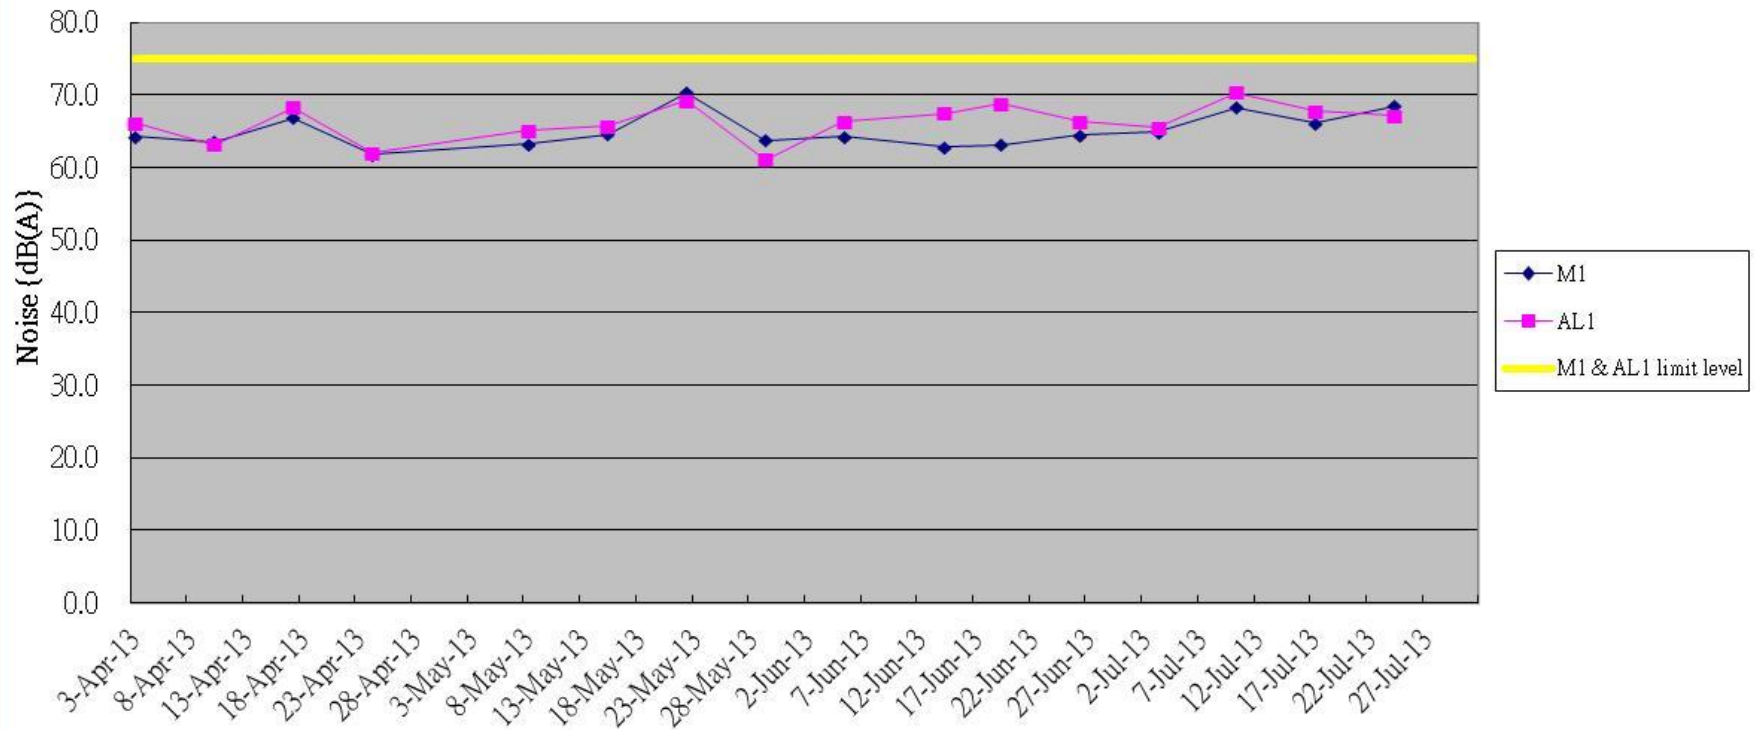
Graphical plots of Noise for M1 & AL1

Remarks: Action limit is when one documented complaint is received

Relevant details of the noise monitoring results are presented in Table 3.4.1. The results of M1 ranged between 64.9dB (A) and 68.5dB (A), and AL1 ranged between 65.5dB (A) and 70.4dB (A), were within the limit levels and therefore, no exceedance was found.

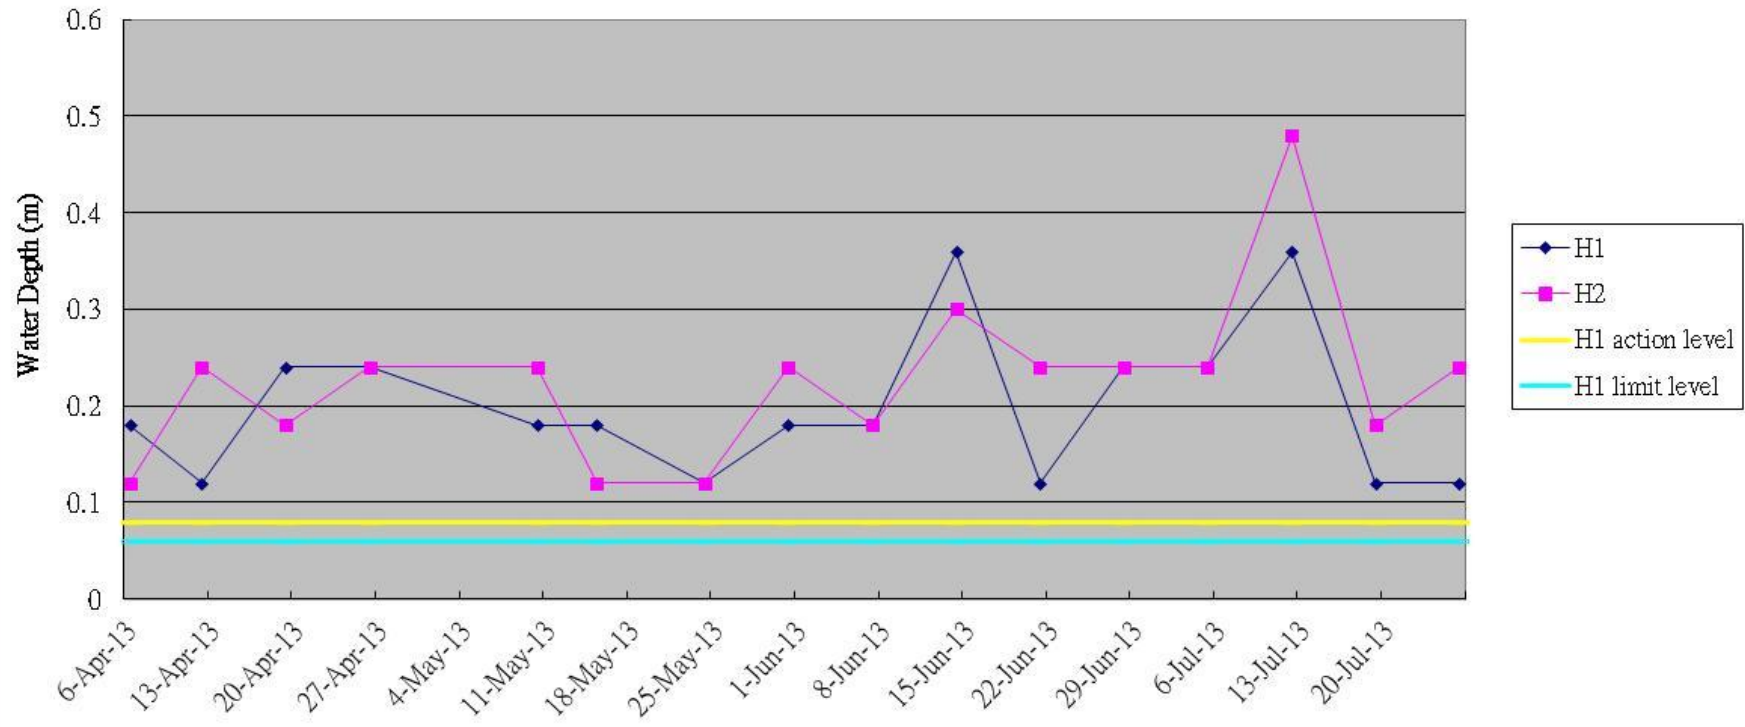
Graphical plots of Hydrological Monitoring(water depth at ebb tide) for H1 & H2

Remarks: Action level: 80% of baseline water depth.
Limit level: 60% of baseline water depth.

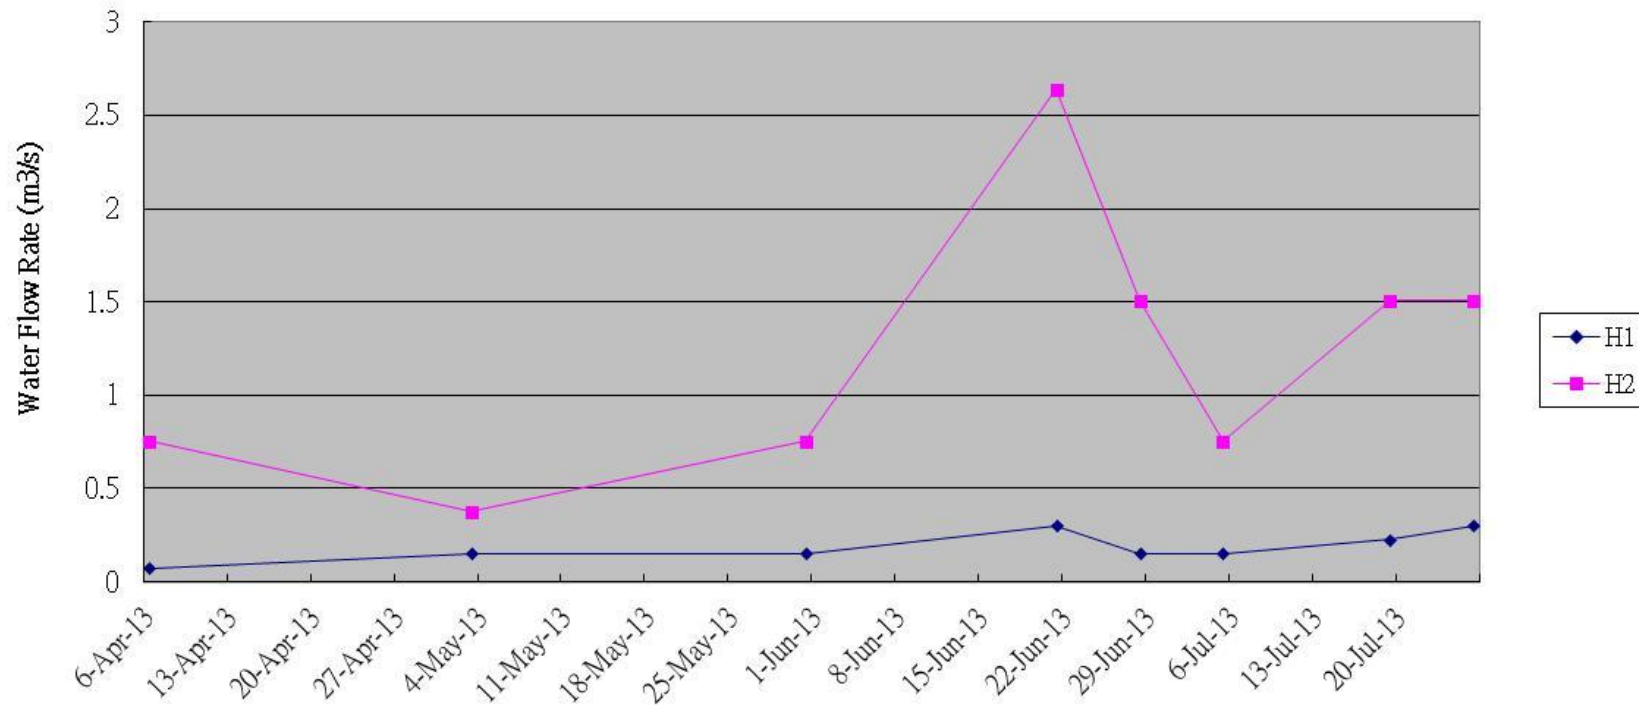
Graphical plots of Hydrological Monitoring(water flow rate at flood tide) for H1 & H2

Remarks: Action level: 120% of control station's water flow rate on the same day of measurement.
Limit level: 140% of control station's water flow rate on the same day of measurement.

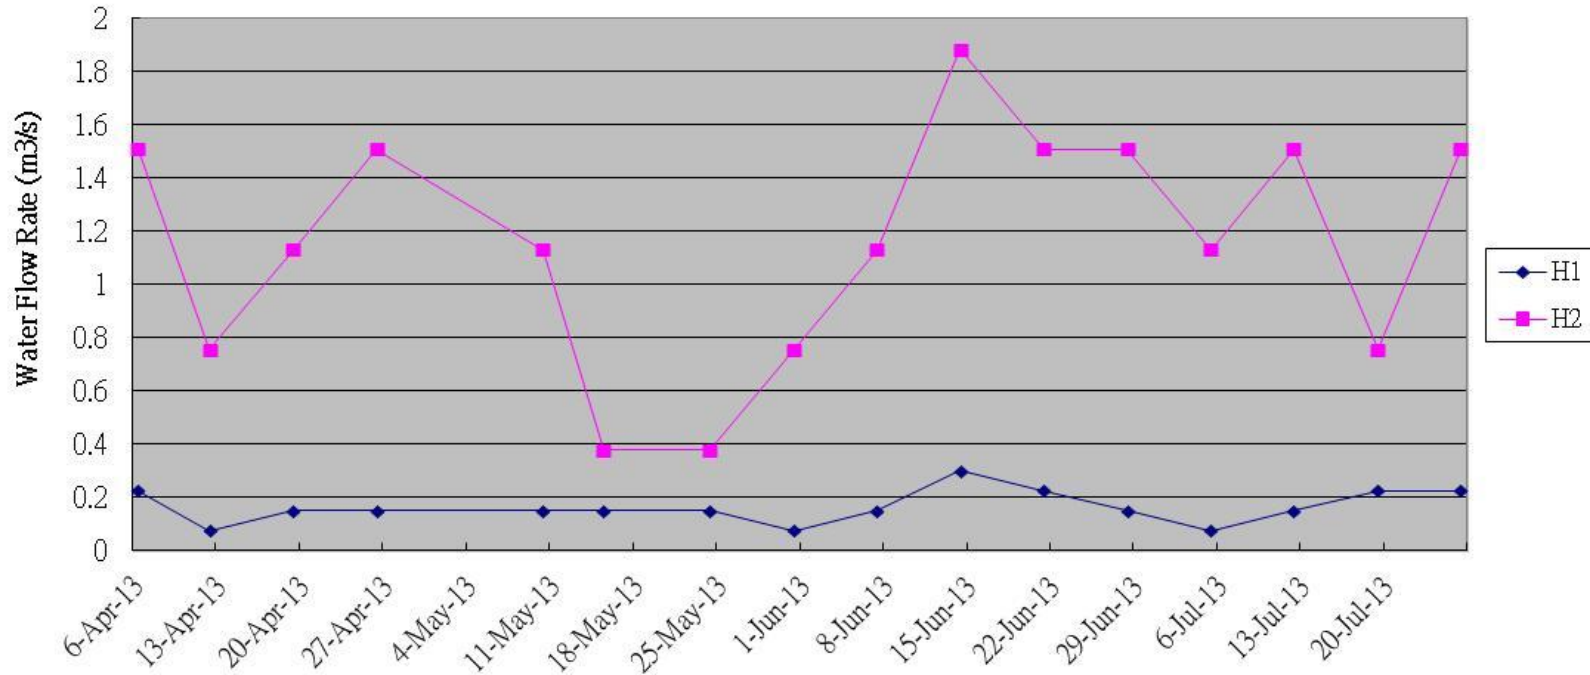
Graphical plots of Hydrological Monitoring(water flow rate at ebb tide) for H1 & H2

Remarks: Action level: 120% of control station's water flow rate on the same day of measurement.
Limit level: 140% of control station's water flow rate on the same day of measurement.
