**CONTRACT NO. DC/2010/02 –
DRAINAGE IMPROVEMENT IN SHUEN WAN AND
SHEK WU WAI**

**MONTHLY ENVIRONMENTAL MONITORING AND
AUDIT REPORT (NO.25) – JULY 2013**

PREPARED FOR
KWAN LEE-KULY JOINT VENTURE

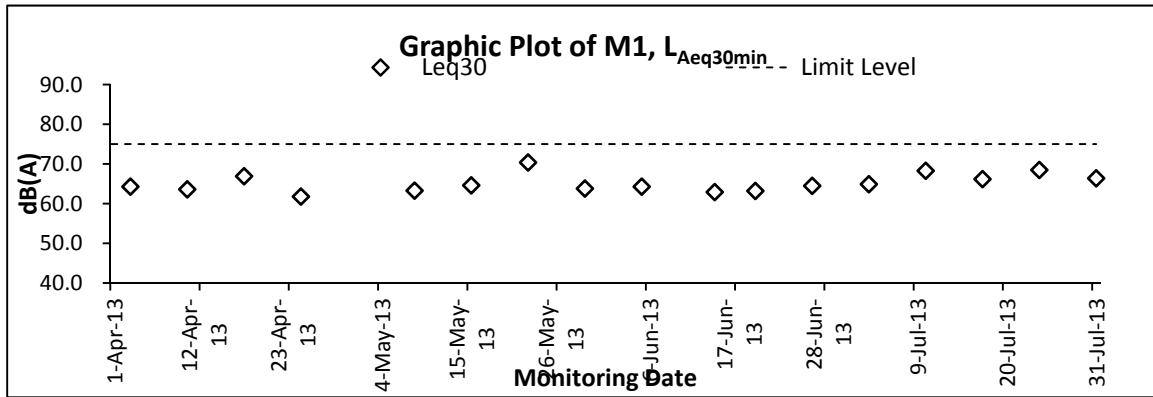
Remark: The monitoring is undertaken under façade situation. No façade correction is added according to acoustical principles and EPD guidelines.

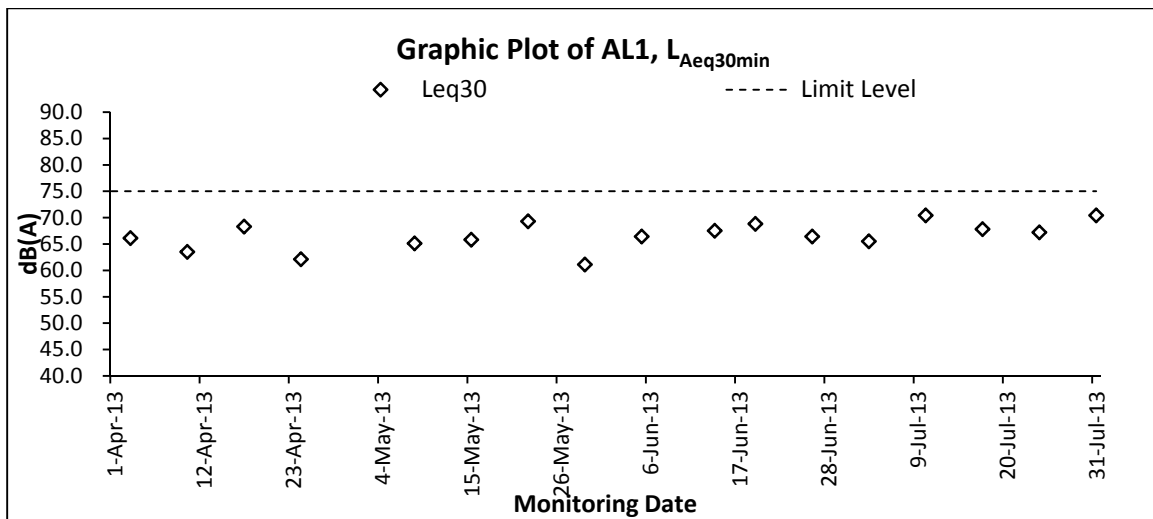
Remark: The monitoring is undertaken under façade situation. No façade correction is added according to acoustical principles and EPD guidelines.

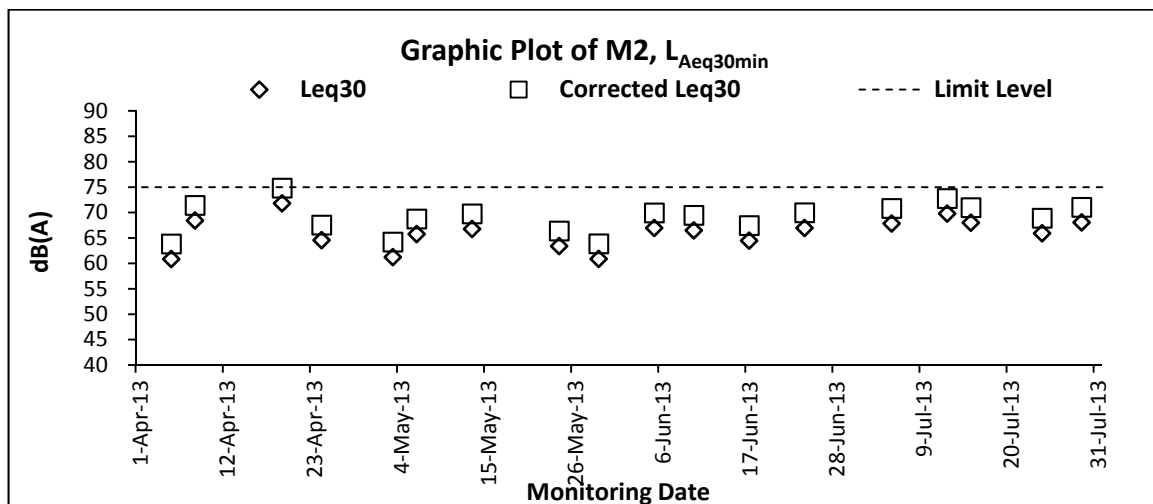
Remark: The monitoring is undertaken under free field situation. A façade correction of +3 dB(A) has been added according to acoustical principles and EPD guidelines.

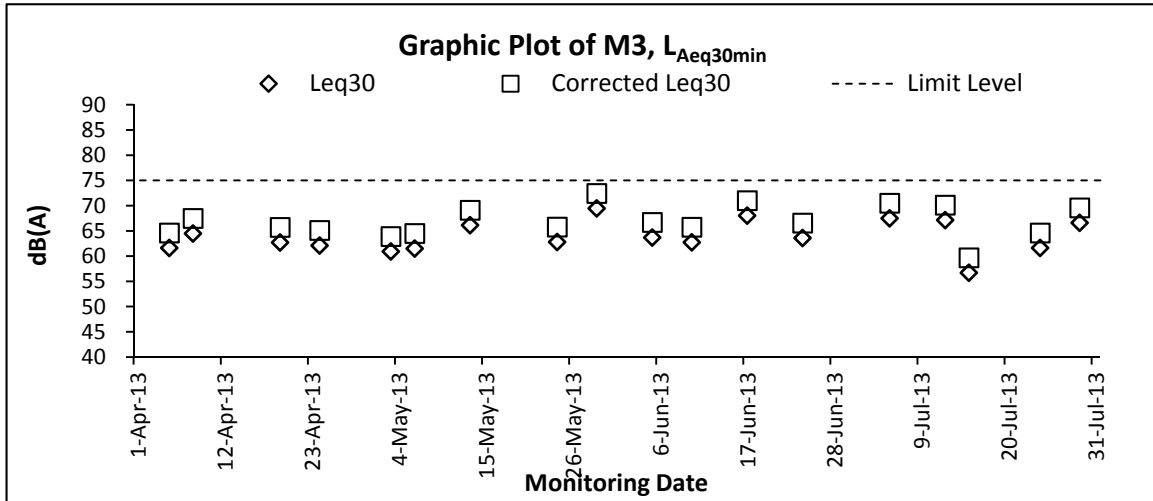
Remark: The monitoring is undertaken under free field situation. A façade correction of +3 dB(A) has been added according to acoustical principles and EPD guidelines

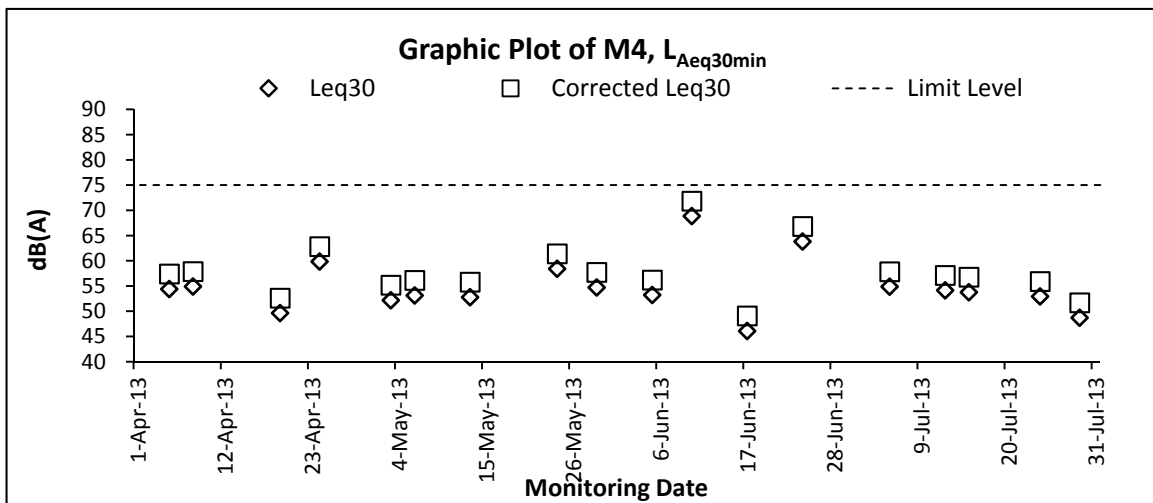
Remark: The monitoring is undertaken under free field situation. A façade correction of +3 dB(A) has been added according to acoustical principles and EPD guidelines

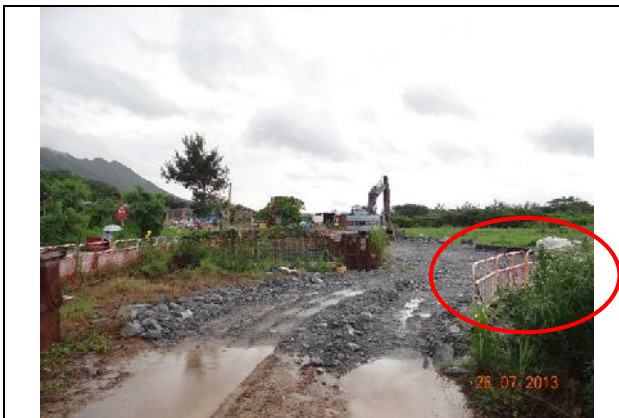
- 3.2.5 To the southeast of Jade View Villa and adjacent to the current active works area, a demarcated wetland rehabilitation area has been maintained by parties other than the Project Proponent, the Project's Contractor and Sub-contractors since January 2012. The wetland rehabilitation area has been surrounded by red strings since April 2012 (**Photo 5**). No vegetation clearance or any other works were observed within this wetland rehabilitation area. Loosened red strings were still observed on the eastern side of the area in July 2013 (**Photo 6**); however, temporary construction barriers were also found surrounding the eastern side of the area (**Photo 7**).

Photo 7 – Temporary construction barriers were erected to surround the eastern side of the wetland rehabilitation area,

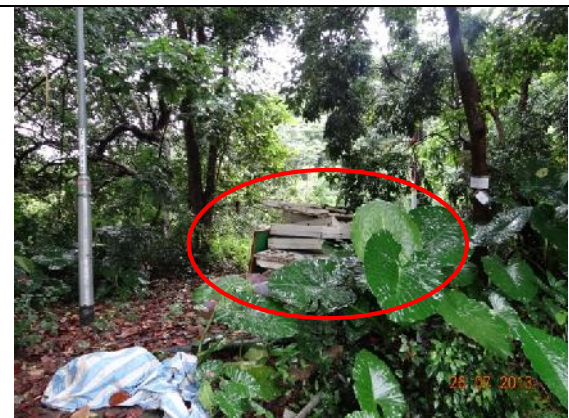
- 3.2.6 Outside the established hoardings of the Project Area, temporary storage of construction materials was still found next to the retained tree T179 in July 2013 (**Photo 8**).

Photo 8 – Temporary storage of construction materials was still found next to the retained tree T179 in July 2013.

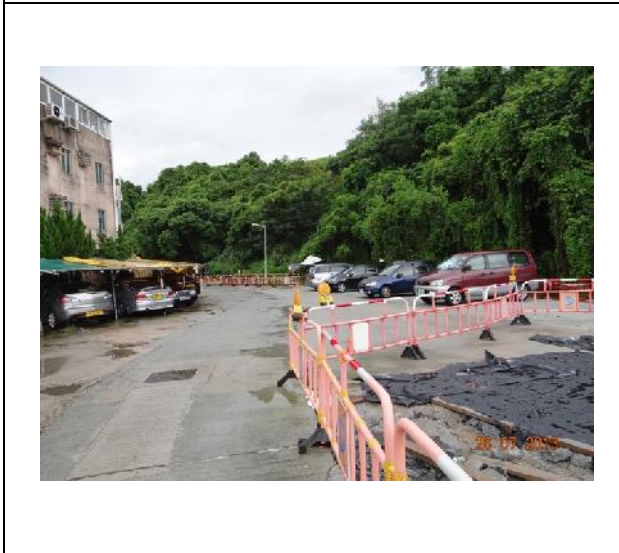
- 3.2.7 As observed in July 2013, a temporary parking area was formed close to the end of the access path to Treasure Spot Garden Phase II (**Photo 9**). An untagged leaning tree was noted at the edge of the area. A Tree Protection Zone (TPZ) was set up with orange construction nets (**Photo 10**). However, the vehicle was parked close to the TPZ.

Photo 9 – Temporary parking area close to the end of the access path of Treasure Spot Garden Phase II.

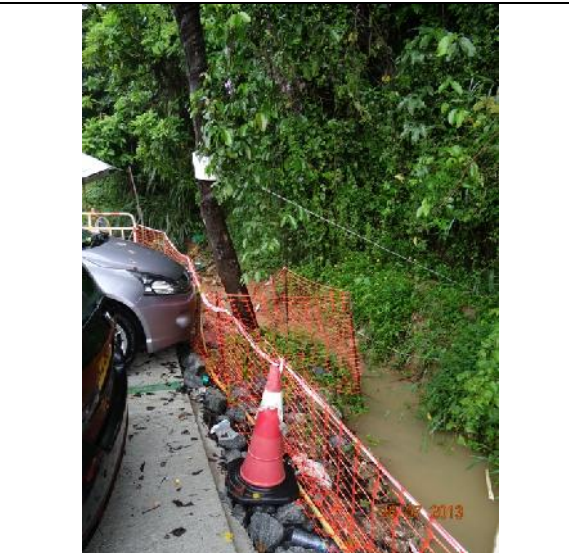
Photo 10 – An untagged leaning tree within the TPZ close to the parking vehicle was noted at the edge of the area.

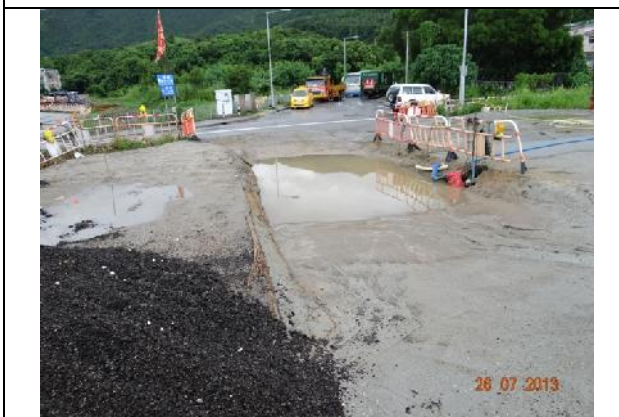
- 3.3.2 Provision of dust control measure (such as wheel washing facilities) has been maintained at two major vehicular exit points of the works area of Contract 2 (**Photo 11**).
- 3.3.3 The sections of granules of the sedimentation beds located from north to south near the retained tree T196 (*Macaranga tanarius* var. *tomentosa*) have been removed since June 2013 (**Photo 12**). However, discharge of machine oil was noted at the marsh area after passing through the sedimentation beds (**Photo 13**). No direct discharge was observed from the construction site to the sedimentation bed and the observation was immediately reported to

Photo 11 – Wheel washing facility has been provided at the vehicular exit point of the works area of Contract 2.

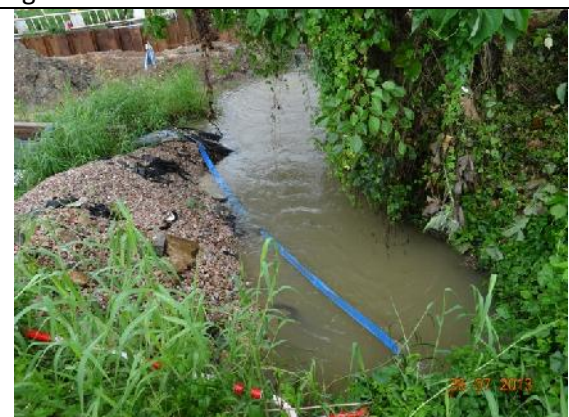
Photo 12 – Granules along the sedimentation beds and PVC liner near the retained tree T196 (*Macaranga tanarius* var. *tomentosa*) were removed and no muddy water was discharged.

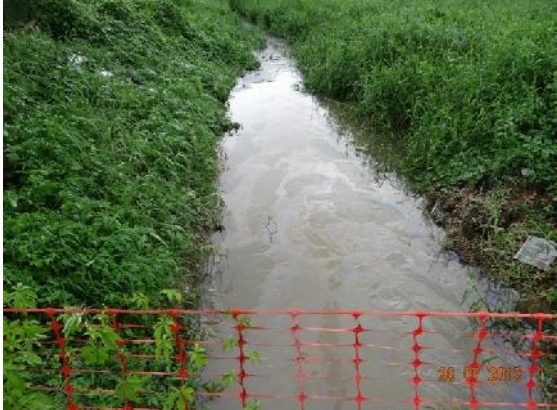
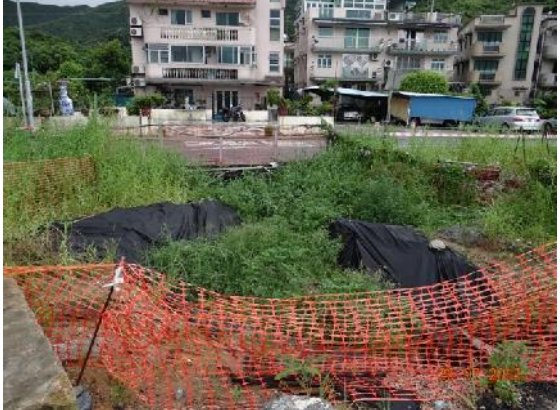
- 3.3.4 Another sedimentation beds aligned from the area opposite to the Jade View Villa towards the marsh area at southeast have been maintained since October 2012. No muddy water was observed to be discharged into the drainage points but the beds were overgrown by dense grassy vegetation (**Photos 14-15**).

<p>Photo 13 – Discharge of machine oil was noted at the marsh area through the sedimentation beds near the retained tree T196 (<i>Macaranga tanarius</i> var. <i>tomentosa</i>).</p>	<p>Photo 14 – The sedimentation beds with gravels and PVC liners were aligned from the area opposite to the Jade View Villa towards the marsh area at southeast. The beds were overgrown by grassy vegetation.</p>

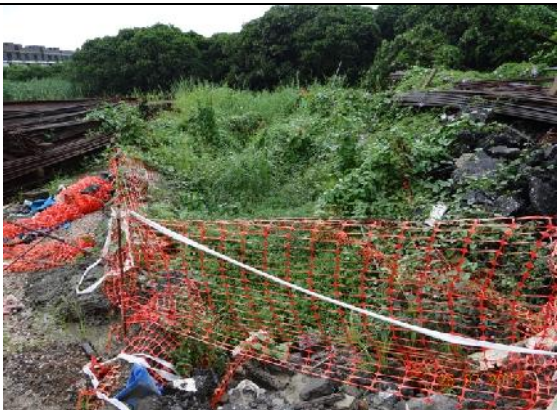
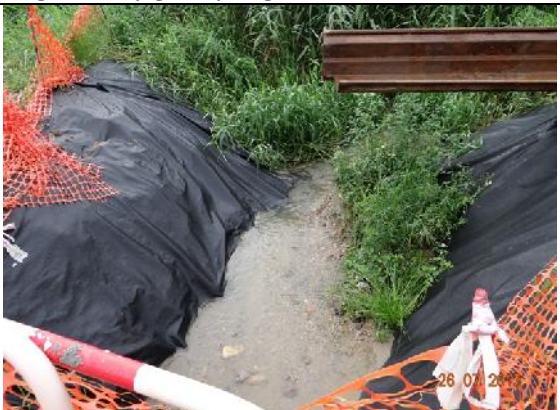
- 3.3.5 There has been another section of sedimentation beds aligned from the area opposite to the eastern part of Jade View Villa towards the marsh area since December 2012. The used water was released into the sedimentation beds and no discharge of muddy water was observed (**Photo 16**).

<p>Photo 15 – An addition photo showing the sedimentation beds with gravels and PVC liners were aligned from the area opposite to the Jade View Villa. The beds were overgrown by grassy vegetation.</p>	<p>Photo 16 – The sedimentation beds with gravels and PVC liners were aligned from the area opposite to the eastern part of Jade View Villa towards the marsh area.</p>

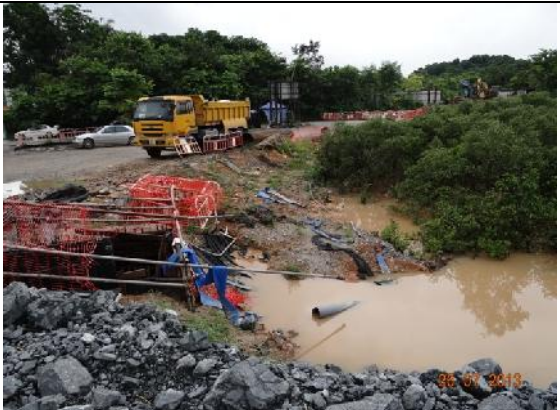
- 3.3.6 The section of sedimentation bed, which had been aligned opposite to San Tau Kok with PVC liner underlying sections of granules since April 2013, was removed in July 2013. No more discharge was noted at the discharge point (**Photo 17**).

<p>Photo 17 – The section of sedimentation bed, which had been aligned opposite to San Tau Kok with PVC liner underlying sections of granules since April 2013, was removed in July 2013. No more discharge was noted at the discharge point.</p>	<p>Photo 18 – No discharge was noted at another section of sedimentation bed which has aligned with PVC liner underlying granules close to the area at which a filtration tank was previously placed opposite to San Tau Kok close to the marsh area.</p>

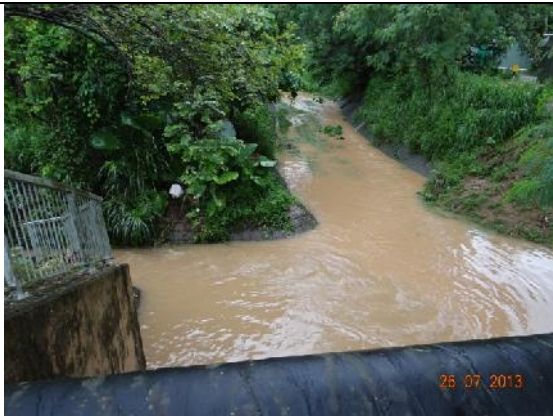
Photo 19 – No discharge of used water was observed at the upper section of Wai Ha River (i.e. to the north of Tung Tsz Shan Road).

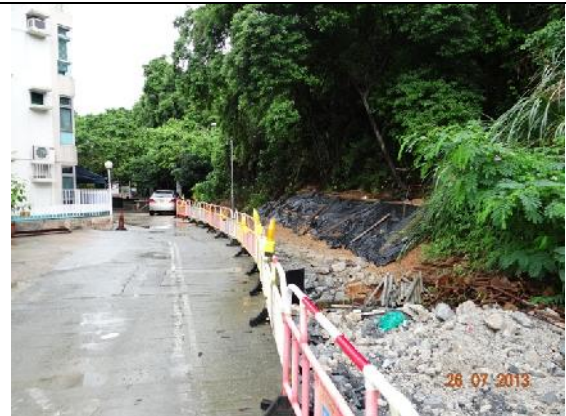
Photo 20 – Vegetation clearance was found near the tree group T93-T94.

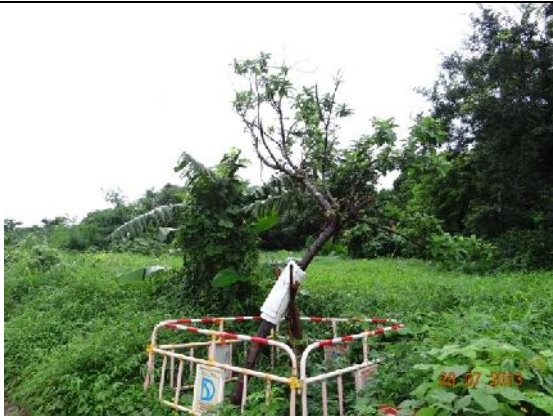
Photo 21 – The leaning tree T190 was supported by the wooden stand in July 2013.

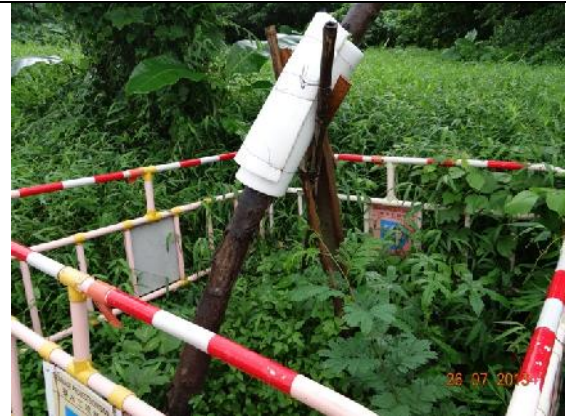
Photo 22 – Plastic foam sheet was observed wrapping around the tree trunk of T190 at the anchorage point of the stand in July 2013.

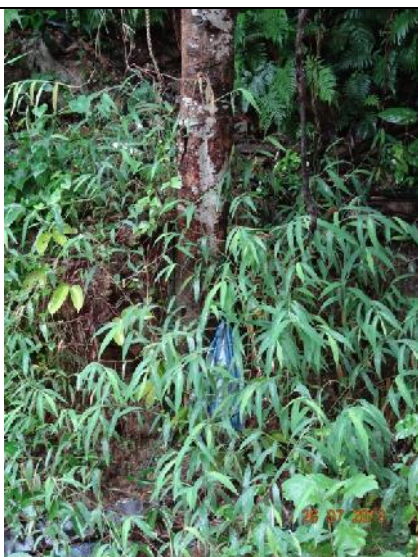
Photo 23 – The refilled soil at the trunk base of the retained tree T103 was loose and sandy, and tapes and ropes were still found tied on the trunk.

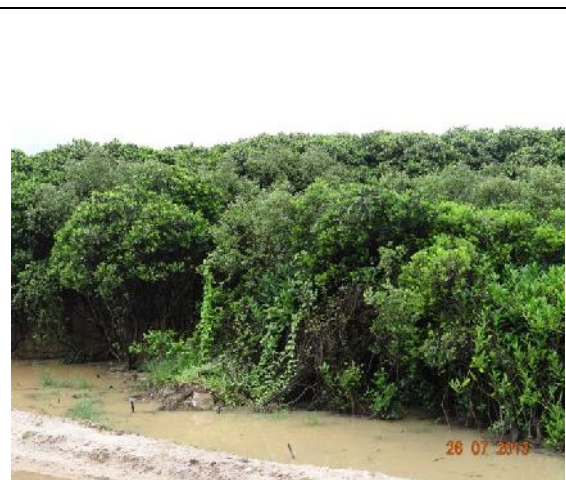
Photo 24 – Some mangrove trees located opposite to San Tau Kok were slightly damaged by previous site works.

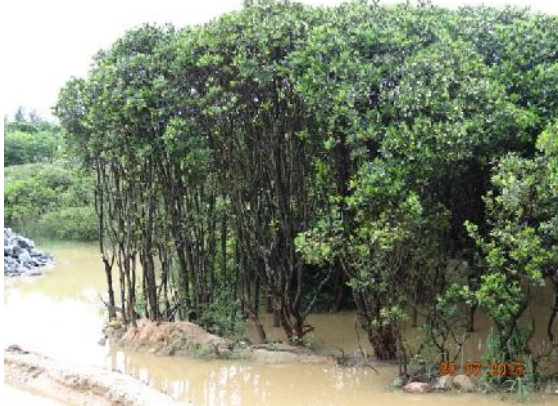
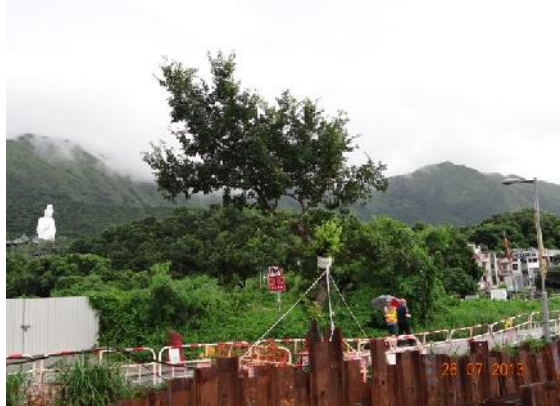
<p>Photo 25 – Piled soil was noted at the trunk base of the mangroves opposite to San Tau Kok.</p>	<p>Photo 26 – The over-pruned retained tree T025 with imbalanced tree form was temporarily guyed by three strings for additional support. Waterspouts were noted developing from the pruning wound.</p>

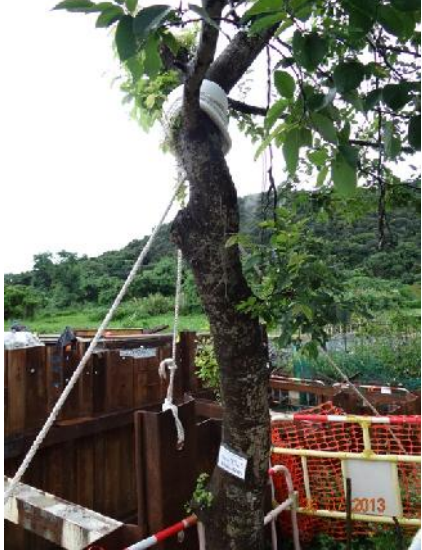
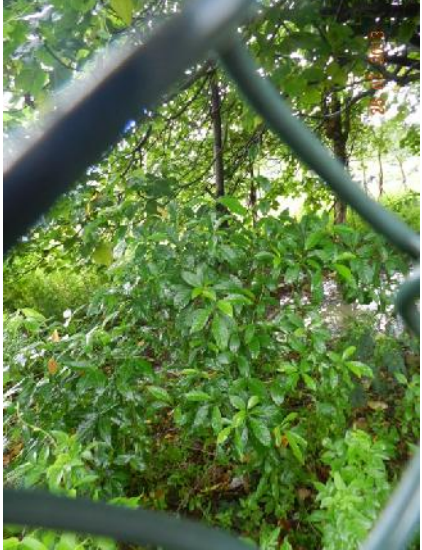
<p>Photo 27 – Close view of the guying of the retained tree T025</p>	<p>Photo 28 – The transplanted shrub of <i>Pavetta hongkongensis</i> (PH03) has remained in satisfactory condition in Area C under Contract 1. Some mangrove trees located opposite to San Tau Kok were found to be damaged.</p>

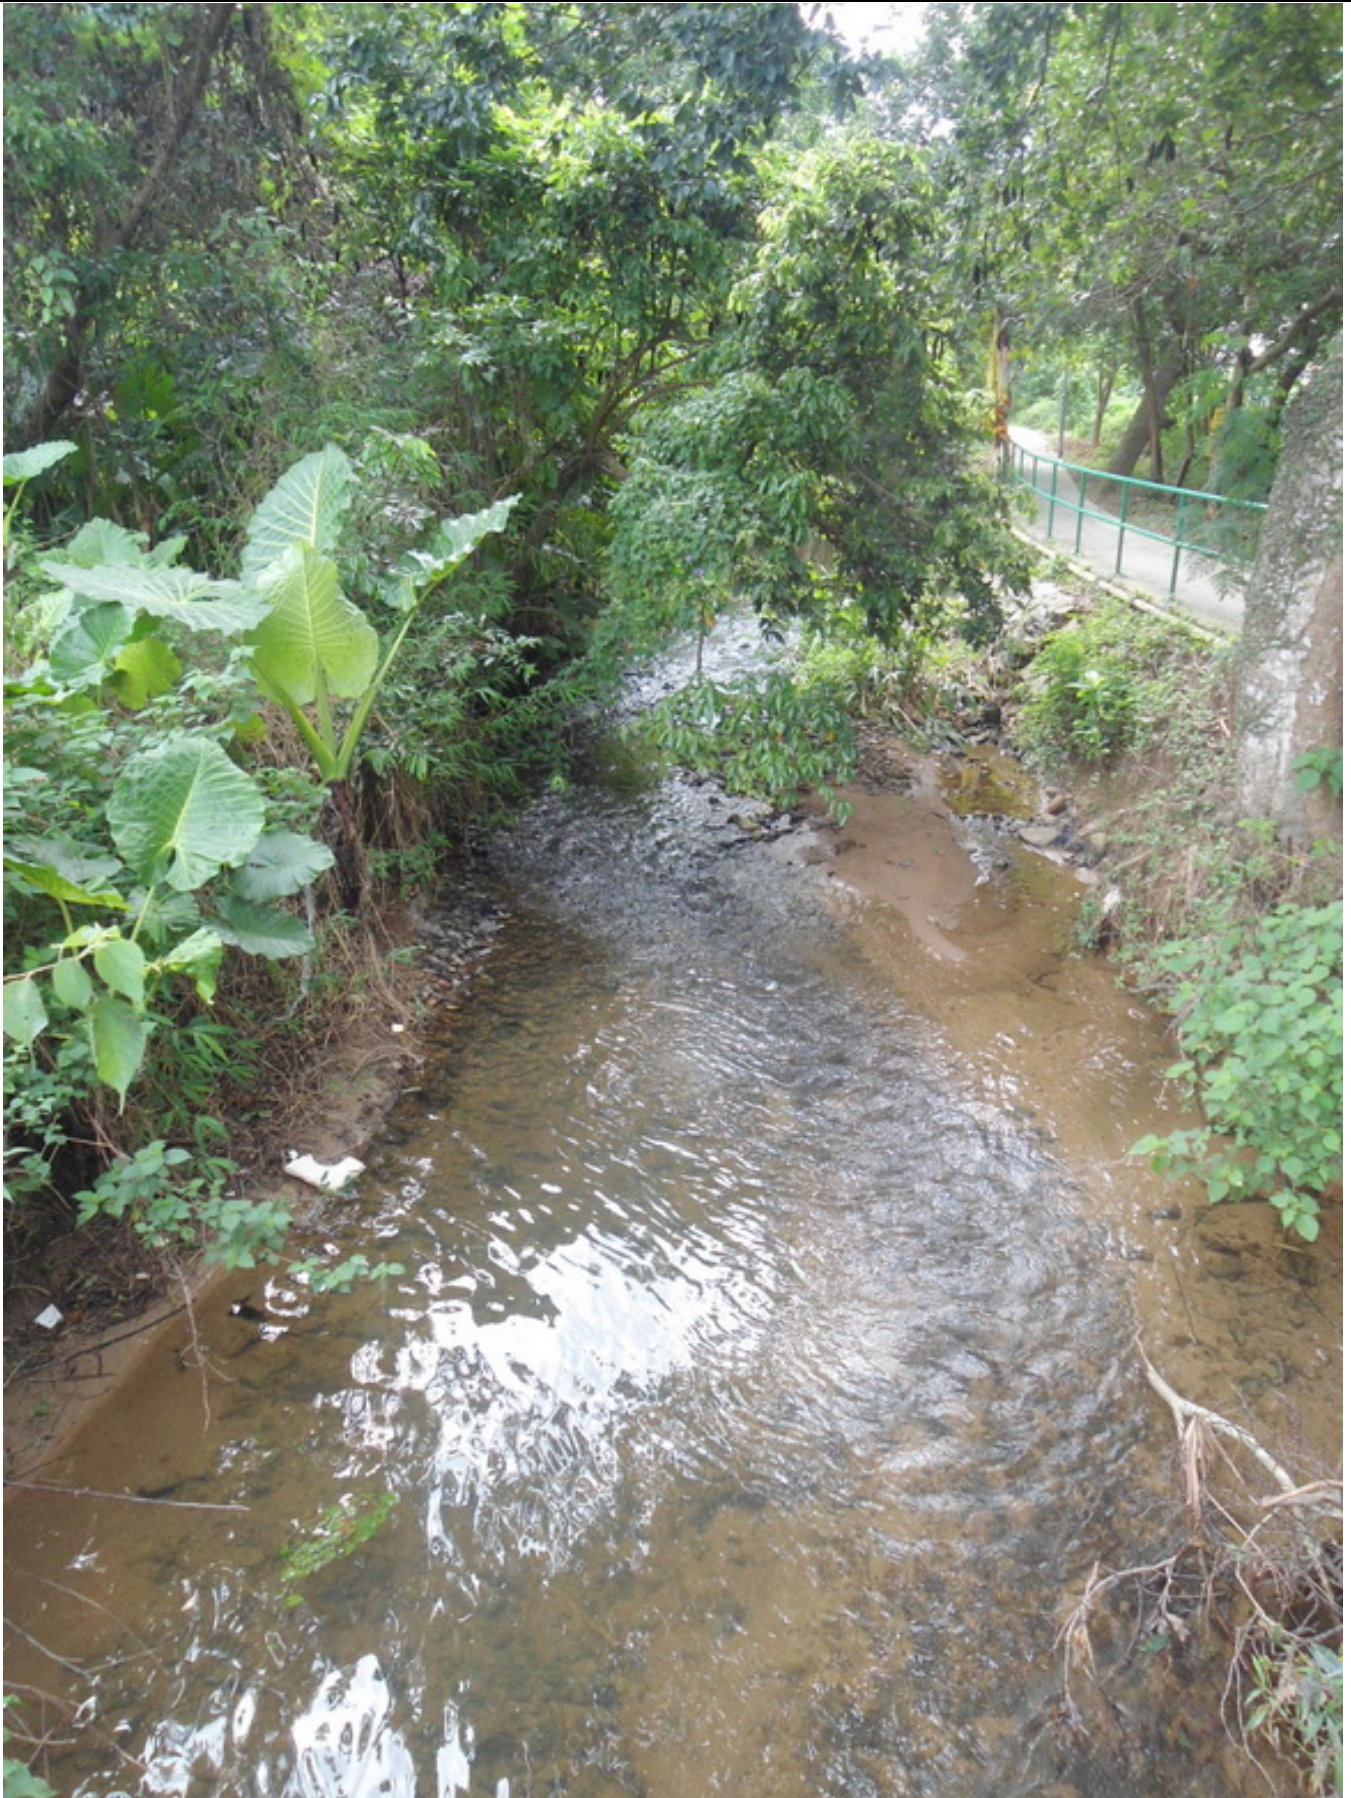
Figure: 2

Title: SEMP 3, the third sampling point of Wai Ha River under Contract 2.

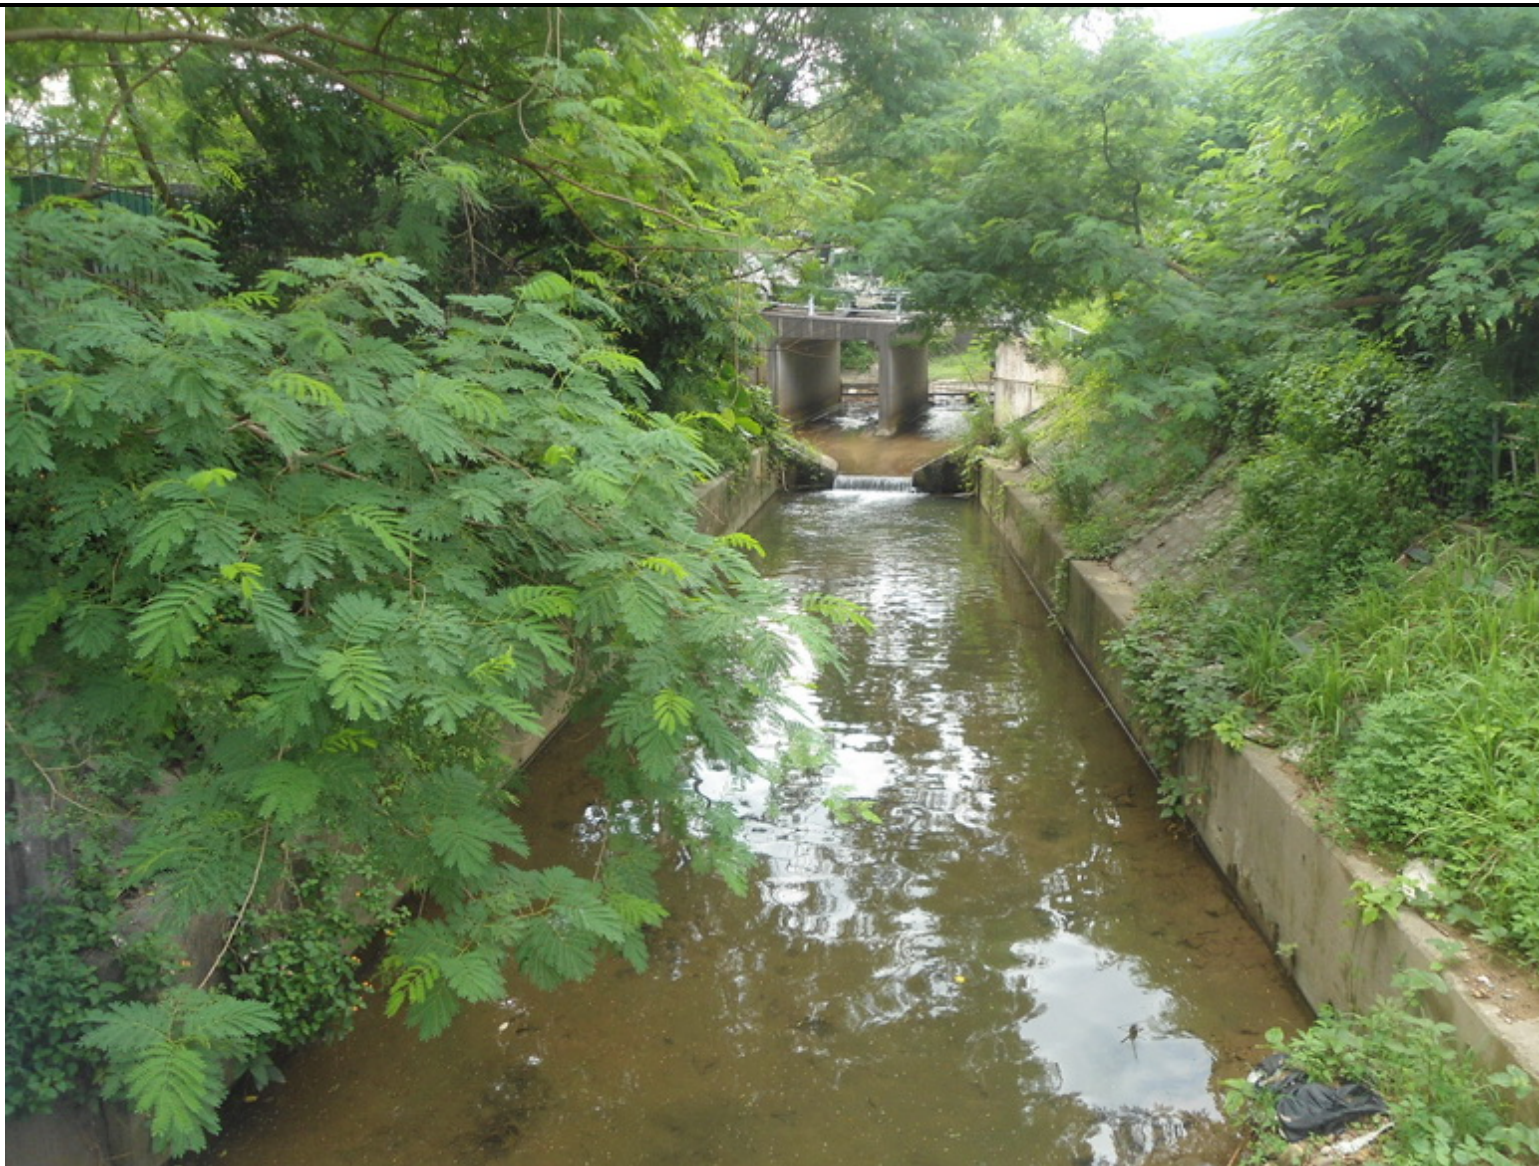
Figure: 3

Title: SEMP 4, the second sampling point along Wai Ha River under Contract 2.
