Monthly Environmental Monitoring & Auditing report for

Contract No.DC/2009/22

Drainage Improvement in Shuen Wan, Tai Po – Contract 1

August 2013

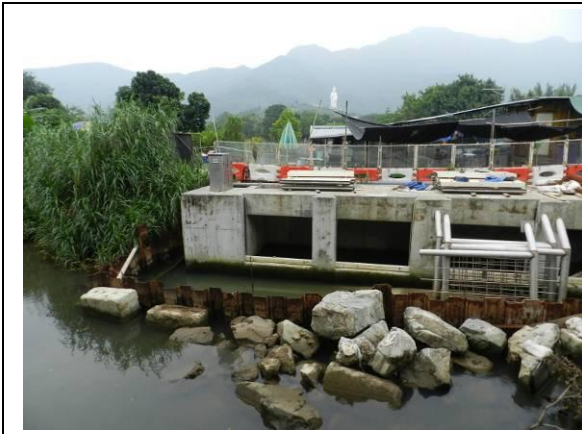
Construction hoardings have been erected in Area A along the entire site boundary. Temporary construction hoardings have been erected around Wai Ha River estuary since the building of an automatic mechanical penstock at the area (**Photo 1**). The works area close to the estuary and located to the south of Area A along Ting Kok Road was completed in August 2013 (**Photo 2**). As observed in August 2013, the site boundary along the western side of Area A was demarcated by temporary construction barriers (**Photo 3**). Since January 2013, the site hoardings along the eastern boundary of Area A have been removed due to the active construction works for the installation of drainage pipe and the associated structure.

Photo 1 – Temporary hoardings have been established to surround the works area at Wai Ha River estuary.

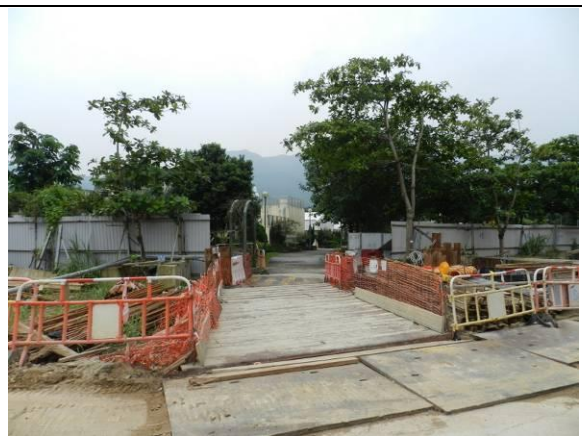
The temporary hoardings have been erected from northwest to southwest parts of Tung Tsz Nursery in Area B since April 2011. Phase 2 construction works have continued and temporary hoardings have been erected since May 2012. The major road access within the Nursery has been maintained to minimize the impact on the nursery's daily operation resulting from the construction works. A section of the temporary hoardings at the eastern end of Phase 1 and western end of Phase 2 works area have been replaced by temporary construction barriers since April 2013 (**Photo 4**).

Photo 4 – The temporary hoardings at the eastern end of Phase 1 and the western end of Phase 2 works area were replaced by temporary construction barriers.

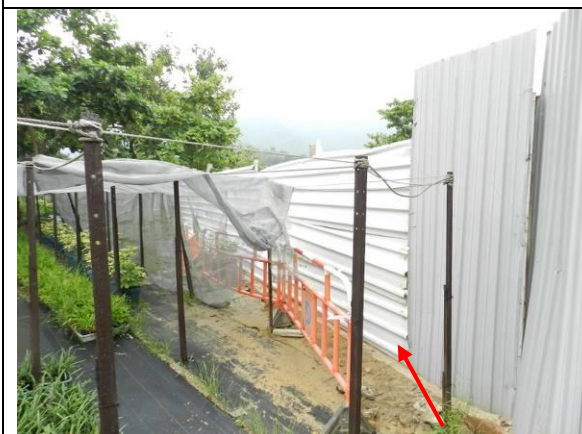
The damaged hoarding close to the retained tree U50 (*Ficus elastica*) at the southwestern part of Phase 1 was fixed as inspected in August 2013. No other follow-up action by the Contractor is required as from the *Monthly EM&A Report for July 2013*.

works boundary from Trees U42 to U62). Another section of temporary hoarding has been erected from southwest to eastern parts (i.e. Phase 2 construction works) of the Nursery since May 2012 and connected with Phase I construction works area. An open section with no construction work has been maintained as a major road access inside Tung Tsz Nursery for their daily operations. Since April 2013, a part of the temporary hoardings at the eastern end of Phase 1 and western end of Phase 2 works area were replaced by temporary construction barriers (**Photo 4**). A section of site hoarding close to the retained tree U50 (*Ficus elastica*) at the southwestern part of Phase 1 was reinstated in August 2013 (**Photo 5**).

Photo 5 – A section of site hoarding close to the retained tree U50 at the southwestern part of Phase 1 was reinstated in August 2013.

The Contractor is suggested to repair the broken site hoarding in Phase 1 construction works in Tung Tsz Nursery.

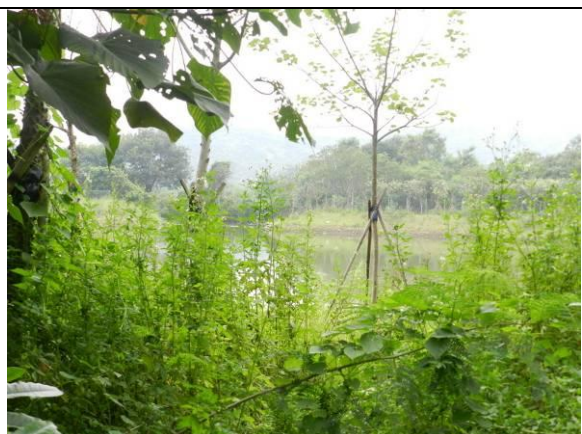
Area C was formally handed over to AFCD on 16th October 2012 for management and maintenance. The pond of the ECA has been connected to Wai Ha River directly as following the scheme design of Habitat Compensatory Plan. No direct discharge of turbid water into the adjacent Wai Ha River was observed through the fence of Tung Tsz Nursery **(Photo 6)**.

Photo 6 – No discharge of muddy water was observed in Area C.

The Contractor should regularly check the condition and locations of the drainage pipes and ensure that all used water should be appropriately filtered and discharged to the manholes/other discharge points agreed by the Engineer and EPD. This is to avoid any potential contamination to the vegetation in Shuen Wan marsh and other vegetated/marinated areas adjacent to the active works area.

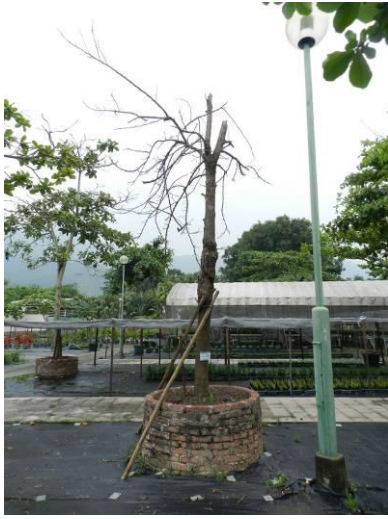
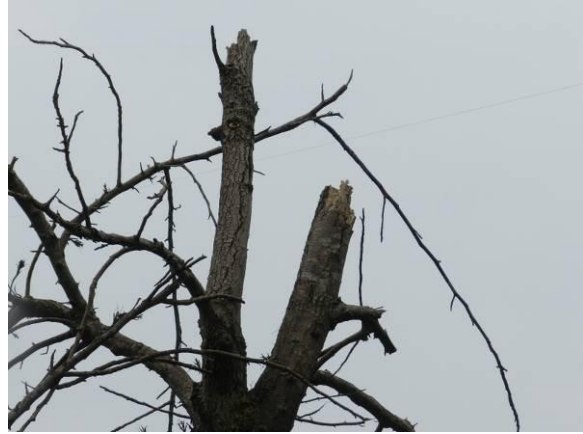
Regular monitoring for all transplanted and retained trees within the nursery was conducted on a bi-weekly basis. For tree U58 (*Grevillea robusta*), its health condition has been very poor in these recent months and no sign of regenerated leaves was observed along the trunk and the remaining branches (**Photo 7**). A few dead branches and twigs broke off from the canopy of this tree (**Photo 8**). No replacement of the broken bamboo stake (reported in *Monthly EM&A Report for July 2013*) was observed. Given the broken bamboo stake provides no support to the trunk of poor structural condition and a significant wound has observed on the middle tree trunk, there is a potential risk of whole tree failure, with its falling zone covering the assess path used by any visitors/ nursery workers in the Nursery.

As highlighted in the Section “Liaison with Nursery”, physiological condition of the transplanted tree U58 (*Grevillea robusta*) has deteriorated significantly since June 2013. The tree was so poor that no sign of recovery was noted and only dead branches remained in the canopy (**Photos 7-8**). A bamboo stake for supporting U58 was broken.

Photo 7 – Overall view of the transplanted tree U58, which was in very poor condition.

Photo 8 – A few dead branches and twigs broke off from the tree canopy.

Close monitoring on the stability of *Grevillea robusta* (U58) has been continued. The tree is in poor physiological and structural conditions, with no sign of recovery. Prior to any tree remedial works (including tree removal), the Contractor is advised to replace the broken bamboo stake with a new one, as well as informing the Nursery Operator to restrict any access within the tree-falling zone of U58. The landscape contractor appointed by the Contractor should assess the tree stability, and consider whether the tree has to be removed as soon as possible.

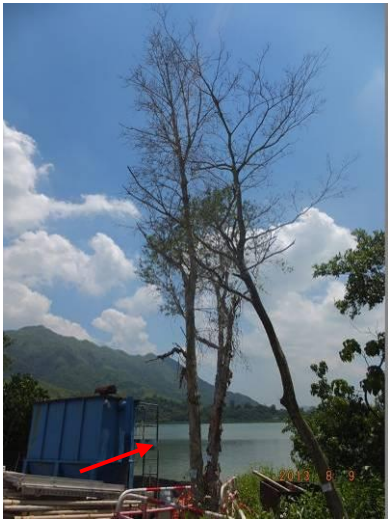
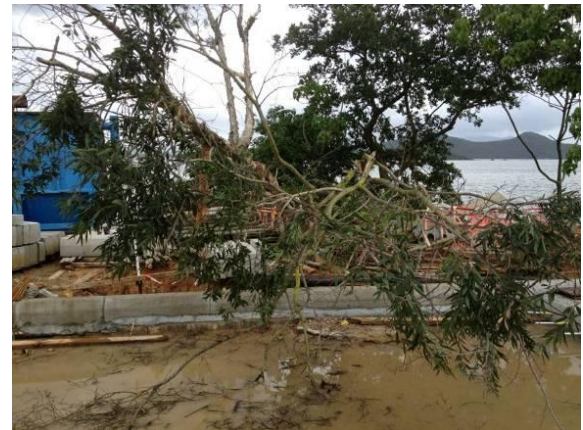
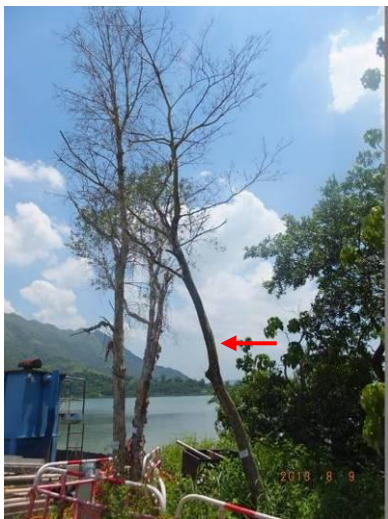
Since October 2012, E18 (*Melaleuca cajuputi* subsp. *cumingiana*) originally located within the TPZs nearby the main gate have been relocated within Area A due to its direct conflict with the works. The tree has remained in poor condition after the relocation in August 2013 (**Photo 9**). As reported by the Main Contractor, this tree was collapsed due to the strike of severe Typhoon Utor (hoisted as Signal No. 8 on 14th August 2013) (**Photo 10**). As inspected on 22nd August 2013, the collapsed tree parts had already been removed.

E97 (*Celtis sinensis*) has been relocated at the northeastern part of Area A since December 2012. Its canopy regenerated with small and green leaves in early wet season, but it has showed significant decline in health condition with wilted foliage since July 2013 (**Photo 11**). Similar to E18, E97 was collapsed due to the strike of severe Typhoon Utor (**Photo 10**). As inspected on 22nd August 2013, the collapsed tree parts had already been removed.

Photo 9 – The relocated E18 was in poor condition as inspected on 9th August 2013.

Photo 10 – Both relocated E18 and E97 collapsed under the strike of Typhoon Utor in August 2013. Photo is provided by the Main Contractor.

Photo 11 –The relocated E97 was in poor condition as inspected on 9th August 2013.

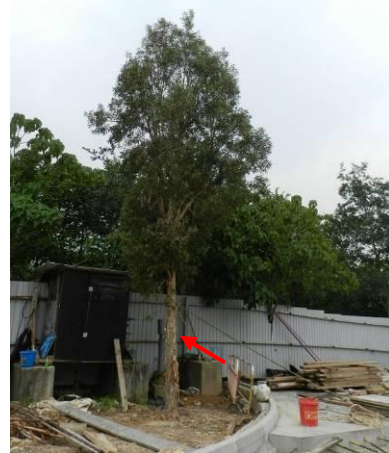
E38 (*Melaleuca cajuputi* subsp. *cumingiana*) was found to be relocated by the contractor from the northern corner to the northern part next to the temporary site office in Area A (**Photo 12**). As inspected on 22nd August 2013, the transplantation skill was poorly applied on this tree, and the tree bark and cambium layer were damaged as a result of the transplantation (**Photo 13**). Dry and wilt leaves were observed in its canopy.

Photo 12 – E38 was recently relocated within Area A and it was guyed by two ropes.

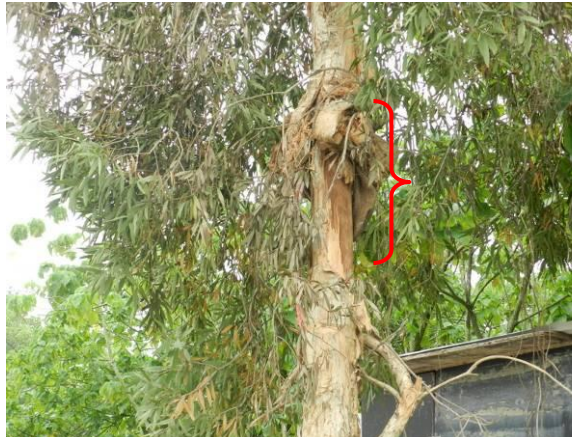
Photo 13 – The tree bark was heavily damaged during the relocation due to poor transplantation skill.

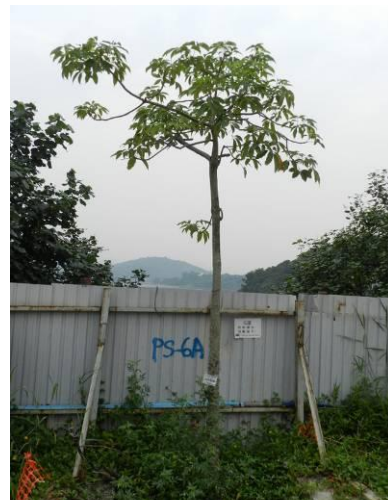
The tree to be transplanted E16 (*Bombax ceiba*) has been relocated to the southern side of Area A next to the site hoarding since July 2012. The tree was in fair condition in August 2013 (**Photo 14**).

Photo 14 – The relocated tree E16 remained in fair condition in August 2013.

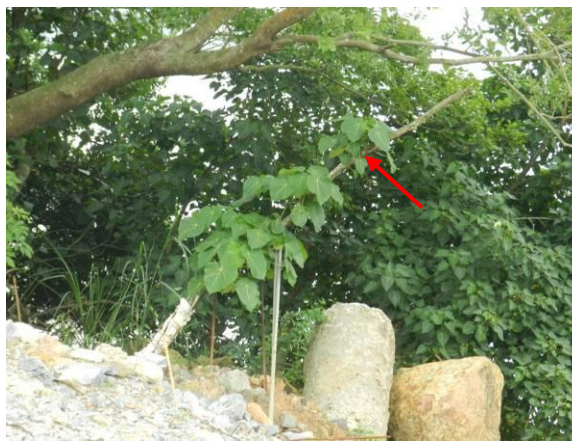
The leaning trunk of E61 (*Macaranga tanarius* var. *tomentosa*) has been burlapped and supported by two steel poles since May 2013. Though new leaves have regenerated along the leaning trunk, this tree is still in poor health condition and under physiological stress (**Photo 15**).

Photo 15 – The wound at the trunk flare of E61 was burlapped and the leaning tree trunk was supported by two steel poles.

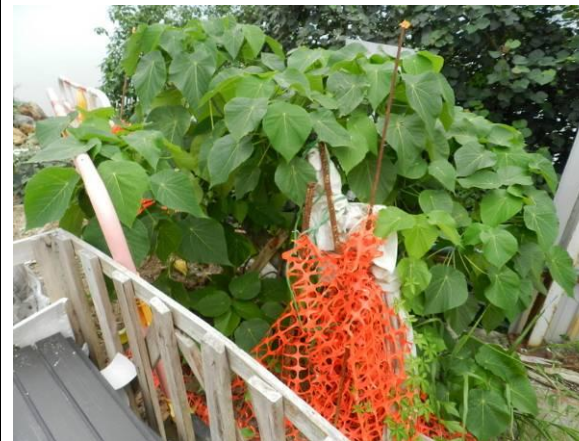
Damaged tree trunk on E55 (*Macaranga tanarius* var. *tomentosa*) was reported in *Monthly EM&A Report for April 2013*. The wound on the trunk of E55 has been burlapped since May 2013. The upper section of the tree trunk was found broken in June 2013. The tree was still in poor condition with most of its foliage as watersprouts only (**Photo 16**).

Photo 16 – E55 with burlapped broken trunk was still in poor condition.

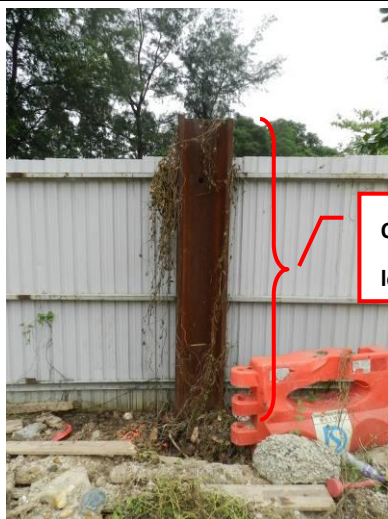
The tree to be transplanted T102 (*Melaleuca cajuputi* subsp. *cumingiana*) has been relocated to the southern part within the Phase 2 construction area of Area B next to the hoarding since November 2012. The tree has remained in very poor condition with no leaves and covered by excessive climbers. This tree was not found in Area B as inspected on 22nd August 2013 (**Photo 17**).

Photo 17 – T102, which has been in very poor condition, was not found in Area B as inspected on 22nd August 2013.

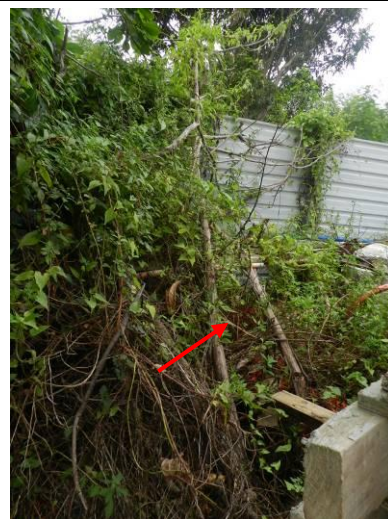
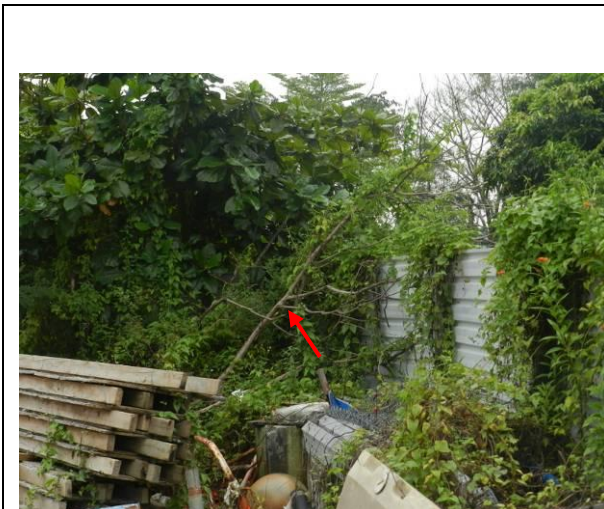
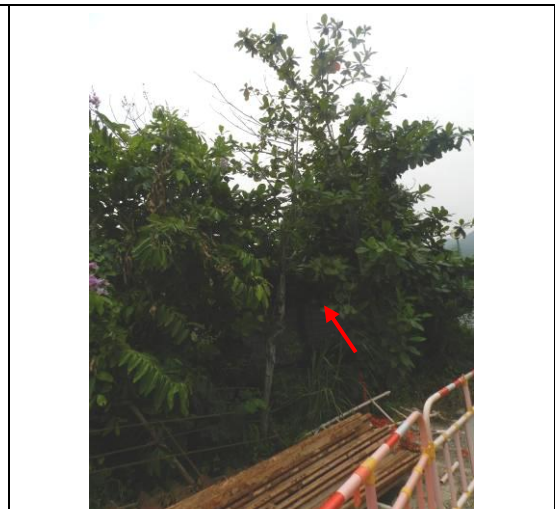
No recovery signs have been observed on the relocated trees U34, U35 and U37 and they are regarded as dead specimens (**Photos 18-20**), in particular, the dead tree trunks of U34 and U35 collapsed as inspected in August 2013. Temporary storage of construction

Photo 18 – The dead trunk of U34 was found collapsed within the Tree Protection Zone.

Photo 19 –The dead trunk of U35 was found collapsed within the Tree Protection Zone.

Photo 20 – No recovery sign of the relocated tree U37 in Area B was observed.

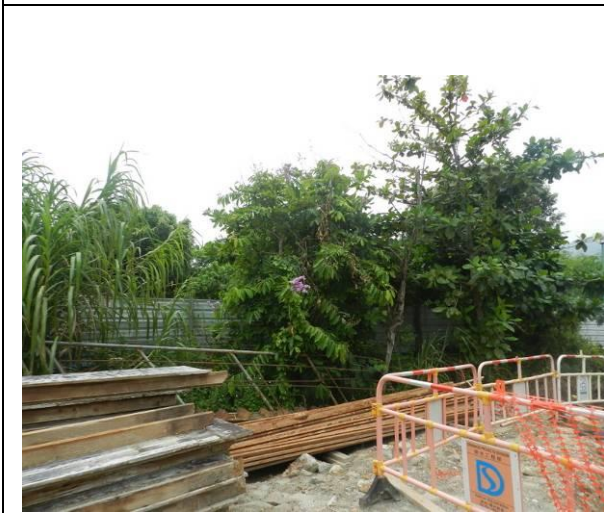
Photo 21 – Temporary storage of construction materials was observed close to the tree groups of U34, U35 and U37 and other trees in Area B.

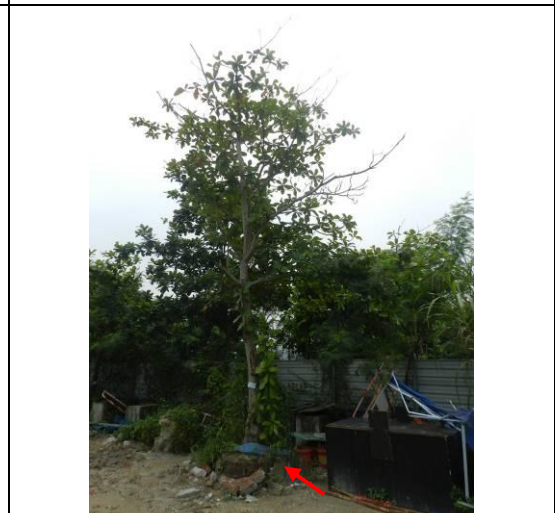
Photo 22 – Half of the planter of U47 was broken.

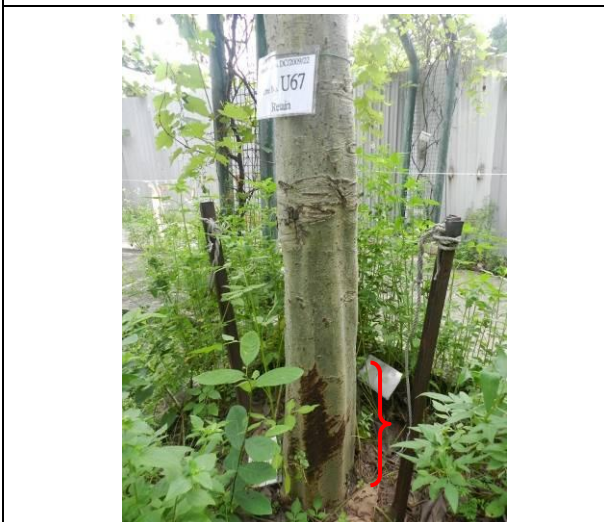
Photo 23 – The retained tree U67 remained in fair condition but sign of suspected termite infestation was noted at its lower trunk.

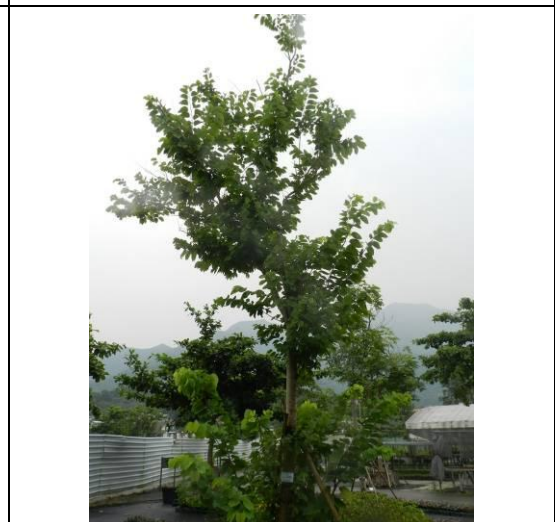
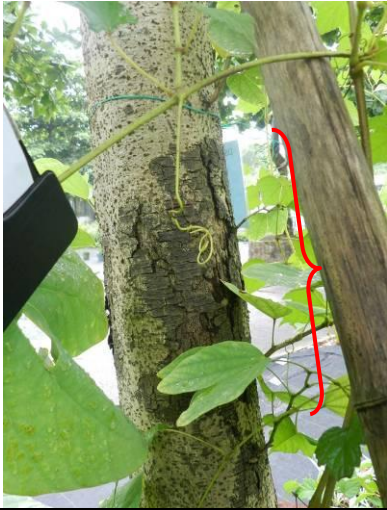
Photo 24 – Overall view of U64 which remained in generally fair health condition.

Photo 25 – Decayed wood and cracked tree bark were observed at the western side of the tree trunk of U64.

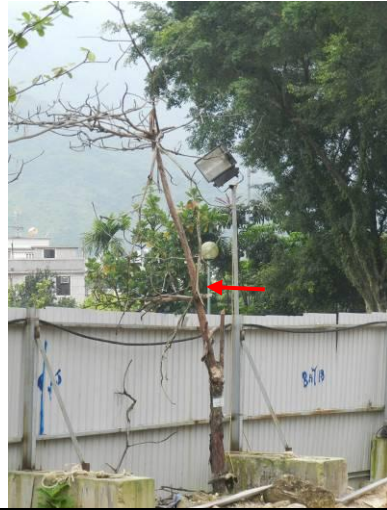
Photo 26 – The relocated tree U77 in Area B was suspected to be a dead suspected.

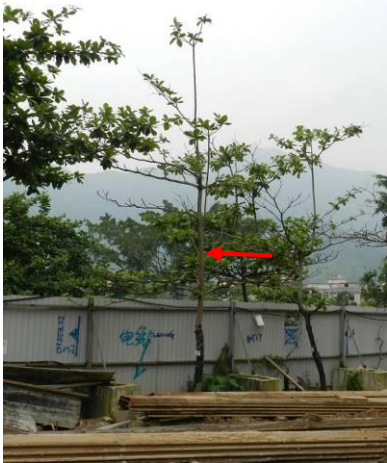
Photo 27 – U76 remained in marginally fair condition with watersprouts in the canopy.

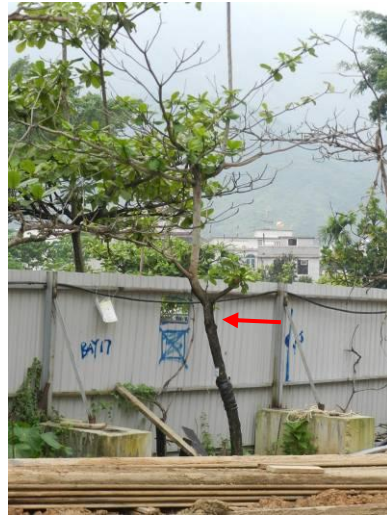
Photo 28 – U78 remained in marginally fair condition with watersprouts in the canopy.

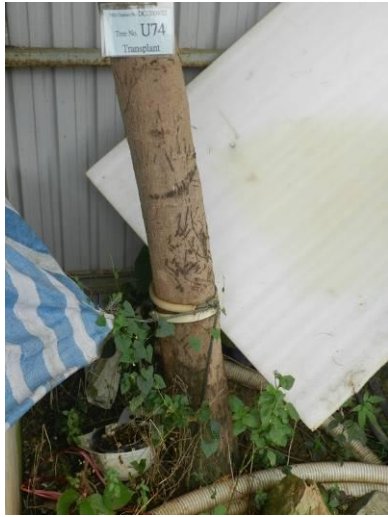
Photo 31 – A few construction materials were stored next to the trunk flare and excessive rain water was retained within the planting hole.

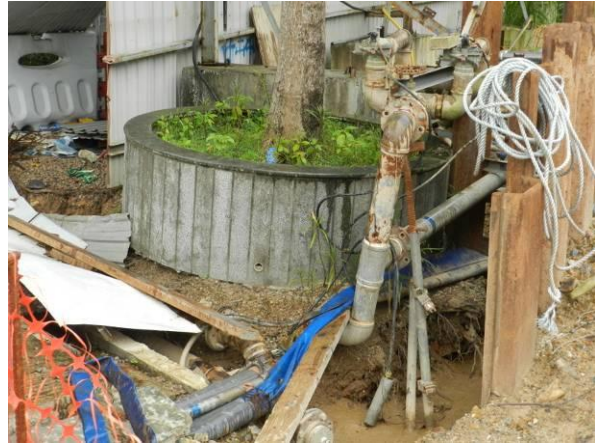
Photo 32 – The excavated area close to the retained tree A40 has not yet refilled as inspected in August 2013.
