**CONTRACT NO. DC/2010/02 –
DRAINAGE IMPROVEMENT IN SHUEN WAN AND
SHEK WU WAI**

**MONTHLY ENVIRONMENTAL MONITORING AND
AUDIT REPORT (NO.26) – AUGUST 2013**

PREPARED FOR
KWAN LEE-KULY JOINT VENTURE

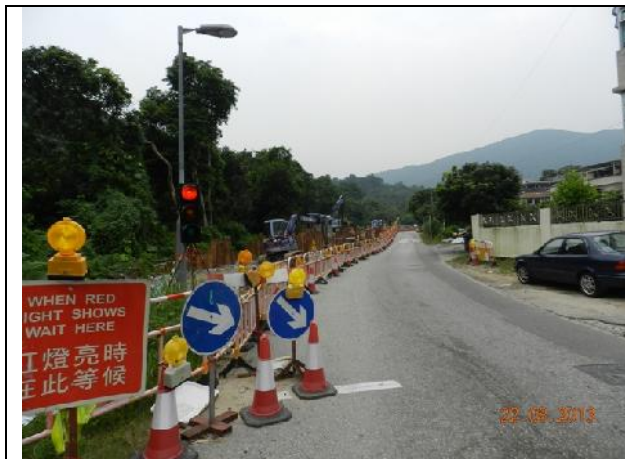
Photo 1 – Temporary hoardings have been erected along Tung Tsz Road opposite to Wai Ha.

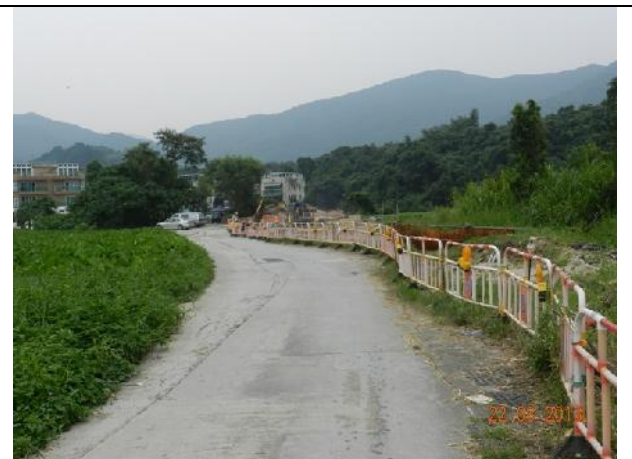
Photo 2 – Temporary hoardings have been erected along the access road from Tung Tsz Road to Treasure Spot Garden II.

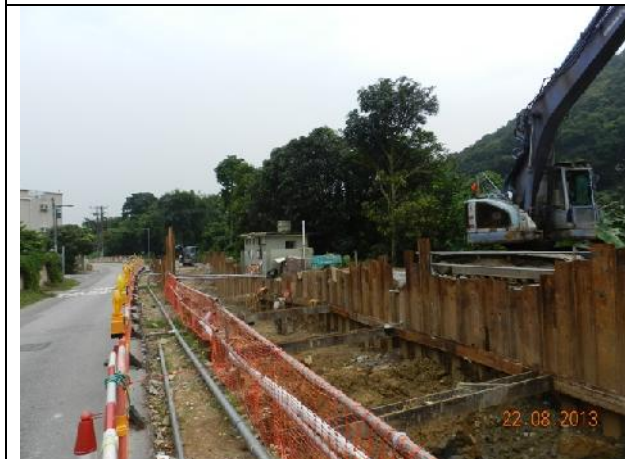
Photo 3 – Sheet piling work continued in the works area along Tung Tsz Road opposite to Wai Ha outside the public toilet.

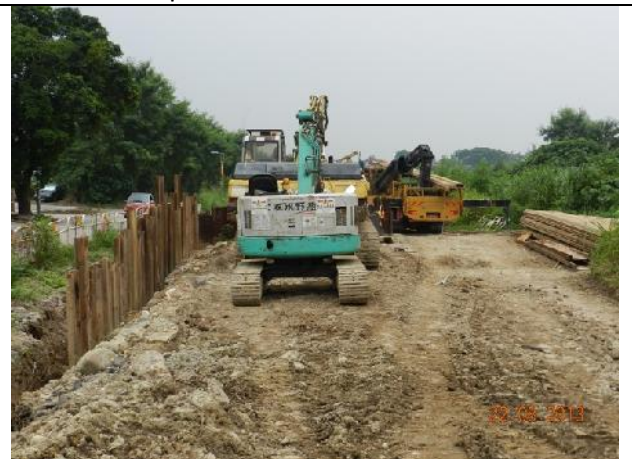
Photo 4 – Sheet piling work continued in the works area near the retained tree T190.

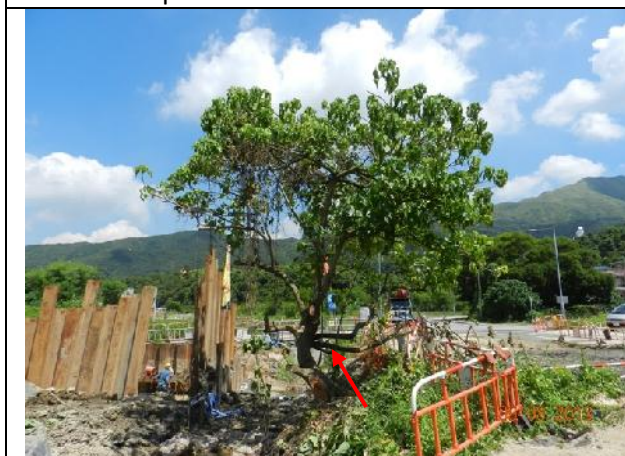
Photo 5 – Sheet piling work was seen close to the retained tree T196 (indicated).

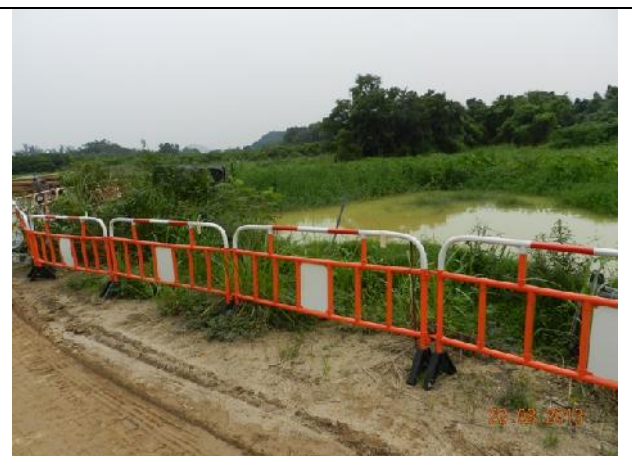
Photo 6 – Temporary construction barriers were seen surrounding the eastern side of the wetland rehabilitation area.

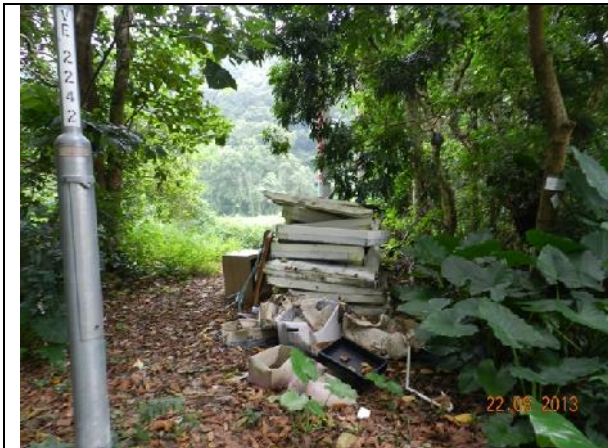
- 3.2.6 Outside the established hoardings of the Project Area, temporary storage of construction materials was still found next to the retained tree T179 in August 2013 (**Photo 7**).

Photo 7 – Temporary storage of construction materials was still found next to the retained tree T179 in August 2013.

- 3.2.9 No specific recommendation is required. However, with regard to the previous dumping incident by other parties on the Taro field near the Treasure Spot Garden, the Contractor is recommended to check the site condition regularly to avoid any extent of dumping or paving of area within the project boundary.
- 3.2.10 The Contractor should also make sure there are no piled rocks, construction materials or programmed construction works influencing the existing trees within the Project Area or the wetland rehabilitation area.
- 3.2.11 The Contractor could establish a warning sign to remind the driver to beware of the presence of the tree(s) close to the temporary parking area.

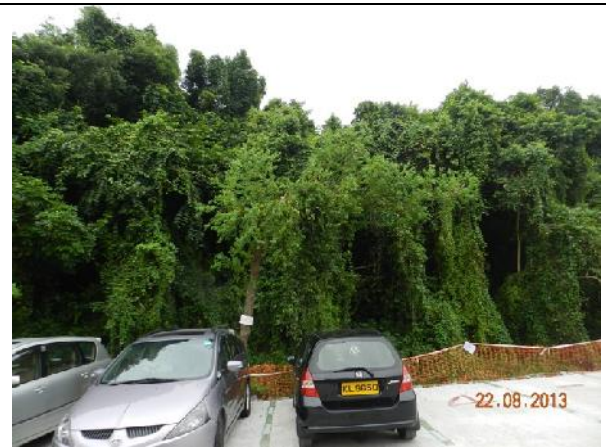
- 3.2.7 The temporary parking area was still observed at the end of the access path to Treasure Spot Garden Phase II (**Photo 8**). The untagged leaning tree was still guyed at the edge of the area within a Tree Protection Zone (TPZ), which was demarcated by orange construction nets (**Photo 9**). However, the vehicle was still parked close to the TPZ.

Photo 8 – Temporary parking area was still observed at the end of the access path to Treasure Spot Garden Phase II.

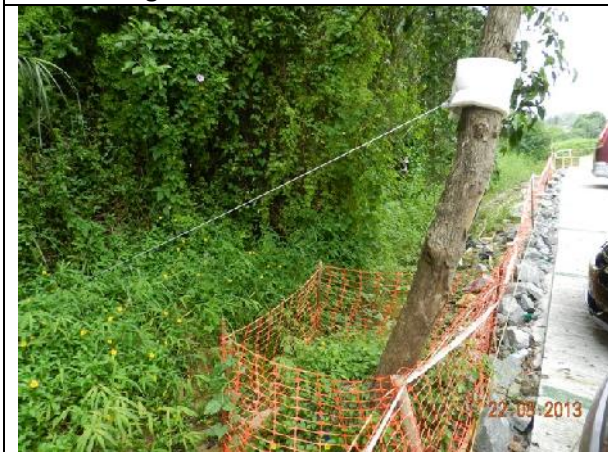
Photo 9 – The untagged leaning tree was guyed at the edge of the parking area within a Tree Protection Zone.

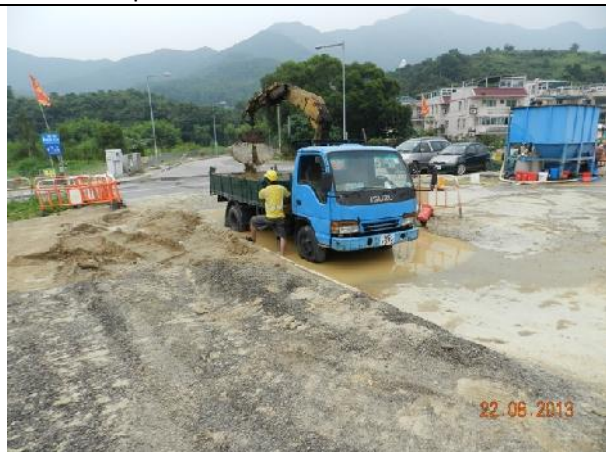
- 3.3.2 Provision of dust control measure (such as wheel washing facilities) has been maintained at two major vehicular exit points of the works area of Contract 2 (**Photo 10**).
- 3.3.3 The sections of granules of the sedimentation beds located from north to south near the retained tree T196 (*Macaranga tanarius* var. *tomentosa*) have been restored in August 2013 (**Photo 11**).
- 3.3.4 Another sedimentation beds aligned from the area opposite to the Jade View Villa towards the marsh area at southeast have been maintained since October 2012. No muddy water was observed to be discharged into the drainage points but the beds were overgrown by dense grassy vegetation (**Photo 12**).

Photo 10 – Provision of wheel washing facilities noted at one major vehicular exit point of the works area of Contract 2.

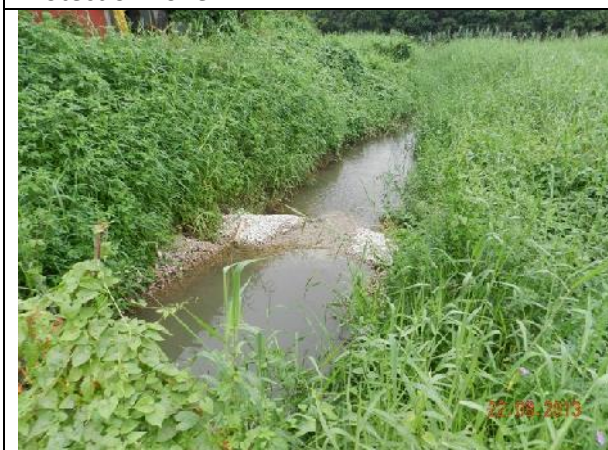
Photo 11 – A section of granules of the sedimentation beds located from north to south near the retained tree T196 (*Macaranga tanarius* var. *tomentosa*) was restored in August 2013.

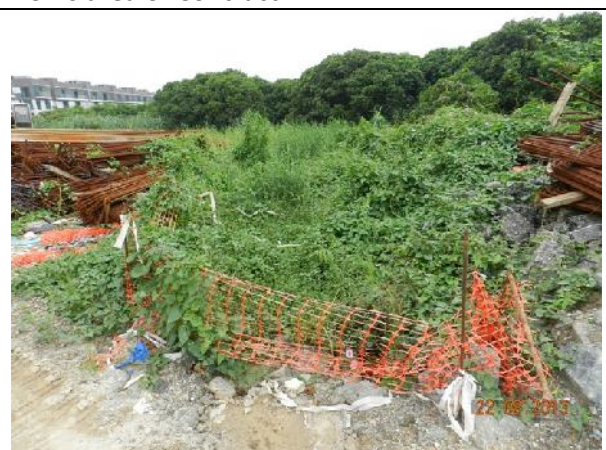
3.4.3 Another sedimentation beds aligned from the area opposite to the Jade View Villa towards the marsh area at southeast have been maintained since October 2012. No muddy water was observed to be discharged into the drainage points but the beds were overgrown by dense grassy vegetation (**Photo 12**).

Photo 12 – A sedimentation beds aligned from the area opposite to the Jade View Villa towards the marsh area at southeast. No muddy water was observed but the beds were overgrown by dense grassy vegetation.

3.3.7 Regular monitoring should be conducted to ensure no direct discharge or leakage of contaminants or any polluted fluid into the adjacent Wai Ha River and the nearby Shuen Wan marsh. The Contractor should maintain regular check (e.g. daily) on the sedimentation and filtration facilities and appropriate sedimentation beds and/or tanks throughout the construction phase (e.g. check the function of the sedimentation beds and remove surplus sand and gravels deposited along the beds or within the tanks) to make sure all discharged water was filtered appropriately prior to any discharge. The Contractor should have *ad hoc* inspection and emergency measures for any accidental spillage of polluted fluid, contaminants or grease from the construction sites. To prevent the impact of the unclear discharge on the nearby vegetated area, it is suggested to overlay PVC liners along the site edge and remove any surplus sand and gravels deposited in the beds and tank even some parts of the construction works may be completed at this stage.

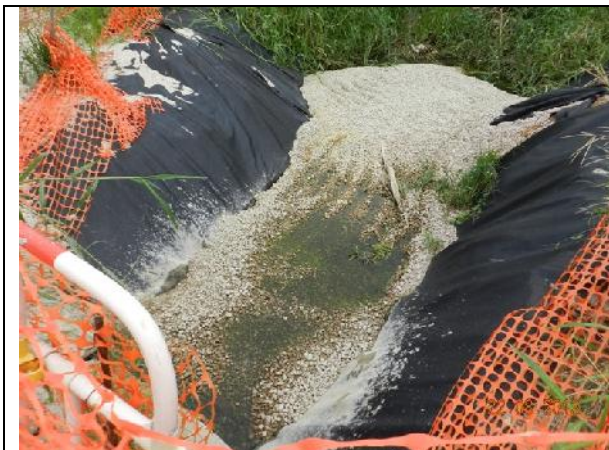
3.3.5 There has been another section of sedimentation beds aligned from the area opposite to the eastern part of Jade View Villa towards the marsh area since December 2012. The used water was released into the sedimentation beds and no discharge of muddy water was observed (**Photo 13**).

3.4.4 There has been another section of sedimentation beds aligned from the area opposite to the eastern part of Jade View Villa towards the marsh area since December 2012. The used water was released into the sedimentation beds and no discharge of muddy water was observed (**Photo 13**).

Photo 13 – A section of sedimentation beds aligned from the area opposite to the eastern part of Jade View Villa towards the marsh area. No muddy water was discharged.

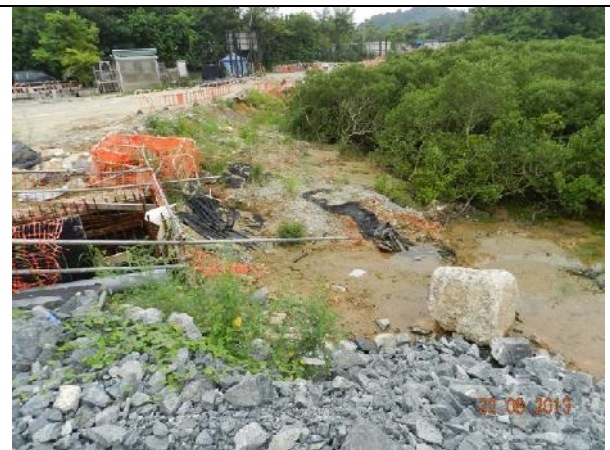
3.3.6 No more discharge was observed at the discharge point at which a filtration tank has been previously placed opposite to San Tau Kok since April 2013 (**Photo 14**).

3.4.1 No more discharge was observed at the discharge point at which a filtration tank has been previously placed opposite to San Tau Kok since April 2013 (**Photo 14**).

Photo 14 – No more discharge was observed at the discharge point at which a filtration tank has been previously placed opposite to San Tau Kok since April 2013.

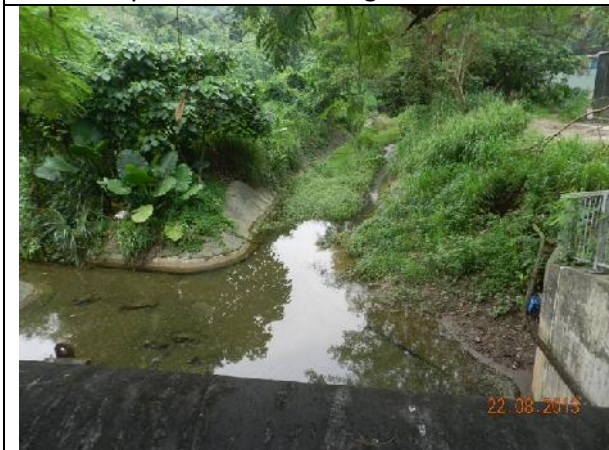
3.4.2 No direct water discharge into the upper stream of Wai Ha River was observed as the active construction works have been concentrated at the lower end of Wai Ha River to the southeast of Tung Tsz Shan Road (**Photo 15**).

Photo 15 – No direct water discharge into the upper stream of Wai Ha River was observed as the construction works have been concentrated at the lower end of the river.

3.4.3 The Contractor should prevent any contaminants and sediments from entering the sensitive water-based habitats (i.e. Shuen Wan marsh and Wai Ha River) and implement pollution control measures to minimize any adverse environmental impacts to the water body. The Contractor should maintain appropriate sedimentation beds and/or tanks throughout the construction phase. The Contractor should adopt a good site practice in maintaining appropriate sedimentation beds and filtration tanks as recommended in the above Section for Contaminant/ Sediment Control.

3.4.4 The Contractor should have *ad hoc* inspection and emergency measures for any accidental spillage of polluted fluid, contaminants or grease from the construction sites. It is also recommended to overlay PVC liners along the site edge and remove any surplus sand and gravels deposited in the beds and tank so as to prevent the impact of the unclear discharge on the nearby vegetated area.

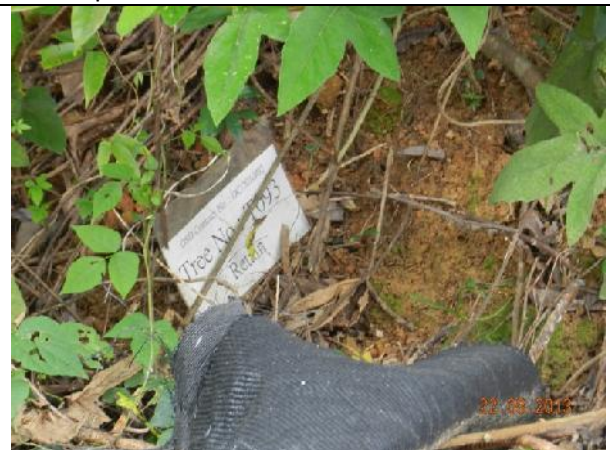
Photo 16 – Tree tag of T093 was found on the ground.

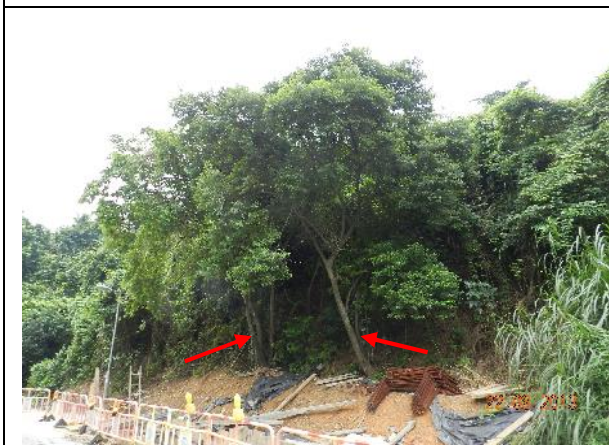
Photo 17 – Temporary storage of construction materials were noted close to the trunk flares and trunks of T093 and T094 (both indicated).

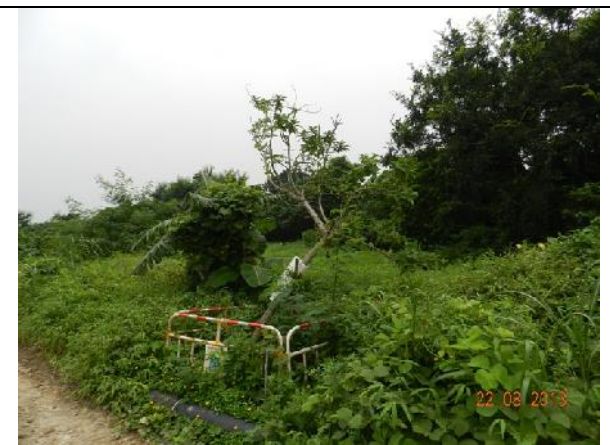
Photo 18 – The leaning tree T190 has been supported by a wooden prop since July 2013.

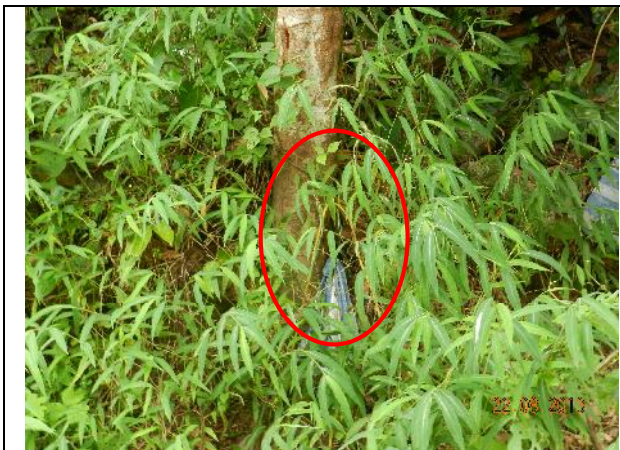
Photo 19 – Tapes and ropes were still found tied on the trunk of the retained tree T103.

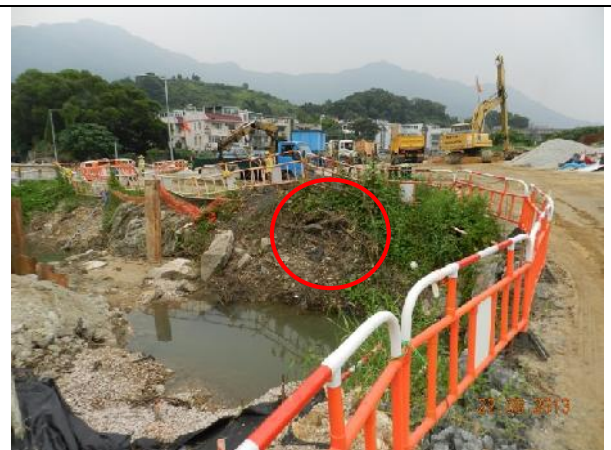
Photo 20 – The retained tree T196 was not found in the site during the monitoring on 22nd August 2013.

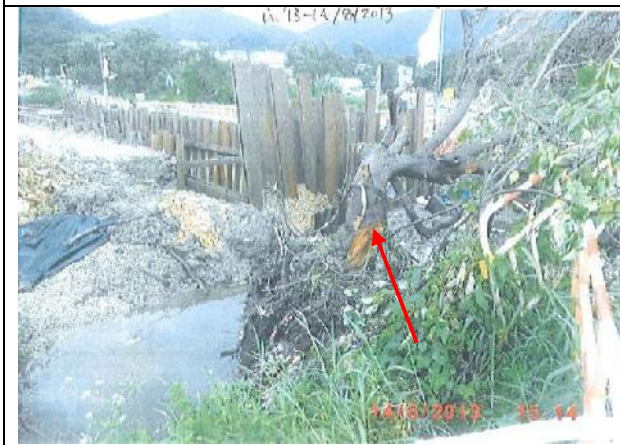
Photo 21 – The retained tree T196 was collapsed under the influence of Typhoon Utor hoisted on 14th August 2013. This photo was provided by the Contractor.

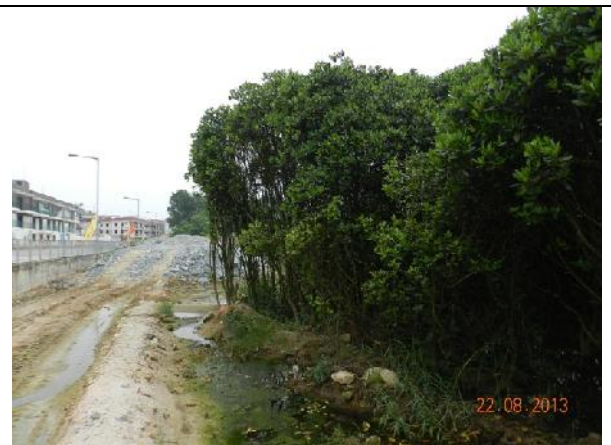
Photo 22 – Stock pile of soil was noted at the trunk bases of some mangrove trees.

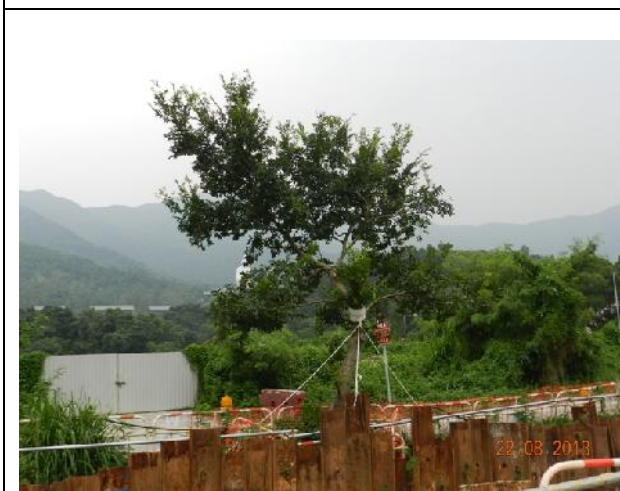
Photo 23 – The retained tree T025 was pruned before and it was temporarily guyed to provide additional support to this tree.

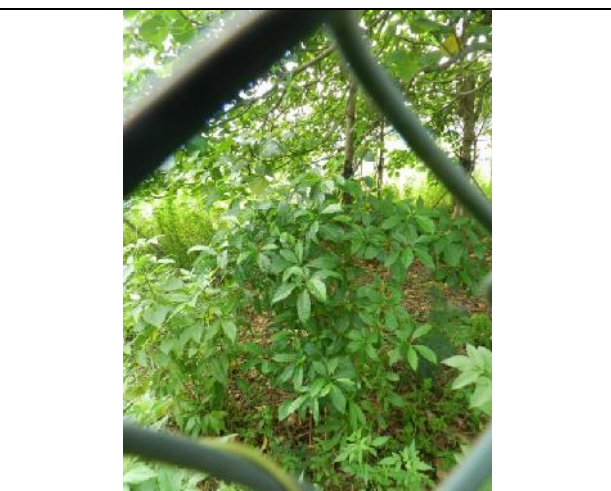
Photo 24 – The transplanted shrub of *Pavetta hongkongensis* (PH03) has remained in satisfactory condition in Area C under Contract 1.
