Monthly Environmental Monitoring & Auditing report for

Contract No.DC/2009/22

Drainage Improvement in Shuen Wan, Tai Po – Contract 1

September 2013

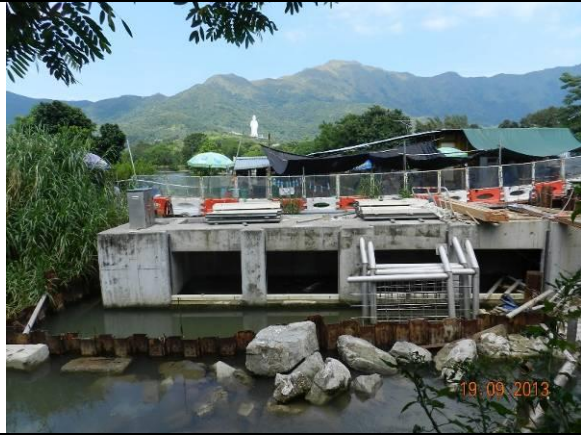
Construction hoardings have been erected in Area A along the entire site boundary. Temporary construction hoardings have been erected around Wai Ha River estuary since the building of an automatic mechanical penstock at the area (**Photo 1**). As observed in September 2013, the permanent boundary wall was establishing along the western side of Area A (**Photo 2**), while those along the northern side was also removed. The main entrance of Area A has also been shifted from the southern corner to the northern corner along the western side of the area (**Photo 3**). Since January 2013, the site hoardings along the eastern boundary of Area A have been removed due to the active construction works for the installation of drainage pipe and the associated structure.

Photo 1 – Temporary hoardings have been established to surround the works area at Wai Ha River estuary.

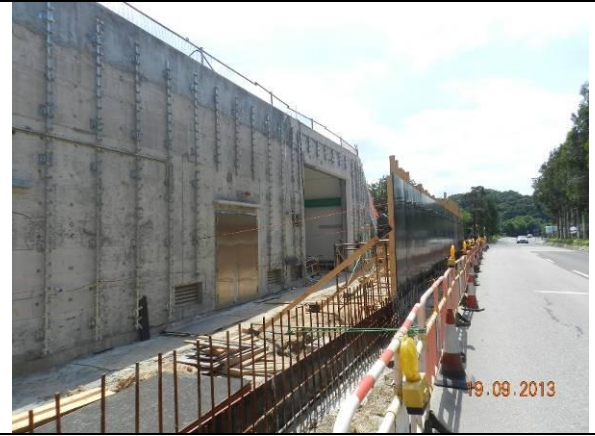
Photo 2 – The permanent boundary wall has started to be established along the western side of Area A.

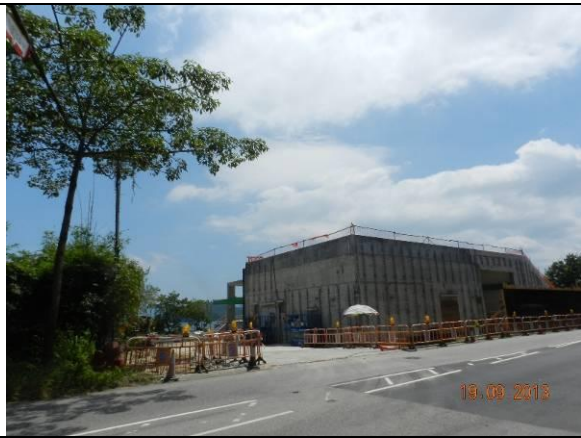
Photo 3 – The main entrance of Area A has been shifted from the south to the north along the western side of the area.

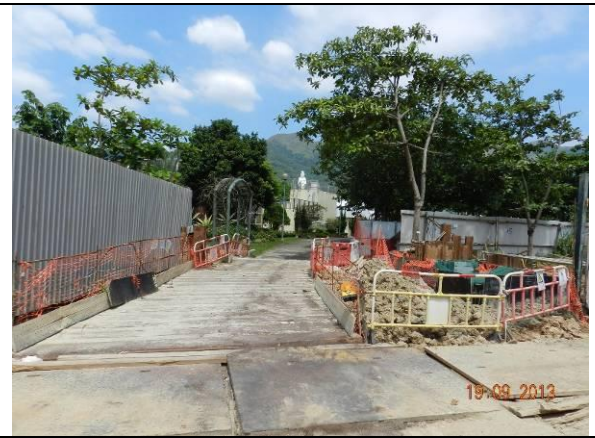
A section of temporary hoarding has been erected from northwest to southwest parts (i.e. Phase 1 construction works) of Tung Tsz Nursery in Area B (approximately along the works boundary from Trees U42 to U62). Another section of temporary hoarding has been erected from southwest to eastern parts (i.e. Phase 2 construction works) of the Nursery since May 2012 and connected with Phase I construction works area. An open section with no construction work has been maintained as a major road access inside Tung Tsz Nursery for their daily operations. As observed in September 2013, temporary construction hoardings had been established along the eastern end of Phase 1 with an entrance, while the western end of Phase 2 works area were still aligned with temporary construction barriers (**Photo 4**).

Photo 4 – Temporary hoardings has been established at the eastern end of Phase 1 with an entrance, while the western end of Phase 2 works area were still aligned with temporary construction barriers (as shown in the photo).

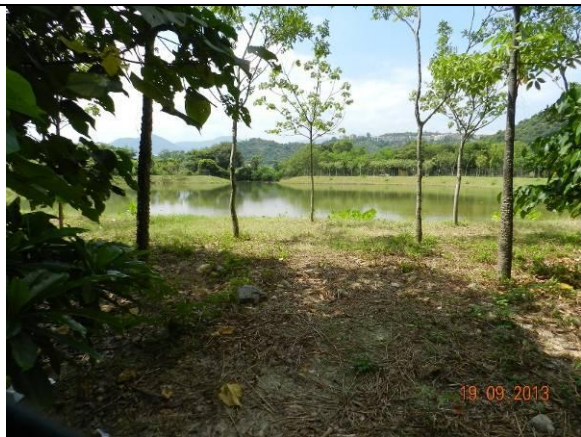
Area C was formally handed over to AFCD on 16th October 2012 for management and maintenance. The pond of the ECA has been connected to Wai Ha River directly as following the scheme design of Habitat Compensatory Plan. No direct discharge of turbid water into the adjacent Wai Ha River was observed through the fence of Tung Tsz Nursery **(Photo 5)**.

Photo 5 – No discharge of muddy water was observed in Area C.

The Contractor should regularly check the condition and locations of the drainage pipes and ensure that all used water should be appropriately filtered and discharged to the manholes/other discharge points agreed by the Engineer and EPD. This is to avoid any potential contamination to the vegetation in Shuen Wan marsh and other vegetated/marinated areas adjacent to the active works area.

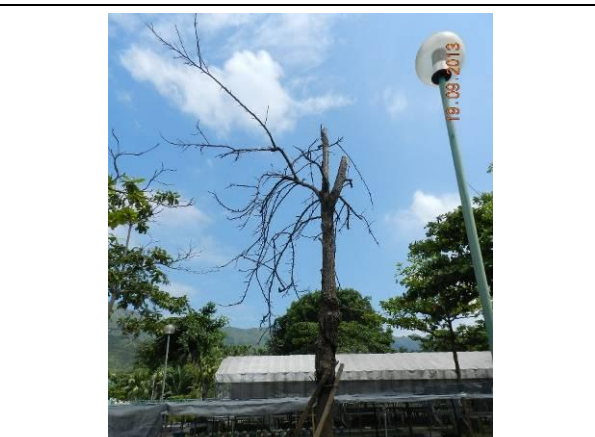
considered to be a dead specimen as no sign of regenerated leaves was observed along the trunk and the remaining branches (Photo 6). There was still no replacement of the broken bamboo stake, which has been reported in Monthly EM&A Report for July 2013, in September 2013. Given the broken bamboo stake provides no support to the dead tree with a significant wound on the middle tree trunk, there is a potential risk of whole tree failure, with its falling zone covering the assess path used by any visitors/ nursery workers in the Nursery.

As highlighted in the Section “Liaison with Nursery”, the transplanted tree *Grevillea robusta* (U58) was considered to be a dead specimen as no sign of regenerated leaves was observed along the trunk and the remaining branches (Photo 6). There was still no replacement of the broken bamboo stake.

Photo 6 – Overall view of the transplanted tree U58, which is considered to be dead.

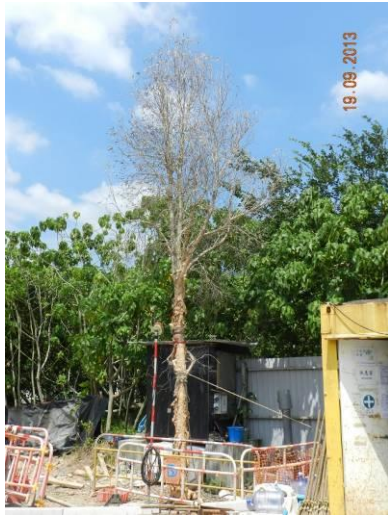
E38 (*Melaleuca cajuputi* subsp. *cumingiana*) was found to be relocated by the contractor from the northern corner to the northern part next to the temporary site office in Area A in late August 2013 (Photo 7). As inspected in September 2013, the tree was in very poor health condition with only dry and wilt leaves in its canopy. Due to the poor transplantation skill applied on this tree, the tree bark and cambium layer along the trunk were damaged and the tree bark along the damaged tree trunk appeared very dry and shrunken (Photo 8).

Photo 7 – Relocated tree E38 was in very poor health condition with only dry and wilt leaves in its canopy.

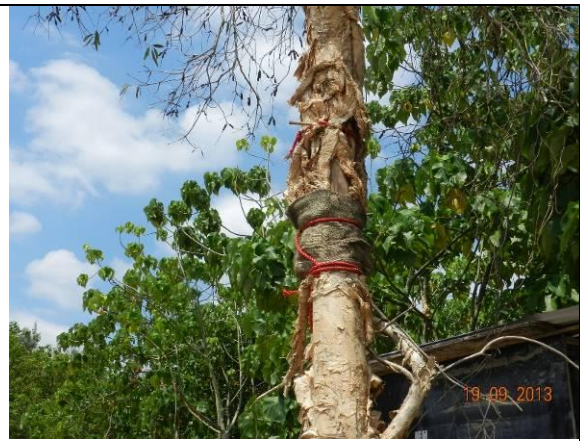
Photo 8 – The tree bark along the damaged tree trunk of E38 appeared to be very dry and shrunken.

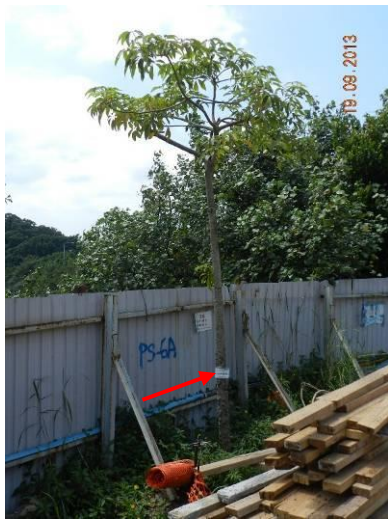
The tree to be transplanted E16 (*Bombax ceiba*) has been relocated to the southern side of Area A next to the site hoarding since July 2012. The tree was in fair condition in September 2013 (Photo 9).

Photo 9 – The relocated tree E16 remained in fair condition in August 2013.

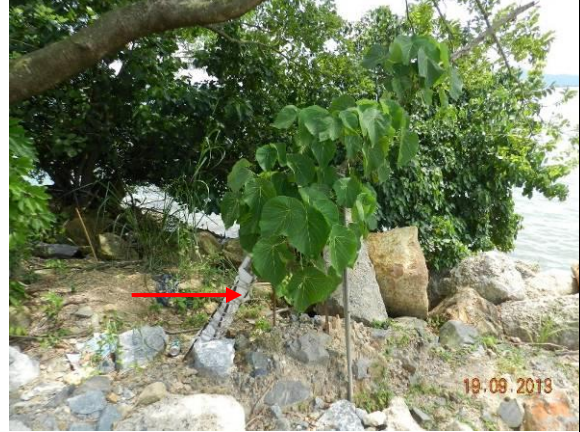
The leaning trunk of E61 (*Macaranga tanarius* var. *tomentosa*) has been burlapped and supported by two steel poles since May 2013. Though new leaves have regenerated along the leaning trunk, this tree is still in poor health condition and under physiological stress (Photo 10). Its structural condition is poor.

Photo 10 – The wound at the trunk flare of E61 was burlapped and the leaning tree trunk was supported by two steel poles.

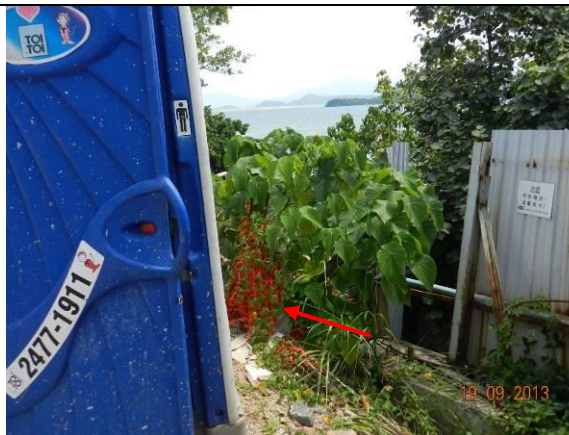
Damaged tree trunk on E55 (*Macaranga tanarius* var. *tomentosa*) was reported in Monthly EM&A Report for April 2013. The wound on the trunk of E55 has been burlapped since May 2013. The upper section of the tree trunk has broken since June 2013. The tree was still in poor condition with most of its foliage as watersprouts only (Photo 11). The tree was located just next to some on-going construction works.

Photo 11 – E55 with burlapped broken trunk was still in poor condition.

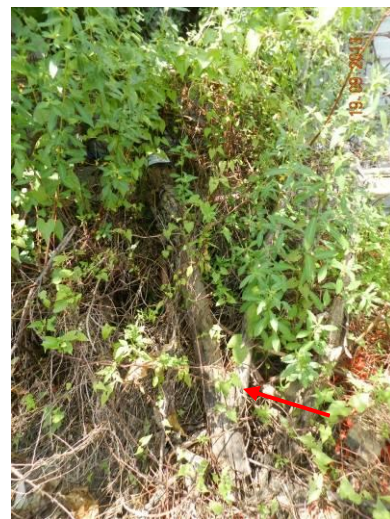
No recovery signs have been observed on the relocated trees U34, U35 and U37 and they are regarded as dead specimens (Photos 12-14); the dead tree trunks of U34 and U35 have collapsed since August 2013. Temporary storage of construction materials was still observed close to the tree group of U34, U35, U37 and other living trees (e.g. U44) in Area B (Photo 15).

Photo 12 – The dead trunk of U34 was found collapsed within the Tree Protection Zone.

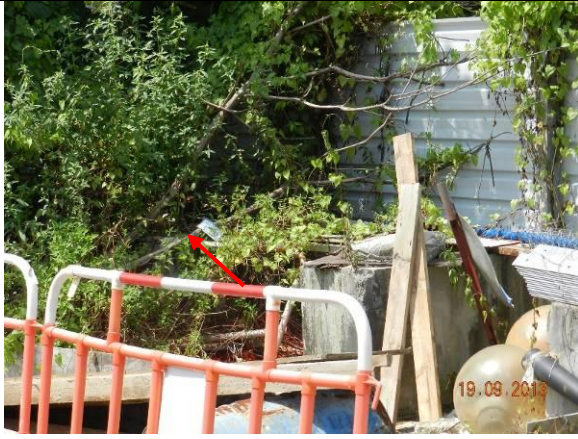
Photo 13 – The dead trunk of U35 was found collapsed within the Tree Protection Zone.

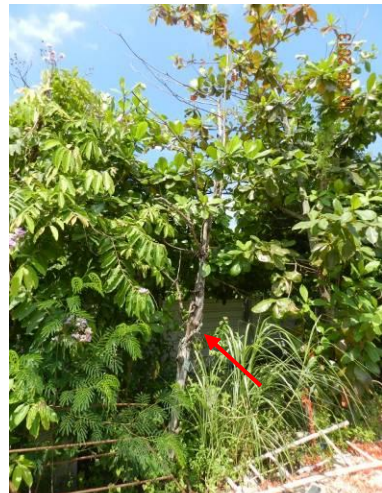
Photo 14 – No recovery sign of the relocated tree U37 in Area B was observed.

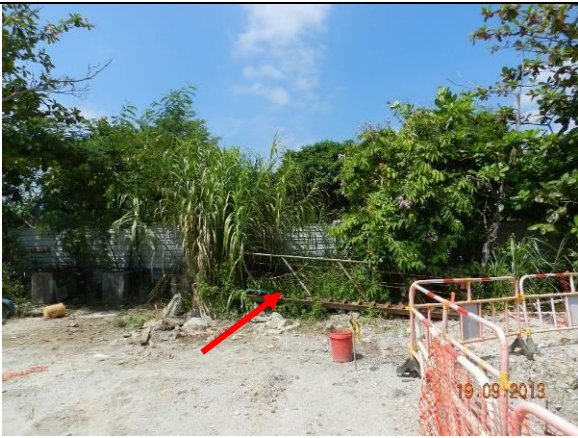
Photo 15 – Temporary storage of construction material was still observed next to the tree groups in Area B.

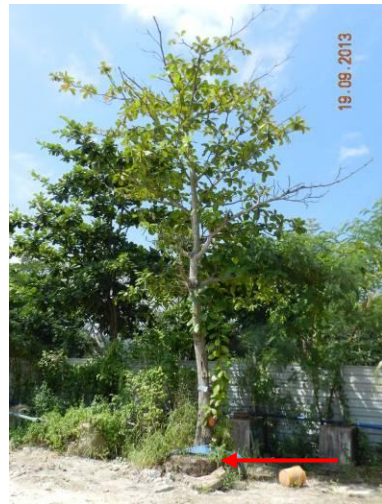
Half of the planter of U47 (*Terminalia catappa*) was found broken in August 2013, and its roots and planter soil were exposed in the air. As inspected in September 2013, the planter was not yet repaired (Photo 16).

Photo 16 – Half of the planter of U47 was broken and not yet repaired.

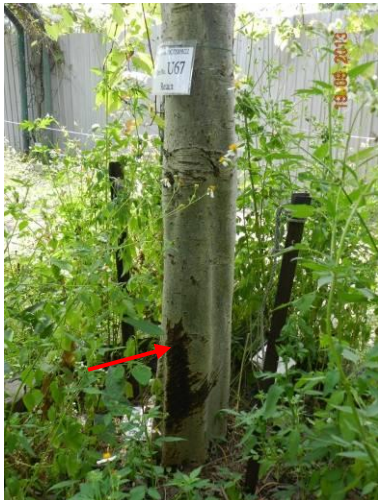
U67 (*Cassia fistula*) has been retained at its original planter. A sign of suspected termite infestation was observed close to its trunk flare (Photo 17). The tree was still in fair health

and structural condition as observed in September 2013.

Photo 17 – A sign of suspected termite infestation was observed close to the trunk flare of U67.

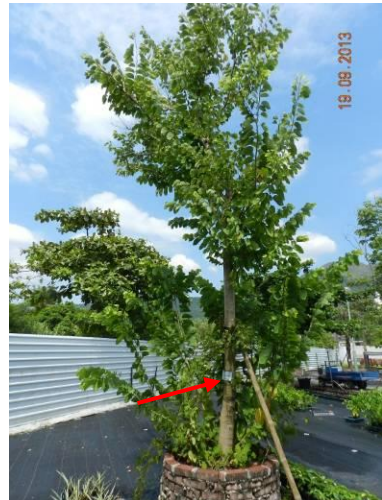
U64 (*Bauhinia purpurea*) has been transplanted to its final receptor site in 2011. The tree appears in generally fair condition, but decayed wood and cracked tree bark have been observed at the western side of the tree trunk in the recent few months (Photos 18-19).

Photo 18 – U64 appears in generally fair condition in September 2013.

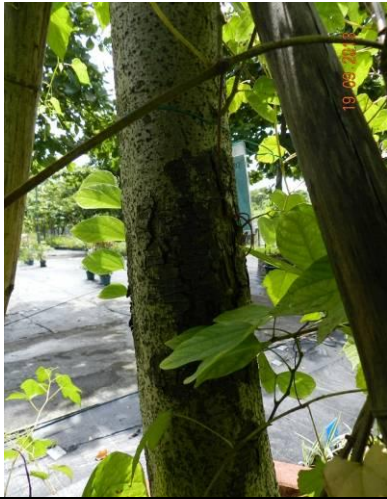
Photo 19 – Decayed wood and cracked tree bark have been observed at the western side of the tree trunk of U64 in the recent months.

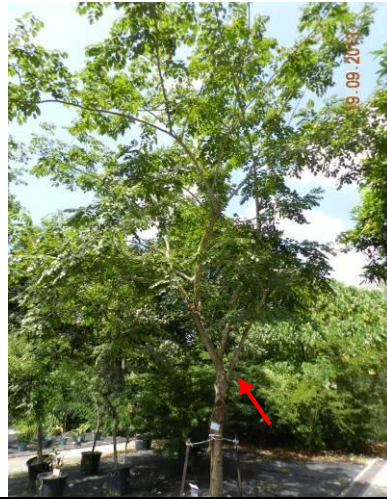
U55 (*Pterocarpus indicus*) has also been transplanted to its final receptor site in 2011 and pest control was applied on this tree in early 2013 due to the sign of termite infestation. Its health condition has been improved (Photo 20), however, a few long dead branches and twigs were observed. Close monitoring on this tree is still required.

Photo 20 – Improved health condition of the transplanted tree U55.

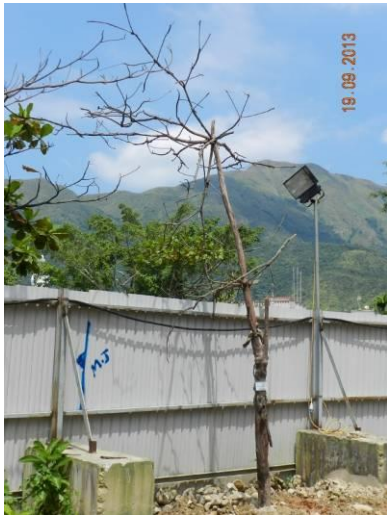
The relocated tree U77 (*Terminalia catappa*) in Phase 2 of Area B was suspected to be dead as no leaves have been observed in the canopy since its relocation, and loose bark was found along the trunk (Photo 21). U76 and U78 (*Terminalia catappa*) remained in marginally fair condition with regenerated leaves concentrated and development of watersprouts in the upper canopy. Dieback twigs were still observed in September 2013 and minor tree bark tearing was observed at the trunk flares of these trees (Photos 22-23).

Photo 21 – The relocated tree U77 in Area B was suspected to be a dead specimen.

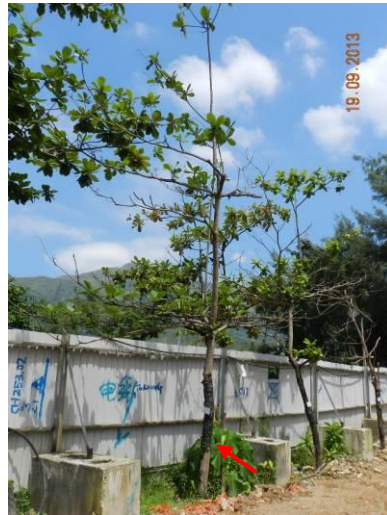
Photo 22 – U76 remained in marginally fair condition with watersprouts in the canopy.

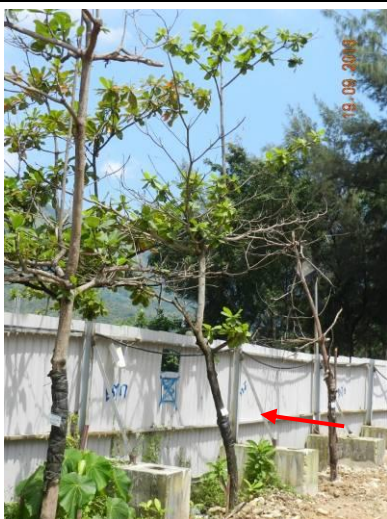
Photo 23 – U78 remained in marginally fair condition with watersprouts in the canopy.

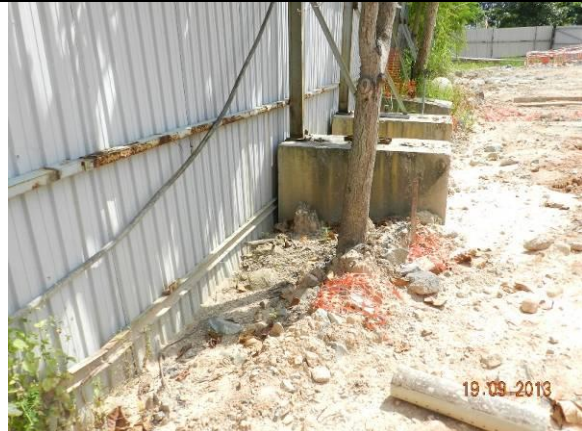
Most of the construction materials piled close to the trunk flare of A43 was removed in July 2013, but surplus soil was still found around the trunk flare (Photo 24).

Photo 24 – Surplus soil was still found around the trunk flare of A43.

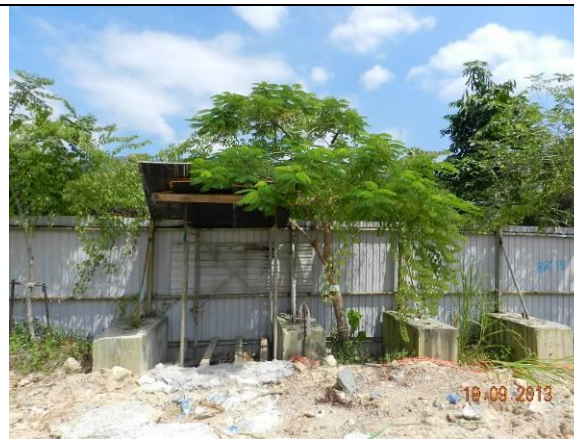
Photo 25 – A temporary shelter was still observed next to the relocated tree U74 in Area B.

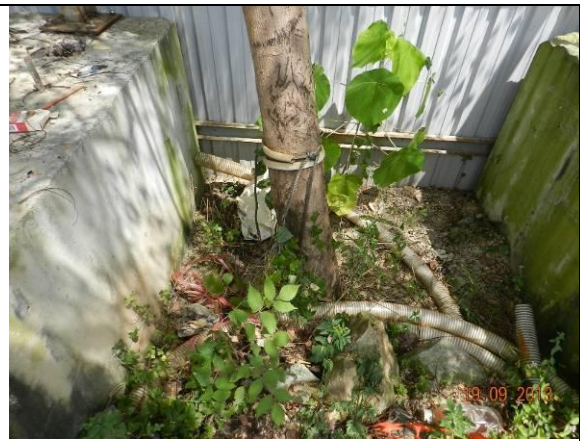
Photo 26 – No more construction material was stored next to the trunk flare.

A temporary shelter was still observed next to the relocated tree U74 (*Delonix regia*), in which the shelter has been established since April 2013 (Photo 25). No significant damage on the tree trunk and canopy caused by the shelter was observed. No more construction materials were stored close to the trunk flare hole (Photo 26).

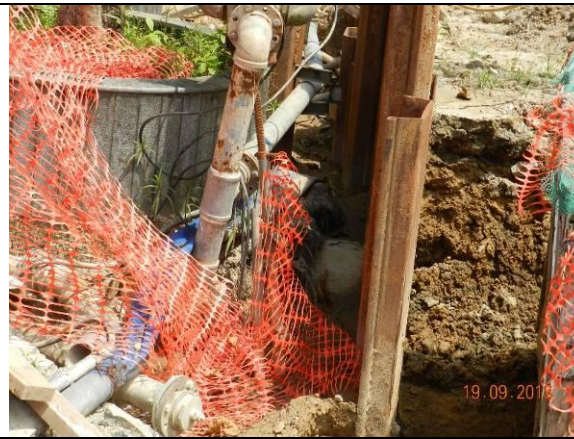
Photo 27 – The excavated area close to the retained tree A40 has not yet refilled as inspected in September 2013.

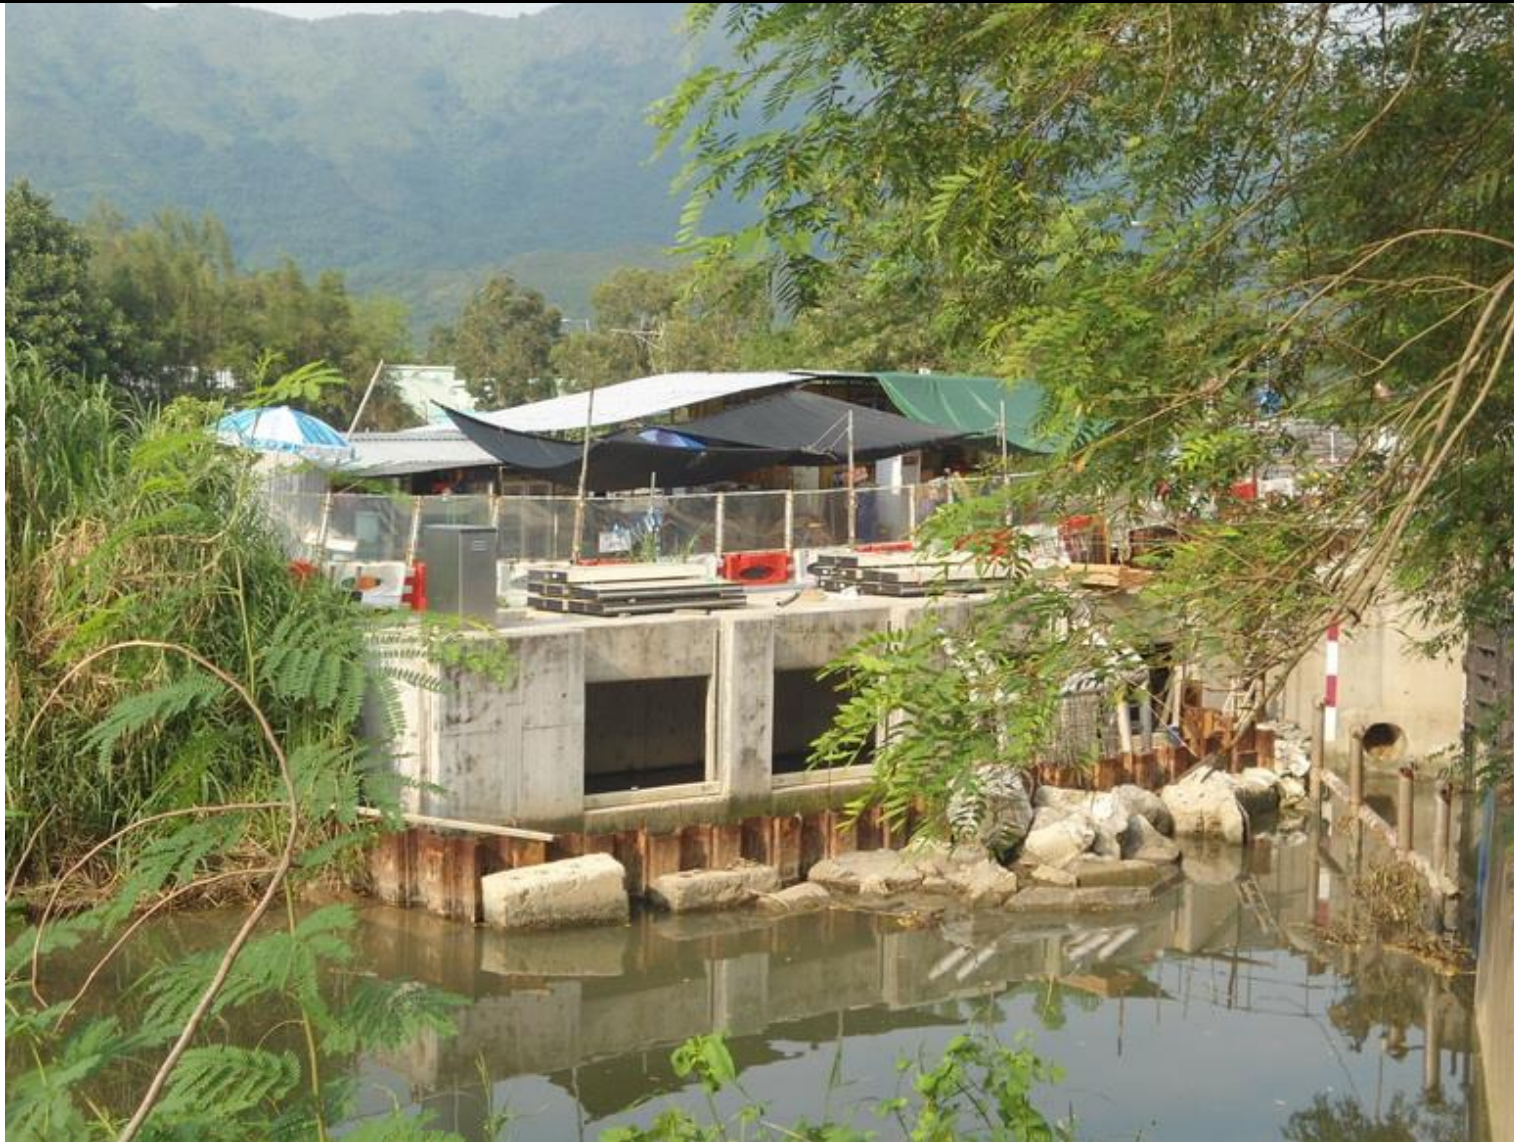
Figure: 2

Title: SEMP 1, the first sampling point of Wai Ha River under Contract 1.

Under Contract 1 (i.e. SEMP 1), a total of 7 fish species, 1 bivalve and 1 snail were recorded and most of them were residing in brackish environments (**Table 7**). Some river works were carried out in SEMP 1 as showed in **Figure 2**. Overall, no protected or rare species were recorded.
