**CONTRACT NO. DC/2010/02 –  
DRAINAGE IMPROVEMENT IN SHUEN WAN AND  
SHEK WU WAI**

**MONTHLY ENVIRONMENTAL MONITORING AND  
AUDIT REPORT (NO.27) – SEPTEMBER 2013**

PREPARED FOR  
**KWAN LEE-KULY JOINT VENTURE**

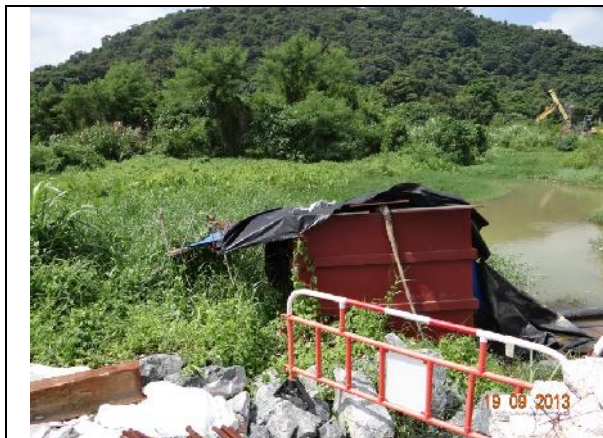
**Photo 7** – A filtration tank covered by plastic mat was found next to the wetland rehabilitation area in September 2013.

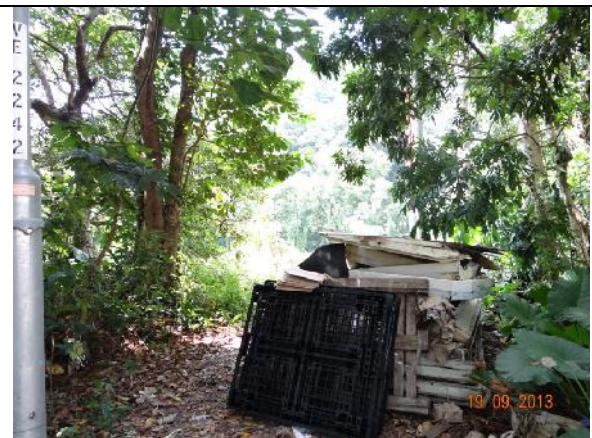
- 3.2.6 Outside the established hoardings of the Project Area, temporary storage of construction materials was still found next to the retained tree T179 in September 2013 (**Photo 8**).

**Photo 8** – Temporary storage of construction materials was still found next to the retained tree T179 in September 2013.

- 3.2.9 No specific recommendation is required. However, with regard to the previous dumping incident by other parties on the Taro field near the Treasure Spot Garden, the Contractor is recommended to check the site condition regularly to avoid any extent of dumping or paving of area within the project boundary.
- 3.2.10 The Contractor should also make sure there are no piled rocks, construction materials or programmed construction works influencing the existing trees within the Project Area or the wetland rehabilitation area.
- 3.2.11 The Contractor could establish a warning sign to remind the driver to beware of the presence of the tree(s) close to the temporary parking area.

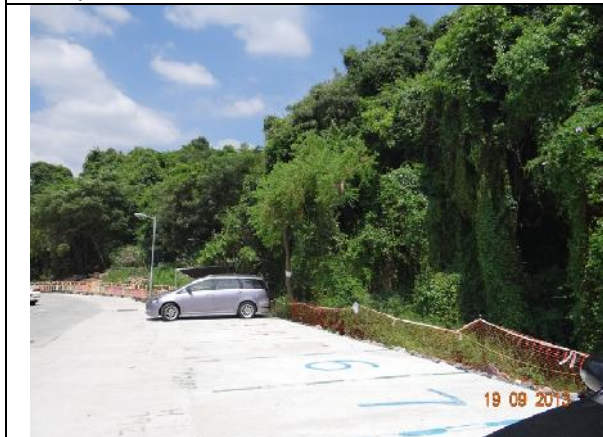
**Photo 9** – Temporary parking area was still observed at the end of the access path to Treasure Spot Garden Phase II.

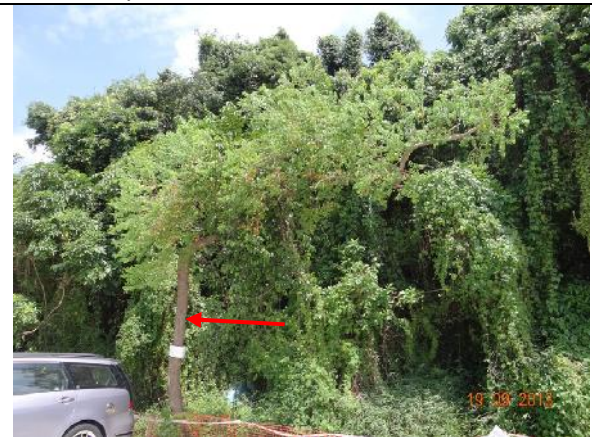
**Photo 10** – The untagged leaning tree was guyed at the edge of the parking area within a Tree Protection Zone.

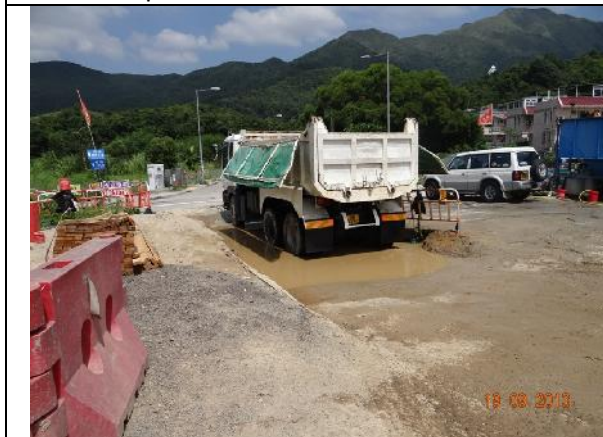
**Photo 11** – Provision of wheel washing facilities was noted at one major vehicular exit point of the works area of Contract 2.

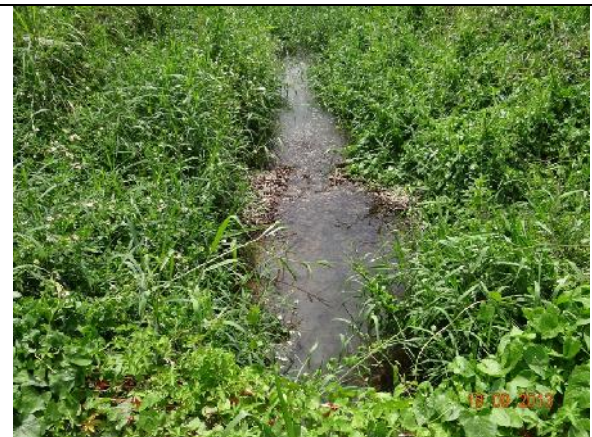
- 3.4.2 As mentioned in Section 3.3, the sections of granules of the sedimentation beds located from north to south near the retained tree T196 (*Macaranga tanarius* var. *tomentosa*) have been restored in August 2013 (**Photo 12**).
- 3.4.3 Another sedimentation beds aligned from the area opposite to the Jade View Villa towards the marsh area at southeast have been maintained since October 2012. No muddy water was observed to be discharged into the drainage points but the beds were overgrown by dense grassy vegetation (**Photo 13**).
- 3.4.4 There has been another section of sedimentation beds aligned from the area opposite to the eastern part of Jade View Villa towards the marsh area since December 2012. The used water was released into the sedimentation beds and no discharge of muddy water was observed (**Photo 14**).

**Photo 12** – A section of granules of the sedimentation beds, which is located from north to south near the previous location of the collapsed tree T196 (*Macaranga tanarius* var. *tomentosa*), has been restored since August 2013.

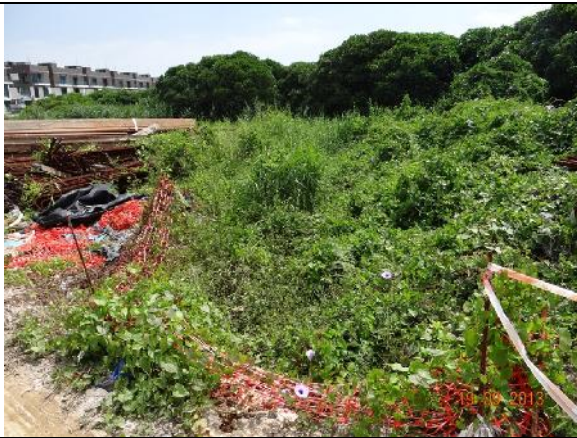
- 3.3.4 Another sedimentation beds aligned from the area opposite to the Jade View Villa towards the marsh area at southeast have been maintained since October 2012. No muddy water was observed to be discharged into the drainage points but the beds were overgrown by dense grassy vegetation (**Photo 13**).

**Photo 13** – A sedimentation beds aligned from the area opposite to the Jade View Villa towards the marsh area at southeast. No muddy water was observed but the beds were overgrown by dense grassy vegetation.

- 3.3.7 Regular monitoring should be conducted to ensure no direct discharge or leakage of contaminants or any polluted fluid into the adjacent Wai Ha River and the nearby Shuen Wan marsh. The Contractor should maintain regular check (e.g. daily) on the sedimentation and filtration facilities and appropriate sedimentation beds and/or tanks throughout the construction phase (e.g. check the function of the sedimentation beds and remove surplus sand and gravels deposited along the beds or within the tanks) to make sure all discharged water was filtered appropriately prior to any discharge. This recommendation should be applied in dealing with the overflow and leakage problems of the filtration tank mentioned in Section 3.3.6.

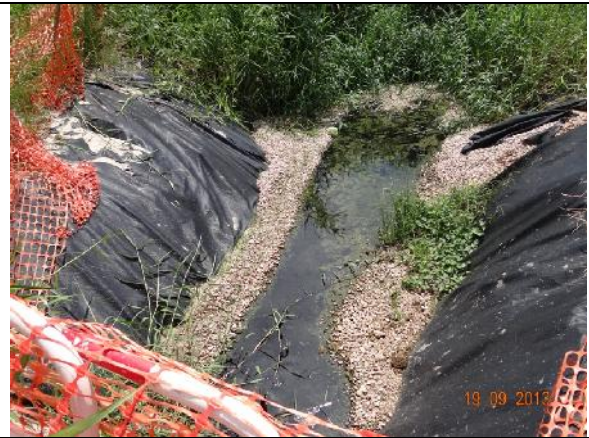
- 3.3.5 There has been another section of sedimentation beds aligned from the area opposite to the eastern part of Jade View Villa towards the marsh area since December 2012. The used water was released into the sedimentation beds and no discharge of muddy water was observed (**Photo 14**).

**Photo 14** – A section of sedimentation beds aligned from the area opposite to the eastern part of Jade View Villa towards the marsh area. No muddy water was discharged.

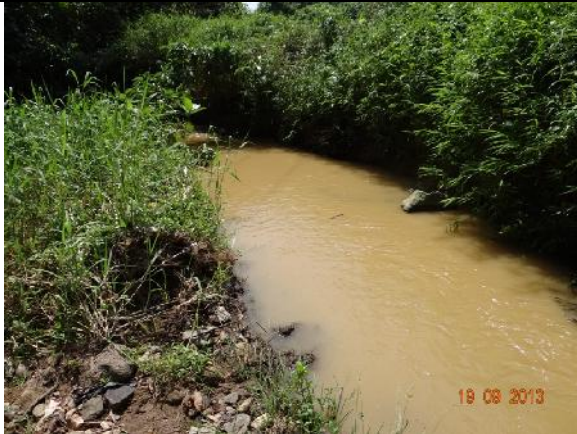
- 3.3.6 Muddy water was noted in the stream along Tung Tsz Road (**Photo 15**). A filtration tank was found on a slope near the public toilet on Tung Tsz Road (**Photo 16**). Muddy water from the works area was pumped to the filtration tank and the muddy water was seen overflowing and leaking into the stream (**Photo 17**).

**Photo 15** – Muddy water was noted in the stream along Tung Tsz Road.

- 3.4.3 The Contractor should prevent any contaminants and sediments from entering the sensitive water-based habitats (i.e. Shuen Wan marsh and Wai Ha River) and implement pollution control measures to minimize any adverse environmental impacts to the water body. The Contractor should maintain appropriate sedimentation beds and/or tanks throughout the construction phase. The Contractor should adopt a good site practice in maintaining appropriate sedimentation beds and filtration tanks as recommended in the above Section for Contaminant/ Sediment Control.

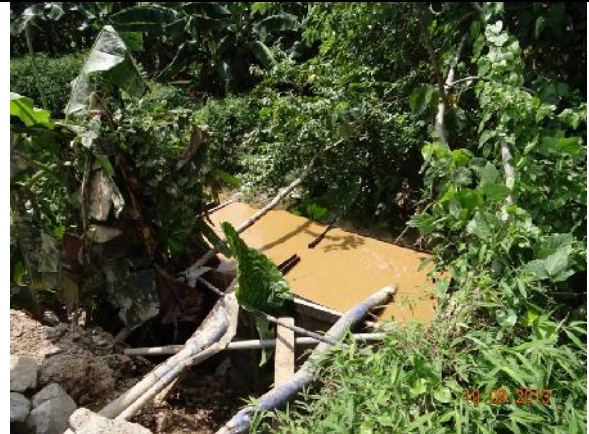
- 3.4.1 Muddy water was noted in the stream along Tung Tsz Road (**Photo 15**). A filtration tank was found on a slope near the public toilet on Tung Tsz Road (**Photo 16**). Muddy water from the works area was pumped to the filtration tank and the muddy water was seen overflowing and leaking into the stream (**Photo 17**).
- 3.4.2 No direct water discharge into the upper stream of Wai Ha River was observed as the active construction works have been concentrated at the lower end of Wai Ha River to the southeast of Tung Tsz Shan Road (**Photo 18**).

**Photo 16** – A filtration tank was found on a slope near the public toilet on Tung Tsz Road. Muddy water from the works area was pumped to the filtration tank and the muddy water was seen overflowing and leaking into the stream.

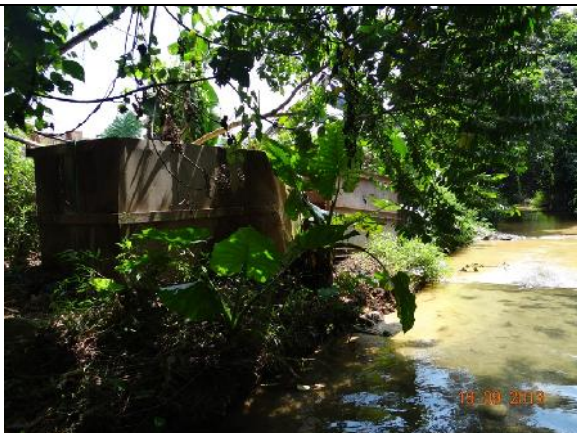
**Photo 17** – Muddy water was seen overflowing and leaking into the stream.

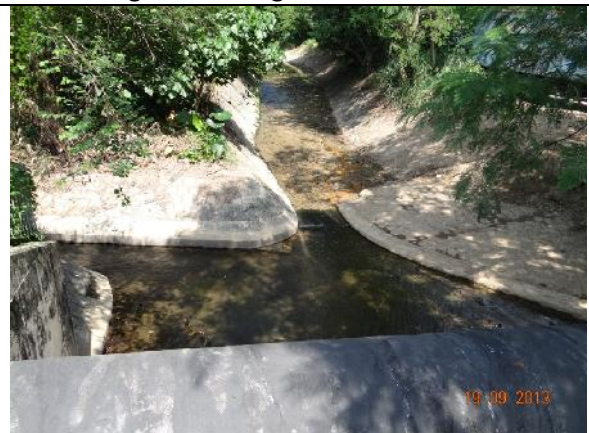
**Photo 18** – No direct water discharge into the upper stream of Wai Ha River was observed as the construction works have been concentrated at the lower end of the river.

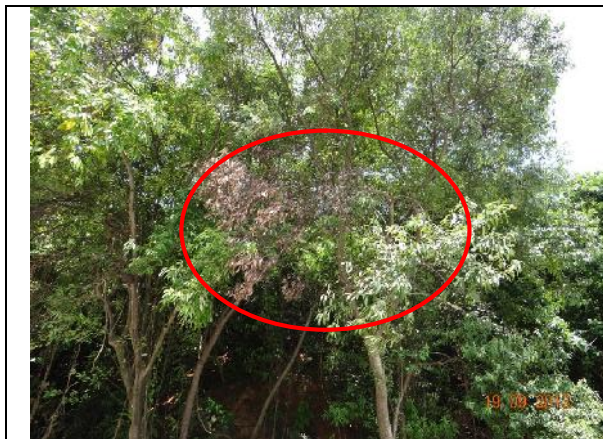
**Photo 19** – A broken branch was seen hanging on the retained tree T093.

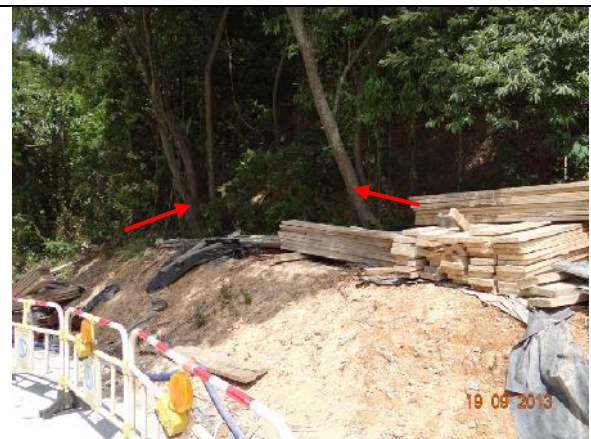
**Photo 20** – Temporary storage of construction materials were still noted close to the trunk flares and trunks of T093 and T094 (both indicated).

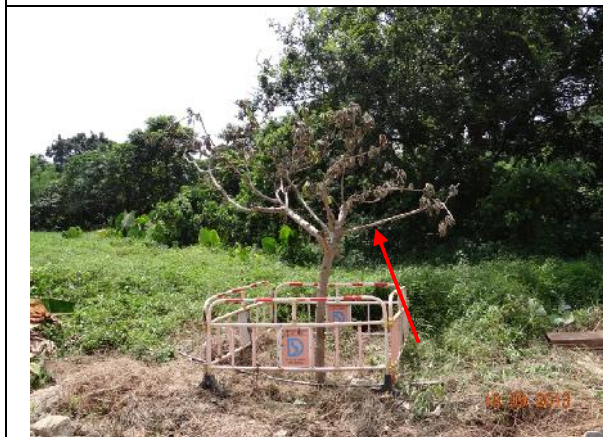
**Photo 21** – The retained tree T190 was suspected to be relocated or re-planted and it appeared to be “up-right” but in very poor health condition.

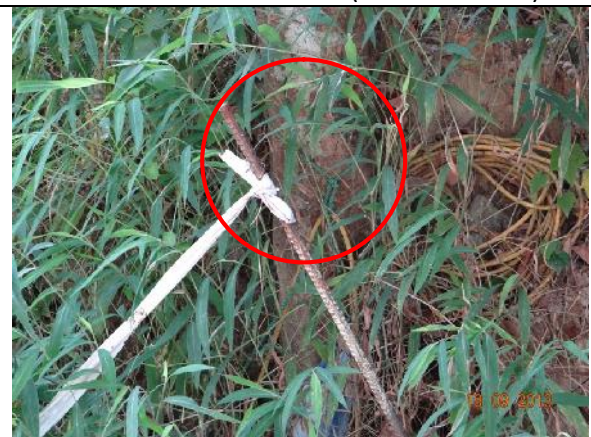
**Photo 22** – Tapes and ropes were still found tied on the trunk of the retained tree T103.

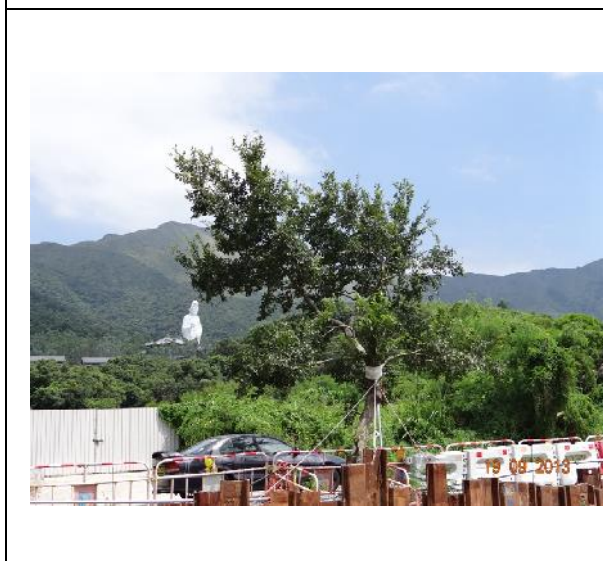
**Photo 23** – The retained tree T025 was pruned before and it was temporarily guyed to provide additional support to this tree.

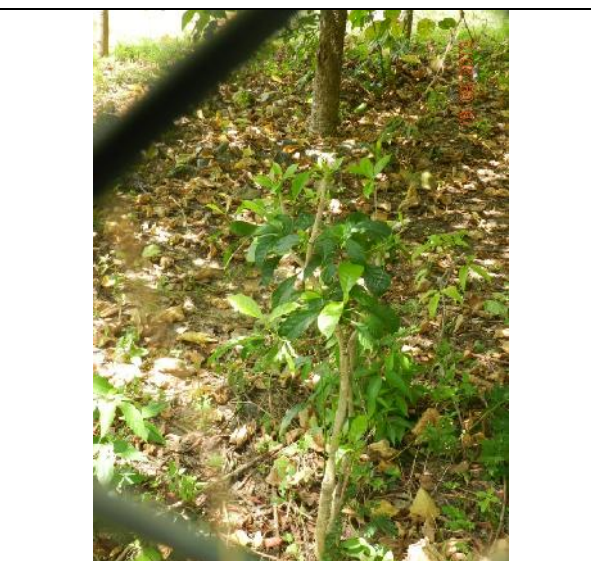
**Photo 24** – The transplanted shrub of *Pavetta hongkongensis* (PH03) in Area C under Contract 1 was heavily pruned in September 2013.
