**Monthly Environmental Monitoring & Auditing report for**

**Contract No.DC/2009/22**

**Drainage Improvement in Shuen Wan, Tai Po – Contract 1**

**October 2013**

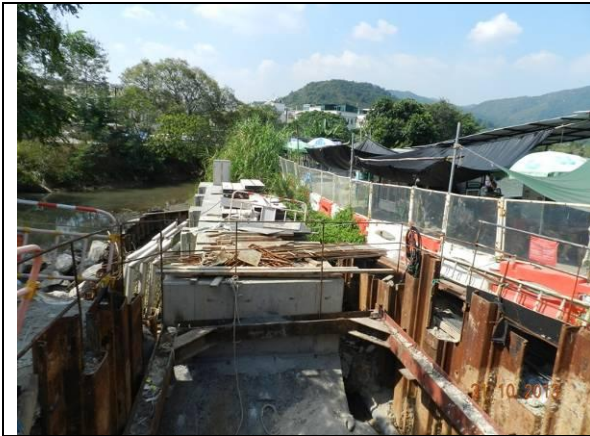
Construction hoardings have been erected in Area A along the entire site boundary. Temporary construction hoardings have been erected around Wai Ha River estuary since the building of an automatic mechanical penstock at the area (**Photo 1**). As observed in October 2013, the permanent boundary wall has been established along the western side of Area A (**Photo 2**), while those along the northern and southern sides were removed. The main entrance of Area A has also been shifted from the southern corner to the northern corner along the western side of the area since September 2013. Since January 2013, the site hoardings along the eastern boundary of Area A have been removed due to the active construction works for the installation of drainage pipes and the associated structures.

**Photo 1** – Temporary hoardings have been established to surround the works area at Wai Ha River estuary.

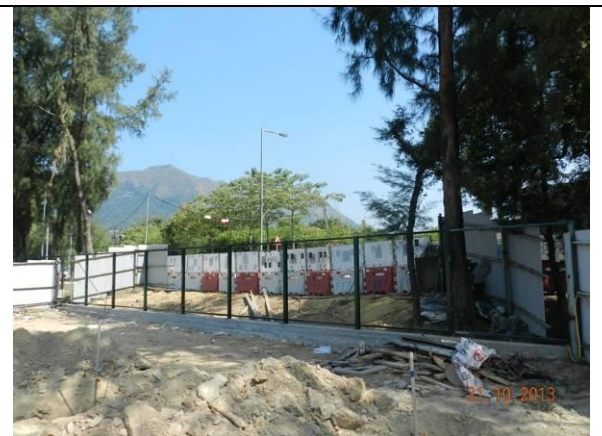
works boundary from Trees U42 to U62). Another section of temporary hoarding has been erected from southwest to eastern parts (i.e. Phase 2 construction works) of the Nursery since May 2012 and connected with Phase I construction works area. An open section with no construction work has been maintained as a major road access inside Tung Tsz Nursery for their daily operations. As observed in October 2013, temporary construction hoardings had been established along the eastern end of Phase 1 with an entrance and the western end of Phase 2 works area (**Photo 3**). Chain link fence was also found installed at the eastern end of Phase 2 works area (**Photo 4**).

**Photo 4** – Chain link fence was installed at the eastern end of Phase 2 works area.

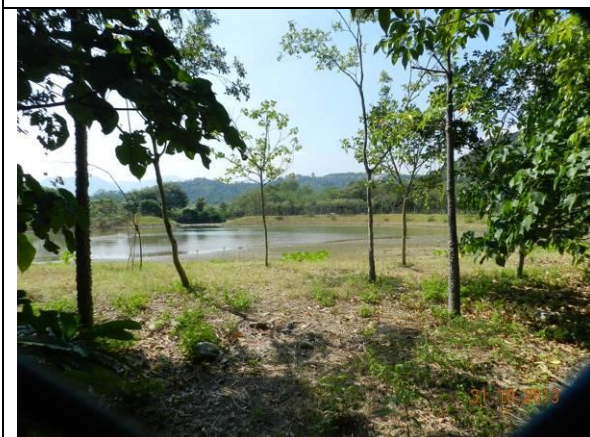
Area C was formally handed over to AFCD on 16<sup>th</sup> October 2012 for management and maintenance. The pond of the ECA has been connected to Wai Ha River directly as following the scheme design of Habitat Compensatory Plan. No direct discharge of turbid water into the adjacent Wai Ha River was observed through the fence of Tung Tsz Nursery (**Photo 5**).

**Photo 5** – No discharge of muddy water was observed in Area C.

The Contractor should regularly check the condition and locations of the drainage pipes and ensure that all used water should be appropriately filtered and discharged to the manholes/other discharge points agreed by the Engineer and EPD. This is to avoid any potential contamination to the vegetation in Shuen Wan marsh and other vegetated/marinated areas adjacent to the active works area.

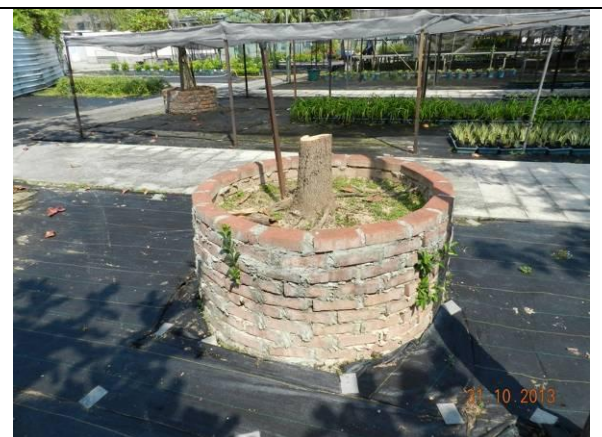
Regular monitoring for all transplanted and retained trees within the nursery was conducted on a bi-weekly basis. The transplanted tree *Grevillea robusta* (U58) was considered to be a dead specimen as no sign of regenerated leaves was observed along the trunk and the remaining branches. The decayed tree trunk was removed as inspected on 18<sup>th</sup> October 2013 and a stump was left in the tree planter (**Photo 6**).

As highlighted in the Section “Liaison with Nursery”, the transplanted tree *Grevillea robusta* (U58) was considered to be a dead specimen as no sign of regenerated leaves was observed along the trunk and the remaining branches. The decayed tree trunk was removed as inspected on 18<sup>th</sup> October 2013 and a stump was left in the tree planter (**Photo 6**).

**Photo 6** – The decayed tree trunk of U58 was removed and a stump was left in the tree planter.

The appointed landscape contractor and the Contractor should closely monitor the health conditions of all transplanted/relocated and retained trees throughout the construction period of the Project.

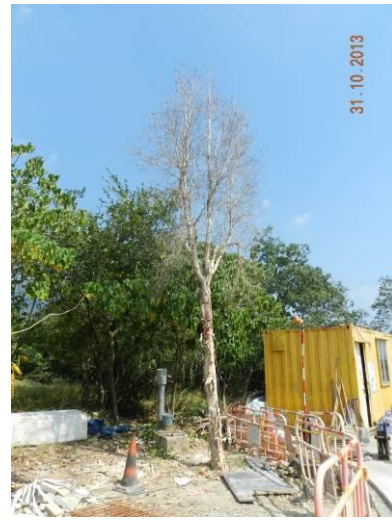
E38 (*Melaleuca cajuputi* subsp. *cumingiana*) was found to be relocated by the contractor from the northern corner to the northern part next to the temporary site office in Area A in late August 2013. As observed in October 2013, the tree was recorded as a dead specimen as there was no live foliage in the canopy and tree bark along the damaged tree trunk appeared very dry and shrunken (**Photo 8**).

**Photo 8** – E38 was recorded as a dead specimen as there was no live foliage and tree bark along the trunk appeared very dry and shrunken.

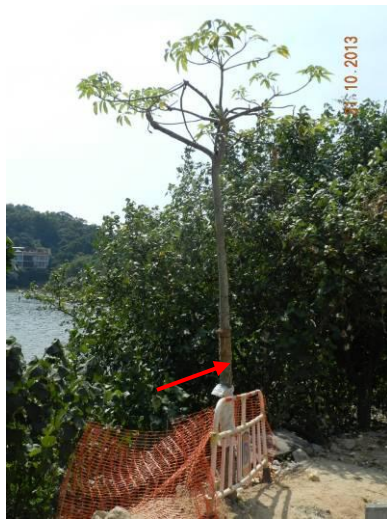
The tree to be transplanted E16 (*Bombax ceiba*) has been relocated to the southern side of Area A next to the site hoarding since July 2012. The tree was in fair condition in October 2013 (**Photo 9**). However, the tree was very close to the construction work as mentioned in Section 3.6.2. Though temporary construction barriers are established to protect the tree, given its close proximity to the active construction work, the tree protection zone could not cover the tree dripline.

**Photo 9** – The relocated tree E16 remained in fair condition and temporary construction barriers were established to protect the tree.

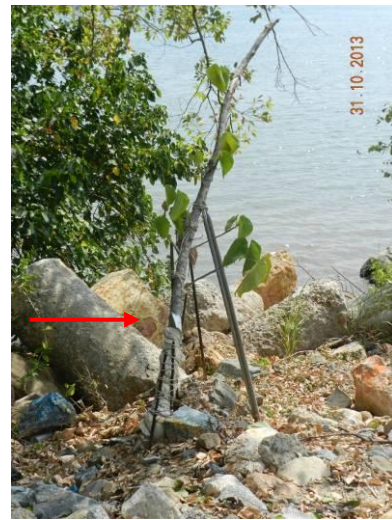
The leaning trunk of E61 (*Macaranga tanarius* var. *tomentosa*) has been burlapped and supported by two steel poles since May 2013. Though new leaves have regenerated along the leaning trunk, this tree is still in poor health condition and under physiological stress (**Photo 10**). Its structural condition is poor.

**Photo 10** – The wound at the trunk flare of E61 was burlapped and the leaning tree trunk was supported by two steel poles.

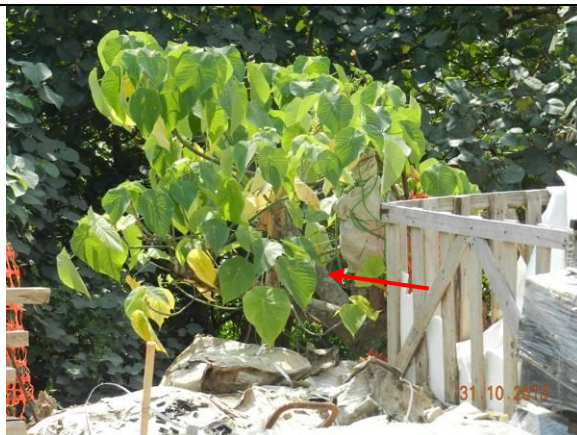
Damaged tree trunk on E55 (*Macaranga tanarius* var. *tomentosa*) was reported in Monthly EM&A Report for April 2013. The wound on the trunk of E55 has been burlapped since May 2013. The upper section of the tree trunk has broken since June 2013. The tree was still in poor condition with most of its foliage as watersprouts only (Photo 11). The tree was located just next to some on-going construction works.

**Photo 11** – E55 with burlapped broken trunk was still in poor condition.

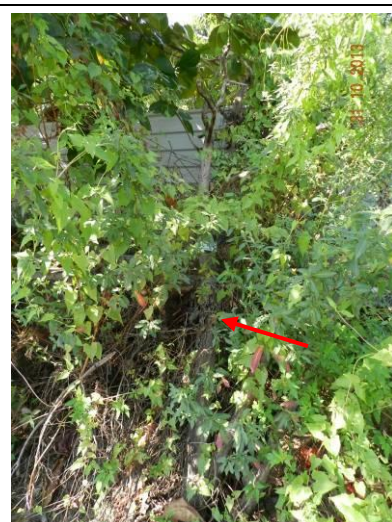
No recovery signs have been observed on the relocated trees U34, U35 and U37 and they are regarded as dead specimens (**Photos 12-14**); the dead tree trunks of U34 and U35 have collapsed since August 2013. As observed, the stockpiled construction material next the tree group of U34, U35, U37 and U44 was removed on 18<sup>th</sup> October 2013 (**Photo 15**).

**Photo 12** – The dead trunk of U34 was found collapsed within the Tree Protection Zone.

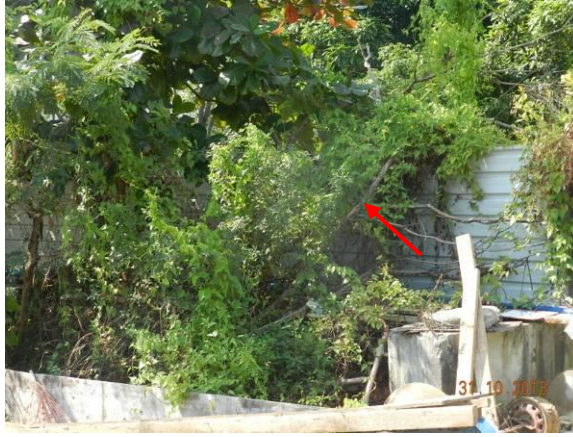
**Photo 13** – The dead trunk of U35 was found collapsed within the Tree Protection Zone.

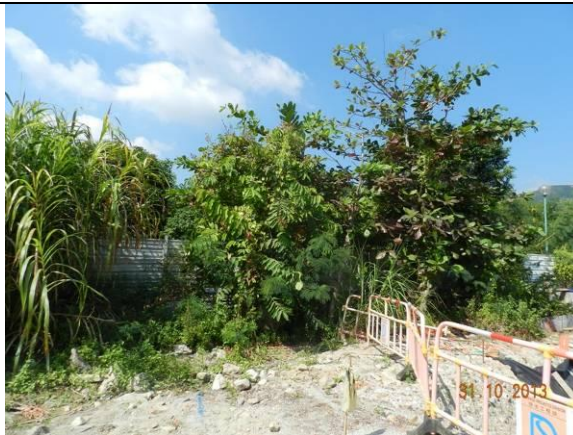
**Photo 15** – No more storage of construction material was observed next to the tree groups in Area B.

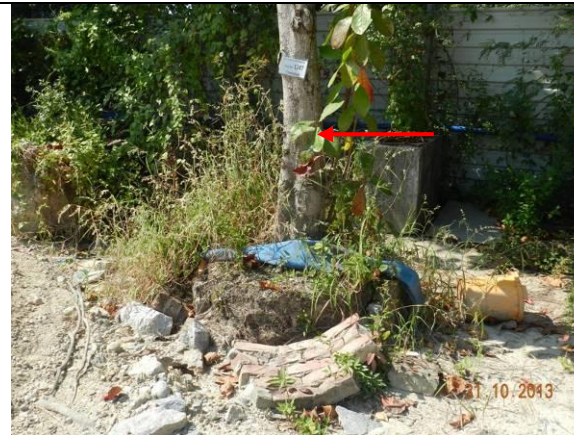
Half of the planter of U47 (*Terminalia catappa*) has broken since August 2013, and its roots and planter soil were exposed in the air. As inspected in October 2013, the planter was not yet repaired (**Photo 16**).

**Photo 16** – Half of the planter of U47 was broken and not yet repaired.

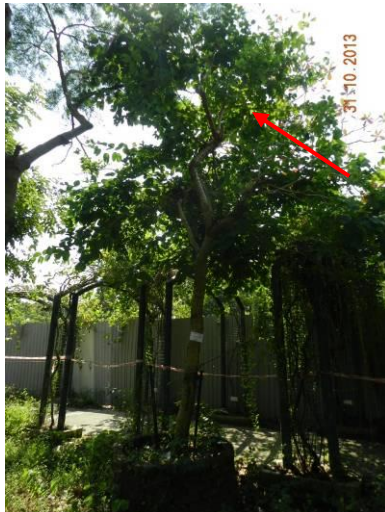
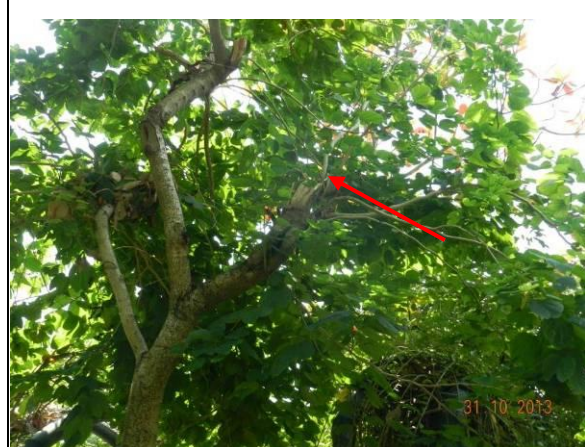
A scaffold limb was found broken off from the upper canopy of U66 (*Bauhinia purpurea*) in October 2013 (**Photos 17-18**).

**Photo 17** – A scaffold limb was found broken off from the upper canopy of U66 in October 2013.

**Photo 18** – A scaffold limb was found broken off from the upper canopy of U66 in October 2013.

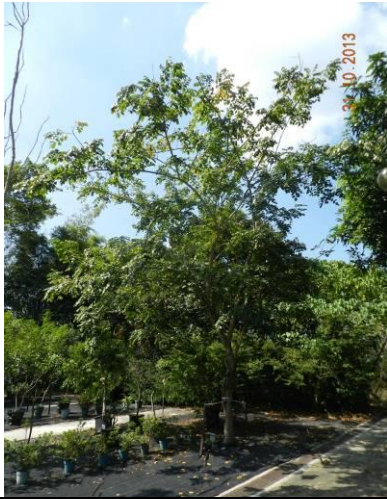
U55 (*Pterocarpus indicus*) has also been transplanted to its final receptor site in 2011 and pest control was applied on this tree in early 2013 due to the sign of termite infestation. Its health condition has been improved (**Photo 19**), however, a few long dead branches and twigs were observed. Close monitoring on this tree is still required.

**Photo 19** – Improved health condition of the transplanted tree U55.

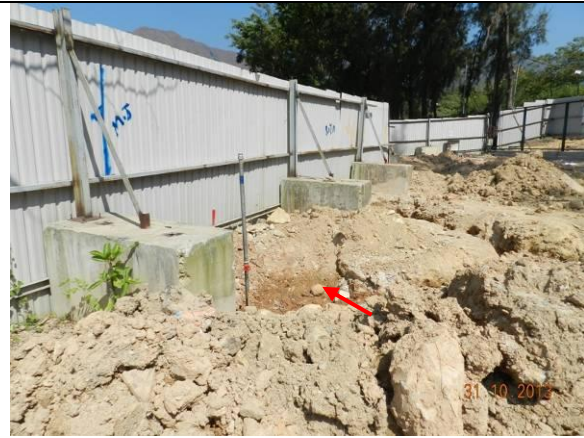
dead and it was removed as inspected on 31<sup>st</sup> October 2013 (**Photo 20**) due to the installation of irrigation pipes. U76 and U78 (*Terminalia catappa*) remained in marginally fair condition with regenerated leaves concentrated in the upper canopy (**Photos 21-22**). Dieback twigs were still observed in October 2013 and cracked tree bark was observed at the lower trunk of these trees (**Photos 23-24**).

**Photo 20** – The relocated tree U77 in Area B was removed from the site.

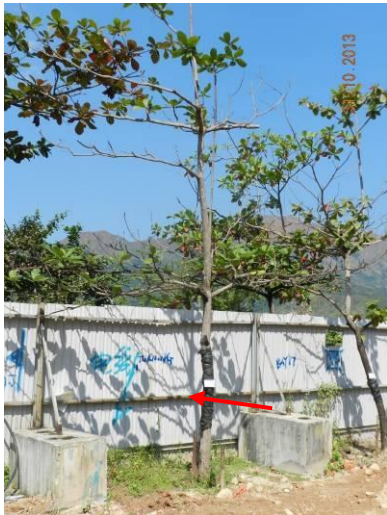
**Photo 21** – U76 remained in marginally fair condition with watersprouts in the canopy.

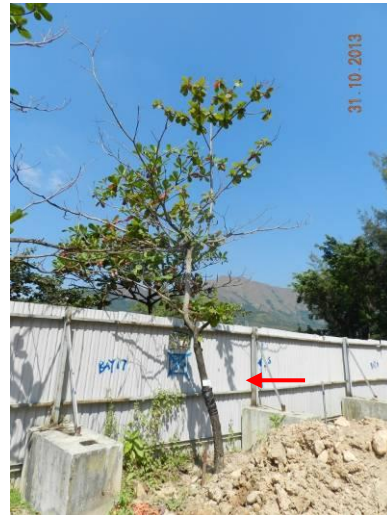
**Photo 22** – U78 remained in marginally fair condition with watersprouts in the canopy.

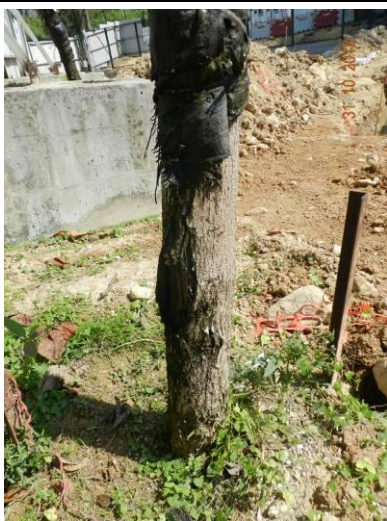
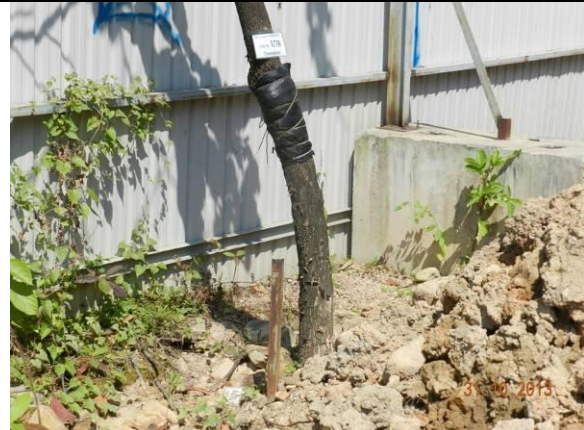
**Photo 23** – Cracked tree bark was observed at the lower trunk of U76.

**Photo 24** – Cracked tree bark was observed at the lower trunk of U76.

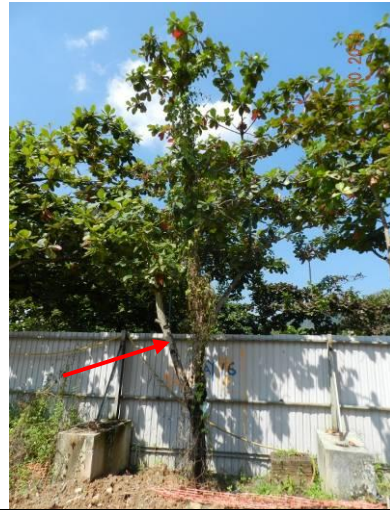
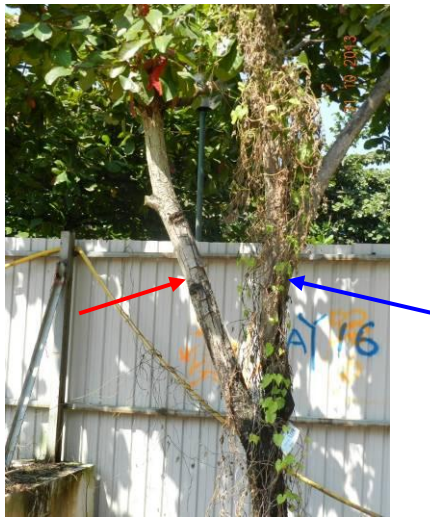
**Photo 26** – Dry and cracked tree bark was observed on a topped scaffold limb of U79.

**Photo 27** – Dry and cracked tree bark on a topped scaffold limb of U79 (Red arrow). Main trunk covered by overgrown climbers (Blue arrow).

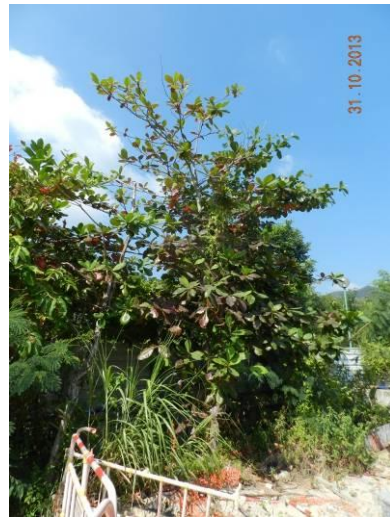
**Photo 28** – Overgrown climbers were found on the canopy of U36.

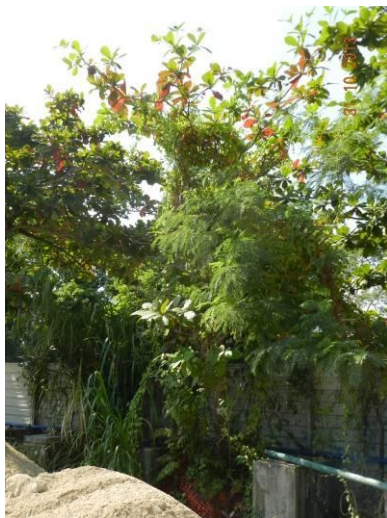
**Photo 29** – Overgrown climbers were found on the canopy of U52.

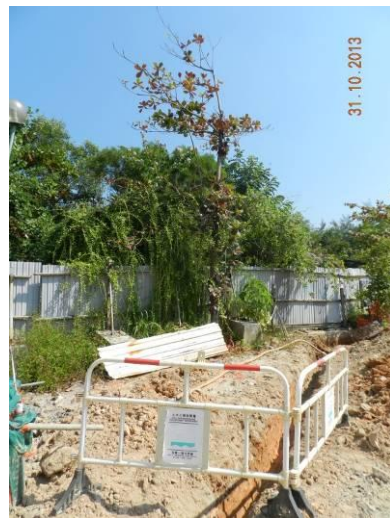
**Photo 30** – Overgrown climbers were found on the canopy U53.

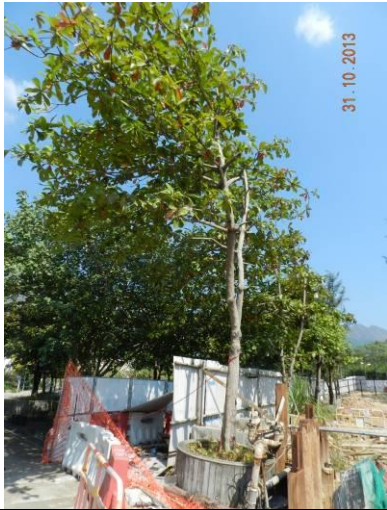
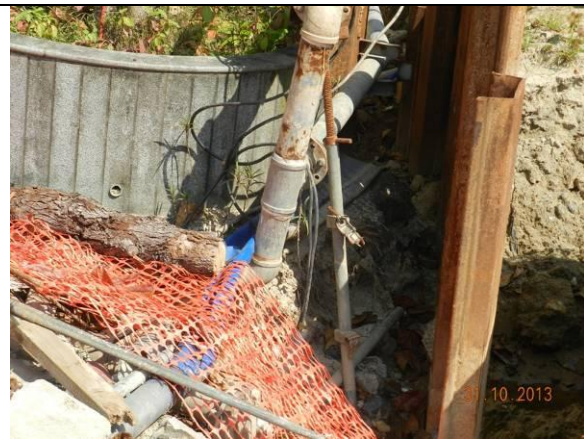
**Photo 31** –The excavated area close to the planter of A40 has not yet refilled with soil.

**Photo 32** – The excavated area close to the planter of A40 has not yet refilled with soil.

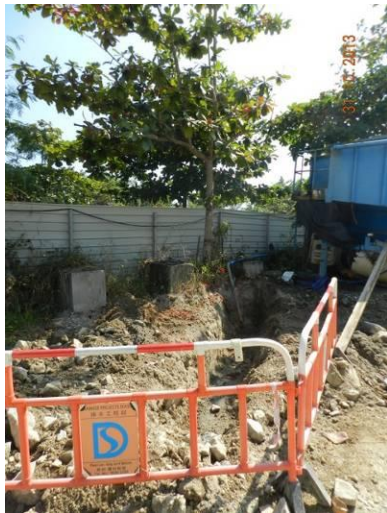
**Photo 33** – The excavated work was conducted very close to the tree U54.

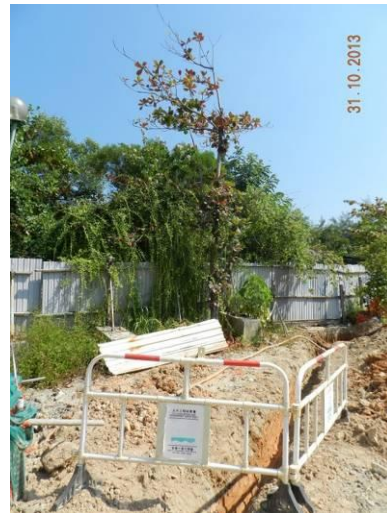
**Photo 34** – The excavated work was conducted close to the tree U53.
