**CONTRACT NO. DC/2010/02 –
DRAINAGE IMPROVEMENT IN SHUEN WAN AND
SHEK WU WAI**

**MONTHLY ENVIRONMENTAL MONITORING AND
AUDIT REPORT (NO.28) – OCTOBER 2013**

PREPARED FOR
KWAN LEE-KULY JOINT VENTURE

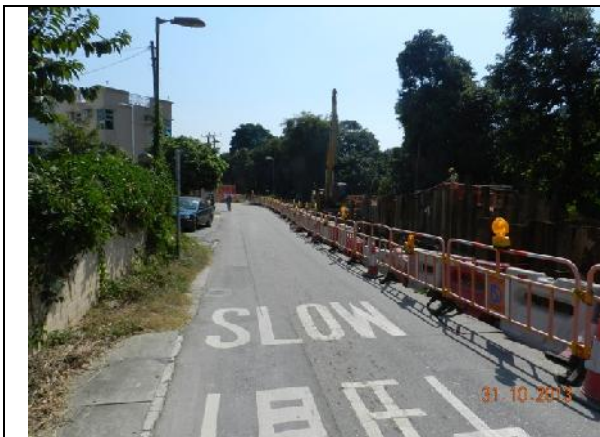
Photo 1 – Temporary hoardings have been erected along Tung Tsz Road opposite to Wai Ha.

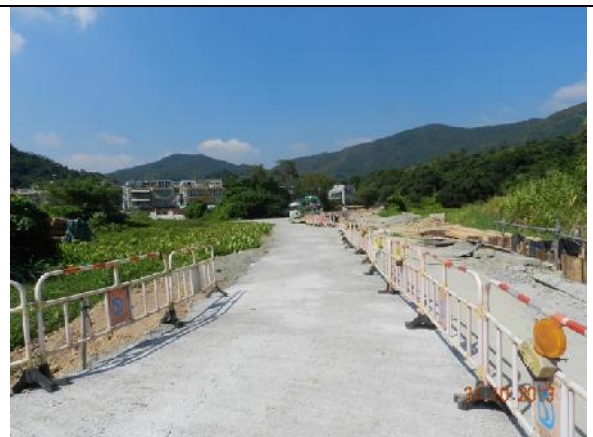
Photo 2 – Temporary hoardings have been erected along the access road from Tung Tsz Road to Treasure Spot Garden II.

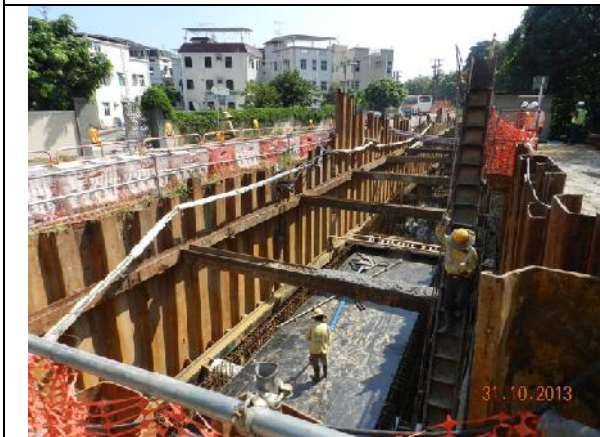
Photo 3 – Construction works for building the box culverts along Tung Tsz Road opposite to Wai Ha outside the public toilet.

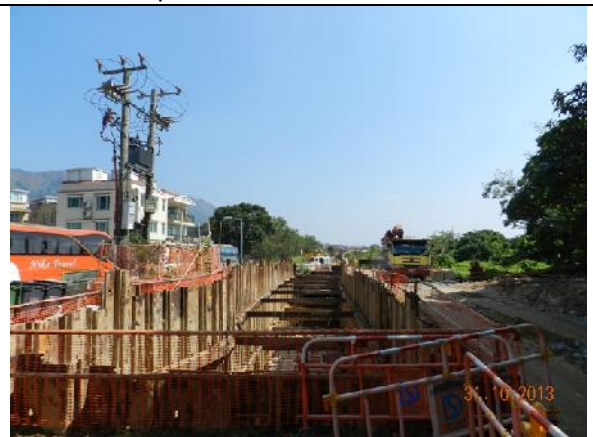
Photo 4 – Construction works for building the box culverts along Tung Tsz Road opposite to Wai Ha and near the tree group T181-184.

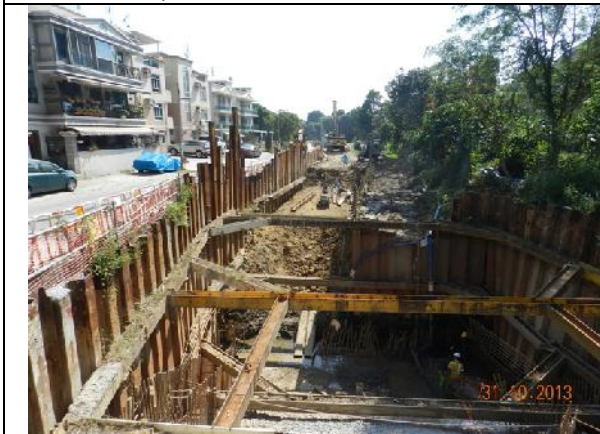
Photo 5 – Construction work was started again along Wai Ha River.

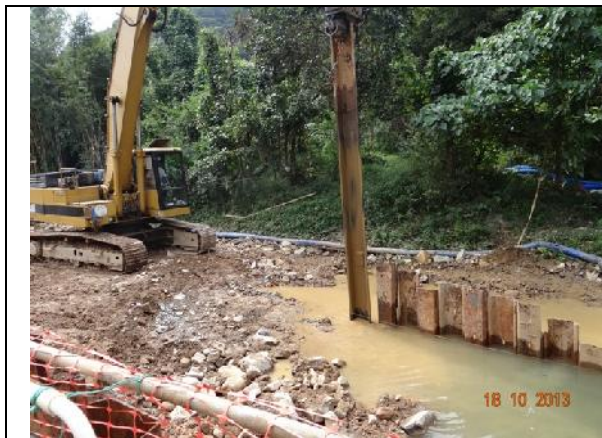
Photo 7 – Sheet piling work in the works area along Wai Ha River on 18th October 2013.

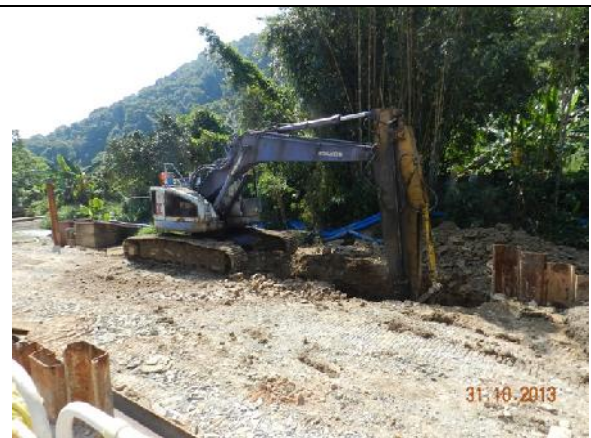
Photo 8 – Excavation works instead of sheet piling work in the works area along Wai Ha River on 31st October 2013.

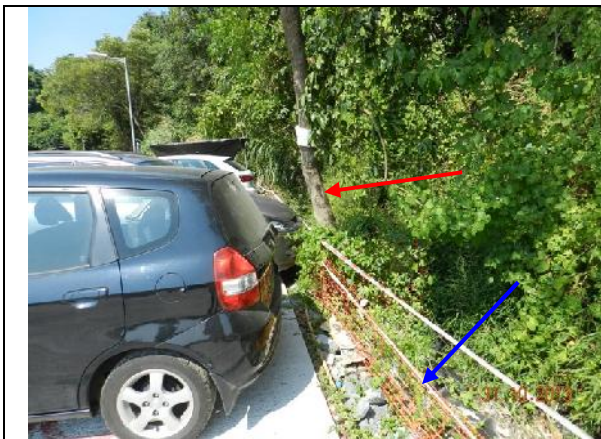
Photo 13 – The untagged leaning tree (Red arrow) was guyed at the edge of the parking area within a Tree Protection Zone demarcated by orange construction nets (Blue arrow).

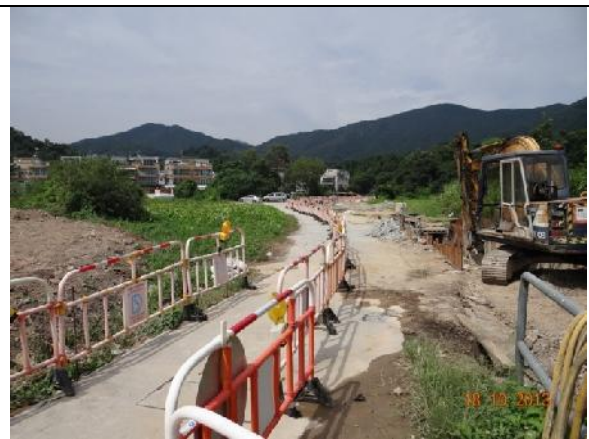
Photo 14 – The path towards Treasure Spot Garden II was expanded towards the Taro field within the period between 18th and 31st October 2013 (Photo taken on 18th October 2013).

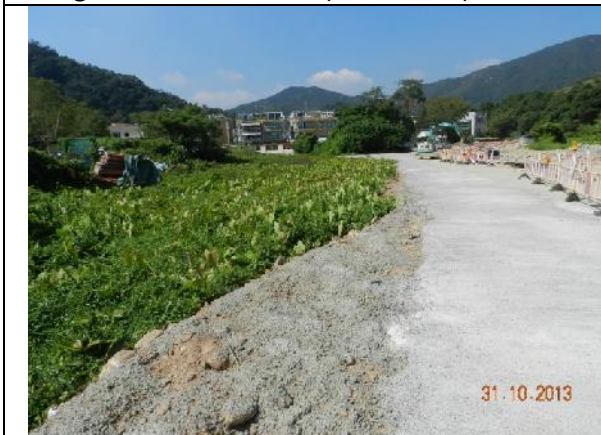
Photo 15 – The path towards Treasure Spot Garden II was expanded towards the Taro field within the period between 18th and 31st October 2013 (Photo taken on 31st October 2013).

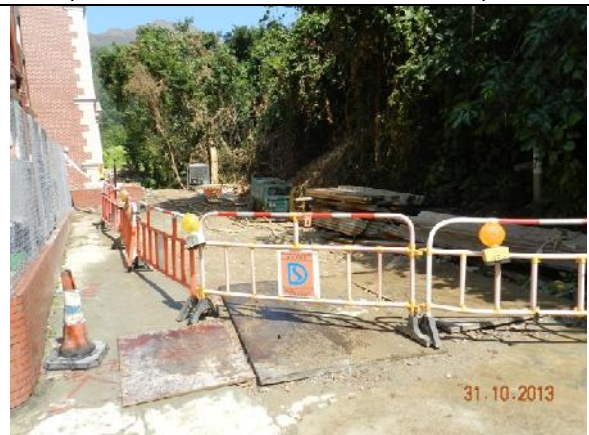
Photo 16 – Works were observed at the end of the Treasure Spot Garden II near the retained tree T103 and the works area was surrounded by temporary construction barriers.

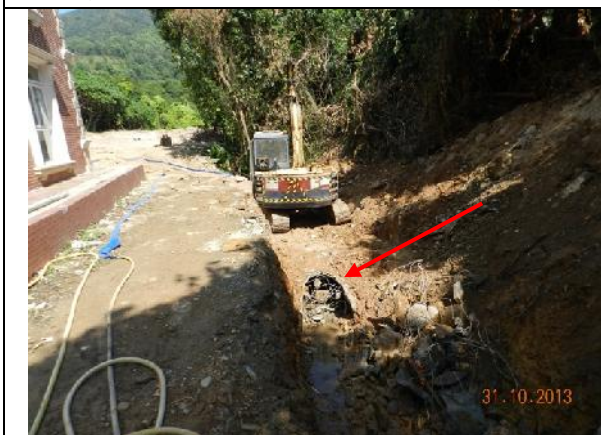
Photo 17 – Excavation work was noted at the end of the Treasure Spot Garden II for joining the old pipe (Red arrow) to the new box culvert.

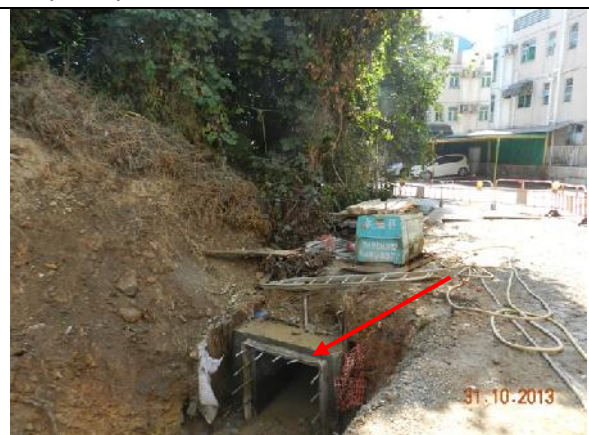
Photo 18 – Excavation work was noted at the end of the Treasure Spot Garden II for joining the old pipe to the new box culvert (Red arrow).

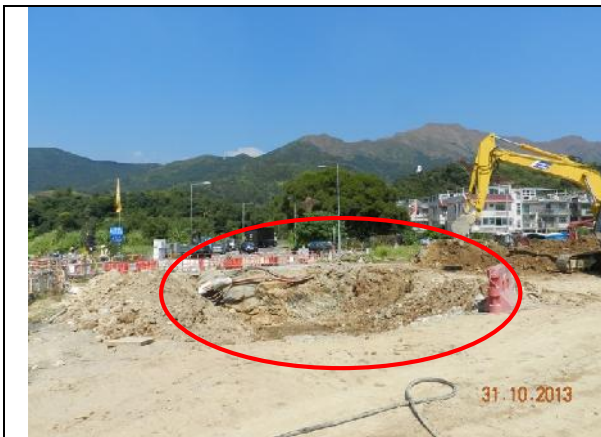
Photo 19 – The previous exit point of Contract 2 works area opposite to the entrance of the access to Treasure Spot Garden II has been closed and the wheel washing pool has not been found since 18th October 2013.

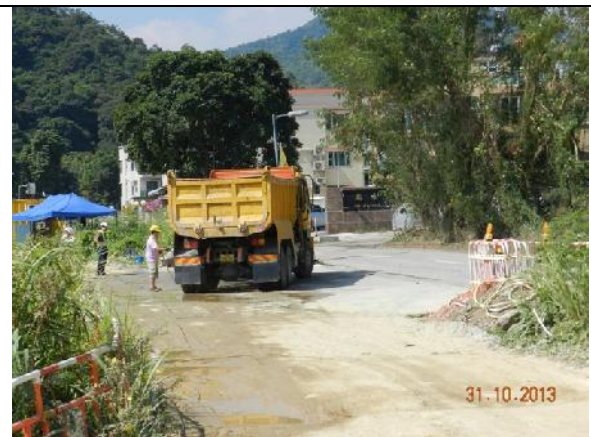
Photo 20 – A new exit for Contract 2 works area was seen opposite to the tree group T021-029 (*Leucaena leucocephala*) and workers were noted washing the wheels of the vehicles which were leaving the works area.

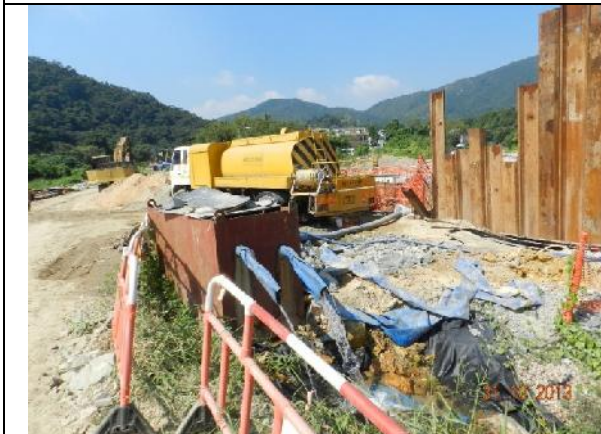
Photo 21 – A sedimentation tank receiving the waste water from the works area near the previous collapsed tree T196 (*Macaranga tanarius* var. *tomentosa*). Clear discharge was noted.

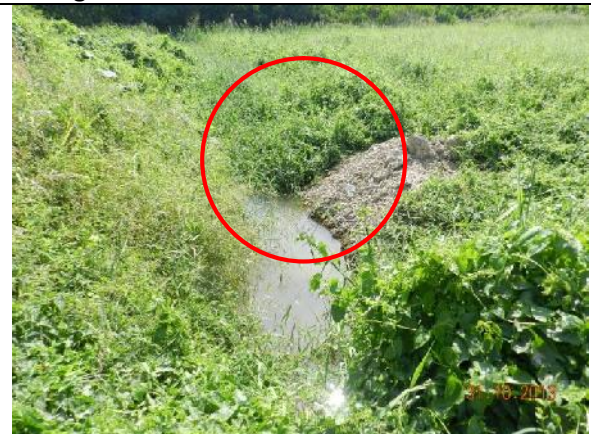
Photo 22 – Granules piled in the previous discharge point near the previous collapsed tree T196 (*Macaranga tanarius* var. *tomentosa*).

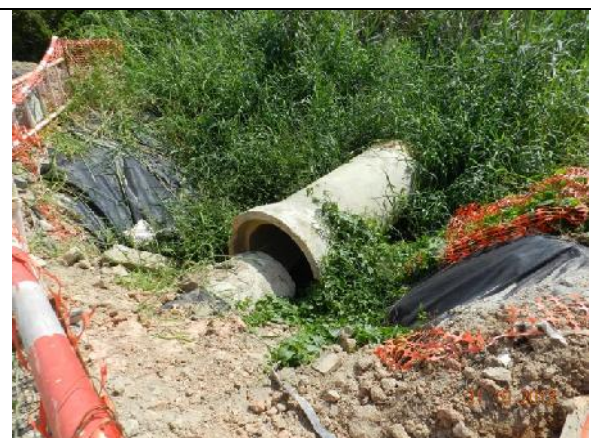
Photo 24 – A section of sedimentation bed aligned from the area opposite to the eastern part of Jade View Villa towards the marsh area. No muddy water was discharged.

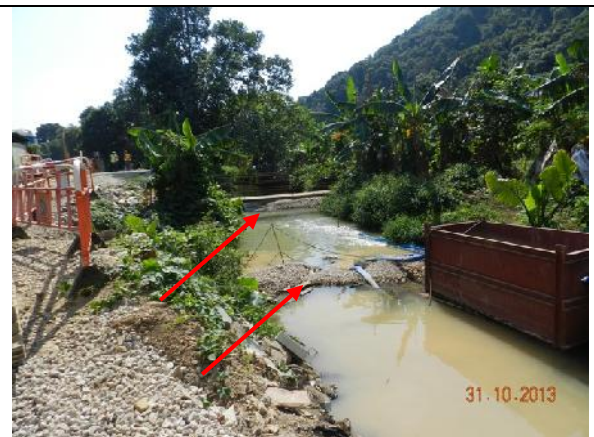
Photo 26 – Sections of granules with underlaid PVC liners were found along the river for further sedimentation.

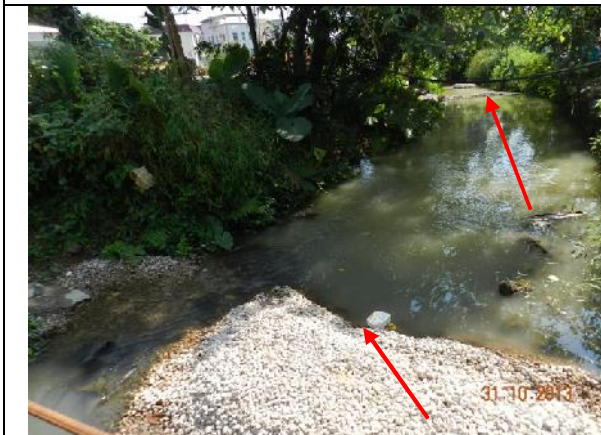
Photo 27 – Sections of granules with underlaid PVC liners were found along the river for further sedimentation.

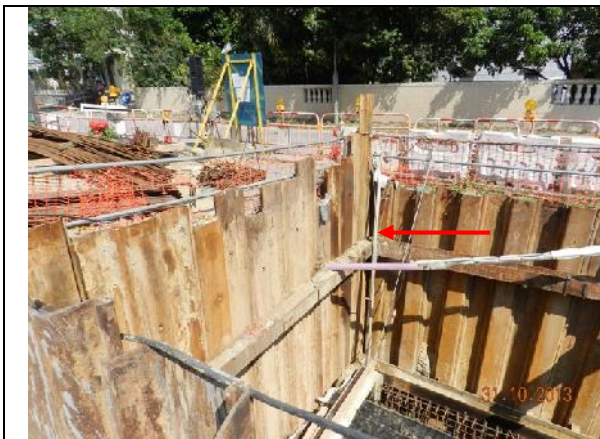
Photo 31 – Water from the box culvert in the works area outside the public toilet was noted pumping to a pipe next to Wai Ha River.

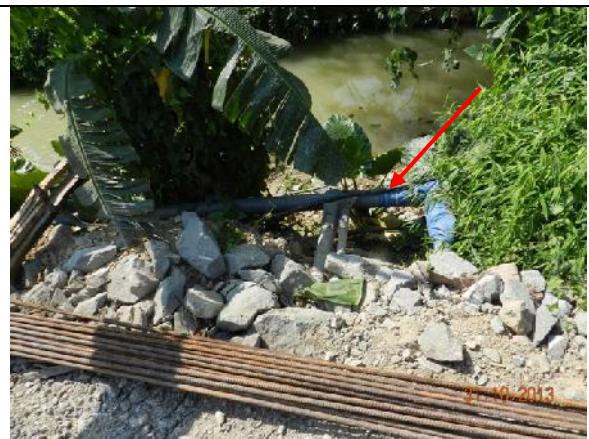
Photo 32 – Water from the box culvert in the works area outside the public toilet was noted pumping to a pipe next to Wai Ha River.

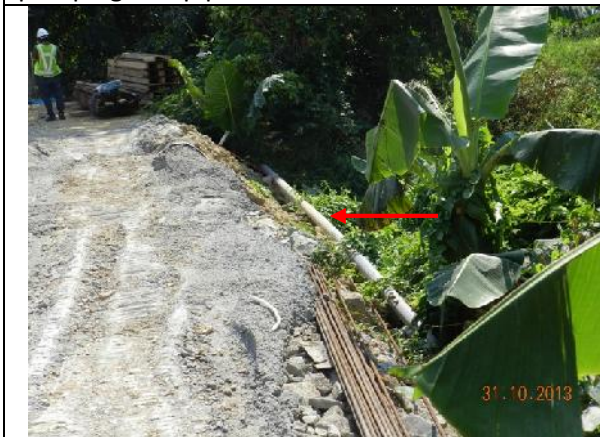
Photo 33 – The pipe was then directed along the river to the grassland behind the tree group T181-183.

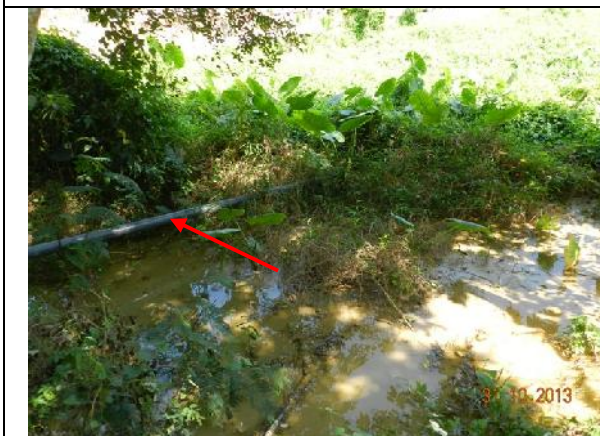
Photo 35 – The pipe was then directed along the river to the grassland behind the tree group T181-183 and the water was then released directly.

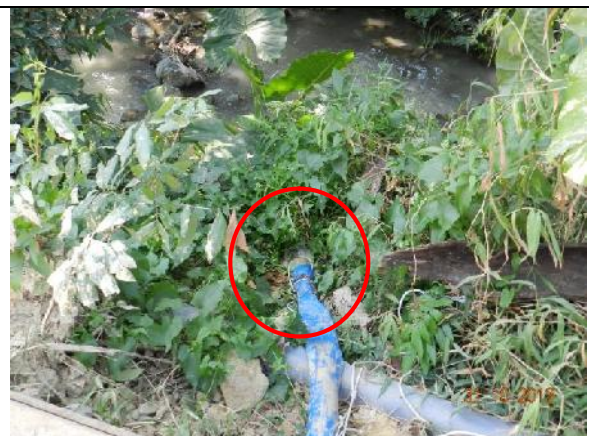
Photo 36 – Some muddy water from the box culvert in the works area was also found pumping to Wai Ha River directly.

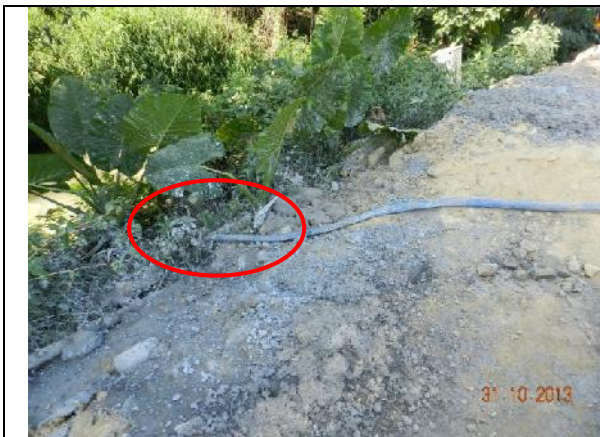
Photo 37 – Some muddy water from the box culvert in the works area was also found pumping to Wai Ha River directly.

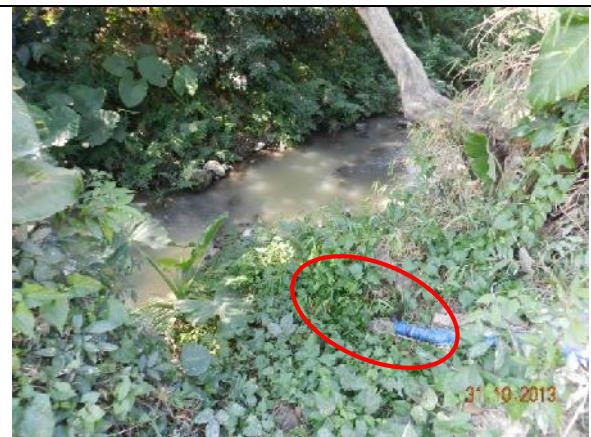
Photo 38 – Some muddy water from the box culvert in the works area was also found pumping to Wai Ha River directly.

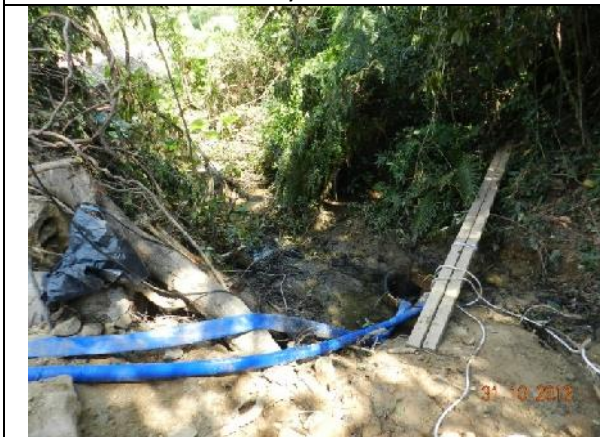
Photo 39 – In the works area at the end of the Treasure Spot Garden II next to the retained tree T103, a stream was blocked and the stream water was pumped to the drainage of the adjacent building.

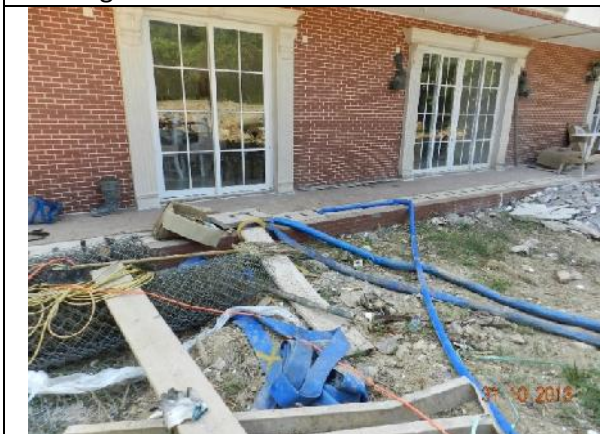
Photo 41 – Another view showing the pipes which pump the stream water from the stream to the drainage of the adjacent building.

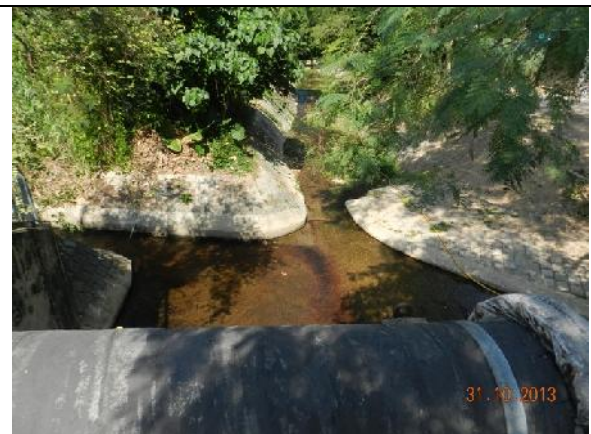
Photo 42 – No direct water discharge into the upper stream of Wai Ha River was observed as the construction works have been concentrated at the lower end of the river.

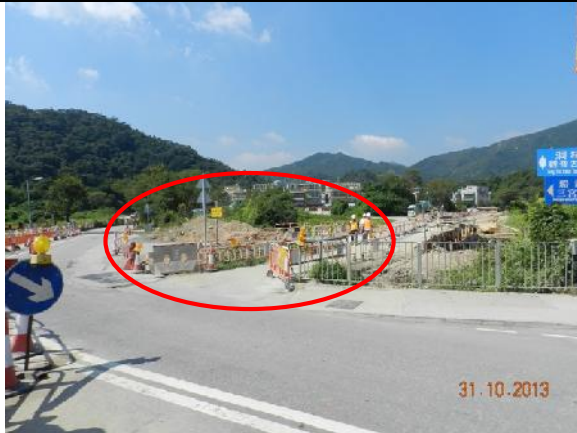
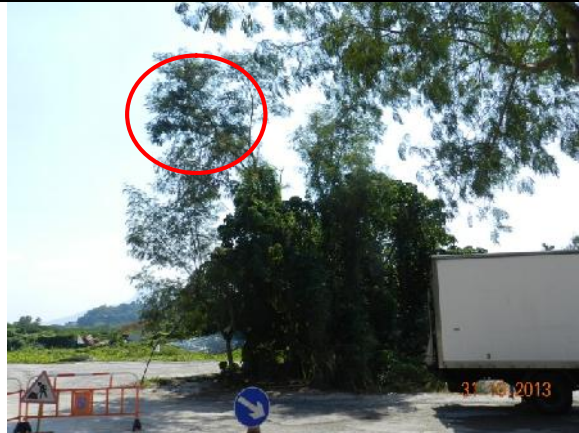
<p>Photo 43 – Vegetation clearance in the works area at the entrance of the access from Tung Tsz Road to Treasure Spot Garden II.</p>	<p>Photo 44 – A broken branch was found hanging in the canopy of the retained tree T091.</p>

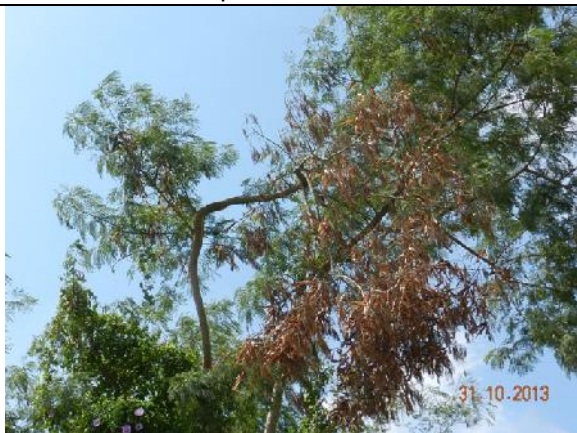
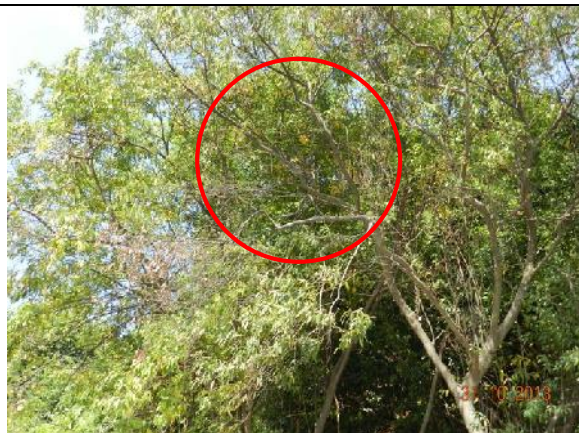
<p>Photo 45 – A broken branch was found hanging in the canopy of the retained tree T091.</p>	<p>Photo 46 – A broken branch was seen hanging on the retained tree T093.</p>

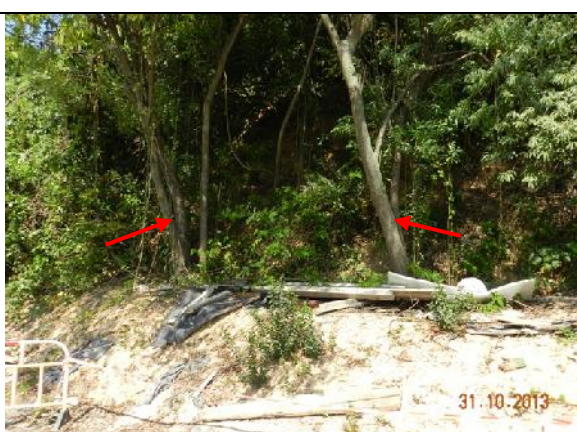
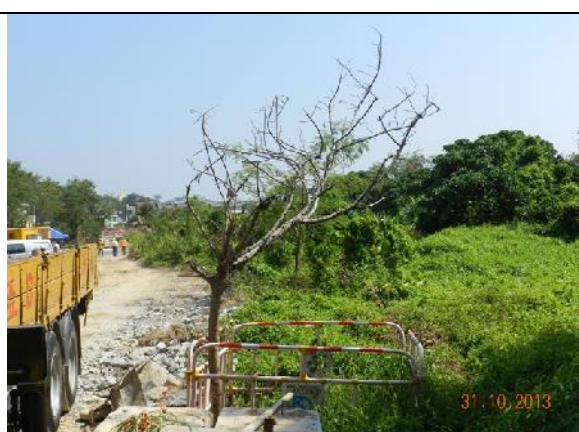
<p>Photo 47 – Temporary storage of construction materials were still noted close to the trunk flares and trunks of T093 and T094 (both indicated).</p>	<p>Photo 48 – The relocated tree T190 was suspected to be dead due to transplantation shock and poor transplantation skill.</p>

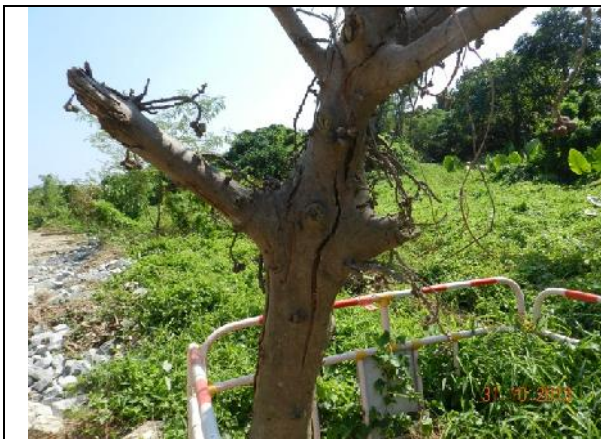
Photo 49 – Loose bark was noted along the trunk and dry fruit was seen on branches of T190.

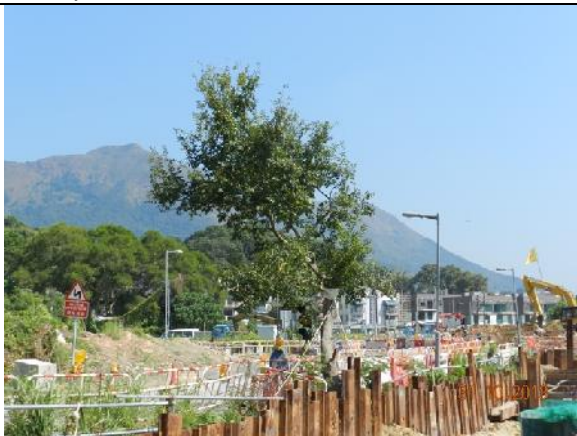
Photo 51 – The retained tree T025 was pruned before and it was temporarily guyed to provide additional support to this tree.

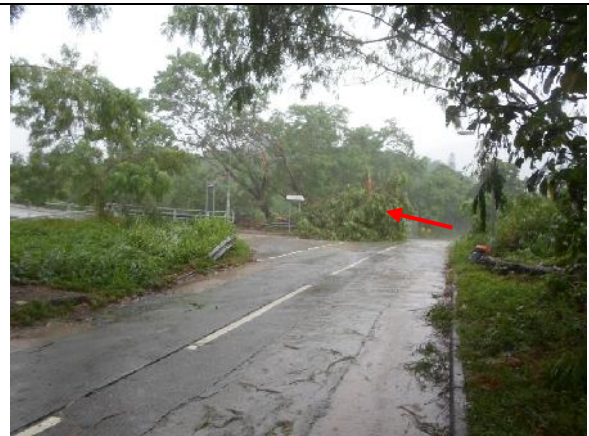
Photo 52 – T085 collapsed and was damaged after the severe typhoon Usagi during 22nd to 23rd September 2013. Photo recorded was provided by the Main Contractor.

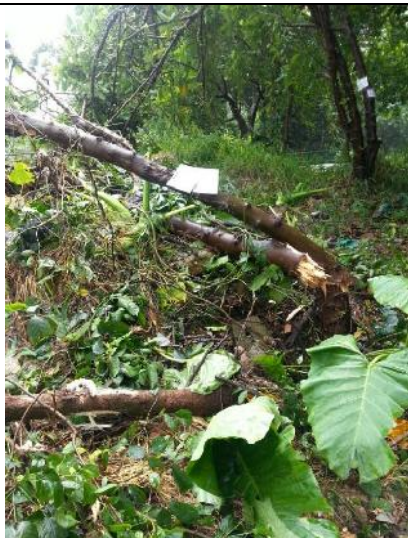
Photo 53 – T184 collapsed and was damaged after the severe typhoon Usagi during 22nd to 23rd September 2013. Photo recorded was provided by the Main Contractor.

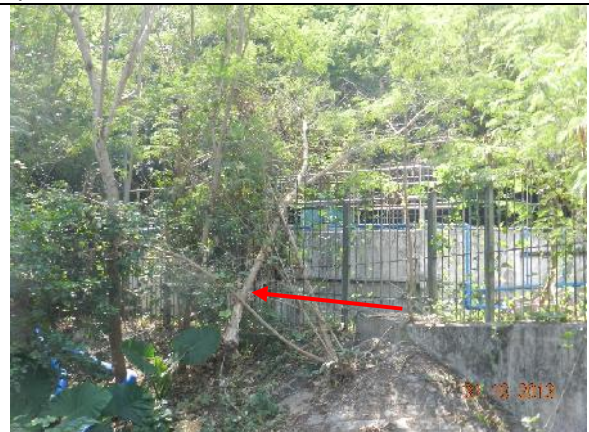
Photo 54 – *Leucaena leucocephala* (suspected to be T107) on the slope next to the Wai Ha River collapsed with decayed trunk.

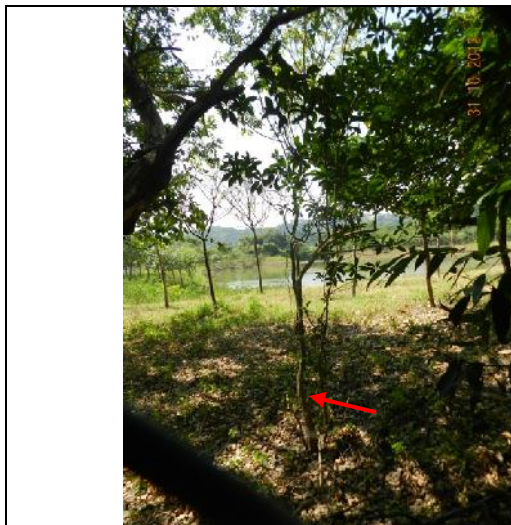
Photo 55 – The transplanted shrub of *Pavetta hongkongensis* (PH01) in Area C under Contract 1 showed regenerated leaves after the pruning work noted in September 2013.

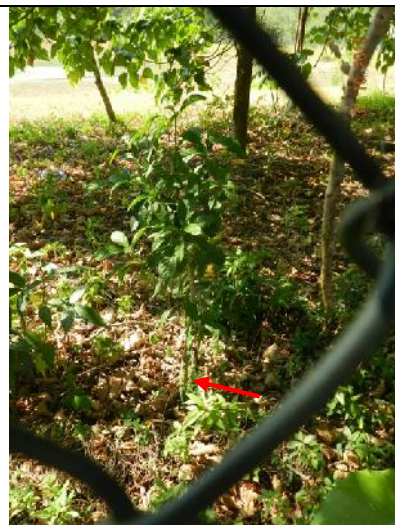
Photo 56 – The transplanted shrub of *Pavetta hongkongensis* (PH03) in Area C under Contract 1 showed regenerated leaves after the pruning work noted in September 2013.
