**Monthly Environmental Monitoring & Auditing report for**

**Contract No.DC/2009/22**

**Drainage Improvement in Shuen Wan, Tai Po – Contract 1**

**November 2013**

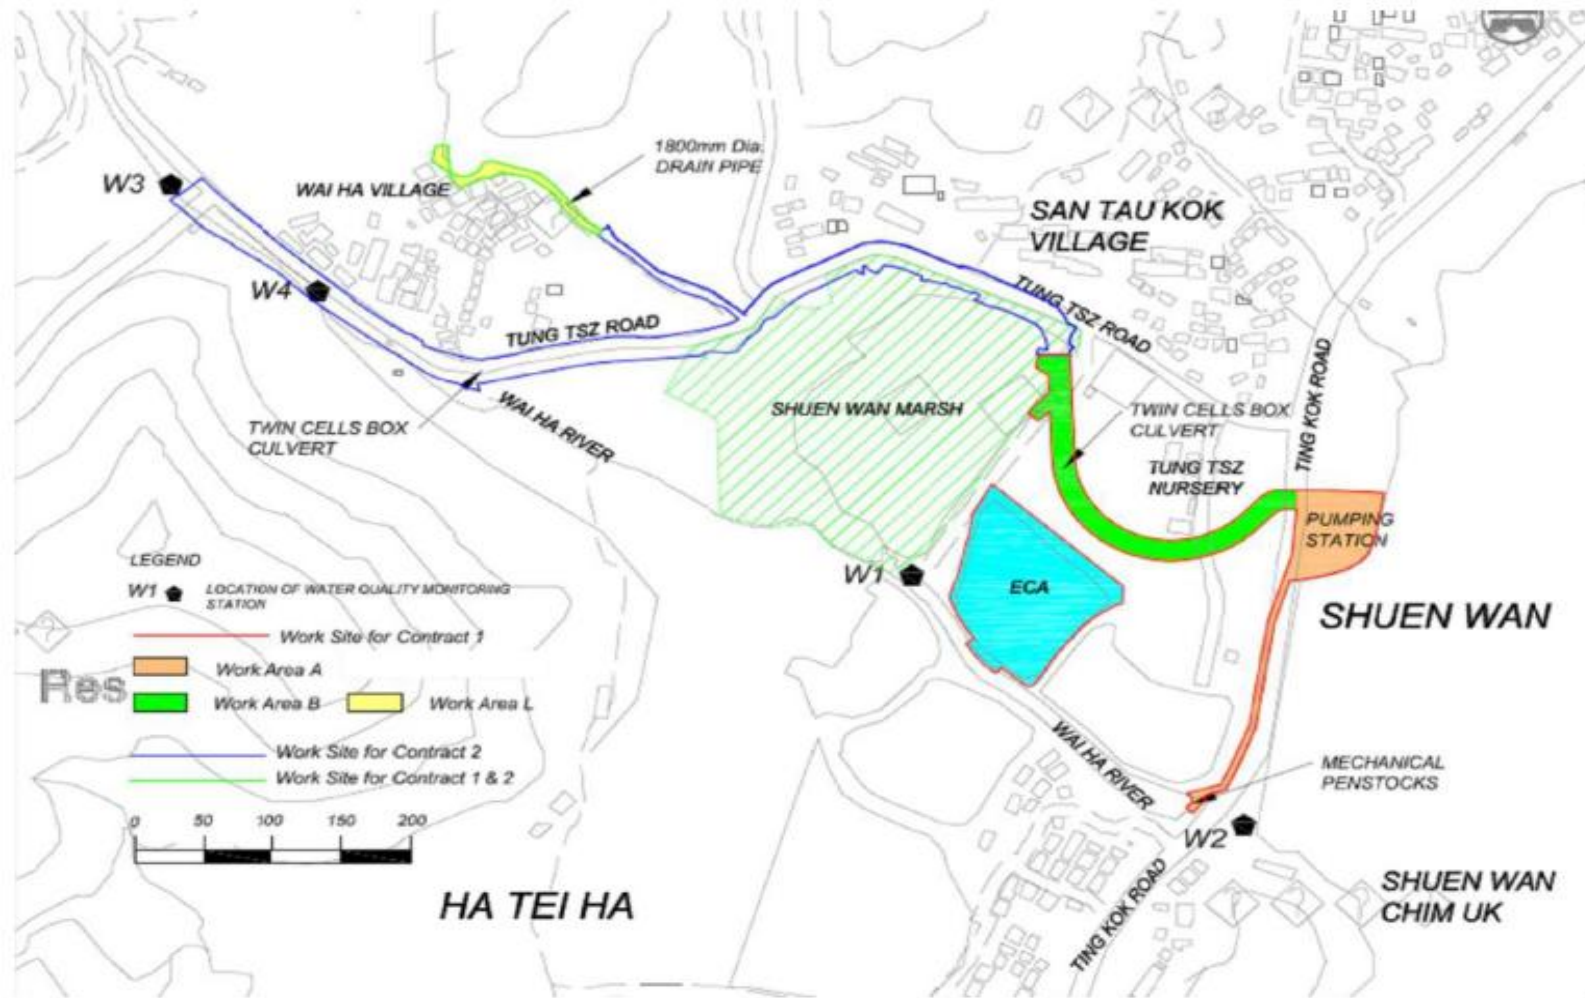
Figure 4.3.1 Water Quality Monitoring Locations

As the depth of water was less than 3m, water samples were collected at mid-depth of each proposed monitoring stations for measurements and sample collection.

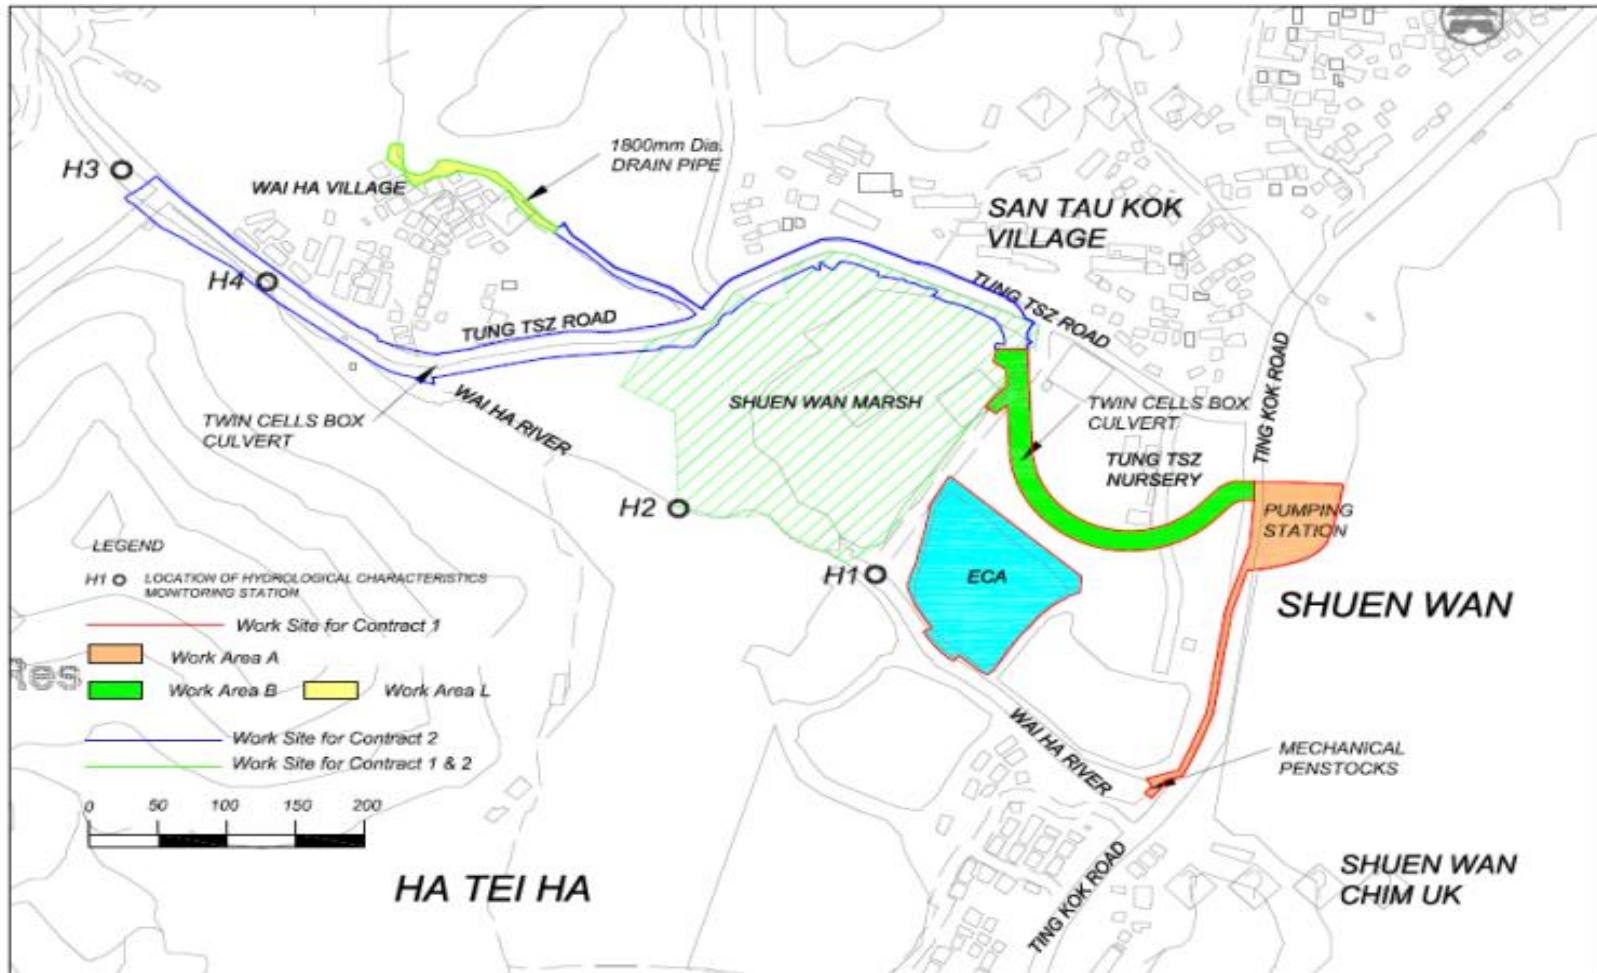
Figure 5.3.1 Hydrological Characteristics Monitoring Locations

As illustrated in Figure 5.3.1, H2 served as the control station while H1 was the monitoring location of hydrological characteristics.

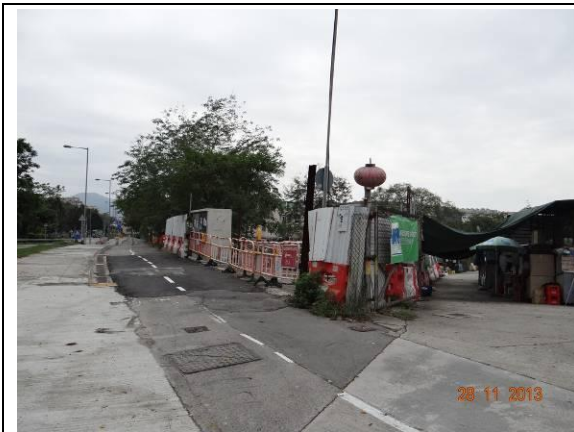
Construction hoardings were once erected along the entire site boundary of Area A. Temporary construction hoardings have been erected around Wai Ha River estuary since the building of an automatic mechanical penstock at the area (**Photo 1**). As observed in November 2013, construction hoarding at the northern and southern side of Area A was removed and boundary walls along the western and part of the northern sides of Area A were under construction (**Photos 2-3**). Since January 2013, the site hoardings along the eastern boundary of Area A have been removed due to the active construction works for the installation of drainage pipes and the associated structures.

**Photo 1** – Temporary hoardings have been established around the works area at Wai Ha River estuary.

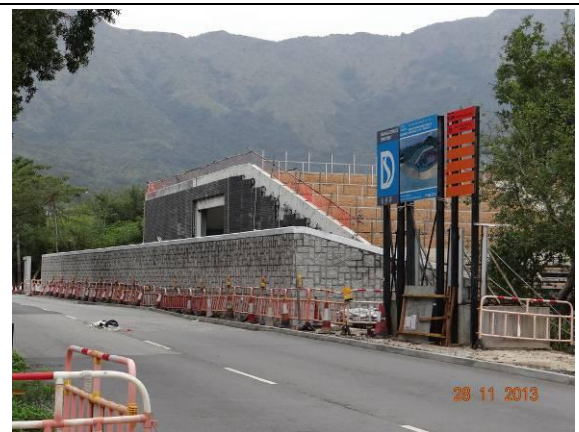
**Photo 2** – The permanent boundary wall has been established along the western side of Area A.

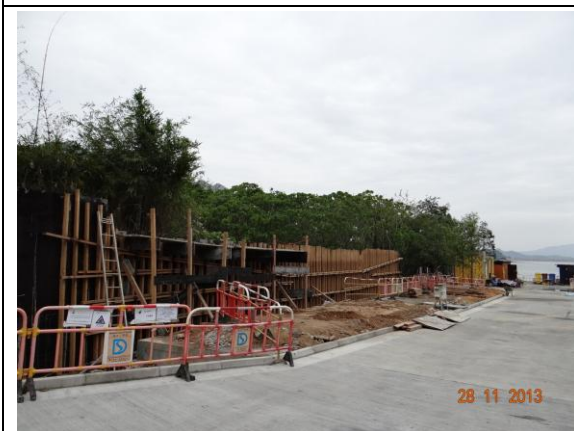
**Photo 3** – The proposed boundary wall along part of the northern side of Area A was under construction.

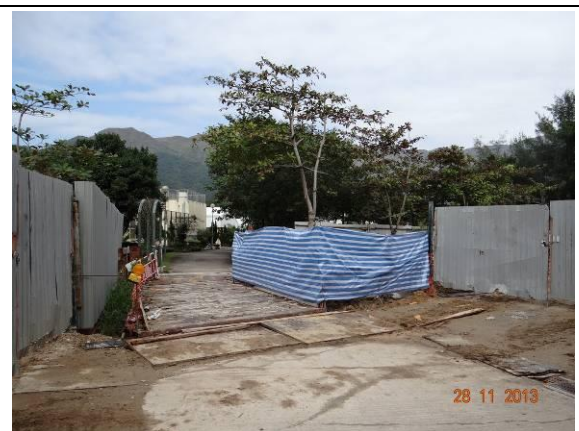
**Photo 4** – The western end of Phase 2 of Area B was demarcated with temporary construction barriers and covered by canvas sheets.

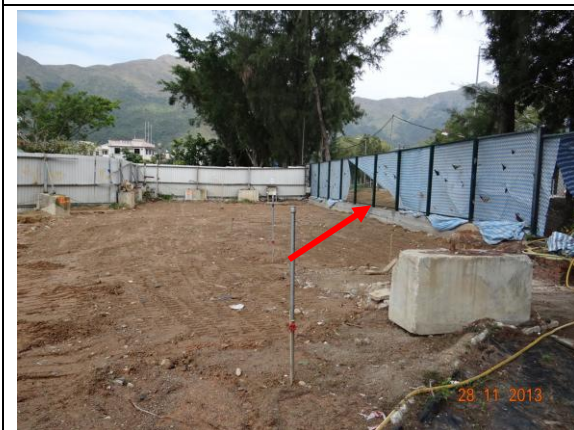
since May 2012 and connected with Phase I construction works area. An open section with no construction work has been maintained as a major road access inside Tung Tsz Nursery for their daily operations, and the construction site in Phase 2 was demarcated by temporary construction hoardings which were screened by canvas sheets (**Photo 4**). As observed in November 2013, the hoarding along the eastern boundary of Phase 2 in Area B (i.e. the section just next to Ting Kok Road) was permanently reinstated with the original chain-link fence. Canvas sheets were put on the reinstated fence to screen off the existing construction site from the pedestrian path (**Photo 5**).

**Photo 5** – Chain-link fence was reinstated at the eastern end of Phase 2 works area and covered by canvas sheets.

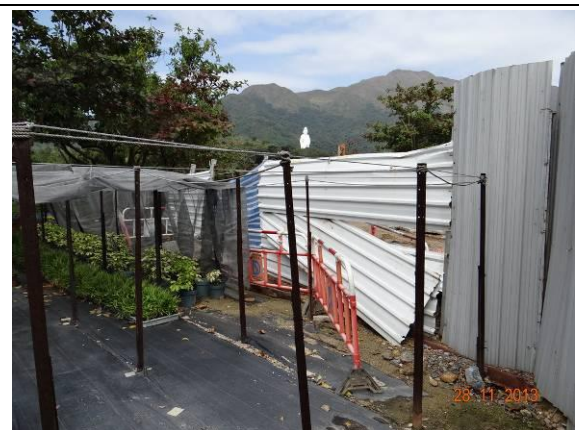
were undertaken in Phases 1 and 2 to reinstate the irrigation pipes for future horticultural practice in the Nursery. As observed in November 2013, small part of the construction hoarding located at the southwestern side of Phase 1 area was removed and covered by canvas sheets for screening the restoration work of the pipes (**Photo 6**).

**Photo 6** – A small section of the temporary hoarding at the southwestern side of Phase 1 works area of Area B was removed and covered by canvas sheets.

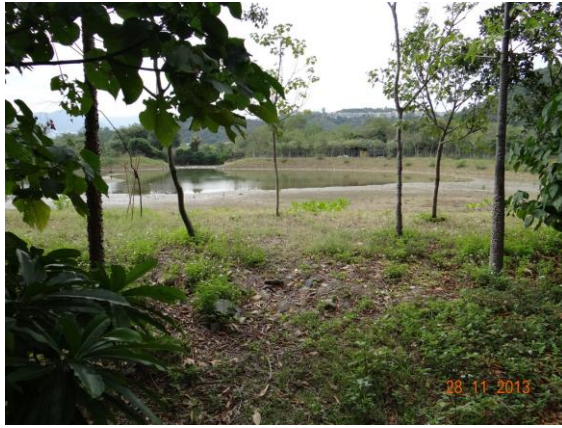
Area C was formally handed over to AFCD on 16<sup>th</sup> October 2012 for management and maintenance. The pond of the ECA has been connected to Wai Ha River directly as following the scheme design of Habitat Compensatory Plan. No direct discharge of turbid water into the adjacent Wai Ha River was observed through the fence of Tung Tsz Nursery (**Photo 7**).

**Photo 7** – No discharge of muddy water was observed in Area C.

The Contractor should regularly check the condition and locations of the drainage pipes and ensure that all used water should be appropriately filtered and discharged to the manholes/other discharge points agreed by the Engineer and EPD. This is to avoid any potential contamination to the vegetation in Shuen Wan marsh and other vegetated/marinated areas adjacent to the active works area.

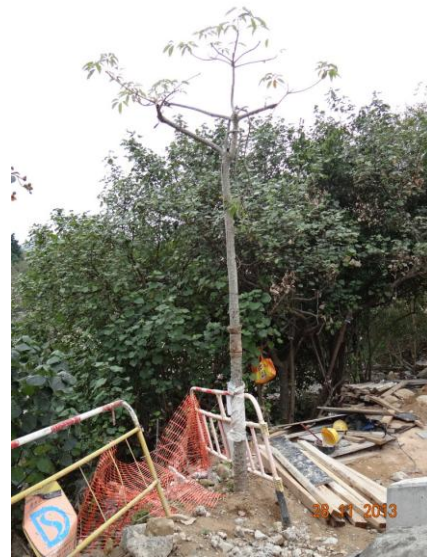
Temporary construction barriers were used to demarcate the tree protection zone for the existing retained and relocated trees. However, as observed in November 2013, site formation and soil excavation works were operated quite close to the canopies of these retained and relocated trees and the temporary construction barriers, which are used to demarcate the tree protection zone, are not always in proper position in protecting the tree part within the tree dripline (e.g. E16 in **Photo 8**).

The tree to be transplanted E16 (*Bombax ceiba*) has been relocated to the southern side of Area A next to the site hoarding since July 2012. The tree was in fair condition in November 2013 (**Photo 8**) but its tree protection zone was not properly maintained. However, the tree was very close to the construction work as mentioned in Section 3.6.2. Given its close proximity to the active construction work, the tree protection zone could not cover the tree dripline.

**Photo 8** – The relocated tree E16 was in fair condition but its tree protection zone was not maintained properly.

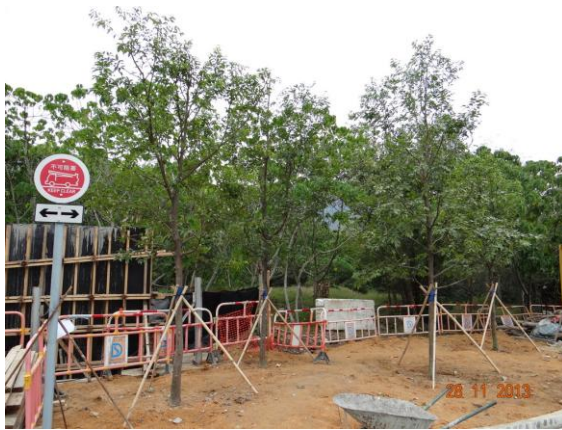
E38 (*Melaleuca cajuputi* subsp. *cumingiana*) was found to be relocated by the contractor from the northern corner to the northern part next to the temporary site office in Area A in late August 2013. As observed on 15<sup>th</sup> November 2013, this tree was removed by the Contractor and a planter was built at the same location in accordance with the approved Landscape Plan. Four new trees of *Cinnamomum burmannii* were planted in this planter (**Photo 9**).

**Photo 9** – The dead, relocated tree E38 was removed, and the planter was planted with four new trees *Cinnamomum burmannii*.

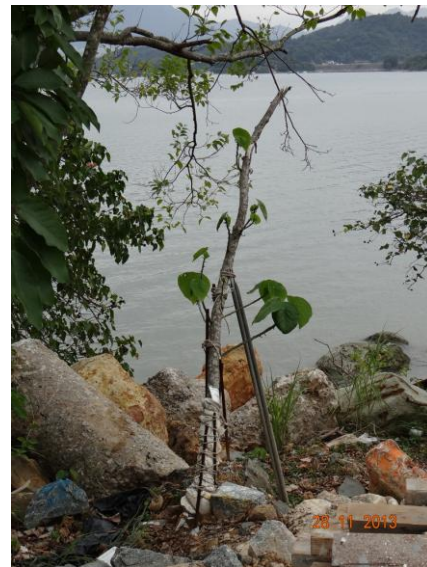
The leaning trunk of E61 (*Macaranga tanarius* var. *tomentosa*) has been burlapped and supported by two steel poles since May 2013. The regenerated leaves along the leaning trunk were weak and this tree is still in poor health condition and under physiological stress (**Photo 10**). Its structural condition is poor.

**Photo 10** – The wound at the trunk flare of E61 was burlapped and the leaning tree trunk was supported by two steel poles.

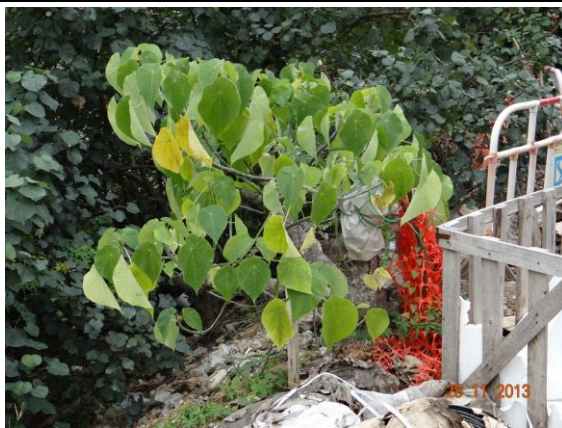
Damaged tree trunk on E55 (*Macaranga tanarius* var. *tomentosa*) was reported in *Monthly EM&A Report for April 2013*. The wound on the trunk of E55 has been burlapped since May 2013. The upper section of the tree trunk has broken since June 2013. The tree was still in poor condition with most of its foliage as watersprouts only (**Photo 11**). The tree was located just next to some on-going construction works and lots of

**Photo 11** – E55 with burlapped broken trunk was still in poor condition.

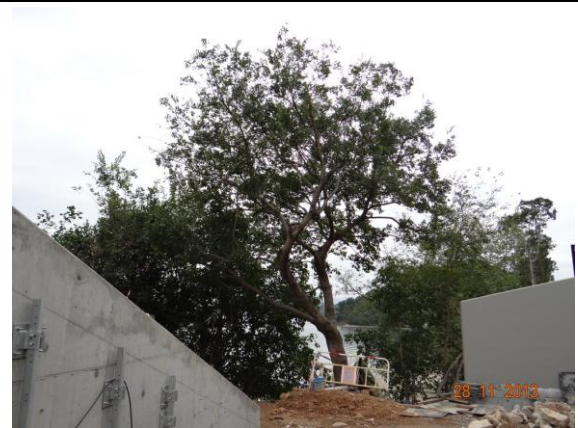
E44 (*Celtis sinensis*), which was proposed to be felled in the approved Tree Felling Application Report, has been remained on-site and protected within a small tree protection zone from the nearby active construction work (**Photo 12**). A few wounds were noted on its trunk since October 2013.

**Photo 12** – E44 was retained *in-situ* and wounds were noted on its trunk.

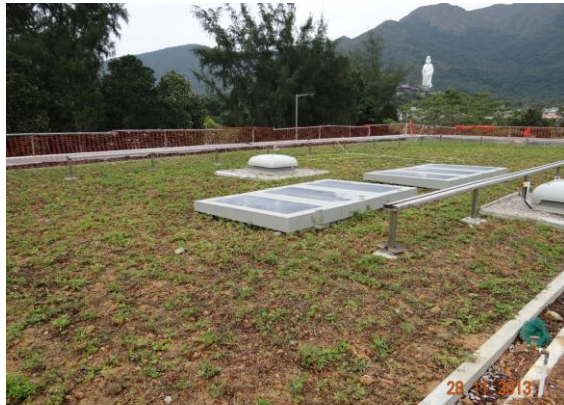
No other significant damages on the crowns, trunks and roots of the remaining trees resulting from the construction machinery were observed during the monitoring in November 2013 in Area A. Herbaceous creeper *Arachis duranensis* were planted on the green roof of the pump house in accordance with the approved Landscape Plan (**Photo 13**)

**Photo 13** – Herbaceous creeper *Arachis duranensis* were planted on the green roof of the pump house.

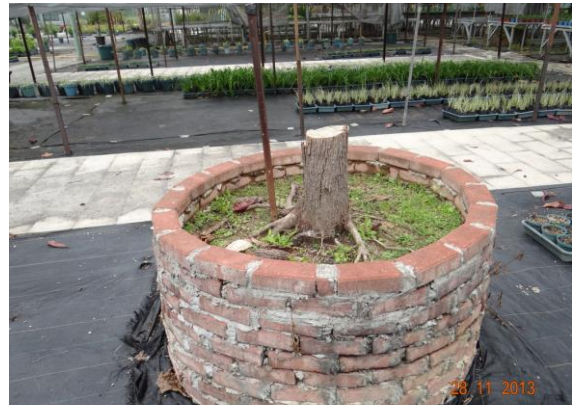
As highlighted in the Section “Liaison with Nursery”, the transplanted tree *Grevillea robusta* (U58) was considered to be a dead specimen as no sign of regenerated leaves was observed along the trunk and the remaining branches. The decayed tree trunk was removed in October 2013 and its stump was left in the tree planter (**Photo 14**).

**Photo 14** – The decayed trunk of U58 was removed, leaving a stump in the planter.

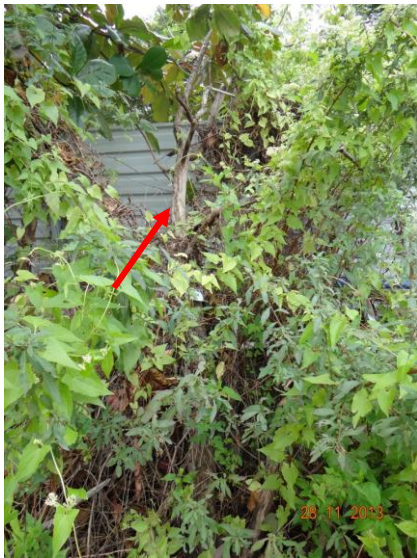
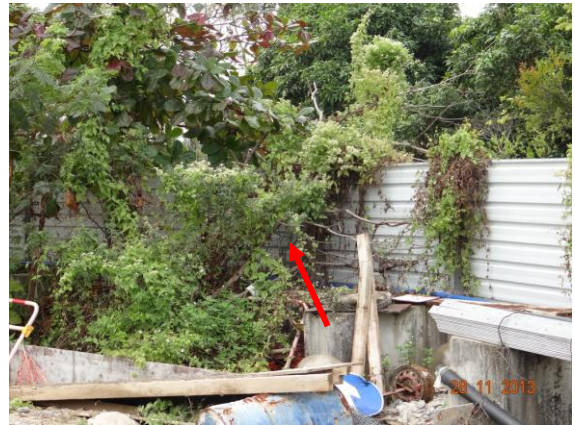
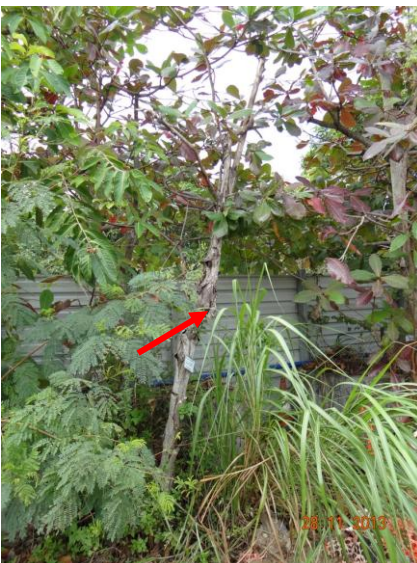
No recovery signs have been observed on the relocated trees U34, U35 and U37 and they are regarded as dead specimens (**Photos 15-17**); the dead tree trunks of U34 and U35 have collapsed since August 2013. Excavated soil was piled close to the relocated trees along both sides of Phase 1 works area in November 2013 (**Photo 18**).

**Photo 15** – The dead tree U34 was collapsed in previous month.

**Photo 16** – The dead tree U35 was collapsed in previous month.

**Photo 17** – The dead tree U37 was still standing in Area B.

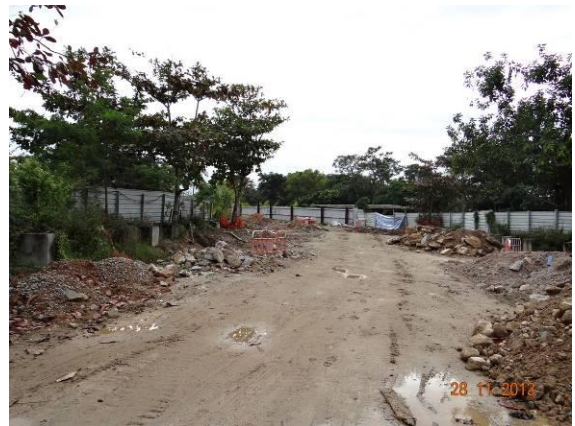
**Photo 18** – Excavated soil was piled close to the relocated trees along both sides of Phase 1 area.

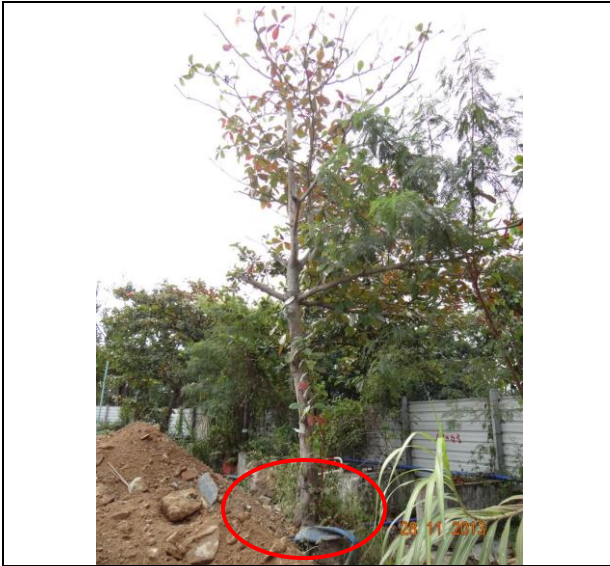
Half of the planter of U47 (*Terminalia catappa*) has broken since August 2013, and some of its roots and planter soil were exposed in the air. As inspected in November 2013, the planter was not yet repaired and soil excavated from the adjacent reinstatement work of irrigation system was piled on the trunk flare and planter (**Photo 19**).

**Photo 19** – The broken planter of U47 was not yet repaired and its trunk flare was piled with soil.

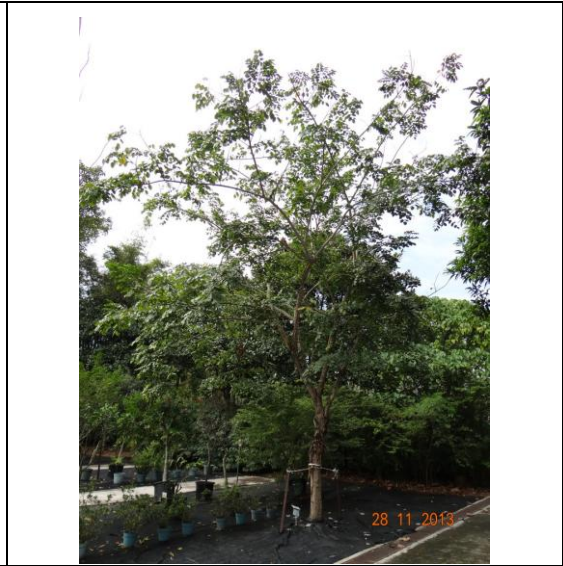
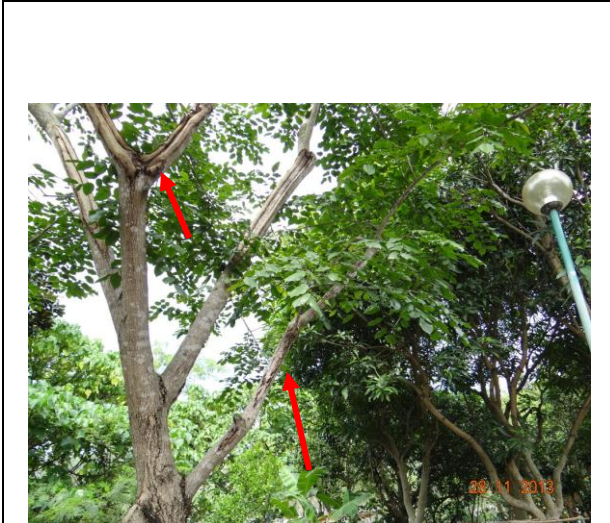
U55 (*Pterocarpus indicus*) has also been transplanted to its final receptor site in 2011 and pest control was applied on this tree in early 2013 due to the sign of termite infestation. Its health condition has been improved (**Photo 20**), however, long branches with wounds and dieback twigs were observed in the canopy (**Photo 21**). Close monitoring on this tree is

**Photo 20** – The health condition of the transplanted U55 was improved.

**Photo 21** – Long branches with wounds and dieback twigs were observed on U55.

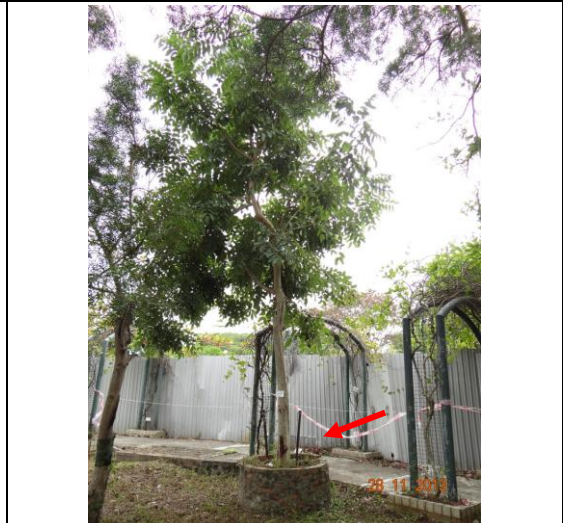
Sign of suspected termite infestation has been observed at the lower trunk of the retained tree U67 (*Cassia fistula*) (**Photo 22**). The tree was still in fair health and structural condition as observed in November 2013, but close monitoring should be undertaken.

**Photo 22** – Sign of suspected termite infestation was observed at the lower trunk of U67.

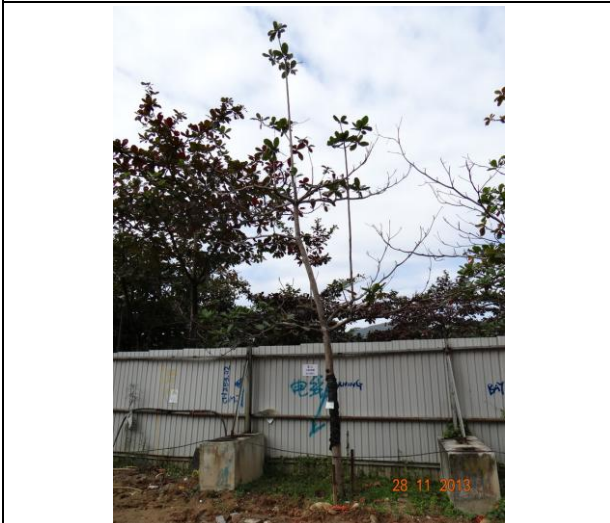
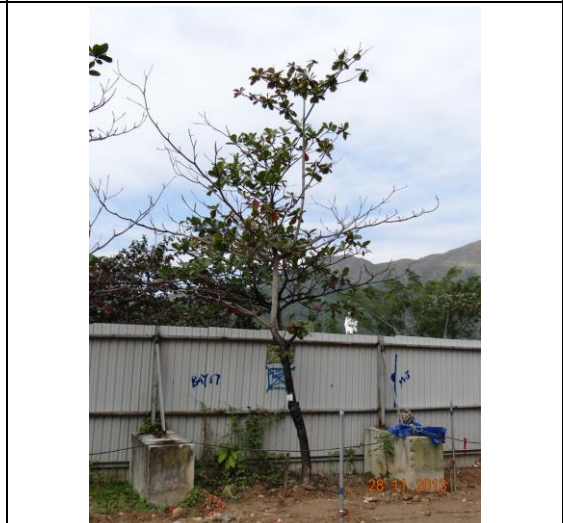
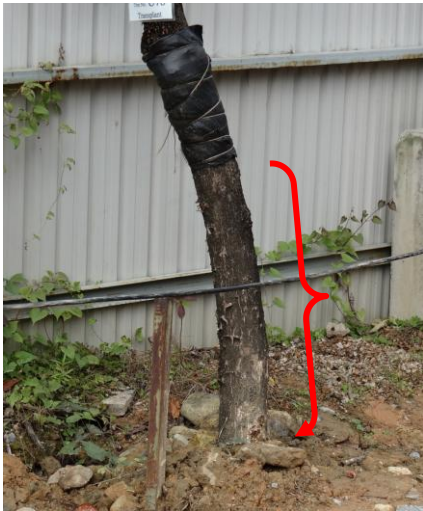
As reported in the submitted *Monthly EM&A Report for October 2013*, the relocated tree U77 (*Terminalia catappa*) in Phase 2 of Area B was dead and removed. Other relocated trees U76 and U78 (*Terminalia catappa*) have remained in marginally fair condition with regenerated leaves concentrated in the upper canopy (**Photos 23-24**). Cracked tree bark was observed at the lower trunk of these trees (e.g. lower trunk of U78 in **Photo 25**).

**Photo 23** – U76 has remained in marginally fair condition only.

**Photo 24** – U78 has remained in marginally fair condition only.

**Photo 25** – Cracked tree bark was observed along the lower trunk of U78.

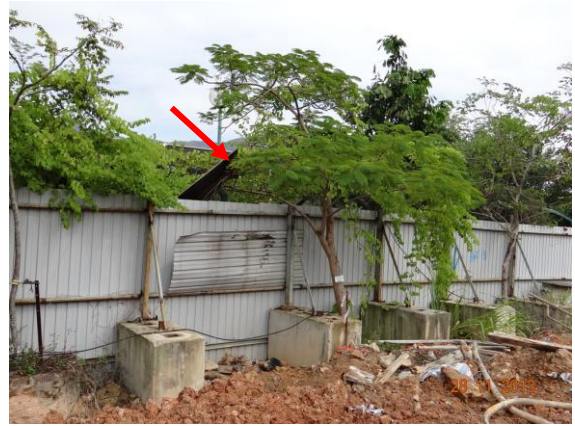
A wooden plate was found discarded among the overgrown climbers and canopy of the relocated tree U74 (*Delonix regia*) (**Photo 26**).

**Photo 26** – A wooden plate was discarded among the overgrown climbers and canopy of U74.

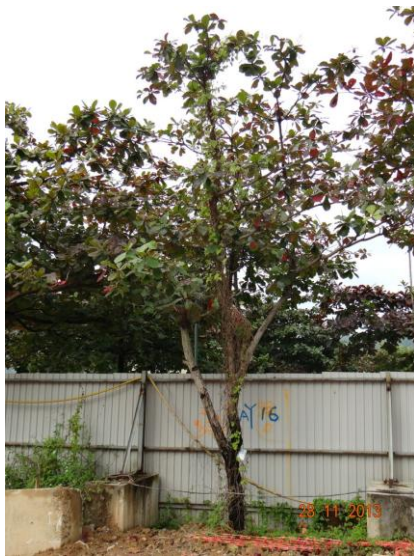
**Photo 27** – Condition of the relocated U79, with cracked bark on the topped scaffold limb.

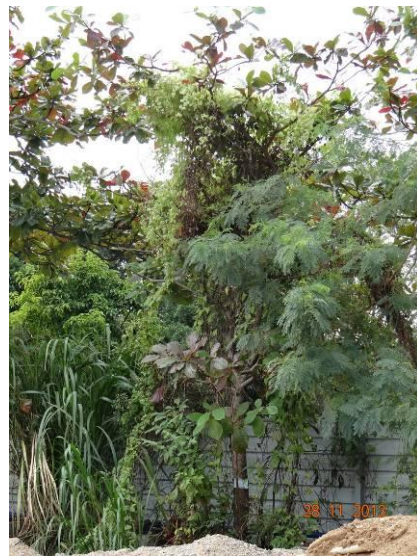
**Photo 28** – Overgrown climbers were found on the canopy of U52.

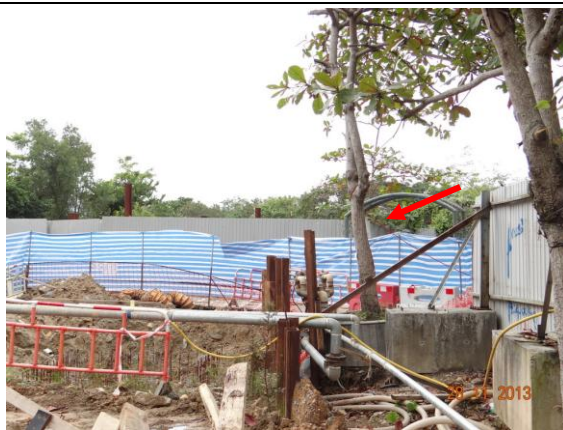
**Photo 29** – Civil works close to the planter of A40 (indicated) were still on-going.

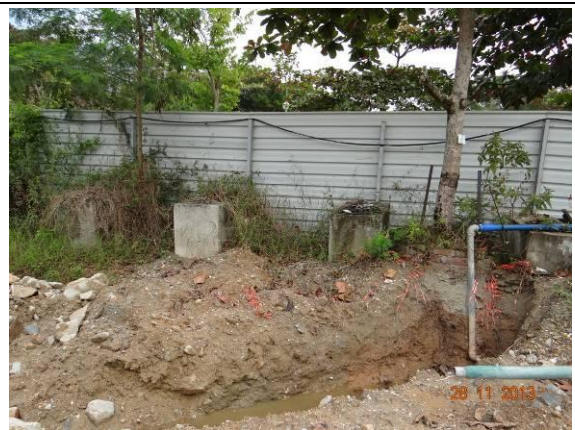
**Photo 30** – Excavated holes have still existed next to the relocated trees.

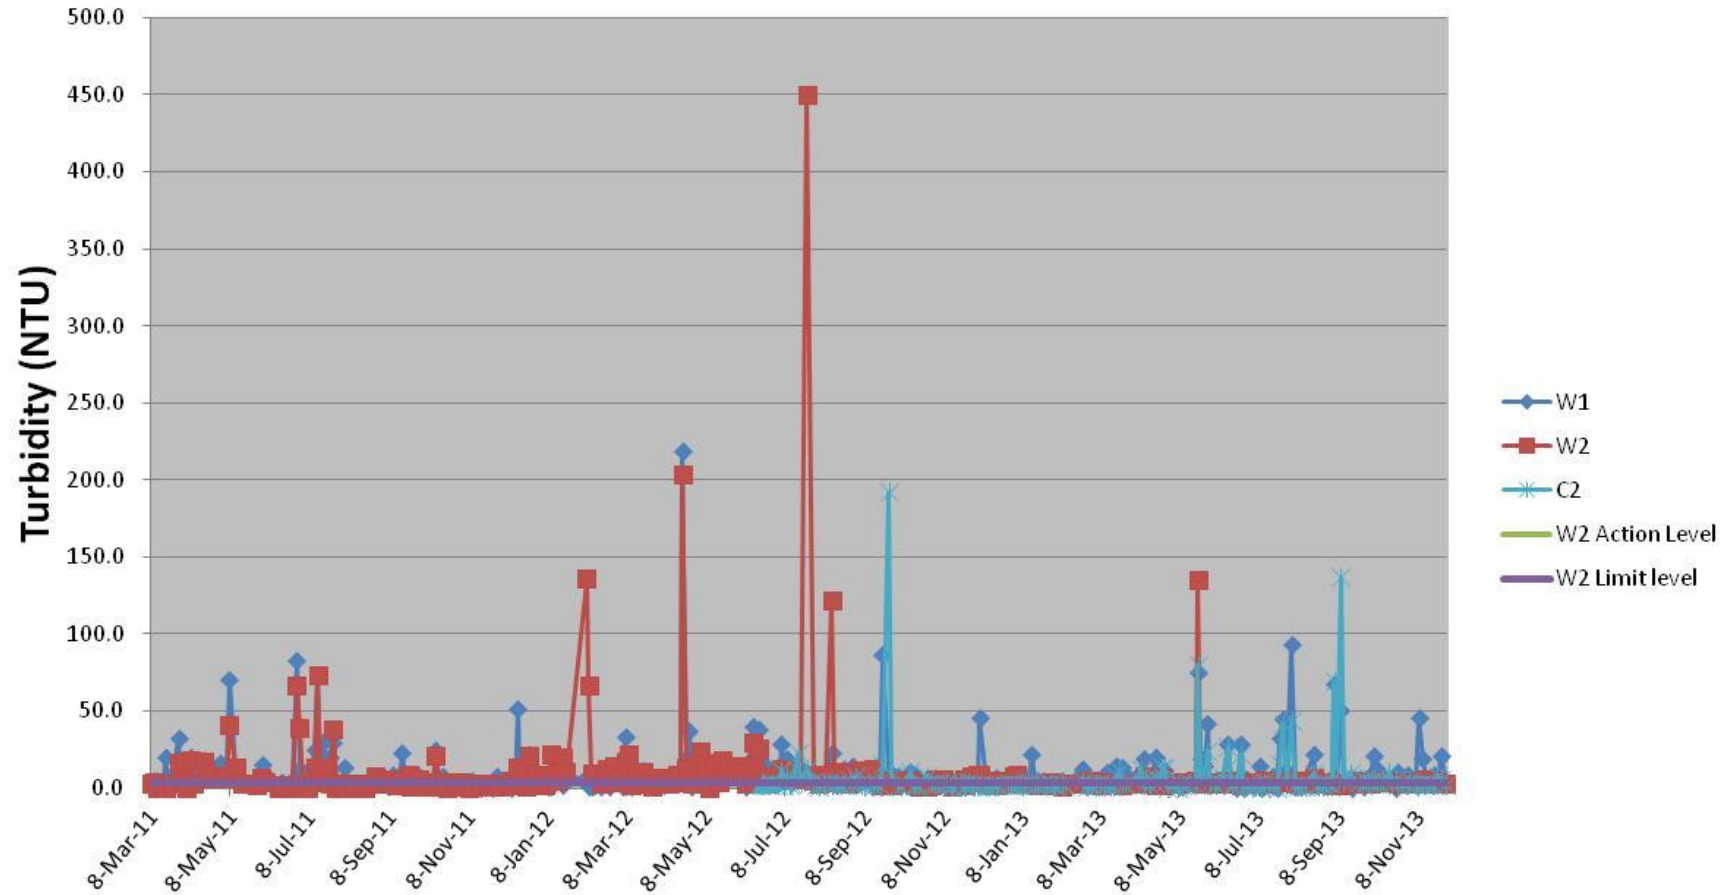
Graphical plots of Turbidity (ebb tide) for W1&W2

Remarks: Action limit is 95% of baseline data or 120% of upstream control station's Turbidity  
 Limit level is 99% of baseline data or 130% of upstream control station's Turb

There were 9 abnormal incidents of water quality limits (Turbidity) were recorded in this reporting month according to the established action and limit levels. ET has arranged site investigations for the abnormal incidents. No construction activities were carried out at the river bed. During the reporting period, no construction activities were conducted near the Wai Ha River. Proper mitigation measures were implemented by contractor to avoid site water releasing to the Wai Ha river and no particular observation of defective site activities were found causing water contamination. The exceedances of Turbidity and SS were believed to be mainly attributed by natural fluctuation. And, since the recorded levels of Turbidity and SS at control station had also exceeded its baseline action or limit level, the exceedances recorded at W2 were unlikely to be related to the Project.

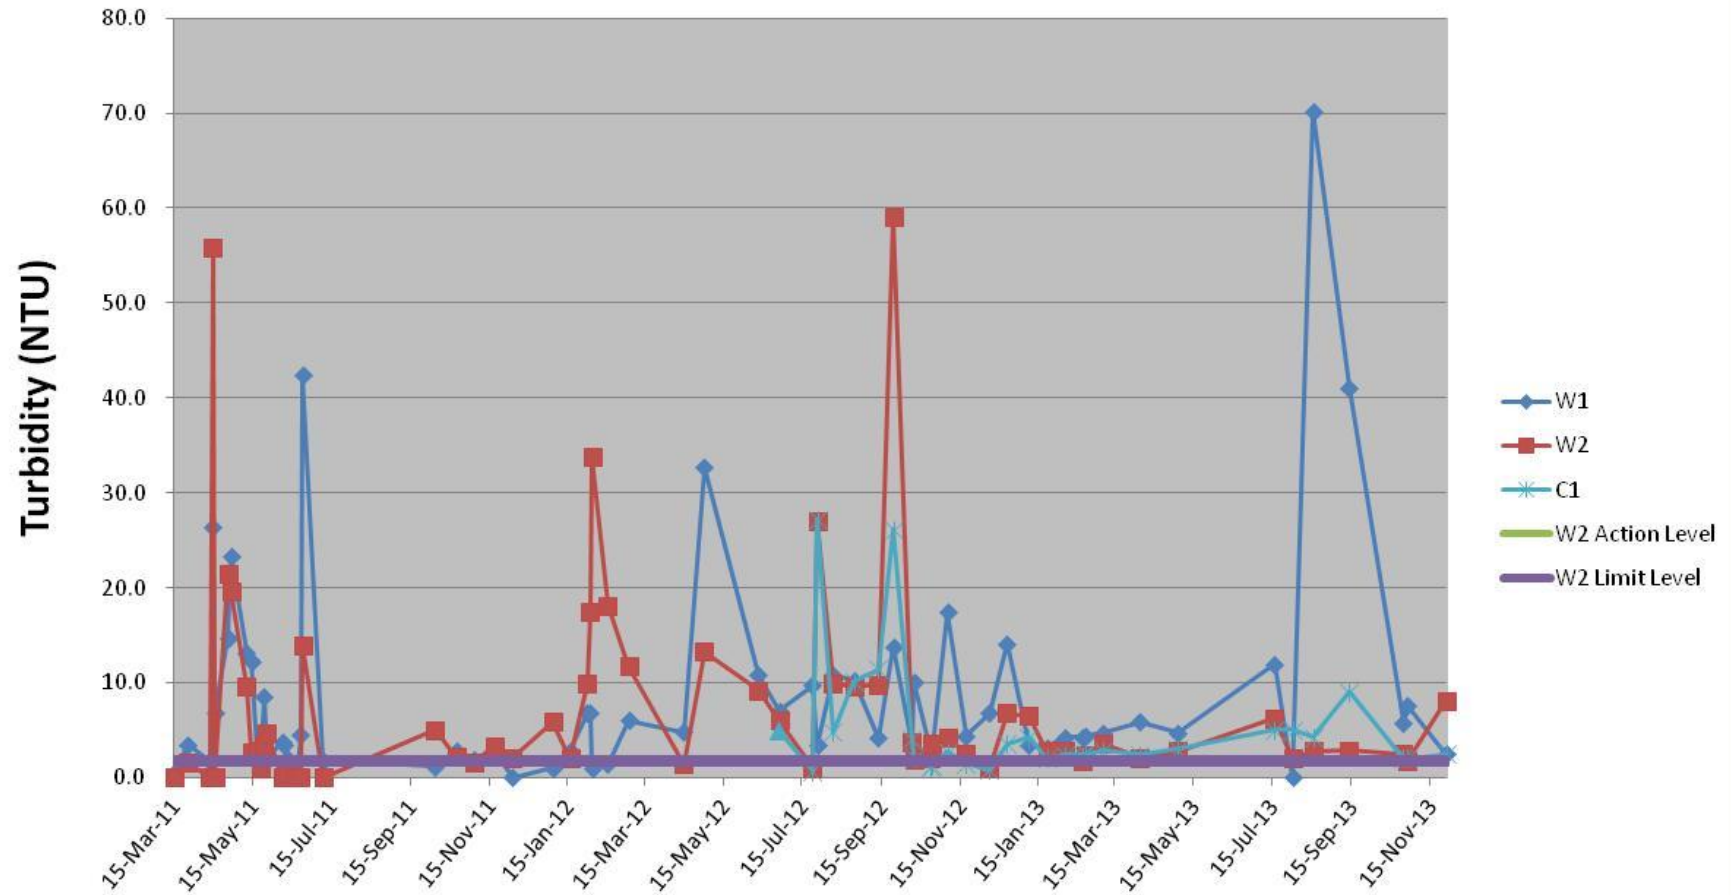
### Graphical plots of Turbidity (flood tide) for W1&W2

Remarks: Action limit is 95% of baseline data or 120% of upstream control station's Turbidity  
 Limit level is 99% of baseline data or 130% of upstream control station's Turb

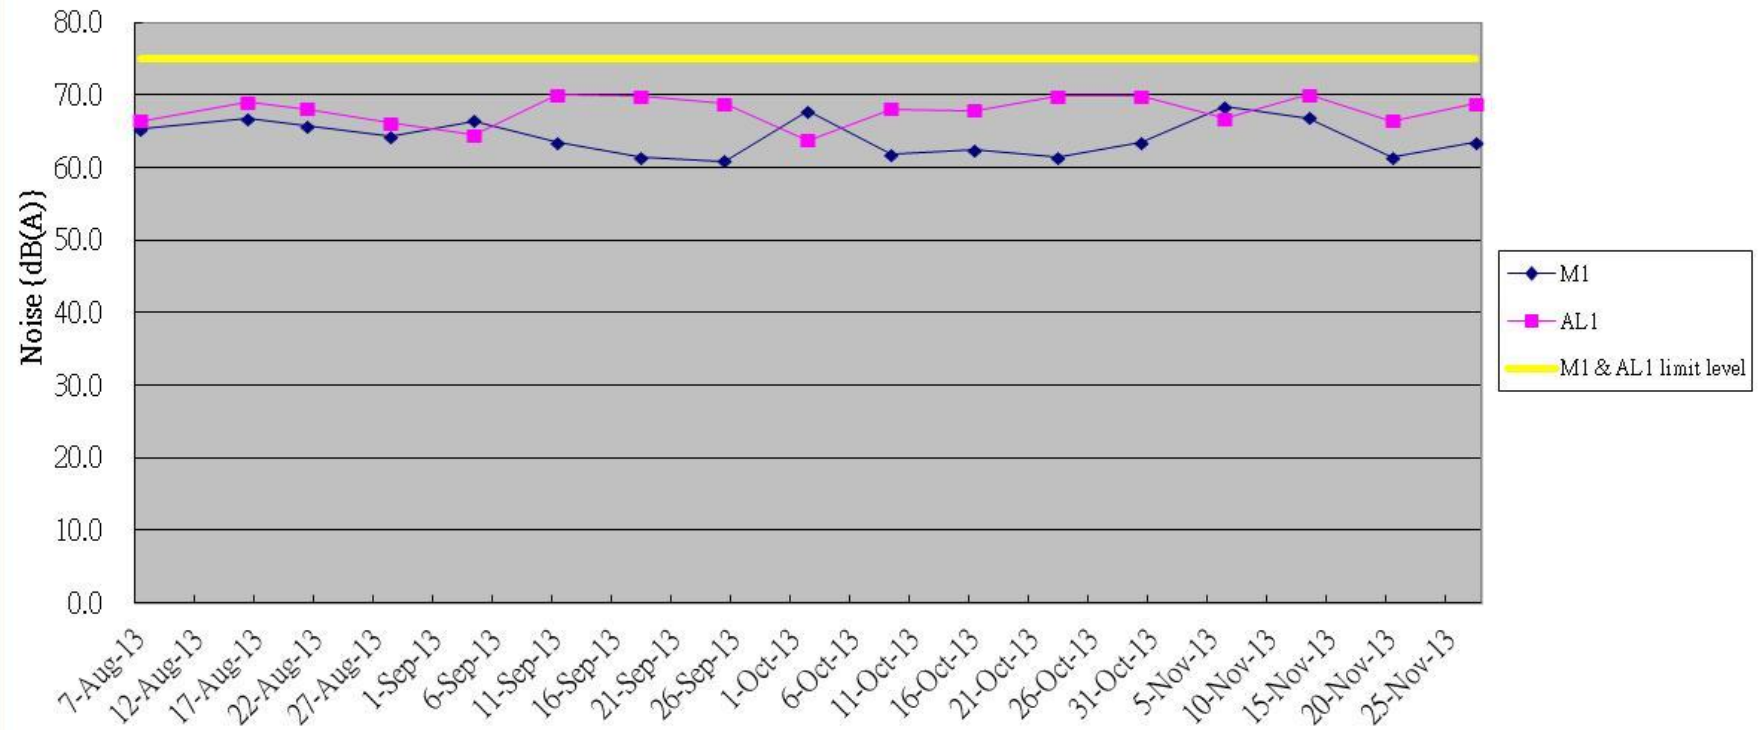
Graphical plots of Noise for M1 & AL1

Relevant details of the noise monitoring results are presented in Table 3.4.1. The results of M1 ranged between 61.5dB (A) and 68.4dB (A), and AL1 ranged between 66.5dB (A) and 70.1dB (A), were within the limit levels and therefore, no exceedance was found.

Remarks: Action limit is when one documented complaint is received

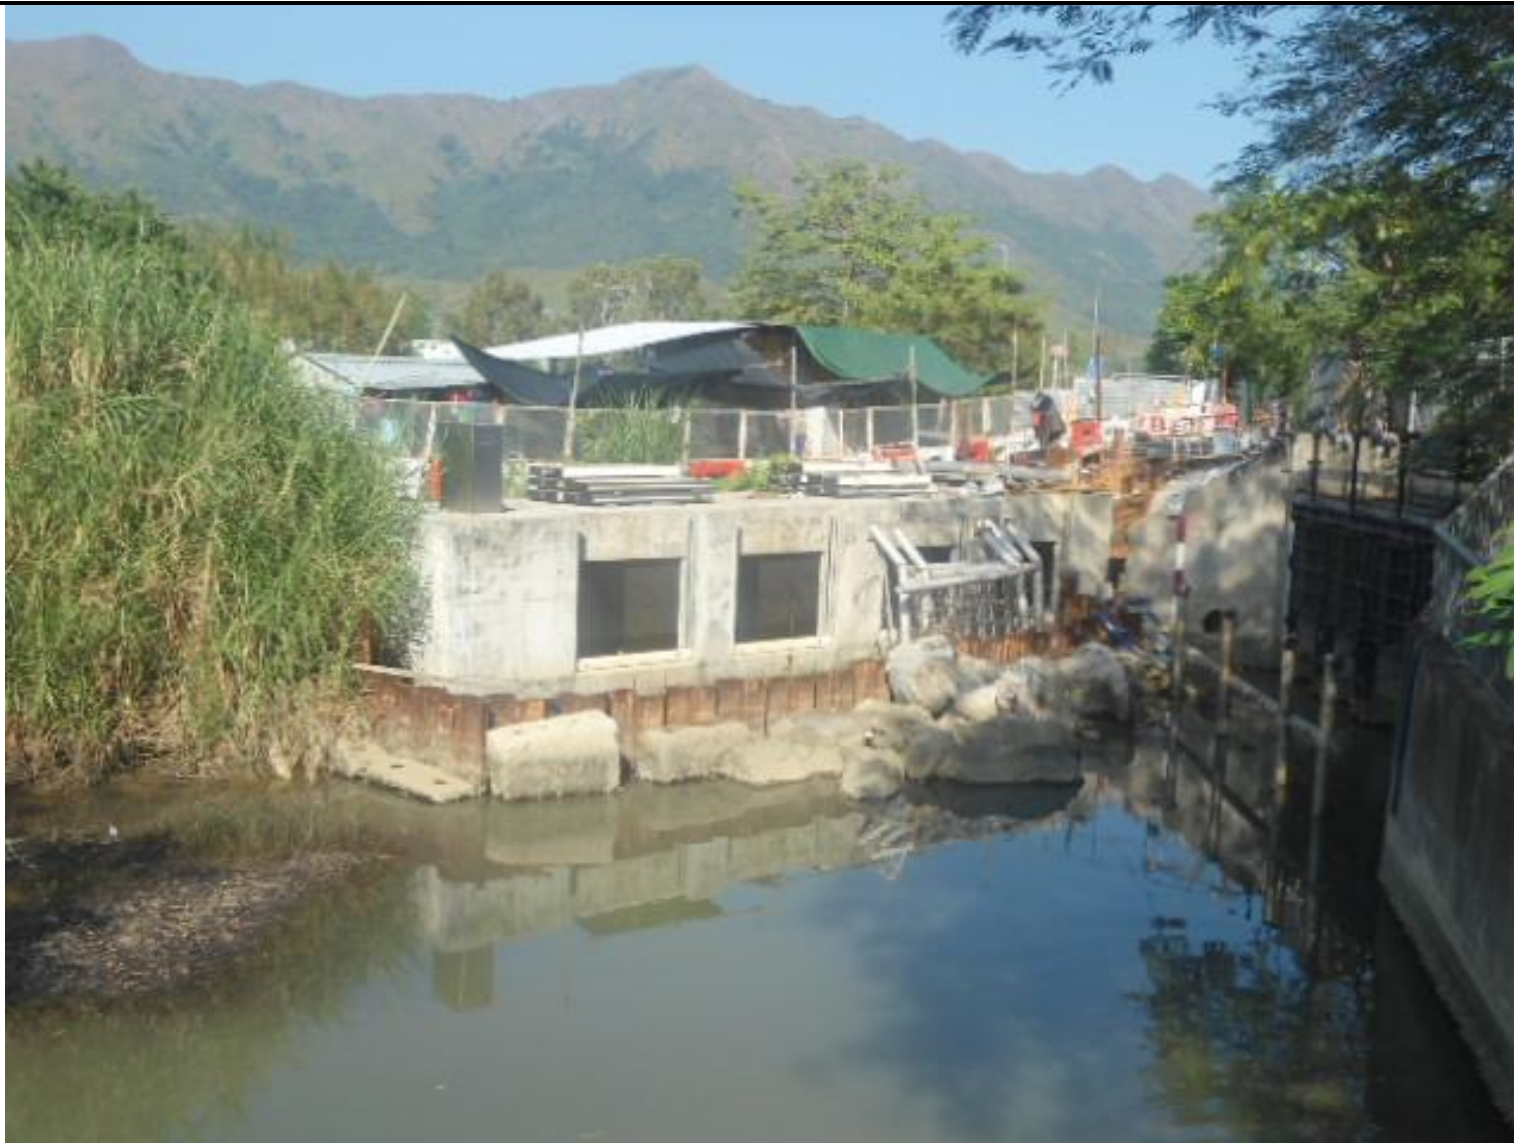
**Figure:** 2

**Title:** SEMP 1, the first sampling point of Wai Ha River under Contract 1.

Under Contract 1 (i.e. SEMP 1), a total of 7 fish species, 1 bivalve and 1 snail were recorded and most of them were residing in brackish environments (**Table 4**). Some river works were carried out in SEMP 1 as showed in **Figure 2**. Overall, no protected or rare species were recorded.

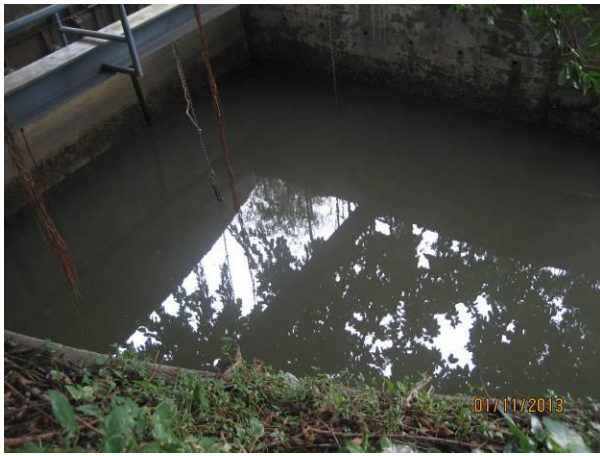
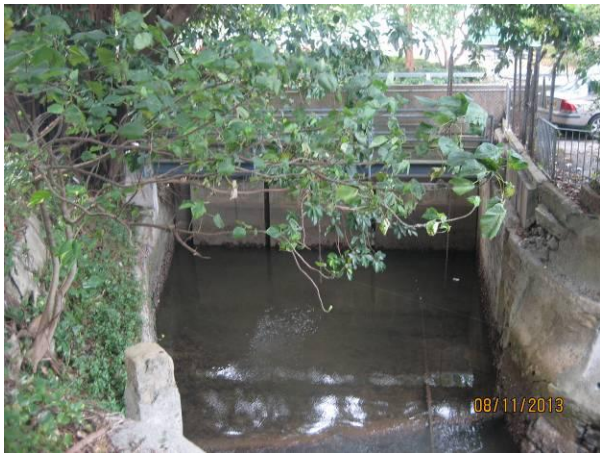
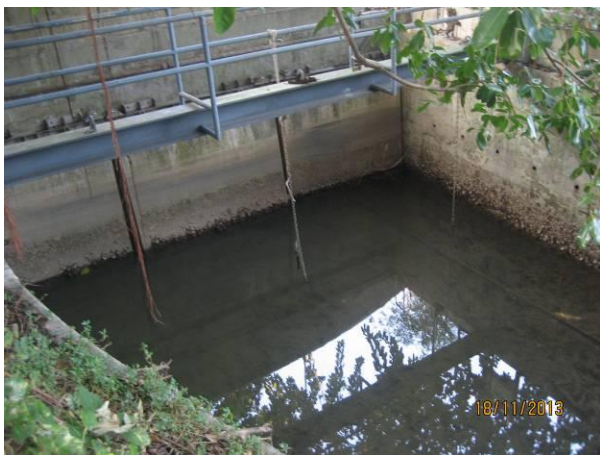
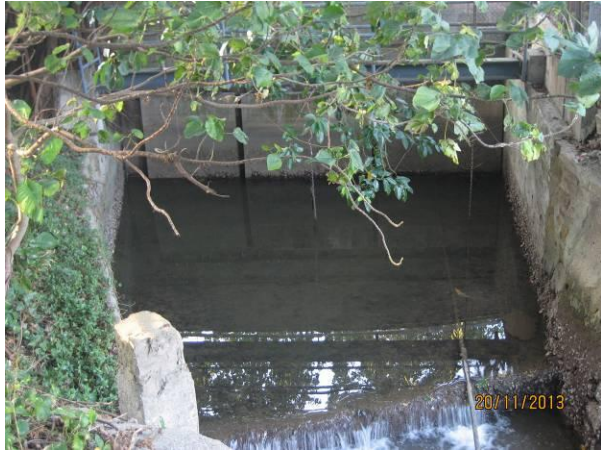
**Photo 1.** Wai Ha River at W2

**Photo 3.** Wai Ha River at W2

**Photo5.** Wai Ha River at W2

**Photo7.** Wai Ha River at W2

The water condition of Wai Ha River is presented in photo attached in **Appendix M**.
