**CONTRACT NO. DC/2010/02 –
DRAINAGE IMPROVEMENT IN SHUEN WAN AND
SHEK WU WAI**

**MONTHLY ENVIRONMENTAL MONITORING AND
AUDIT REPORT (NO.29) – NOVEMBER 2013**

PREPARED FOR
KWAN LEE-KULY JOINT VENTURE

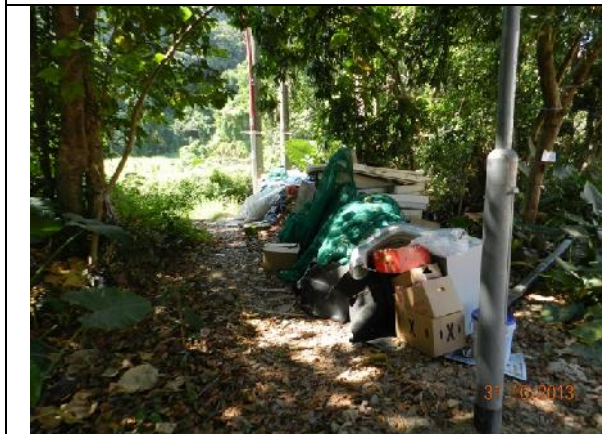
- 3.2.6 Outside the established hoardings of the Project Area, temporary storage of construction materials was still found next to the retained tree T179 in October 2013 (**Photo 11**).

Photo 11 – Temporary storage of construction materials next to the retained tree T179 in October 2013.

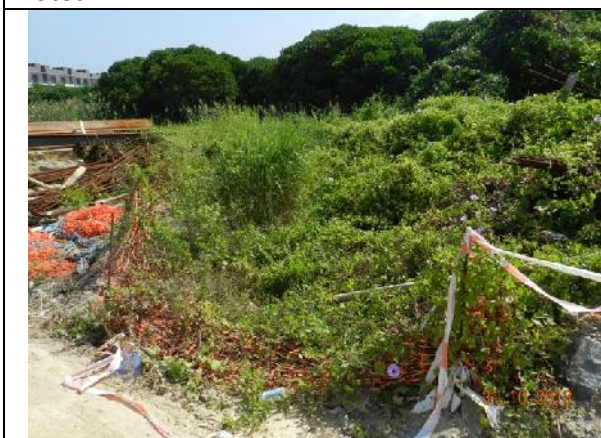
Photo 23 – A sedimentation bed aligned from the area opposite to the Jade View Villa towards the marsh area at southeast. No muddy water was observed but the bed were overgrown by dense grassy vegetation.

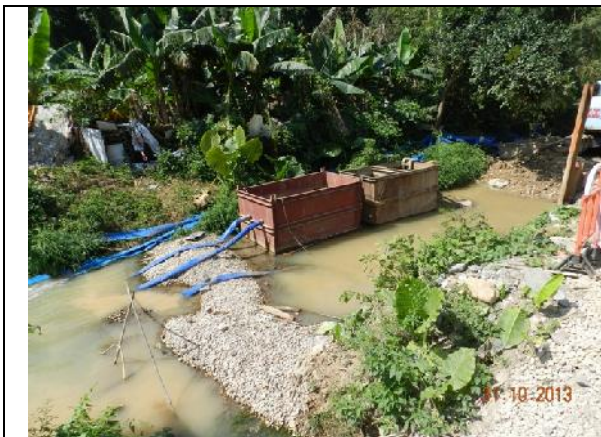
Photo 25 – The muddy water from the works area along Wai Ha River was pumped out from the river to a sedimentation tank settled at the end of the works area.

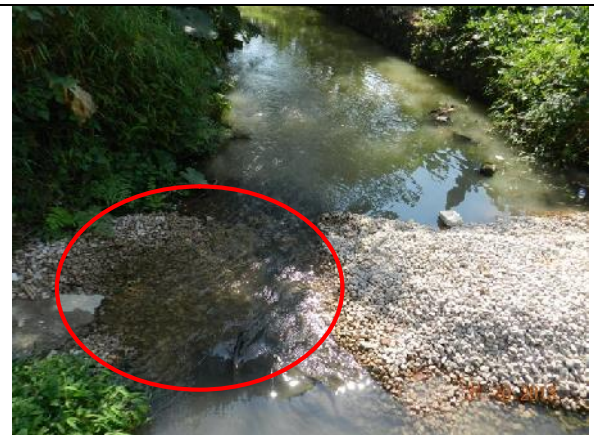
Photo 28 – Several sections of granules were washed away and the muddy water ran through it directly.

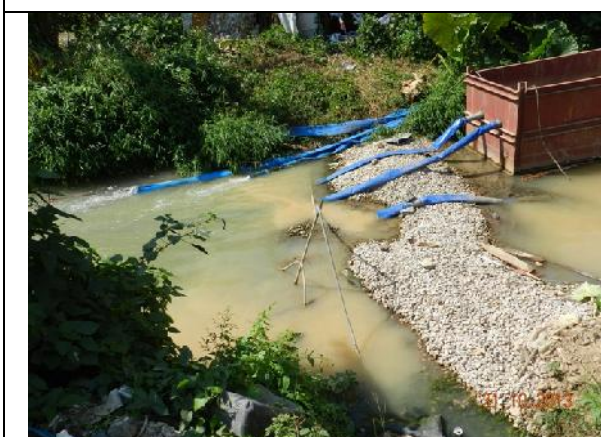
Photo 29 – Muddy water was noted at the lower stream.

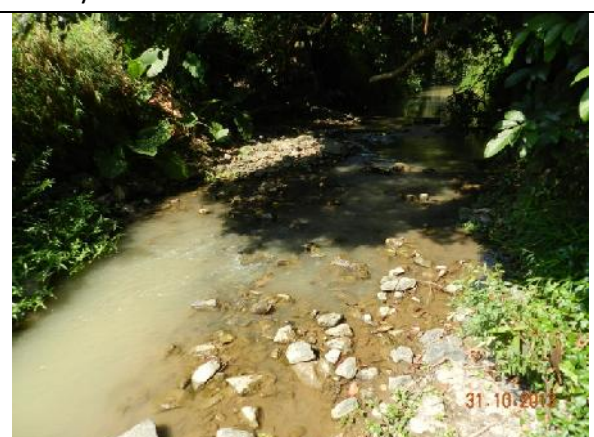
Photo 30 – Muddy water was noted at the lower stream.

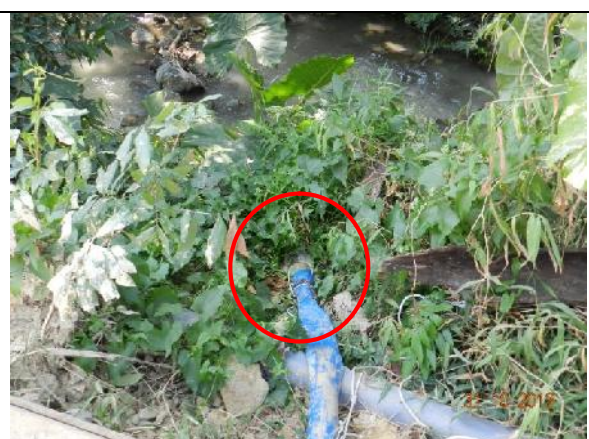
Photo 36 – Some muddy water from the box culvert in the works area was also found pumping to Wai Ha River directly.

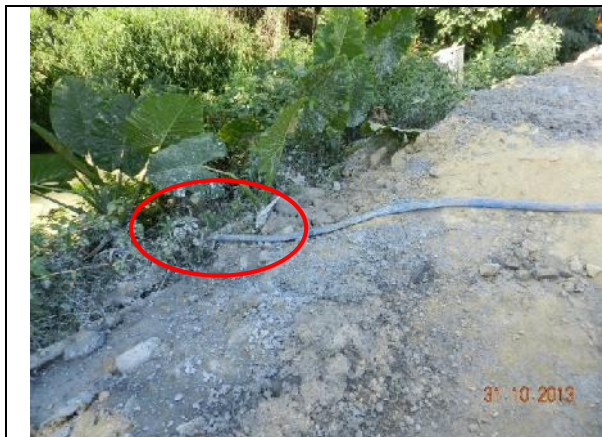
Photo 37 – Some muddy water from the box culvert in the works area was also found pumping to Wai Ha River directly.

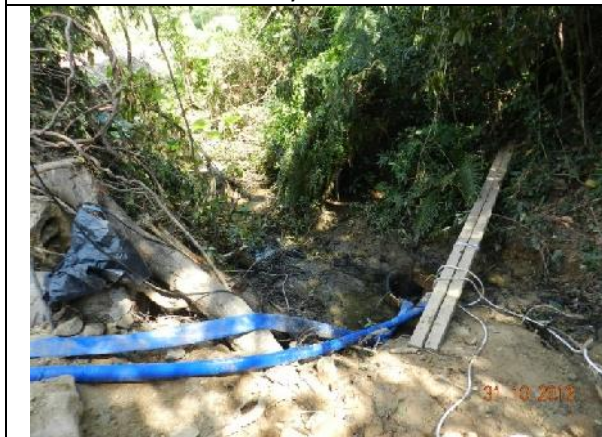
Photo 39 – In the works area at the end of the Treasure Spot Garden II next to the retained tree T103, a stream was blocked and the stream water was pumped to the drainage of the adjacent building.

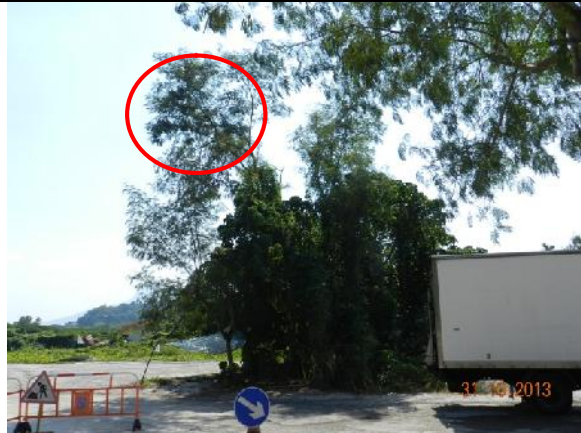
<p>Photo 43 – Vegetation clearance in the works area at the entrance of the access from Tung Tsz Road to Treasure Spot Garden II.</p>	<p>Photo 44 – A broken branch was found hanging in the canopy of the retained tree T091.</p>

<p>Photo 45 – A broken branch was found hanging in the canopy of the retained tree T091.</p>	<p>Photo 46 – A broken branch was seen hanging on the retained tree T093.</p>

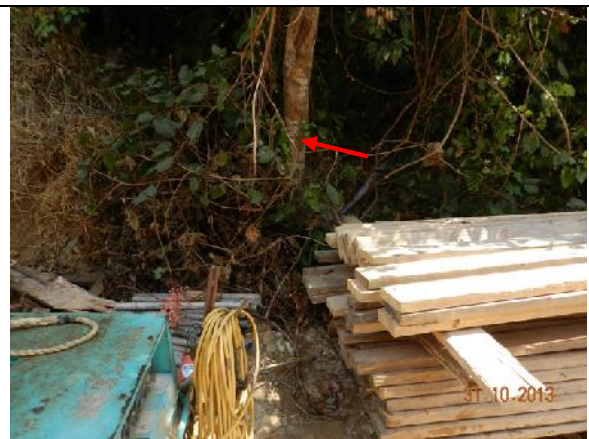
Photo 50 – Stockpiling were noted close to the trunk base of the retained tree T103.

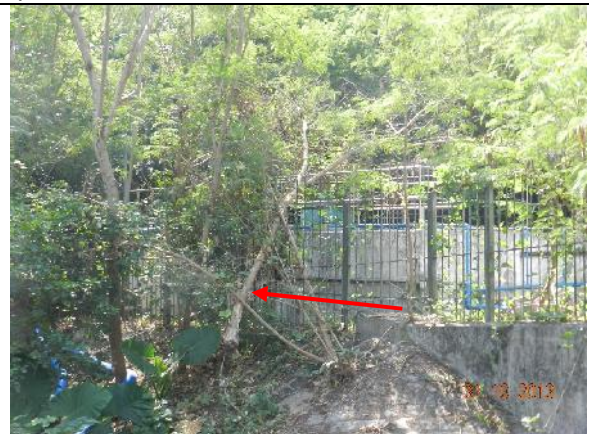
Photo 54 – *Leucaena leucocephala* (suspected to be T107) on the slope next to the Wai Ha River collapsed with decayed trunk.
