**CONTRACT NO. DC/2010/02 –
DRAINAGE IMPROVEMENT IN SHUEN WAN AND
SHEK WU WAI**

**MONTHLY ENVIRONMENTAL MONITORING AND
AUDIT REPORT (NO.30) – DECEMBER 2013**

PREPARED FOR
KWAN LEE-KULY JOINT VENTURE

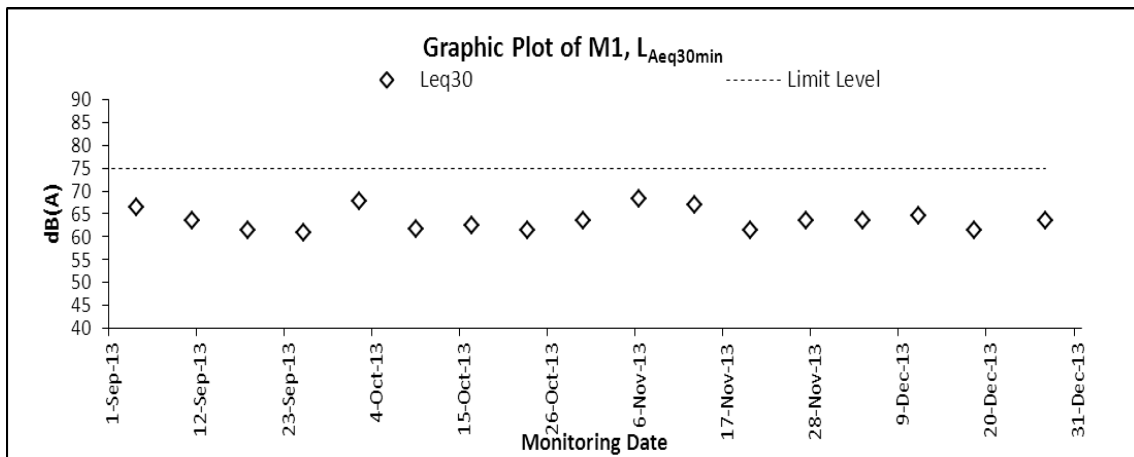
Remark: The monitoring is undertaken under façade situation. No façade correction is added according to acoustical principles and EPD guidelines.

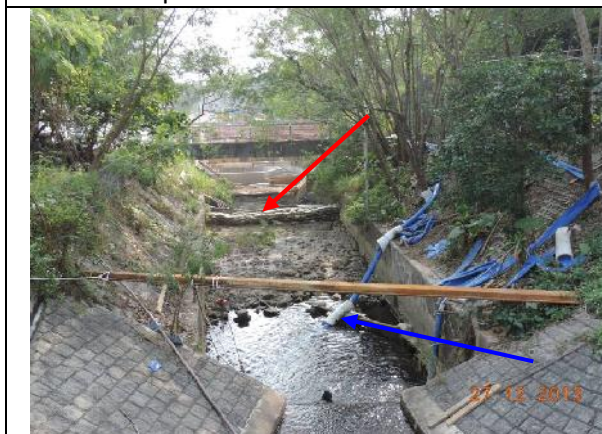
Photo 5 – The river was divided by sand bags (Red arrow) and water from the upper stream was pumped to the lower stream behind the works area along Wai Ha River (Blue arrow).

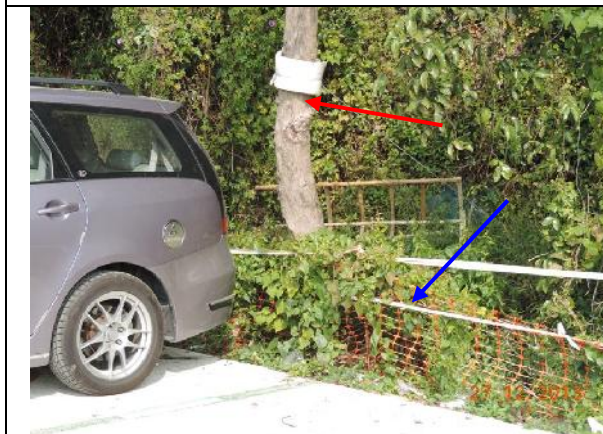
Photo 9 – The untagged tree (Red arrow) was guyed at the edge of the parking area within a Tree Protection Zone demarcated by orange construction nets (Blue arrow).

- 3.2.10 No specific recommendation is required. However, with regard to the previous dumping incident by other parties on the Taro field near the Treasure Spot Garden, the Contractor is recommended to check the site condition regularly to avoid any extent of dumping or paving of area within the project boundary.
- 3.2.11 The Contractor should also make sure there are no piled rocks, construction materials or programmed construction works influencing the existing trees within the Project Area or the wetland rehabilitation area. Otherwise, the Contractor should request the on-site workers to remove those piled rocks or construction materials.
- 3.2.12 The Contractor could establish a warning sign to remind the driver to beware of the presence of the tree(s) close to the temporary parking area.

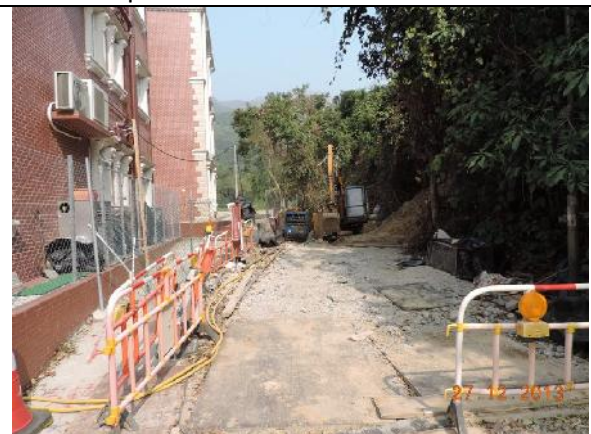
- 3.2.8 Works were observed at the end of the Treasure Spot Garden II near the retained tree T103 and the works area was surrounded by temporary construction barriers and chain-link fence (**Photo 10**). Active construction works were also seen on the pathway to the Treasure Spot Garden II near the retained tree group (T097-098) (**Photo 11**). The works area was also surrounded by temporary construction barriers.

Photo 10 – Works were observed at the end of the Treasure Spot Garden II near the retained tree T103 and the works area was surrounded by temporary construction barriers and chain-link fence.

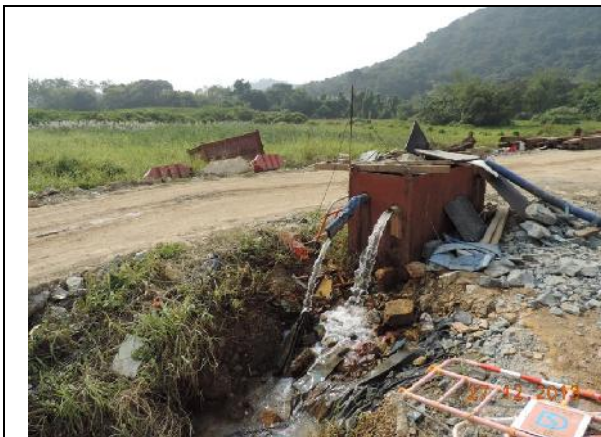
Photo 13 – A sedimentation tank was seen receiving the waste water from the works area near the previous collapsed tree T196 and the discharge was seen to be clear.

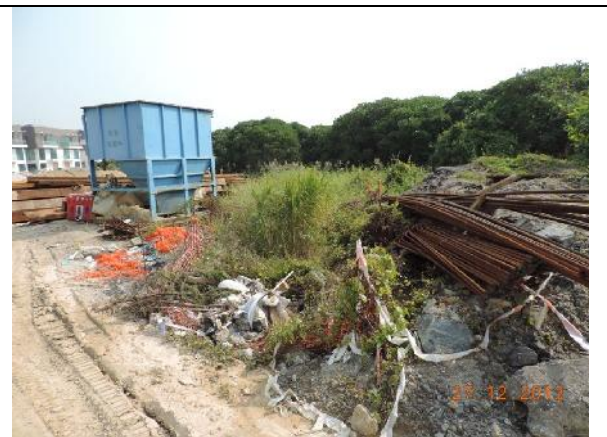
Photo 14 – Abandoned sedimentation bed aligned from the area opposite to the Jade View Villa towards the marsh area at southeast with overgrown dense grassy vegetation.

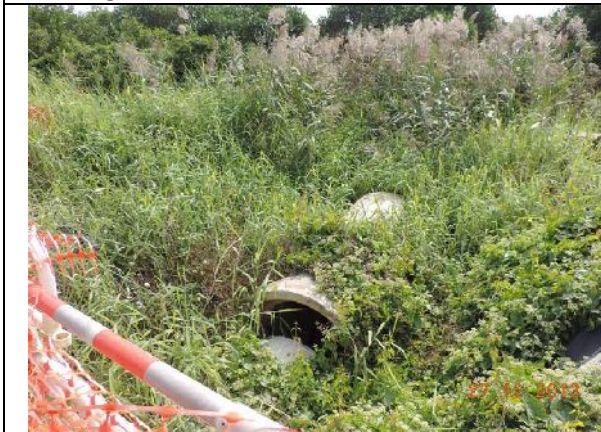
Photo 15 – Abandoned sedimentation bed aligned from the area opposite to the eastern part of Jade View Villa towards the marsh area with overgrown dense grassy vegetation.

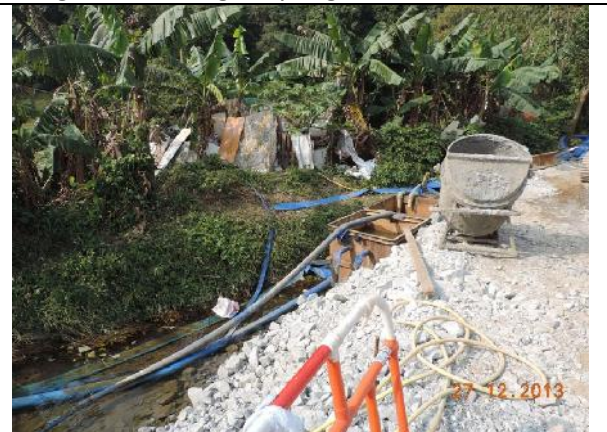
3.3.5 As mentioned above, construction works have been resumed along Wai Ha River. The muddy water from the works area was pumped out from the river and back to a sedimentation tank settled at the end of the works area (**Photo 16**). As observed in December 2013, the water was directed along the river and pumped to the grassland behind the tree group T181-183 (**Photo 17**), and the discharge was clear. The remaining water pumped from the upper stream was released back to the river near the sedimentation tank. Sections of granules with underlaid PVC liners were found along the river for further sedimentation but several sections of granules were washed away (**Photo 18**). The water was still noted clear at the lower stream (**Photo 19**).

Photo 16 – The muddy water from the works area was pumped out from the river and back to a sedimentation tank settled at the end of the works area.

3.3.7 Regular monitoring should be conducted to ensure no direct discharge or leakage of contaminants or any polluted fluid into the adjacent Wai Ha River and the nearby Shuen Wan marsh. The Contractor should maintain regular check (e.g. daily) on the sedimentation and filtration facilities and appropriate sedimentation beds and/or tanks throughout the construction phase (e.g. check the function of the sedimentation beds and remove surplus sand and gravels deposited along the beds or within the tanks) to make sure all discharged water was filtered appropriately prior to any discharge.

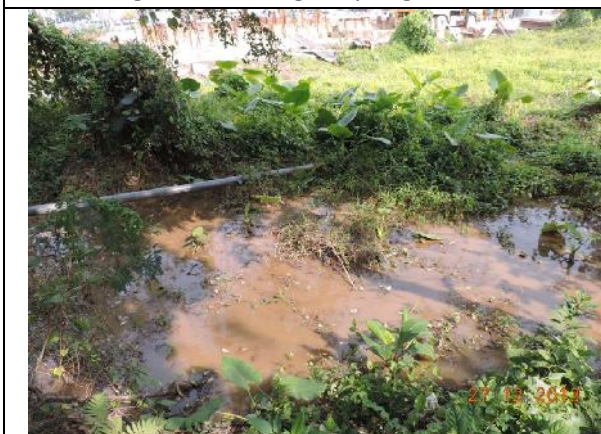
Photo 17 – The water from the sedimentation tank was directed along the river to the grassland behind the tree group T181-183. The discharge was clear in December 2013.

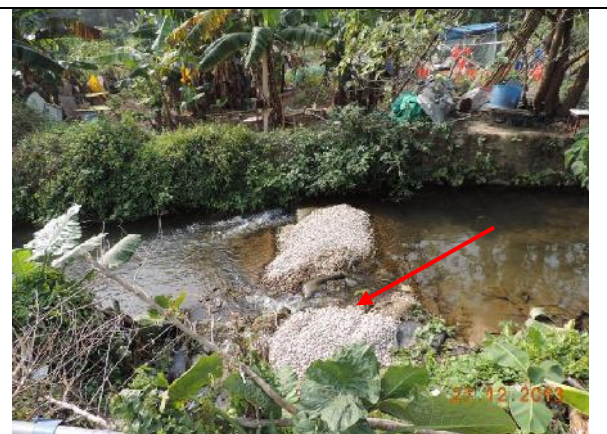
Photo 18 – Sections of granules with underlaid PVC liners were found along the river for further sedimentation but several sections of granules were washed away.

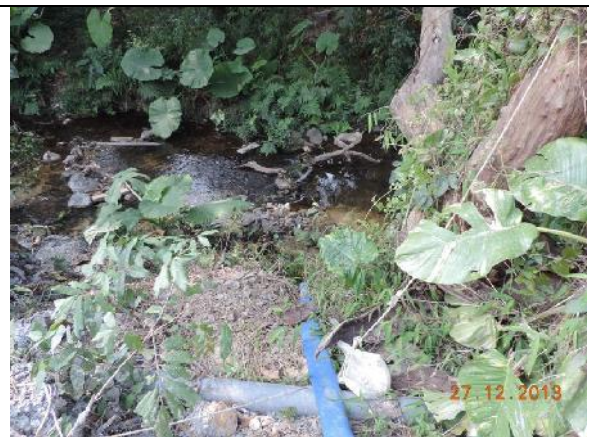
3.3.6 Water from the box culvert in the works area outside the public toilet was noted pumping out and releasing to Wai Ha River (**Photo 20**). The released water was clear as monitored in December 2013.

Photo 20 – Water from the box culvert in the works area outside the public toilet was noted pumping out and releasing to Wai Ha River.

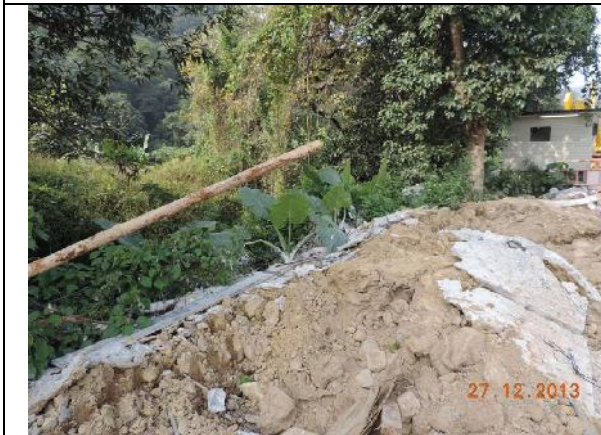
Photo 21 – In the works area near the public toilet, cement mortar and surplus soil were spread onto the slope and the vegetation next to Wai Ha River.

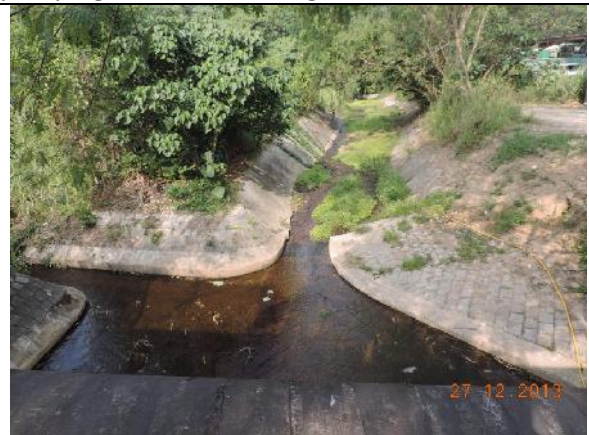
3.4.7 No direct water discharge into the upper stream of Wai Ha River was observed as the active construction works have been concentrated at the lower end of Wai Ha River to the southeast of Tung Tsz Shan Road (**Photo 22**).

Photo 22 – No direct water discharge into the upper stream of Wai Ha River was observed as the construction works have been concentrated at the lower end of the river.

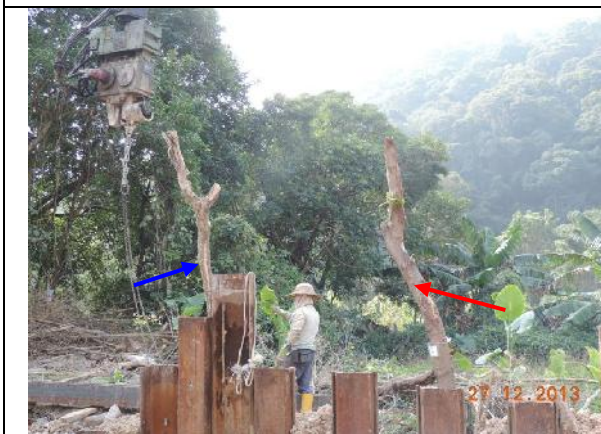
Photo 23 – Topped T167 (Red arrow) and T168 (Blue arrow) were in poor health condition with very sparse foliage.

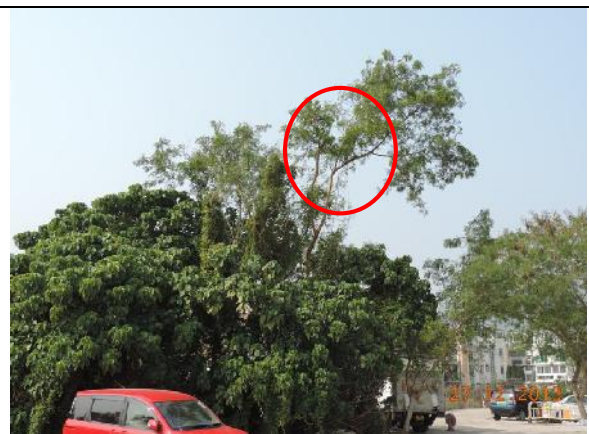
Photo 24 – A broken branch hanging in the canopy of the retained tree T091 was removed.
