Monthly Environmental Monitoring & Auditing report for

Contract No.DC/2009/22

Drainage Improvement in Shuen Wan, Tai Po – Contract 1

January 2014

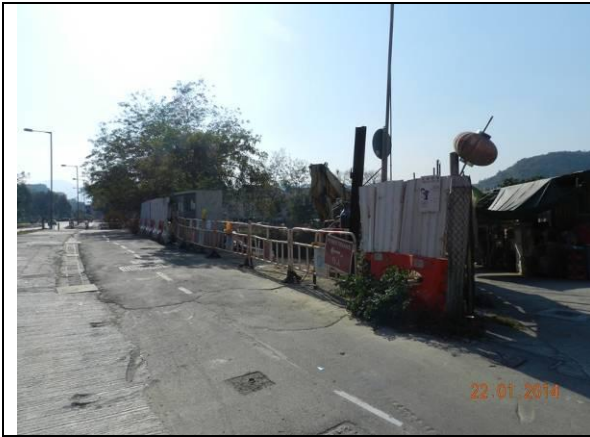
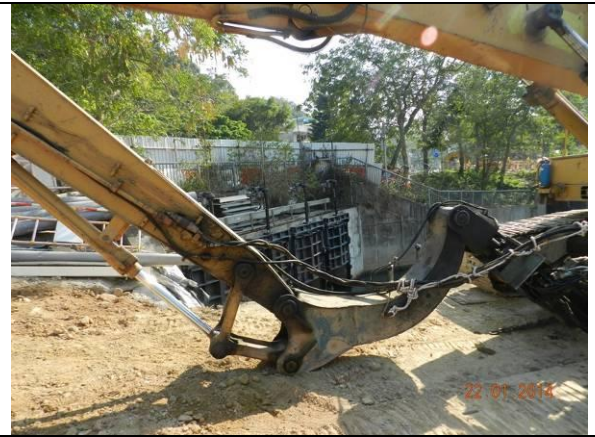
Construction hoardings were once erected along the entire site boundary of Area A. Temporary construction hoardings have been erected around Wai Ha River estuary since the building of an automatic mechanical penstock at the area (**Photos 1-2**). As observed in January 2014, temporary construction hoardings at the northern and southern sides of Area A (i.e. the proposed pump house station) were removed and construction of boundary walls along the western and part of the northern sides of Area A was in progress (**Photo 3**), while the proposed chain-link fence has partly erected along the rest of the boundary sides of Area A as inspected in January 2014 (**Photo 4**). Since January 2013, the site hoardings along the eastern boundary of Area A have been removed due to the active construction works for the installation of drainage pipes and the associated structures.

Photo 1 – Temporary construction hoardings have been established around the works area at Wai Ha River estuary.

Photo 2 – Temporary construction hoardings have been established around the works area at Wai Ha River estuary.

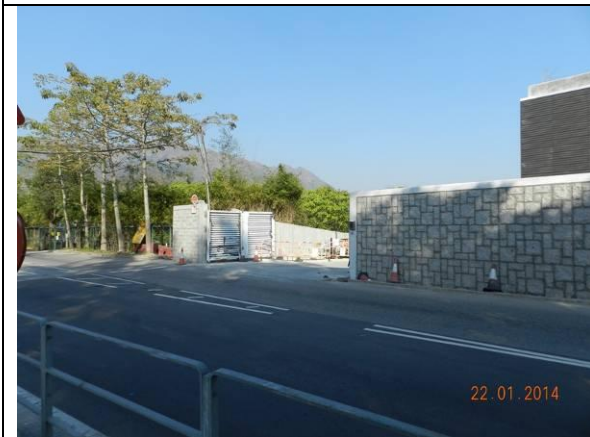
Photo 3 – Construction of the proposed boundary walls along part of the northern and western sides of Area A was in progress.

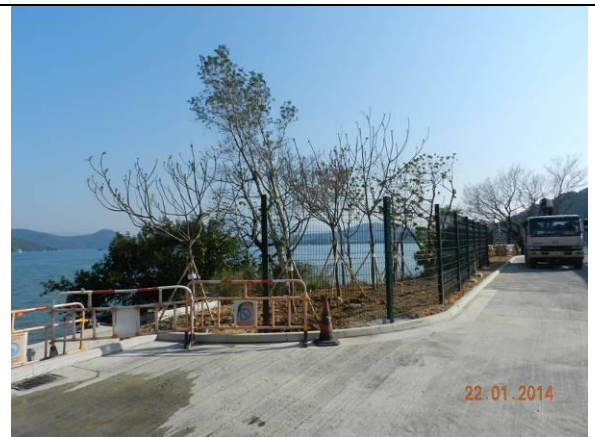
Photo 4 – Proposed chain-link fence has partly erected along the rest of the boundary sides of Area A.

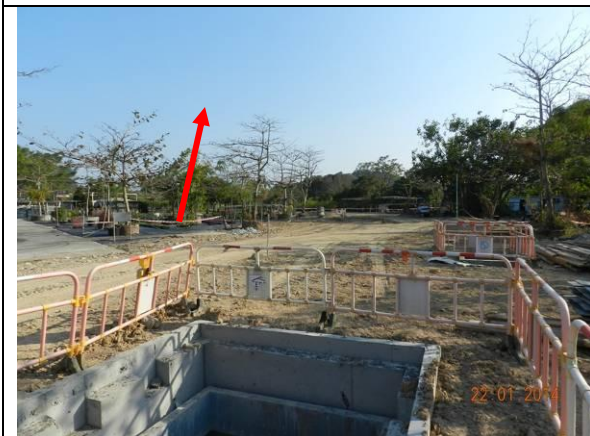
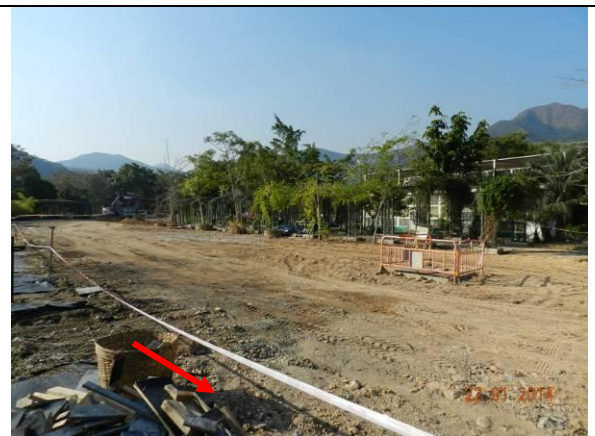
Photo 5 – The temporary construction hoardings in Phase 1 were removed and replaced by barrier tape.

Photo 6 – The temporary construction hoardings in Phase 1 were removed and replaced by barrier tape.

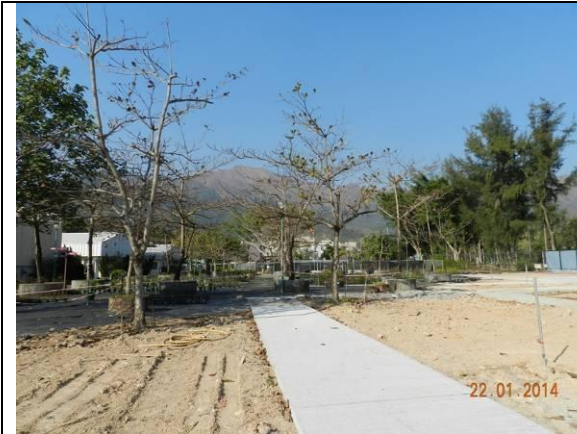
Photo 7 – The open section between Phases 1 and 2 work areas was opened again after the reinstatement works.

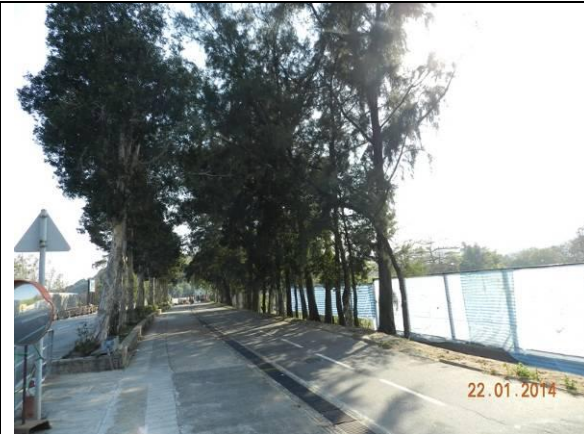
Photo 8 – Chain-link fence was reinstated at the eastern end of Phase 2 work area and covered by canvas sheets.

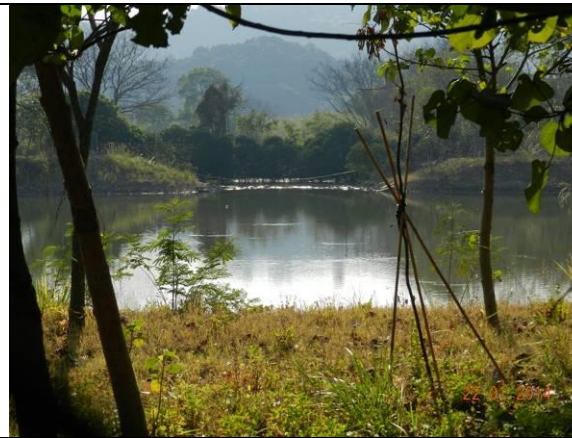
Area C was formally handed over to AFCD on 16th October 2012 for management and maintenance. The pond of the ECA has been connected to Wai Ha River directly as following the scheme design of Habitat Compensatory Plan. No direct discharge of turbid water into the adjacent Wai Ha River was observed through the fence of Tung Tsz Nursery (**Photo 9**).

Photo 9 – No discharge of muddy water was observed in Area C.

The Contractor should regularly check the condition and locations of the drainage pipes and ensure that all used water should be appropriately filtered and discharged to the manholes/other discharge points agreed by the Engineer and EPD. This is to avoid any potential contamination to the vegetation in Shuen Wan marsh and other vegetated/marinated areas adjacent to the active works area.

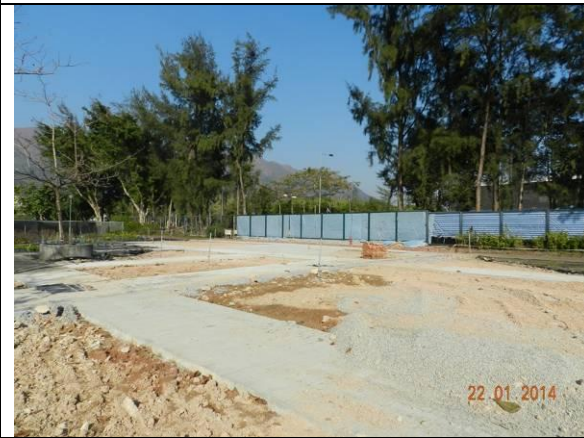
As observed in January 2014, no more excavation works were undertaken in Phases 1 and 2. The reinstatement works for the original access paths and ground of the nursery beds were still in progress (**Photo 10**).

Photo 10 – The reinstatement works for the original access paths and ground of the nursery beds were about to be finished in Phase 2.

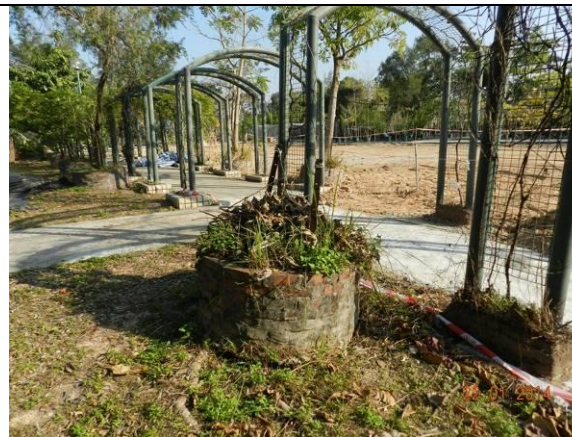
As reported in the previous *Monthly EM&A Reports*, the retained tree U68 (*Gmelina arborea*) was found fallen after the severe typhoon in July 2012, with its leaning trunk being pruned and removed in August 2012 (as reported in *Monthly EM&A Report for August 2012*). Regular removal of generated watersprouts was sometimes noted throughout the monitoring period. The regenerated watersprouts were removed in December 2013 as vegetation management practice in the Nursery and no more regenerated watersprouts were seen in January 2014 (**Photo 11**).

Photo 11 – No more regenerated watersprouts were seen from the stump of U68 in January 2014.

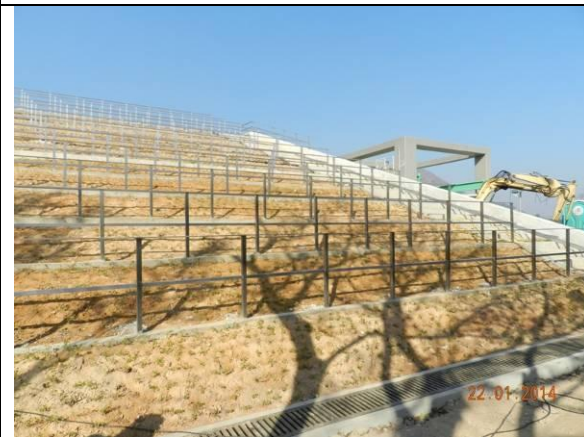
Photo 12 – The proposed green roof of the pumping house was vegetated with ground cover *Arachis duranensis*.

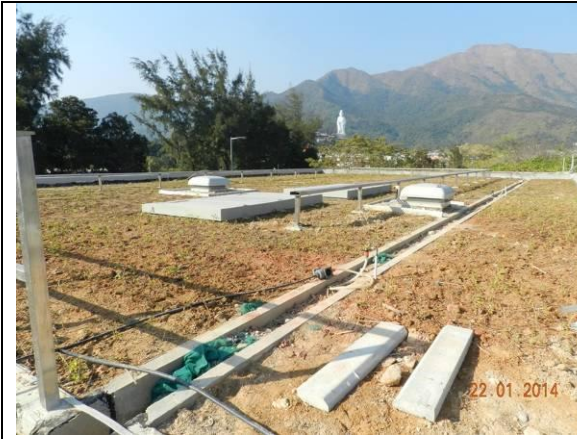
Photo 13 – The rooftop of the pumping house was vegetated with ground cover *Arachis duranensis*.

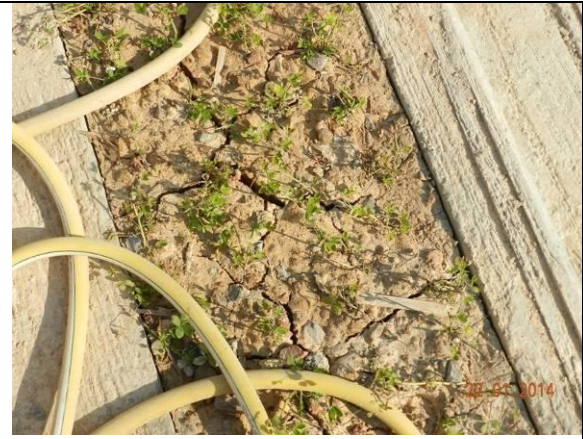
Photo 14 – The soil of the ground cover *Arachis duranensis* along the stairs to the roof appeared to be quite dry.

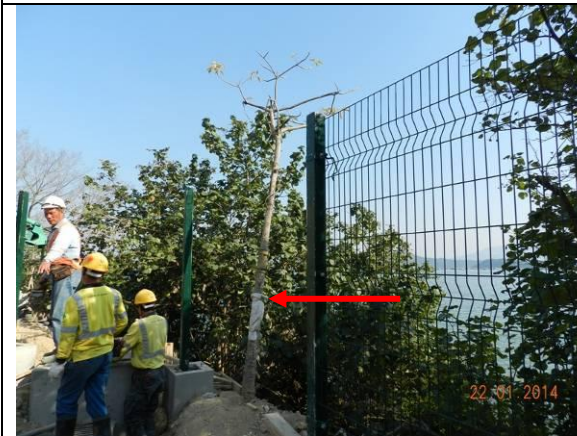
The tree to be transplanted E16 (*Bombax ceiba*) was relocated to the southern side of Area A next to the site hoarding in July 2012. The tree was in fair condition in January 2014 (**Photo 15**) but no more TPZ was noted around the tree during the monitoring on 22nd January 2014. Soil grade change was also observed around the trunk base and minor exposed roots were found (**Photo 16**). The stability of the tree may be affected. Given that its close proximity to the construction work which may be resumed close to the pumping house, the condition and stability of this tree should be regularly monitored.

Photo 15 – The TPZ around of the relocated E16 was removed.

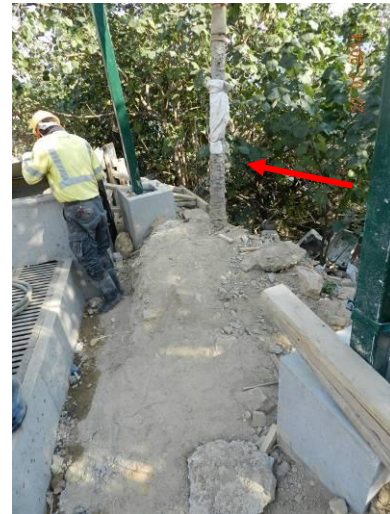
Photo 16 – Soil grade change was observed around the trunk base of E16 and minor exposed roots were found.

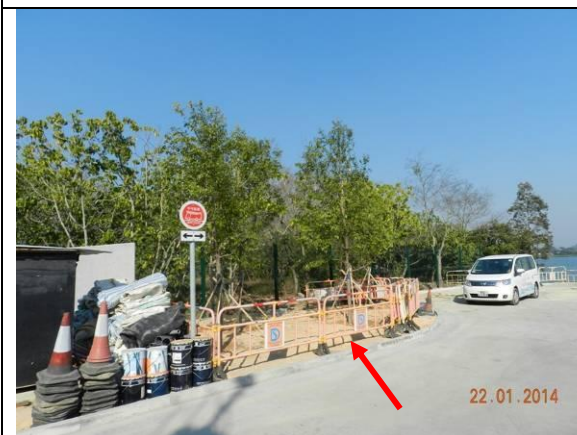
The relocated tree E38 (*Melaleuca cajuputi* subsp. *cumingiana*) was found dead after its relocation in August 2013, and it was removed by the Contractor in November 2013 (reported in *Monthly EM&A Report for November 2013*). A planter was built at the same location in accordance with the approved Landscape Plan. Four newly planted *Cinnamomum burmannii* appeared in fair condition in January 2014 (**Photo 17**). No further planting of shrubs and trees was noted in Area A.

Photo 17 – Four new trees of *Cinnamomum burmannii* were planted in the planter.

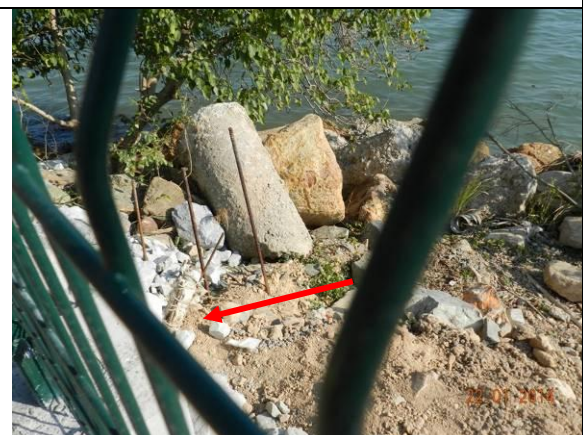
The leaning trunk of E61 (*Macaranga tanarius* var. *tomentosa*) has been burlapped and supported by two steel poles since May 2013. However, the tree was found to be removed as inspected on 22nd January 2014 (**Photo 18**).

Photo 18 – The leaning E61 was removed in January 2014. Its original location is indicated.

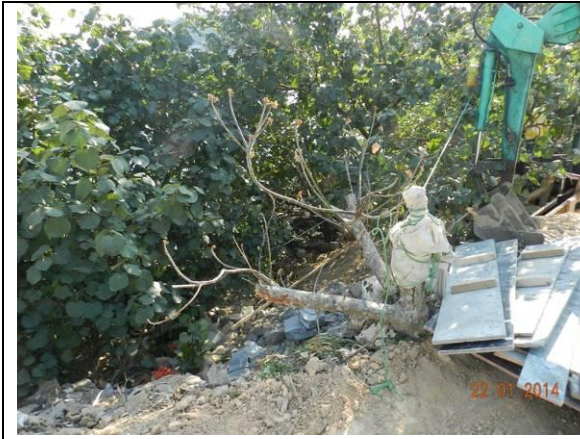
Damaged tree trunk on E55 (*Macaranga tanarius* var. *tomentosa*) was reported in *Monthly EM&A Report for April 2013*. The wound on the trunk of E55 has been burlapped since May 2013. The upper section of the tree trunk has broken since June 2013. The tree was still in poor condition with most of its foliage as dry watersprouts only (**Photo 19**). The tree was located just next to a temporary storage area of construction materials.

Photo 19 – The burlapped tree E55 was still in poor condition with dry leaves.

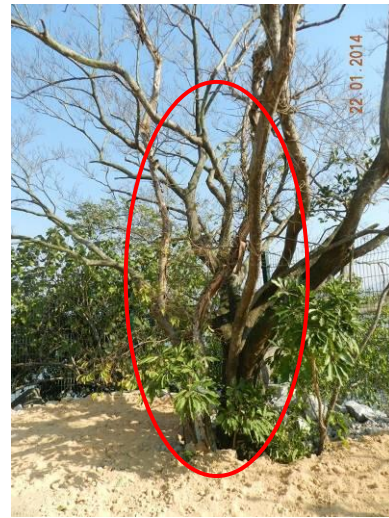
A retained tree T253 (*Bridelia tomentosa*) was in poor condition (Photo 20). Dead scaffold limbs with dry, peeled bark were observed. This identified tree defect may be only related to the intrinsic physiological and structural condition of T253. The tree was closely monitored in January 2014.\

Photo 20 – The retained tree T253 was in marginally fair condition.

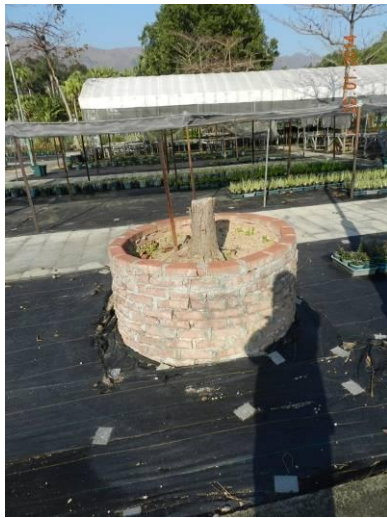
Photo 21 – The transplanted tree U58 was dead and removed.

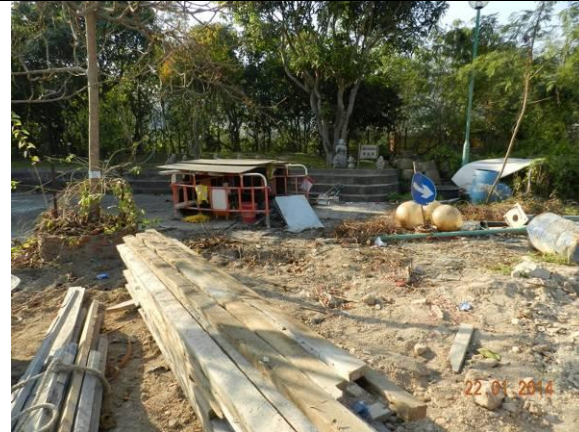
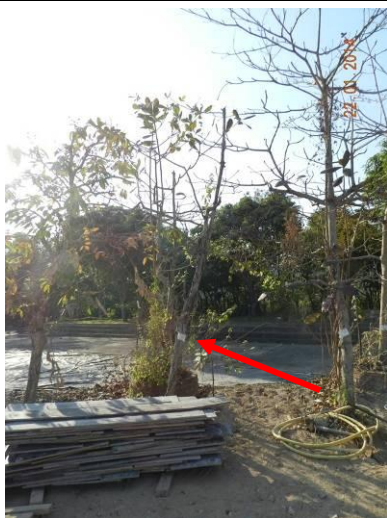
The relocated trees U34, U35 and U37 were certified as dead specimens (**Photos 22-23**). The collapsed dead tree trunk of U34 was removed in January 2014. As mentioned in previous *Monthly EM&A Report*, U35 could not be found in December 2013 and it was suspected to be removed in December 2014. Most of the excavated soil piled close to the relocated trees along both sides of Phase 1 works area was generally removed in January 2014.

Photo 22 – The collapsed tree trunks of dead tree U34 and U35 were removed.

Photo 23 – Dead tree U37.

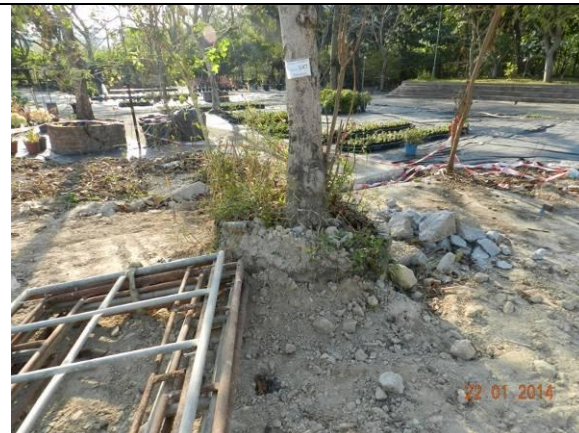
Half of the planter of U47 (*Terminalia catappa*) has broken since August 2013, and some of its roots and planter soil were exposed in the air. As inspected in January, the planter was still not yet repaired (**Photo 24**). Besides U47, the planters of U54 (*Terminalia catappa*) and two untagged *Terminalia catappa* to the southeast of U54 (**Photos 25-27**), as well as the relocated tree U69 (*Alstonia scholaris*) were also broken and not yet repaired. Exposed roots and planter soil were observed. On the other hand, excavated soil

Photo 24 – Half of the planter of U47 was broken, but has not yet been repaired.

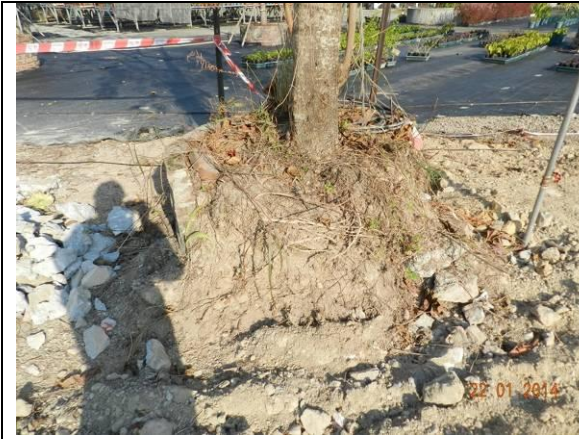
Photo 25 – The planter of U54 was broken and exposed roots and soil were observed.

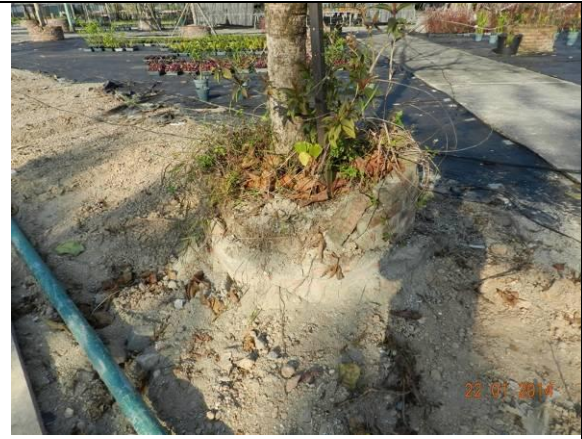
Photo 26 – The planter of an untagged *Terminalia catappa* next to U54 was broken, with exposed roots and soil .

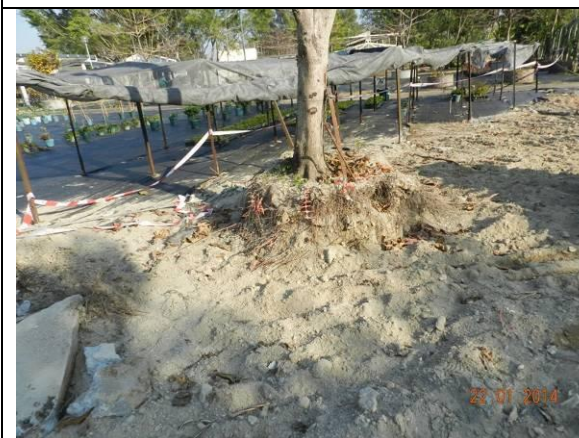
Photo 27 – The planter of another untagged *Terminalia catappa* next to U54 was broken, with exposed roots and soil.

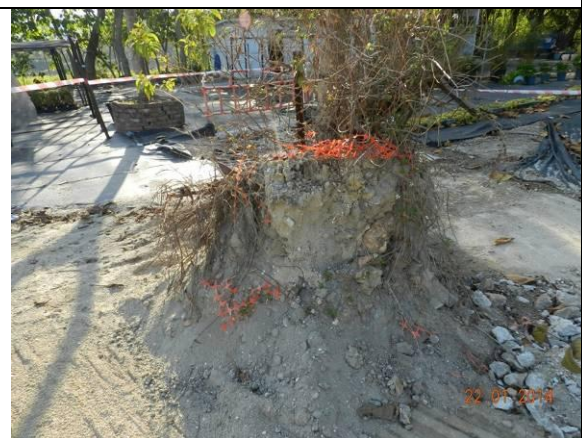
Photo 28 – Excavated soil was piled around the planter and on the root flare of U51.

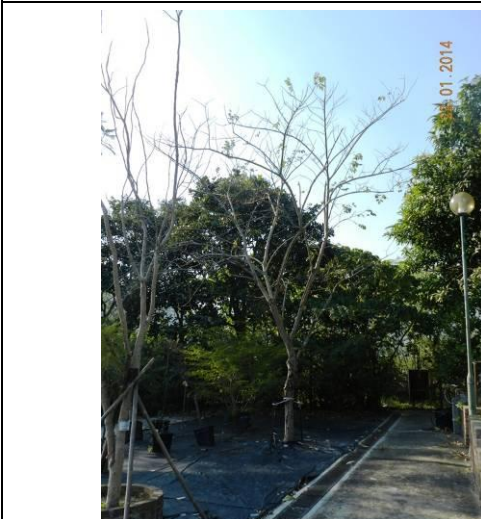
U55 (*Pterocarpus indicus*) has been transplanted to its final receptor site in 2011 and pest control was applied on this tree in early 2013 due to the sign of termite infestation. Its health condition has been improved (**Photo 29**), but long branches with wounds and dieback twigs were still observed in the canopy. Close monitoring on this tree is still required.

Photo 29 –The health condition of U55 has been improved.

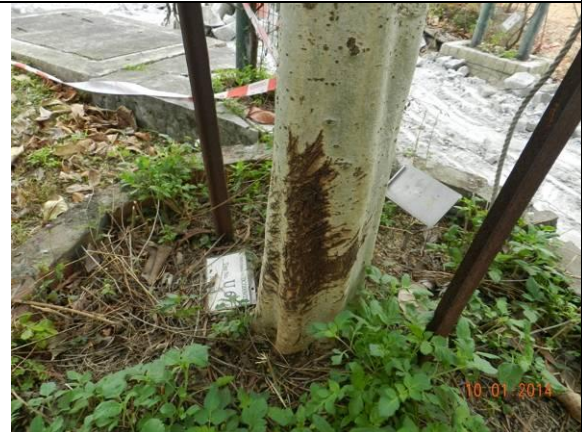
Sign of suspected termite infestation has been observed at the lower trunk of the retained tree U67 (*Cassia fistula*) (**Photo 30**). The tree was still in fair health and structural condition as observed in January 2014, but close monitoring should be undertaken.

Photo 30 – Sign of suspected termite infestation was observed at the lower trunk of U67.

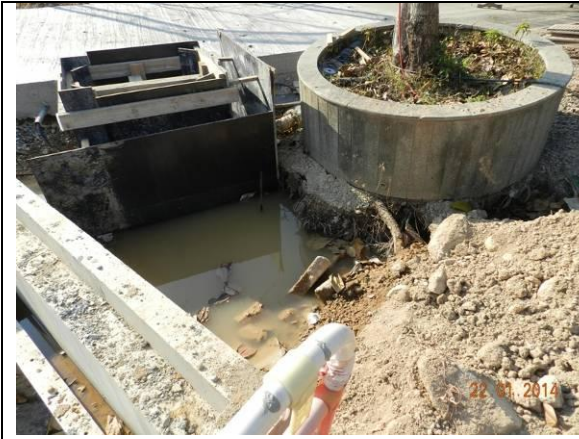
For the retained tree A40 (*Terminalia catappa*) at the entrance of Phase 2 construction areas, the excavated area close to its planter has not yet refilled with soil and some of the tree roots growing underneath the tree planter are still under a risk of being damaged by any future minor civil works (**Photo 31**). The tree may have a risk of leaning if its underground roots are further damaged or the ground is not backfilled soon.

Photo 31 – The excavated area close to the planter of A40 has not yet been refilled with soil.

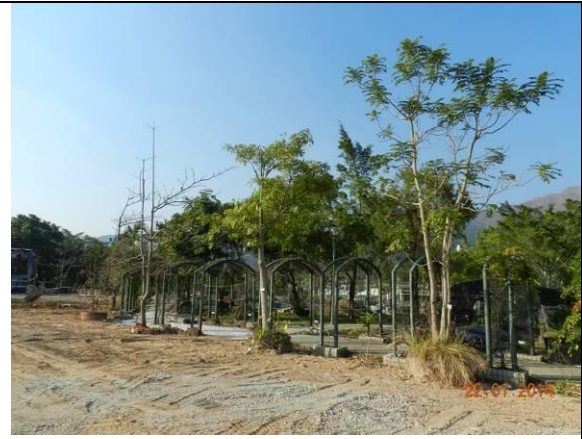
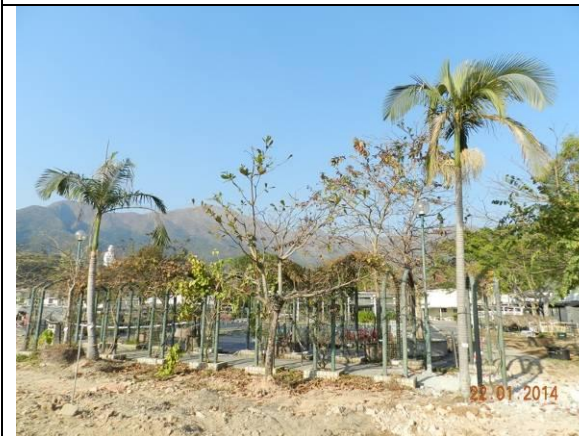
No more excavated holes were found next to the relocated trees (including A36, A43, U48, U53, U54, U69 and U70) in Phase 1 (**Photos 32-33**).

Photo 32 – No more excavated holes were found next to the relocated trees (including A36, A43, U48, U53, U54, U69 and U70) in Phase 1.

Photo 33 – No more excavated holes were found next to the relocated trees (including A36, A43, U48, U53, U54, U69 and U70) in Phase 1.

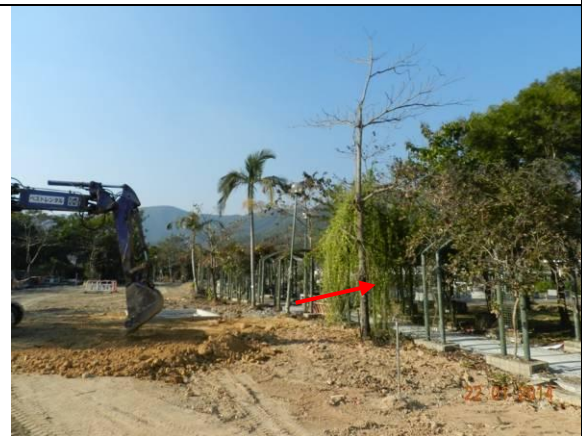
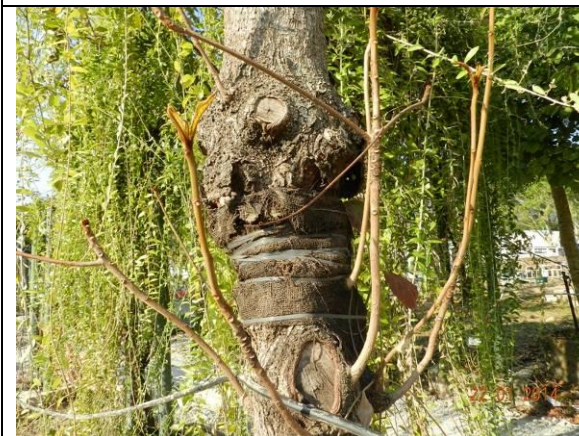
Photo 34 – The trunk of the transplanted tree U53 was tied tightly by strings and a hessian wrapping which was left after the transplantation of the tree.

Photo 35 – Close-up of the hessian wrapping on the trunk of U53.

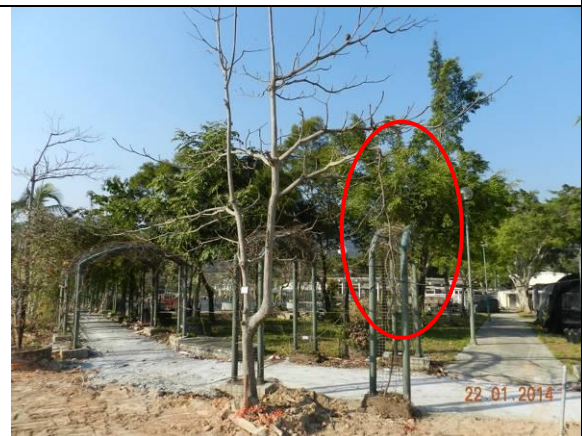
Photo 36 – A broken branch was noted on the transplanted tree A43 hanging near a footpath of the Nursery.
