**CONTRACT NO. DC/2010/02 –  
DRAINAGE IMPROVEMENT IN SHUEN WAN AND  
SHEK WU WAI**

**MONTHLY ENVIRONMENTAL MONITORING AND  
AUDIT REPORT (NO.31) – JANUARY 2014**

PREPARED FOR  
**KWAN LEE-KULY JOINT VENTURE**

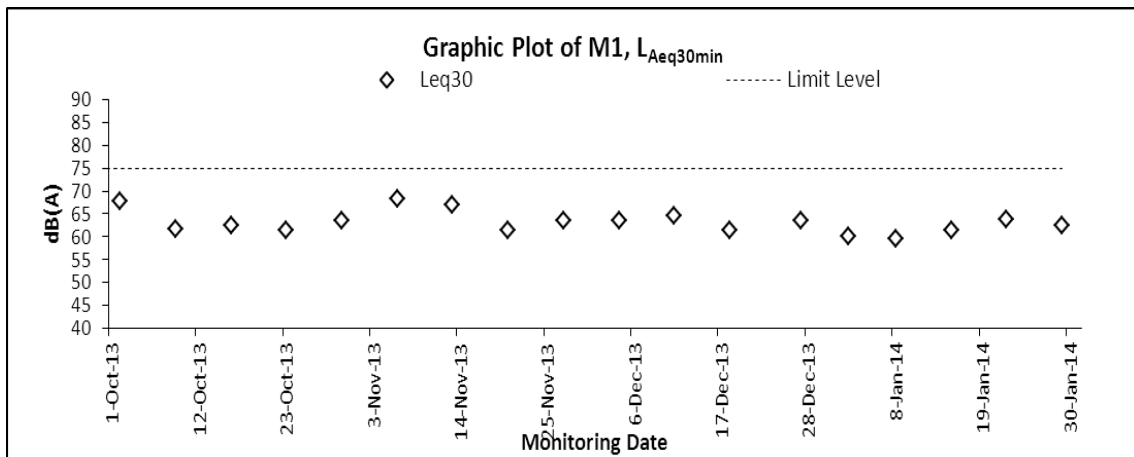
Remark: The monitoring is undertaken under façade situation. No façade correction is added according to acoustical principles and EPD guidelines.

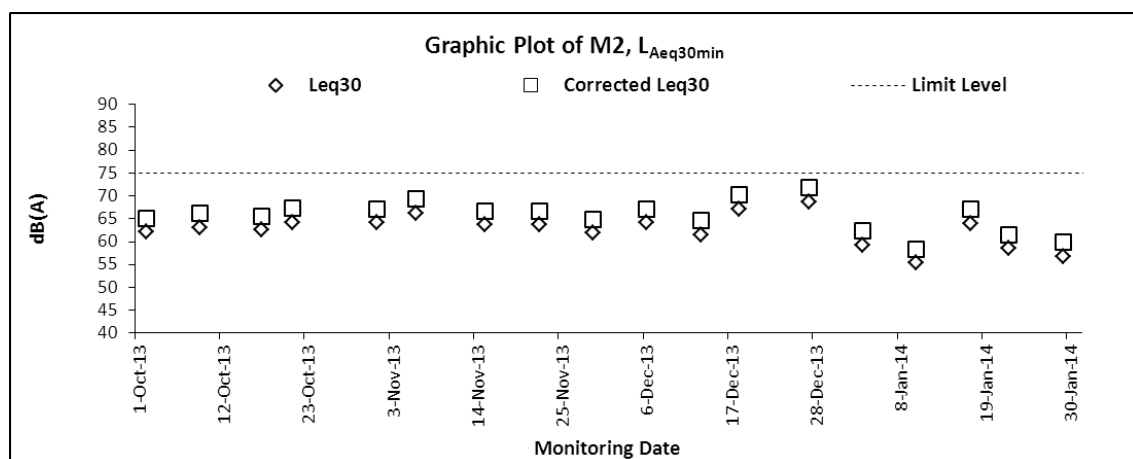
Remark: The monitoring is undertaken under free field situation. A façade correction of +3 dB(A) has been added according to acoustical principles and EPD guidelines.

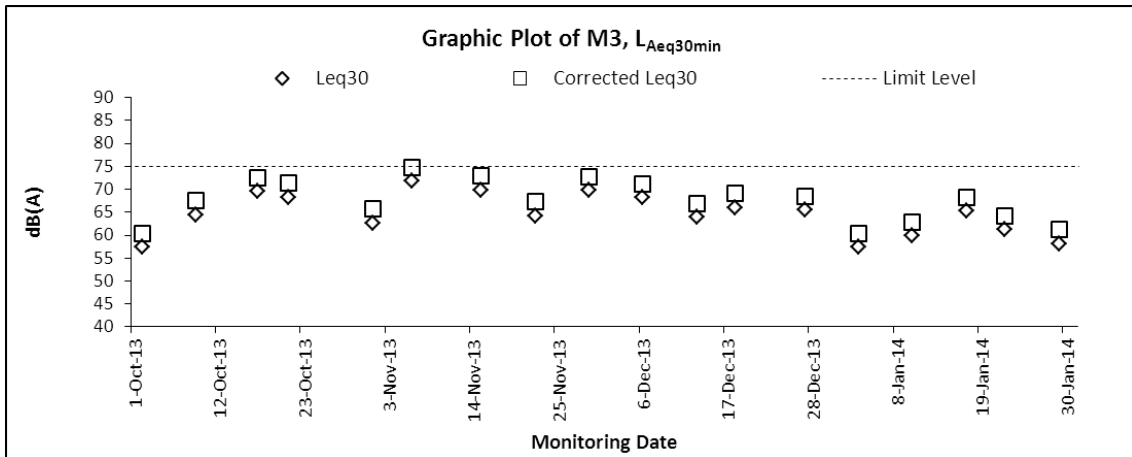
Remark: The monitoring is undertaken under free field situation. A façade correction of +3 dB(A) has been added according to acoustical principles and EPD guidelines

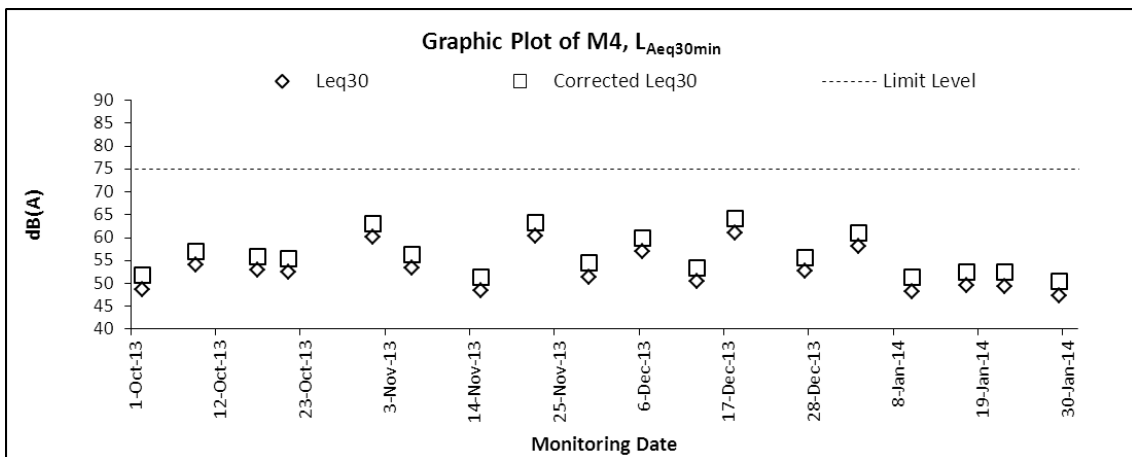
Remark: The monitoring is undertaken under free field situation. A façade correction of +3 dB(A) has been added according to acoustical principles and EPD guidelines

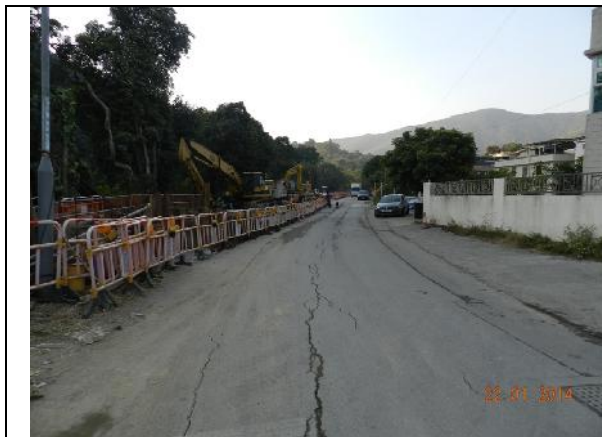
**Photo 1** – Temporary hoardings have been erected along Tung Tsz Road opposite to Wai Ha.

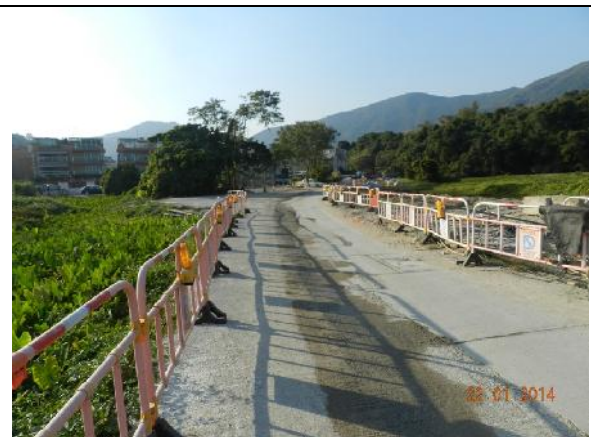
**Photo 2** – Temporary hoardings have been erected along the access road from Tung Tsz Road to Treasure Spot Garden II.

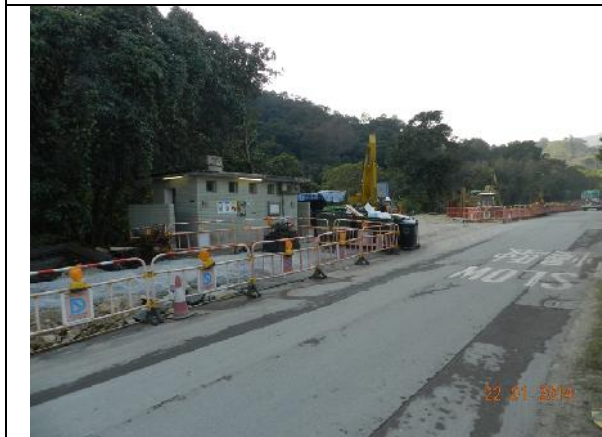
**Photo 3** – Construction works for building the box culverts along Tung Tsz Road opposite to Wai Ha outside the public toilet.

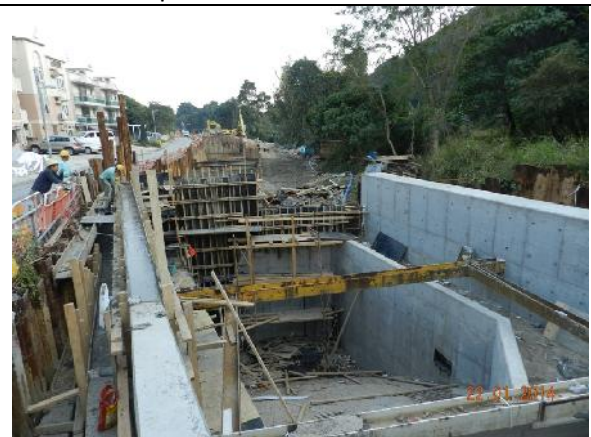
**Photo 4** – Construction works continued along Wai Ha River.

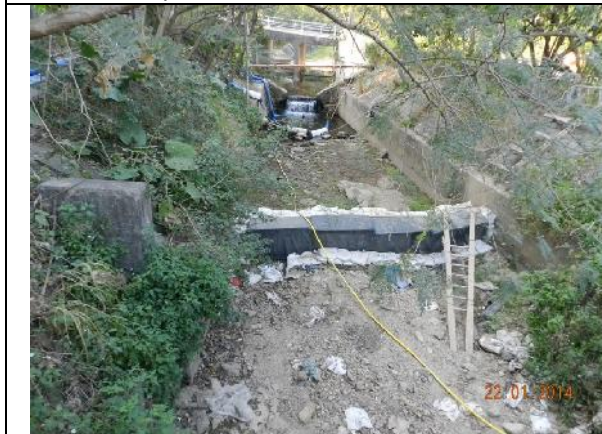
**Photo 5** – The river was divided by sand bags and water from the upper stream was pumped to the lower stream behind the works area along Wai Ha River.

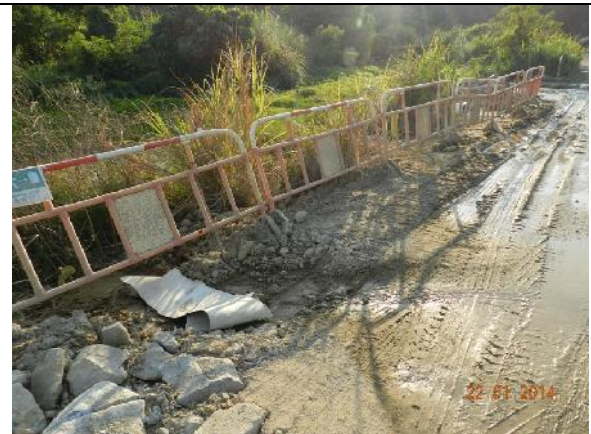
**Photo 6** – Temporary construction barriers surrounded the eastern side of the wetland rehabilitation area.

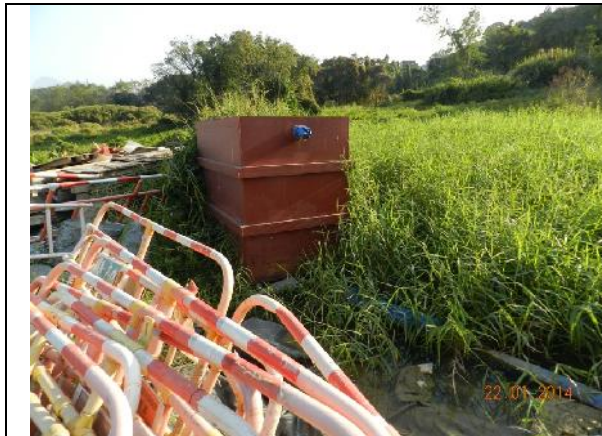
- 3.2.5 To the southeast of Jade View Villa and adjacent to the current active works area, a demarcated wetland rehabilitation area has been maintained by parties other than the Project Proponent, the Project's Contractor and Sub-contractors since January 2012. Temporary construction barriers were surrounding the eastern side of the area (**Photo 6**). A filtration tank was still found next to the area in January 2014 (**Photo 7**). As observed on 22<sup>nd</sup> January 2014, the filtration tank was not in use as no water was pumped into the tank.

**Photo 7** – A filtration tank, which was not in use in January 2014, was still placed next to the wetland rehabilitation area.

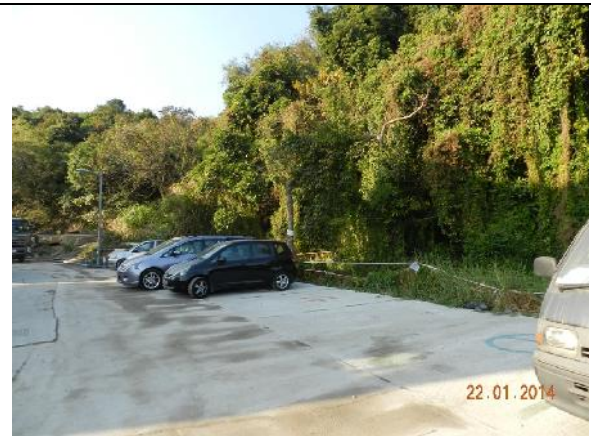
**Photo 8** – Temporary parking area was still maintained at the end of the access path to Treasure Spot Garden Phase II in January 2014.

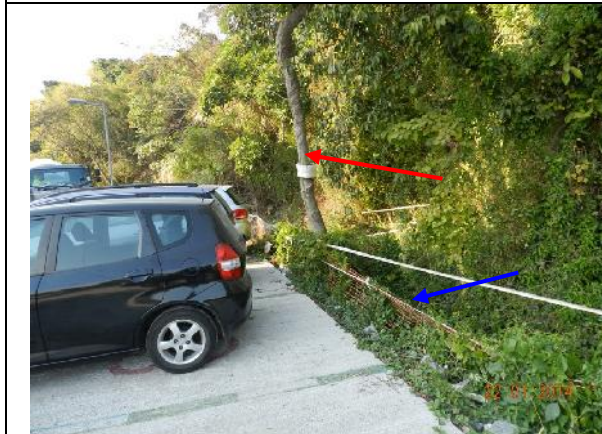
**Photo 9** – The untagged tree (Red arrow) was guyed at the edge of the parking area within a Tree Protection Zone demarcated by orange construction nets (Blue arrow).

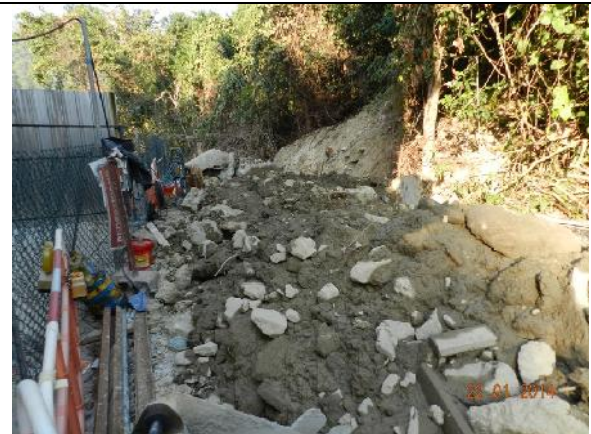
- 3.2.8 Works were observed at the end of the Treasure Spot Garden II near the retained tree T103 and the works area was surrounded by temporary construction barriers and chain-link fence (**Photo 10**). Construction works along the pathway to the Treasure Spot Garden II near the retained tree group (T097-098) were noted about to be finished as the excavated ground has been paved already (**Photo 11**).

**Photo 10** – Works were observed at the end of the Treasure Spot Garden II near the retained tree T103 and the works area was surrounded by temporary construction barriers and chain-link fence.

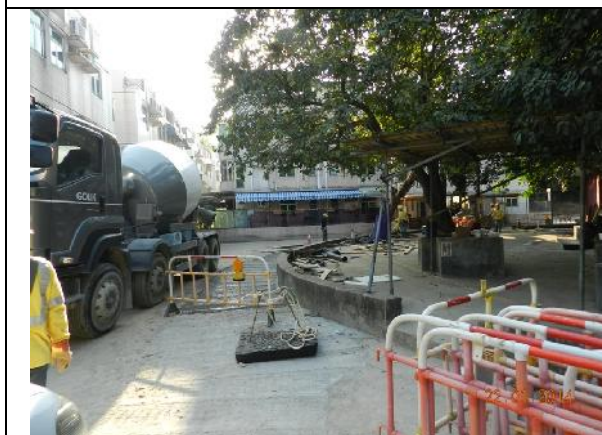
**Photo 11** – Construction works were almost finished on the pathway to the Treasure Spot Garden II near the retained tree group (T097-098).

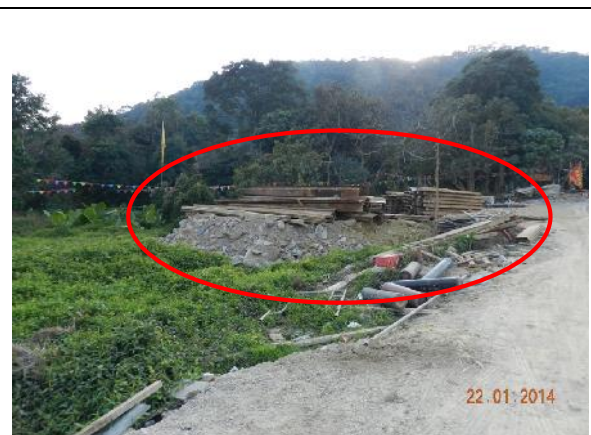
**Photo 12** – The works area near the previous collapsed tree T190 (*Ficus hispida*) was found to be expanded to the grassland on the southern side. The expanded area was seen to be used for storage of construction materials.

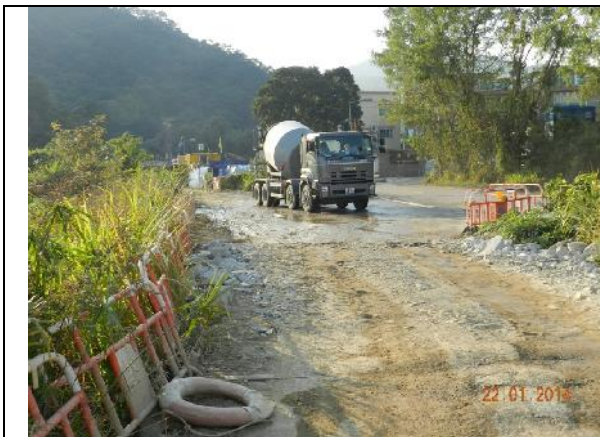
**Photo 13** – One exit point was seen opposite to the tree group T021-029 (*Leucaena leucocephala*).

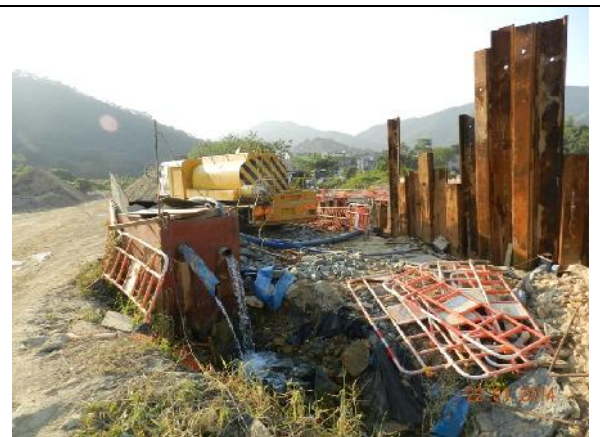
**Photo 14** – A sedimentation tank was seen receiving the waste water from the works area near the previous collapsed tree T196 and the discharge was seen to be clear.

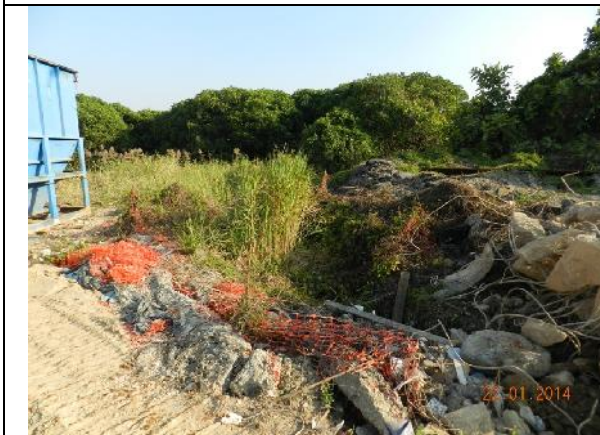
**Photo 15** – Abandoned sedimentation bed aligned from the area opposite to the Jade View Villa towards the marsh area at southeast. This bed was overgrown by dense grassy vegetation.

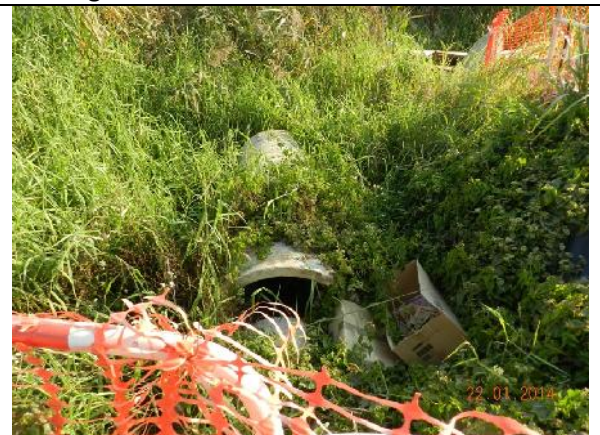
**Photo 16** – Close-up view of this abandoned sedimentation bed overgrown with dense grassy vegetation.

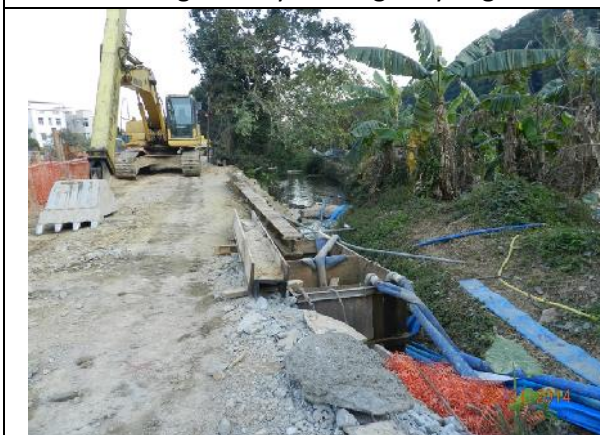
**Photo 17** – The muddy water from the works area was pumped out from the river and back to a sedimentation tank settled at the end of the works area.

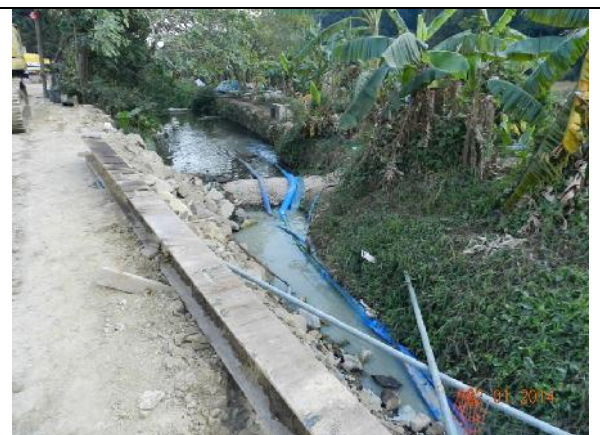
**Photo 18** – The discharge from the sedimentation tank was released back to the sections of granules with underlaid PVC liners along the river. The discharge was seen unclear when released and then became clean after filtration.

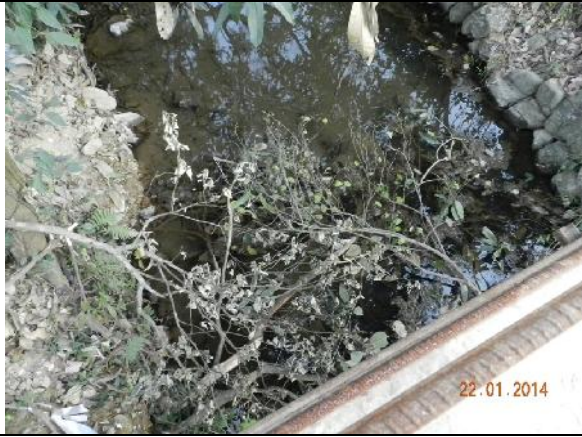
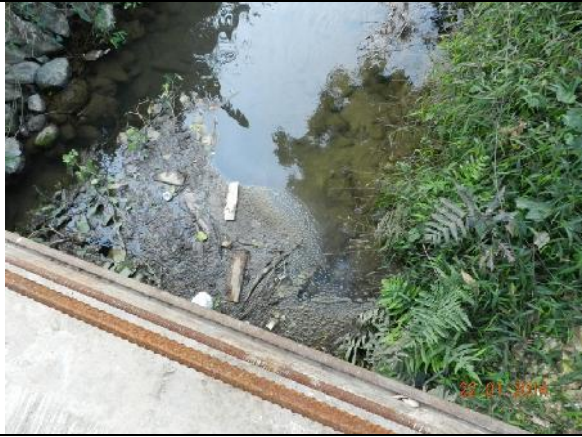
<p><b>Photo 19</b> – Down the stream near the public toilet, broken branches from the adjacent trees were noted blocking the stream.</p>	<p><b>Photo 20</b> – Greasy substances were trapped by the broken branches in the stream.</p>

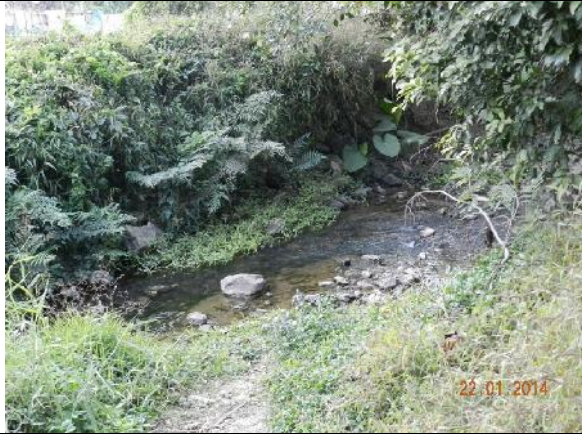
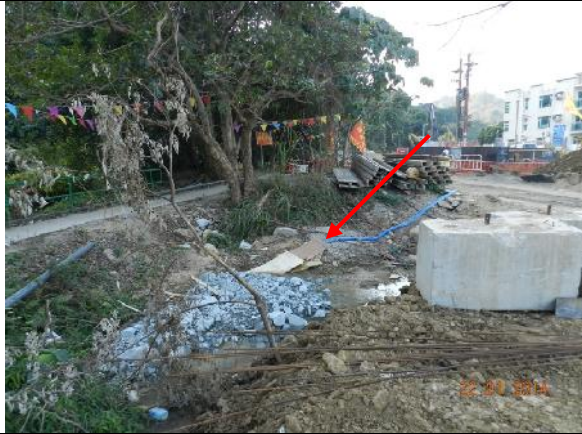
<p><b>Photo 21</b> – The water was still noted clear at the lower stream.</p>	<p><b>Photo 22</b> – Next to the expanded works area near the previous collapsed tree T190, water from the nearby box culvert was found pumping out and releasing to the southern side of the area.</p>

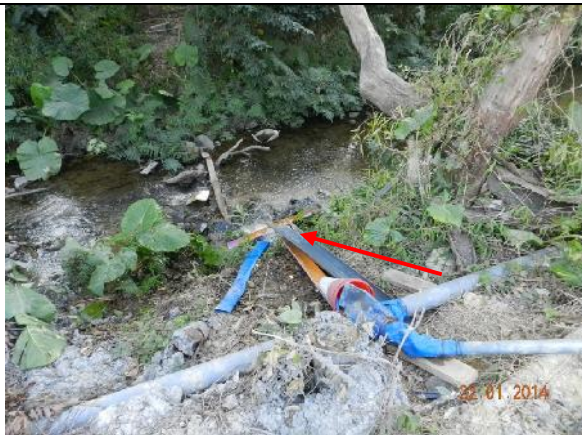
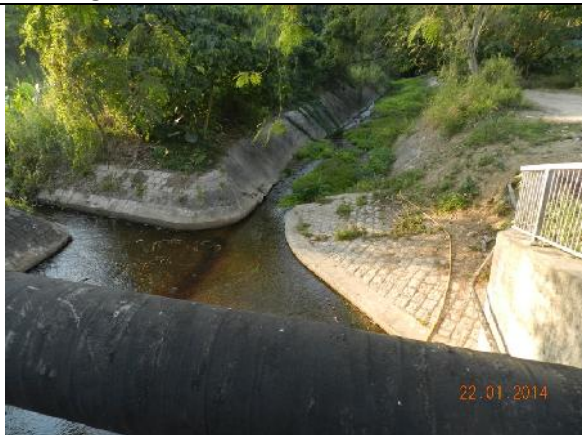
<p><b>Photo 23</b> – Water from the box culvert in the works area outside the public toilet was noted pumping out and releasing to Wai Ha River.</p>	<p><b>Photo 24</b> – No direct water discharge into the upper stream of Wai Ha River was observed as the construction works have been concentrated at the lower end of the river.</p>

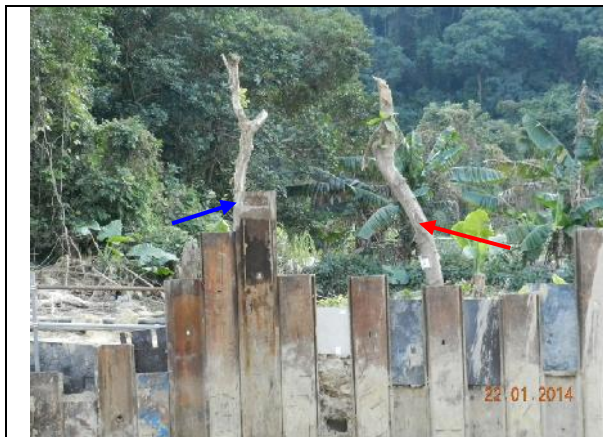
**Photo 25** – Topped T167 (Red arrow) and T168 (Blue arrow) were in poor health condition with very sparse foliage.

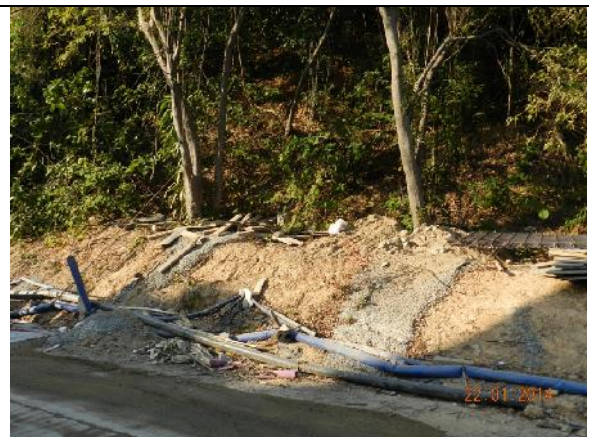
**Photo 26** – No more storage of construction materials was noted close to the trunk flares and trunks of T093 and T094.

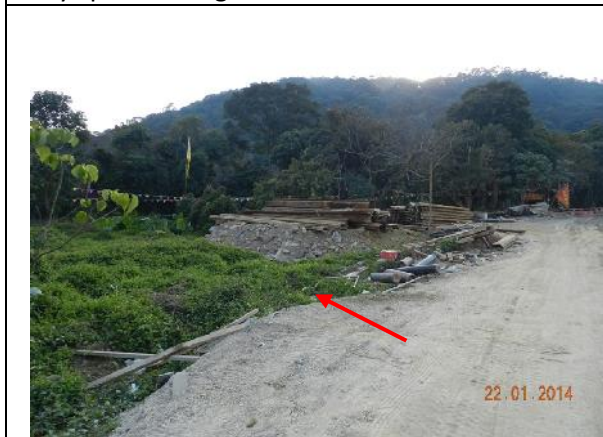
**Photo 27** – The collapsed dead tree T190 was removed from the site in January 2014. The original location is indicated by Red Arrow.

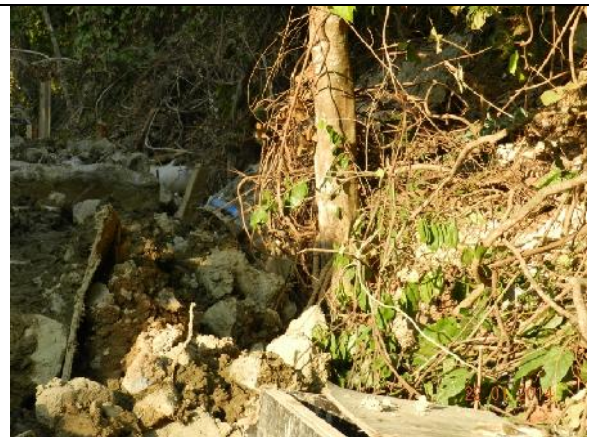
**Photo 28** – Excavated soil and rocks were noted piling close to the trunk base of the retained tree T103.

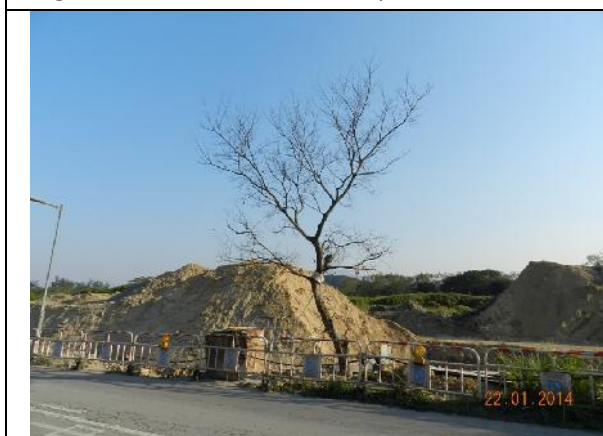
**Photo 29** – The retained tree T025 was pruned before and it was temporarily guyed to provide additional support to this tree.

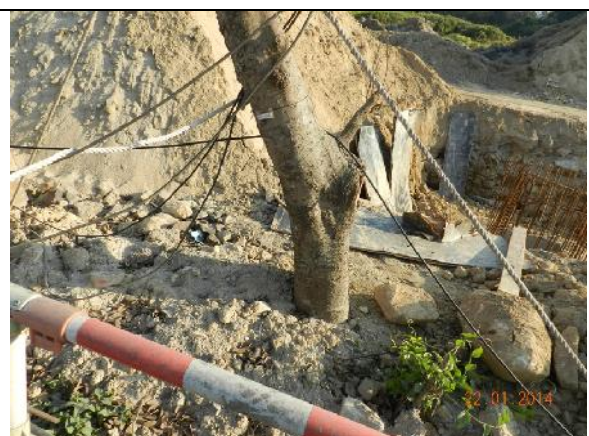
**Photo 30** – Excessive soil was still piled around the root flare of T025.

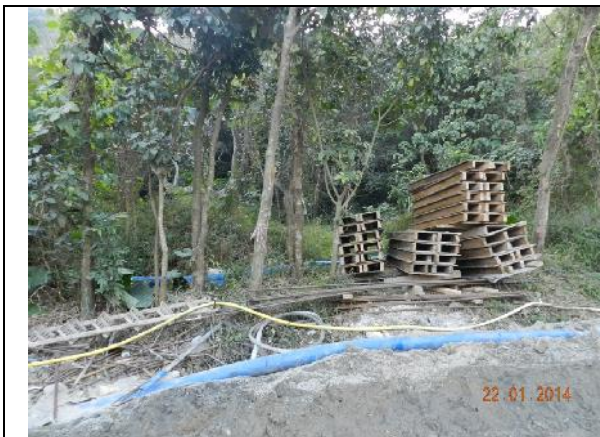
**Photo 31** – No more stockpiling of construction materials was found touching the trunk flares of the tree group (T119-122) next to the works area in Wai Ha River, however these materials were relocated and put within the tree dripline area.

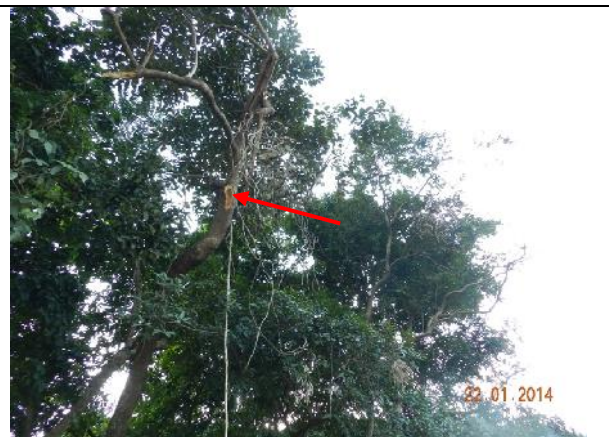
**Photo 32** – A wound (Red Arrow) was observed on a branch of T176.

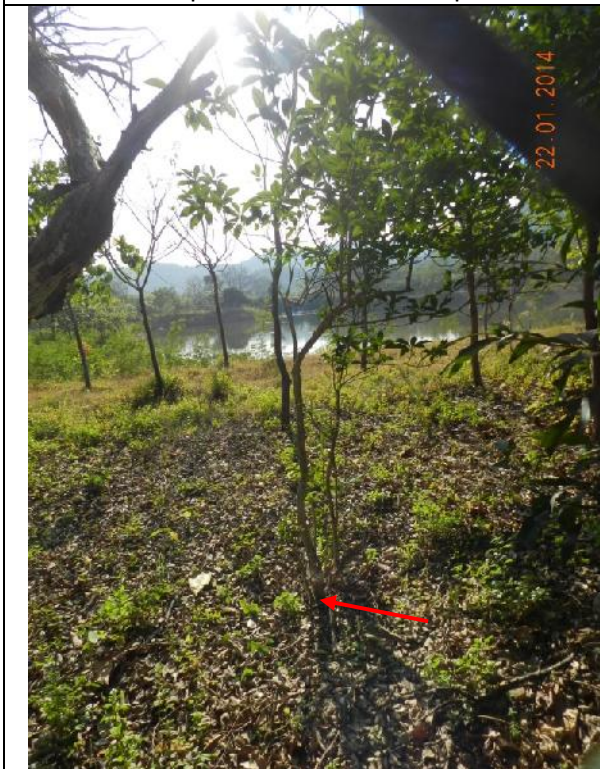
**Photo 33** – The transplanted shrub of *Pavetta hongkongensis* (PH01) in Area C under Contract 1 remained in satisfactory condition in January 2014.

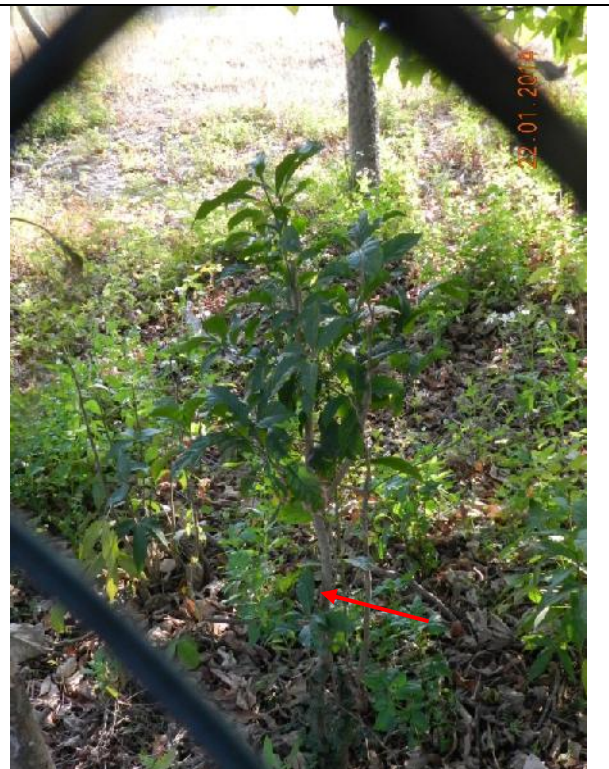
**Photo 34** – The transplanted shrub of *Pavetta hongkongensis* (PH03) in Area C under Contract 1 remained in satisfactory condition in January 2014.
