Monthly Environmental Monitoring & Auditing report for

Contract No.DC/2009/22

Drainage Improvement in Shuen Wan, Tai Po – Contract 1

February 2014

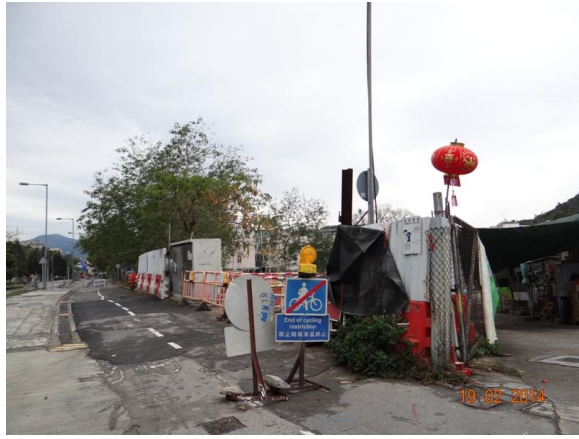
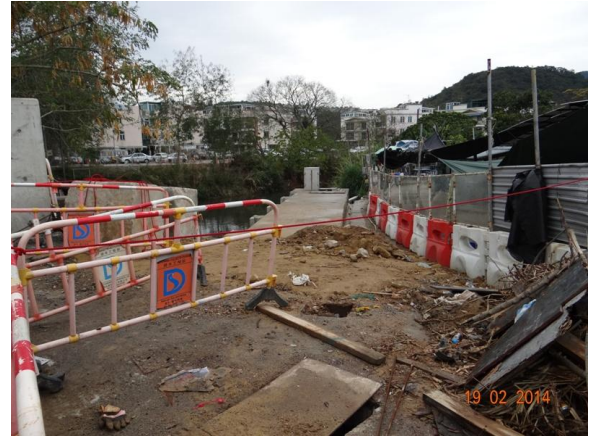
Construction hoardings were once erected along the entire site boundary of Area A. Temporary construction hoardings have been erected around Wai Ha River estuary since the building of an automatic mechanical penstock at the area (**Photos 1-2**). As observed in February 2014, the construction of boundary walls along the western and part of the northern sides of Area A (i.e. the proposed pump house station) was finished (**Photo 3**), while the proposed chain-link fence has been erected along the rest of the boundary sides of Area A in February 2014 (**Photos 4-5**).

Photo 1 – Temporary construction hoardings have been established around the works area at Wai Ha River estuary.

Photo 2 – Temporary construction hoardings have been established around the works area at Wai Ha River estuary.

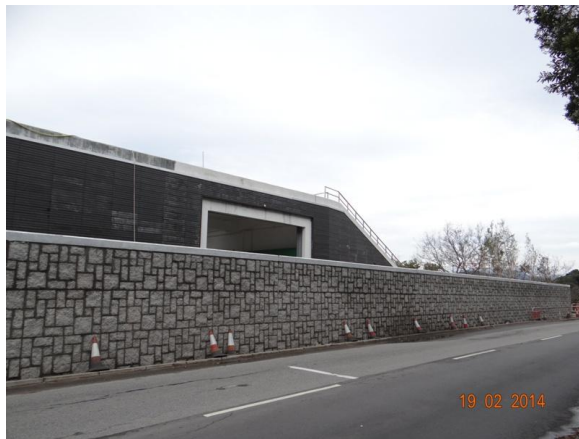
Photo 3 – Construction of the proposed boundary walls along part of the northern and western sides of Area A was finished.

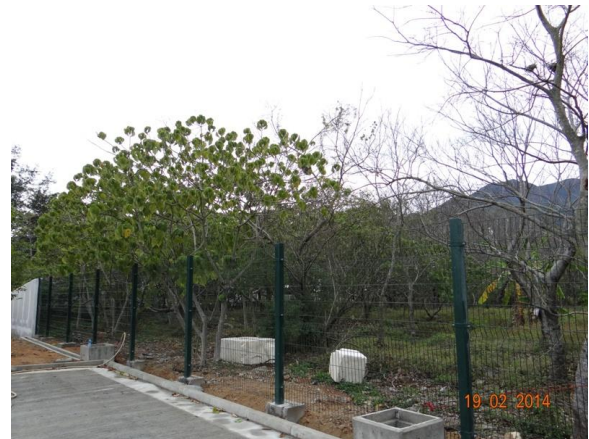
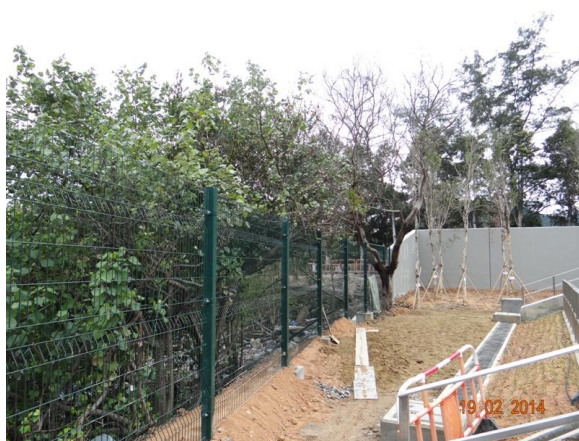
Photo 4 – Proposed chain-link fence has been erected along the rest of the boundary sides of Area A.

Photo 5 – Proposed chain-link fence has been erected along the rest of the boundary sides of Area A.

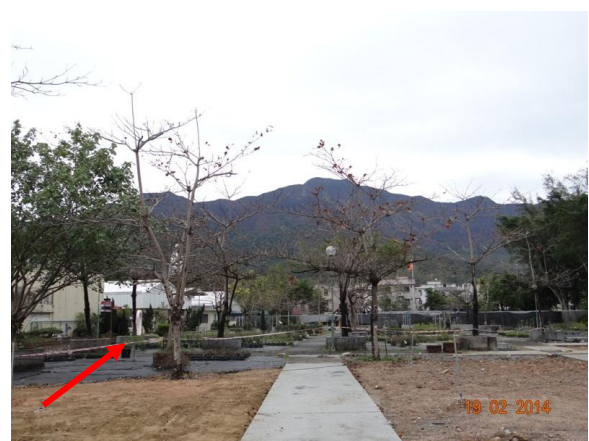
Photo 6 – The temporary construction hoardings in Phase 1 were removed and replaced by barrier tape (red arrow).

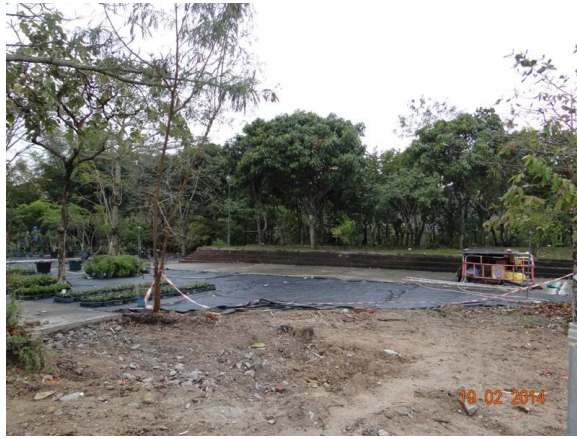
Photo 7 – The temporary construction hoardings in Phase 1 were removed and replaced by barrier tape. Some tapes were not firmly tied.

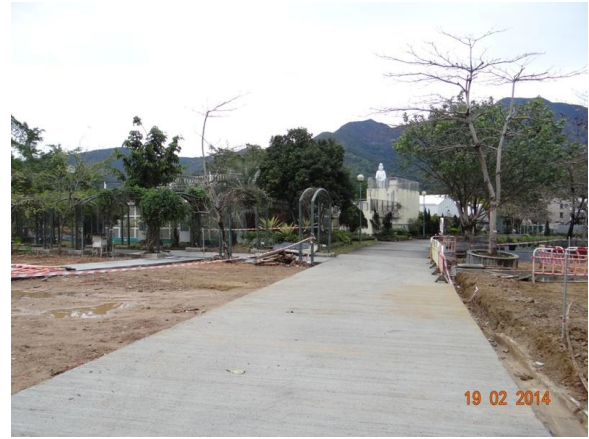
Photo 8 – The open section between Phases 1 and 2 works areas was opened again after the reinstatement works.

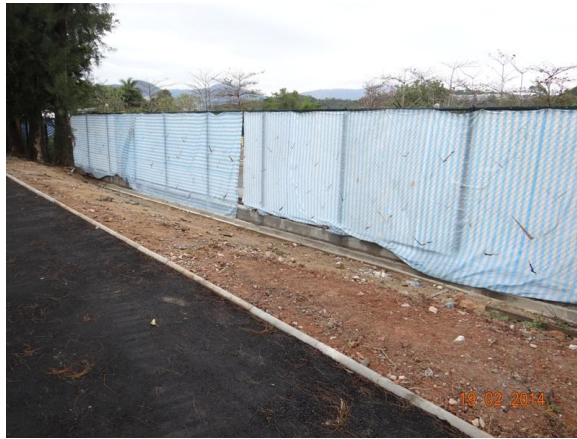
Photo 9 – Chain-link fence was reinstated at the eastern end of Phase 2 works area and covered by canvas sheets.

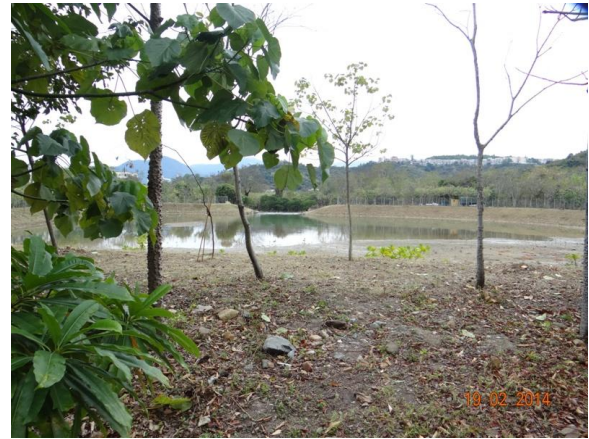
Area C was formally handed over to AFCD on 16th October 2012 for management and maintenance. The pond of the ECA has been connected to Wai Ha River directly as following the scheme design of Habitat Compensatory Plan. No direct discharge of turbid water into the adjacent Wai Ha River was observed through the fence of Tung Tsz Nursery (**Photo 10**).

Photo 10 – No discharge of muddy water was observed in Area C.

The Contractor should regularly check the condition and locations of the drainage pipes and ensure that all used water should be appropriately filtered and discharged to the manholes/other discharge points agreed by the Engineer and EPD. This is to avoid any potential contamination to the vegetation in Shuen Wan marsh and other vegetated/marinated areas adjacent to the active works area.

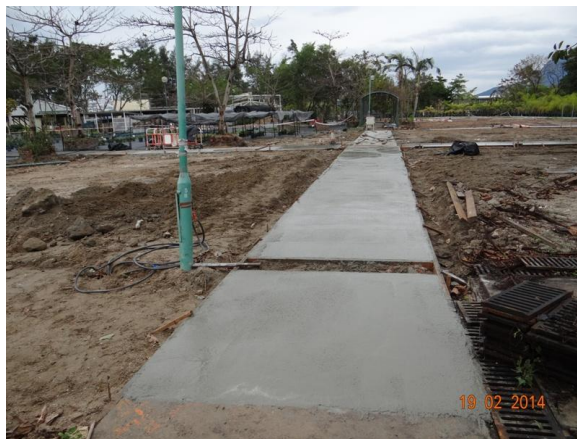
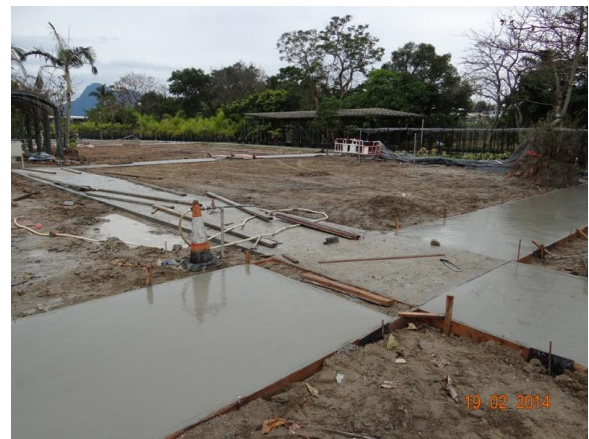
As observed since January 2014, no more excavation works has been undertaken in Phases 1 and 2. The reinstatement works for the original access paths and ground of the nursery beds were still in progress in both Phases 1 and 2 areas (**Photos 11-12**).

Photo 11 – The reinstatement works for the original access paths and ground of the nursery beds in Phase 1 area in Area B.

Photo 12 – The reinstatement works for the original access paths and ground of the nursery beds in Phase 1 area in Area B.

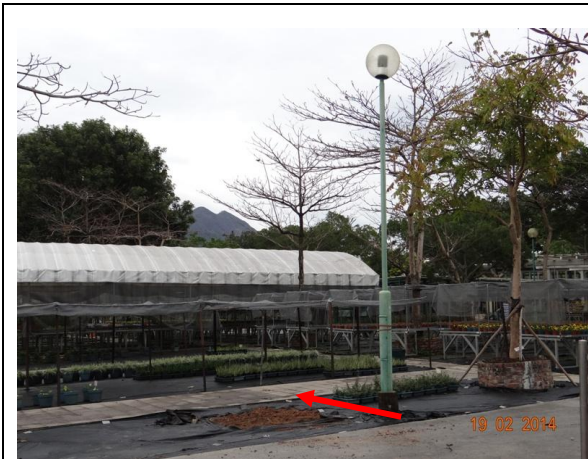
Regular monitoring for all transplanted and retained trees within the nursery was conducted on a bi-weekly basis. The dead, transplanted tree *Grevillea robusta* (U58) was removed by the Contractor and its dry stump was left in the planter from October 2013. As observed during the monitoring on 19th February 2014, the entire planter of the removed tree was also removed (**Photo 13**).

As highlighted in the Section “Liaison with Nursery”, the transplanted tree *Grevillea robusta* (U58) was removed in October 2013 as it was certified as dead specimen. As observed on 19th February 2014, the entire planter of this removed tree was also removed (**Photo 13**).

Photo 13 – The entire planter of the removed tree U58 was removed in February 2014 (Red arrow).

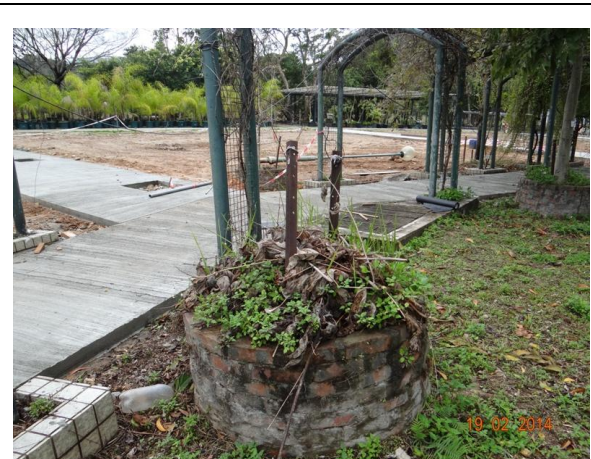
As reported in the previous *Monthly EM&A Reports*, the retained tree U68 (*Gmelina arborea*) was found fallen after the severe typhoon in July 2012, with its leaning trunk being pruned and removed in August 2012 (as reported in *Monthly EM&A Report for August 2012*). Regular removal of generated watersprouts was sometimes noted throughout the monitoring period. The regenerated watersprouts were removed in December 2013 as vegetation management practice in the Nursery and no more regenerated watersprouts were seen in February 2014 (**Photo 14**).

Photo 14 – No more regenerated watersprouts were seen from the stump of U68 in February 2014.

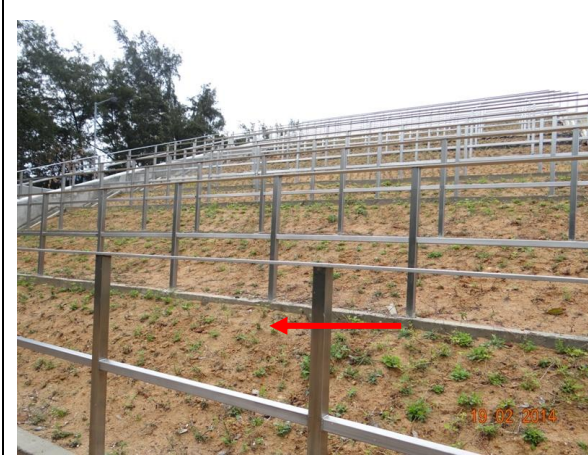
Photo 15 – The proposed green roof of the pumping house was vegetated with ground cover *Arachis duranensis*.

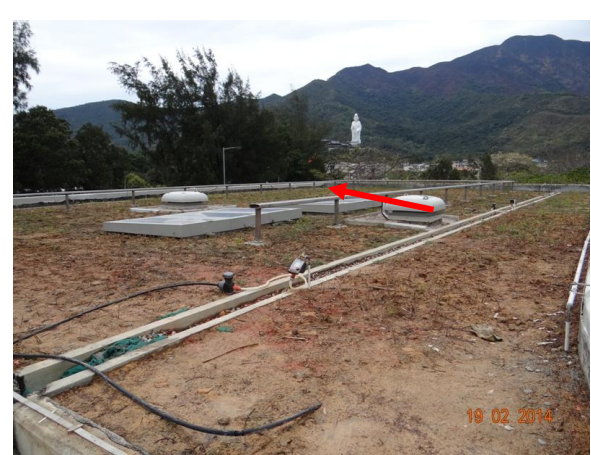
Photo 16 – The rooftop of the pumping house was vegetated with ground cover *Arachis duranensis*.

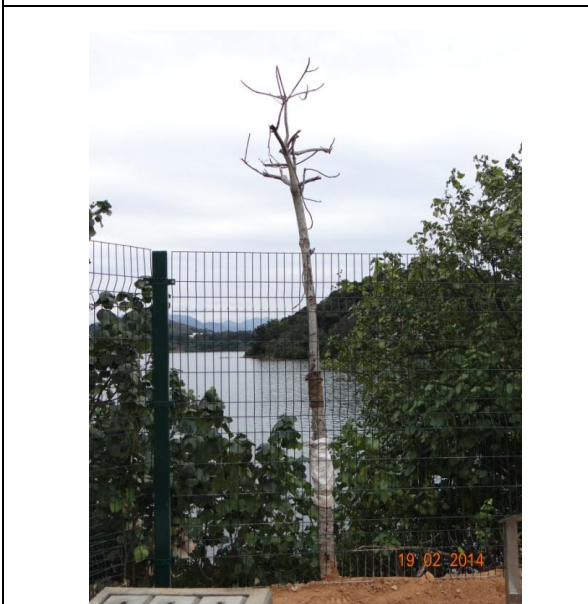
The tree to be transplanted E16 (*Bombax ceiba*) was relocated to the southern side of Area A next to the site hoarding in July 2012. The tree was in marginally fair condition in February 2014 (**Photo 17**) and it was separated outside the proposed chain-link fence along the boundary sides of Area A. Soil grade change was observed around the trunk base and minor exposed roots were found in January 2014. As inspected during the monitoring on 19th February 2014, soil was piled around the root flare and some exposed root was found (**Photo 18**). The stability of the tree may be affected. Given that it is in close proximity to the construction work which may be resumed close to the pumping house, the condition and stability of this tree should be regularly monitored.

Photo 17 – The relocated E16 was in marginally fair condition in February 2014 and it was separated outside the newly erected chain-link fence along the boundary sides of Area A.

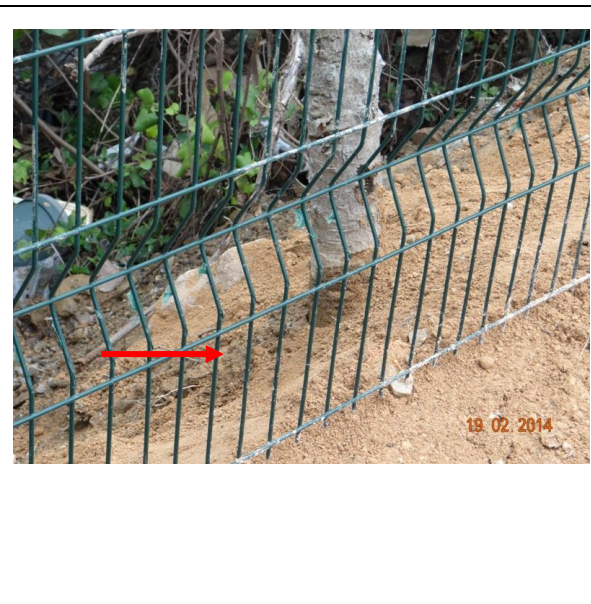
Photo 18 – Soil was piled around the root flare of E16 and some exposed root was found (Red arrow).

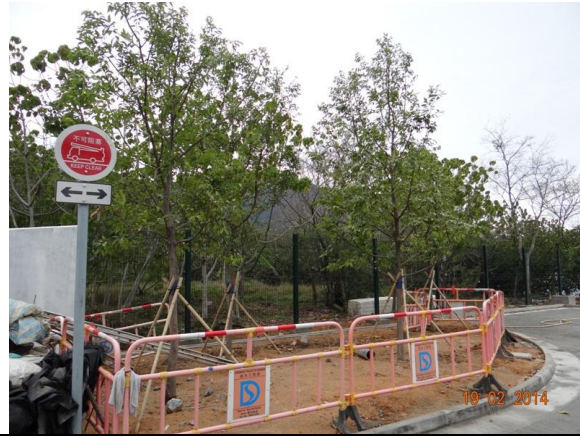
The relocated tree E38 (*Melaleuca cajuputi* subsp. *cumingiana*) was found dead after its relocation in August 2013, and it was removed by the Contractor in November 2013 (reported in *Monthly EM&A Report for November 2013*). A planter was built at the same location in accordance with the approved Landscape Plan. Four newly planted *Cinnamomum burmannii* appeared in fair condition in February 2014 (**Photo 19**). No further planting of shrubs and trees was noted in Area A.

Photo 19 – Four new trees of *Cinnamomum burmannii* were planted in the planter.

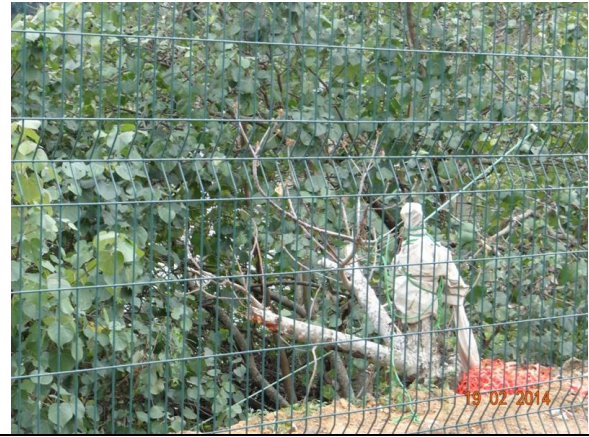
Damaged tree trunk on E55 (*Macaranga tanarius* var. *tomentosa*) was reported in *Monthly EM&A Report for April 2013*. The wound on the trunk of E55 has been burlapped since May 2013. The upper section of the tree trunk was broken in June 2013. The tree was still in poor condition with most of its foliage as dry watersprouts only and it was separated outside the proposed chain-link fence along the boundary sides of Area A in February 2014 (**Photo 20**).

Photo 20 – The burlapped tree E55 was still in poor condition with dry leaves and it was separated outside the proposed chain-link fence along the boundary sides of Area A in February 2014.

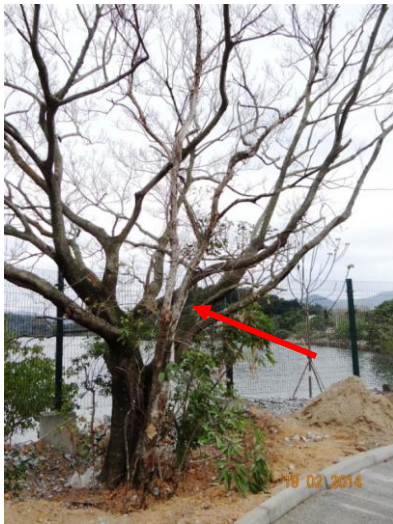
A retained tree T253 (*Bridelia tomentosa*) was in poor condition (**Photo 21**). Dead scaffold limbs with dry, peeled bark were observed. This identified tree defect may be only related to the intrinsic physiological and structural condition of T253. The tree was closely monitored in February 2014.

Photo 21 – The retained tree T253 was in marginally fair condition (Red arrow).

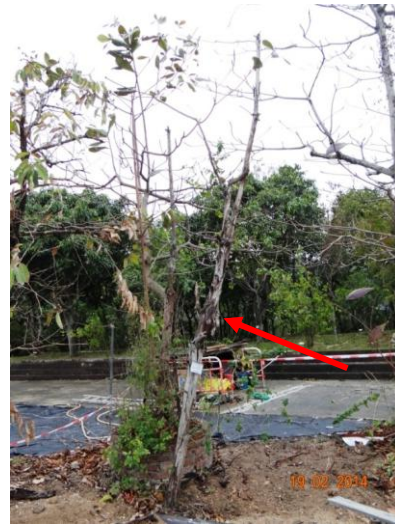
Photo 22 – Dead tree U37.

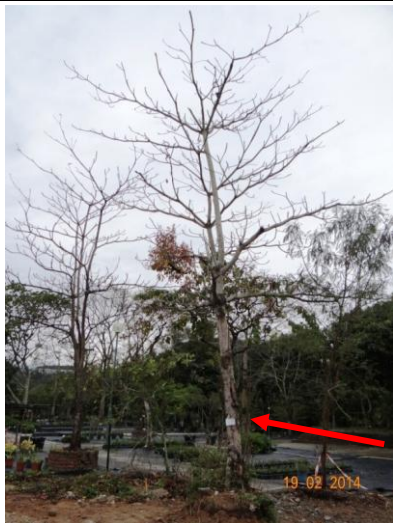
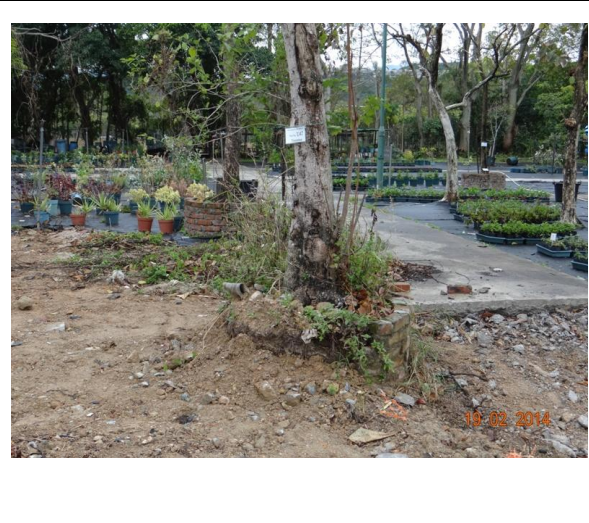
Half of the planter of U47 (*Terminalia catappa*) has broken since August 2013, and some of its roots and planter soil were exposed in the air. As inspected in February 2014, the planter was still not yet repaired (**Photos 23-24**). A fungal fruiting body was found at the trunk base (**Photo 26**) and parasitic plants were observed in the canopy (**Photo 26**). In addition to U47, the planters of U54 (*Terminalia catappa*) and two untagged *Terminalia catappa* to the southeast of U54 (**Photos 27-29**), as well as the relocated tree U69 (*Alstonia scholaris*) were also broken and not yet repaired (**Photo 30**). Exposed roots and planter soil were observed. On the other hand, excavated soil has been piled around the planter and on the root flare of U51 (*Terminalia catappa*) (**Photo 31**).

Photo 23 – The planter of U47 was broken.

Photo 24 – Half of the planter of U47 was broken, but has not yet been repaired.

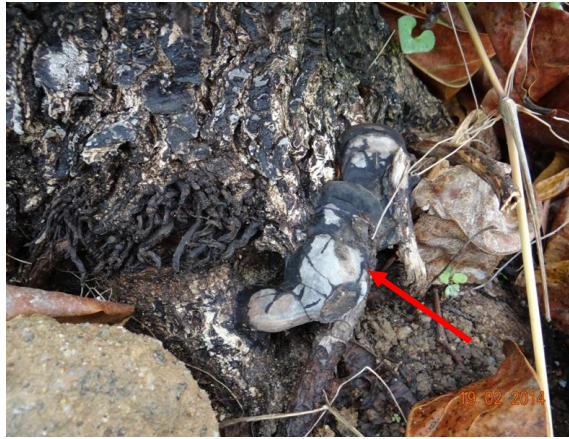
Photo 25 – Fungal fruiting body was found at the trunk base of U47.

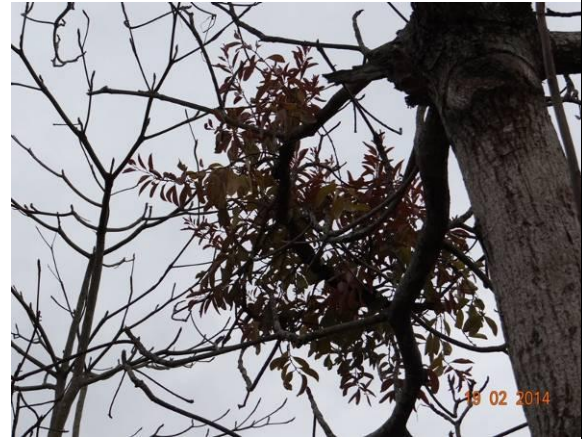
Photo 26 – Parasitic plants were observed in the canopy of U47.

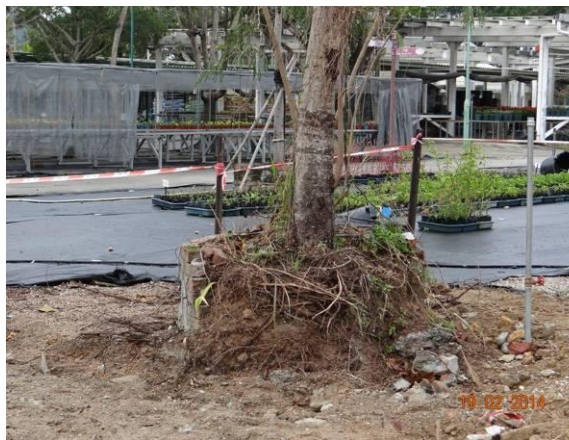
Photo 27 – The planter of U54 was broken and exposed roots and soil were observed.

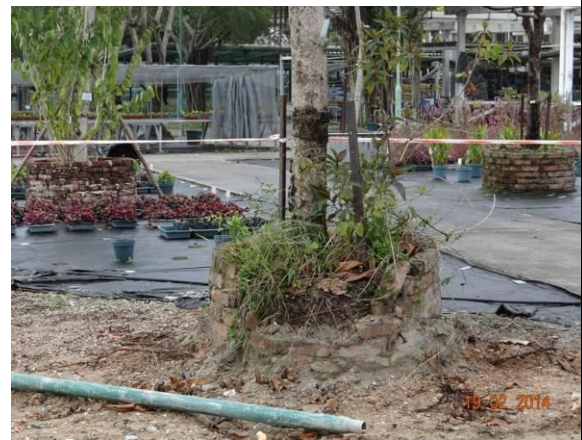
Photo 28 – The planter of an untagged *Terminalia catappa* next to U54 was broken, with exposed roots and soil.

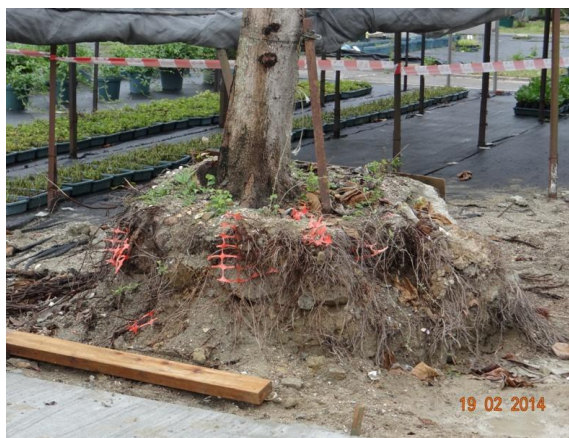
Photo 29 – The planter of another untagged *Terminalia catappa* next to U54 was broken, with exposed roots and soil.

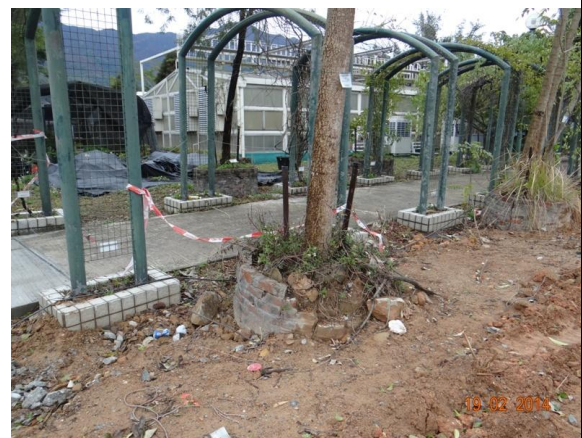
Photo 30 – The planter of U69 was broken and exposed roots and soil were observed.

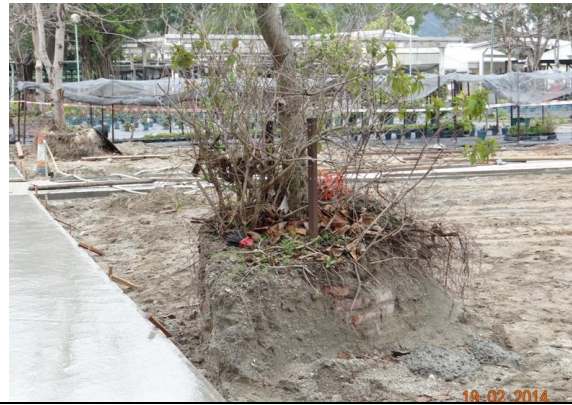
Photo 31 – Excavated soil was piled around the planter and on the root flare of U51.

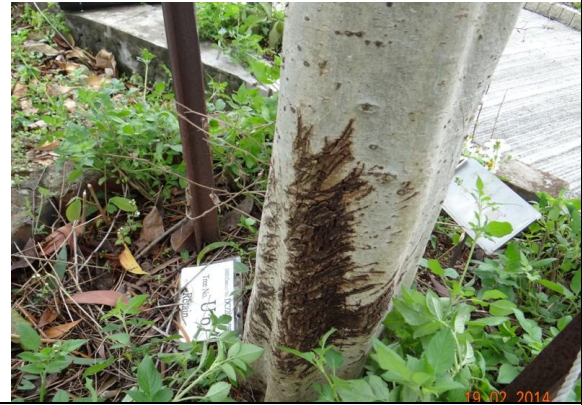
Sign of suspected termite infestation has been observed at the lower trunk of the retained tree U67 (*Cassia fistula*) (**Photo 32**). The tree was still in fair health and structural condition as observed in February 2014, but close monitoring should be undertaken.

Photo 32 – Sign of suspected termite infestation was observed at the lower trunk of U67.

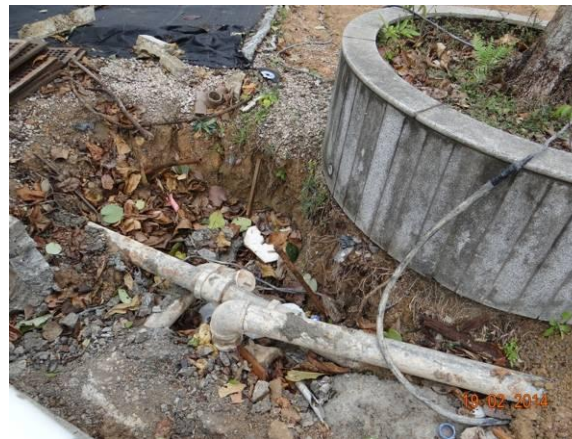
For the retained tree A40 (*Terminalia catappa*) at the entrance of Phase 2 construction areas, the southern excavated area was refilled but the northern excavated area close to its planter has not yet backfilled with soil, and some of the tree roots growing underneath the tree planter are still under a risk of being damaged by any future minor civil works (**Photo 33**). The tree may have a risk of leaning if its underground roots are further damaged or the ground is not backfilled soon.

Photo 33 – The excavated area close to the planter of A40 has not yet been refilled with soil.

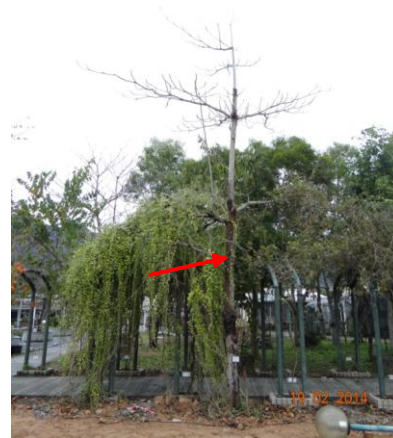
Photo 34 – The trunk of the transplanted tree U53 was tied tightly by strings and a hessian wrapping which was left after the transplantation of the tree.

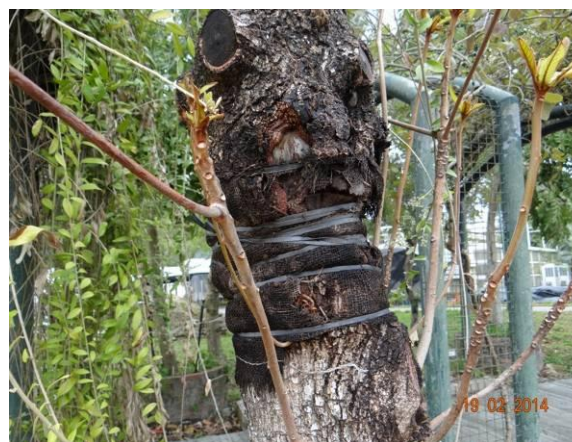
Photo 35 – Close-up of the hessian wrapping on the trunk of U53.

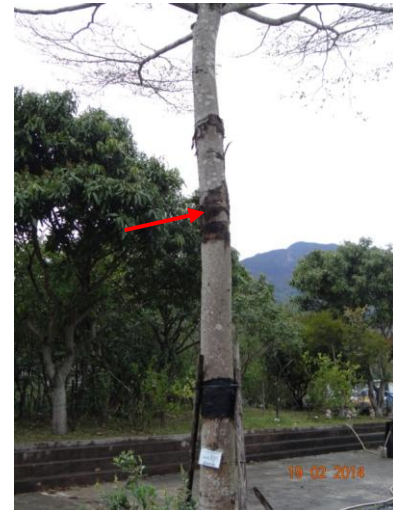
Photo 36 – Hessian wrapping was found on the trunk of the transplanted tree U57 (Red arrow).

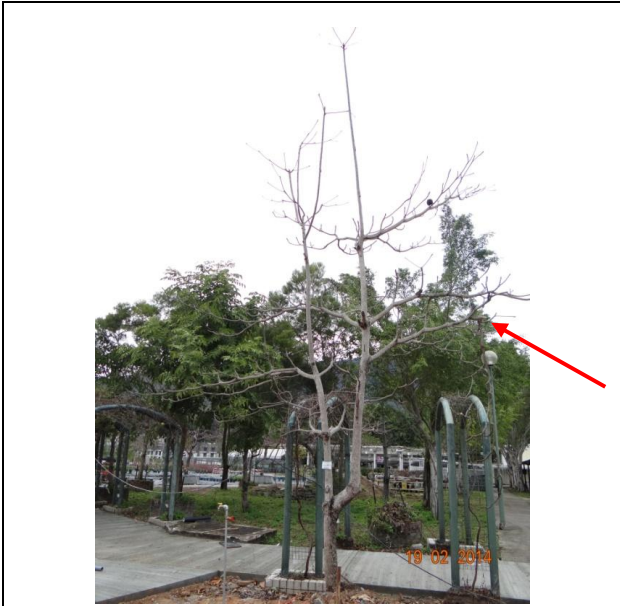
A broken branch was still noted hanging on the transplanted tree A43 (*Terminalia catappa*) (**Photo 37**). It was hanging near a footpath of the Nursery.

Photo 37 – A broken branch was still noted hanging on the transplanted tree A43 (Red arrow).
