**CONTRACT NO. DC/2010/02 –  
DRAINAGE IMPROVEMENT IN SHUEN WAN AND  
SHEK WU WAI**

**MONTHLY ENVIRONMENTAL MONITORING AND  
AUDIT REPORT (NO.32) – FEBRUARY 2014**

PREPARED FOR  
**KWAN LEE-KULY JOINT VENTURE**

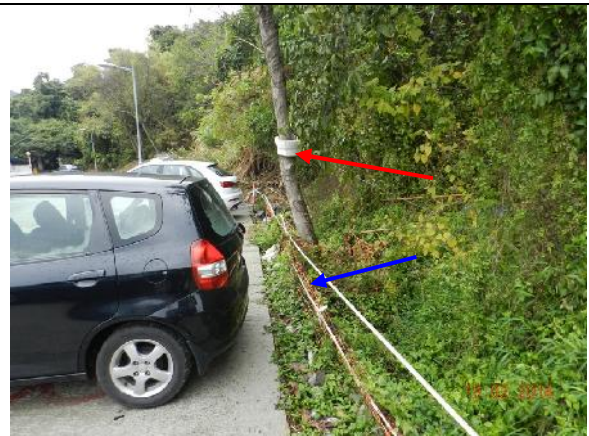
**Photo 8** – The untagged tree (Red arrow) was guyed at the edge of the parking area within a Tree Protection Zone demarcated by orange construction nets (Blue arrow).

- 3.2.11 No specific recommendation is required. However, with regard to the previous dumping incident by other parties on the Taro field near the Treasure Spot Garden, the Contractor is recommended to check the site condition regularly to avoid any extent of dumping or paving of area within the project boundary.
- 3.2.12 The Contractor should also make sure there are no piled rocks, construction materials or programmed construction works influencing the existing trees within the Project Area or the wetland rehabilitation area. Otherwise, the Contractor should request the on-site workers to remove those piled rocks or construction materials.
- 3.2.13 The Contractor could establish a warning sign to remind the driver to beware of the presence of the tree(s) close to the temporary parking area.

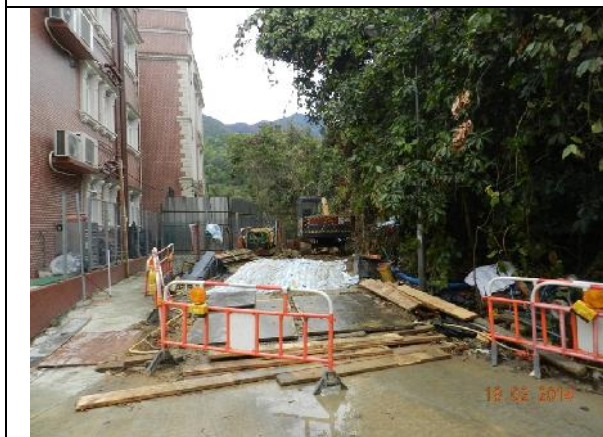
- 3.2.8 Works were observed at the end of the Treasure Spot Garden II near the retained tree T103 and the works area was surrounded by temporary construction barriers and chain-link fence (**Photo 9**). Construction works along the pathway to the Treasure Spot Garden II near the retained tree group (T097-098) were finished.

**Photo 9** – Works were observed at the end of the Treasure Spot Garden II near the retained tree T103 and the works area was surrounded by temporary construction barriers and chain-link fence.

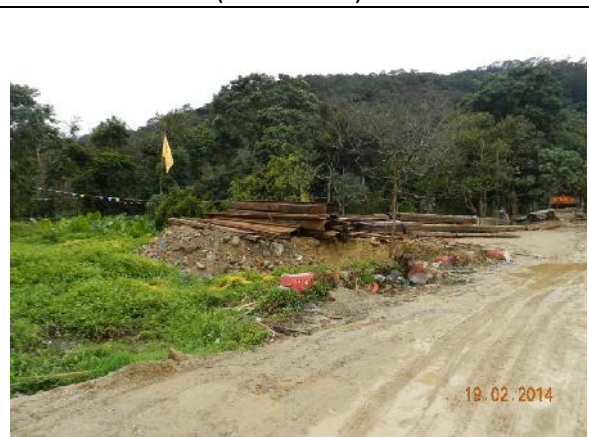
- 3.2.9 The works area near the previous collapsed tree T190 (*Ficus hispida*) was found to be expanded to the grassland on the south in January 2014. The expanded area was still used for storage of construction materials in February 2014 (**Photo 10**).

**Photo 10** – The expanded works area near the previous collapsed tree T190 (*Ficus hispida*) was still used for storage of construction materials.

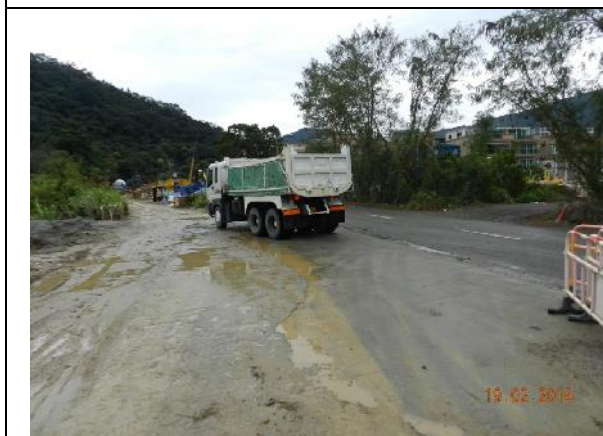
**Photo 11** – One exit point was seen opposite to the tree group T021-029 (*Leucaena leucocephala*).

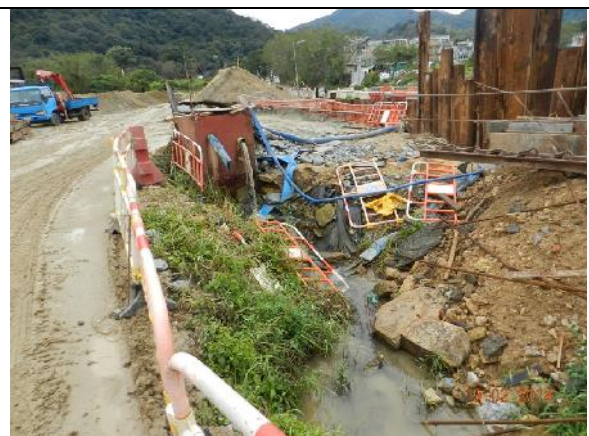
**Photo 12** – A sedimentation tank was seen receiving the waste water from the works area near the previous collapsed tree T196 and the discharge was seen to be clear.

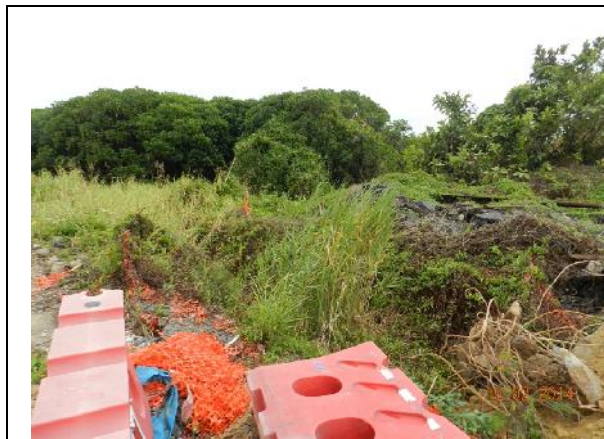
**Photo 13** – Abandoned sedimentation bed aligned from the area opposite to the Jade View Villa towards the marsh area at southeast. This bed was overgrown by dense grassy vegetation.

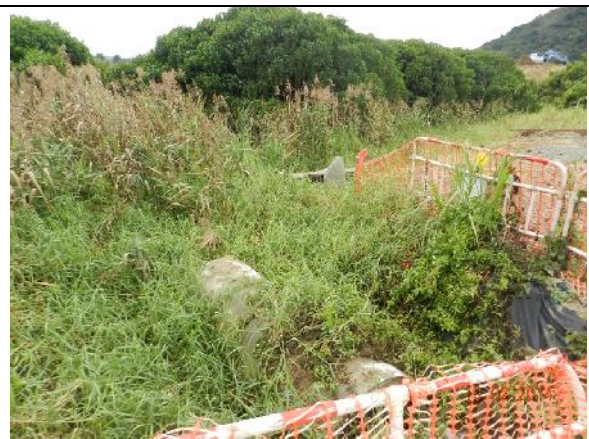
**Photo 14** – Abandoned sedimentation bed aligned from the area opposite to the eastern part of Jade View Villa towards the marsh area. This bed was overgrown by dense grassy vegetation.

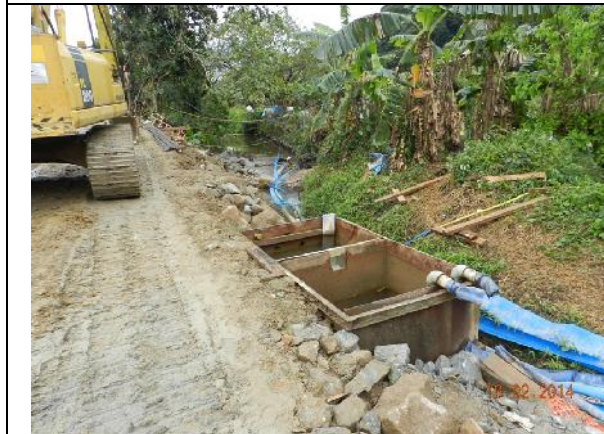
3.3.5 As mentioned above, construction works have been resumed along Wai Ha River. As observed in February 2014, no more muddy water from the works area was pumped to the sedimentation tank settled at the end of the works area (**Photo 15**). It was because the construction works at the upper stream was about to finish. The river water from the upper stream was released back to the river near the sedimentation tank (**Photo 16**). Down the stream near the public toilet, broken branches from the adjacent trees were still found blocking the stream (**Photo 17**). The water was still noted clear at the lower stream (**Photo 18**).

**Photo 15** – No more muddy water from the works area was pumped to the sedimentation tank settled at the end of the works area.

3.3.8 Regular monitoring should be conducted to ensure no direct discharge or leakage of contaminants or any polluted fluid into the adjacent Wai Ha River and the nearby Shuen Wan marsh. The Contractor should maintain regular check (e.g. daily) on the sedimentation and filtration facilities and appropriate sedimentation beds and/or tanks throughout the construction phase (e.g. check the function of the sedimentation beds and remove surplus sand and gravels deposited along the beds or within the tanks) to make sure all discharged water was filtered appropriately prior to any discharge.

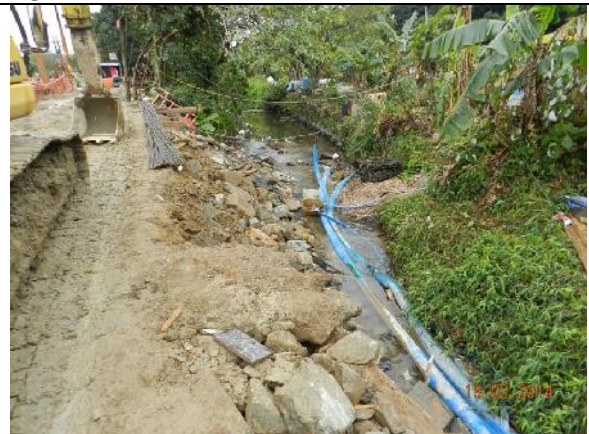
**Photo 16** – The river water from the upper stream was released back to the river near the sedimentation tank.

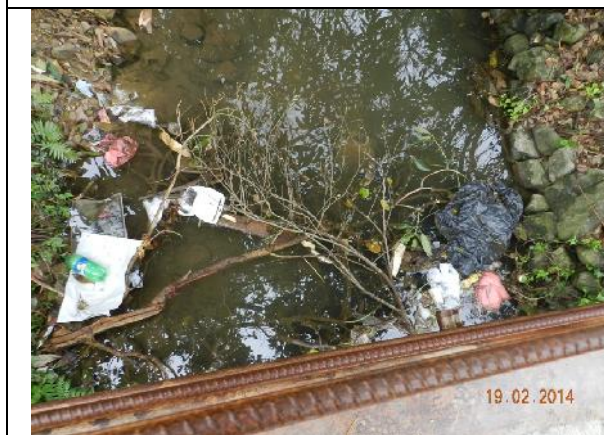
**Photo 17** – Down the stream near the public toilet, broken branches from the adjacent trees were noted blocking the stream.

3.3.9 The Contractor should have *ad hoc* inspection and emergency measures for any accidental spillage of polluted fluid, contaminants or grease from the construction sites. To prevent the impact of the unclear discharge on the nearby vegetated area, it is suggested to overlay PVC liners along the site edge and remove any surplus sand and gravels deposited in the beds and tank even some parts of the construction works may be completed at this stage. The Contractor is also suggested to remove the broken branches in the stream so as to prevent their blockage of the stream flow and trapping greasy substances in the stream.

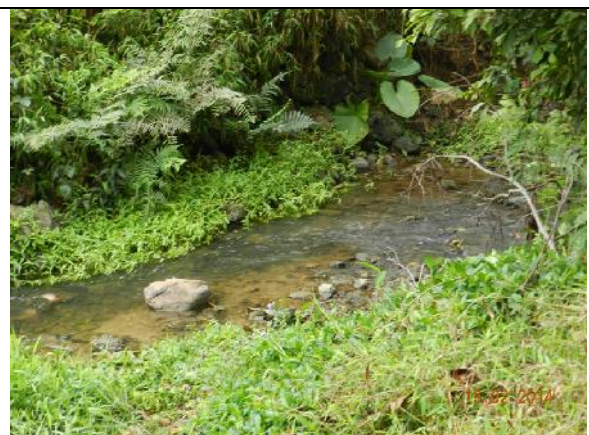
**Photo 18** – The water was still noted clear at the lower stream.

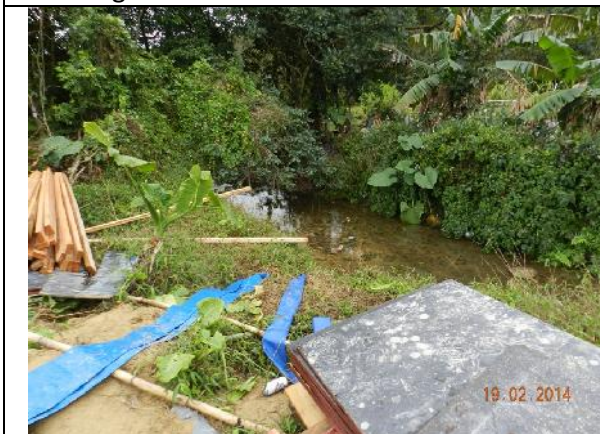
**Photo 21** – No more water from the box culvert in the works area outside the public toilet was noted pumping out and releasing to Wai Ha River.

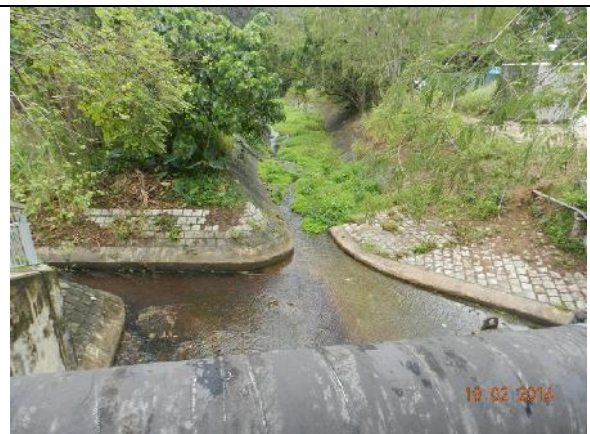
**Photo 22** – No direct water discharge into the upper stream of Wai Ha River was observed as the construction works have been concentrated at the lower end of the river.

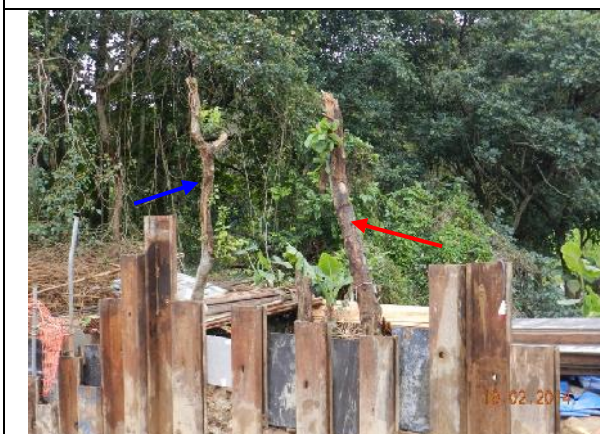
**Photo 23** – Topped T167 (Red arrow) and T168 (Blue arrow) were in poor health condition with very sparse foliage.

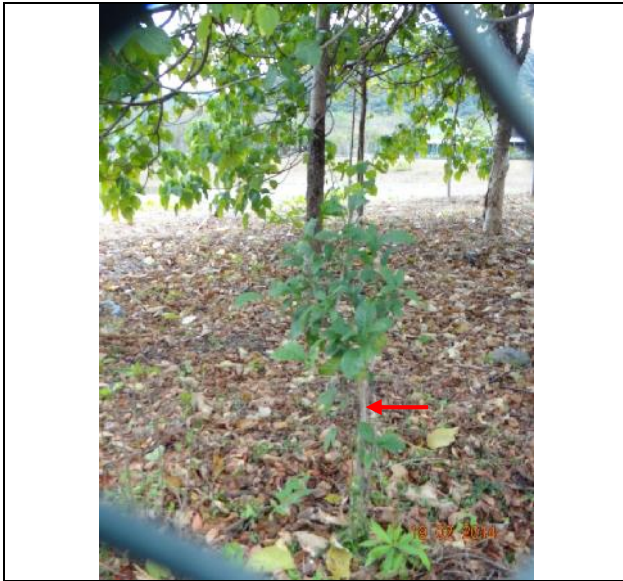
**Photo 31** – The transplanted shrub of *Pavetta hongkongensis* (PH03) in Area C under Contract 1 has remained in satisfactory condition.
