Monthly Environmental Monitoring & Auditing report for

Contract No.DC/2009/22

Drainage Improvement in Shuen Wan, Tai Po – Contract 1

March 2014

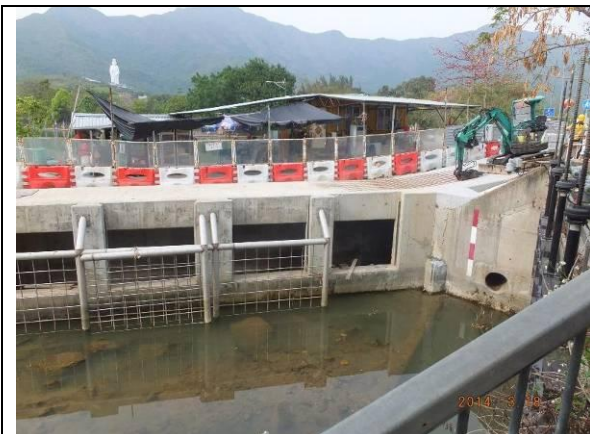
Photo 1 – Temporary construction hoardings have been established around the works area at Wai Ha River estuary.

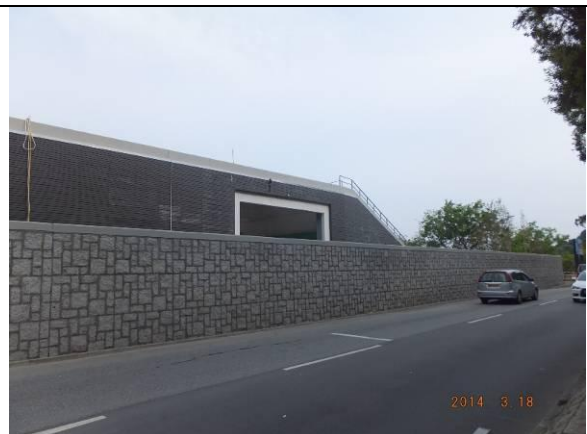
Photo 2 – The proposed boundary wall along part of the western side of Area A.

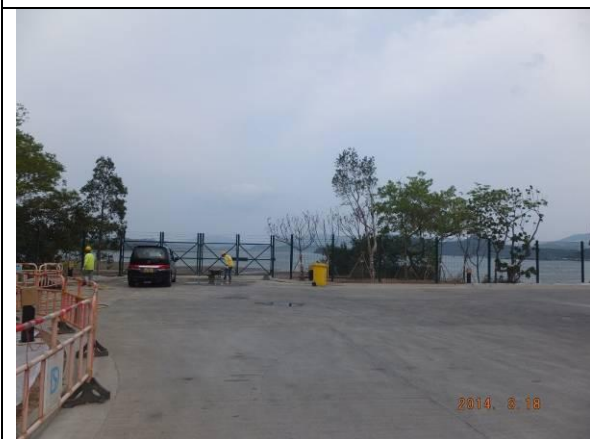
Photo 3 – Proposed chain-link fence has been erected along the rest of the boundary sides of Area A.

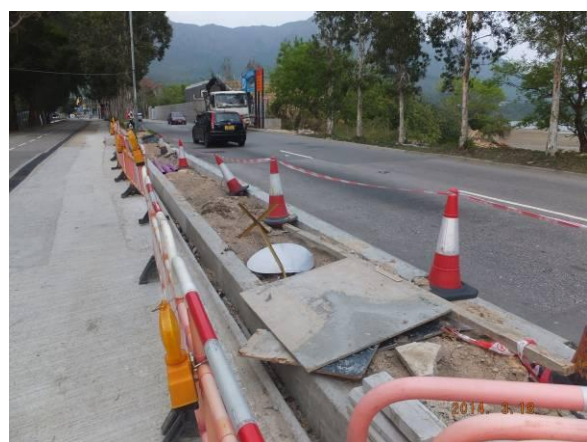
Photo 4 – Construction of a roadside planter along Ting Kok Road.

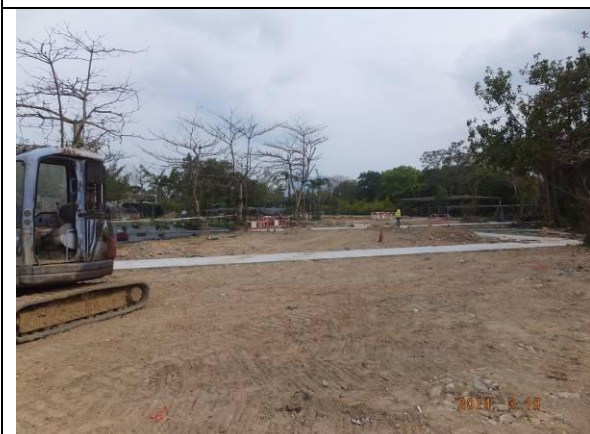
Photo 5 – The reinstatement works continued in Area B and the areas were demarcated with loosened barrier tapes.

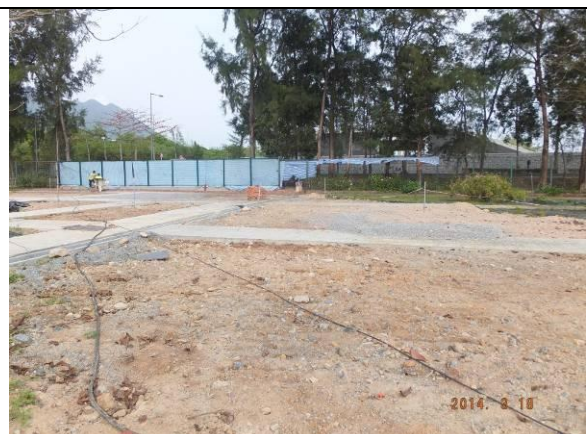
Photo 6 – The reinstatement works continued in Phase 2 of Area B within Tung Tze Nursery.

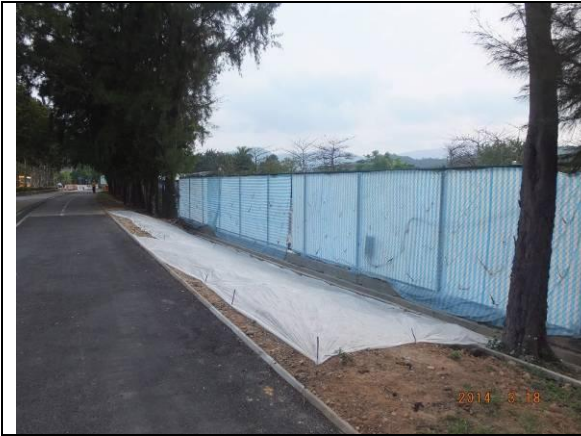
The temporary hoardings established for demarcating the construction site boundary of Phases 1 and 2 construction works area of Area B in Tung Tsz Nursery have been removed since January 2014. The reinstatement works continued in the nursery and the areas were demarcated with loosened barrier tapes (**Photos 5-6**). The open section between Phases 1 and 2 works areas was maintained during the reinstatement works, providing an access path for the daily operation of the nursery. Since November 2013, the hoarding along the eastern boundary of Phase 2 in Area B (i.e. the section next to Ting Kok Road) was permanently reinstated with the original chain-link fence. Canvas sheets were put on the reinstated fence to screen off the existing construction site from the pedestrian path (**Photo 7**).

Photo 7 – Chain-link fence was reinstated at the eastern end of Phase 2 works area and covered by canvas sheets. Hydroseeding was applied on a roadside planting area next to Ting Kok Road.

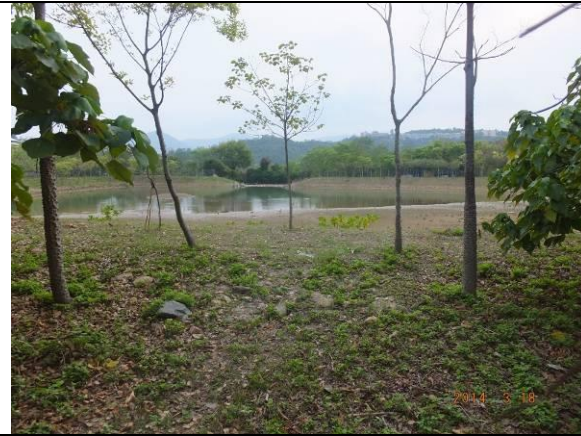
Area C was formally handed over to AFCD on 16th October 2012 for management and maintenance. The pond of the ECA has been connected to Wai Ha River directly as following the scheme design of Habitat Compensatory Plan. No direct discharge of turbid water into the adjacent Wai Ha River was observed through the fence of Tung Tsz Nursery **(Photo 8)**.

Photo 8 – No discharge of muddy water was observed in Area C.

The Contractor should regularly check the condition and locations of the drainage pipes and ensure that all used water should be appropriately filtered and discharged to the manholes/other discharge points agreed by the Engineer and EPD. This is to avoid any potential contamination to the vegetation in Shuen Wan marsh and other vegetated/marinated areas adjacent to the active works area.

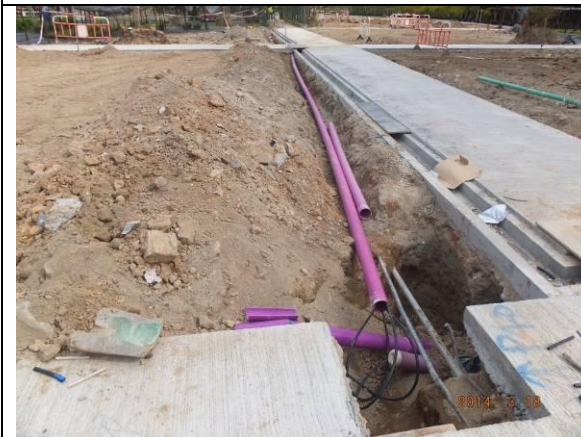
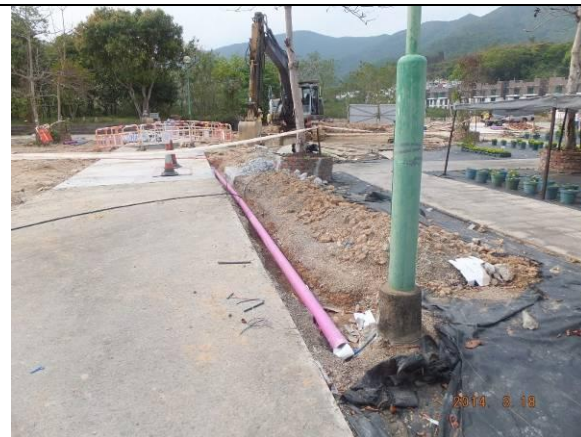
As observed in March 2014, no major excavation works were undertaken in Phases 1 and 2. The reinstatement works for the original access paths, ground of the nursery beds and basic nursery utility (such as irrigation pipes and lamp posts) were still in progress in both Phases 1 and 2 areas (**Photos 9-10**).

Photo 9 – The reinstatement works for the ground of the nursery beds and basic nursery utility were still in progress in both Phases 1 and 2 areas in Area B.

Photo 10 – The reinstatement works for the original access paths, ground of the nursery beds and basic nursery utility were still in progress in both Phases 1 and 2 areas in Area B.

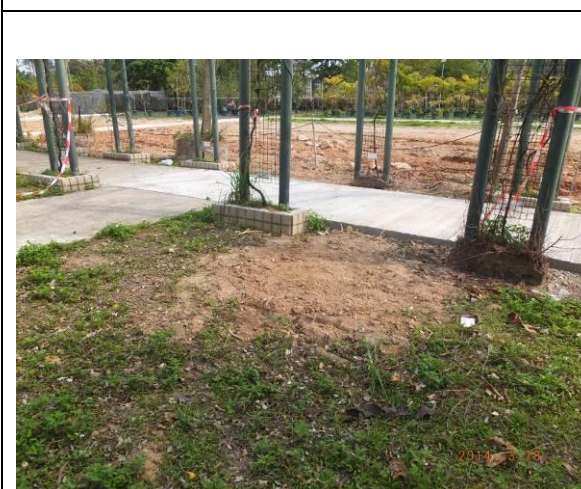
As reported in the previous *Monthly EM&A Reports*, the retained tree U68 (*Gmelina arborea*) was found fallen after the severe typhoon in July 2012, with its leaning trunk being pruned and removed in August 2012 (as reported in *Monthly EM&A Report for August 2012*). Regular removal of generated watersprouts was sometimes noted throughout the monitoring period. The entire planter was noted to be removed in March 2014 (**Photo 11**).

Photo 11 – The entire planter of the removed tree U68 was also removed in March 2014.

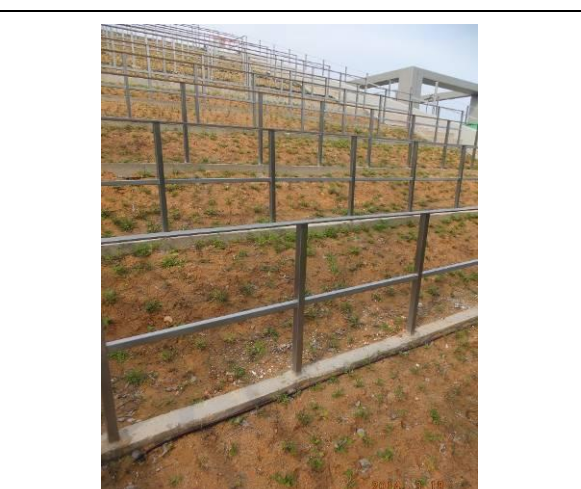
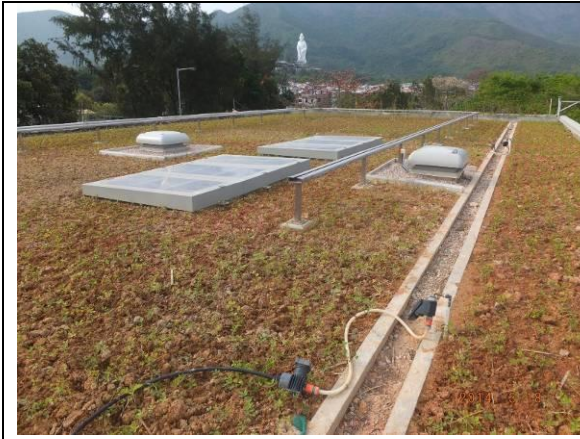
approved Landscape Plan (**Photos 12-13**). In addition, the proposed climbers, including *Bauhinia glauca* on the green roof, and *Ficus pumila* and *Parthenocissus dalzielii* on the ground for vertical greening) were also planted as observed in March 2014.

Photo 12 – The proposed green roof of the pumping house was vegetated with ground cover *Arachis duranensis*.

Photo 13 – The rooftop of the pumping house was vegetated with ground cover *Arachis duranensis*.

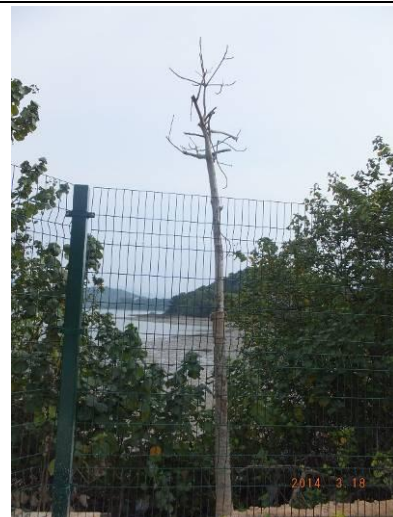
The tree to be transplanted E16 (*Bombax ceiba*) was relocated to the southern side of Area A next to the site hoarding in July 2012. The tree was still in marginally fair condition in March 2014 (**Photo 14**) and it was separated outside the proposed chain-link fence along the boundary sides of Area A. Soil grade change was observed around the trunk base and minor exposed roots were found in January 2014. As observed in March 2014, soil was still piled around the root flare and some exposed root was found (**Photo 15**). The stability of the tree may be affected. Though this tree is fenced outside the chain-link fence, the condition and stability of this tree should be regularly monitored.

Photo 14 – The relocated E16 was in marginally fair condition in March 2014 and it was separated outside the chain-link fence along the boundary sides of Area A.

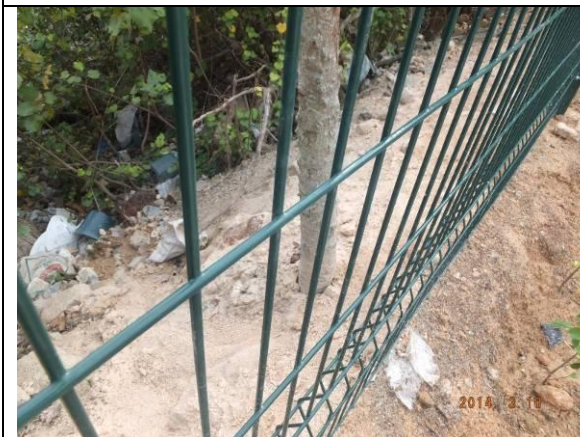
Photo 15 – Soil was piled around the root flare of E16 and some exposed root was found.

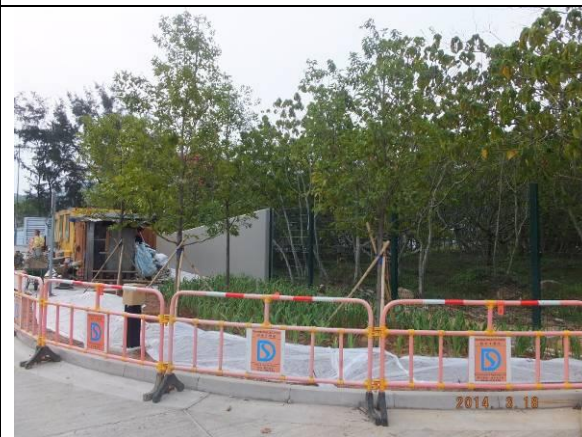
Photo 16 – Four new trees of *Cinnamomum burmannii* were planted in the planter.

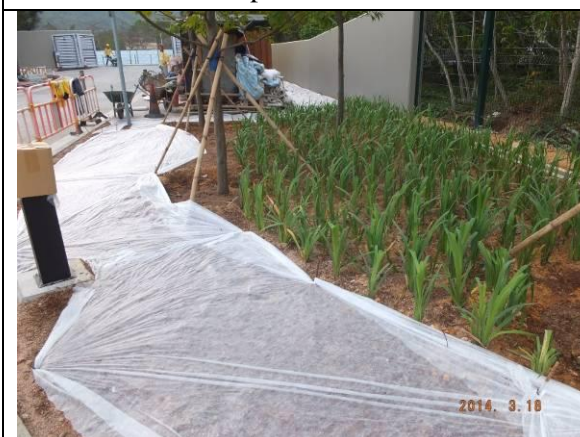
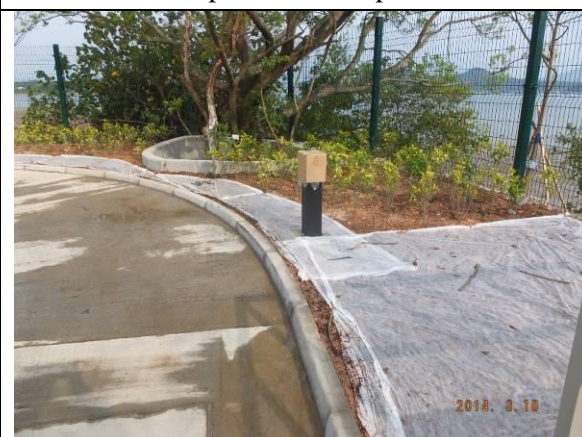
The relocated tree E38 (*Melaleuca cajuputi* subsp. *cumingiana*) was found dead after its relocation in August 2013, and it was removed by the Contractor in November 2013 (reported in *Monthly EM&A Report for November 2013*). A planter was built at the same location in accordance with the approved Landscape Plan. Four newly planted *Cinnamomum burmannii* appeared in fair condition (**Photo 16**). Planting of ground cover (*Iris tectorum*), shrubs (*Ficus microcarpa* (Golden Leaf)) and hydroseeding were also observed in the planters in Area A (**Photos 17-18**).

Photo 17 – Planting of shrubs and hydroseeding were observed in the newly built planters in Area A.

Photo 18 – Planting of shrubs and hydroseeding were observed in the newly built planters in Area A.

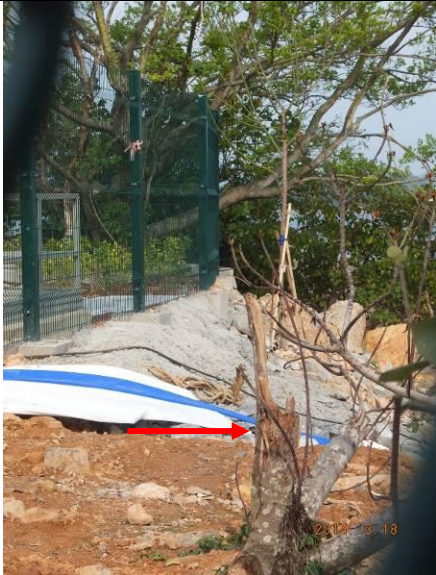
Damaged tree trunk on E55 (*Macaranga tanarius* var. *tomentosa*) was reported in *Monthly EM&A Report for April 2013*. The wound on the trunk of E55 has been burlapped since May 2013. The upper section of the tree trunk was broken in June 2013. The tree was still in very poor condition with most of its foliage as dry watersprouts only

Photo 19 – The burlapped tree E55 was still in poor condition with dry leaves and it was separated outside the chain-link fence along the boundary sides of Area A in March 2014.

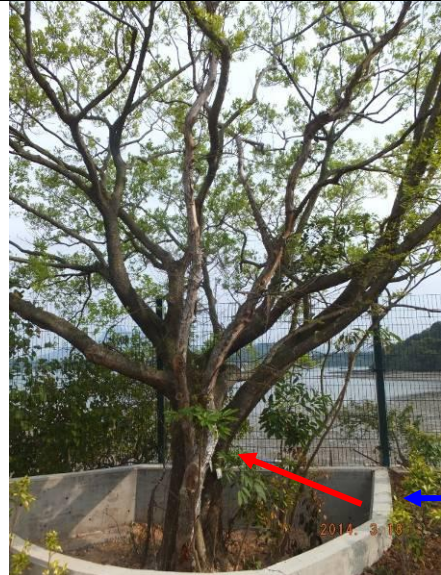
A retained tree T253 (*Bridelia tomentosa*) was in poor condition (**Photo 20**). Dead scaffold limbs with dry, peeled bark were observed. This identified tree defect may be only related to the intrinsic physiological and structural condition of T253. The tree was closely monitored in March 2014. Besides, a large planter was built to surround the retained trees T253 and E63 (*Celtis sinensis*) in Area A (planter is indicated in **Photo 20**).

Photo 20 – The retained tree T253 was in poor condition (red arrow). A planter (blue arrow) was built to protect the retained trees T253 and E63.

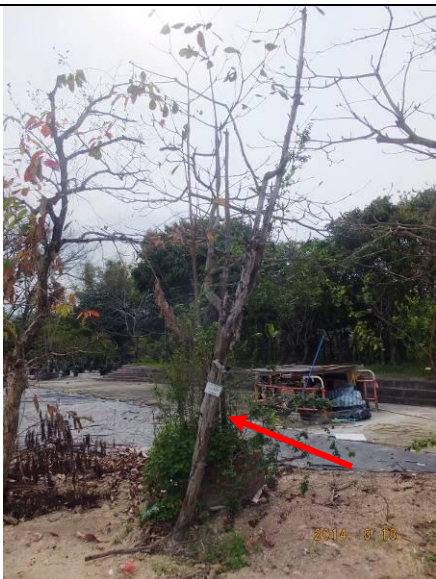
Photo 21 – Dead tree U37.

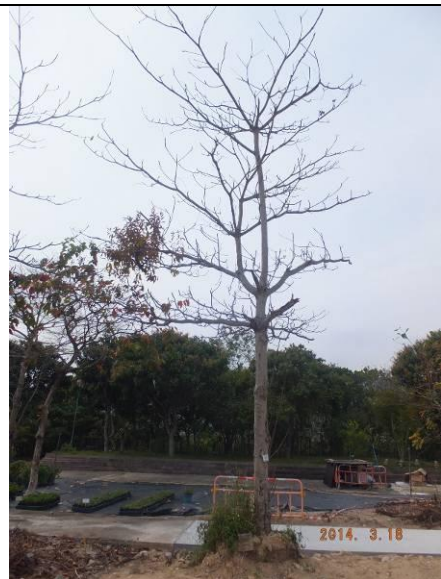
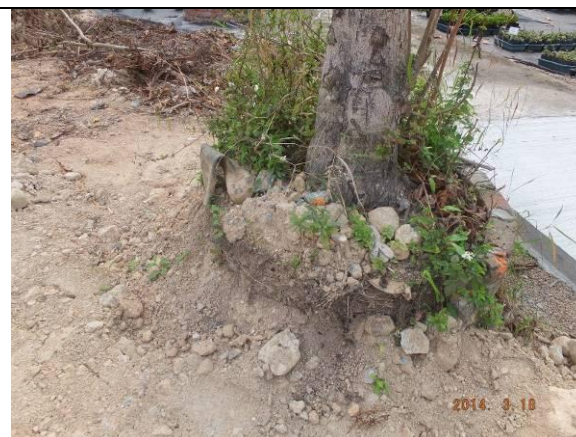
Half of the planter of U47 (*Terminalia catappa*) has been broken since August 2013, and some of its roots and planter soil were exposed in the air. As inspected in March 2014, the planter was still not yet repaired (**Photos 22-23**). As reported in *Monthly EM&A Report for February 2014*, a fungal fruiting body was found at the trunk base and parasitic plants were observed in the canopy. The condition of the tree was closely monitored. In addition to U47, the planters of U54 (*Terminalia catappa*) and another two untagged *Terminalia catappa* to the southeast of U54 (**Photos 24-26**), as well as the relocated tree U69

Photo 22 – The planter of U47 was broken.

Photo 23 – Half of the planter of U47 was broken, but has not yet been repaired.

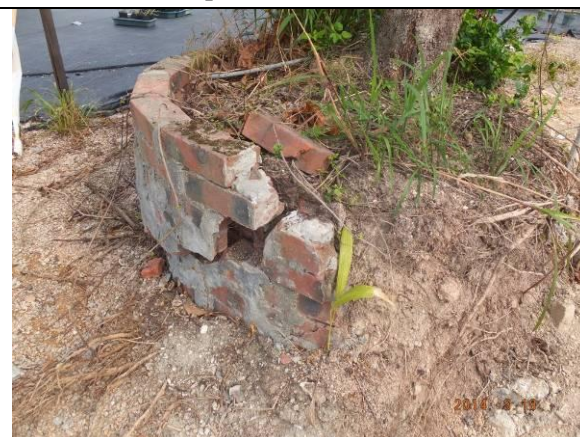
Photo 24 – The planter of U54 was broken and exposed roots and soil were observed.

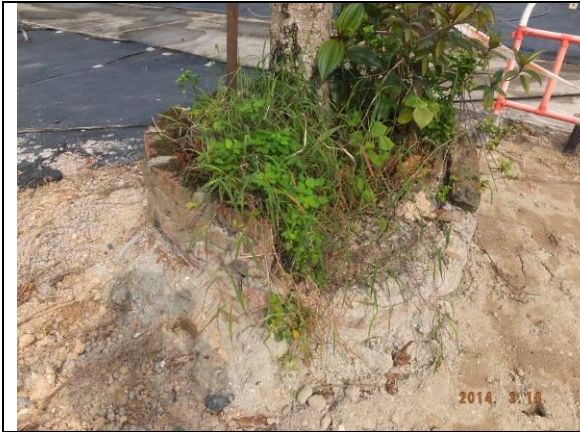
Photo 25 – The planter of an untagged *Terminalia catappa* next to U54 was broken, with exposed roots and soil.

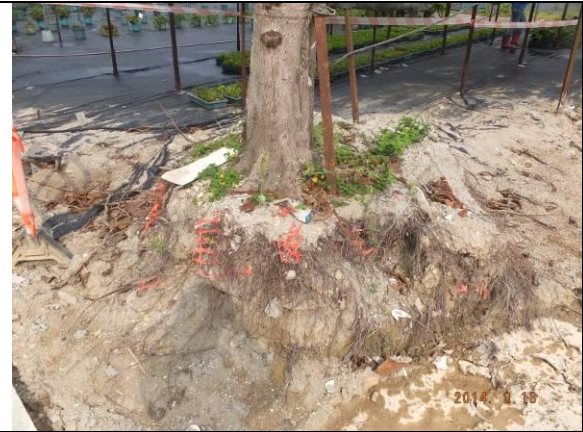
Photo 26 – The planter of another untagged *Terminalia catappa* next to U54 was broken, with exposed roots and soil.

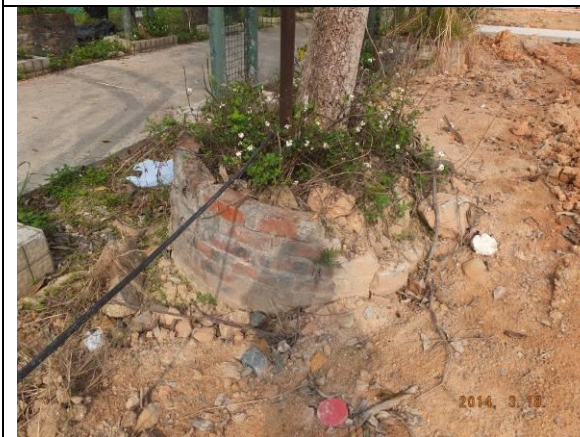
Photo 27 – The planter of U69 was broken and exposed roots and soil were observed. A risk of leaning tree trunk was observed.

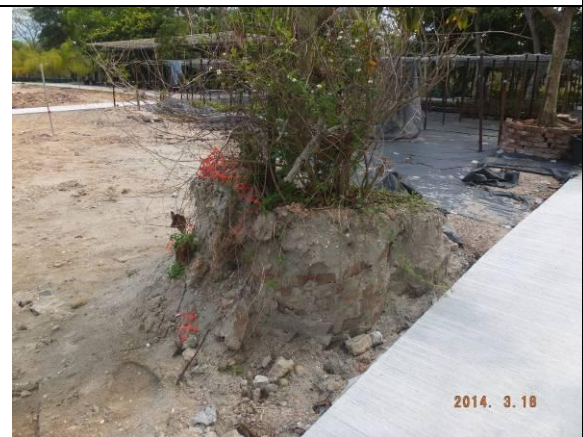
Photo 28 – Excavated soil was piled around the planter and on the root flare of U51.

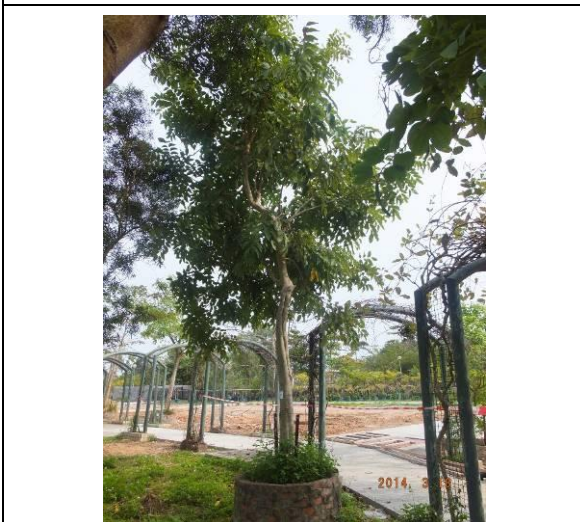
Photo 29 – Sign of suspected termite infestation was observed at the lower trunk of U67 and the tree was still in fair condition in March 2014.

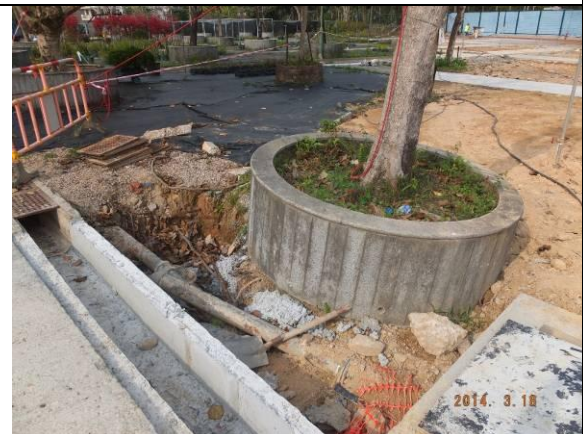
Photo 30 – The excavated area close to the planter of A40 has not yet been refilled with soil. The tree trunk of A40 was guyed to the nearby tree planter.

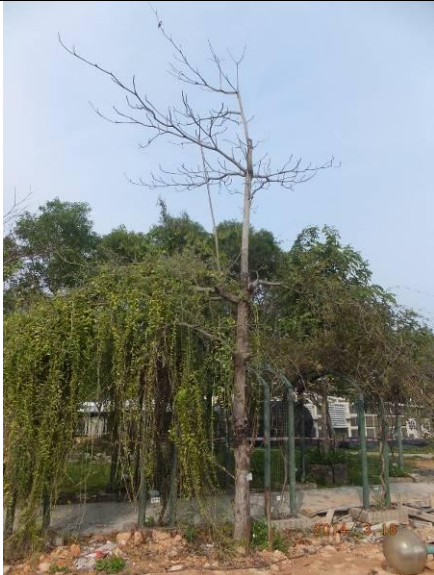
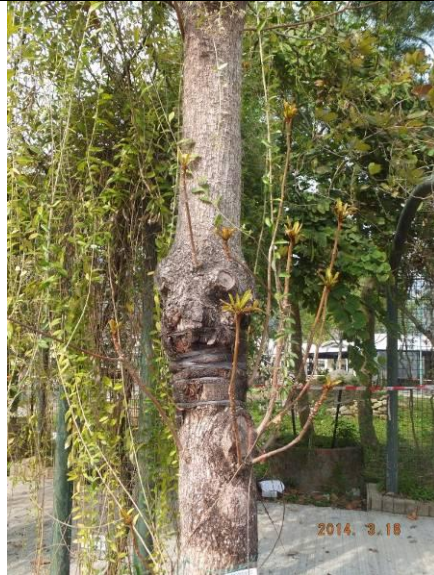
Photo 31 – The trunk of the transplanted tree U53 was tied tightly by strings and a hessian wrapping which was left after the transplantation of the tree.

Photo 32 – Close-up view of the hessian wrapping on the trunk of U53.

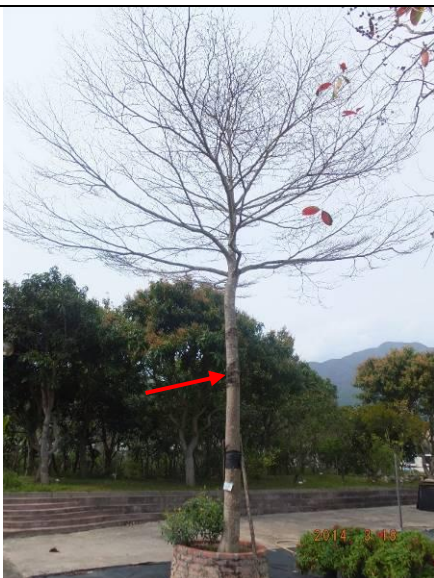
Photo 33 – Hessian wrapping was found on the trunk of the transplanted tree U57 (Red arrow).

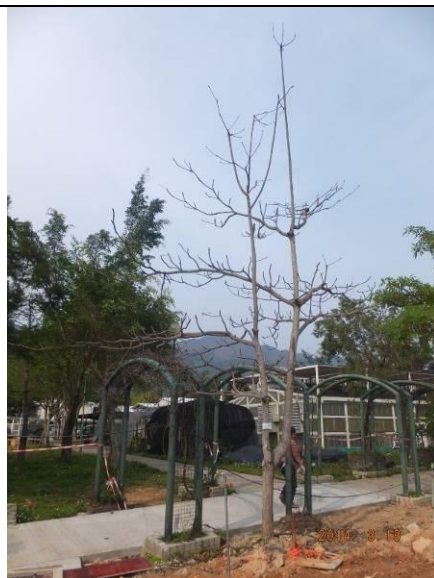
The broken branch on the transplanted tree A43 (*Terminalia catappa*) was removed in March 2014 (**Photo 34**).

Photo 34 – The broken branch on the transplanted tree A43 was removed in March 2014.

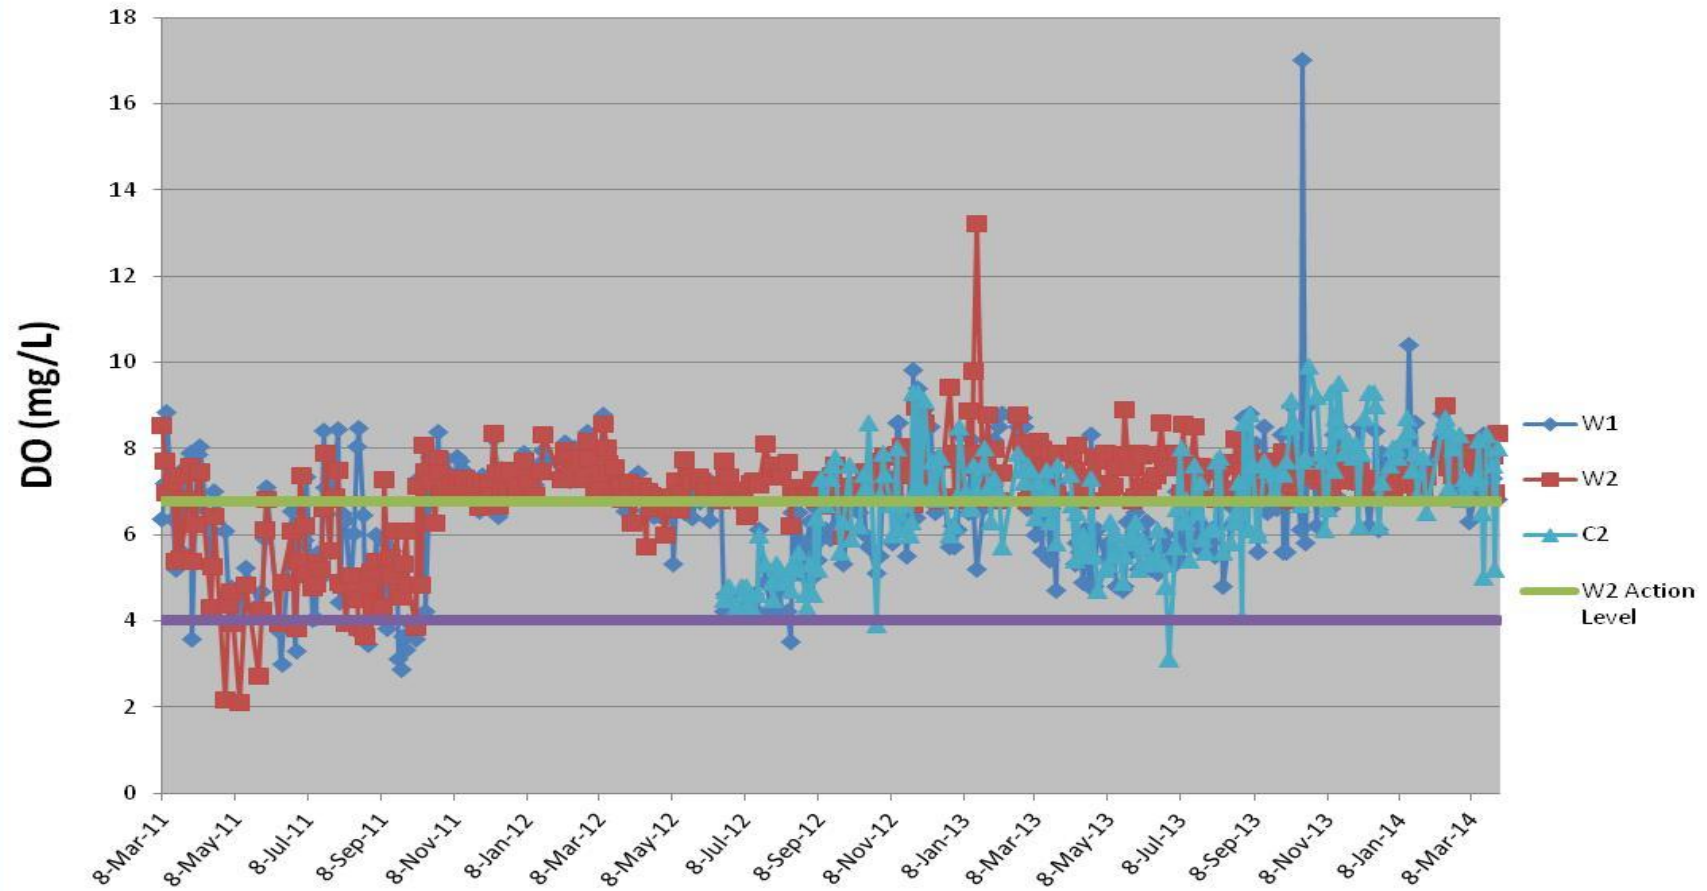
Graphical plots of DO (ebb tide) for W1&W2

Remarks: Action level: 5 percentile of baseline data
Limit level: 1 percentile of baseline

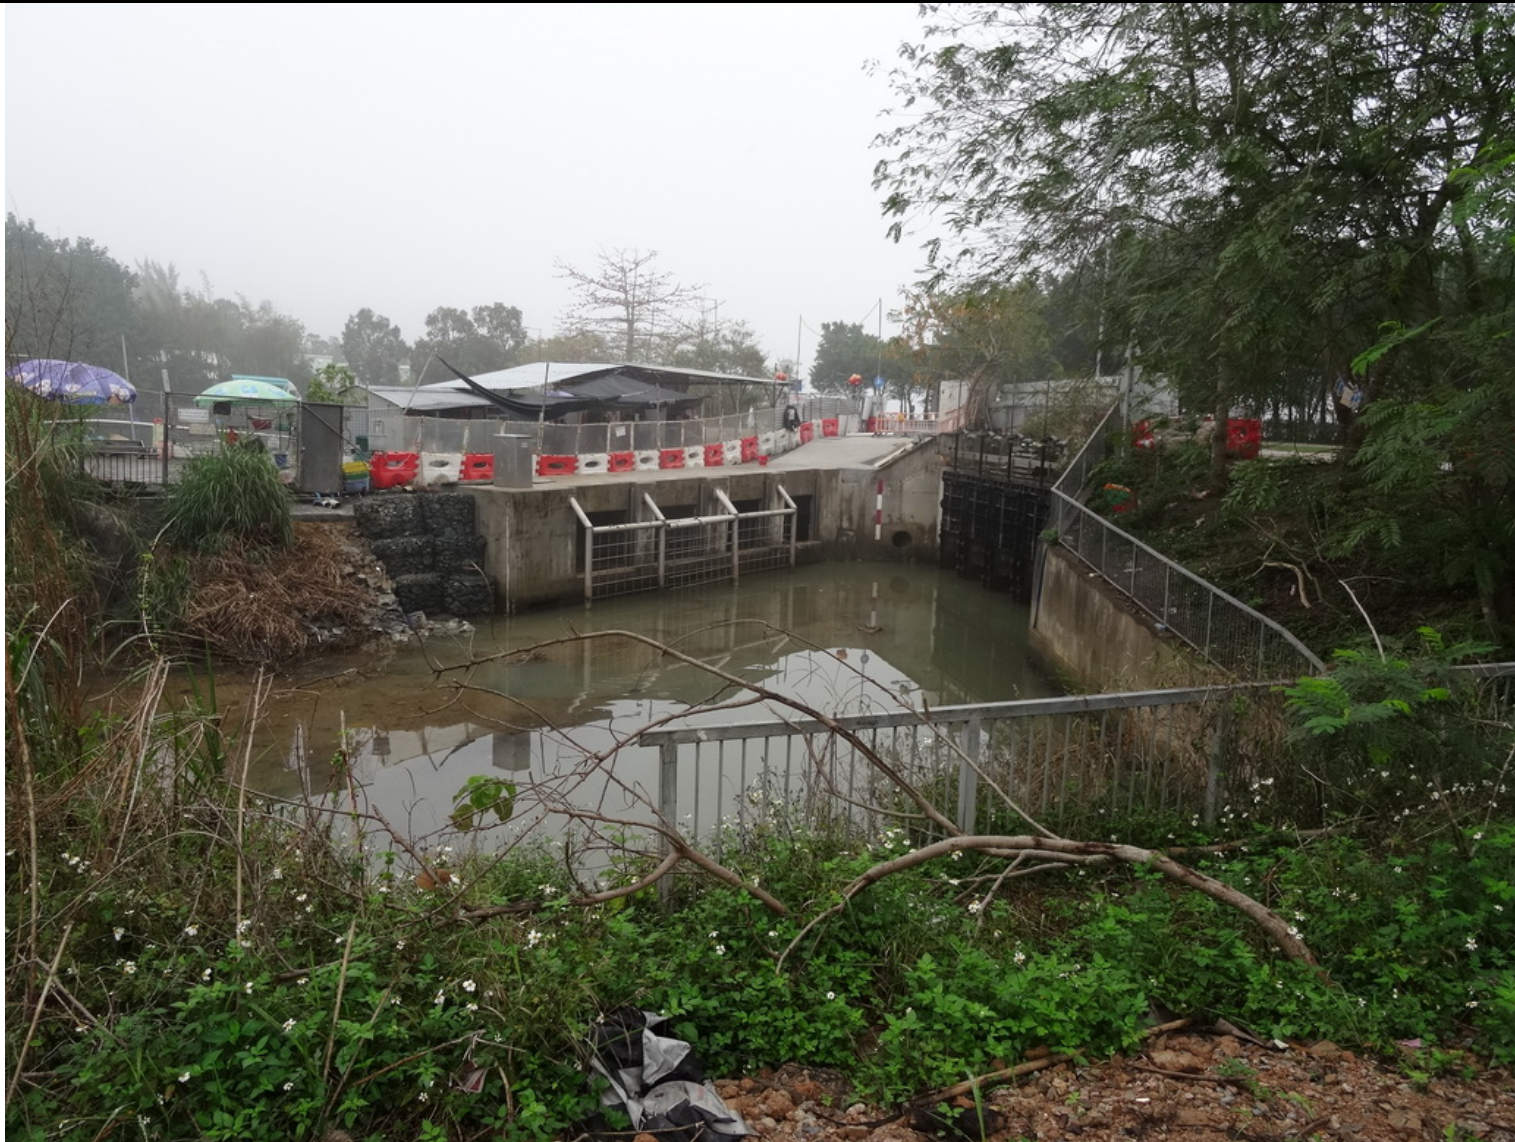
Figure: 2

Under Contract 1 (i.e. SEMP 1), a total of 7 fish species, 1 bivalve and 1 snail were recorded and most of them were residing in brackish environments (**Table 4**). Some river works were carried out in SEMP 1 as showed in **Figure 2**. Overall, no protected or rare species were recorded.

Title: SEMP 1, the first sampling point of Wai Ha River under Contract 1.
