**CONTRACT NO. DC/2010/02 –
DRAINAGE IMPROVEMENT IN SHUEN WAN AND
SHEK WU WAI**

**MONTHLY ENVIRONMENTAL MONITORING AND
AUDIT REPORT (NO.33) – MARCH 2014**

PREPARED FOR
KWAN LEE-KULY JOINT VENTURE

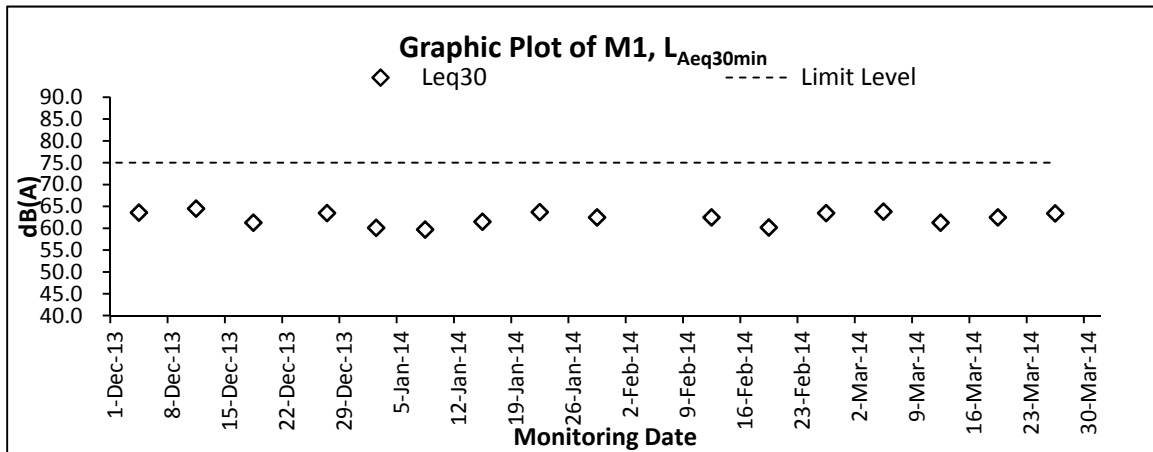
Remark: The monitoring is undertaken under façade situation. No façade correction is added according to acoustical principles and EPD guidelines.

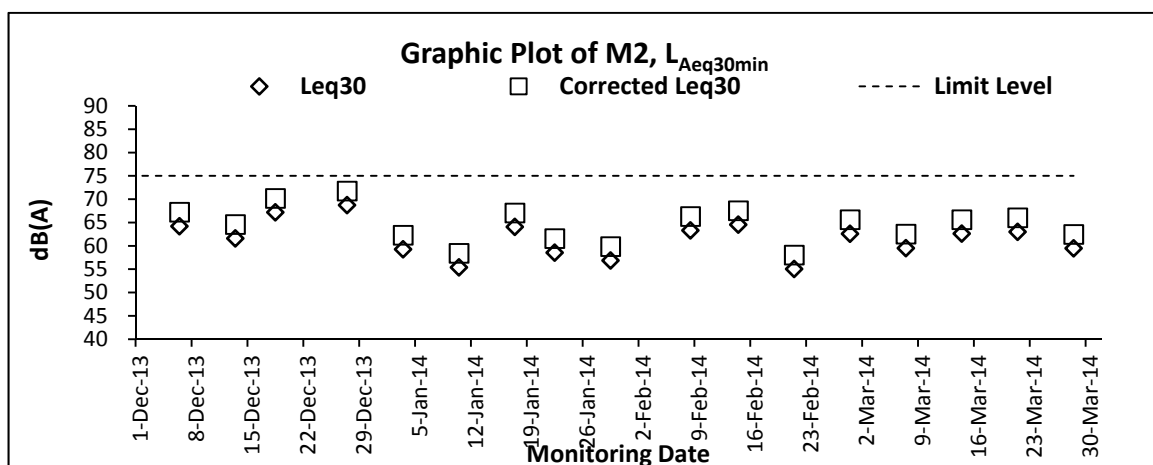
Remark: The monitoring is undertaken under free field situation. A façade correction of +3 dB(A) has been added according to acoustical principles and EPD guidelines.

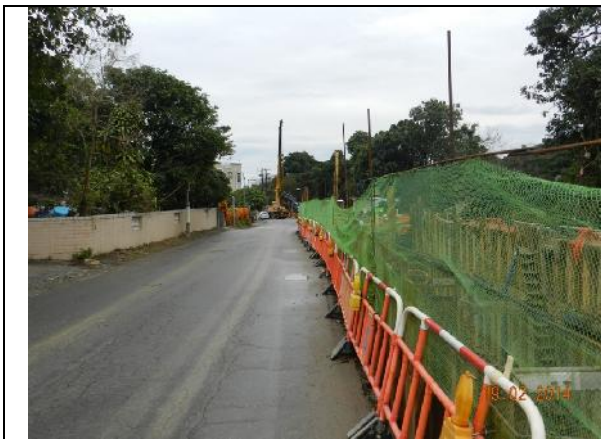
Photo 1 – Temporary hoardings have been erected along Tung Tsz Road opposite to Wai Ha.

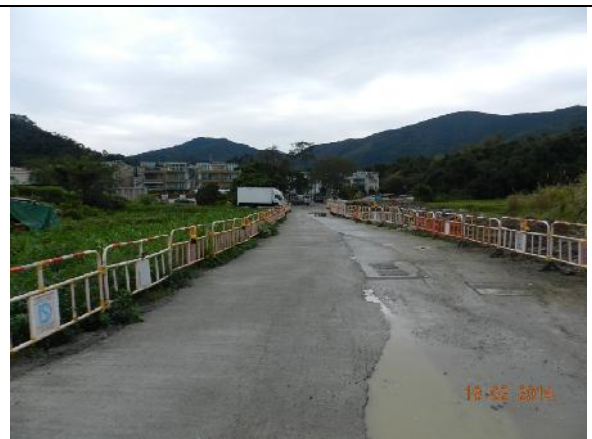
Photo 2 – Temporary hoardings have been erected along the access road from Tung Tsz Road to Treasure Spot Garden II.

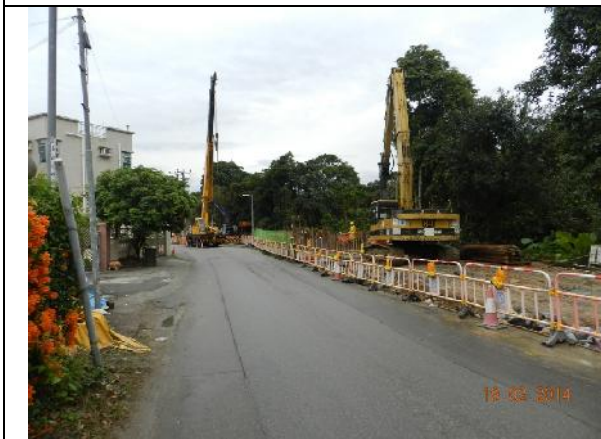
Photo 3 – Construction works for building the box culverts along Tung Tsz Road opposite to Wai Ha outside the public toilet.

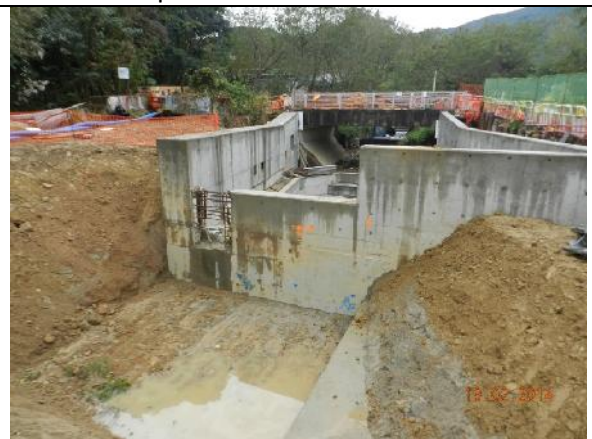
Photo 4 – Construction works continued along Wai Ha River.

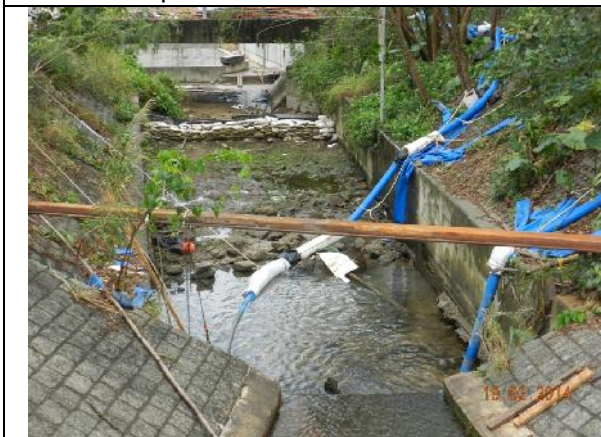
Photo 5 – The river was divided by sand bags and water from the upper stream was pumped to the lower stream behind the works area along Wai Ha River.

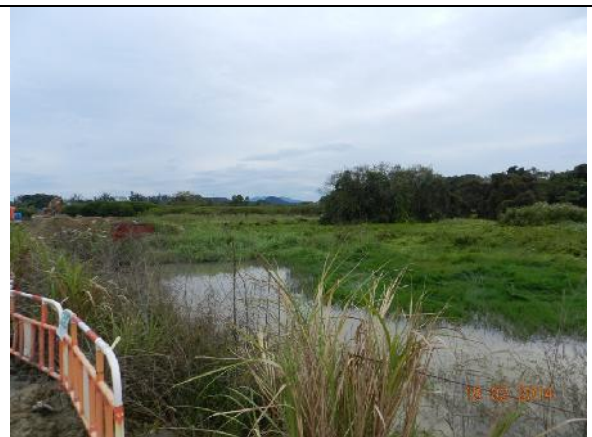
Photo 6 – Temporary construction barriers surrounded the eastern side of the wetland rehabilitation area.

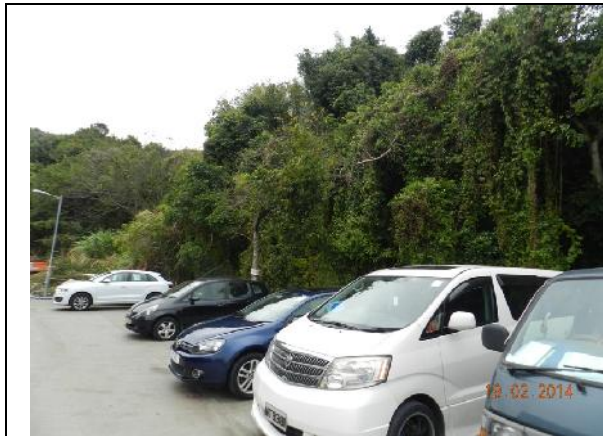
- 3.2.7 As reported in the previous *Monthly EM&A Reports*, dumping on the Taro field located along the path towards the Treasure Spot Garden was observed and a paved area created for parking next to the retained tree groups (T088 – T091) has been found since November 2012. In October 2013, the path to Treasure Spot Garden II was expanded towards the Taro field due to the re-provision of vehicular access road to the villagers during the works at the entrance of the Treasure Spot Garden. No more expansion of the pathway was seen in February 2014.

Photo 7 – Temporary parking area was still maintained at the end of the access path to Treasure Spot Garden Phase II in February 2014.

- 3.2.11 No specific recommendation is required. However, with regard to the previous dumping incident by other parties on the Taro field near the Treasure Spot Garden, the Contractor is recommended to check the site condition regularly to avoid any extent of dumping or paving of area within the project boundary.
- 3.2.12 The Contractor should also make sure there are no piled rocks, construction materials or programmed construction works influencing the existing trees within the Project Area or the wetland rehabilitation area. Otherwise, the Contractor should request the on-site workers to remove those piled rocks or construction materials.
- 3.2.13 The Contractor could establish a warning sign to remind the driver to beware of the presence of the tree(s) close to the temporary parking area.

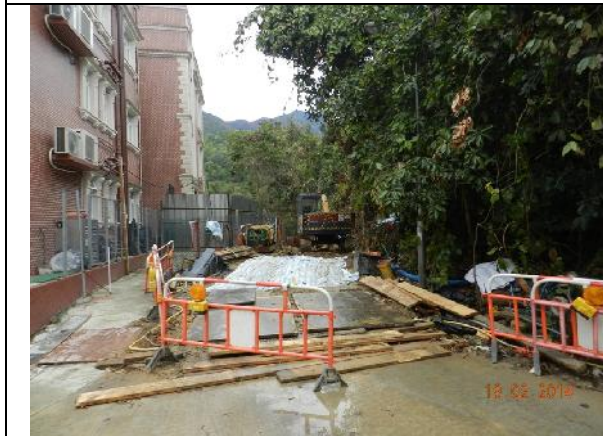
- 3.2.8 Works were observed at the end of the Treasure Spot Garden II near the retained tree T103 and the works area was surrounded by temporary construction barriers and chain-link fence (**Photo 9**). Construction works along the pathway to the Treasure Spot Garden II near the retained tree group (T097-098) were finished.

Photo 9 – Works were observed at the end of the Treasure Spot Garden II near the retained tree T103 and the works area was surrounded by temporary construction barriers and chain-link fence.

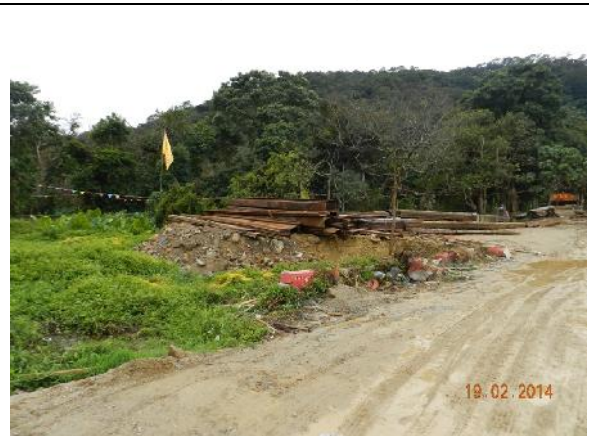
- 3.2.9 The works area near the previous collapsed tree T190 (*Ficus hispida*) was found to be expanded to the grassland on the south in January 2014. The expanded area was still used for storage of construction materials in February 2014 (**Photo 10**).

Photo 10 – The expanded works area near the previous collapsed tree T190 (*Ficus hispida*) was still used for storage of construction materials.

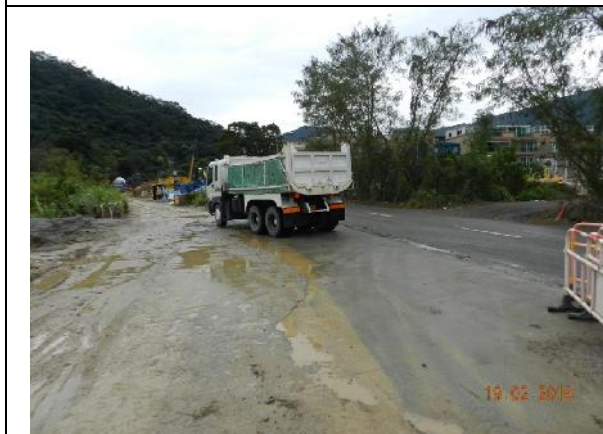
Photo 11 – One exit point was seen opposite to the tree group T021-029 (*Leucaena leucocephala*).

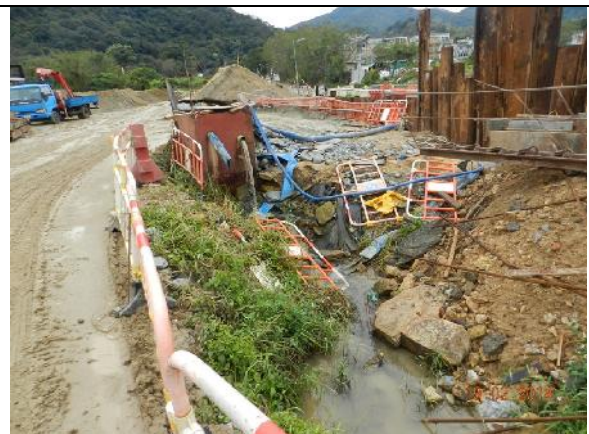
Photo 12 – A sedimentation tank was seen receiving the waste water from the works area near the previous collapsed tree T196 and the discharge was seen to be clear.

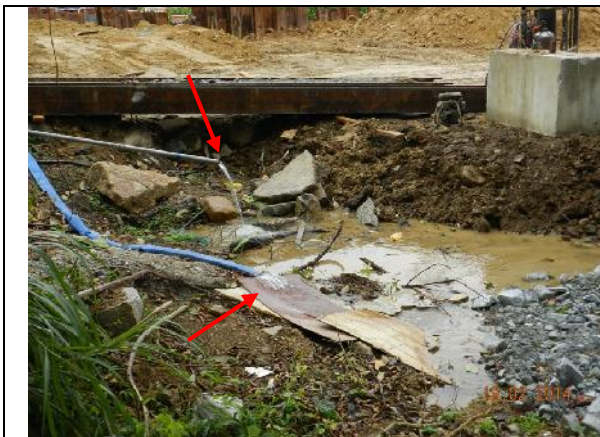
3.3.6 Near the expanded works area near the previous collapsed tree T190 (*Ficus hispida*), water from the nearby box culvert and from the works area opposite to Wai Ha was found pumping out and releasing to the southern side of the area (**Photos 19-20**). This area was connected to the adjacent grassland. The water trapped within this small area appeared to be quite muddy.

Photo 19 – Next to the expanded works area near the previous collapsed tree T190, water from the nearby box culvert was found pumping out and releasing to the southern side of the area.

3.3.8 Regular monitoring should be conducted to ensure no direct discharge or leakage of contaminants or any polluted fluid into the adjacent Wai Ha River and the nearby Shuen Wan marsh. The Contractor should maintain regular check (e.g. daily) on the sedimentation and filtration facilities and appropriate sedimentation beds and/or tanks throughout the construction phase (e.g. check the function of the sedimentation beds and remove surplus sand and gravels deposited along the beds or within the tanks) to make sure all discharged water was filtered appropriately prior to any discharge.

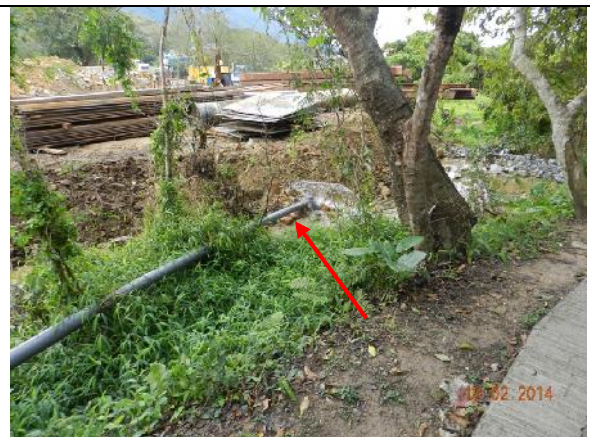
Photo 20 – Another view showing the water pumped from the nearby box culvert and released to the southern side of the area.

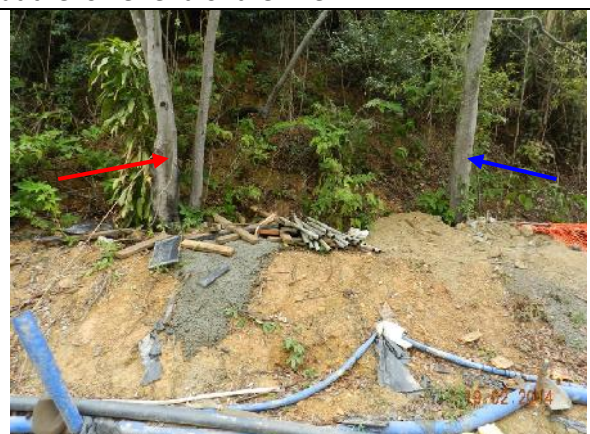
Photo 24 –Storage of construction materials was noted close to the trunk flares and trunks of T093 (Red arrow) and sand piling was seen close to the trunk flare of T094 (Blue arrow).
