**Monthly Environmental Monitoring & Auditing report for**

**Contract No.DC/2009/22**

**Drainage Improvement in Shuen Wan, Tai Po – Contract 1**

**April 2014**

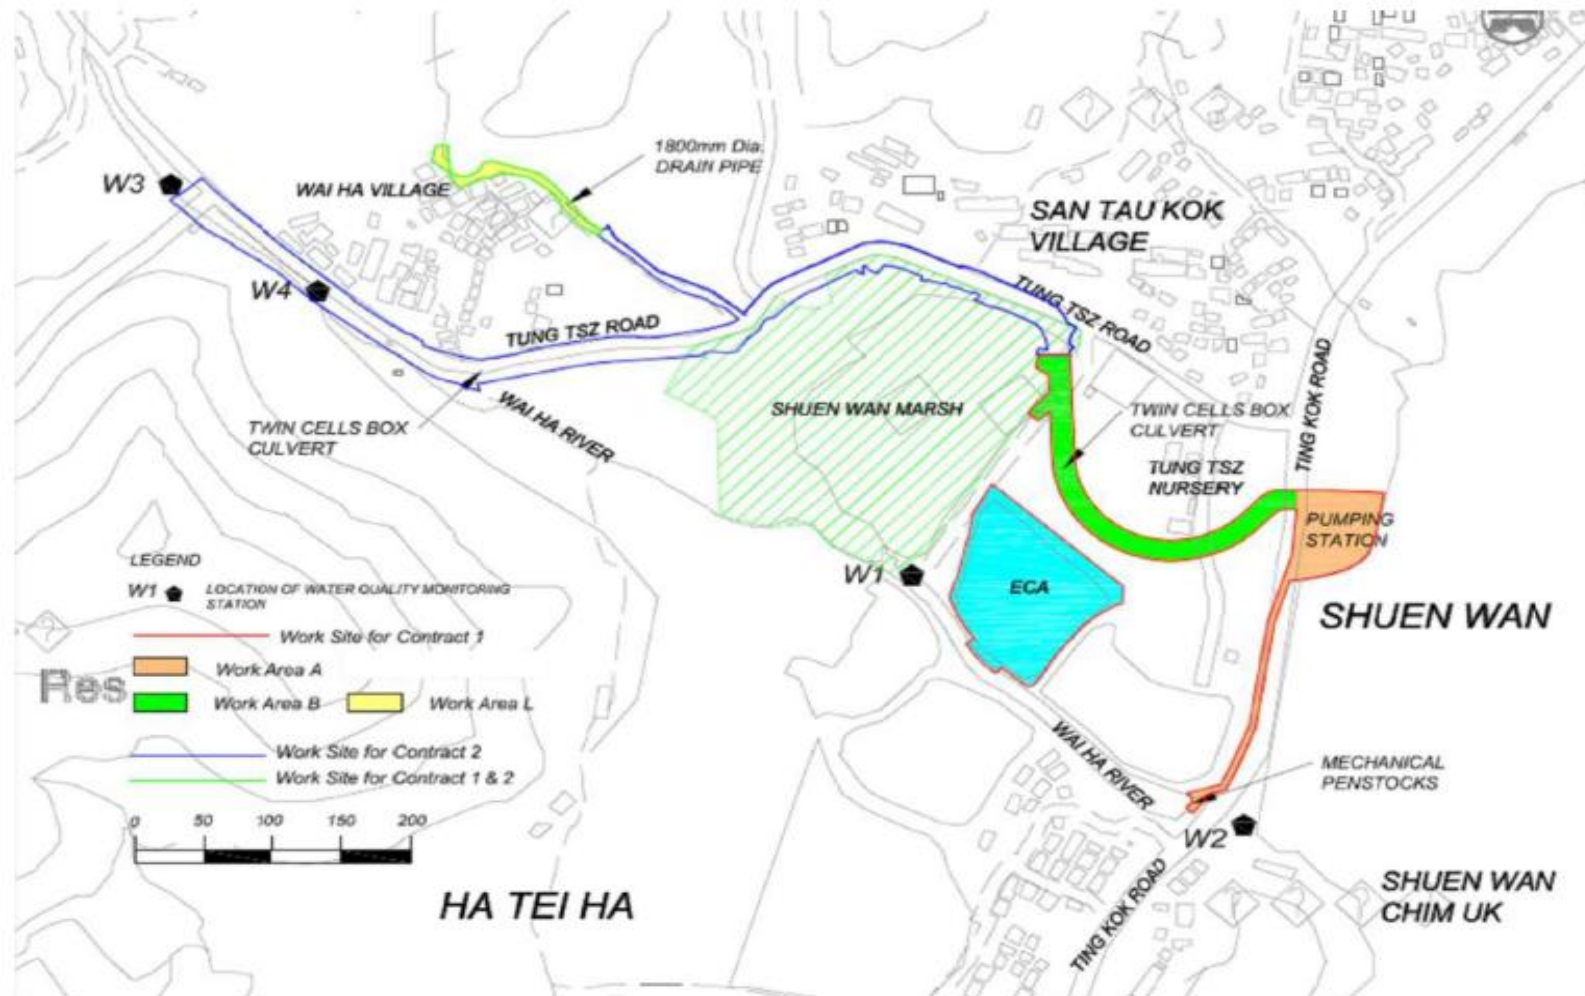
Figure 4.3.1 Water Quality Monitoring Locations

As the depth of water was less than 3m, water samples were collected at mid-depth of each proposed monitoring stations for measurements and sample collection.

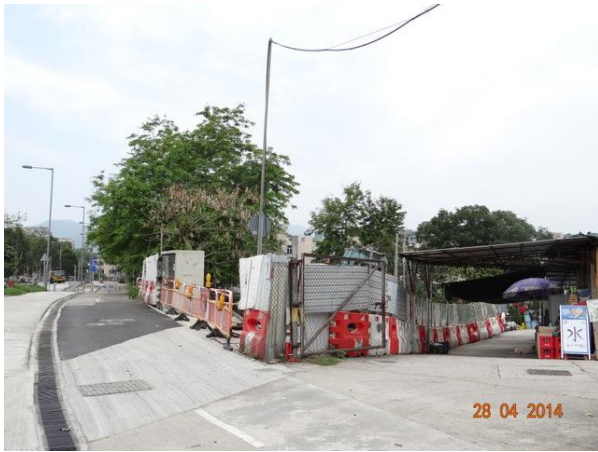
Temporary construction hoardings have been erected around Wai Ha River estuary since the building of an automatic mechanical penstock at the area (**Photo 1**). Since February 2014, the construction hoardings surrounding Area A (i.e. the proposed pump house station) have been replaced by the built boundary walls along the western and part of the northern sides of Area A (**Photo 2**), and chain-link fence erected along the rest of the boundary sides of Area A (**Photo 3**). Construction of the proposed roadside planters along

**Photo 1** – Temporary construction hoardings have been established around the works area at Wai Ha River estuary.

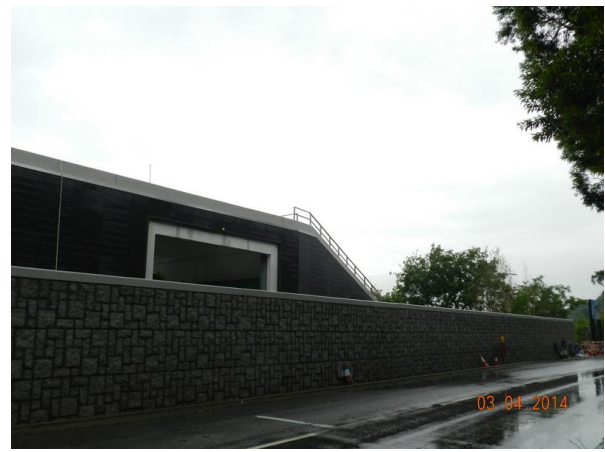
**Photo 2** – The proposed boundary wall along the western boundary of Area A.

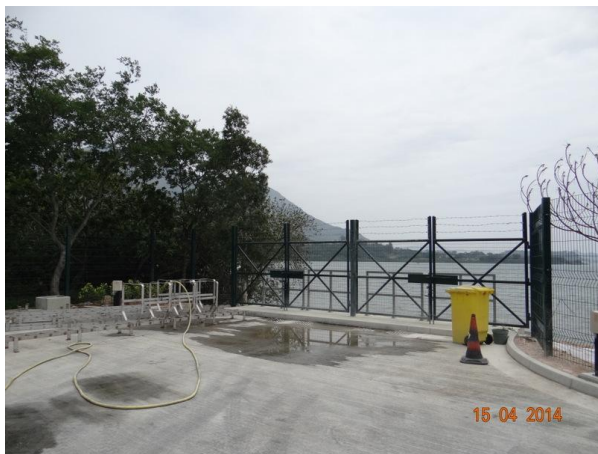
**Photo 3** – Proposed chain-link fence and gate along the eastern boundary of Area A.

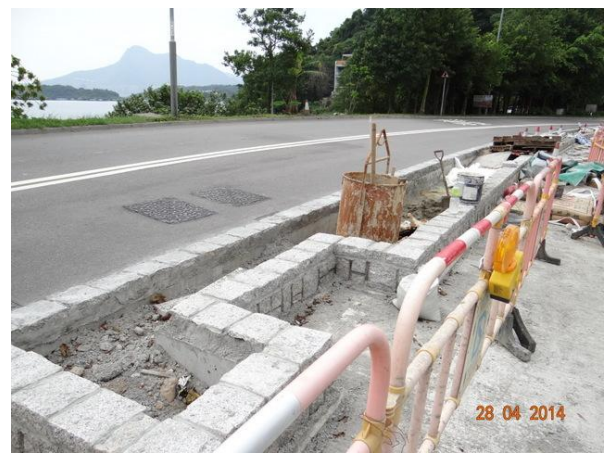
**Photo 4** – Construction of a roadside planter along Ting Kok Road.

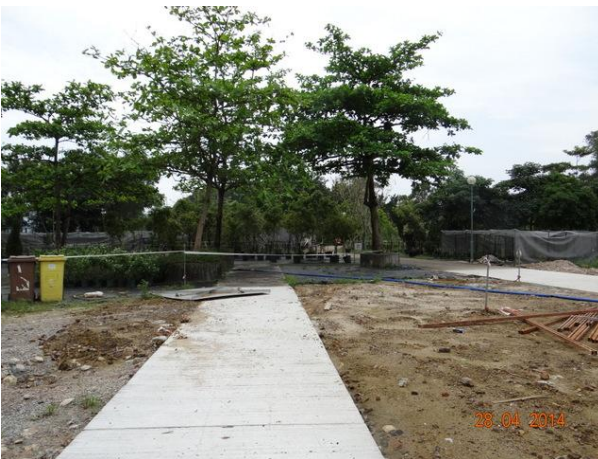
**Photo 5** – The reinstatement work in Phase 2 area of Area B was demarcated by barrier tape.

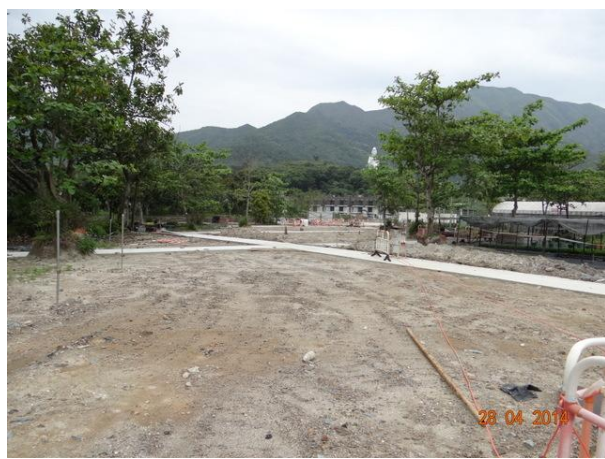
**Photo 6** – Phase 1 area of Area B was demarcated by loosened barrier tape.

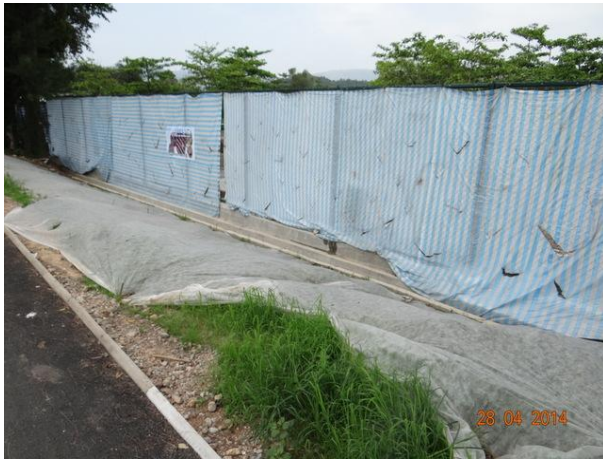
The temporary hoardings established for demarcating the construction site boundary of Phases 1 and 2 construction works area of Area B in Tung Tsz Nursery have been removed since January 2014. The reinstatement works in the nursery have been under progress and the areas were partly demarcated with loosened barrier tapes (**Photos 5-6**). The open section and other reinstated access path connecting between Phases 1 and 2 works areas have been maintained during the current reinstatement work period, providing an access path for the daily operation of the nursery. Since November 2013, the hoarding along the eastern boundary of Phase 2 in Area B (i.e. the section next to Ting Kok Road) was permanently reinstated with the original chain-link fence. Canvas sheets were put on the reinstated fence to screen off the existing construction site from the pedestrian path (**Photo 7**).

**Photo 7** – Chain-link fence was reinstated at the eastern end of Phase 2 works area and covered by canvas sheets. Grass germination was noted in the hydroseeded area applied next to the fence.

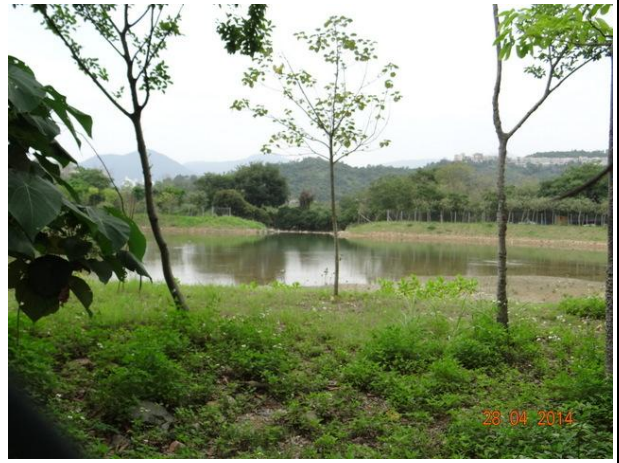
Area C was formally handed over to AFCD on 16<sup>th</sup> October 2012 for management and maintenance. The pond of the ECA has been connected to Wai Ha River directly as following the scheme design of Habitat Compensatory Plan. No direct discharge of turbid water into the adjacent Wai Ha River was observed through the fence of Tung Tsz Nursery (**Photo 8**).

**Photo 8** – No discharge of muddy water was observed in Area C.

The Contractor should regularly check the condition and locations of the drainage pipes and ensure that all used water should be appropriately filtered and discharged to the manholes/other discharge points agreed by the Engineer and EPD. This is to avoid any potential contamination to the vegetation in Shuen Wan marsh and other vegetated/marinated areas adjacent to the active works area.

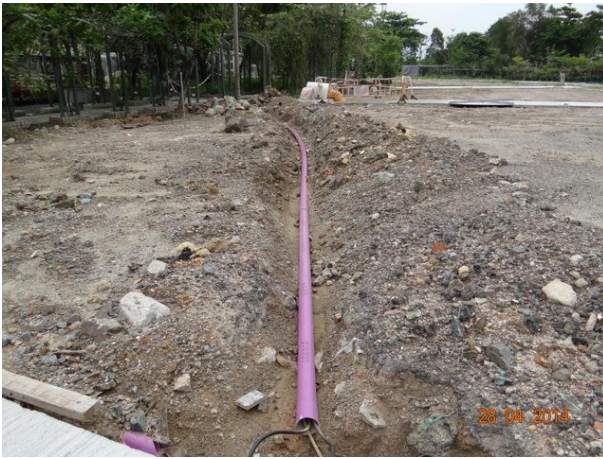
**Photo 9** – The reinstatement work for the basic nursery utility was still under progress in Phase 1 area of Area B.

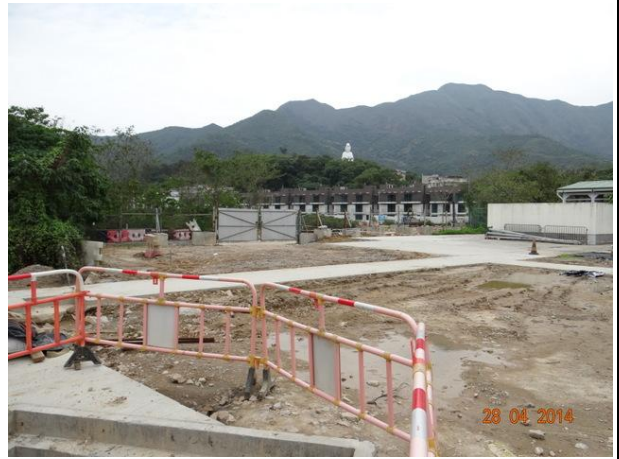
**Photo 10** – The reinstatement works for the ground of the nursery beds and basic nursery utility were still under progress in both Phases 1 and 2 areas in Area B.

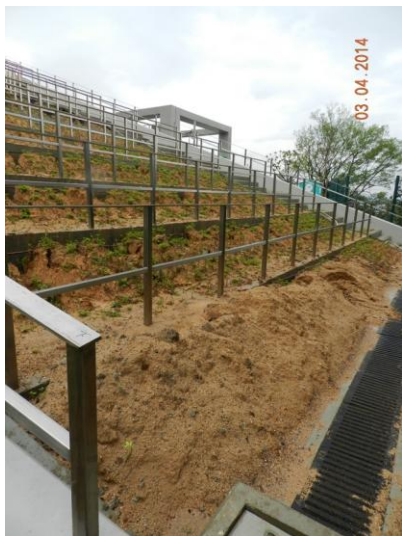
**Photo 11** – The soil was washed away from the planting area down to the bottom of the pumping house as observed on 3<sup>rd</sup> April 2014.

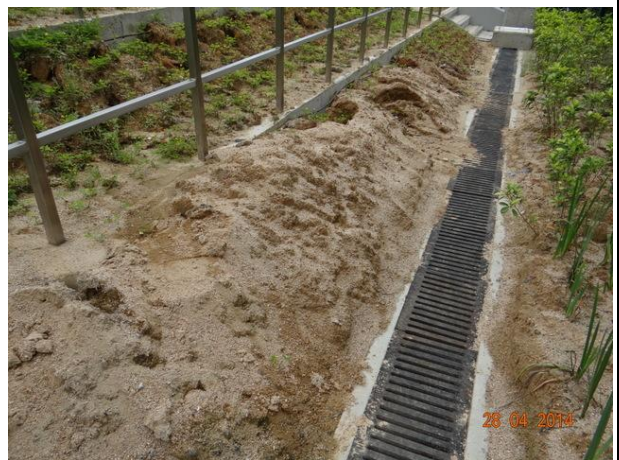
**Photo 12** – Some soil which was washed away from the slanting component of the pumping house was removed subsequently.

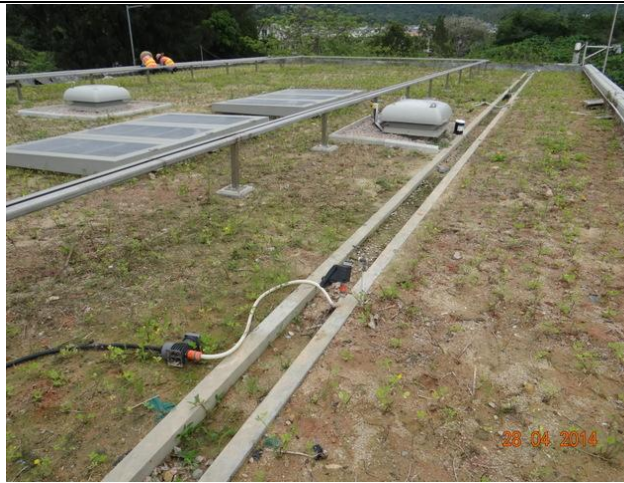
No significant damage caused by the severe weather was observed on the green roof of the pumping house (**Photo 13**), and other planted vegetation in Area A (such as *Ficus pumila* and *Parthenocissus dalzielii* on the ground for vertical greening, planted shrub *Ficus microcarpa* (Golden Leaf) and tree *Cinnamomum burmannii*) (**Photos 14-15**) in April 2014. However, some hydroseeded area may be affected as the sprayed grass seeds may be washed out by the heavy storm.

**Photo 13** – No significant damage was observed on the rooftop of the pumping house.

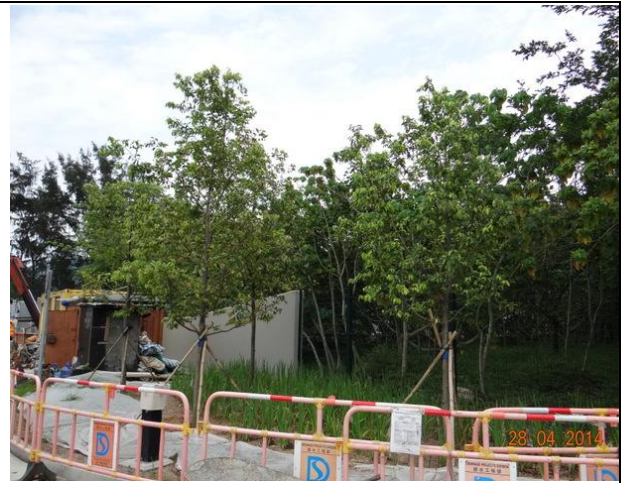
The relocated tree E38 (*Melaleuca cajuputi* subsp. *cumingiana*) was found dead after its relocation in August 2013, and it was removed by the Contractor in November 2013 (reported in *Monthly EM&A Report for November 2013*). A planter was built at the same location in accordance with the approved Landscape Plan. The four newly planted *Cinnamomum burmannii* appeared in fair condition (**Photo 14**).

**Photo 14** – The planted trees *Cinnamomum burmannii* and ground cover *Iris tectorum* were not influenced by severe weather.

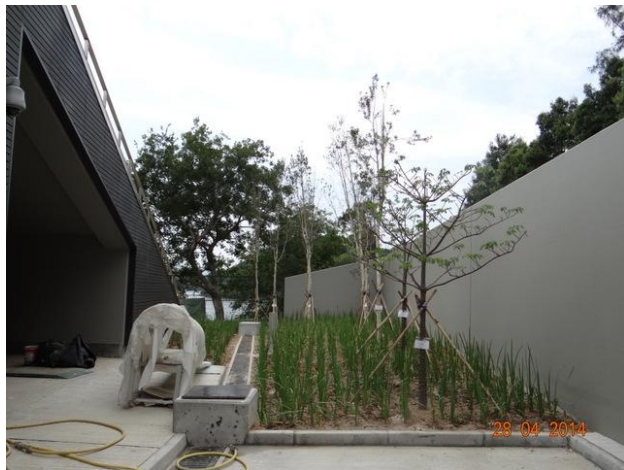
**Photo 15** – The planted trees and ground cover were protected within the built planting area and the vegetation was not influenced by severe weather.

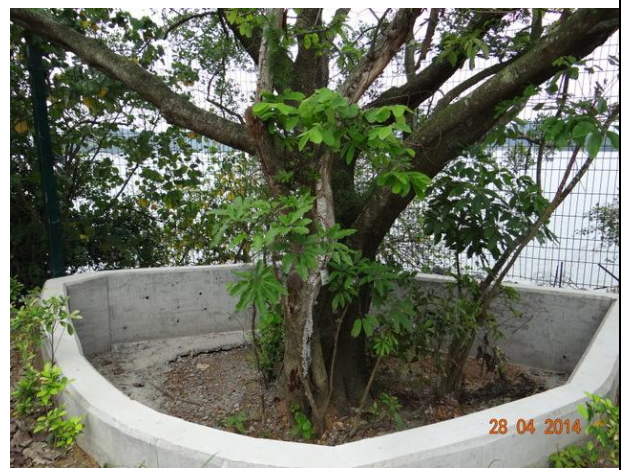
As observed in April 2014, the existing retained, relocated and compensatory trees in Area A were generally protected within the built planting areas or fenced outside the boundary fence (**Photo 16**). In addition, some sections of the newly established chain-link fence were cut to facilitate the growth of large scaffold branch of E44 (**Photo 17**).

**Photo 16** – Example of built planting area to protect the retained trees (T263 and E63).

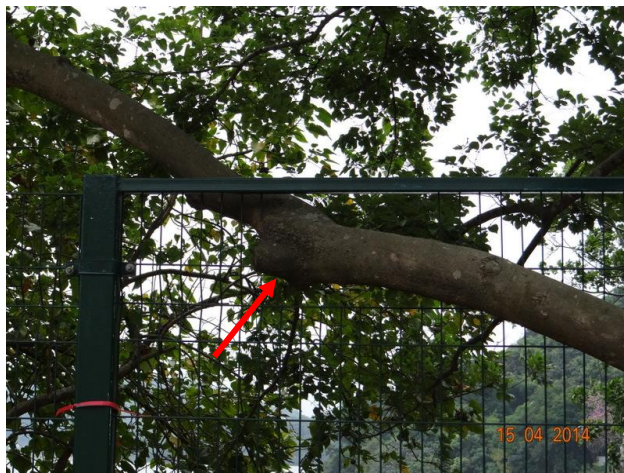
**Photo 17** – Example of cut chain-link fence to facilitate the growth of a large scaffold branch of E44.

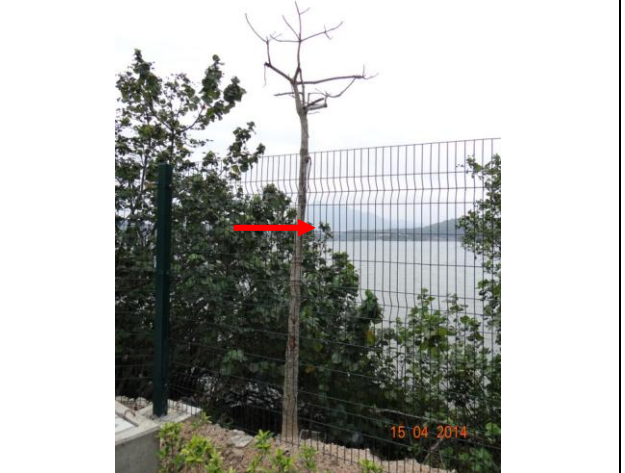
The tree to be transplanted E16 (*Bombax ceiba*) was relocated to the southern side of Area A next to the site hoarding in July 2012. The tree was still in marginally fair condition in April 2014 (**Photo 18**) and it was separated outside the proposed chain-link fence along the boundary sides of Area A. Soil grade change was observed around the trunk base and minor exposed roots were found in January 2014. The stability of the tree may be affected. Though this tree is fenced outside the chain-link fence, the condition and stability of this tree should be regularly monitored.

**Photo 18** – The relocated E16 was in marginally fair condition and separated outside the chain-link fence.

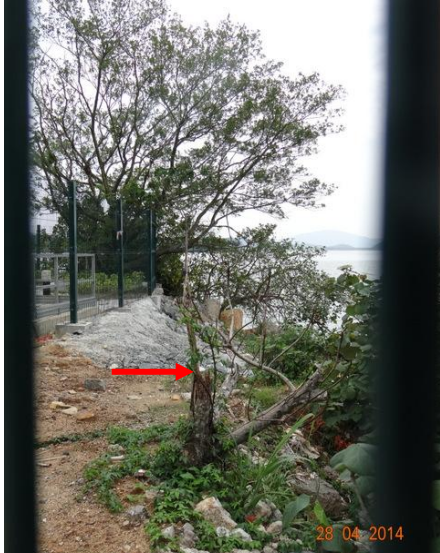
Damaged tree trunk on E55 (*Macaranga tanarius* var. *tomentosa*) has been reported in the submitted *Monthly EM&A Reports* since May 2013. The wound on the trunk of E55 has been burlapped since May 2013. The upper section of the tree trunk was broken in June 2013. The tree was still in very poor condition with most of its foliage as dry watersprouts only and it was separated outside the proposed chain-link fence along the boundary sides of Area A in March 2014 (**Photo 19**).

**Photo 19** – The burlapped tree E55 was still in poor condition and it was separated outside the chain-link fence of Area A.

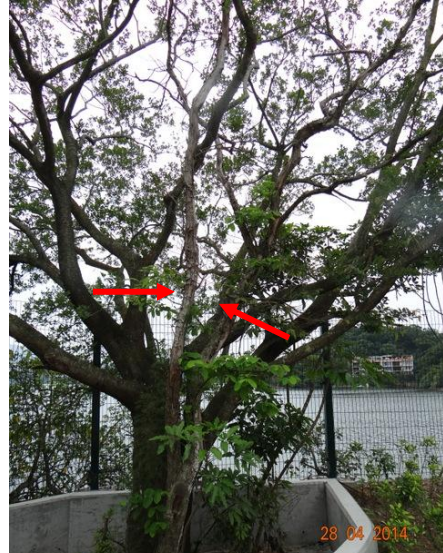
A retained tree T253 (*Bridelia tomentosa*) was in poor condition (**Photo 20**). Dead scaffold limbs with dry, peeled bark were observed. This identified tree defect may be only related to the intrinsic physiological and structural condition of T253. The tree was closely monitored in April 2014.

**Photo 20** – The retained tree T253 was in poor condition and the dead scaffold limbs (as indicated) were still observed.

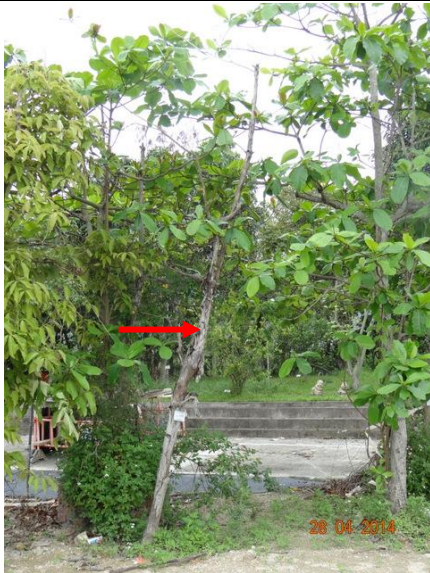
**Photo 21** – Dead tree U37.

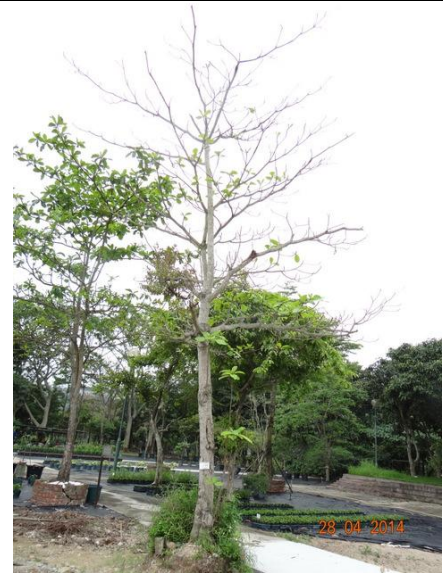
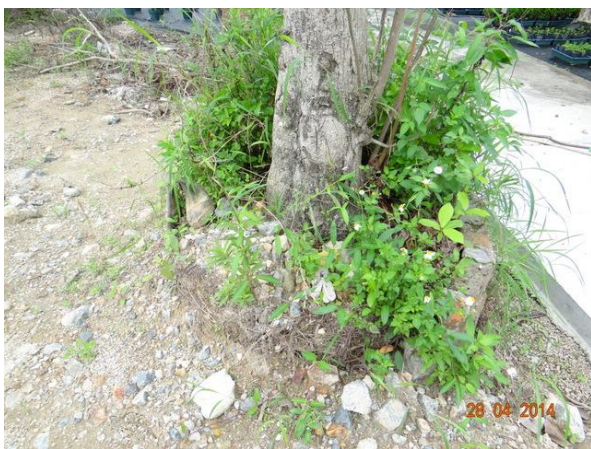
Half of the planter of U47 (*Terminalia catappa*) has been broken since August 2013, and some of its roots and planter soil were exposed in the air. As inspected in April 2014, the planter was still not yet repaired (**Photos 22-23**). The condition and stability of this tree was closely monitored. In addition to U47, the planters of U54 (*Terminalia catappa*) and another two untagged *Terminalia catappa* to the southeast of U54 (**Photos 24-26**), as well as the relocated tree U69 (*Alstonia scholaris*) were also broken and not yet repaired (**Photo 27**). Exposed roots and planter soil were observed. Leaning tree trunk was also observed on U69, probably due to the lack of intact planting soil to be supported within the broken planter. On the other hand, excavated soil was still piled around the planter and on the root flare of U51 (*Terminalia catappa*) (**Photo 28**).

**Photo 22** – The planter of U47 was broken.

**Photo 23** – Close-up view of the broken planter of U47.

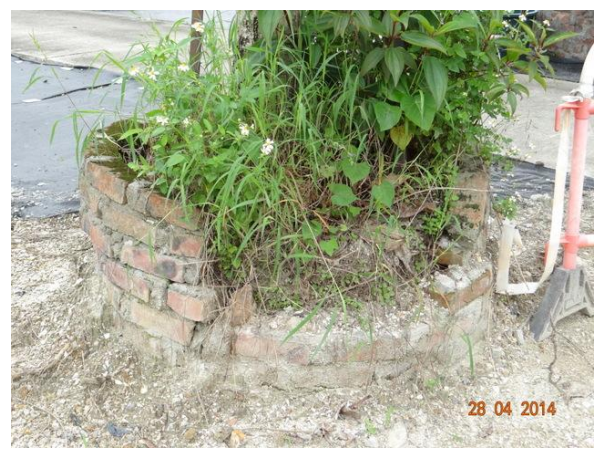
**Photo 24** – The planter of U54 was broken and the exposed roots and soil were observed.

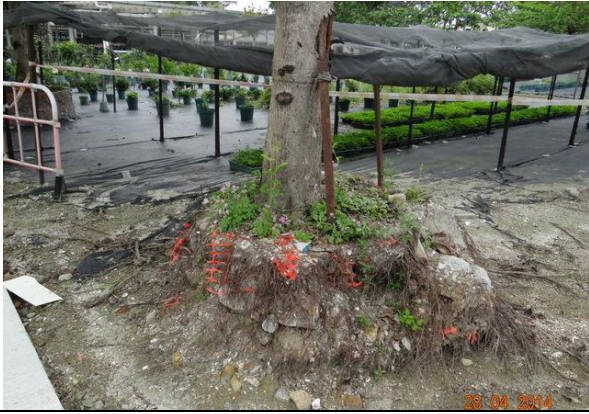
**Photo 25** – The planter of an untagged *Terminalia catappa* next to U54 was broken, with exposed roots and soil.

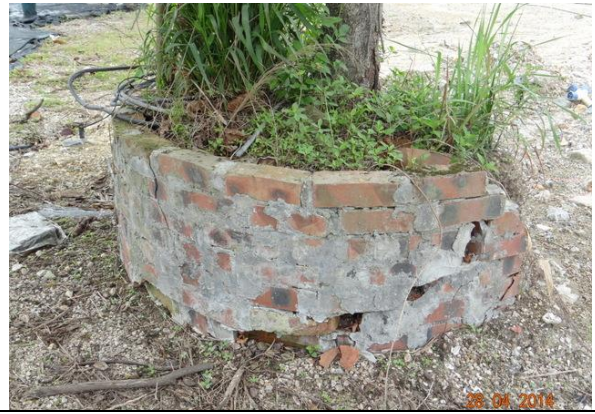
**Photo 26** – The planter of another untagged *Terminalia catappa* next to U54 was broken, with exposed roots and soil.

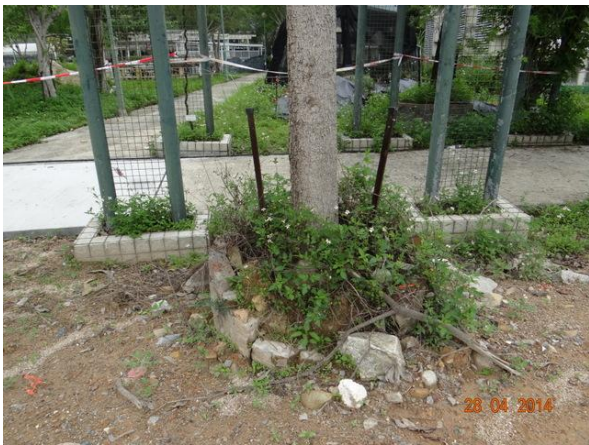
**Photo 27** – The planter of U69 was broken and the exposed roots and soil were observed.

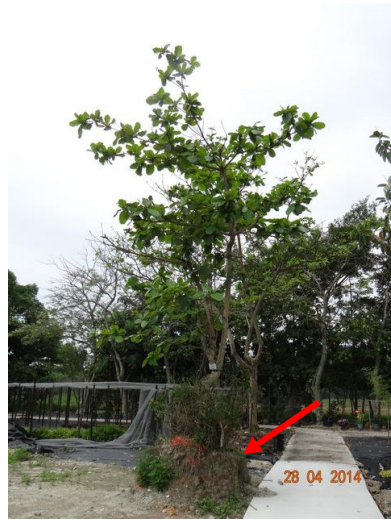
**Photo 28** – The piled soil around the planter and on the root flare of U51 was not yet removed.

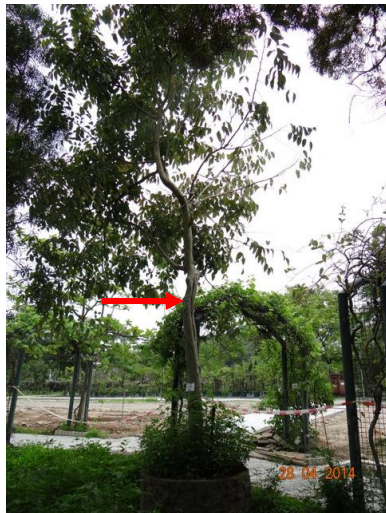
Sign of suspected termite infestation was observed at the lower trunk of the retained tree U67 (*Cassia fistula*). The tree was still in fair health and structural condition as observed in April 2014 (**Photo 29**), but close monitoring should be undertaken.

**Photo 29** – Sign of suspected termite infestation was observed at the lower trunk of U67 and the tree was still in fair condition in April 2014.

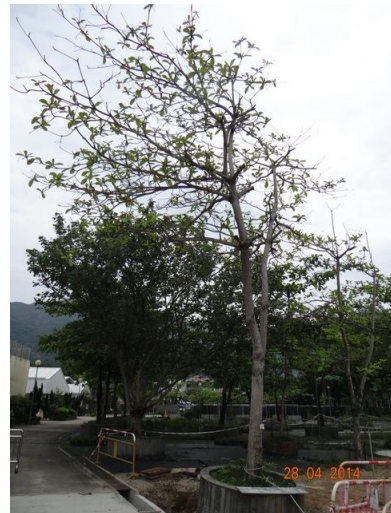
**Photo 30** – The condition of the retained tree A40 was in fair condition only, with the risk of leaning tree trunk.

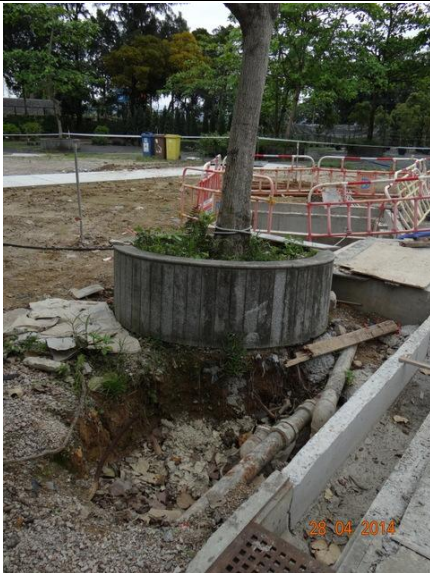
areas, the southern excavated area was refilled but the northern excavated area close to its planter has not yet backfilled with soil, and some of the tree roots growing underneath the tree planter are still under a risk of being damaged by any future minor civil works (**Photos 30-31**). The tree trunk was not guyed to the nearby tree planter as observed in April 2014. The tree may have a risk of leaning if its underground roots are further damaged or the ground is not backfilled soon.

**Photo 31** – The northern excavated area close to the planter of the retained tree A40 was not yet refilled.

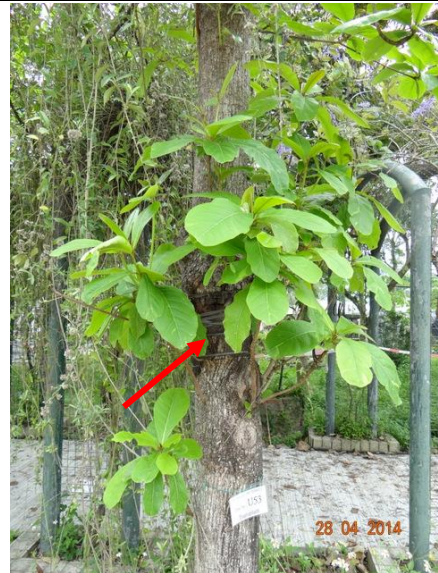
**Photo 32** – Close-up view of the hessian wrapping and tied string (as indicated) on the trunk of U53. The wrapping was not yet removed.

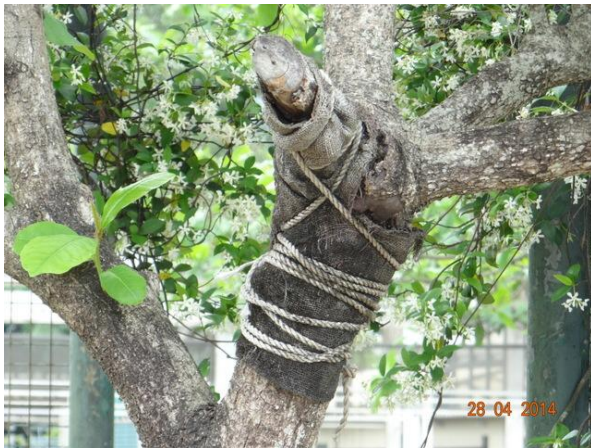
**Photo 33** – Hessian wrapping was found on the scaffold limb of the relocated tree A22.
