PROJECT NO.: TCS/00553/11

**CONTRACT NO. DC/2010/02 –
DRAINAGE IMPROVEMENT IN SHUEN WAN AND
SHEK WU WAI**

**MONTHLY ENVIRONMENTAL MONITORING AND
AUDIT REPORT (NO.34) – APRIL 2014**

PREPARED FOR
KWAN LEE-KULY JOINT VENTURE

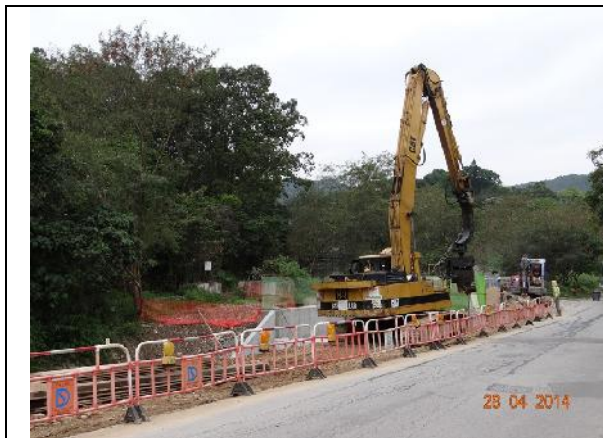
Photo 1 – Temporary hoardings have been erected along Tung Tsz Road opposite to Wai Ha.

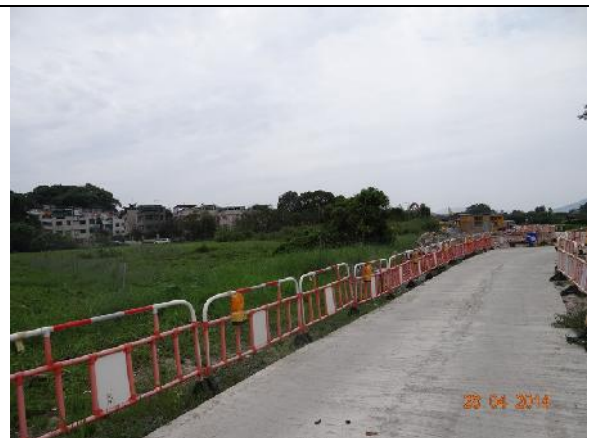
Photo 2 – Temporary hoardings have been erected along the access road from Tung Tsz Road to Treasure Spot Garden II.

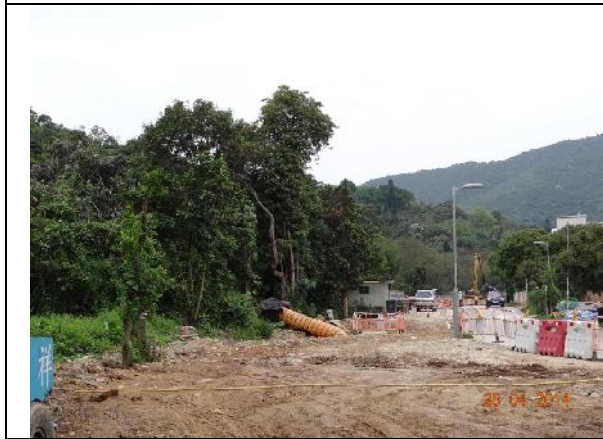
Photo 3 – Construction works for building the box culverts along Tung Tsz Road opposite to Wai Ha outside the public toilet.

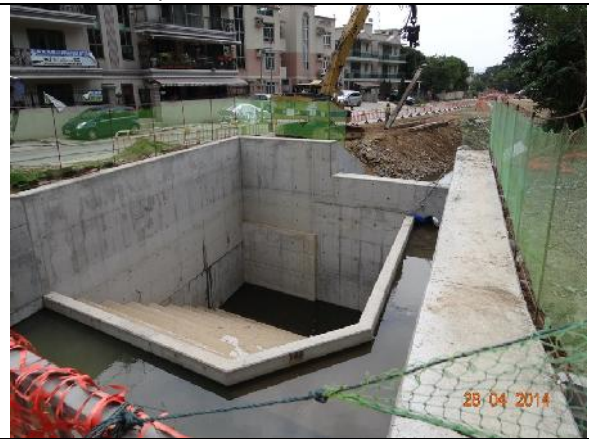
Photo 4 – Construction works continued next to Wai Ha River.

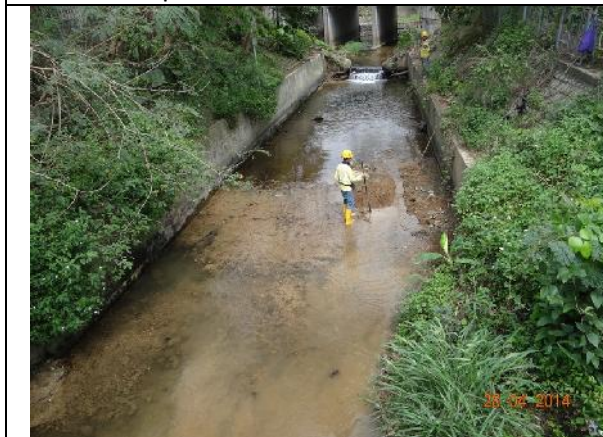
Photo 5 – The sand bags used to divide the river were removed and the worker removed the sediment washed away from the upper stream.

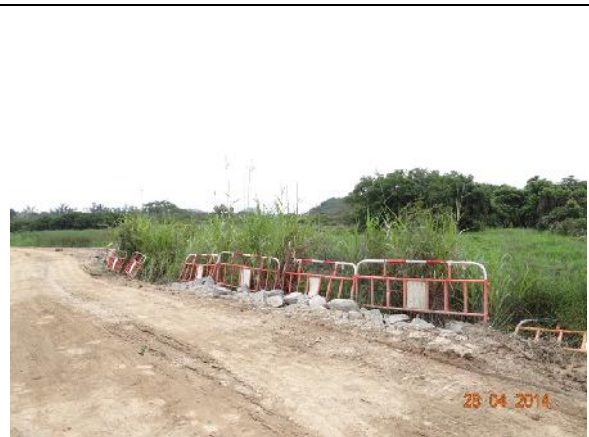
Photo 6 – Temporary construction barriers surrounded the eastern side of the wetland rehabilitation area.

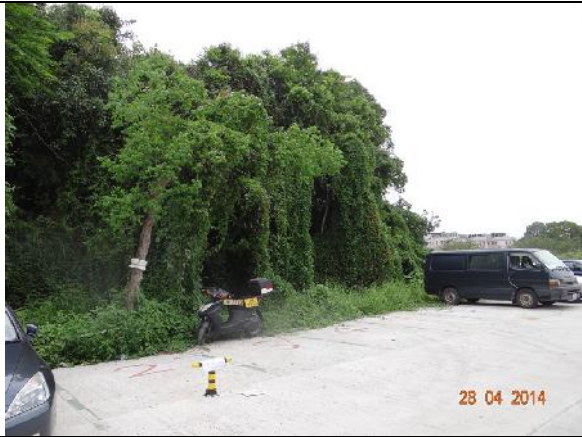
<p>Photo 7 – Temporary parking area was still maintained at the end of the access path to Treasure Spot Garden Phase II.</p>	<p>Photo 8 – The untagged tree (Red arrow) was guyed at the edge of the parking area within a Tree Protection Zone demarcated by orange construction nets (Blue arrow).</p>

- 3.2.12 No specific recommendation is required. However, with regard to the previous dumping incident by other parties on the Taro field near the Treasure Spot Garden, the Contractor is recommended to check the site condition regularly to avoid any extent of dumping or paving of area within the project boundary.
- 3.2.13 The Contractor should also make sure there are no piled rocks, construction materials or programmed construction works influencing the existing trees within the Project Area or the wetland rehabilitation area. Otherwise, the Contractor should request the on-site workers to remove those piled rocks or construction materials. As a reminder, the Contractor should keep all construction works within the Project Boundary.
- 3.2.14 The Contractor could establish a warning sign to remind the driver to beware of the presence of the tree(s) close to the temporary parking area.

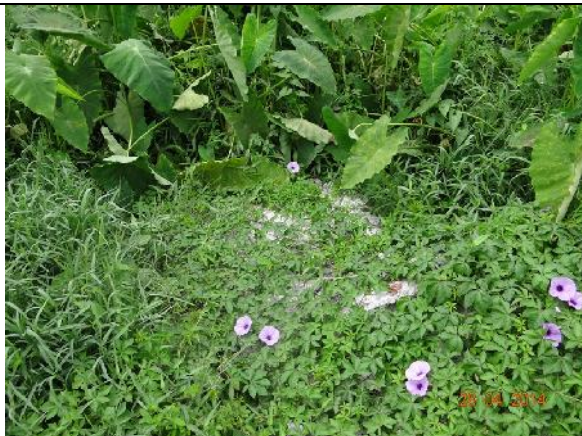
- 3.2.7 As reported in the previous *Monthly EM&A Reports*, dumping on the Taro field located along the path towards the Treasure Spot Garden was observed and a paved area created for parking next to the retained tree groups (T088 – T091) has been found since November 2012. In October 2013, the path to Treasure Spot Garden II was expanded towards the Taro field due to the reprovision of vehicular access road to the villagers during the works at the entrance of the Treasure Spot Garden. Cement mortar discharged to the Taro field was observed in March 2014 and such as was covered by ground vegetation (**Photo 9**).

<p>Photo 9 – Cement mortar was discharged to the Taro field next to the access road from Tung Tsz Road to Treasure Spot Garden II. This area was covered by ground vegetation as observed in April 2014.</p>	<p>Photo 10 – Works were observed at the end of the Treasure Spot Garden II near the retained tree T103 and the works area was surrounded by temporary construction barriers and chain-link fence.</p>

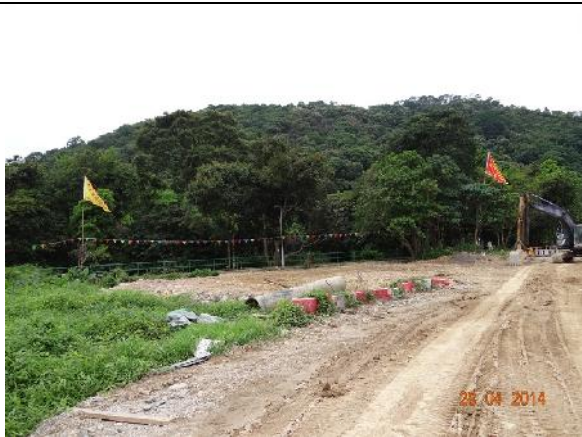
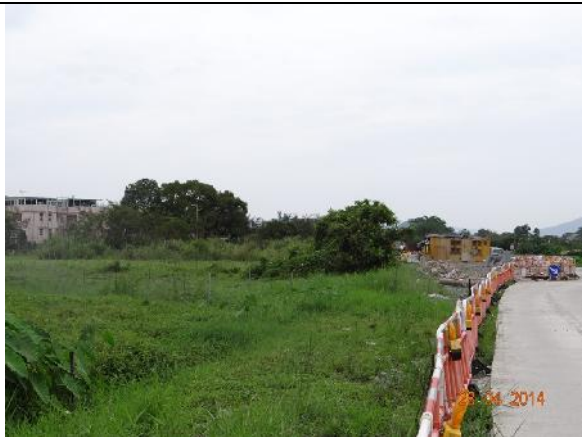
- 3.2.9 The works area near the previous collapsed tree T190 (*Ficus hispida*) was found to be expanded to the grassland on the south in January 2014. Most of the construction materials stored in this area were removed in April 2014 (**Photo 11**).

<p>Photo 11 –The construction materials stored on the works area near the location of the previously removed tree T190 (<i>Ficus hispida</i>) were removed.</p>	<p>Photo 12 – A fenced area was seen on the field next to the construction site along the access to Treasure Spot Garden in March 2014. The area was still surrounded by chain-link fence by an unknown party.</p>

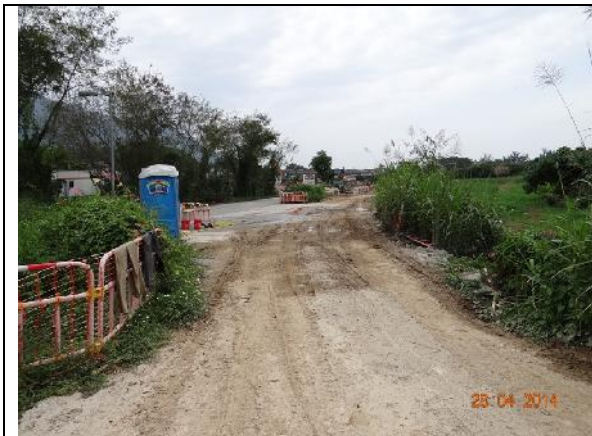
Photo 13 – One exit point was seen opposite to the tree group T021-029 (*Leucaena leucocephala*).

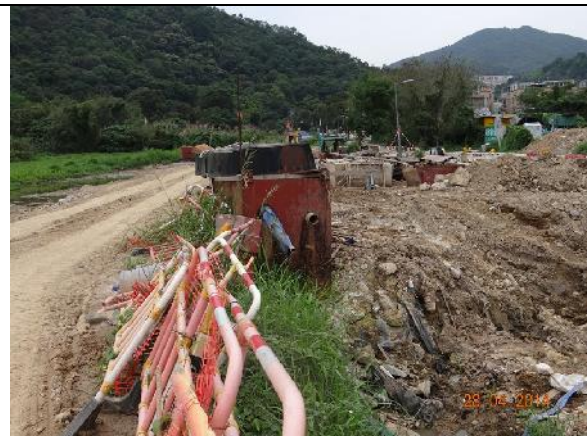
3.3.3 A sedimentation tank near the location of the previously removed tree T196 (*Macaranga tanarius* var. *tomentosa*) has not been in use since March 2014. As observed, the nearby construction works were about to be finished and hence no more wastewater from the works area was discharged (**Photo 14**).

3.4.2 As mentioned in Section 3.3, a sedimentation tank near the location of the removed tree T196 (*Macaranga tanarius* var. *tomentosa*) has not been in use since March 2014. As observed, the nearby construction works were about to be finished and hence no more wastewater from the works area was discharged (**Photo 14**).

Photo 14 – A sedimentation tank was not in used.

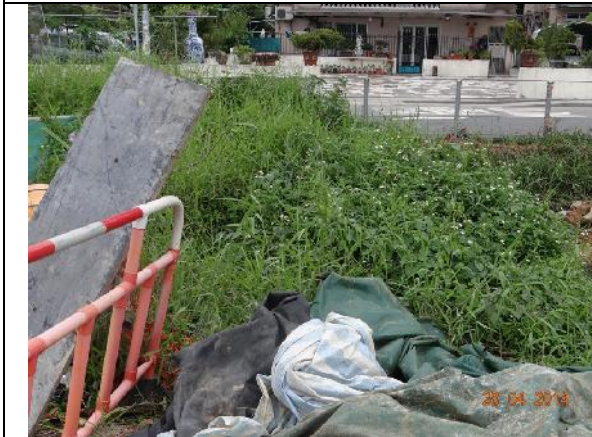
Photo 15 – Abandoned sedimentation bed aligned from the area opposite to the Jade View Villa towards the marsh area at southeast. This bed was overgrown by dense grassy vegetation.

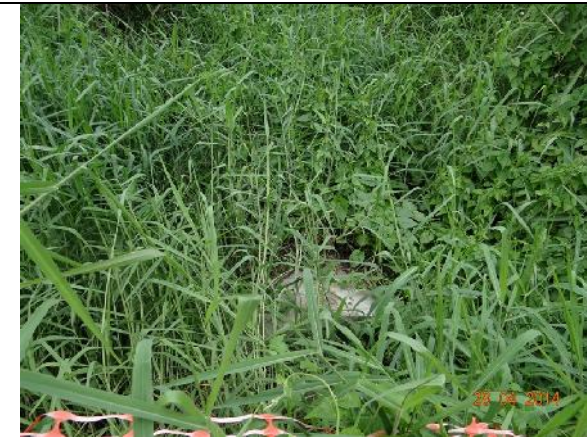
Photo 16 – Abandoned and overgrown sedimentation bed aligned from the area opposite to the eastern part of Jade View Villa towards the marsh area.

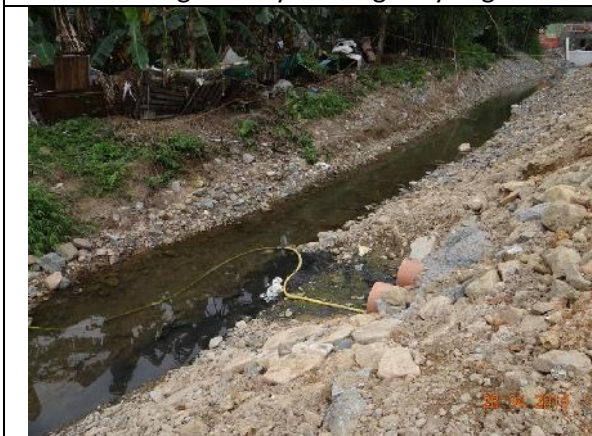
Photo 17 – The river water was noted clear near tree group T119-122.

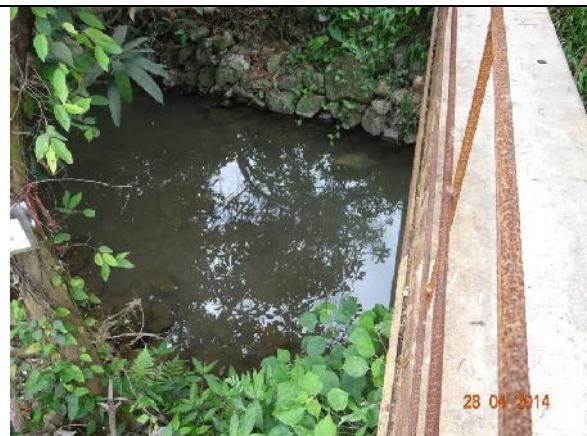
3.3.5 As mentioned above, construction works have been resumed along Wai Ha River. Since February 2014, no more muddy water has been released from the works area as the construction works at the upper stream was almost finished. The river water generally noted clear (**Photos 17-19**). Down the stream near the public toilet, no more litter and broken branches from the adjacent trees were found blocking the stream (**Photo 18**).

3.4.4 Construction works have been resumed along Wai Ha River. Since February 2014, no more muddy water has been released from the works area as the construction works at the upper stream was almost finished. The river water generally noted clear (**Photos 17-19**). Down the stream near the public toilet, no more litter and broken branches from the adjacent trees were found blocking the stream (**Photo 18**).

Photo 18 – Down the stream near the public toilet, the water was noted clear and free of any blockage from litter and broken branches.

3.3.8 The Contractor should have *ad hoc* inspection and emergency measures for any accidental spillage of polluted fluid, contaminants or grease from the construction sites. To prevent the impact of the unclear discharge on the nearby vegetated area, it is suggested to overlay PVC liners along the site edge and remove any surplus sand and gravels deposited in the beds and tank even some parts of the construction works may be completed at this stage. The Contractor is also suggested to remove the broken branches in the stream so as to prevent their blockage of the stream flow and trapping greasy substances in the stream.

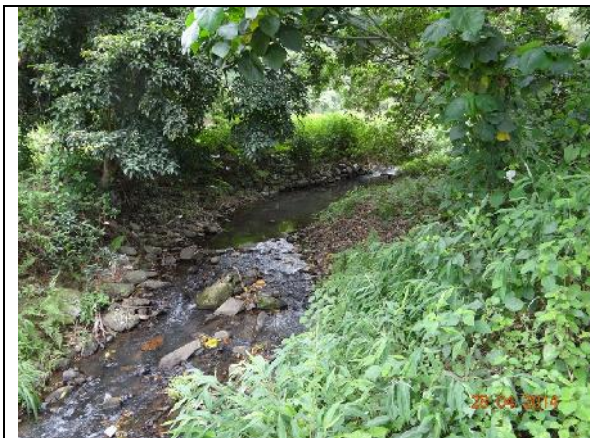
Photo 19 – The water was still noted clear at the lower stream.

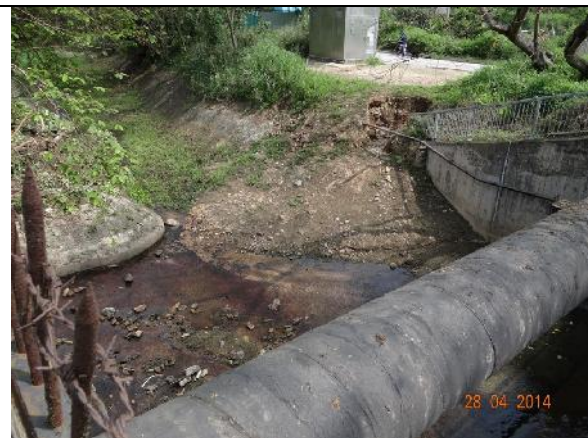
3.4.6 No direct water discharge into the upper stream of Wai Ha River was observed as the active construction works have been concentrated at the lower end of Wai Ha River to the southeast of Tung Tsz Shan Road (**Photo 20**).

Photo 20 – No direct water discharge into the upper stream of Wai Ha River was observed as the construction works have been concentrated at the lower end of the river.

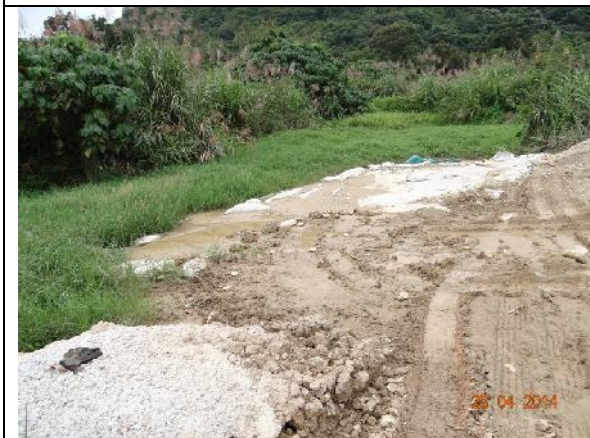
3.4.7 Cement mortar was found spraying along the southern boundary edge close to the wetland rehabilitation habitat in February 2014. The cement mortar has been removed and the area has been covered by a mat since mid-March 2014 (**Photo 21**).

Photo 21 – Cement mortar along the southern boundary edge close to the wetland rehabilitation habitat was removed and the area was covered by a mat.

3.4.11 The Contractor should have *ad hoc* inspection and emergency measures for any accidental spillage of polluted fluid, contaminants or grease from the construction sites. It is also recommended to overlay PVC liners along the site edge and remove any surplus sand and gravels deposited in the beds and tank so as to prevent the impact of the unclear discharge on the nearby vegetated area. Moreover, the Contractor should restrict and control the works areas where cement mortar has to be applied, and avoid spraying the cement mortar and chemical fluids on vegetation and waterbody.

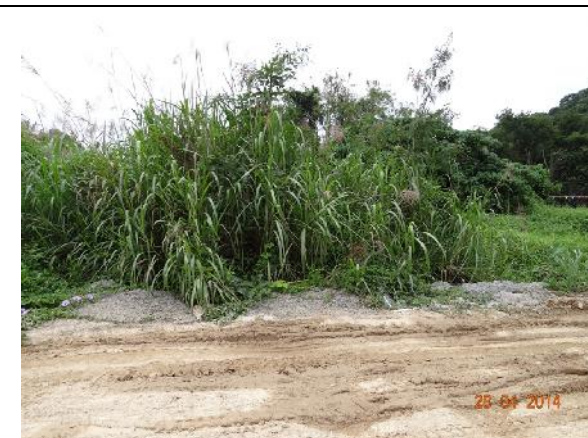
3.4.8 As observed in April 2014, cement mortar was discharged and construction materials were dumped next to the rehabilitation wetland nearby the exit point and opposite to the tree group T021-029 (**Photos 22-23**).

Photo 22 – Cement mortar was discharged next to the rehabilitation wetland near the exit point opposite to the tree group T021-029

3.4.10 The Contractor should prevent any contaminants and sediments from entering the sensitive water-based habitats (i.e. Shuen Wan marsh and Wai Ha River) and implement pollution control measures to minimize any adverse environmental impacts to the water body. The Contractor should maintain appropriate sedimentation beds and/or tanks throughout the construction phase. The Contractor should adopt a good site practice in maintaining appropriate sedimentation beds and filtration tanks as recommended in the above Section for Contaminant/ Sediment Control. Muddy water pumped from the works area should be filtered appropriately through sedimentation beds or other filtration system prior to the discharge.

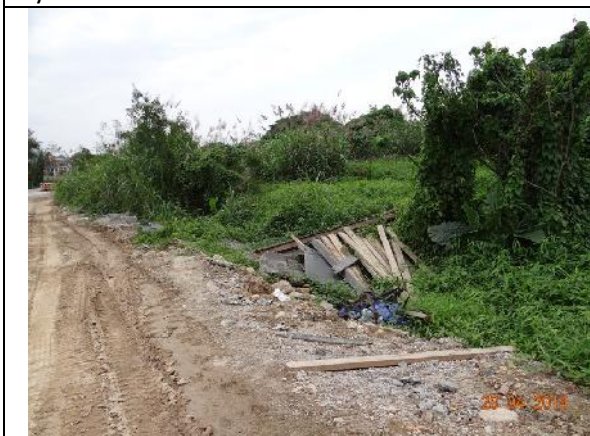
Photo 23 – Construction materials were dumped next to the rehabilitation wetland near the exit point opposite to the tree group T021-029

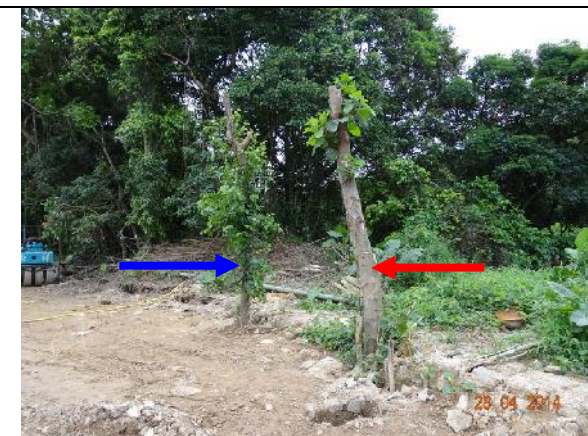
Photo 24 – Topped T167 (Red arrow) and T168 (Blue arrow) were in poor health condition with some developed watersprouts. Excavated soil was noted piling around the trunk flare.

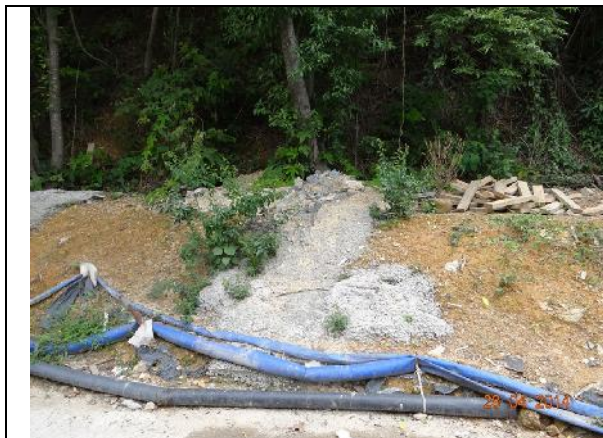
Photo 25 – Storage of construction materials and sand piling was noted close to the trunk flares and trunk of T093. Cement mortar was also noted on the soil surface close to T093.

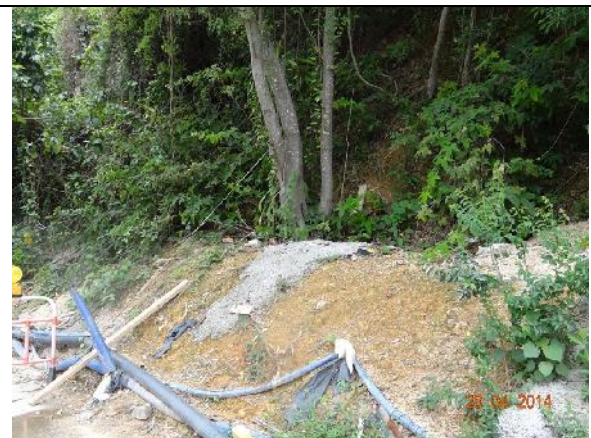
Photo 26 – Storage of construction materials and sand piling was noted close to the trunk flares and trunk of T094. Cement mortar was also noted on the soil surface close to T094.

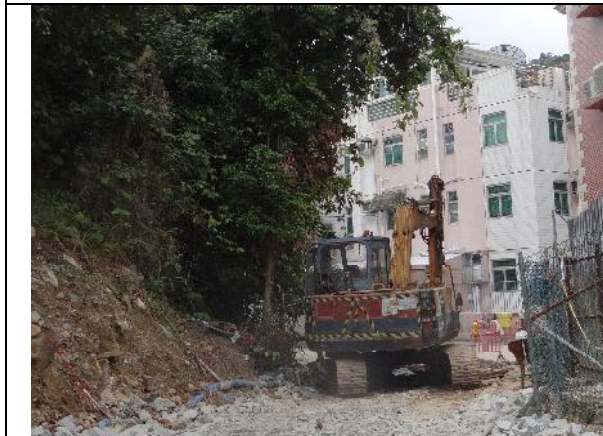
Photo 27 – Excavated soil and rocks and construction materials were noted piling close to the trunk base of the retained tree T103.

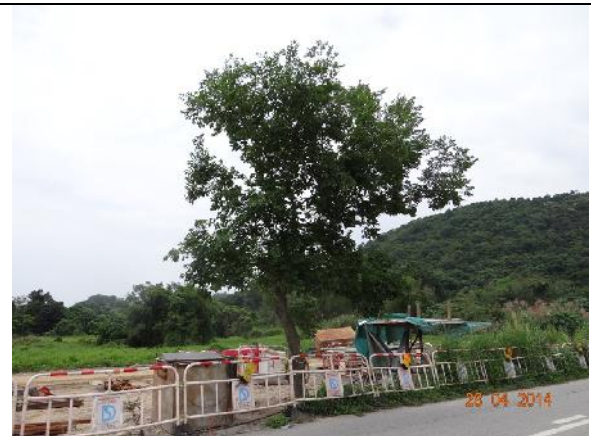
Photo 28 – The retained tree T025 was temporarily guyed to provide additional support to this tree.

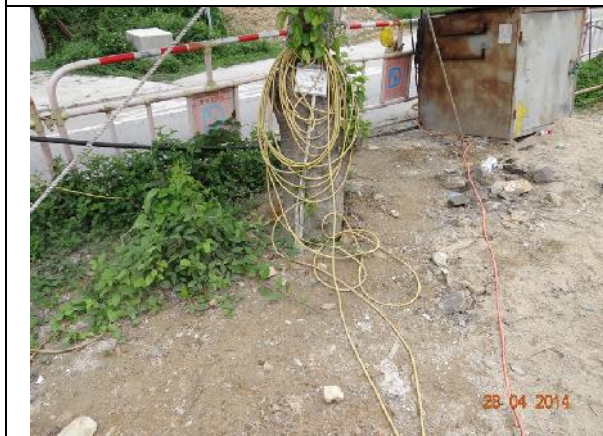
Photo 29 – Excessive soil were still piled close to the root flare of T025.

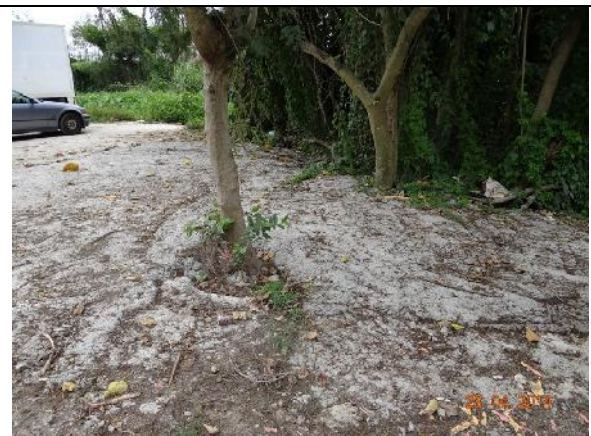
Photo 30 – Concrete pavement was observed close to the root flare of the tree group T089-091.

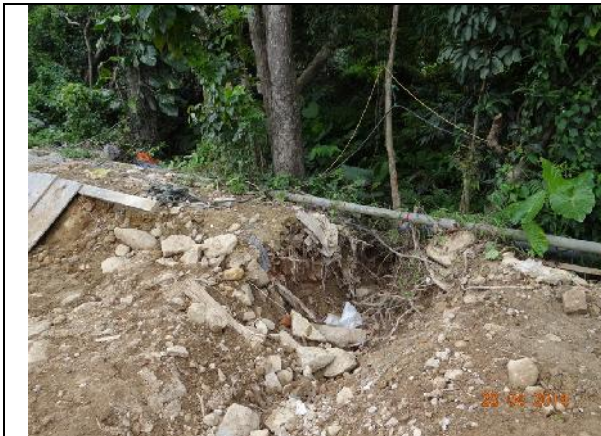
Photo 31 – Excavation work was noted between T153 and T155 and severe exposed roots were noted on these two trees.

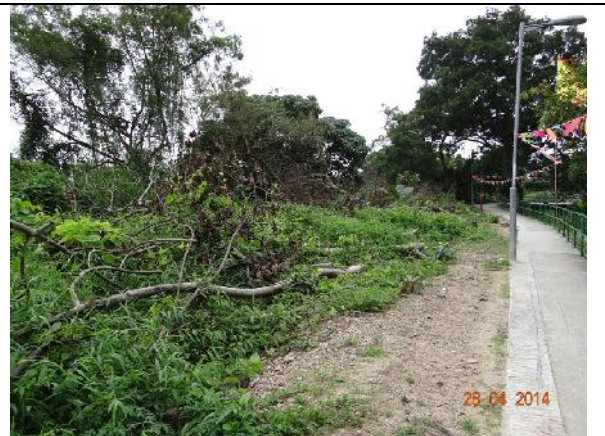
Photo 32 – More trees outside the major work area along the road leading to the Shuen Wan Tin Hau Temple were found felled in April 2014.

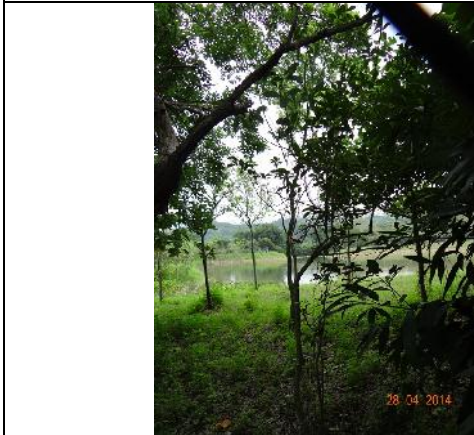
Photo 33 – The transplanted shrub of *Pavetta hongkongensis* (PH01) in Area C under Contract 1 has remained in satisfactory condition.

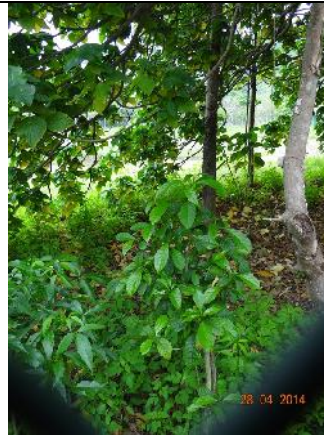
Photo 34 – The transplanted shrub of *Pavetta hongkongensis* (PH03) in Area C under Contract 1 has remained in satisfactory condition.
