Monthly Environmental Monitoring & Auditing report for

Contract No.DC/2009/22

Drainage Improvement in Shuen Wan, Tai Po – Contract 1

May 2014

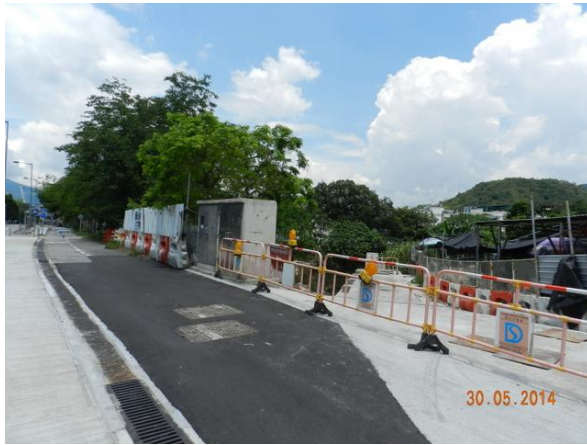
Temporary construction hoardings have been erected around Wai Ha River estuary since the building of an automatic mechanical penstock at the area (**Photo 1**). Since February 2014, the construction hoardings surrounding Area A (i.e. the proposed pump house station) have been replaced by the built boundary walls along the western and part of the northern sides of Area A (**Photo 2**), and chain-link fence erected along the rest of the boundary sides of Area A (**Photo 3**). As observed on 30th May 2014, all the planting

Photo 1 – Temporary construction hoardings have been established around the works area at Wai Ha River estuary.

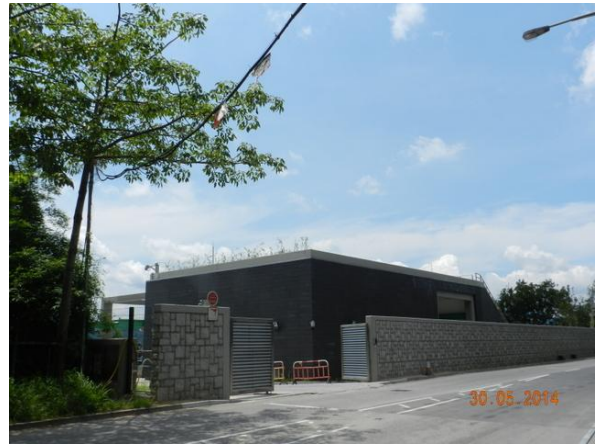
Photo 2 – The proposed boundary wall along the western boundary of Area A.

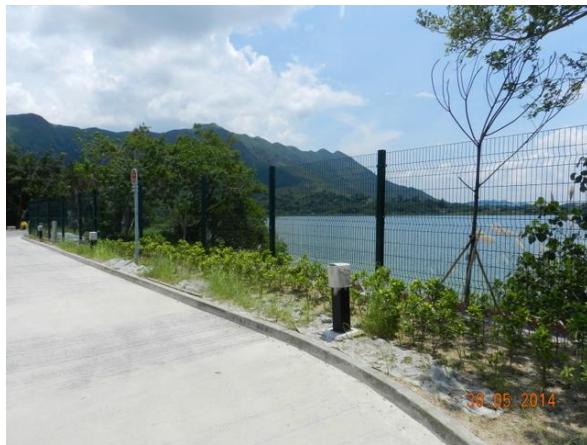
Photo 3 – Proposed chain-link fence and gate along the eastern boundary of Area A.

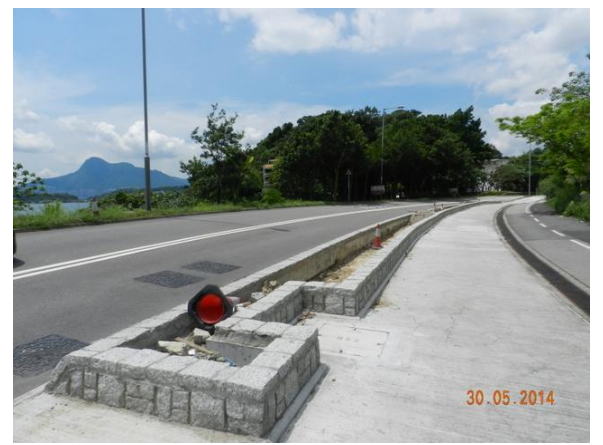
Construction of the proposed roadside planters along Ting Kok Road has commenced in March 2014. The temporary construction barriers erected around the built planters were removed as observed on 30th May 2014 (**Photo 4**).

Photo 4 – Construction of a roadside planter along Ting Kok Road.

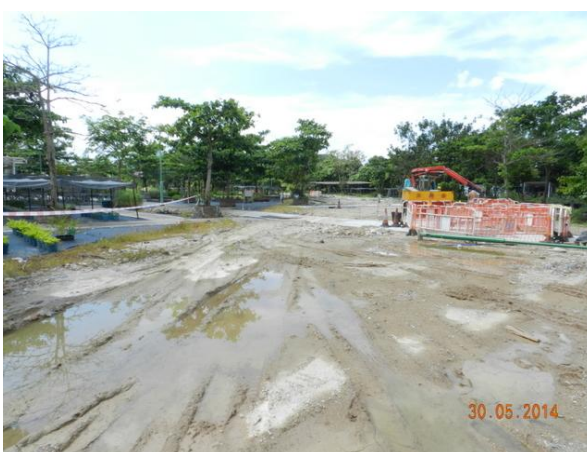
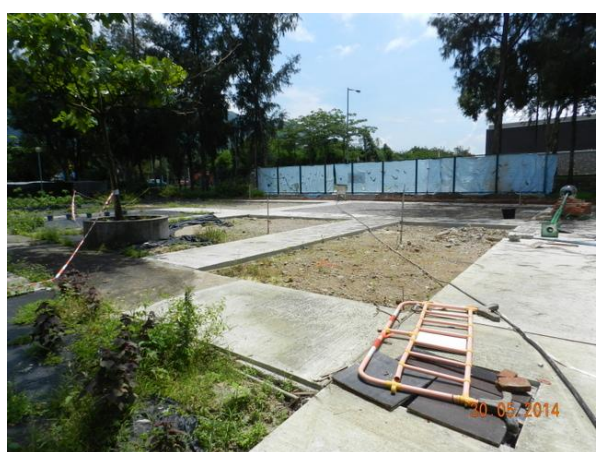
Major excavation works have been completed in Phases 1 and 2. The reinstatement works for the original access paths, ground of the nursery beds and basic nursery utility (such as irrigation pipes and lamp posts) were still in progress in both Phases 1 and 2 areas. However, no active reinstatement work was noted in Phases 1 and 2 as observed in May 2014 (**Photos 5-6**).

Photo 5 – The reinstatement work in Phase 2 area of Area B was demarcated by barrier tape, and no reinstatement work was in progress as observed in May 2014.

Photo 6 – Phase 1 area of Area B was demarcated by loosened barrier tape, and no reinstatement work was in progress as observed in May 2014.

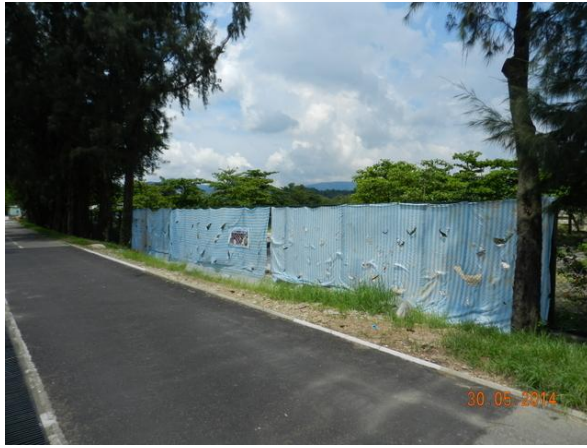
The temporary hoardings established for demarcating the construction site boundary of Phases 1 and 2 construction works area of Area B in Tung Tsz Nursery have been removed since January 2014. The reinstatement works in the nursery have been under progress and the areas were partly demarcated with loosened barrier tapes (**Photos 5-6**). The open section and other reinstated access path connecting between Phases 1 and 2 works areas have been maintained during the current reinstatement work period, providing an access path for the daily operation of the nursery. Since November 2013, the hoarding along the eastern boundary of Phase 2 in Area B (i.e. the section next to Ting Kok Road) was permanently reinstated with the original chain-link fence. Canvas sheets were put on the reinstated fence to screen off the existing construction site from the pedestrian path (**Photo 7**).

Photo 7 – Chain-link fence was reinstated at the eastern end of Phase 2 works area and covered by canvas sheets.

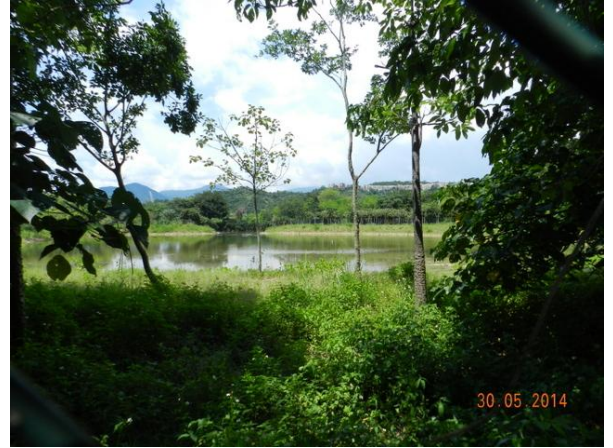
Area C was formally handed over to AFCD on 16th October 2012 for management and maintenance. The pond of the ECA has been connected to Wai Ha River directly as following the scheme design of Habitat Compensatory Plan. No direct discharge of turbid water into the adjacent Wai Ha River was observed through the fence of Tung Tsz Nursery (**Photo 8**).

Photo 8 – No discharge of muddy water was observed in Area C.

The Contractor should regularly check the condition and locations of the drainage pipes

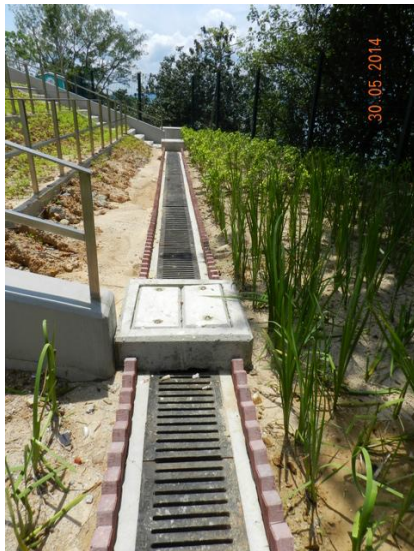
Construction of the slanting component of the proposed green roof and pumping house was completed by end of January 2014. The proposed green roof on the pumping house was vegetated with herbaceous ground cover *Arachis duranensis* in accordance with the approved Landscape Plan. The planting soil, which was washed out from green roof and pumping house during the heavy rainstorm in late-March 2014, still accumulated at the nearby planting area of ground cover (*Iris tectorum*) was found removed as observed on 30th May 2014 (**Photo 9**).

Photo 9 – The planting soil accumulated at the nearby planting area was found removed as observed on 30th May 2014.

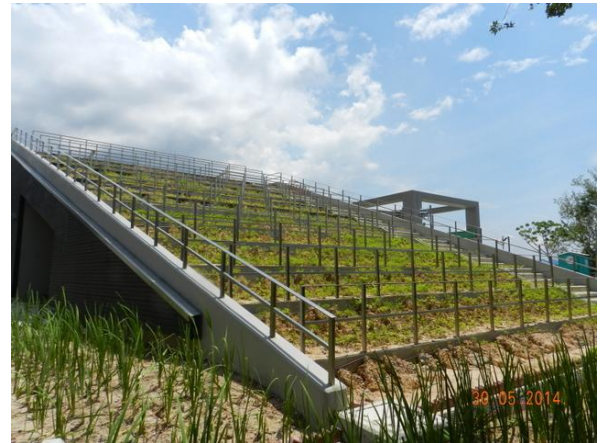
As observed in May 2014, the planted ground cover *Arachis duranensis* on the green roof was in fair condition (**Photo 10**), and other planted vegetation, including *Ficus pumila* and *Parthenocissus dalzielii* on the ground for vertical greening, planted shrub *Ficus microcarpa* (Golden Leaf) and tree *Cinnamomum burmannii*, were also in fair condition (**Photos 11-12**). However, grass germination at some hydroseeded area was less satisfactory as the sprayed grass seeds may be washed out by the heavy rainstorm in March 2014.

Photo 10 – The planted ground cover *Arachis duranensis* on the green roof was in fair condition.

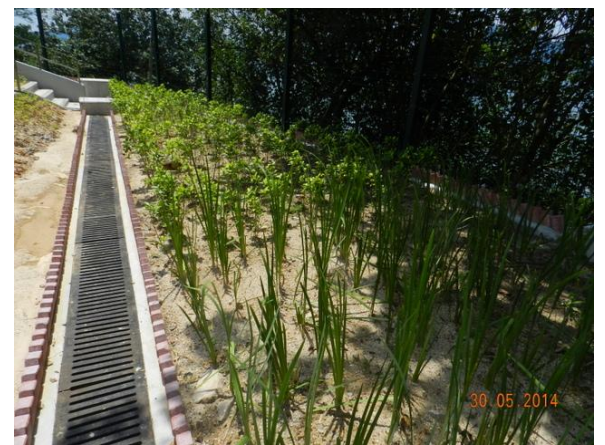
Photo 12 – The planted shrub *Ficus microcarpa* (Golden Leaf) and ground cover *Iris tectorum* were in fair condition.

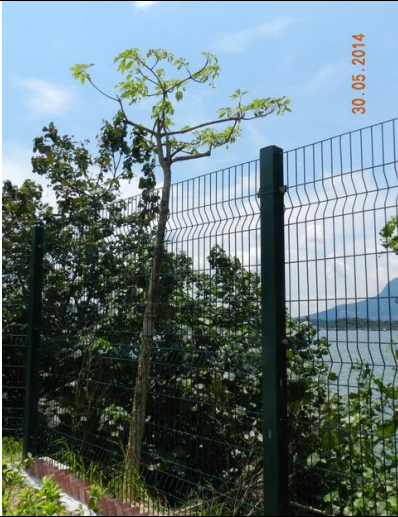
The tree to be transplanted E16 (*Bombax ceiba*) was relocated to the southern side of Area A next to the site hoarding in July 2012. The tree was still in marginally fair condition with regeneration of new leaves as observed in May 2014 (**Photo 13**). However, it was separated outside the proposed chain-link fence along the boundary sides of Area A. Soil grade change was observed around the trunk base and minor exposed roots were found in January 2014. The stability of the tree may be affected. Though this tree is fenced outside

the chain-link fence, the condition and stability of this tree should be regularly monitored.

Photo 13 – The tree E16 (*Bombax ceiba*) was relocated to the southern side of Area A and now outside the boundary fence.

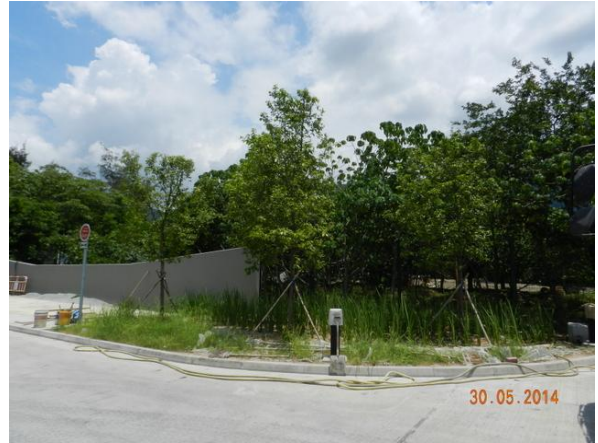
The relocated tree E38 (*Melaleuca cajuputi* subsp. *cumingiana*) was found dead after its relocation in August 2013, and it was removed by the Contractor in November 2013 (reported in *Monthly EM&A Report for November 2013*). A planter was built at the same location in accordance with the approved Landscape Plan. The four newly planted *Cinnamomum burmannii* appeared in fair condition (**Photo 14**).

Photo 14 – The planted trees *Cinnamomum burmannii* and ground cover *Iris tectorum* were in fair condition.

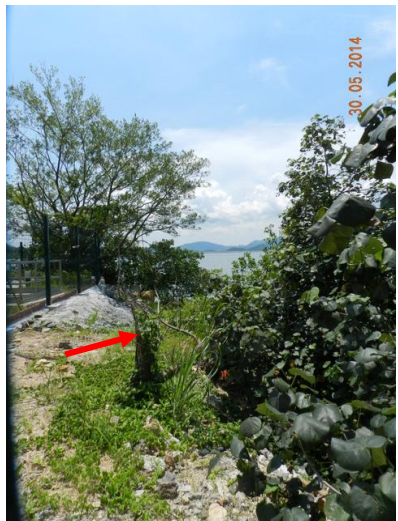
Damaged tree trunk on E55 (*Macaranga tanarius* var. *tomentosa*) has been reported in the submitted *Monthly EM&A Reports* since May 2013. The wound on the trunk of E55 has been burlapped since May 2013. The upper section of the tree trunk was broken in June 2013. The tree was suspected to be a dead specimen with no sign of vigor. It was separated outside the proposed chain-link fence along the boundary sides of Area A (**Photo 15**).

Photo 15 – Tree E55 (*Macaranga tanarius* var. *tomentosa*) was suspected to be a dead specimen with no sign of vigor.

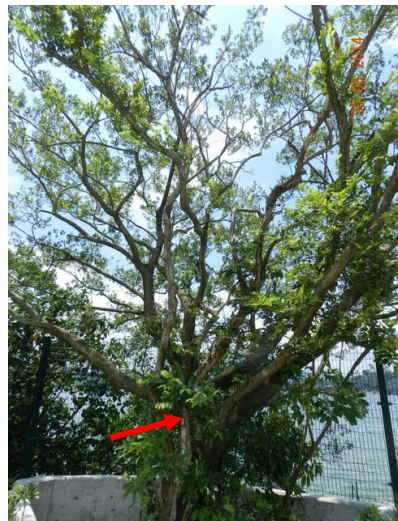
A retained tree T253 (*Bridelia tomentosa*) was in poor condition (**Photo 16**). Dead scaffold limbs with dry, peeled bark were observed. This identified tree defect may be only related to the intrinsic physiological and structural condition of T253.

Photo 16 – A retained tree T253 (*Bridelia tomentosa*) was in poor condition, with dead scaffold limbs and dry, peeled tree bark.

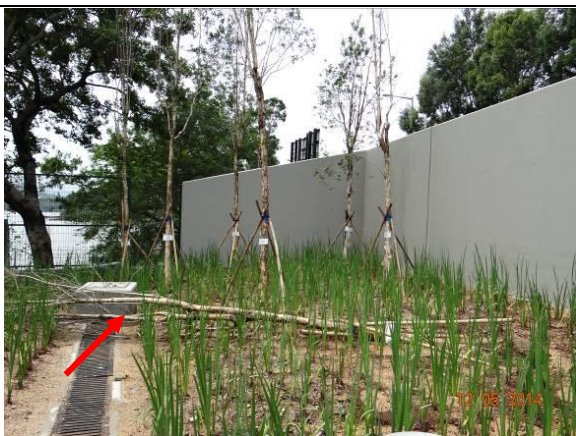
Photo 17 – A newly planted tree *Melaleuca cajuputi* subsp. *cumingiana* (tagged as “E19” collapsed as observed on 12th May 2014.

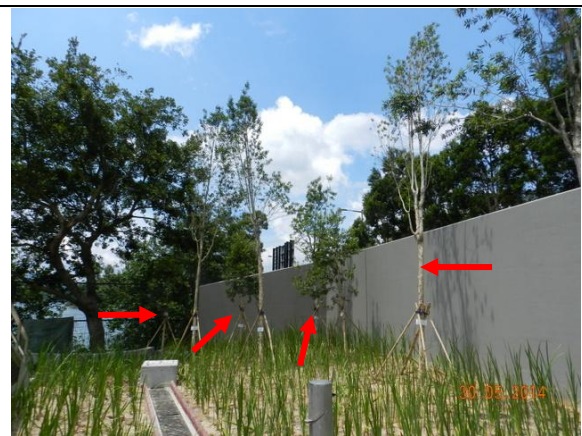
Photo 18 – Four new trees of *Melaleuca cajuputi* subsp. *cumingiana* were planted in the planter area at the southeastern corner of Area A.

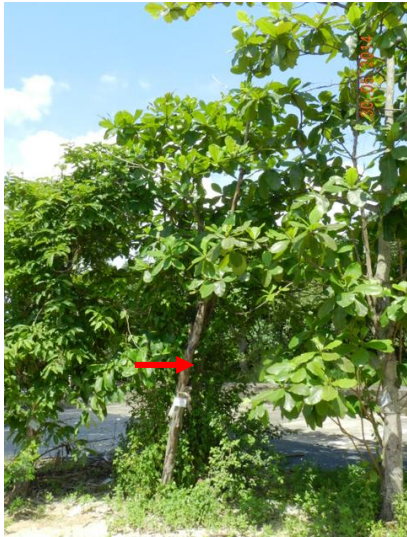
The relocated tree U37 was certified as a dead specimen (**Photo 19**). No significant stockpiling of excavated soil was observed close to the relocated trees along both sides of Phase 1 works area.

Photo 19 – Dead tree U37.

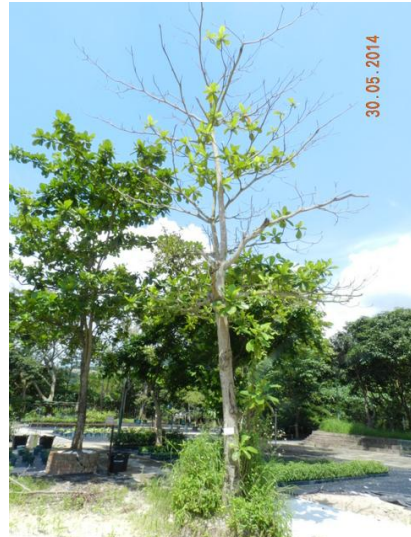
Photo 20 – Half of the planter of U47 (*Terminalia catappa*) has been broken since August 2013.

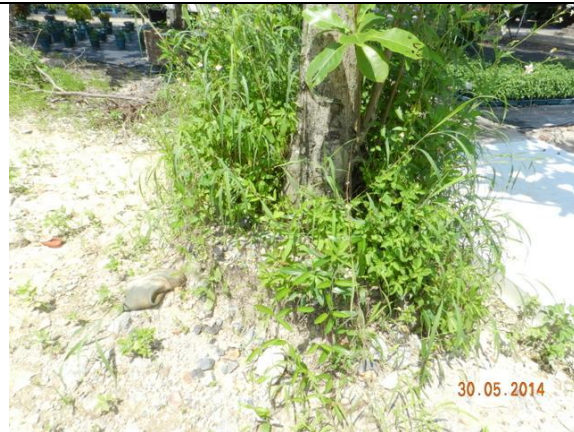
Photo 21 – Close-up view of the broken planter of U47.

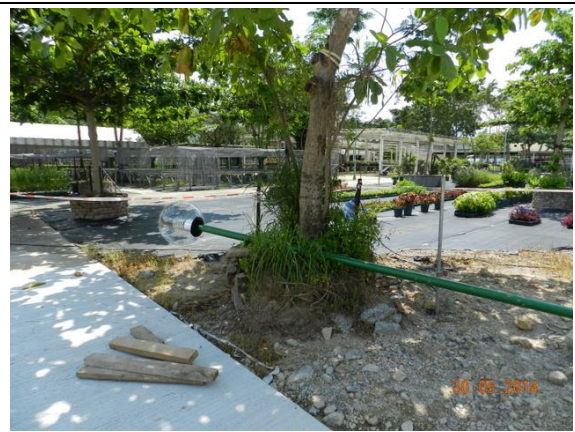
Photo 22 – The planter of an untagged *Terminalia catappa* next to U54 was broken, with exposed roots and soil.

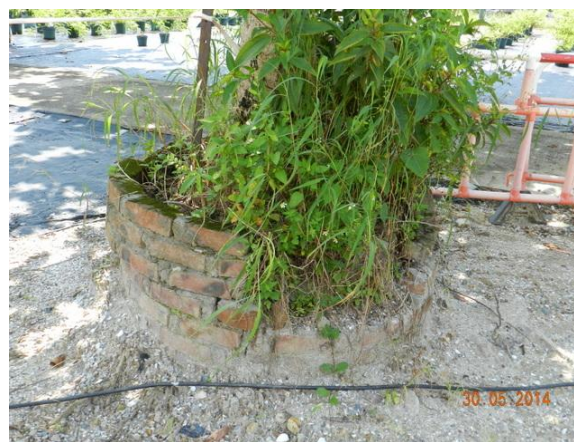
Photo 23 – The planter of U54 (*Terminalia catappa*) was broken and the exposed roots and soil was observed.

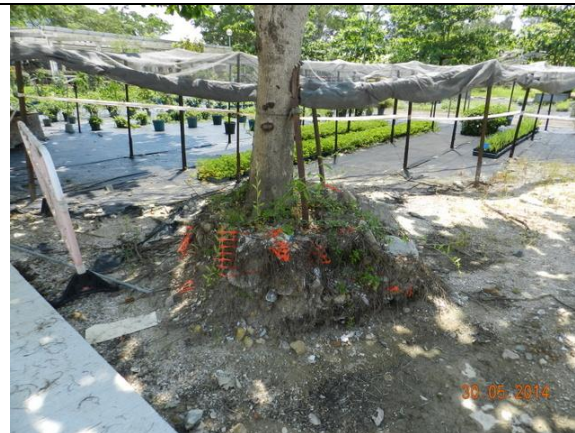
Photo 24 – The planter of another untagged *Terminalia catappa* next to U54 was broken, with exposed roots and soil.

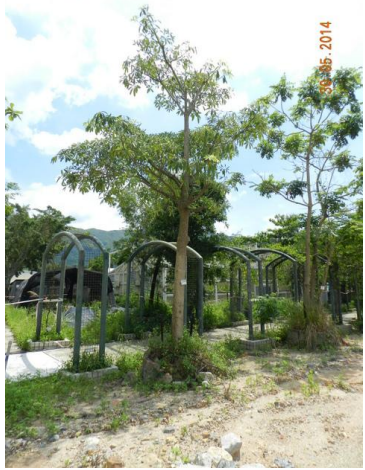
Photo 25 – The planter of U69 (*Alstonia scholaris*) was broken and the exposed roots and soil were observed.

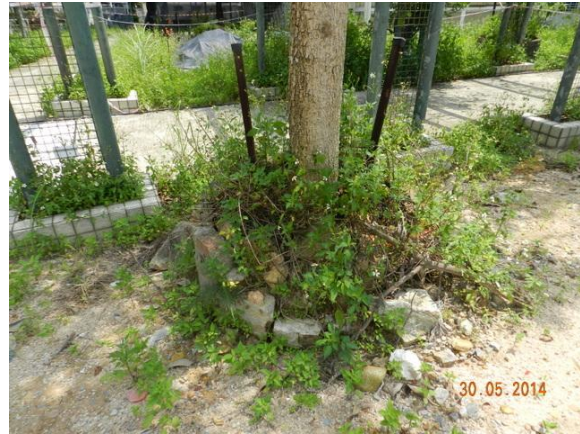
Photo 26 – Close-up view of the broken planter of U69.

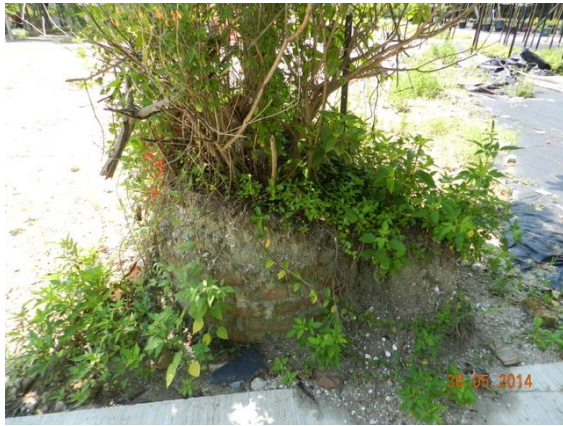
Photo 27 – The piled soil around the planter and on the root flare of U51 (*Terminalia catappa*) was not yet removed.

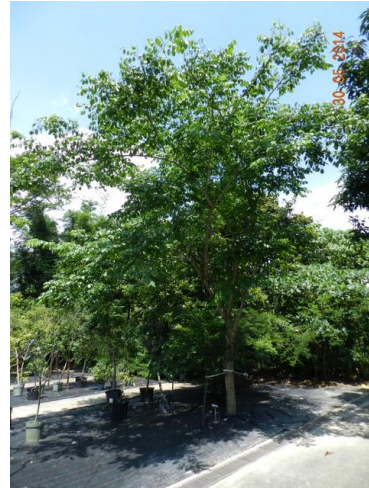
Photo 28 – The relocated tree U55 (*Pterocarpus indicus*) was in fair condition.

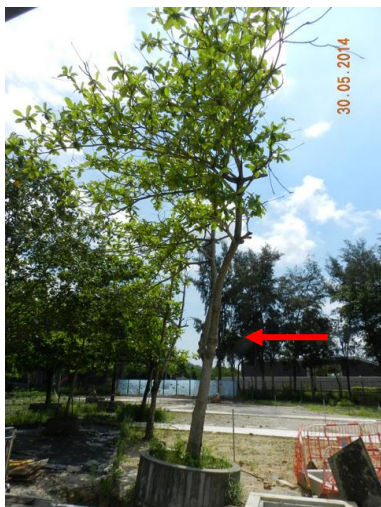
Photo 29 – The condition of the retained tree A40 (*Terminalia catappa*) was in fair condition only, with the risk of leaning tree trunk.

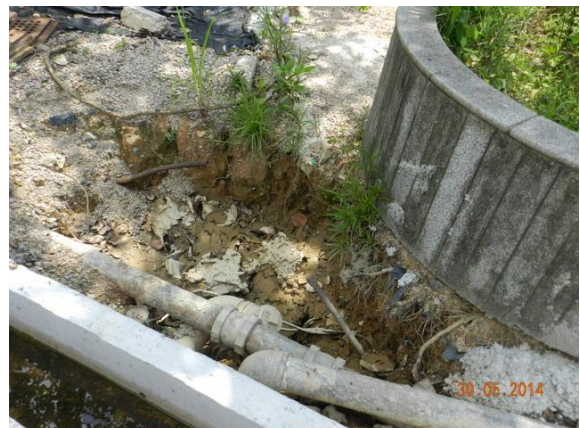
Photo 30 – The northern excavated area close to the planter of the retained tree A40 was not yet refilled.

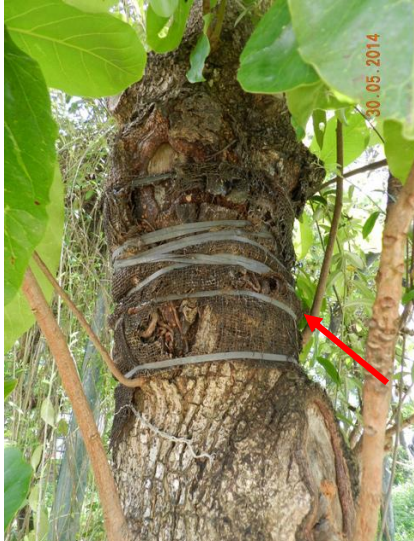
Photo 31 – Close-up view of the hessian wrapping and tied string (as indicated) on the trunk of U53. The wrapping was not yet removed.

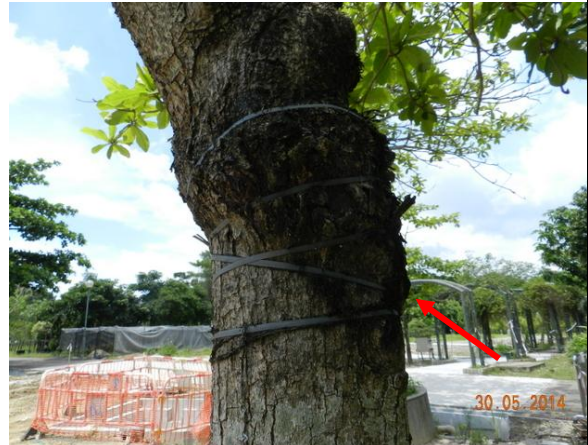
Photo 32 – Close-up view of the tied string on the relocated tree.

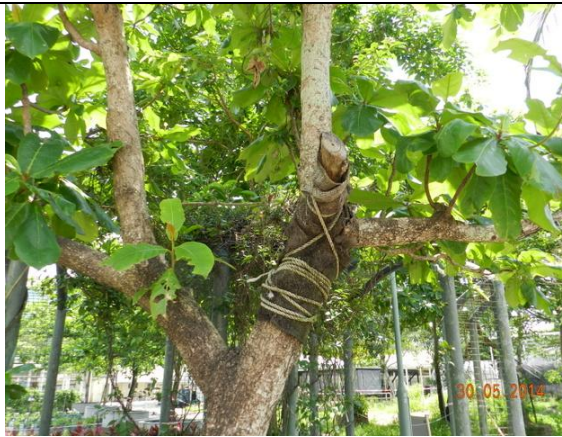
Photo 33 – Hessian wrapping was found on the scaffold limb of the relocated tree A22.

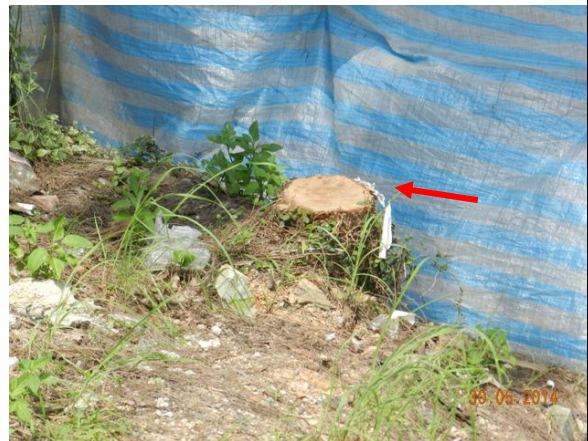
Photo 34 – Tree T103 (*Casuarina equisetifolia*) was felled as observed in May 2014.

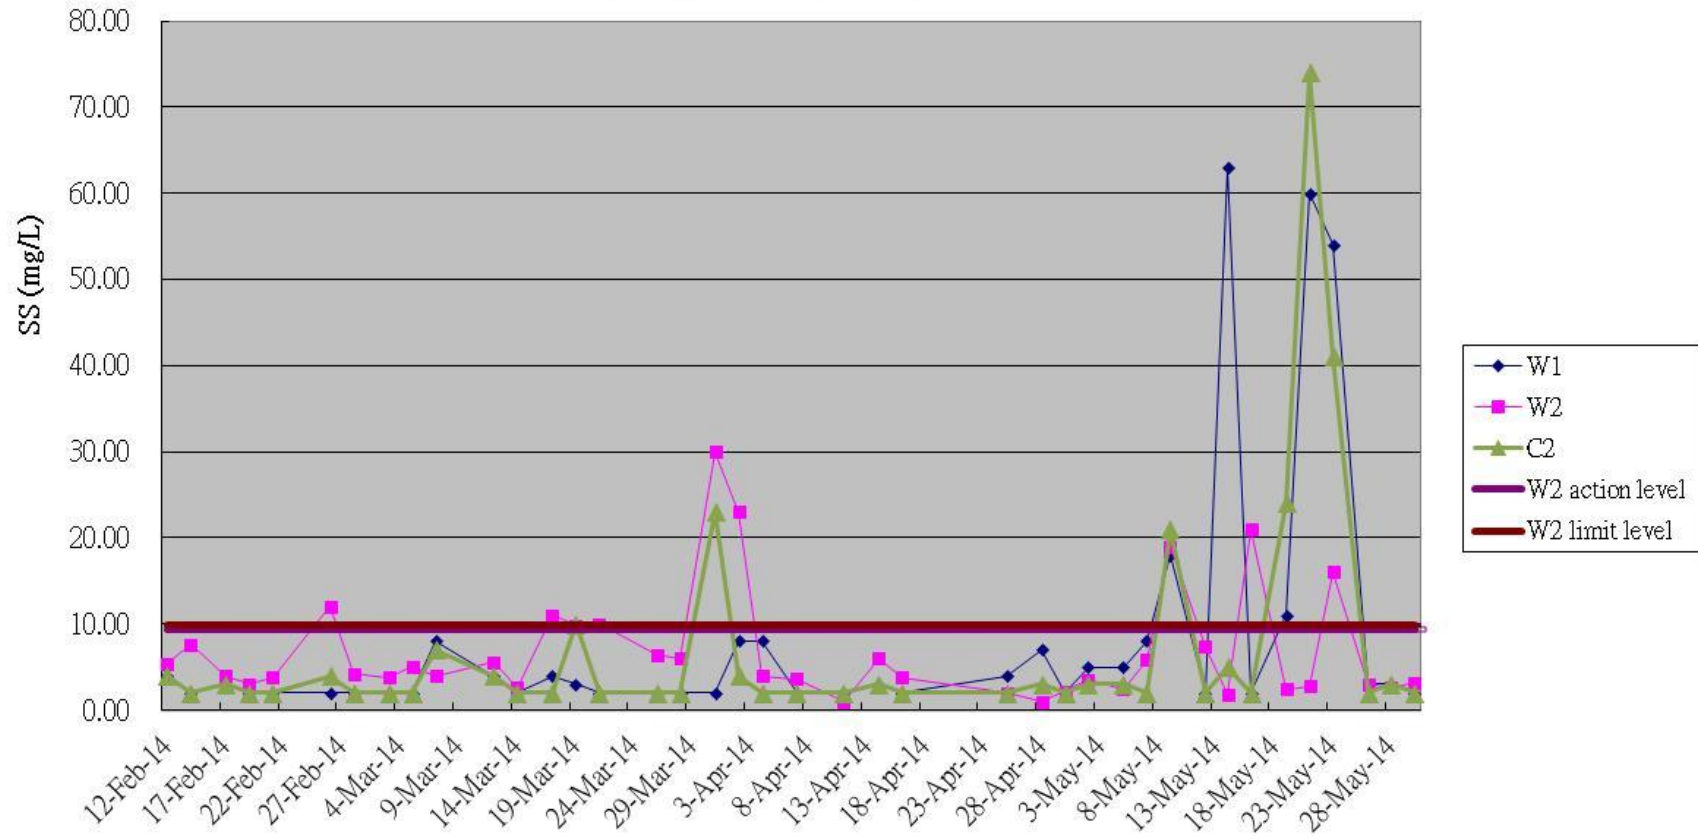
Graphical plots of SS (ebb tide) for W1&W2

Remarks: Action limit is 95% of baseline data or 120% of upstream control station's SS
 Limit level is 99% of baseline data or 130% of upstream control station's SS

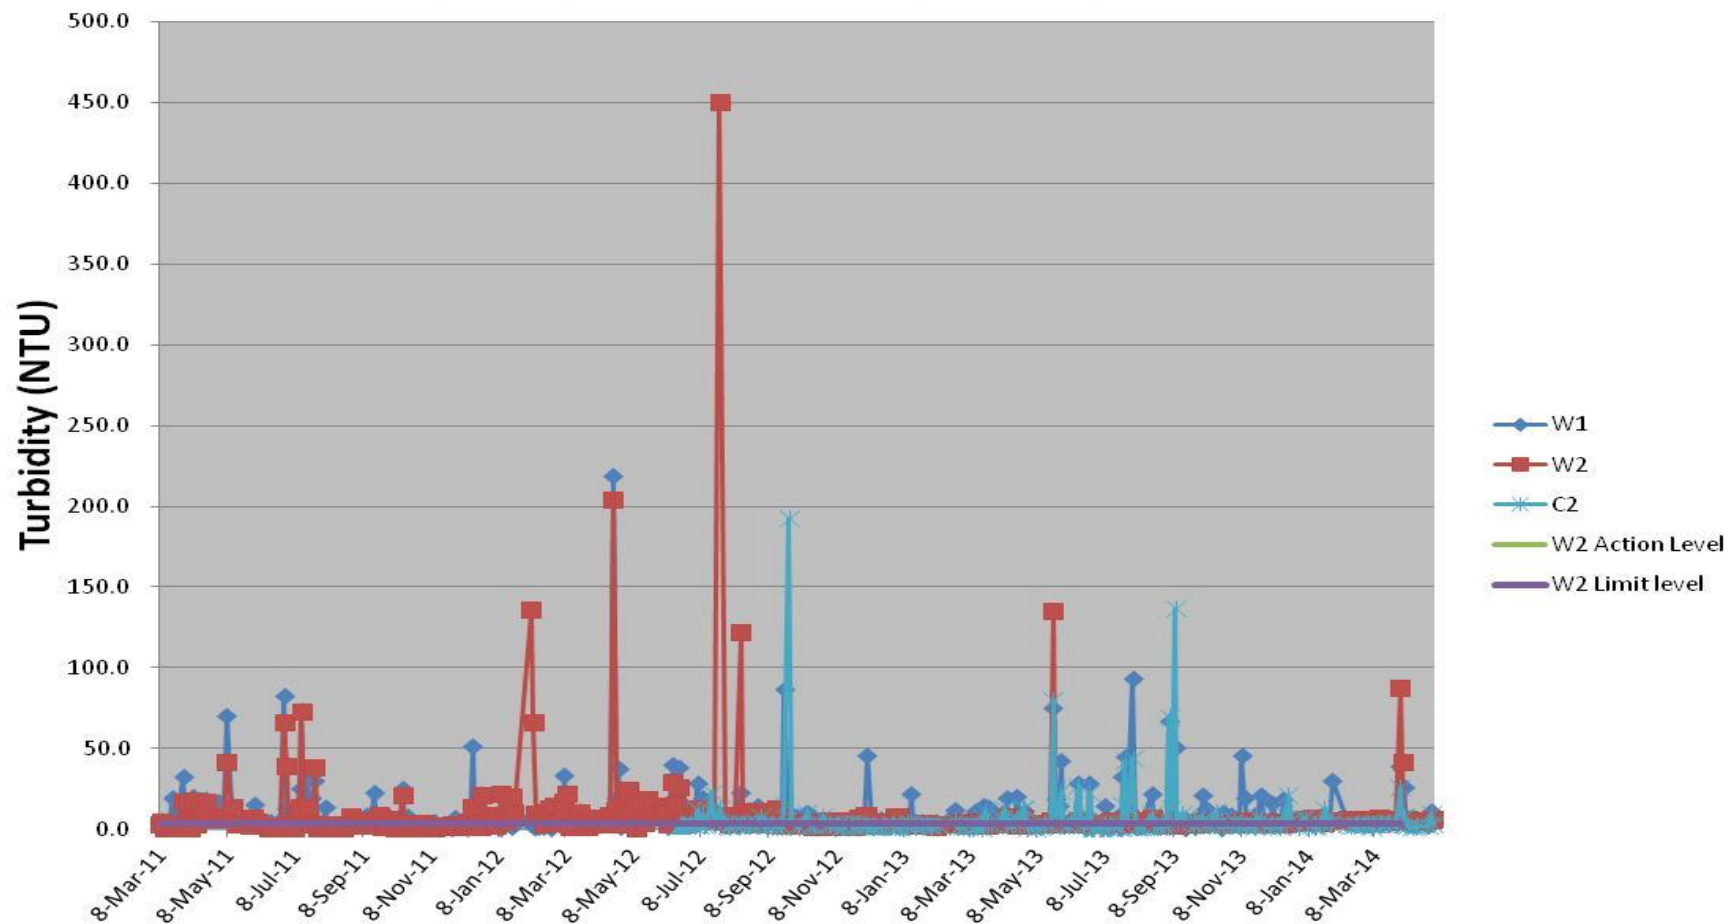
Graphical plots of Turbidity (ebb tide) for W1&W2

Remarks: Action limit is 95% of baseline data or 120% of upstream control station's Turbidity
 Limit level is 99% of baseline data or 130% of upstream control station's Turb

There were 13 abnormal incidents of water quality limits (Turbidity) were recorded in this reporting month according to the established action and limit levels. ET has arranged site investigations for the abnormal incidents. No construction activities were carried out at the river bed. During the reporting period, no construction activities were conducted near the Wai Ha River. Proper mitigation measures were implemented by contractor to avoid site water releasing to the Wai Ha river and no particular observation of defective site activities were found causing water contamination. The exceedances of Turbidity and SS were believed to be mainly attributed by natural fluctuation and adverse weather. And, since the recorded levels of Turbidity and SS at control station had also exceeded its baseline action or limit level, the exceedances recorded at W2 were unlikely to be related to the Project.

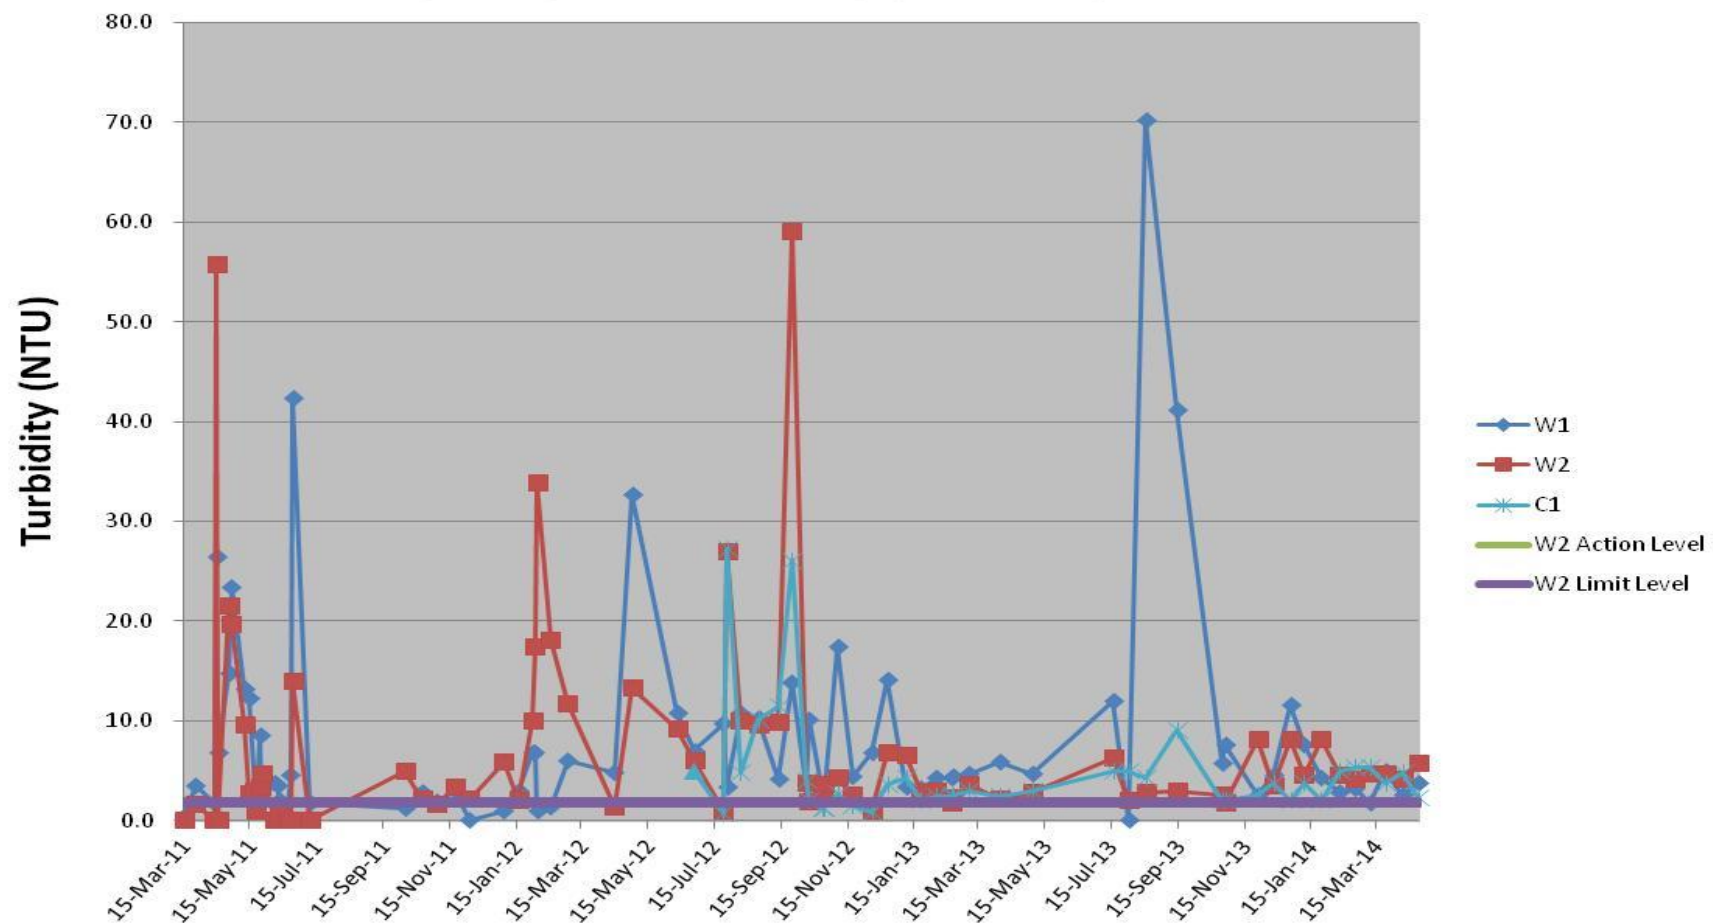
Graphical plots of Turbidity (flood tide) for W1&W2

Remarks: Action limit is 95% of baseline data or 120% of upstream control station's Turbidity
 Limit level is 99% of baseline data or 130% of upstream control station's Turb

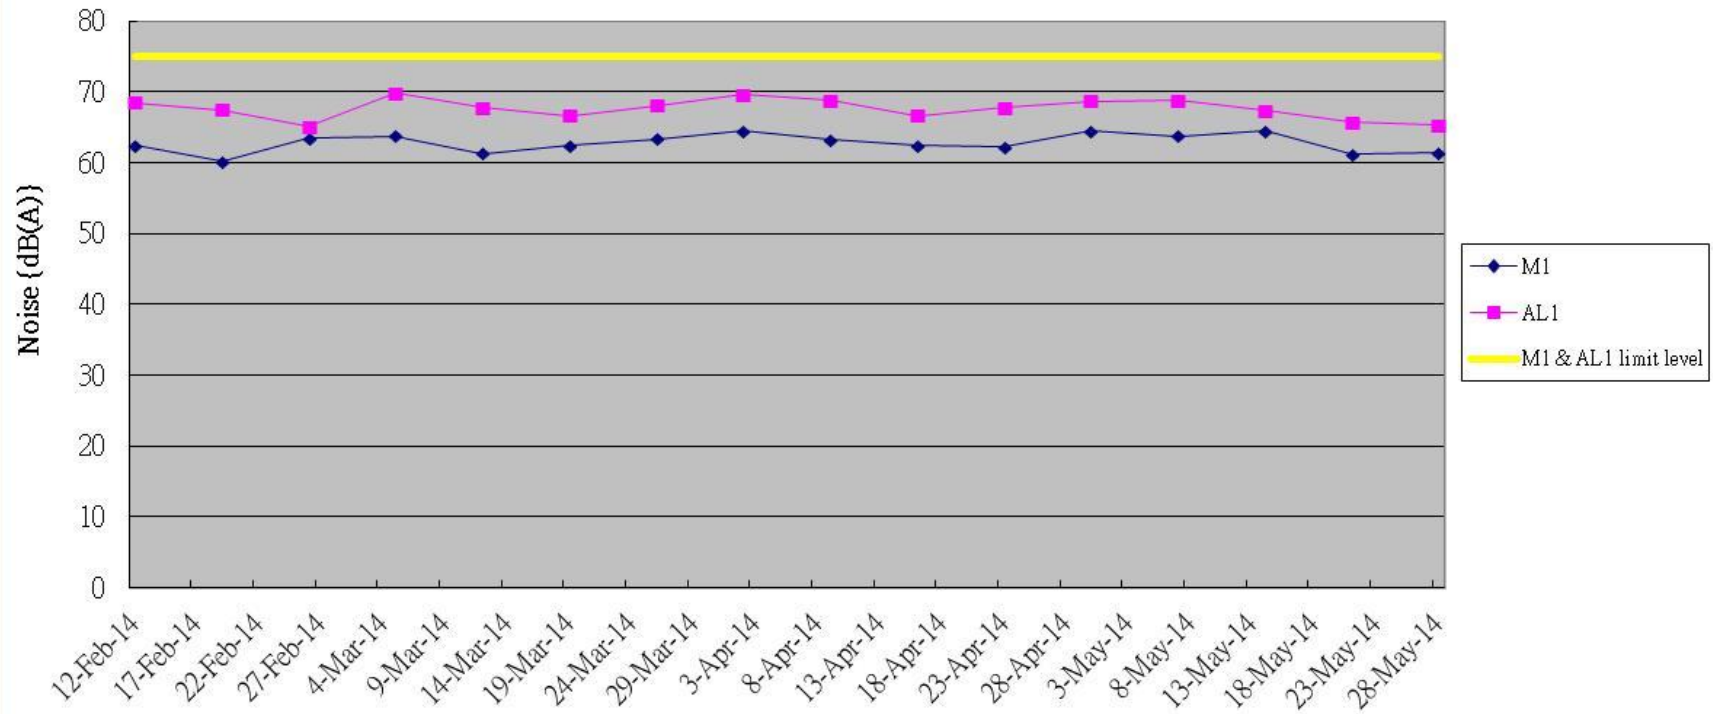
Graphical plots of Noise for M1 & AL1

Relevant details of the noise monitoring results are presented in Table 3.4.1. The results of M1 ranged between 61.2dB (A) and 64.5dB (A), and AL1 ranged between 65.4dB (A) and 68.8dB (A), were within the limit levels and therefore, no exceedance was found.

Remarks: Action limit is when one documented complaint is received

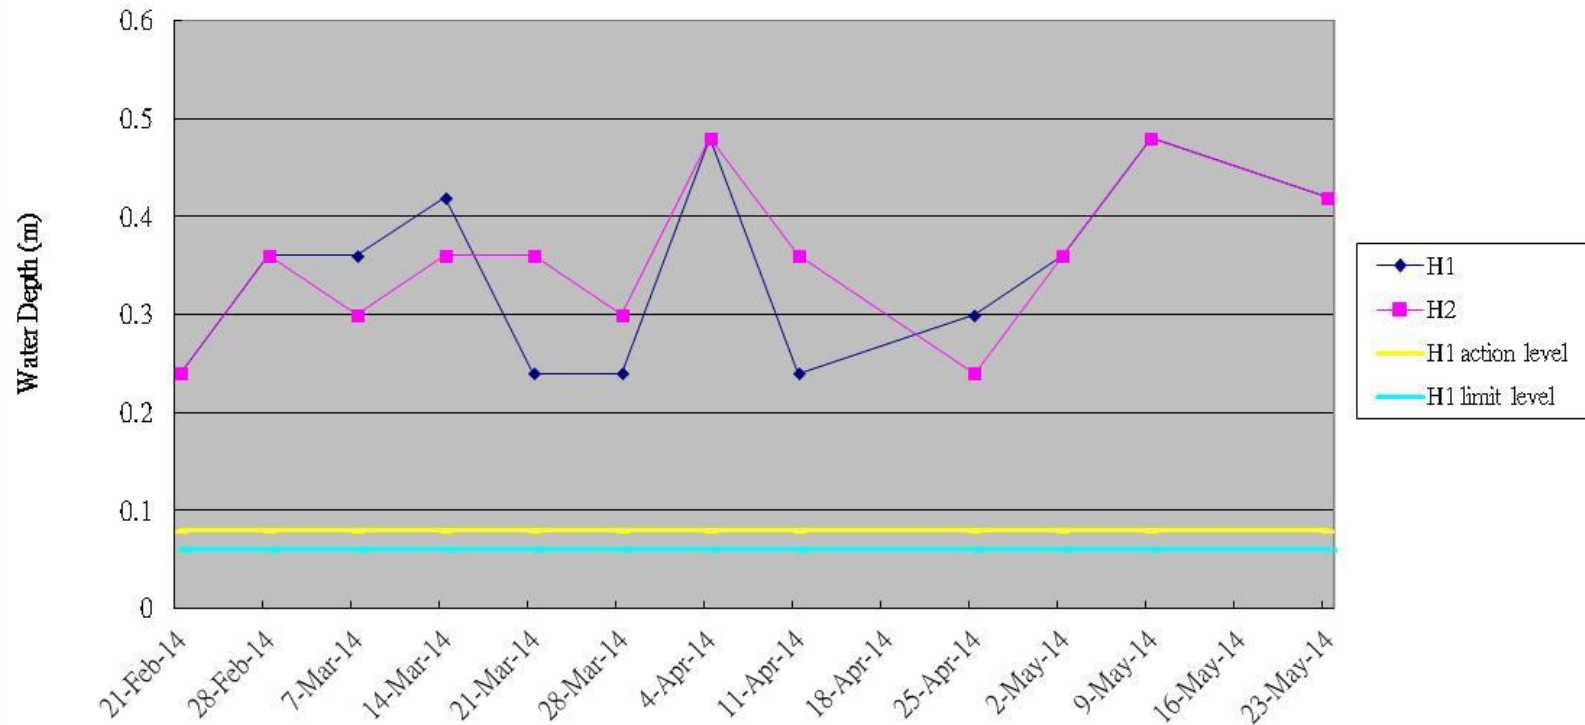
Graphical plots of Hydrological Monitoring(water depth at flood tide) for H1 & H2

Remarks: Action level: 80% of baseline water depth.
Limit level: 60% of baseline water depth.

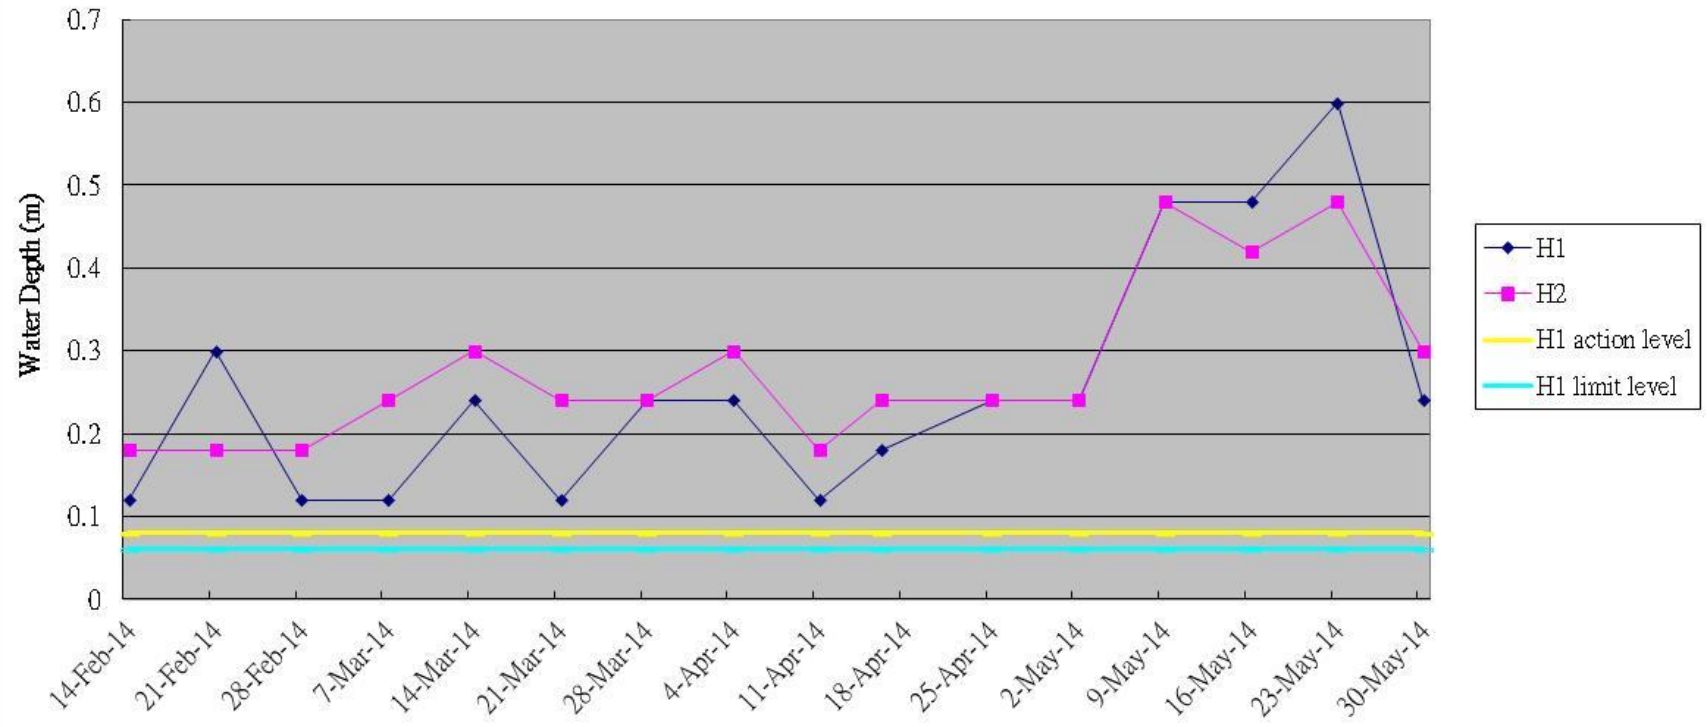
Graphical plots of Hydrological Monitoring(water depth at ebb tide) for H1 & H2

Remarks: Action level: 80% of baseline water depth.
Limit level: 60% of baseline water depth.

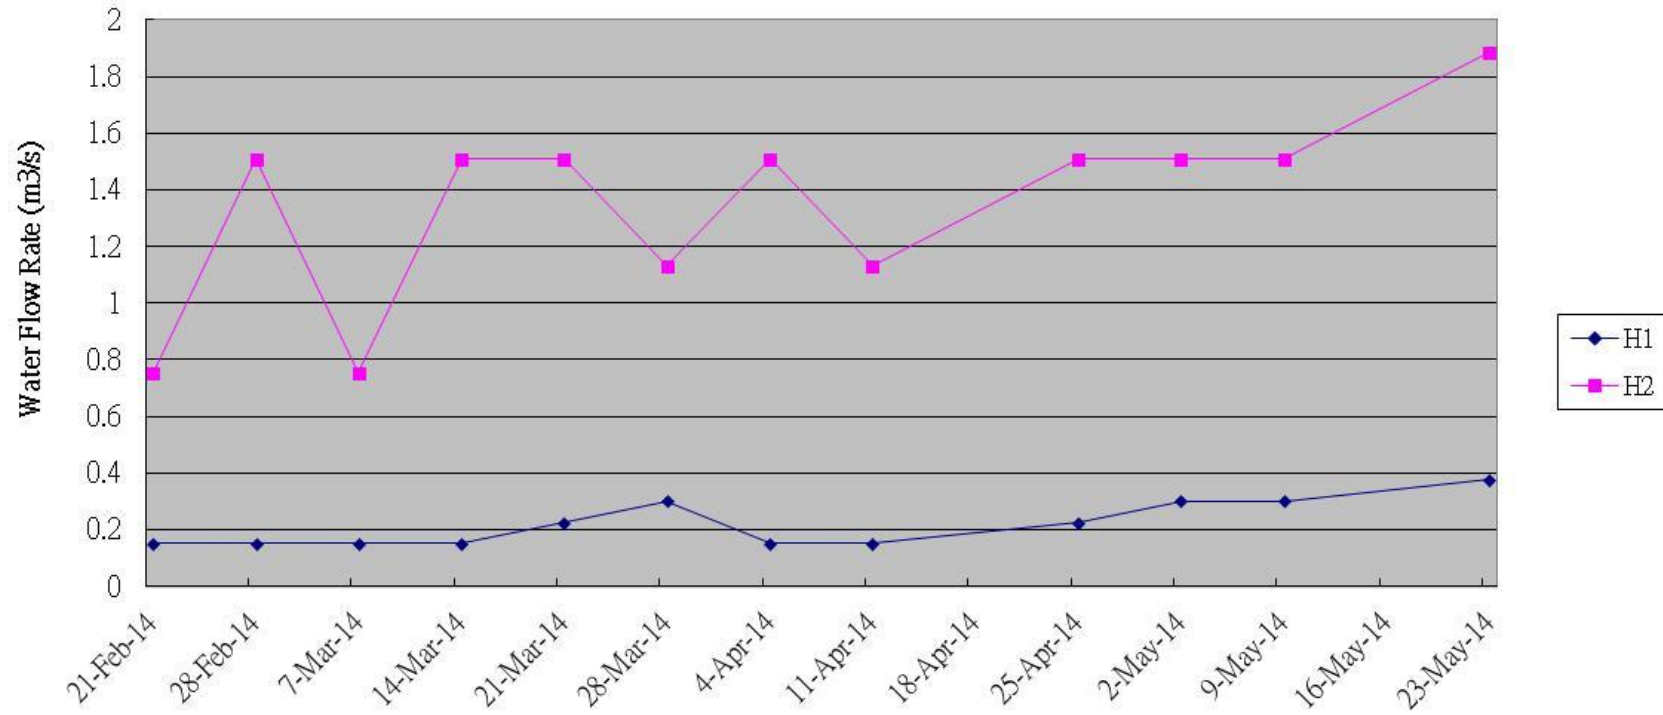
Graphical plots of Hydrological Monitoring(water flow rate at flood tide) for H1 & H2

Remarks: Action level: 120% of control station's water flow rate on the same day of measurement.
Limit level: 140% of control station's water flow rate on the same day of measurement.

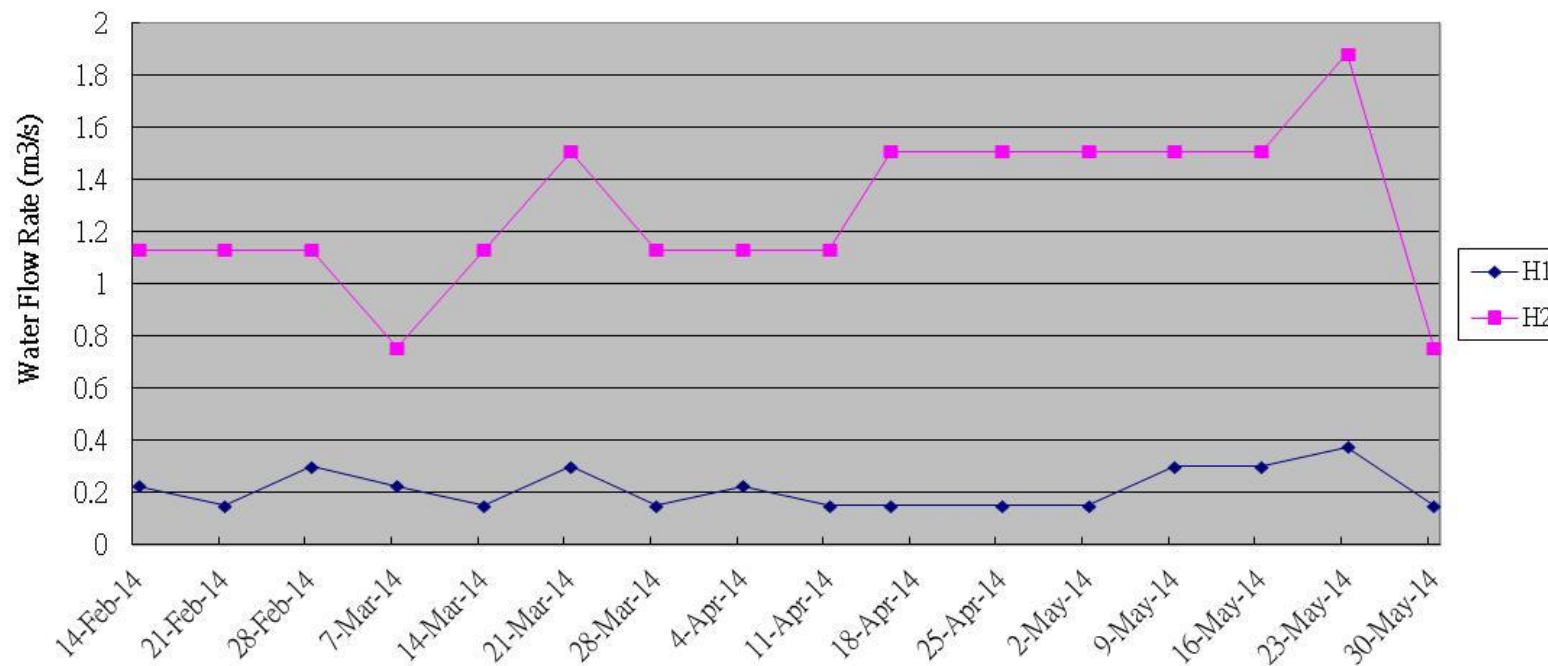
Graphical plots of Hydrological Monitoring(water flow rate at ebb tide) for H1 & H2

Remarks: Action level: 120% of control station's water flow rate on the same day of measurement.
Limit level: 140% of control station's water flow rate on the same day of measurement.
