**CONTRACT NO. DC/2010/02 –
DRAINAGE IMPROVEMENT IN SHUEN WAN AND
SHEK WU WAI**

**MONTHLY ENVIRONMENTAL MONITORING AND
AUDIT REPORT (NO.35) – MAY 2014**

PREPARED FOR
KWAN LEE-KULY JOINT VENTURE

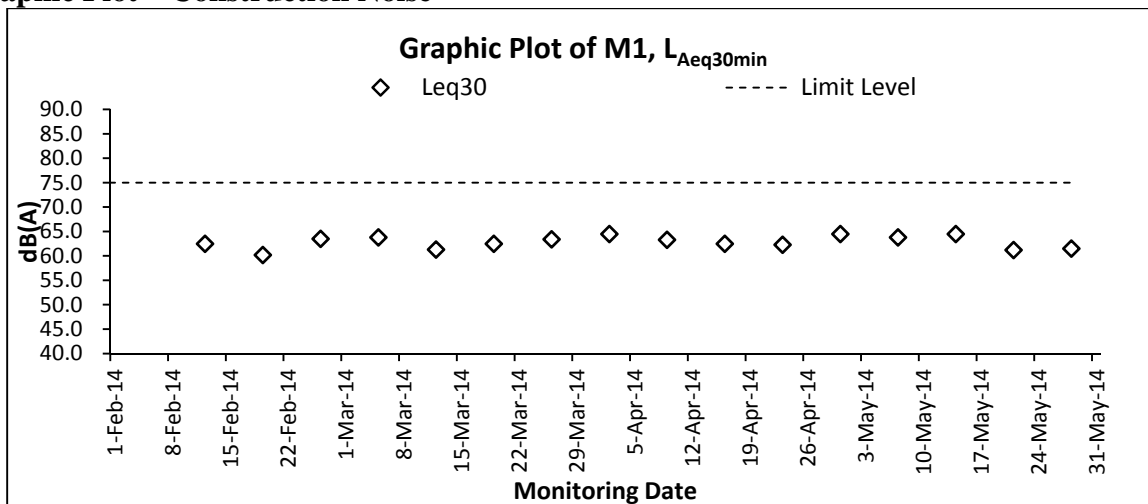
Remark: The monitoring is undertaken under façade situation. No façade correction is added according to acoustical principles and EPD guidelines.

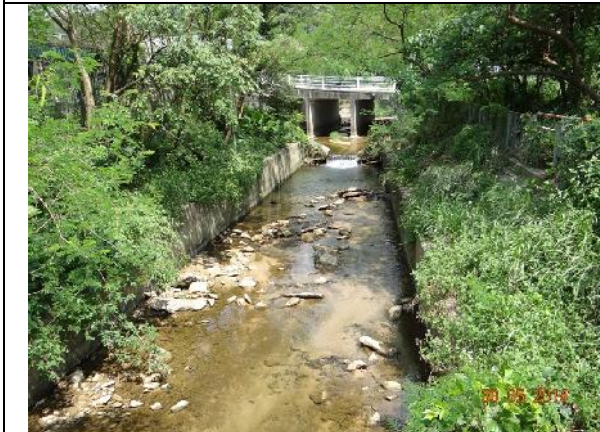
Photo 5 – The sand bags used to divide the river were removed.

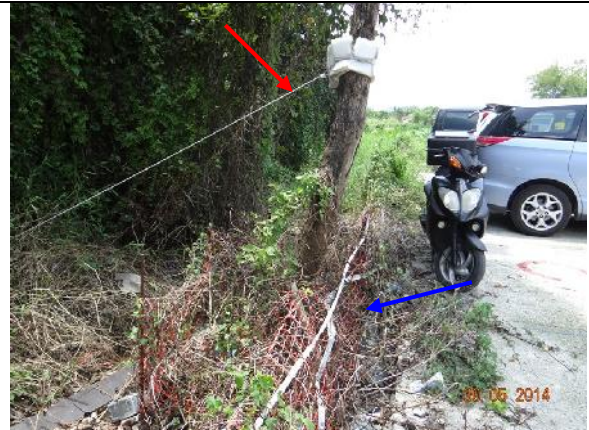
Photo 8 – The untagged tree (Red arrow) was guyed at the edge of the parking area within a Tree Protection Zone demarcated by orange construction nets (Blue arrow).

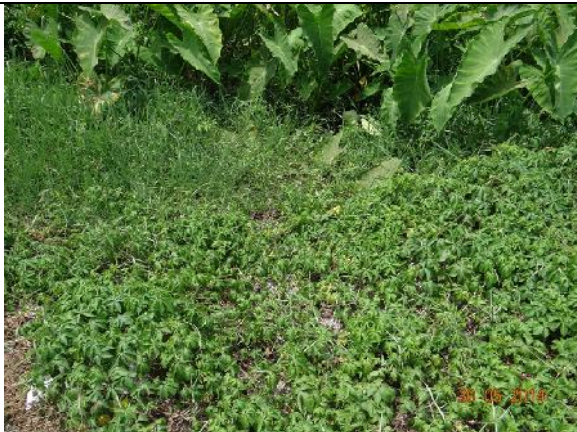
- 3.2.7 As reported in the previous *Monthly EM&A Reports*, dumping on the Taro field located along the path towards the Treasure Spot Garden was observed and a paved area created for parking next to the retained tree groups (T088 – T091) has been found since November 2012. In October 2013, the path to Treasure Spot Garden II was expanded towards the Taro field due to the re-provision of vehicular access road to the villagers during the works at the entrance of the Treasure Spot Garden. Cement mortar discharged to the Taro field was observed in March 2014 and such as was covered by ground vegetation (**Photo 9**).

Photo 9 – Cement mortar was discharged to the Taro field next to the access road from Tung Tsz Road to Treasure Spot Garden II. This area was covered by ground vegetation as observed in May 2014.

- 3.2.12 No specific recommendation is required. However, with regard to the previous dumping incident by other parties on the Taro field near the Treasure Spot Garden, the Contractor is recommended to check the site condition regularly to avoid any extent of dumping or paving of area within the project boundary.
- 3.2.13 The Contractor should also make sure there are no piled rocks, construction materials or programmed construction works influencing the existing trees within the Project Area or the wetland rehabilitation area. Otherwise, the Contractor should request the on-site workers to remove those piled rocks or construction materials. As a reminder, the Contractor should keep all construction works within the Project Boundary.
- 3.2.14 The Contractor could establish a warning sign to remind the driver to beware of the presence of the tree(s) close to the temporary parking area.

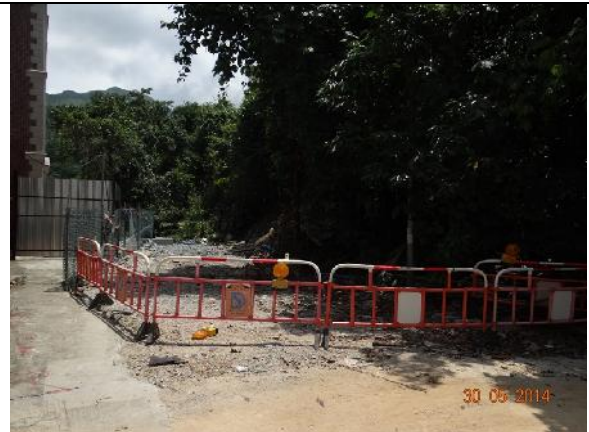
- 3.2.8 Works were observed at the end of the Treasure Spot Garden II near the retained tree T103 and the works area was surrounded by temporary construction barriers and chain-link fence (**Photo 10**).

Photo 10 – Works were observed at the end of the Treasure Spot Garden II near the retained tree T103 and the works area was surrounded by temporary construction barriers and chain-link fence.

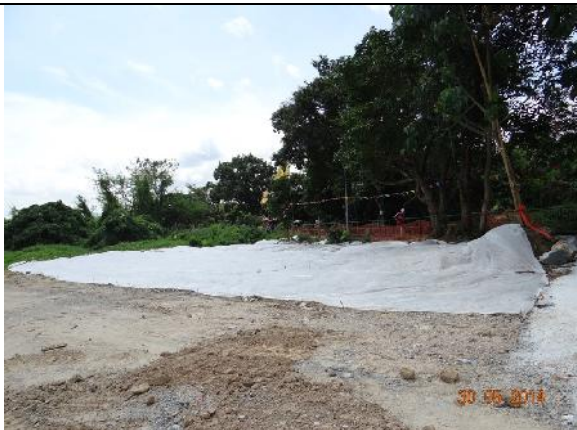
- 3.2.9 The works area near the previous collapsed tree T190 (*Ficus hispida*) was found to be expanded to the grassland on the south in January 2014. Most of the construction materials stored in this area were removed in April 2014 and this area has been covered by a mat in May 2014 (**Photo 11**).

Photo 11 –The construction materials stored on the works area near the location of the previously removed tree T190 (*Ficus hispida*) were removed. This area has been covered by a mat.

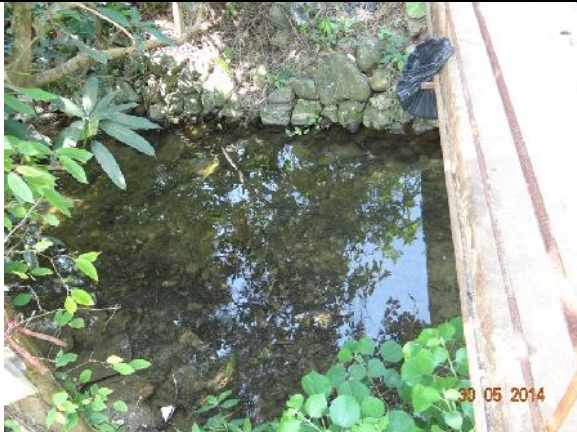
Photo 15 – Down the stream near the public toilet, the water was noted clear and free of any blockage from litter and broken branches.

3.3.6 The Contractor should have *ad hoc* inspection and emergency measures for any accidental spillage of polluted fluid, contaminants or grease from the construction sites. To prevent the impact of the unclear discharge on the nearby vegetated area, it is suggested to overlay PVC liners along the site edge and remove any surplus sand and gravels deposited in the beds and tank even some parts of the construction works may be completed at this stage. If needed (e.g. after heavy rainfall), the Contractor is suggested to remove the broken branches in the stream so as to prevent their blockage of the stream flow and trapping greasy substances in the stream.

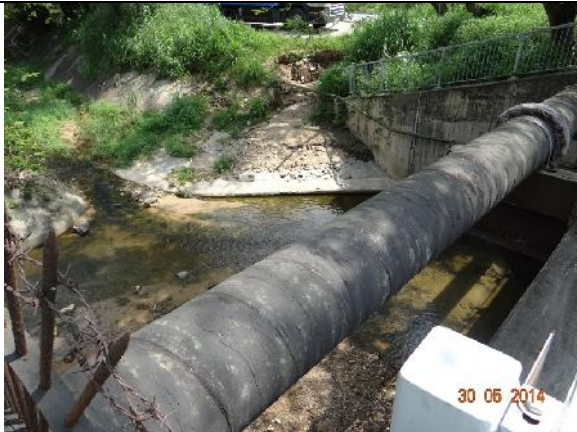
- 3.4.4 No direct water discharge into the upper stream of Wai Ha River was observed as the active construction works have been concentrated at the lower end of Wai Ha River to the southeast of Tung Tsz Shan Road (**Photo 17**).

Photo 17 – No direct water discharge into the upper stream of Wai Ha River was observed as the construction works have been concentrated at the lower end of the river.

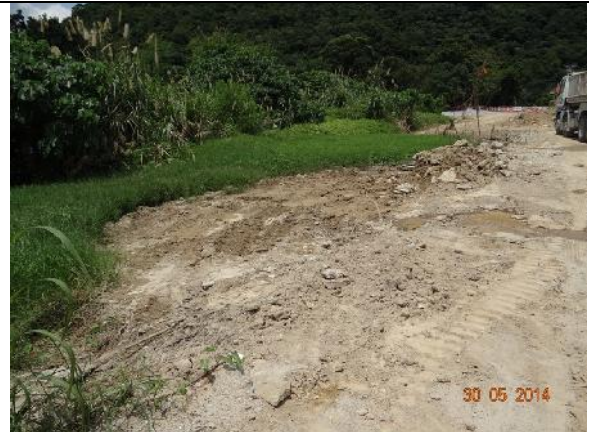
- 3.4.5 Cement mortar was found spraying along the southern boundary edge close to the wetland rehabilitation habitat in February 2014. The cement mortar at this area has been removed. A mat was found covering this area with cement mortar in mid-March 2014, and it was removed in May 2014 (**Photo 18**).

Photo 18 – Cement mortar along the southern boundary edge close to the wetland rehabilitation habitat was removed. The mat covering this area in mid-March 2014 was removed in May 2014.

- 3.4.8 The Contractor should prevent any contaminants and sediments from entering the sensitive water-based habitats (i.e. Shuen Wan marsh and Wai Ha River) and implement pollution control measures to minimize any adverse environmental impacts to the water body. The Contractor should maintain appropriate sedimentation beds and/or tanks throughout the construction phase. The Contractor should adopt a good site practice in maintaining appropriate sedimentation beds and filtration tanks as recommended in the above Section for Contaminant/ Sediment Control. Muddy water pumped from the works area should be filtered appropriately through sedimentation beds or other filtration system prior to the discharge.

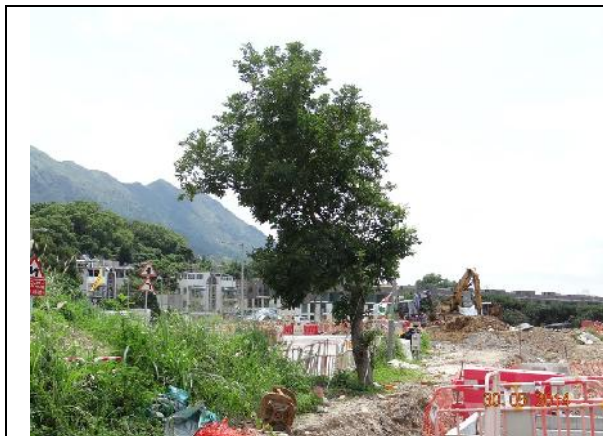
Photo 25 – The retained tree T025 was temporarily guyed to provide additional support to this tree.

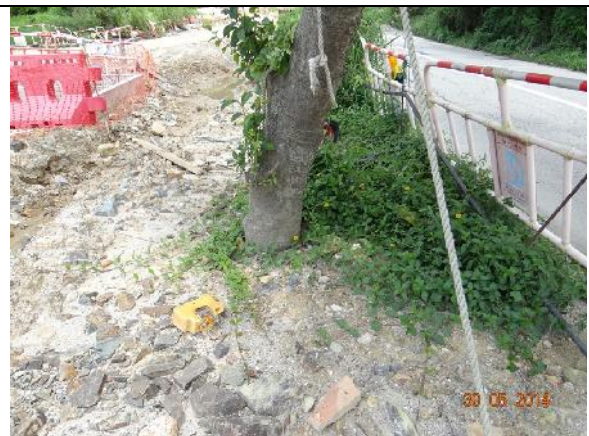
Photo 26 – Excessive soil were still piled close to the root flare of T025.

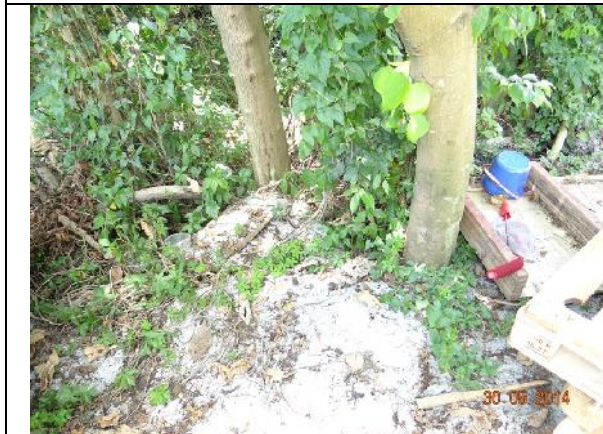
Photo 27 – Concrete pavement was observed close to the root flare of the tree group T089-091

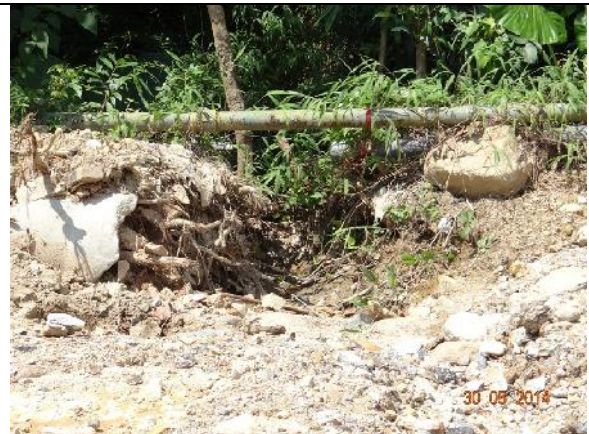
Photo 28 – Excavation work was noted between T153 and T155 and severe exposed roots were noted on these two trees.

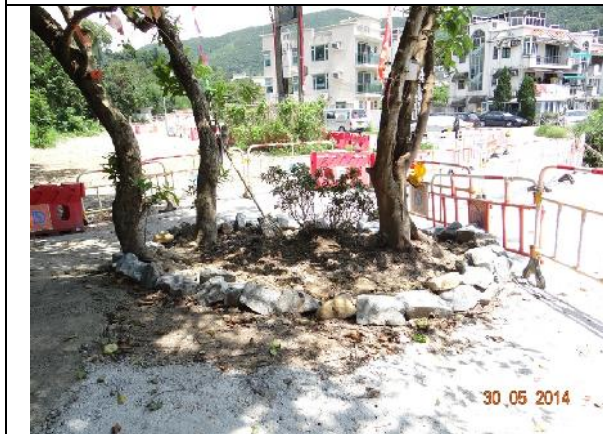
Photo 29 – Excavation work was noted very close to the tree group T181-T183. Excavated soil was noted piling around their trunk flare and the orange construction nets covered on the three trees were removed. These trees have been surrounded by some stones.

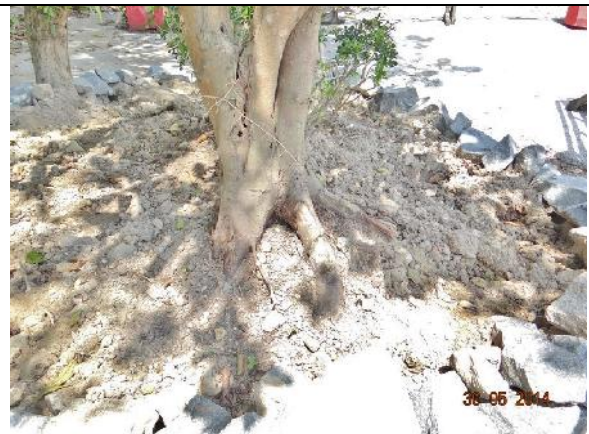
Photo 30 – Exposed and pruned roots was noted on T183.
